## **7 DISCUSSION**

### **7.3 Failure mode of flanges**

### **7.3.4 Failure mechanisms of flanges**

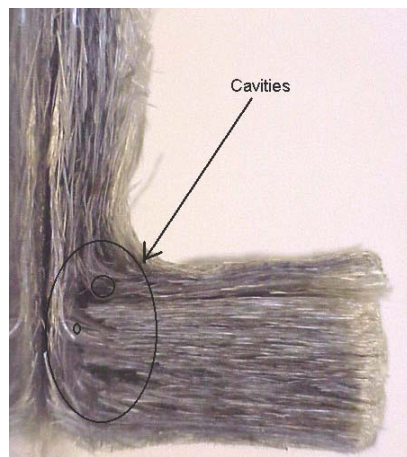
(Figure 7.4). Figure 7.4 and 7.5 show a large amount of cavities at the change in direction of fibre location and area of additional glass reinforcement insertion. High matrix contents observed at these locations are probably due to the following:

- As recommended by BS 6464, additional fibres must be inserted into the flange at the manufacturing stage to give stub thickness. Therefore, more resin is often used to prevent voids and to maintain additional glass reinforcement in the stub flange.
- Due to the large change of direction that occurs at the flange radius and the resistance of the reinforcement to bend easily through ninety degrees, CSM glass fibres tend to disperse out of the reinforcement mat and thereby cause a decrease in the fibre content. Thus a large amount of resin may be needed to avoid voids.

**Figure 7.4: Fabricated burned out stub**

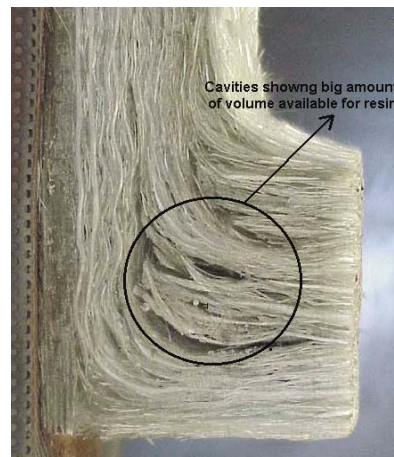
**Figure 7.5: Amitech burned out stub**

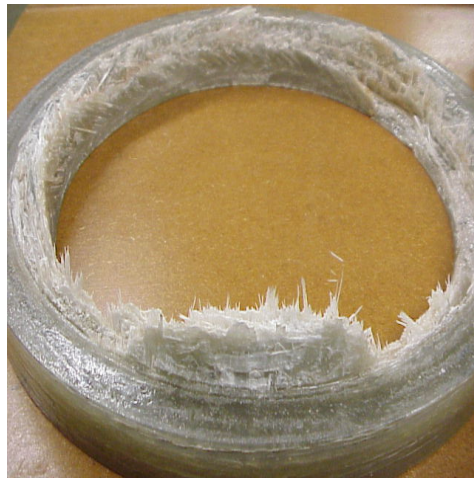
The two types of failure that are described below occurred in flange 1 at different places along the flange radius (Figure 7.15). At location one, two types of cracks are observed. Figure 7.16 shows that the failure is initiated by debonding between the pipe edge and the heel of the flange. When the system is pressurized, the axial load, which is developed by water pressure acting on the stoppers, tends to pull the pipe wall axially whereas the backing ring tends to retain the flange. This generates interfacial shear stresses between the surface contact of the pipe and hub flange. The stress analysis showed a shear stress of magnitude 25.1 MPa as the flange was loaded at 8.0 MPa (Figure 5.1). The pressure load acting on the hub flange in the radial direction generates a bending moment relative to the constrained stub. This gives rise to a peel stress at the heel of the flange. Thus, the resultant stress due to shear and peel may make the flange prone to failure by debonding. As the pressure load increases substantially, the debonding is initiated and propagates through the structure. Thus, the joint capability is compromised to some extent although the integrity of the individual component (pipe and flange laminates) remains intact. As a result, the stress is released at the edge of the pipe and the hub flange strained axially and circumferentially carries integrally the pressure load. The release of stress was indicated by the drop of the axial strain reading (at test pressure greater than 7.0 MPa) exhibited by the strain gauge positioned axially at location one (Figure 4.2). A visual inspection showed that the damage of the hub was a fibre dominated failure. The ultimate failure was characterized by breakage of the fibres (fibre pull-out) across the entire width of the hub. The damage by debonding between the pipe wall and hub

**Figure 7.15: Failed stub flange**

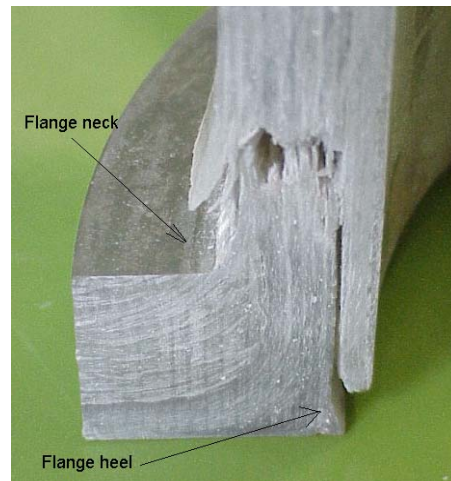
flange could be considered as a matrix dominated failure since in practice the first layers of flange construction laid upon the chamfered piece of pipe are effectively matrix bonded. The bonding between the pipe wall and hub flange might also be encouraged to some extent by the drop of joint stiffness over the test period because the pressure load was maintained for an extended period of two hours at different specified test pressures.

**Figure 7.16: Failure by pipe debonding and stub cracks**

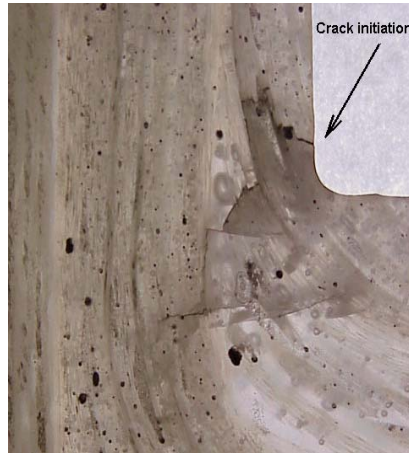
**Figure 7.17: Micro crack occurrence at the flange neck**

Visual inspection of failed test specimens showed that the fibre dominated failure took place at similar locations. Cracks extending through the laminate occurred around the flange radius. This indicates that the flange radius is the most critical part of the stub-flange. Figures 7.17, 7.18, 7.20 and 7.21 show that the failure modes exhibited by failed test flanges are generally characterized by fibre dominated failure. This indicates that the design and manufacturing specifications used in the construction of the flanges provide adequate restrictions to prevent poor material properties at the flange radius <sup>(3, 11)</sup>. However, Amitech specimens also experienced failure characterized by pipe debonding (Figure 7.15 and 7.16). This is probably due to their design and manufacturing methods. Flanges were made by applying wet layers of CSM and WR onto existing dry pipes. In addition, as the hub and pipe laminates have different material properties (stiffness and CTE's) in both axial and circumferential

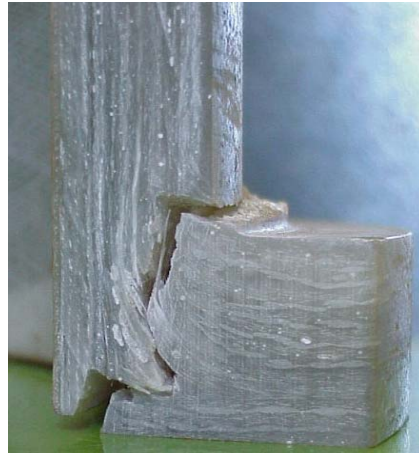
Figure 7.18 shows a fibre dominated failure. In this case, the crack pattern is not similar to that shown in Figure 7.16. The examination of the profile view of the failed flange shows cracks extending through the flange radius. The fracture plane is inclined at about sixty degrees with respect to the radial axis of the stub. Contrarily to the failure mode depicted in figure 7.16, minor signs of pipe debonding are noticed at the flange heel. This indicates an effective interfacial bond between the pipe and hub flange around this area. The stress analysis predicted cracking that is similar to that shown in figure 7.17. Figure 5.1 and 5.4 show predicted shear (12.5 MPa) and compressive radial (20.5 MPa) stresses at the neck of the flange as the joint is loaded at 8.0 MPa. The combination of these two stresses may initiate micro-cracks over time.

**Figure 7.18: Crack extending through the flange radius**

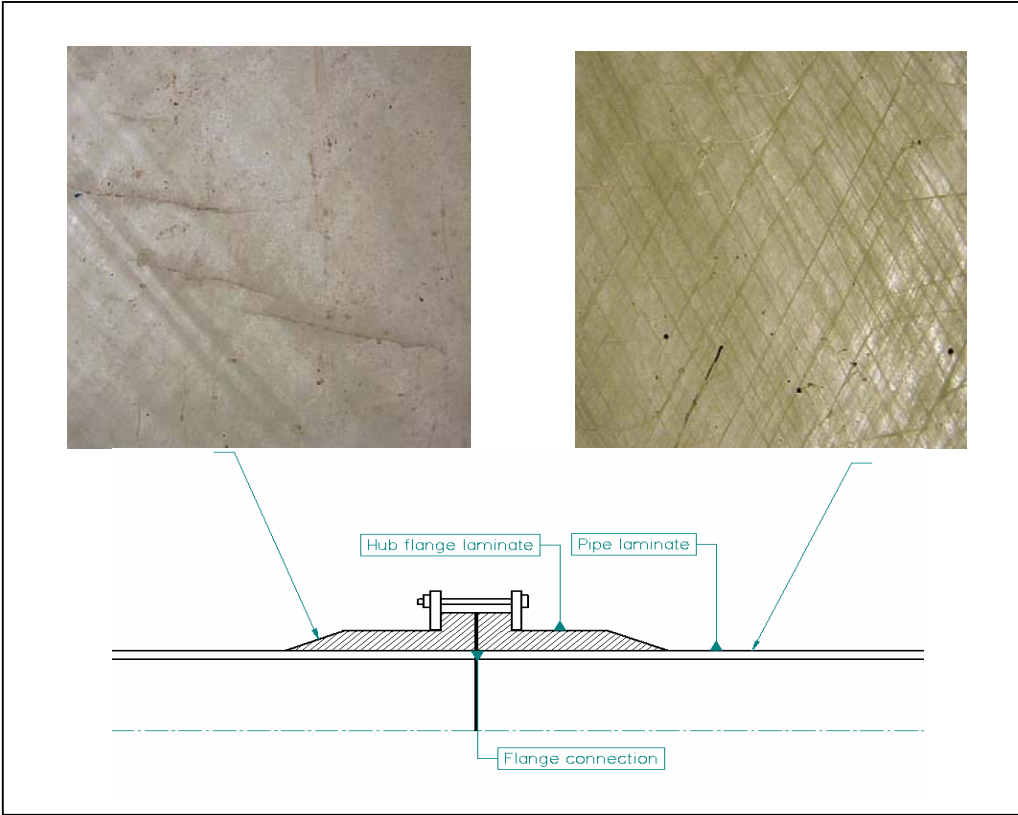
At location 3 the pipe wall laminate failed by leakage caused by matrix tensile cracking (Figure 7.19). No evidence of fibre breakage was noticed. The failure was characterized by the occurrence of matrix cracks parallel to the fibre direction. However, slight matrix cracks oriented transversally were noticed. Maximum in-plane shear stresses of magnitude 66.8 MPa were predicted at this location (Figure 5.1). However, the laminate was still capable of carrying the pressure load, although diffusion of water through the pipe wall occurred. The pressure gauge was found to be insensitive to the leakage rate through the pipe wall, thus the pressure load could be maintained for an extended period of time. The pipe leakage was not associated to

At 6.80 MPa pressure, cracks characterized by matrix dominated failure were observed at the upper edge of the hub (Figure 7.19). This location is a region prone to stress concentration effects because of the change in laminate thickness. In addition, it has a high resin concentration (See section 7.2). One should also recognize that at the curing stage, unfavourable residual tensile stresses caused by the mismatch of material properties (stiffness and CTE's) especially in the hoop direction between the pipe and flange laminates, might occur and therefore encourage matrix crack initiation as the flange is pressurized. The stress analysis predicted shear stresses of magnitudes ranging between 25.1 MPa and 50.1 MPa at a test pressure of magnitude 8.00 MPa. Only the 10 bar Amitech flanges show this type of matrix failure.

**Figure 7.19: Matrix cracking location on the 10 bar Amitech flange**

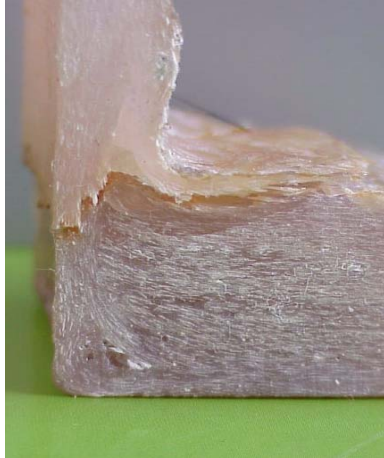
The ultimate material failure of fabricated flanges was characterized by fibre dominated failure. No significant sign of matrix-dominated failure was noticed. This is probably due to the way these flanges were designed. An examination of a close-up profile view of flange 1 showed that the failure pattern was mainly characterized by crack propagations extending through the hub. At location two, fibre dominated failure characterized by cracks through the entire width of the hub and oriented transversally to the axial axis of the flange was noticed (Figure 7.20). However, the flange did not undergo similar failure all the way around the flange radius. Fibre breakage across the width of the hub at the neck of the flange and followed by slight debonding between the filler and the main wall of the hub was noticed. Cracks characterized by fibre pull-out through the main wall of the hub were observed above the heel of the flange (Figure 7.21). This difference of failure patterns is probably due to the unexpected inconsistency of the homogeneity of material distribution along the flange radius. The material inconsistency occurred probably at the manufacturing stage. A visual inspection of the butt weld and pipe construction did not show any sign of defect. The stress analysis predicted compressive radial stresses of magnitudes ranging between 17.8 and 34.2 MPa at the flange radius when the test flange was loaded at 6.6 MPa. This is not sufficient to induce material failure. However, factors such as unfavourable pre-load residual stresses due to the pull-back effect of the stub could encourage crack occurrences.

**Figure 7.20: Cracks across the entire hub flange**

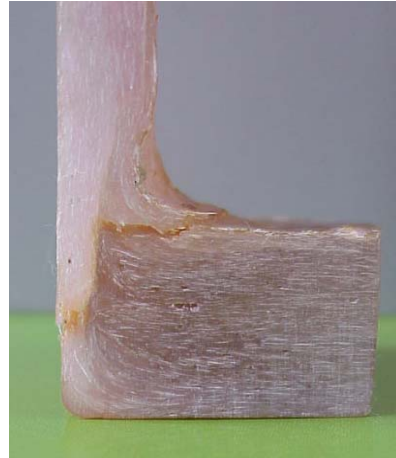
**Figure 7.21: Cracks and fibre pull-out across the flange neck**

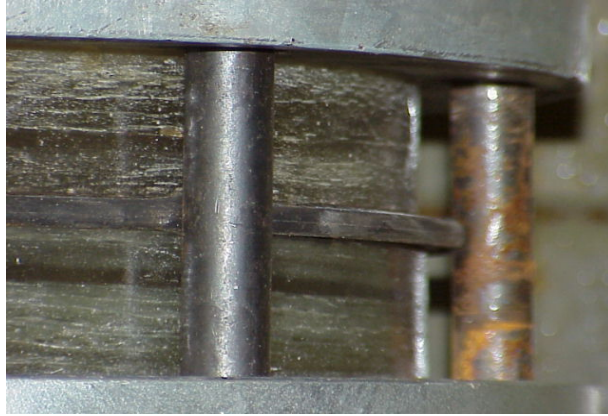
Gasket blow-out was experienced by the 16 bar Amitech flanges when loaded at 9.4 MPa (Figure 7.23). The flow rate was found to be 0.33 ml/min. As the fasteners are tightened to create the required initial load and to seal the joint, the bolts elongate negligibly whereas the gasket compresses appreciably because of its low stiffness. This generates the flange pressure. The gasket, strained in compression, acts as a compressed spring that presses against the stub flanges and conforms to their face irregularities in order to ensure the leak tightness of the joint. As the test specimens are loaded to test pressures less than the critical pressure, the internal pressure load tends to separate the flanges. This implies an increase in the bolt axial load and a decrease in the clamping load between gasket and stubs. Being stiffer, the bolts elongate once again negligibly in comparison to the gasket. The small elastic stretch of the bolts does not allow the gasket to expand significantly between the stub flanges; consequently the flange pressure is still substantially preserved to maintain the seal of the joint. As the internal pressure increases, the axial load induced by the pressure load tends to separate the flanges. As a result, the compressive force holding the gasket between the stubs decreases appreciably and the gasket tends to expand in the radial direction. As the gasket contact pressure reaches a level that is less than the recommended flange pressure, the joint becomes prone to failure.

**Figure 7.23: Gasket failure**
