# IDENTIFICATION OF REFRACTORY MATERIAL FAILURES IN CEMENT KILNS

A dissertation submitted to the Faculty of Engineering and the  
Built Environment, University of the Witwatersrand,  
Johannesburg, in fulfilment of the requirements for the degree of  
Master of Science in Engineering

Johannesburg, 11 October 2016

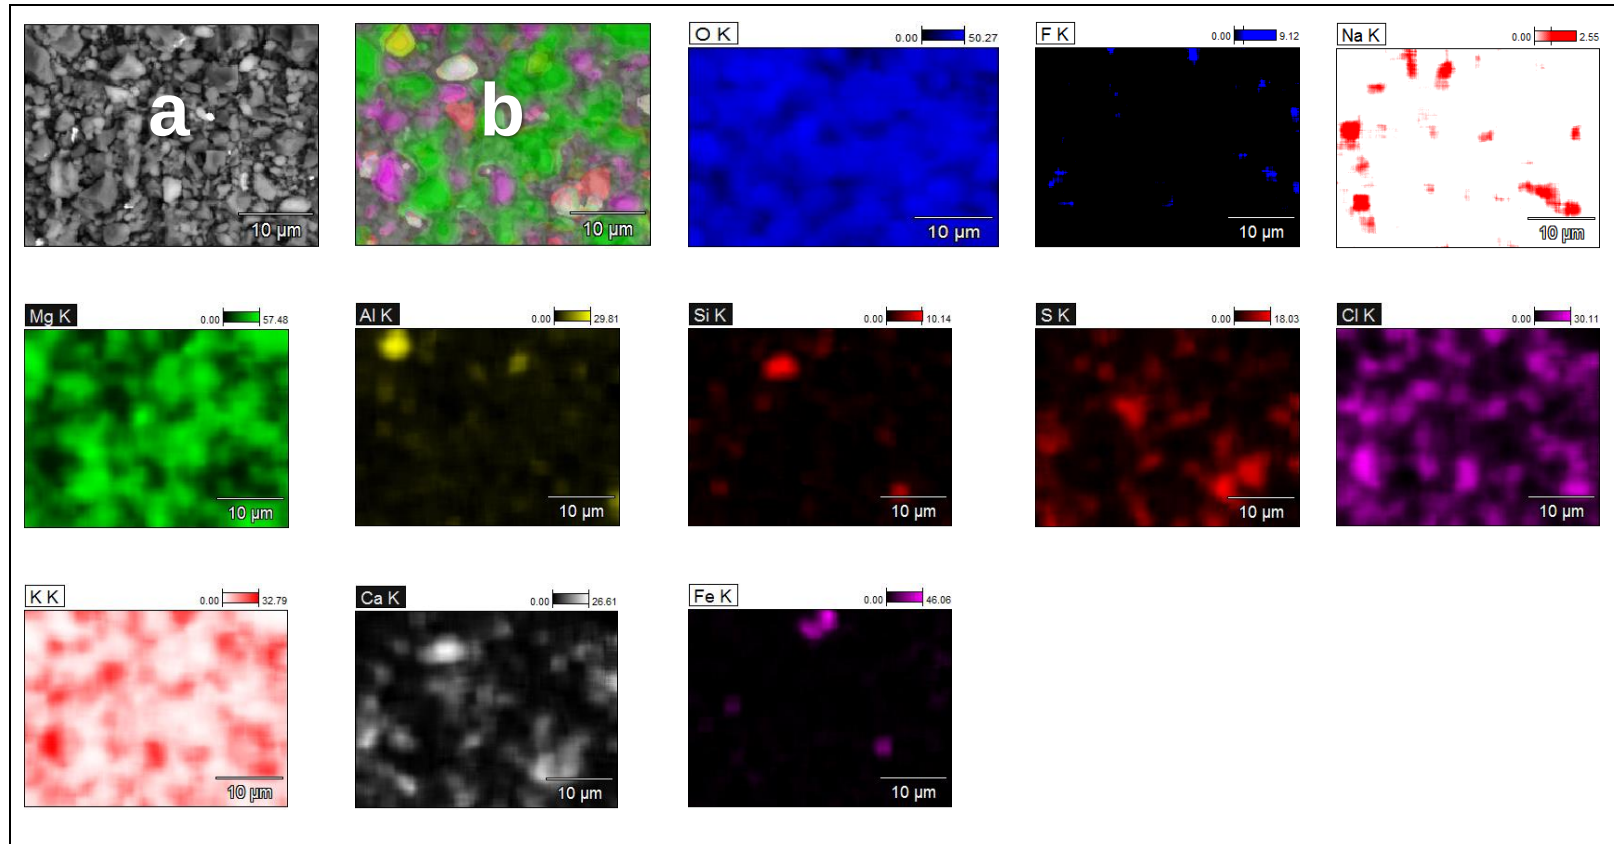
Figure 4-1. SEM-EDS mapping of magnesia-spinel brick type A

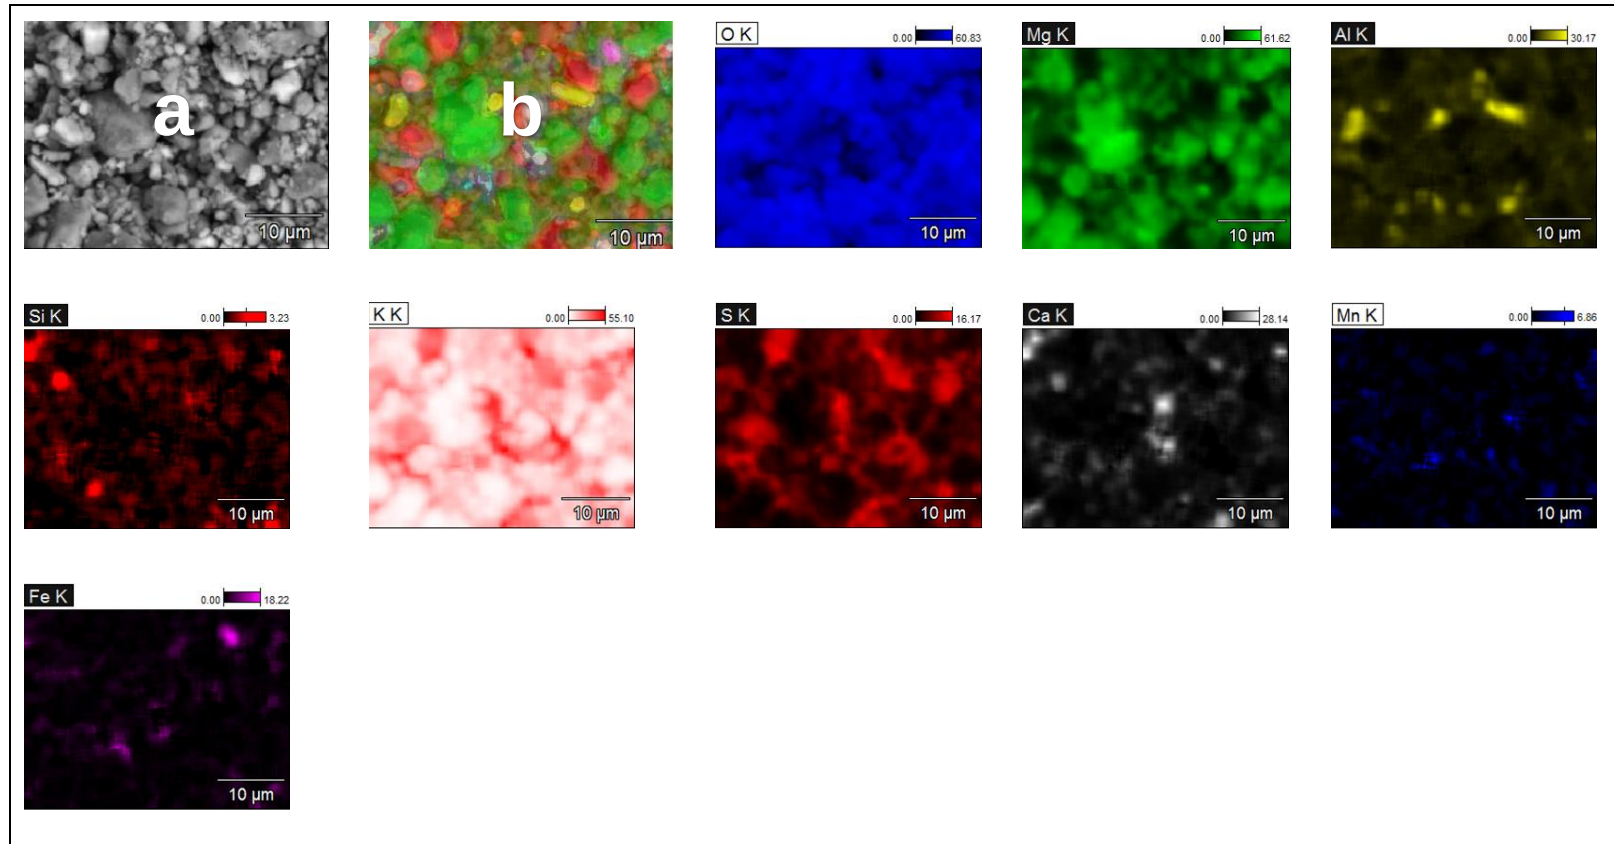
Figure 4-2. SEM-EDS mapping of magnesia-spinel brick type B

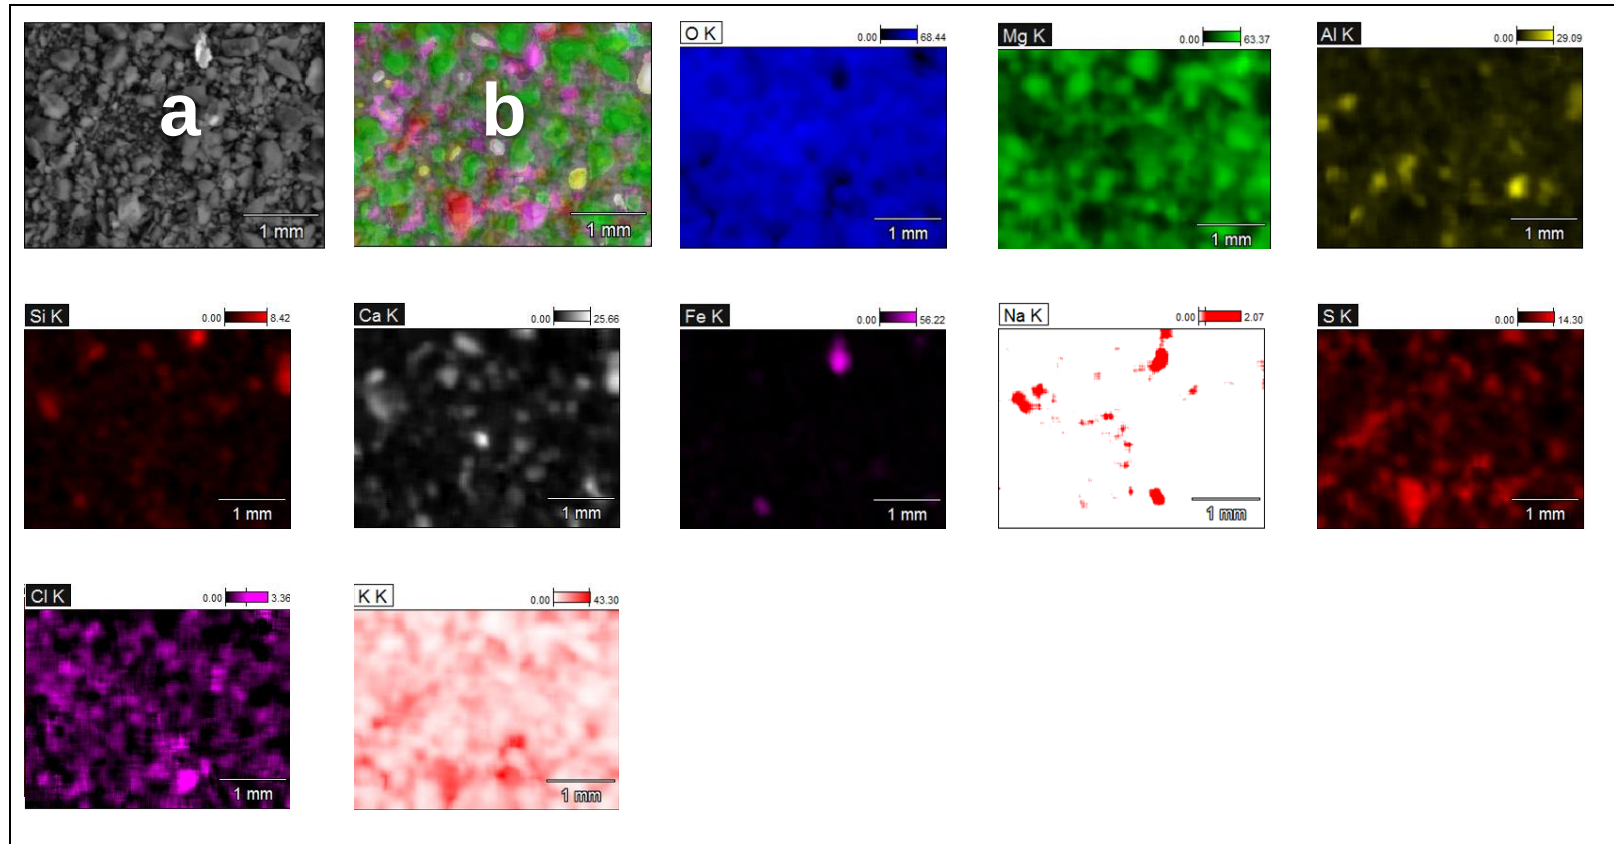
Figure 4-3. SEM-EDS mapping magnesia-fused spinel

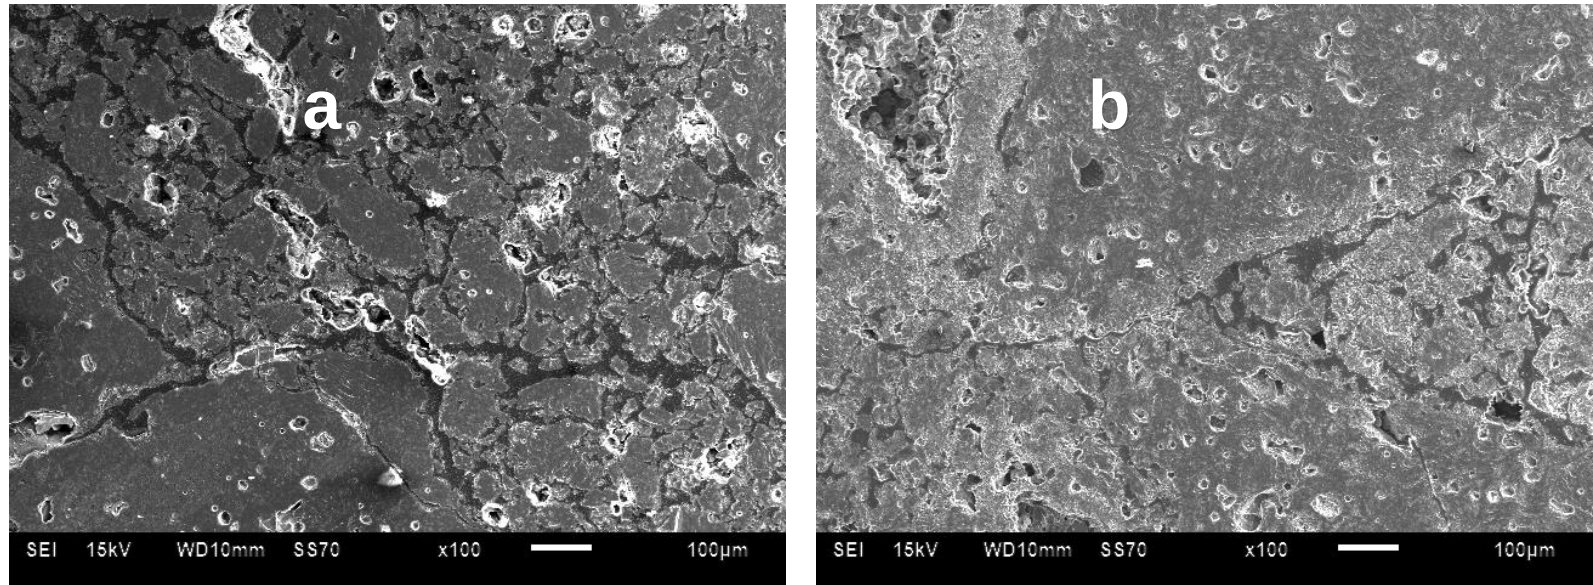
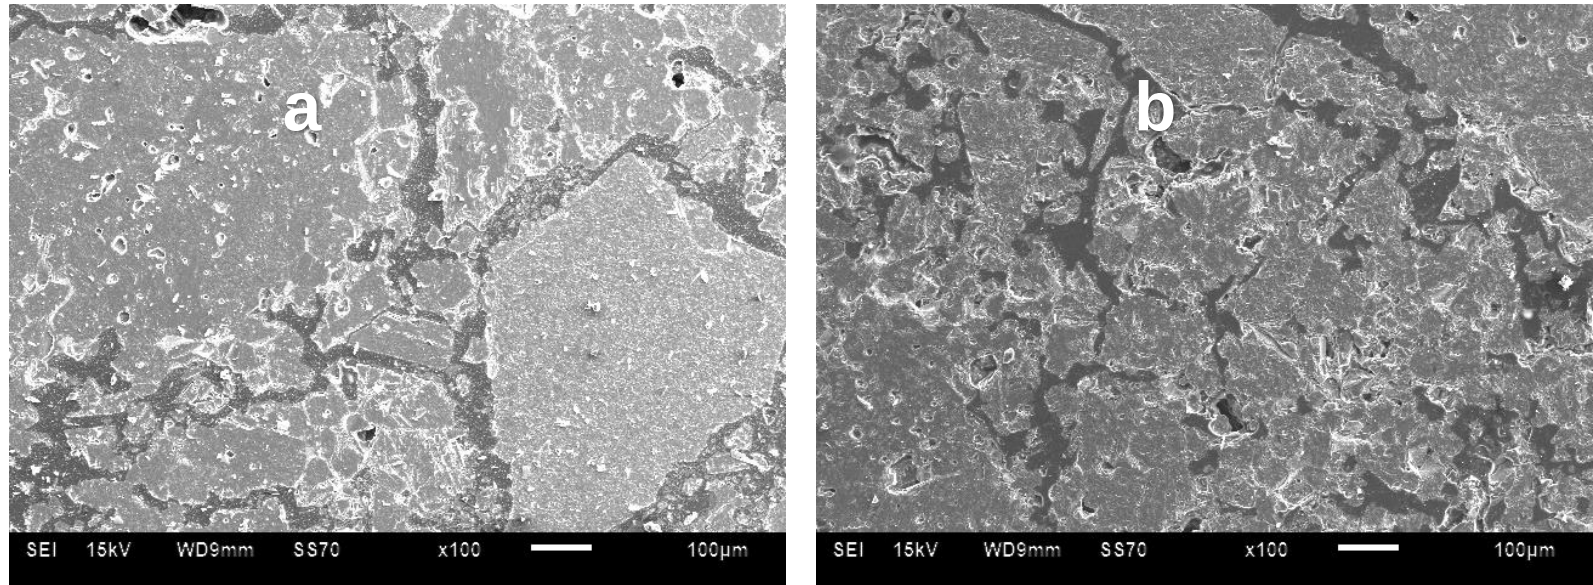
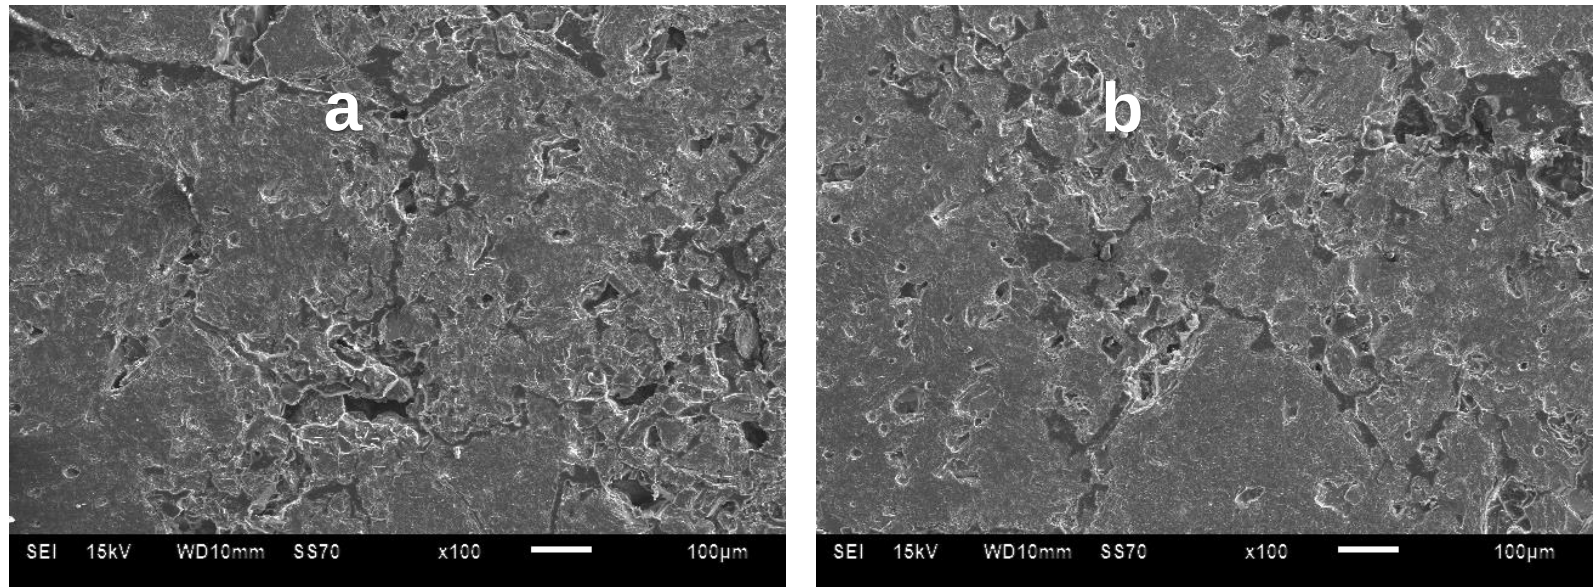
decreased from 9% to 7% for the magnesia-spinel brick type A and from 14% to 8% for the magnesia-spinel brick type B.

Figure 4-4. The SEM micrograph polished brick section of magnesia-spinel brick type A, a) the unused, and b) the damaged

Figure 4-5. The SEM micrograph polished brick section of magnesia-spinel brick type B, a) the unused, and b) the damaged

Figure 4-6. The SEM micrograph polished brick section of magnesia-fused spinel, a) the unused, and b) the damaged

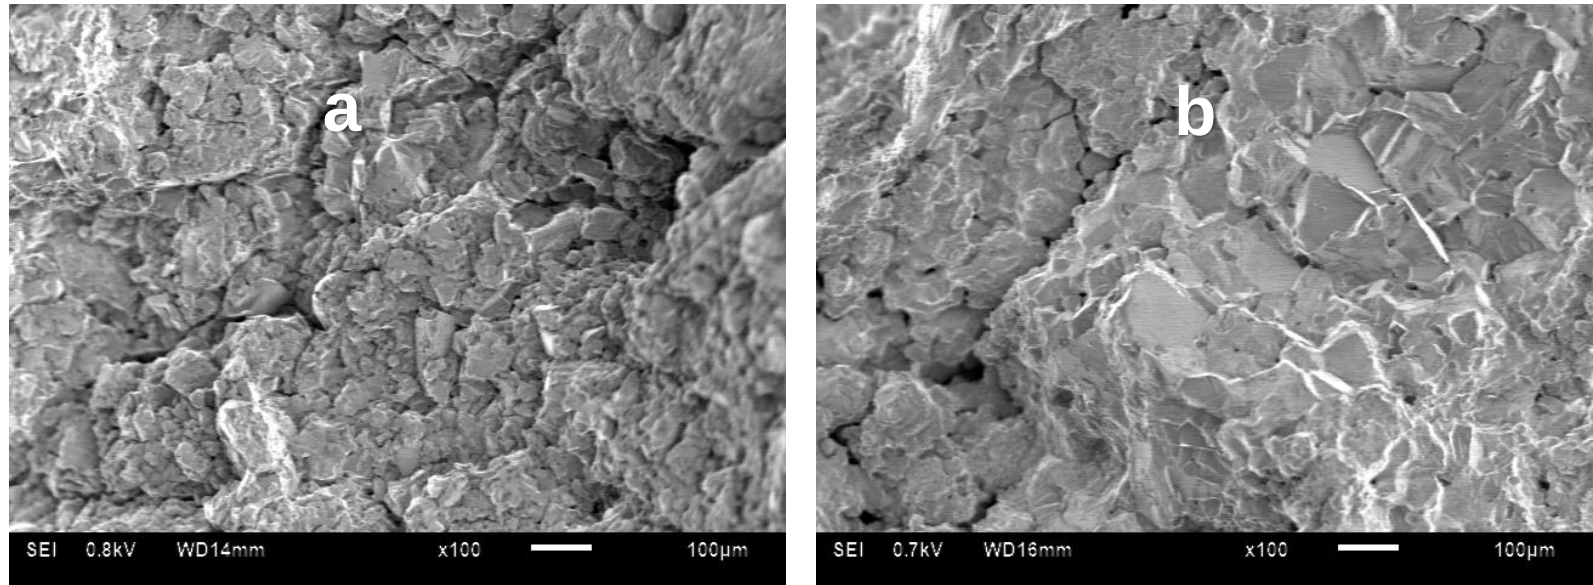
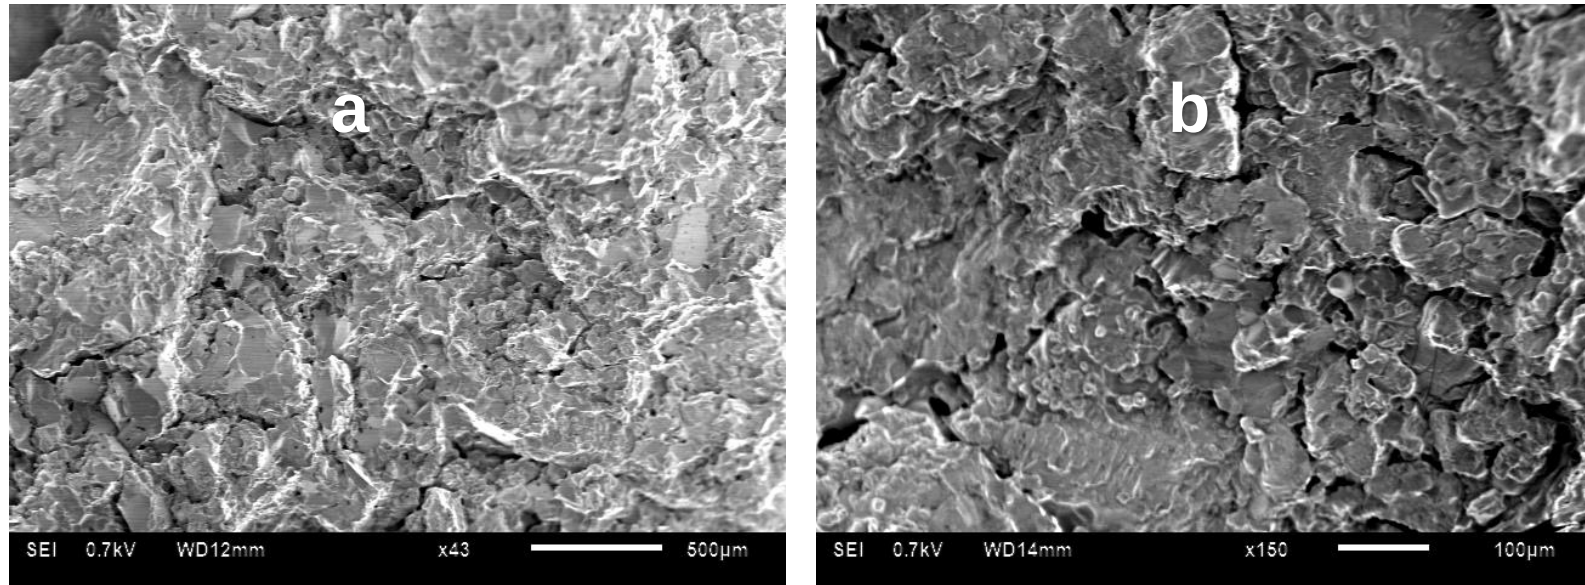
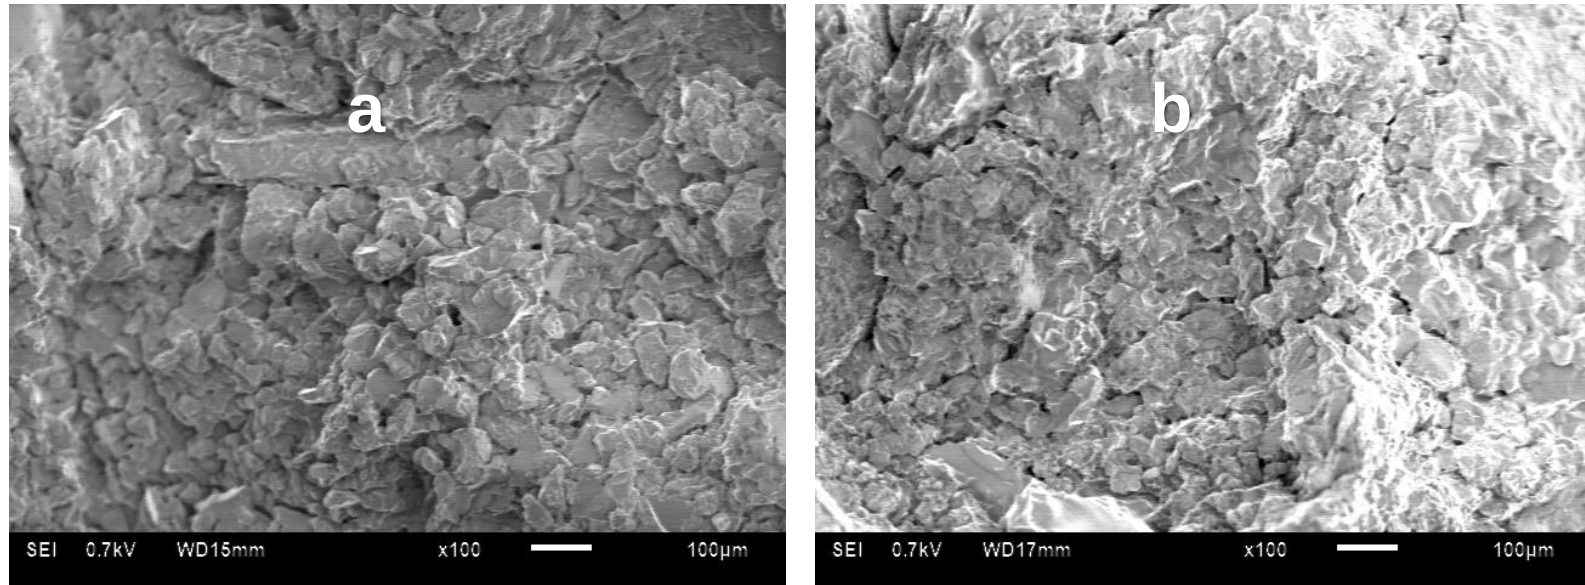
Figure 4-7. The SEM micrograph fracture of magnesia-spinel brick type A, a) the unused, and b) the damaged

Figure 4-8. The SEM micrograph fracture of magnesia-spinel brick type B, a) the unused, and b) the damaged

Figure 4-9. The SEM micrograph fracture of magnesia-fused spinel brick, a) the unused, and b) the damaged

The failure of the refractory brick by thermal shock attack was investigated through microstructural analysis of the polished sections of unused and damaged magnesia lining, using SEM equipped with EDS. The SEM microstructures of tested refractory bricks are given in Figure 4-7, 4-8, 4-9.

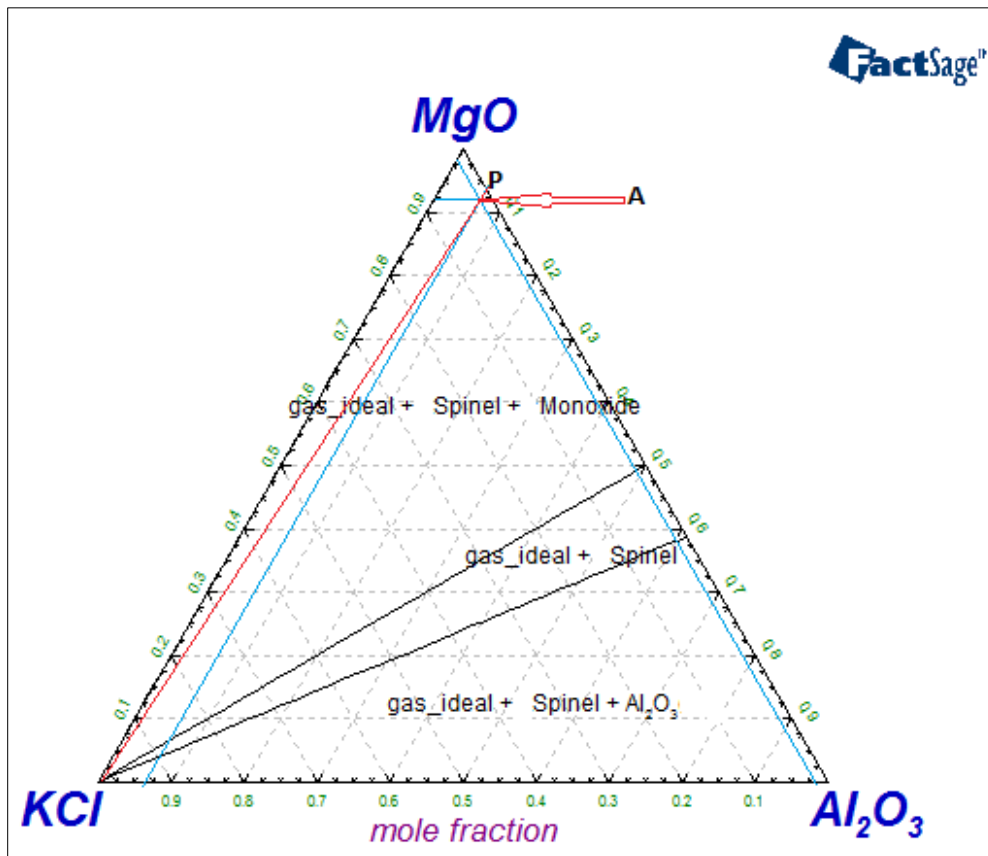
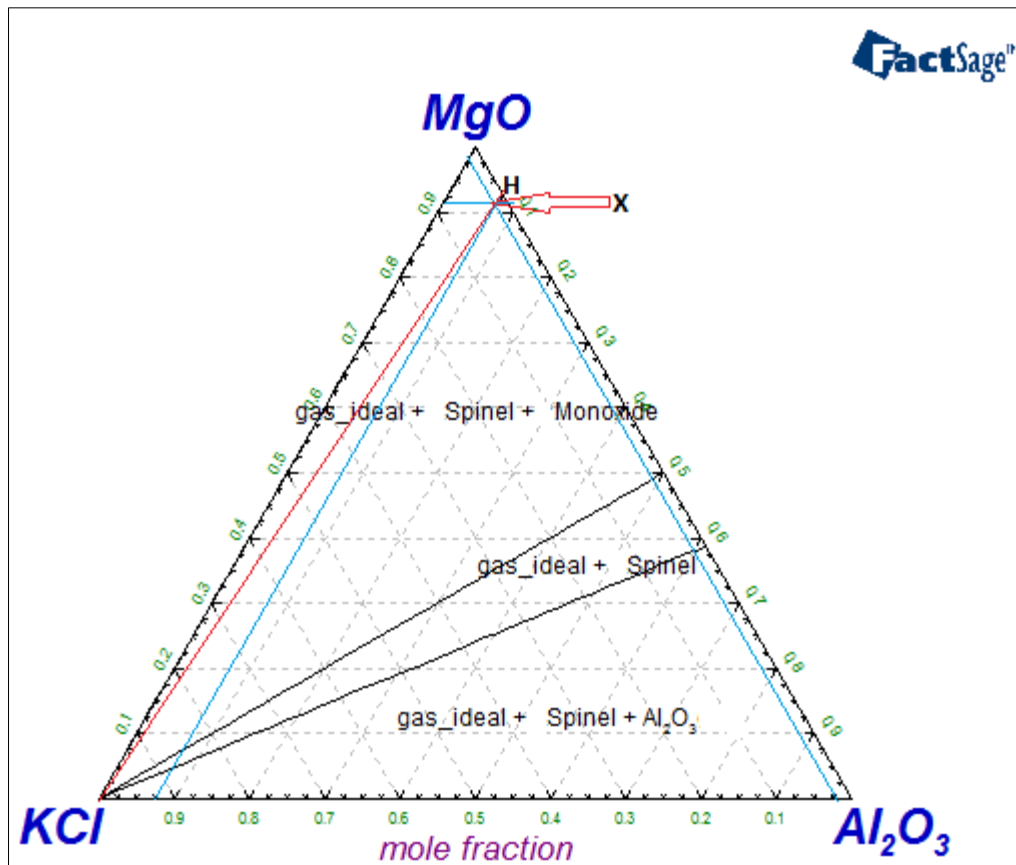
Figure 4-10. System MgO-Al<sub>2</sub>O<sub>3</sub>-KCl ternary phase diagram at 1500 °C and 1 atmosphere for magnesia-spinel brick type A

Figure 4-11. System MgO- $\text{Al}_2\text{O}_3$ -KCl ternary phase diagram at 1500 °C and 1 atmosphere for magnesia-fused spinel

At point P (Figure 4-10) and point H (Figure 4-11), only  $\text{MgAl}_2\text{O}_4$  and free MgO exist. Moving along the KCl line (red line), no phase transformation takes place. On this phase diagram prediction, the effect of KCl does not result in phase transformation and does not explain the refractory brick failure.

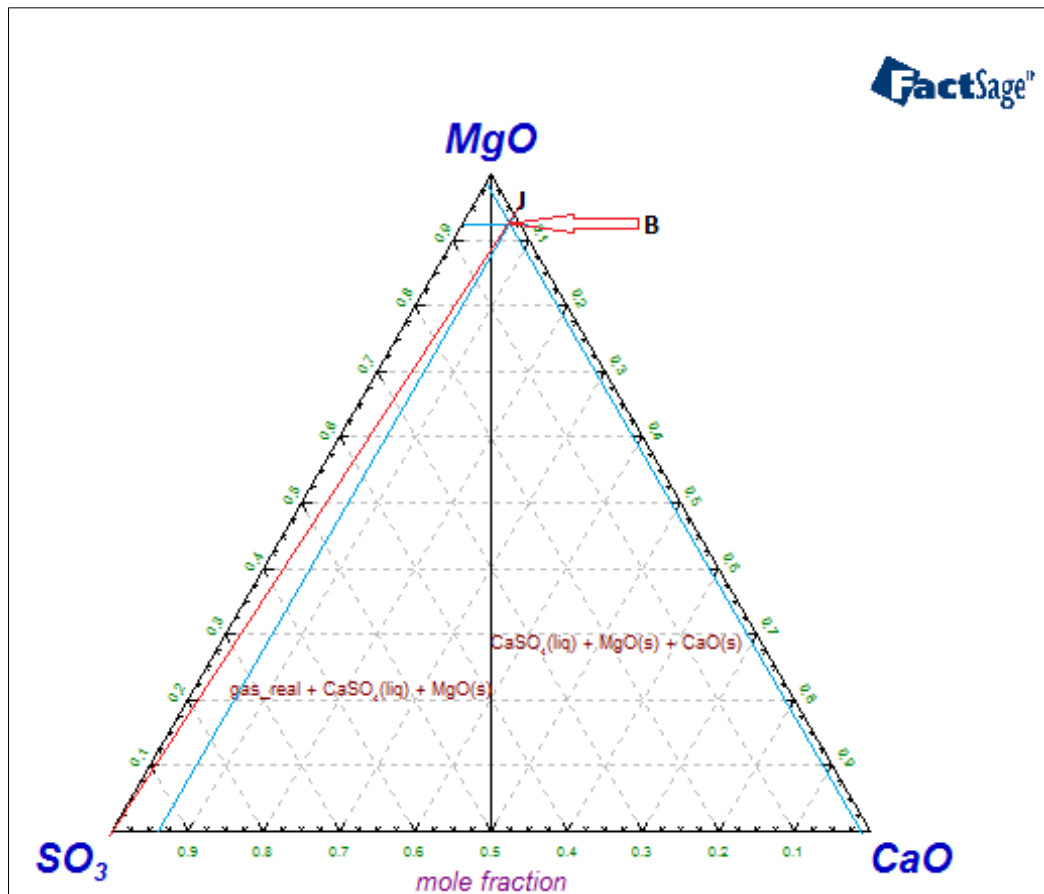
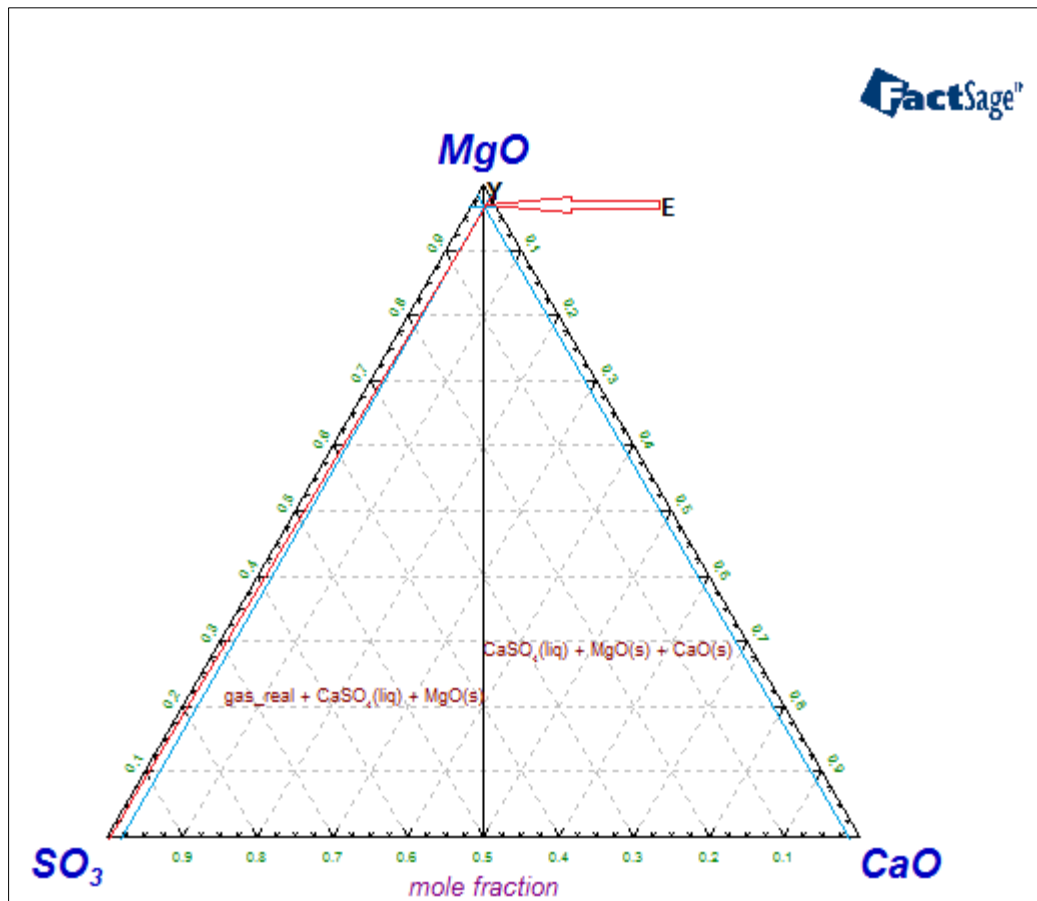
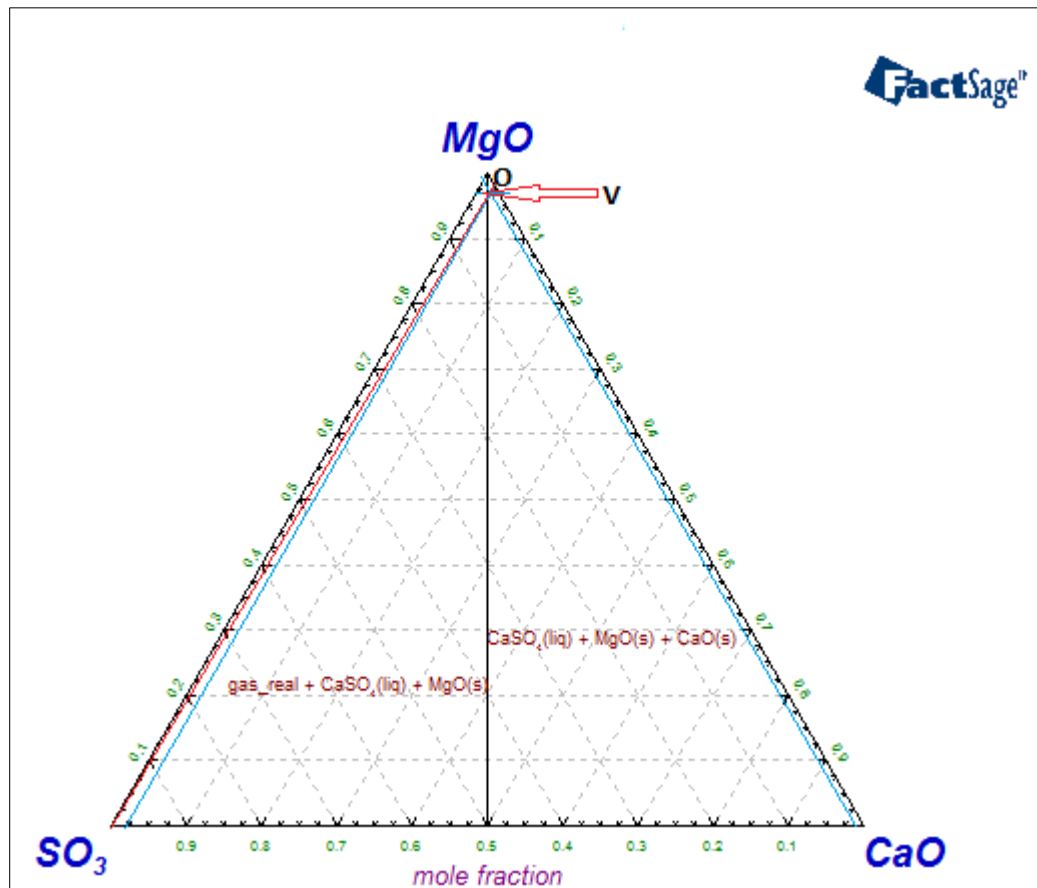
At point J, Y and O, only CaO and MgO exist. Moving along the SO<sub>3</sub> line (red line), phase transformation occurs. The effect of SO<sub>3</sub> is the formation of liquid (CaSO<sub>4</sub> (liquid)) in the magnesia-spinel bricks which compromise the refractoriness of the brick resulting in premature failure.

Figure 4-12. System MgO-CaO-SO<sub>3</sub> ternary phase diagram at 1500 °C and 1 atmosphere for magnesia-spinel brick type A

Figure 4-13. System MgO-CaO-SO<sub>3</sub> ternary phase diagram at 1500 °C and 1 atmosphere for magnesia-spinel brick type B

Figure 4-14. System MgO-CaO-SO<sub>3</sub> ternary phase diagram at 1500 °C and 1 atmosphere for magnesia-fused spinel

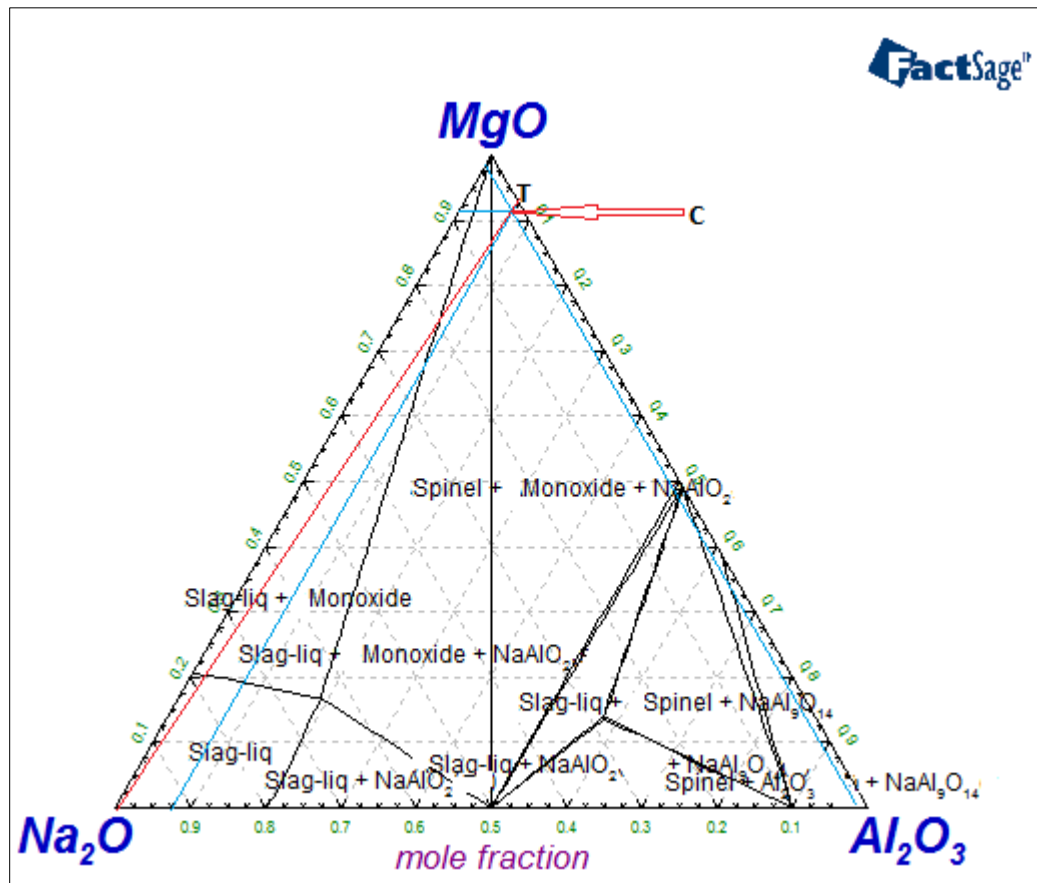
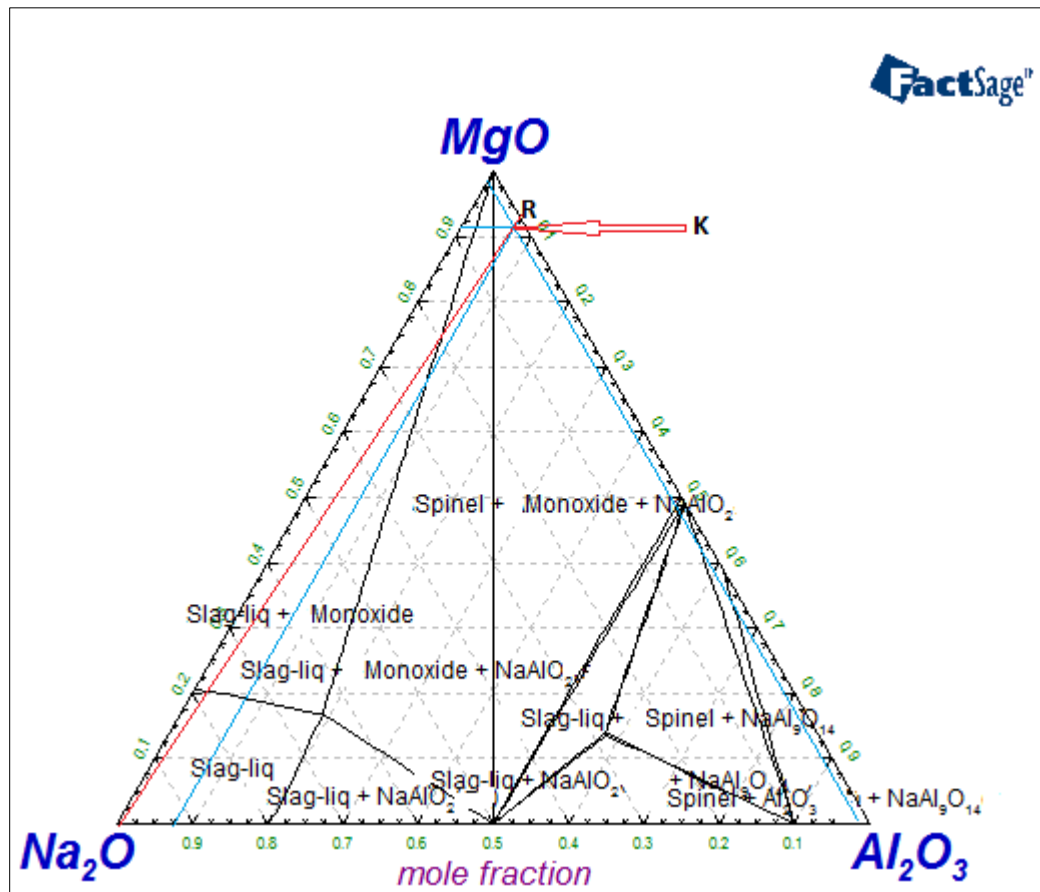
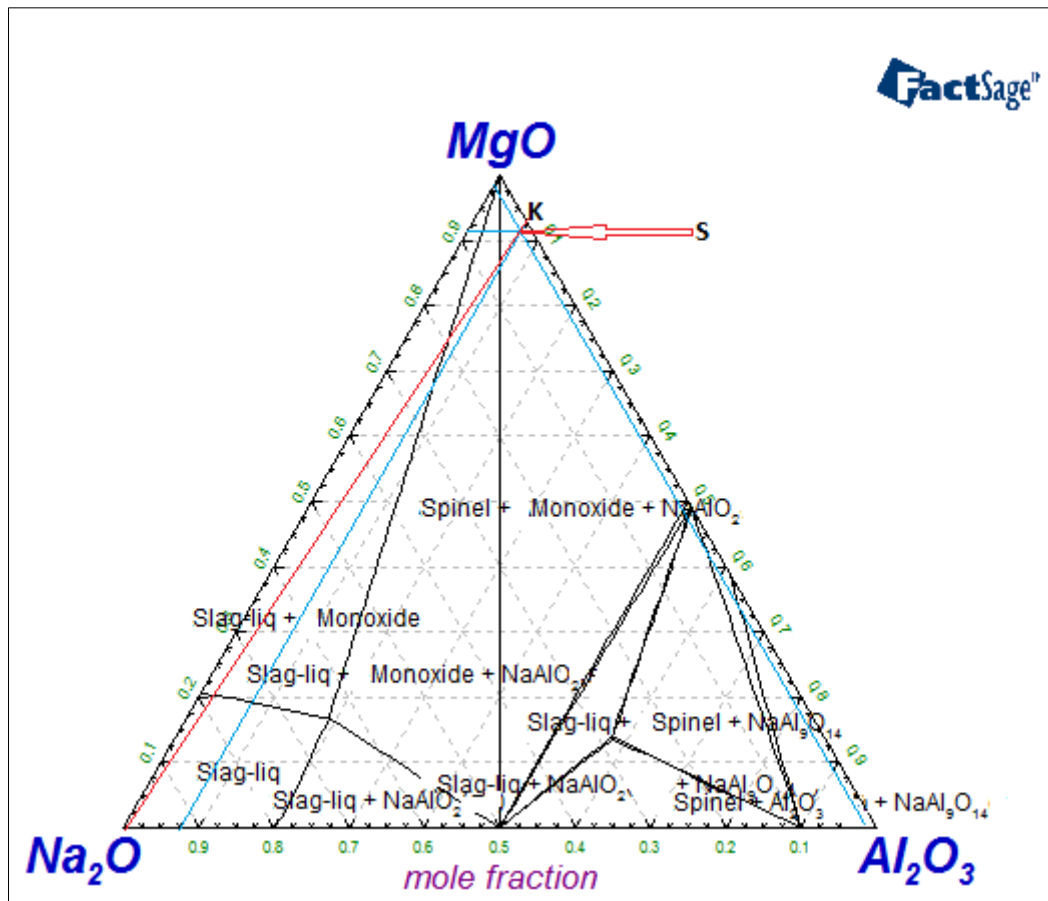
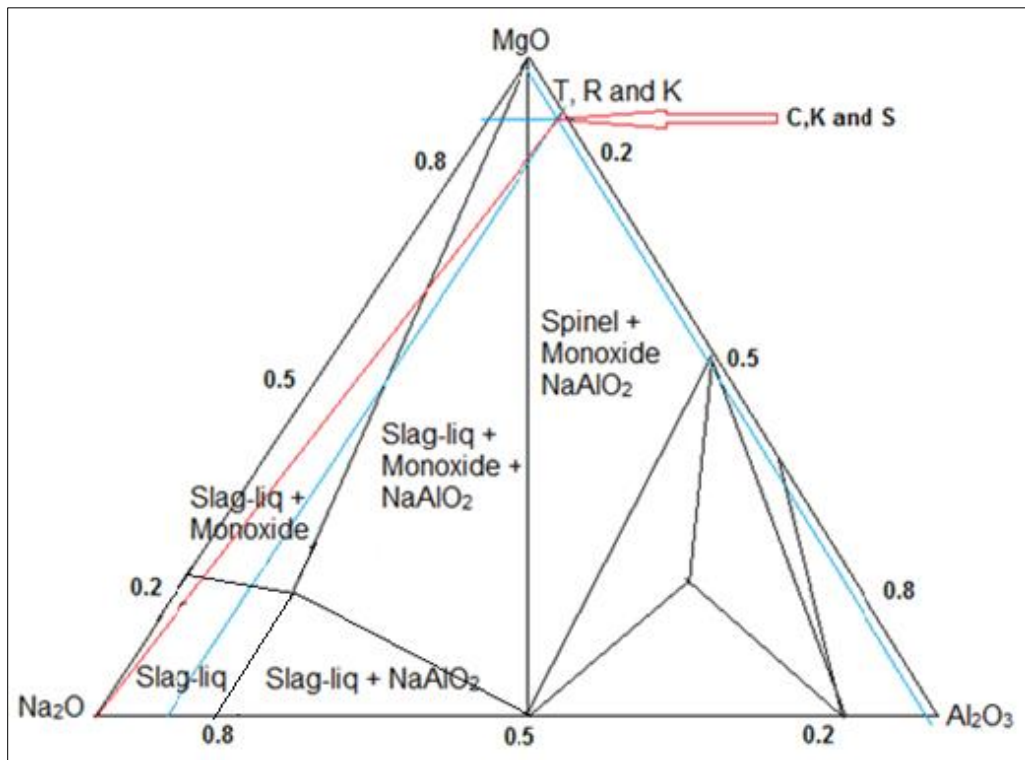
It can be concluded that the effect of sodium oxide is driving by the formation of NaAlO<sub>2</sub> which promotes liquid formation when Na<sub>2</sub>O content increases in the magnesia refractory lining. The liquid formation will compromise the refractoriness of the brick resulting in premature failure.

Figure 4-15. System MgO-Al<sub>2</sub>O<sub>3</sub>-Na<sub>2</sub>O ternary phase diagram at 1500 °C and 1 atmosphere for magnesia-spinel brick type A

Figure 4-16. System MgO-Al<sub>2</sub>O<sub>3</sub>-Na<sub>2</sub>O ternary phase diagram at 1500 °C and 1 atmosphere for magnesia-spinel brick type B

Figure 4-17. System  $\text{MgO}-\text{Al}_2\text{O}_3-\text{Na}_2\text{O}$  ternary phase diagram at  $1500^\circ\text{C}$  and 1 atmosphere for magnesia-fused spinel

Figure 4-18. System MgO-Al<sub>2</sub>O<sub>3</sub>-Na<sub>2</sub>O ternary phase diagram at 1500 °C and 1 atmosphere

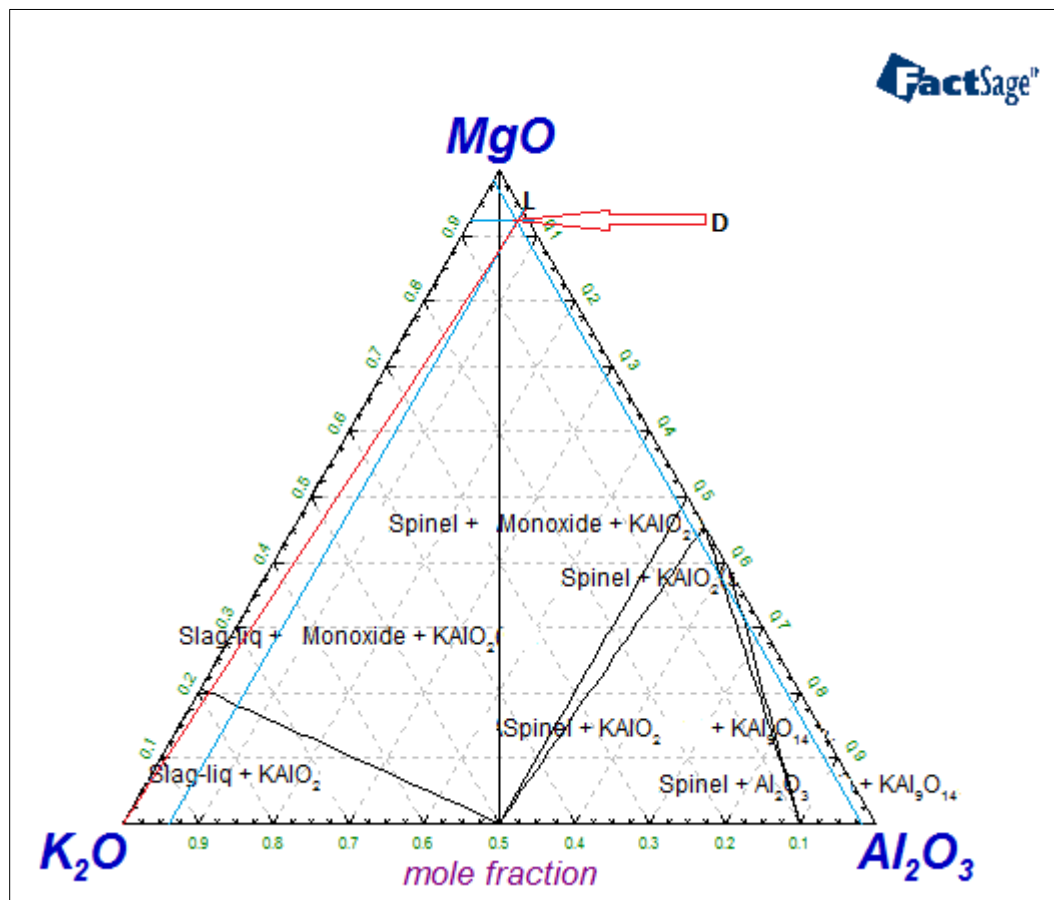
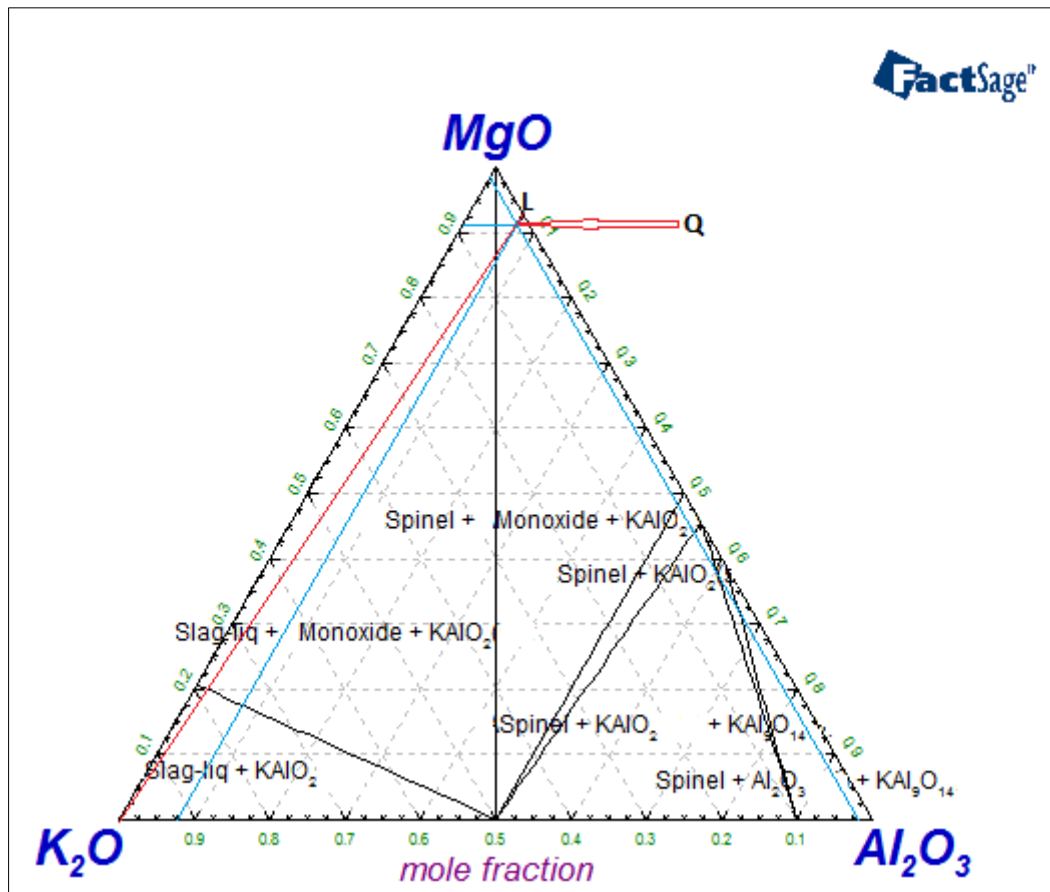
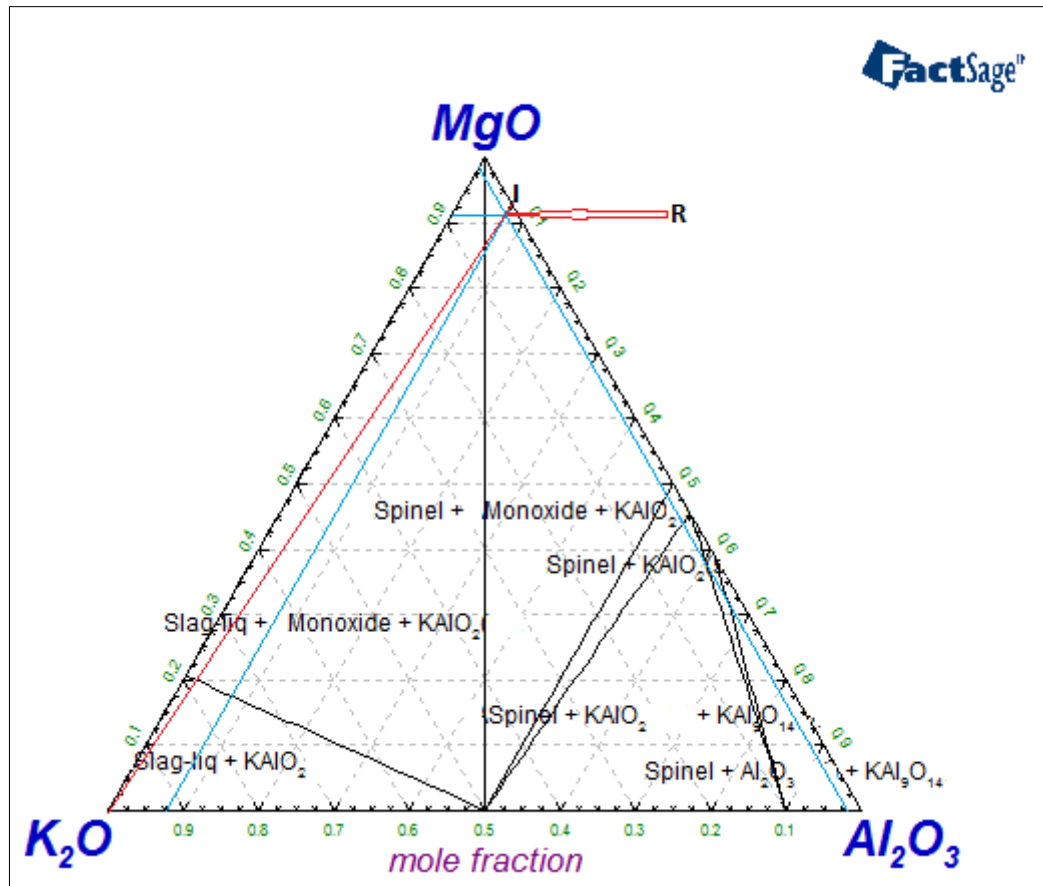
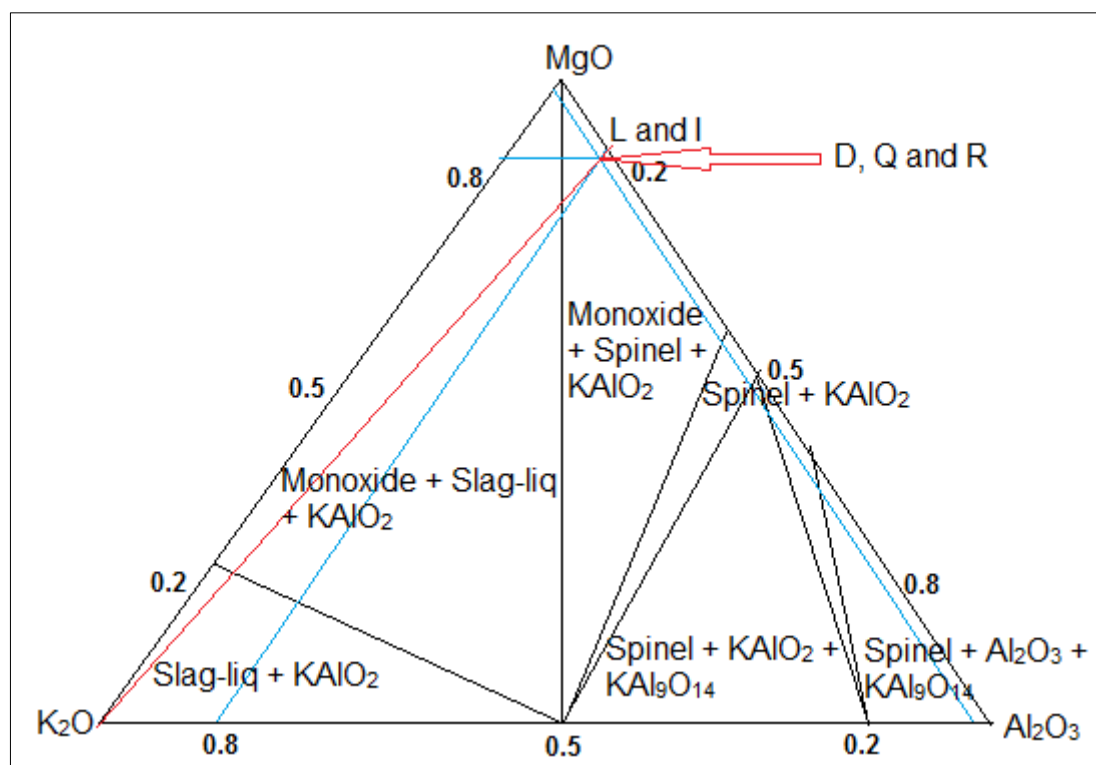
It can be concluded that the effect of sodium oxide is driving by the formation of KAIO<sub>2</sub> which promotes liquid formation when K<sub>2</sub>O content increases in the magnesia refractory lining. The liquid formation will compromise the refractoriness of the brick resulting in premature failure.

Figure 4-19. System  $\text{MgO}-\text{Al}_2\text{O}_3-\text{K}_2\text{O}$  ternary phase diagram at  $1500^\circ\text{C}$  and 1 atmosphere for magnesia-spinel brick type A

Figure 4-20. System  $\text{MgO}-\text{Al}_2\text{O}_3-\text{K}_2\text{O}$  ternary phase diagram at  $1500^\circ\text{C}$  and 1 atmosphere for magnesia-spinel brick type B

Figure 4-21. System MgO-Al<sub>2</sub>O<sub>3</sub>-K<sub>2</sub>O ternary phase diagram at 1500 °C and 1 atmosphere for magnesia-fused spinel

Figure 4-22. System  $\text{MgO-Al}_2\text{O}_3\text{-K}_2\text{O}$  ternary phase diagram at 1500 °C and 1 atmosphere
