# IDENTIFICATION OF REFRACTORY MATERIAL FAILURES IN CEMENT KILNS

A dissertation submitted to the Faculty of Engineering and the  
Built Environment, University of the Witwatersrand,  
Johannesburg, in fulfilment of the requirements for the degree of  
Master of Science in Engineering

Johannesburg, 11 October 2016

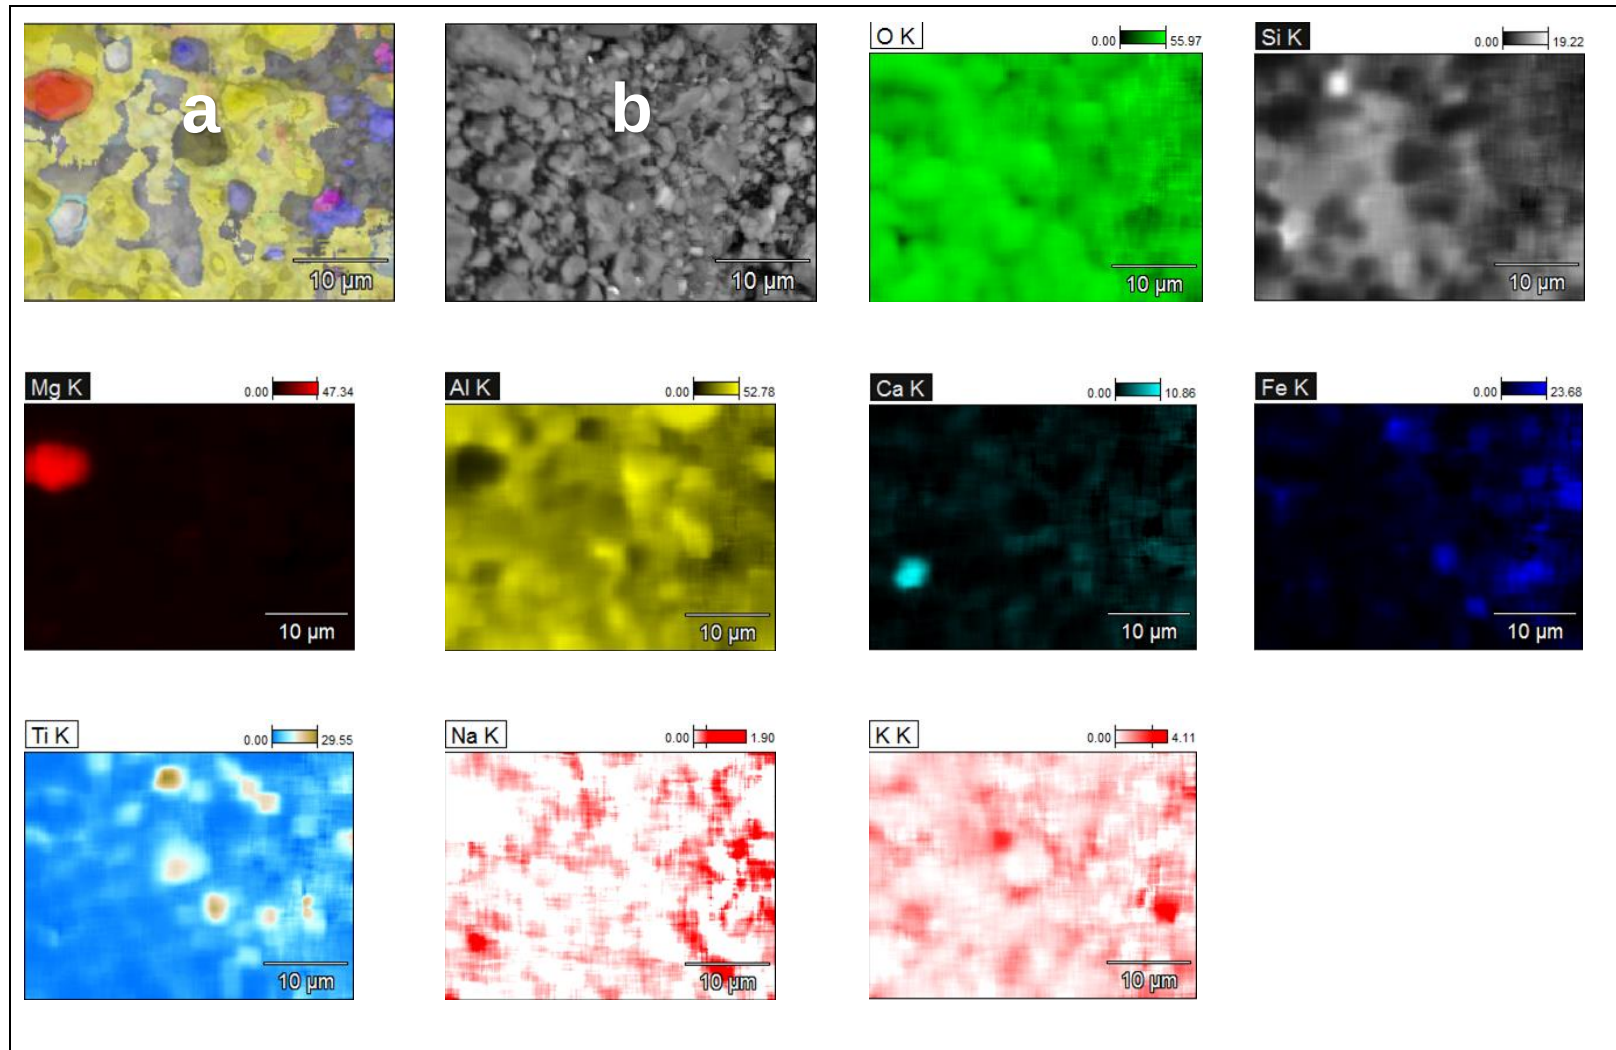
Figure 5-1. SEM-EDS mapping of the damaged high-alumina powder sample

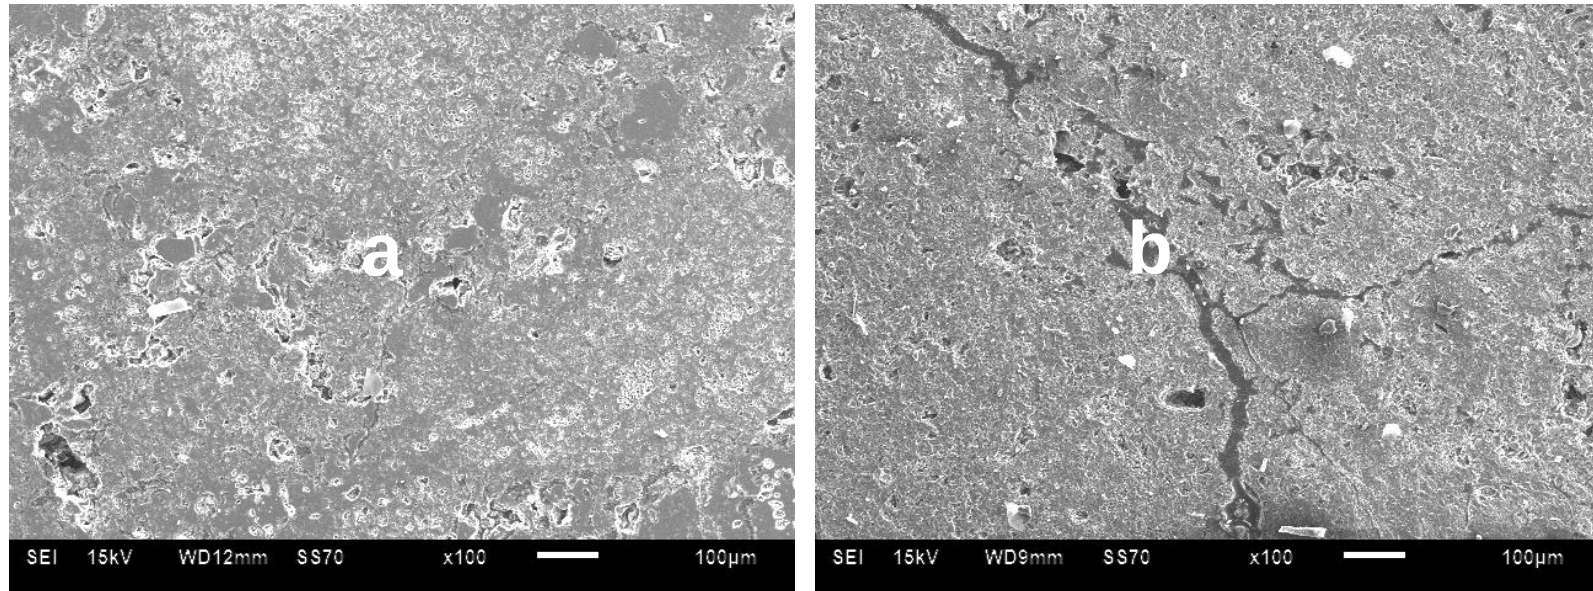
Further analysis of SEM micrographs, in Figure 5-2, revealed that no clinker diffusion into the refractory lining took place. The clinker diffusion is likely to be present as devitrified glassy phase (see figure 2-1) in the refractory materials due to refractory-clinker chemical reaction (Pena et al., 2007). There were also no longitudinal or transverse cracks in the polished sections of the used high-alumina refractory brick.

Figure 5-2. The SEM micrograph of high-alumina polished brick section, a) the unused, and b) the damaged

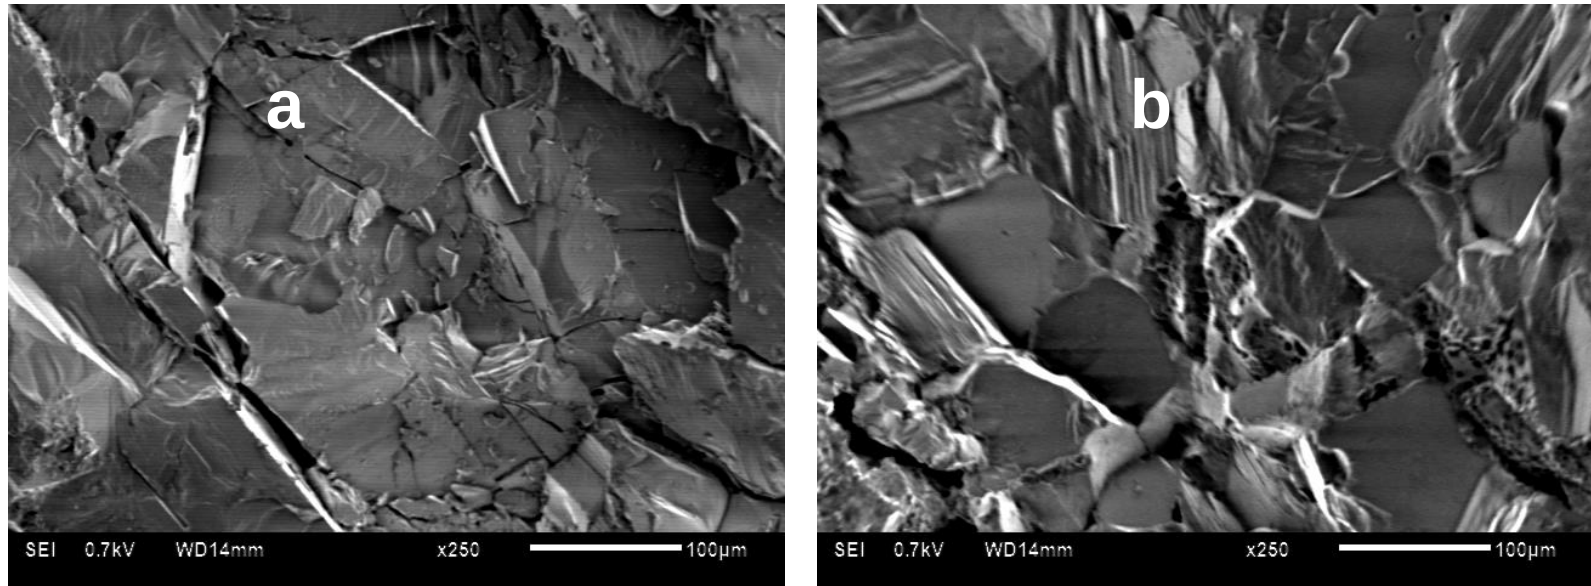
The thermal shock attack was studied based on SEM fracture analysis of the brick microstructures (Figure 5-3). It can be seen that there are no major cracks in both unused and used high-alumina brick sections. Fracture analysis shows similar microstructure of both unused and used high-alumina brick, they are both transgranular fracture (see Figure 2-4). The absence of micro cracks excludes thermal shock attack as a failure mechanism for the high-alumina brick.

Figure 5-3. The SEM micrograph of fracture high-alumina brick, a) the unused, and b) the damaged

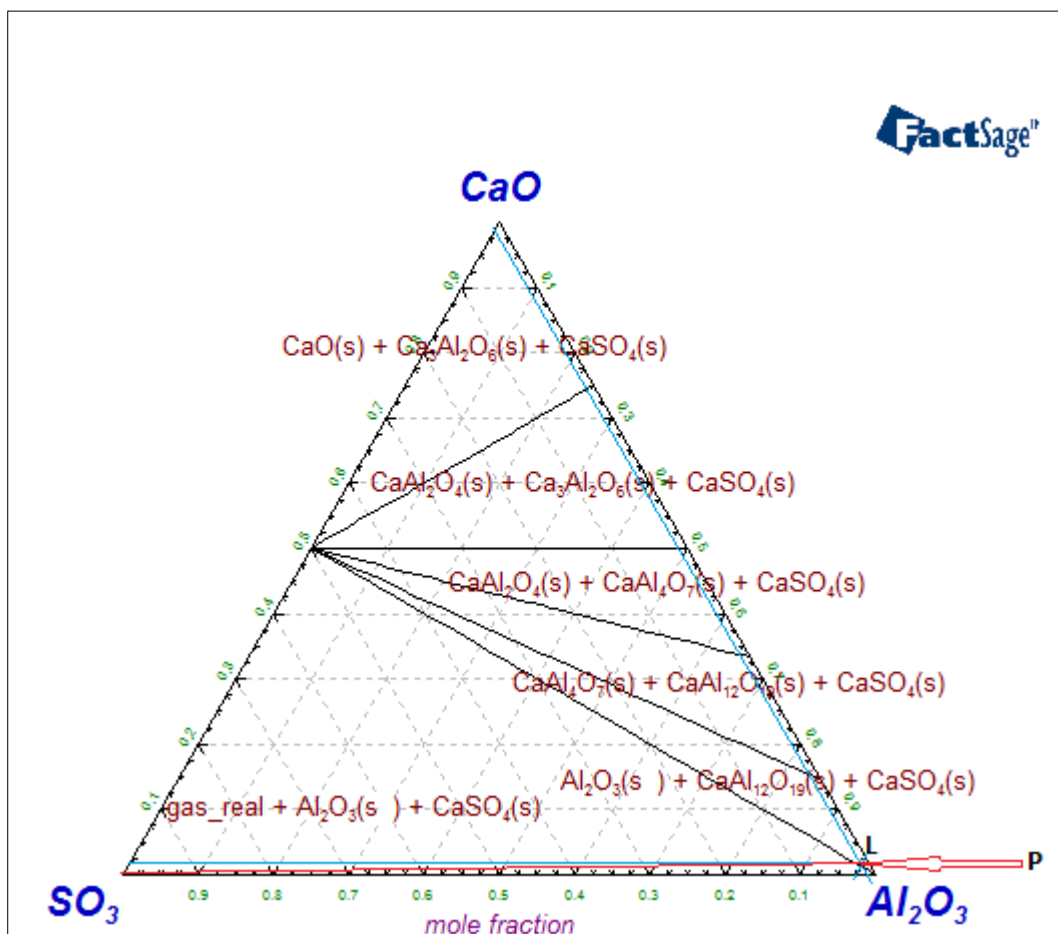
At point L, only  $\text{CaAl}_{12}\text{O}_{19}$  and  $\text{Al}_2\text{O}_3$  exist. Moving along the  $\text{SO}_3$  line (red line) there is phase transformation. The effect of  $\text{SO}_3$  is the formation of  $\text{CaSO}_4$  (s) which compromise the refractoriness of the high-alumina brick.

Figure 5-4. System Al<sub>2</sub>O<sub>3</sub>-CaO-SO<sub>3</sub> ternary phase diagram at 1200°C and 1 atmosphere

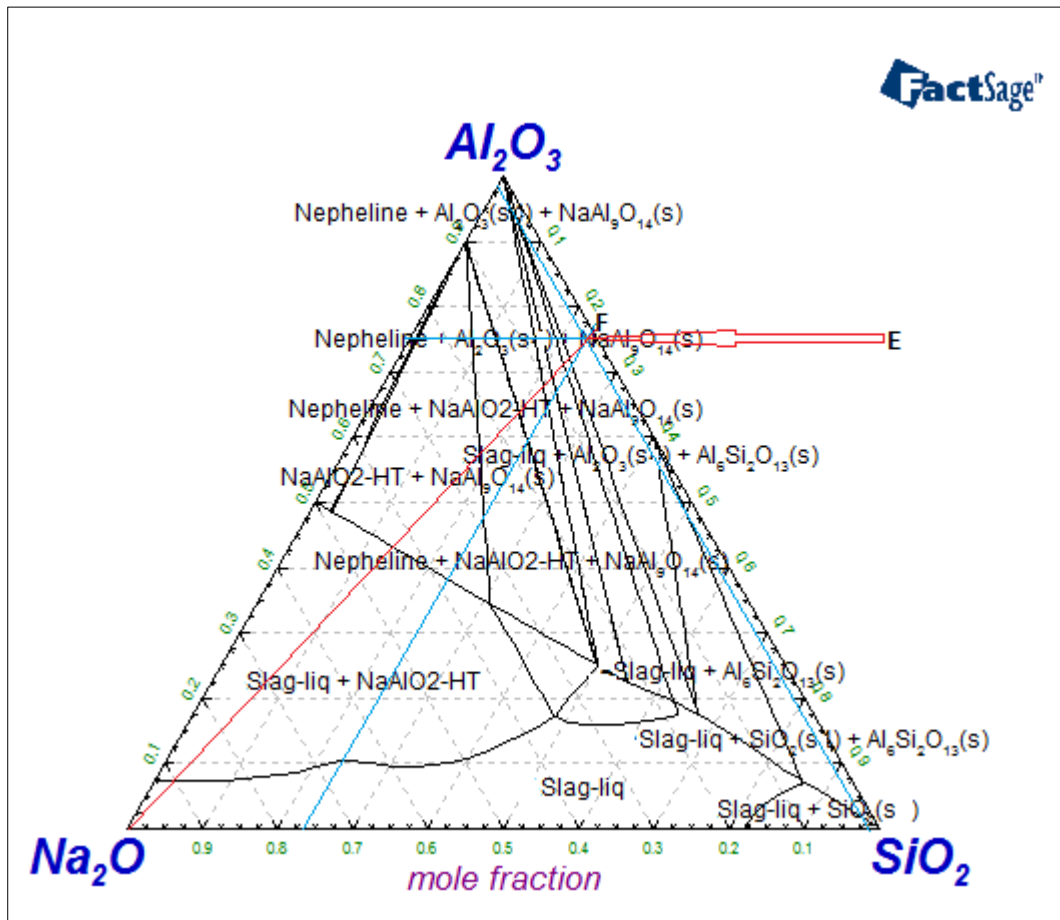
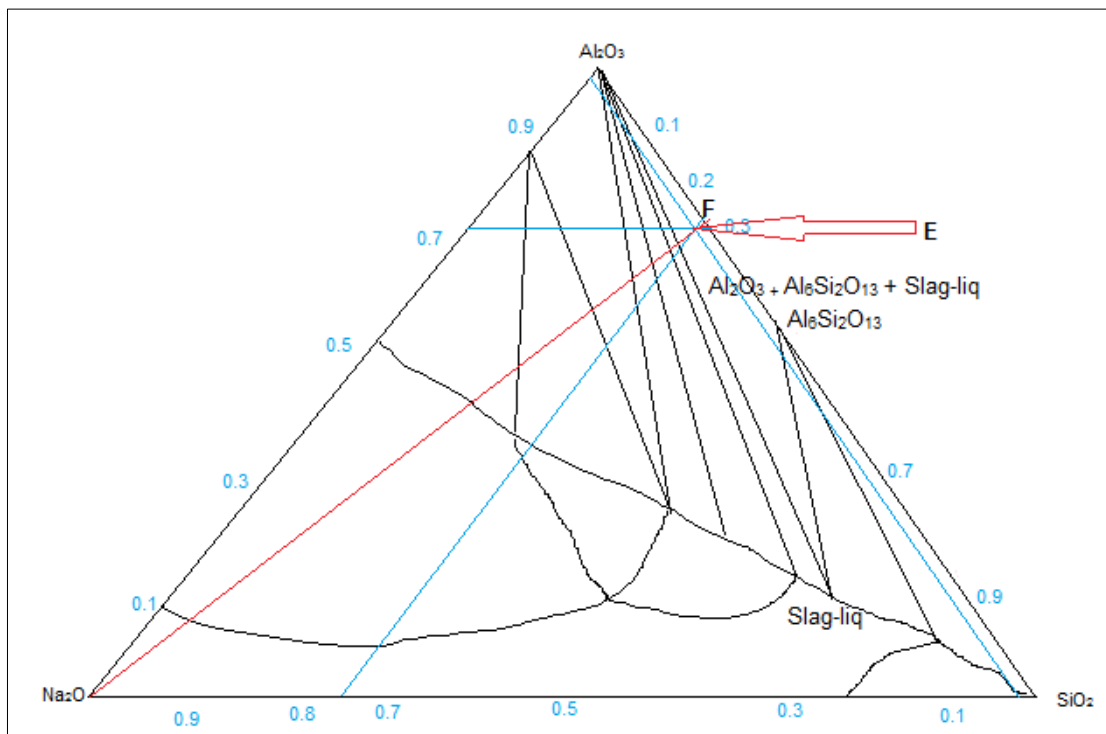
The presence of  $\text{Na}_2\text{O}$  content at any given concentration in the high-alumina brick automatically result in liquid formation in the brick. This liquid formation will result in premature failure of the high-alumina brick.

Figure 5-5. System  $\text{Al}_2\text{O}_3$ - $\text{SiO}_2$ - $\text{Na}_2\text{O}$  ternary phase diagram at 1200°C and 1 atmosphere

Figure 5-6. System  $\text{Al}_2\text{O}_3$ - $\text{SiO}_2$ - $\text{Na}_2\text{O}$  ternary phase diagram at  $1200^\circ\text{C}$  and 1 atmosphere

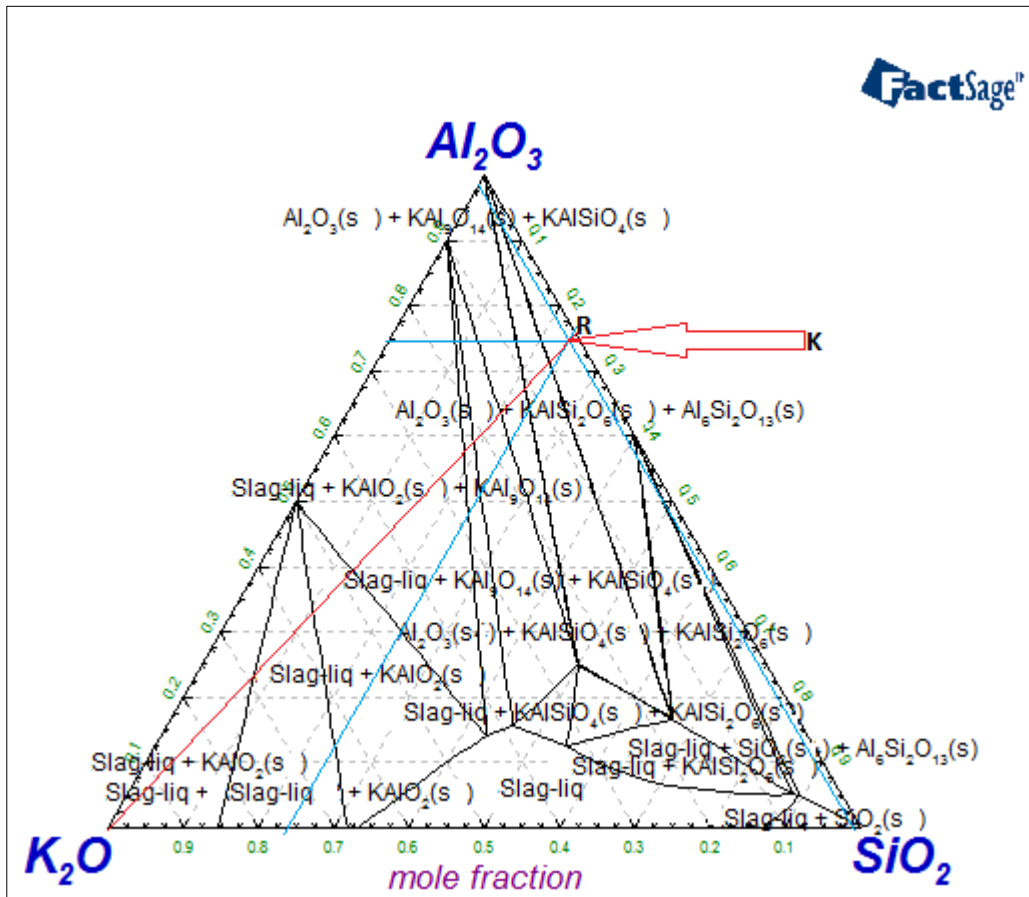
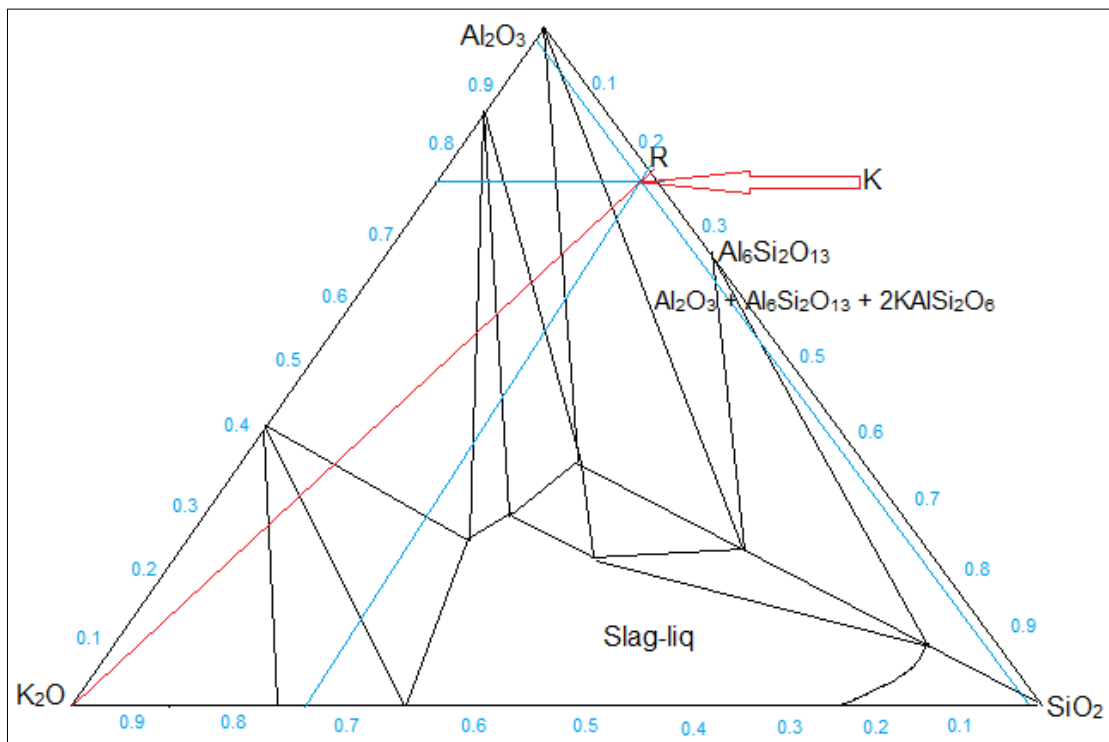
lining. These phase transformations to slag-liquid result in premature failure of the high-alumina brick.

Figure 5-7. System  $\text{Al}_2\text{O}_3$ - $\text{SiO}_2$ - $\text{K}_2\text{O}$  ternary phase diagram at  $1200^\circ\text{C}$  and 1 atmosphere

Figure 5-8. System  $\text{Al}_2\text{O}_3$ - $\text{SiO}_2$ - $\text{K}_2\text{O}$  ternary phase diagram at  $1200^\circ\text{C}$  and 1 atmosphere
