**MINE GAS AND COAL DUST EXPLOSIONS AND METHANE OUTBURSTS - THEIR  
CAUSES AND PREVENTION**

**A Dissertation submitted to the Faculty of Engineering,  
University of the Witwatersrand, Johannesburg, for the Degree of  
Master of Science in Engineering**

**Johannesburg 1990**

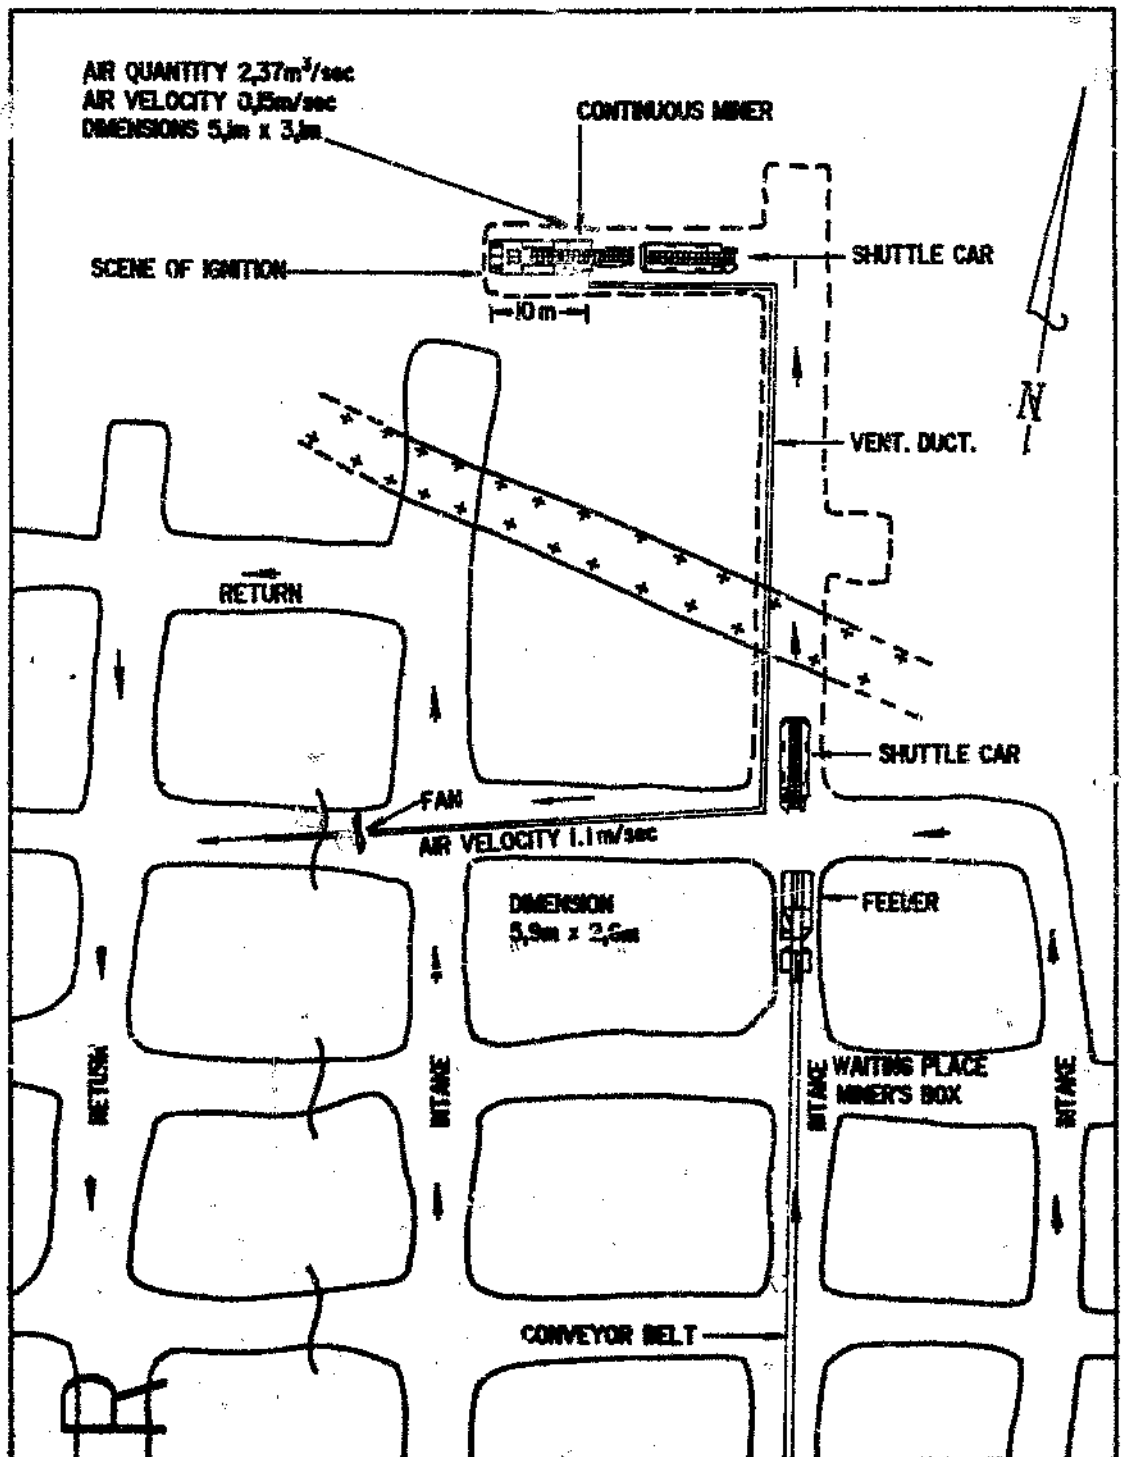
**Figure 22**

The No. 4 seam lies at a depth of approximately 180 metres and the explosion scene is depicted on the plan Figure 22. The section, worked on the bord and pillar system, had intersected a 6 metre wide dyke which had burnt the coal on either side for approximately 15 metres. Both the main and the left hand companion had penetrated the dyke and the split off the main haulage was being advanced in a westerly direction to hole with the left hand companion. The face was 37 metres from the last through road which recorded a velocity of intake air of 1,1 metres per second, well above the legal standard of 0,25 metres per second. The seam height in the section was approximately 3 metres.

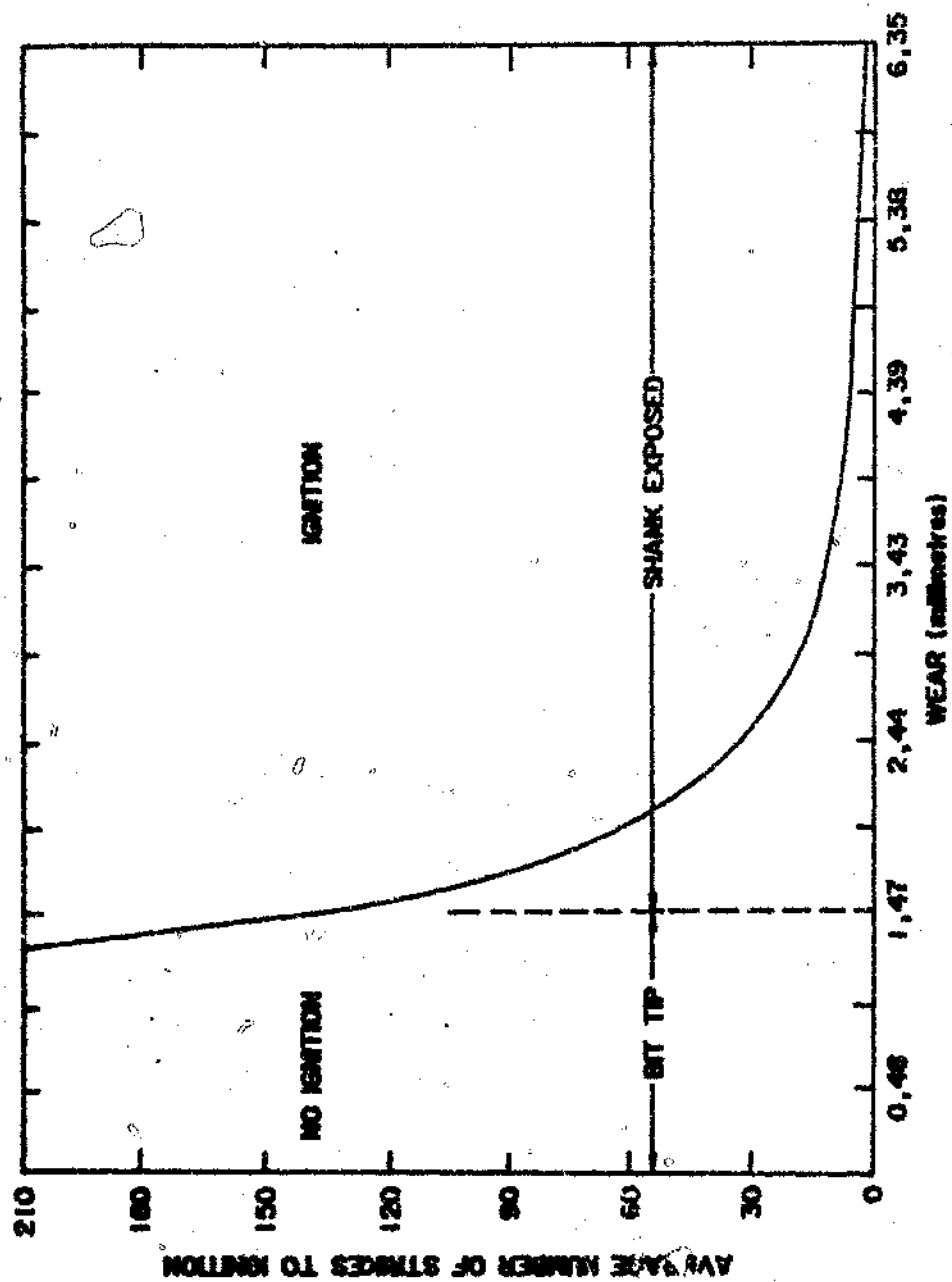
**Figure 40**

The main feature of both of the designs pictured for each bit type is a modification in tip geometry to prevent early exposure of the shank during the cutting cycle. The plumb-bob design has recently been evaluated in laboratory studies using the modified bits mounted on the Joy shearer drum. Both the conventional plumb-bob bit and a modified "mushroom" plumb-bob design were mounted on the drum at diametrically opposed points and tested against a sandstone block.

**EFFECT OF CUTTING BIT WEAR IN INCREASING  
THE POTENTIAL OCCURRENCE OF FRICTIONAL  
IGNITIONS OF METHANE-AIR MIXTURES**

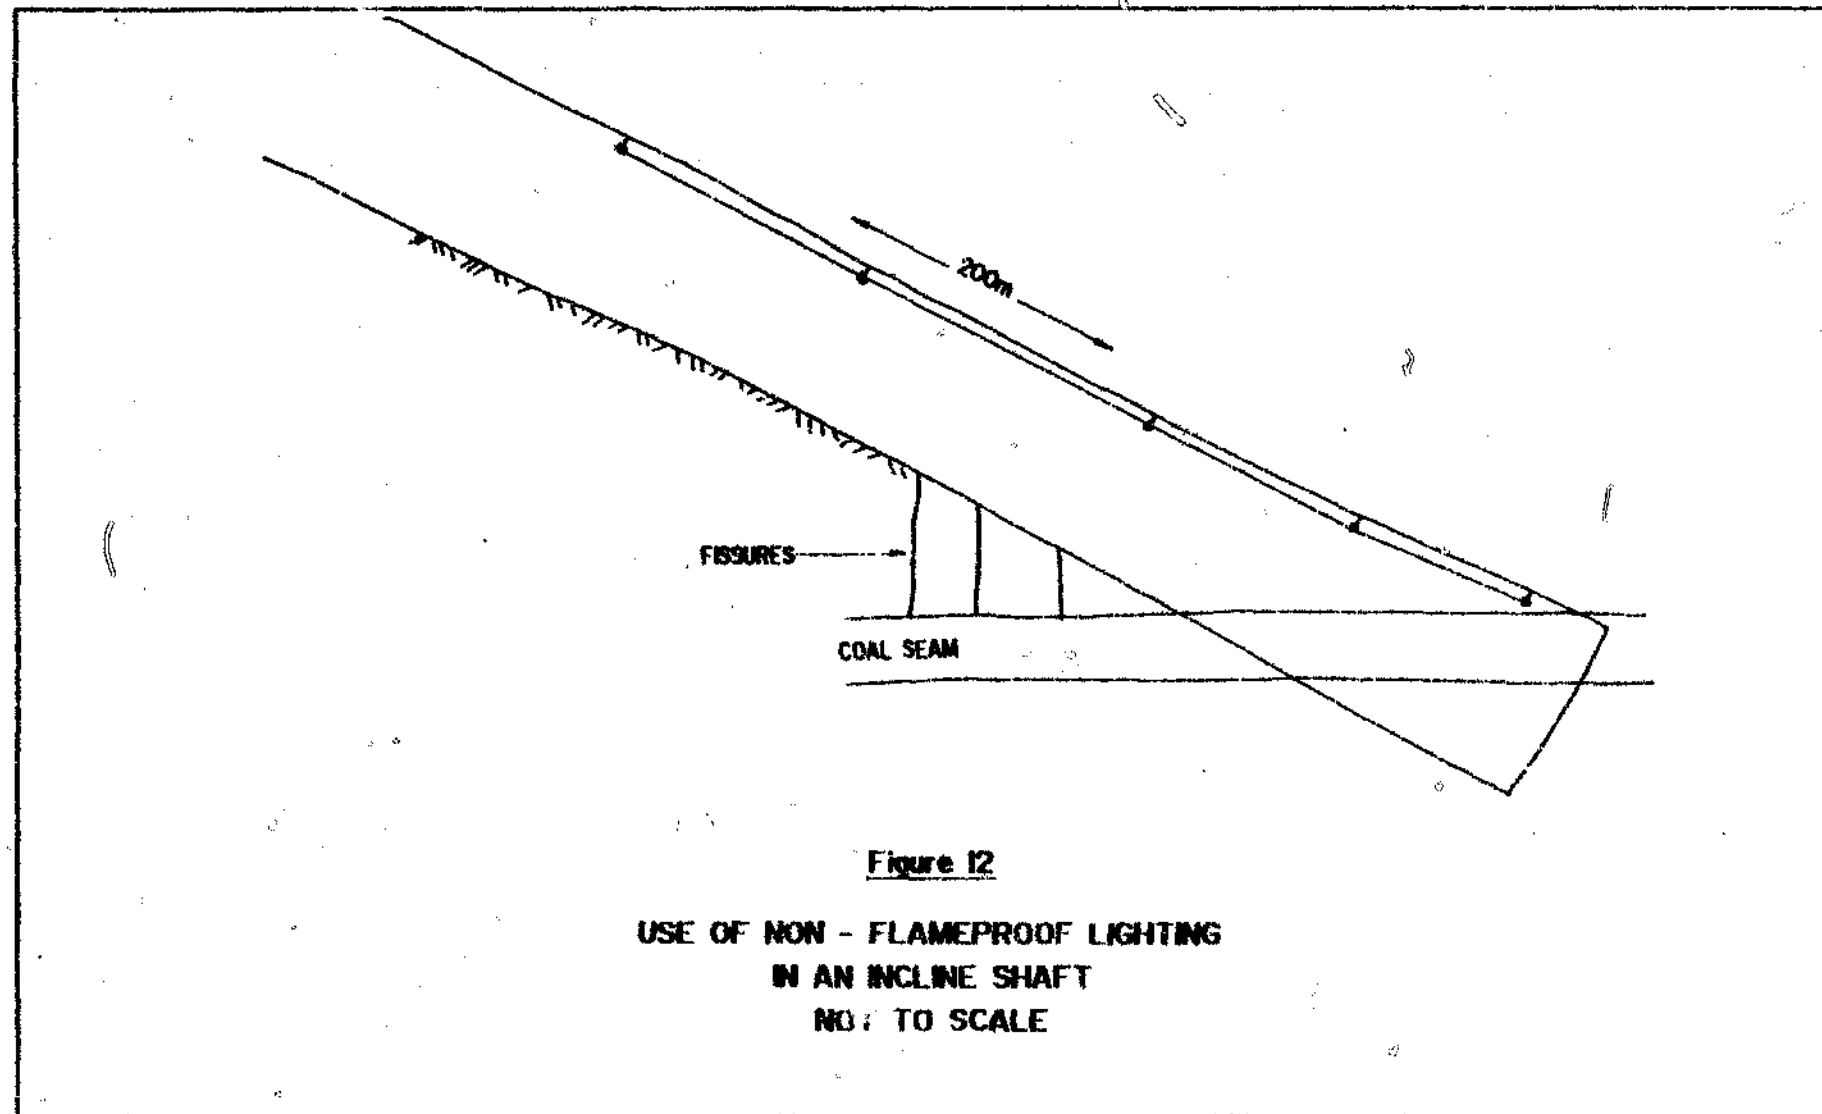
12. The use of non-flameproof lights in a sinking shaft where methane is being given off freely, could lead to a methane explosion. The methane being diluted has to flow back up the shaft over non-flameproof lights as shown in Figure 12.

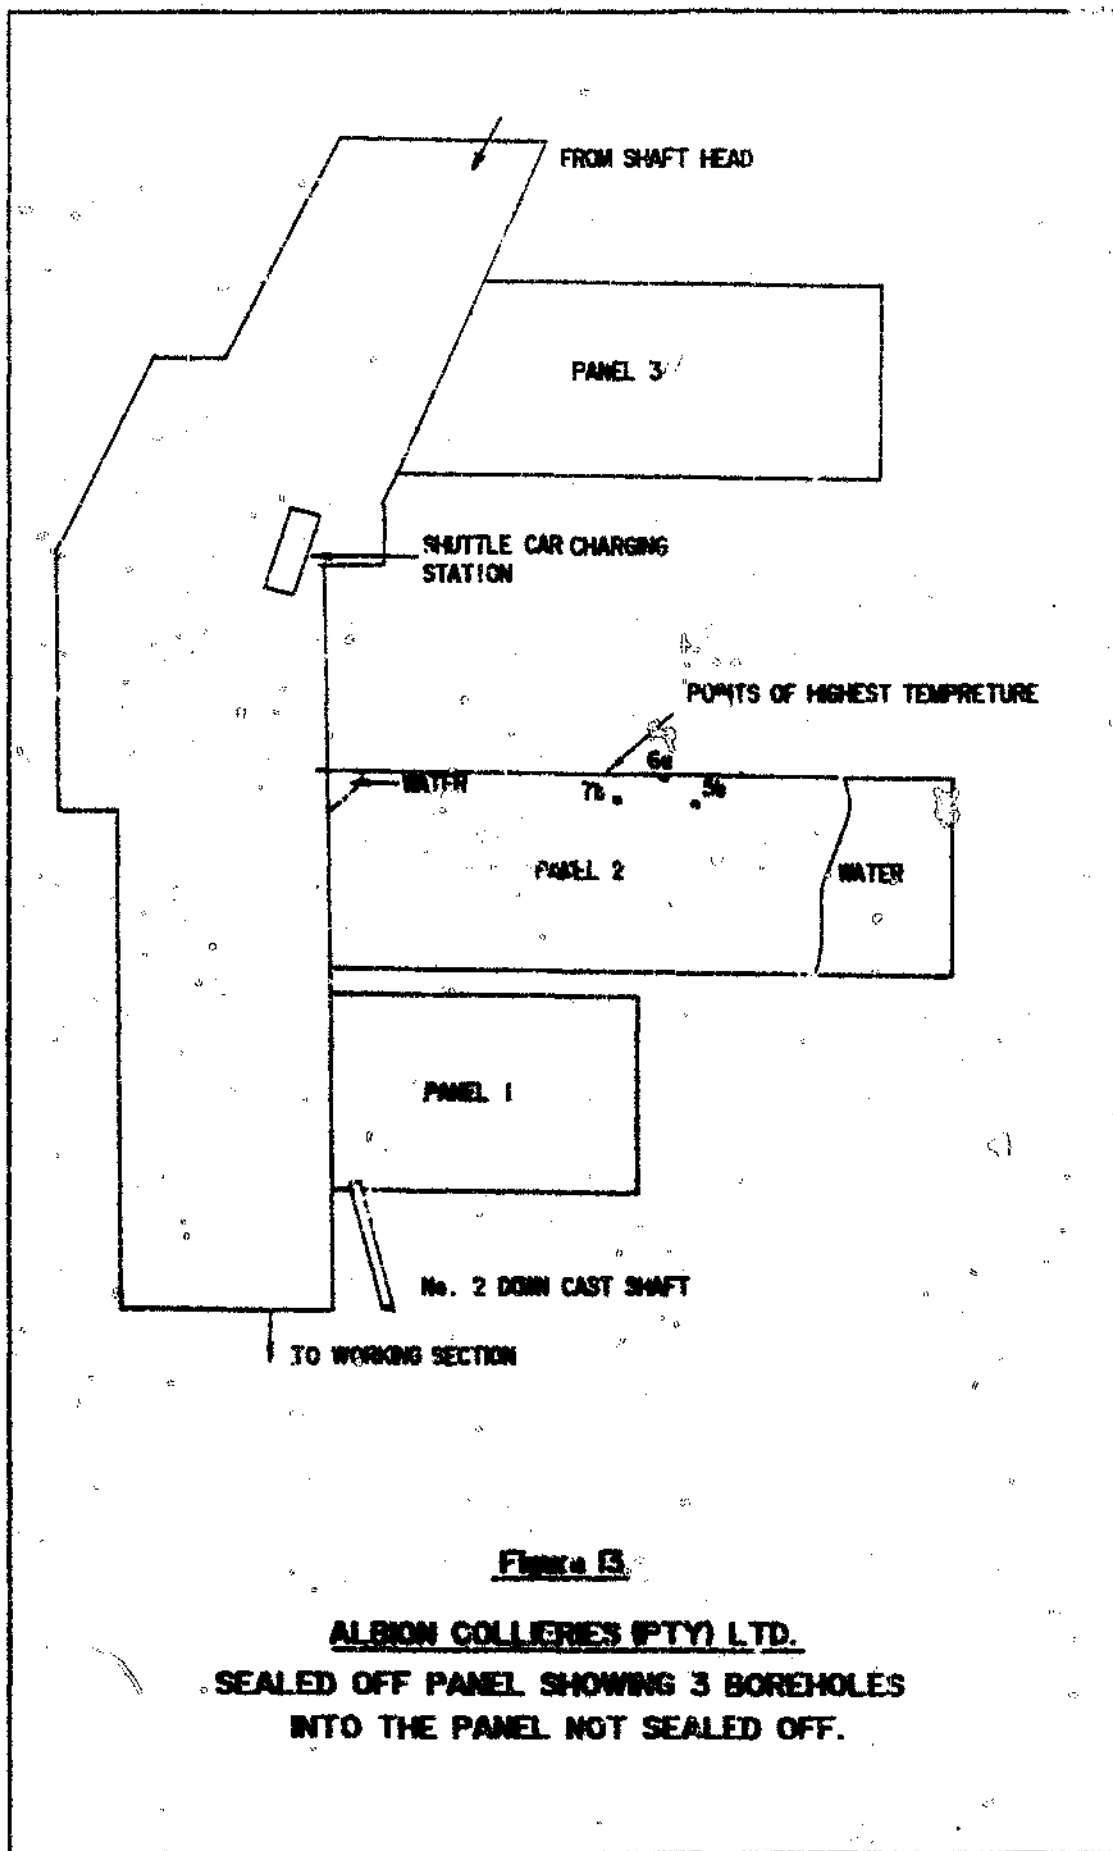
**Figure 13**

13. In the Albion Colliery explosion, three prospecting boreholes from surface to an abandoned panel (the seat of the explosion) were not shown on the mine plans and hence not sealed on surface. One of these boreholes was cased with a steel pipe. See Figure 13.
