**Mitigating against induced stress from the Merensky Reef pillars  
on the UG2 Reef mining environment,  
Tumela 1 Shaft, Anglo American Platinum**

Carol Hunter  
(Student number: 693554)

A research report submitted to the Faculty of Engineering and the Built Environment, University of the Witwatersrand, in partial fulfilment of the requirements for the degree of Master of Science in Engineering.

20 December 2019

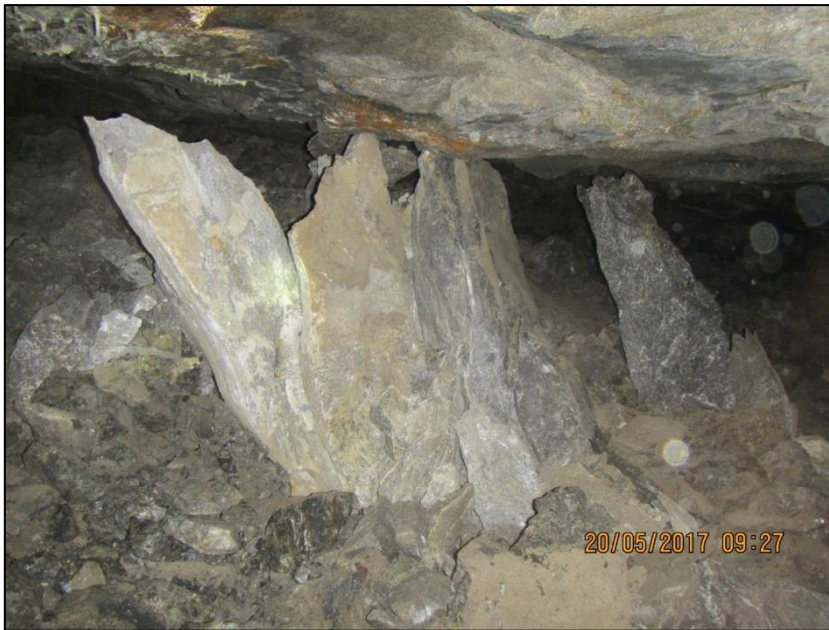
Figure 13: Rotation of footwall slabs due to footwall heave at 11-32W Merensky Reef panel

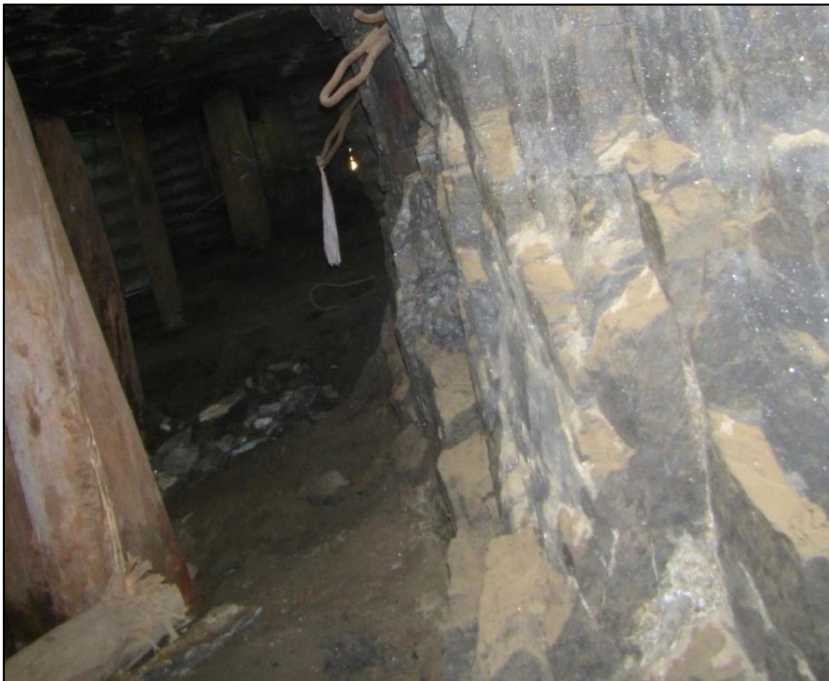
Figure 14: The superimposed UG2 Reef pillar corner, at the panel below the 11-32W Merensky Reef dynamic pillar failure, which had little sign of damage

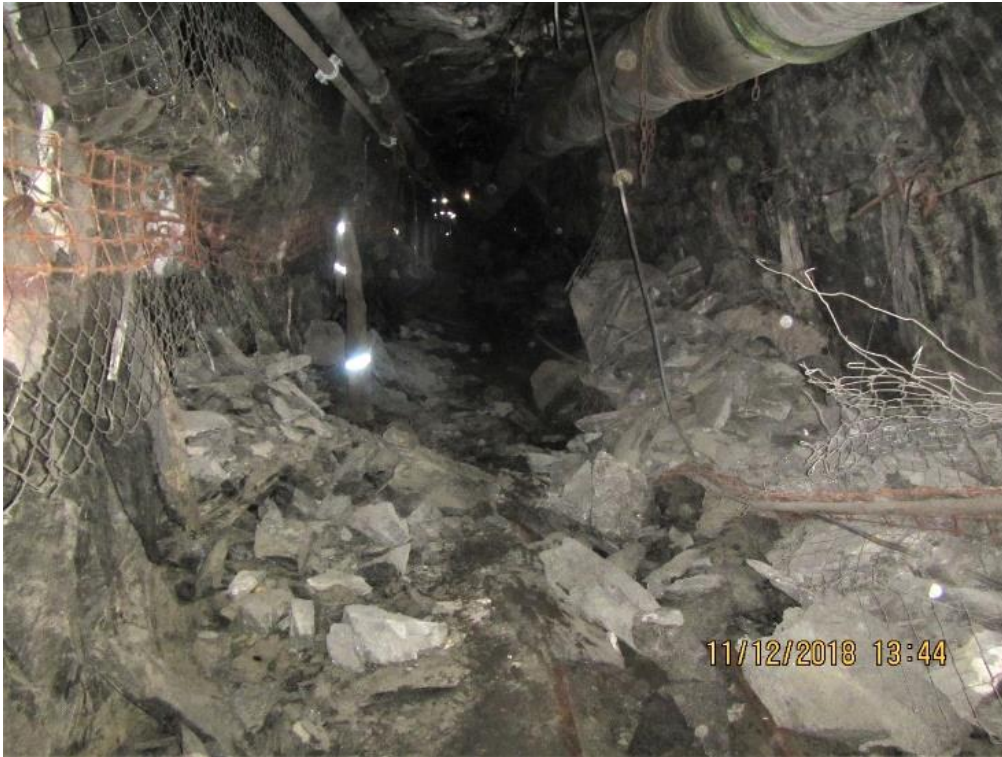
This event was unexpected as a dynamic failure of a crosscut, such as this one, had never occurred at Tumela Mine previously. Scaling of the crosscut sidewalls was observed from mid-2017, but this was deemed to be manageable with the installation of secondary support and visual monitoring.

Figure 16: Photograph showing the 14-23W crosscut after dynamic failure

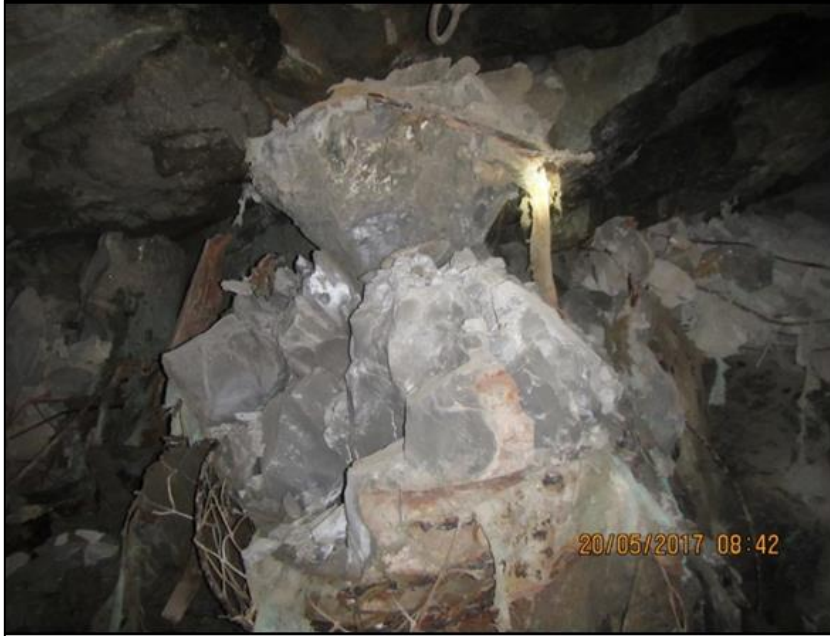
Figure 28: Grout pack failure showing excessive closure. These grout packs were adjacent to the centre gully. This pack was originally 1.0 m in diameter

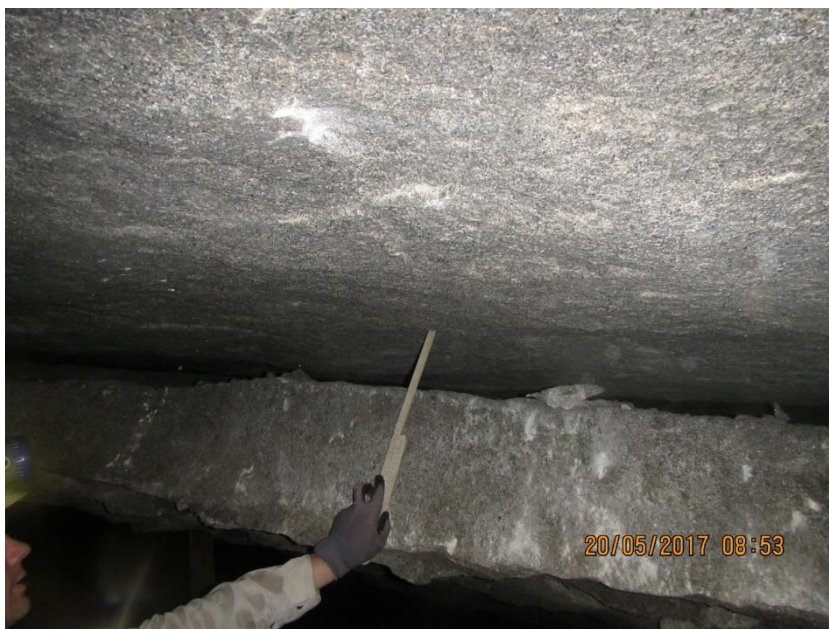
Figure 29: Hangingwall detachment in the vicinity of the failed pillar

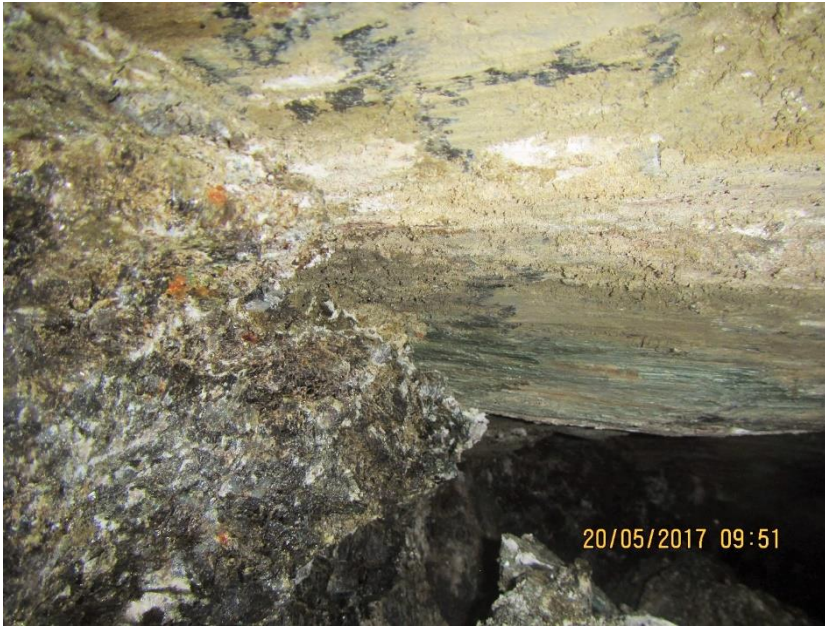
Figure 30: The failed Merensky Reef pillar. Movement along a contact plane between the pillar and the hangingwall

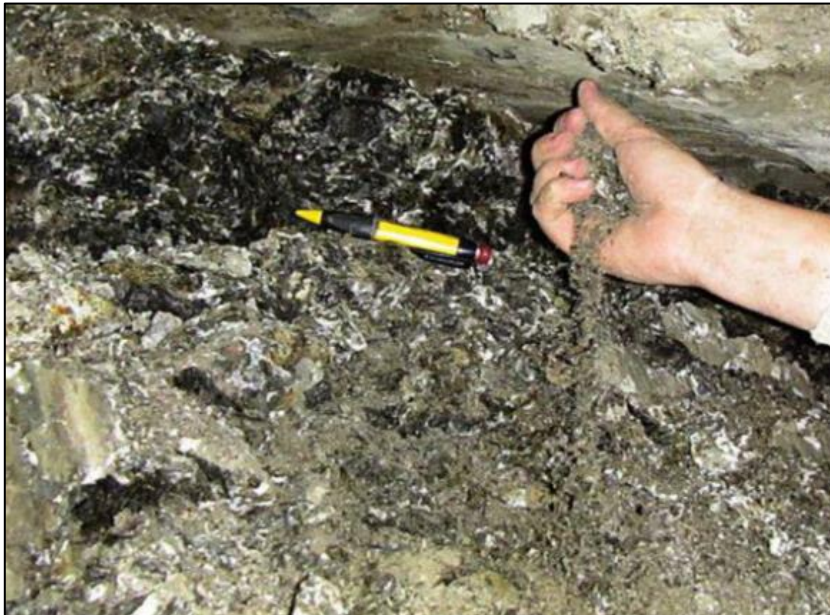
Figure 31: The failed Merensky Reef pillar showing the high energy release to completely disintegrate the structure of rock

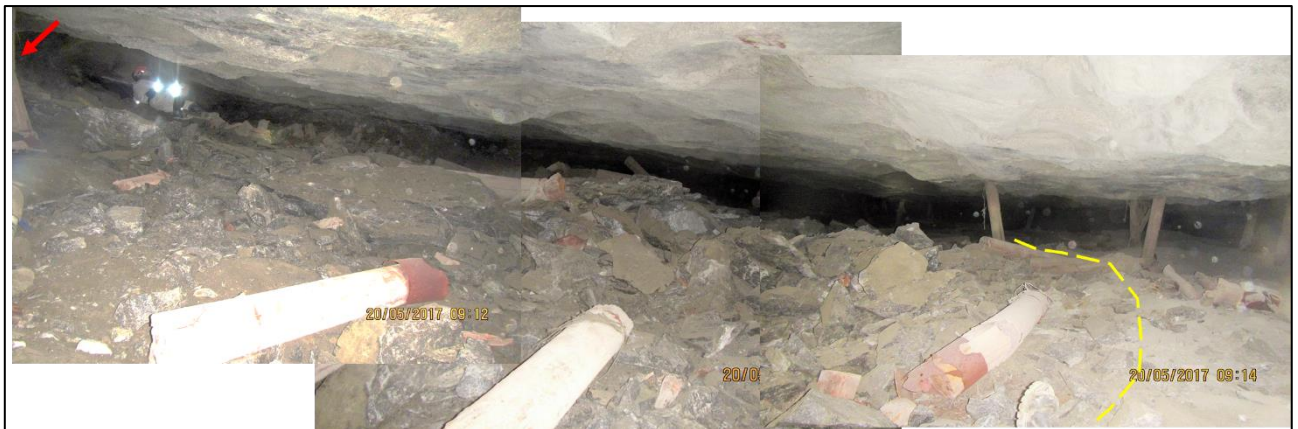
Figure 32: The footwall heave zone (approximately 10 m radius) around the failed Merensky Reef pillar. The red arrow indicates the pillar position

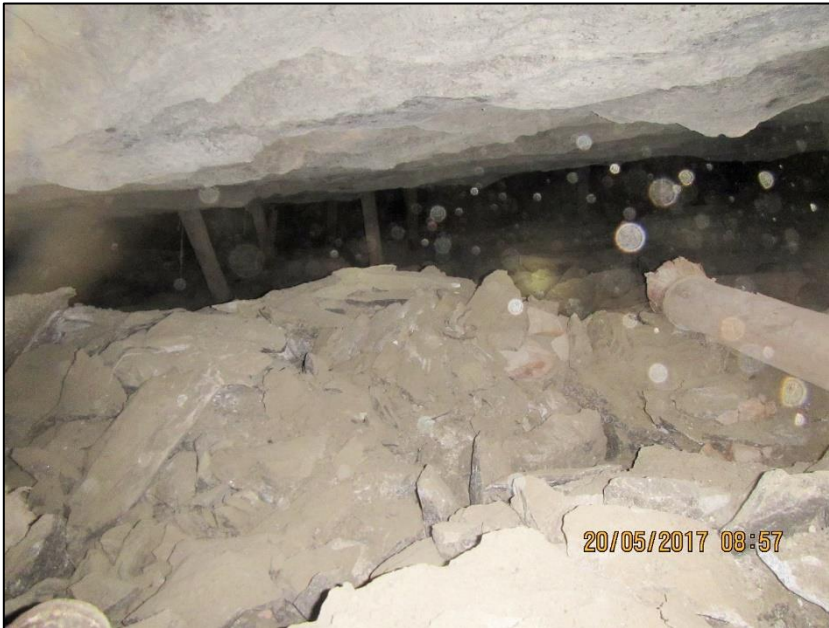
Figure 33: Footwall heave around the failed Merensky Reef pillar

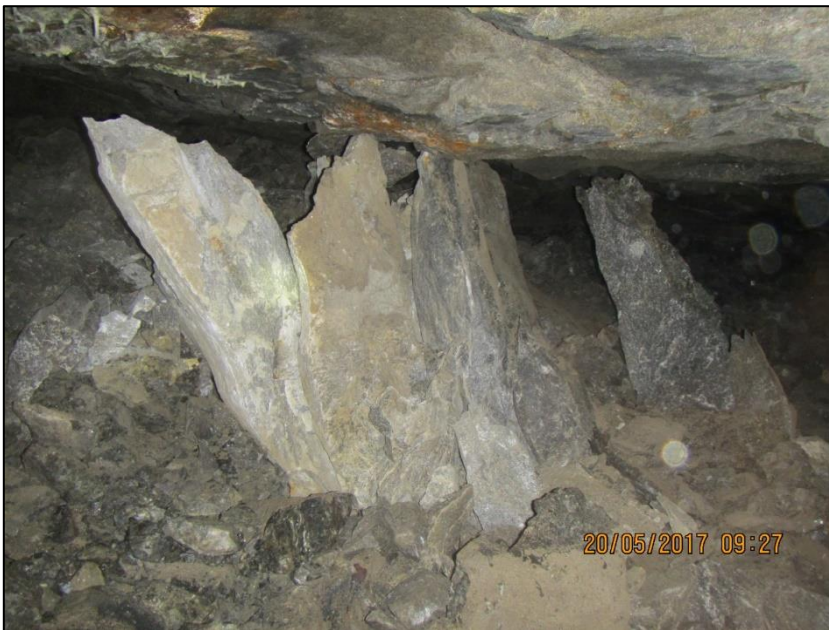
Figure 34: Rotation of footwall slabs due to footwall heave

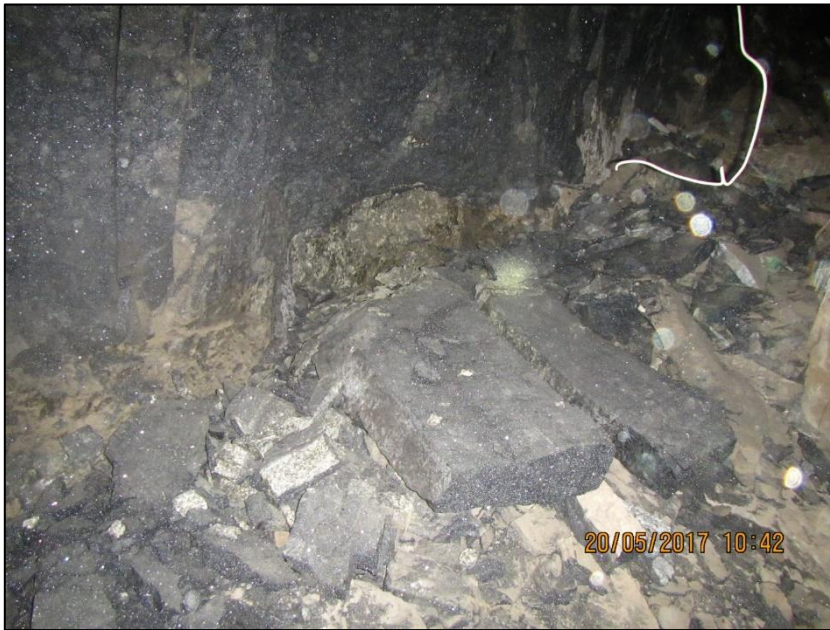
Figure 35: The superimposed UG2 Reef pillar, which had little sign of damage

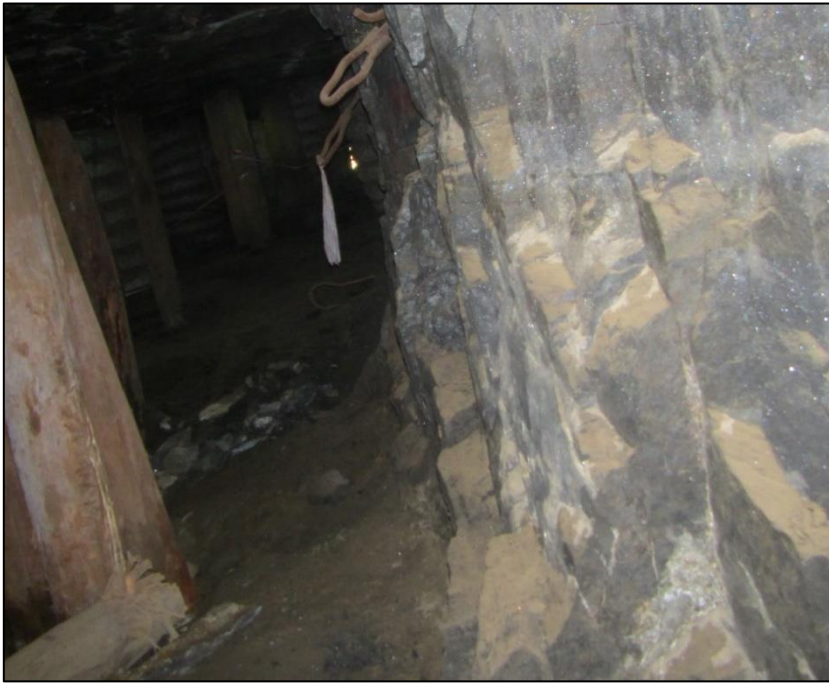
Figure 36: The superimposed UG2 Reef pillar corner, which had little sign of damage

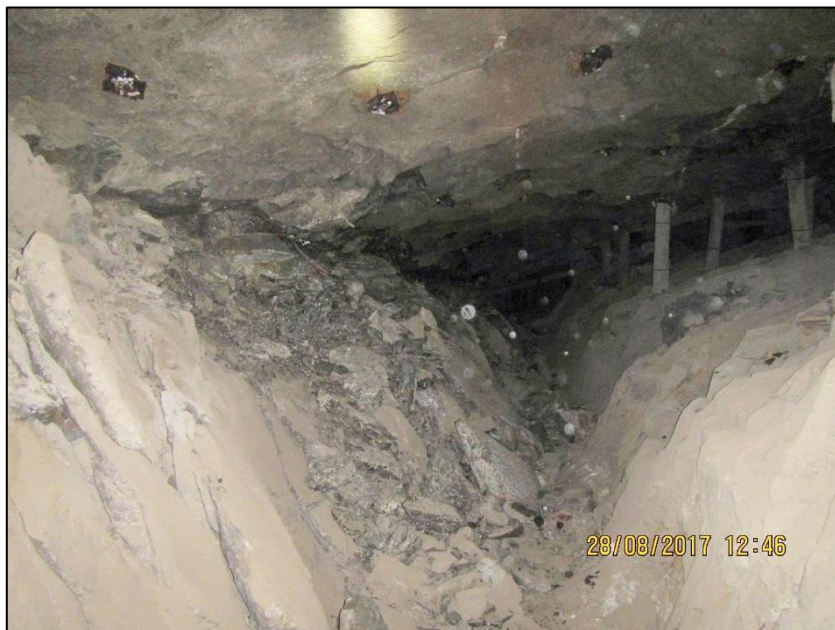
Figure 38: Lateral dilation of the Merensky Reef pillar into the ASG

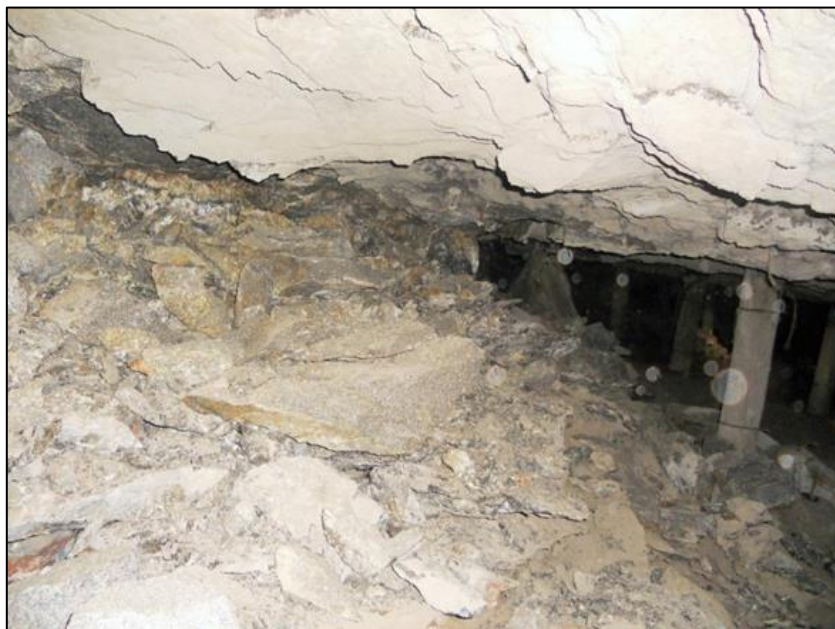
Figure 39: Damage to Merensky Reef pillar

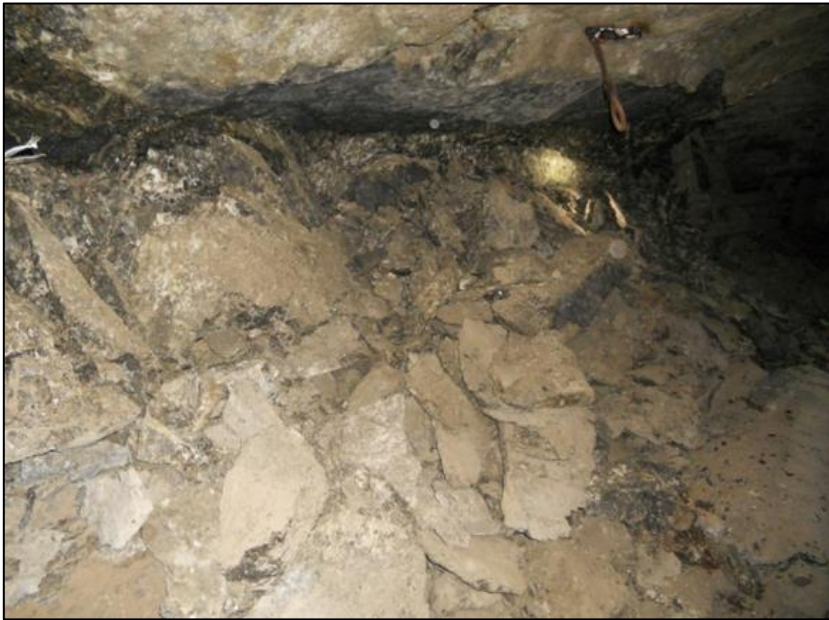
Figure 40: The failed Merensky Reef pillar

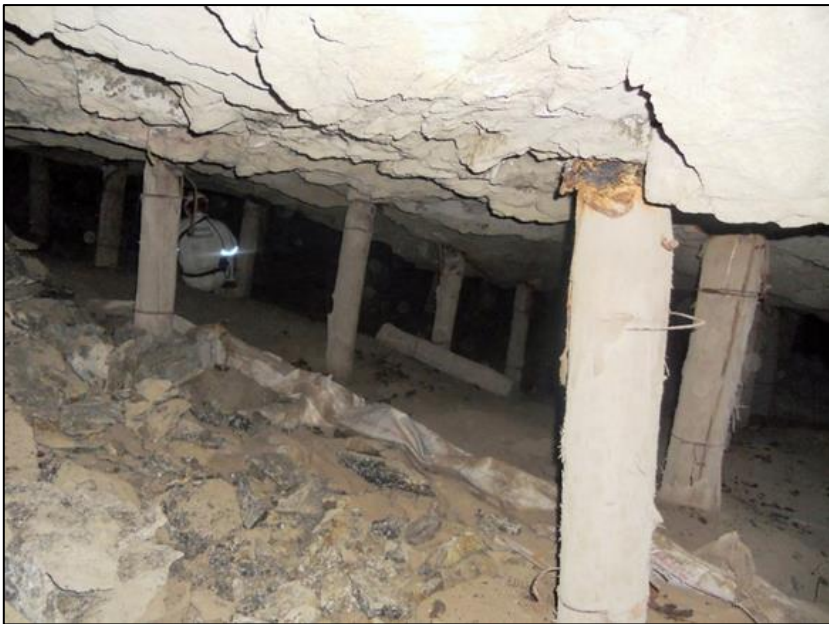
Figure 41: Footwall heave around the failed pillar

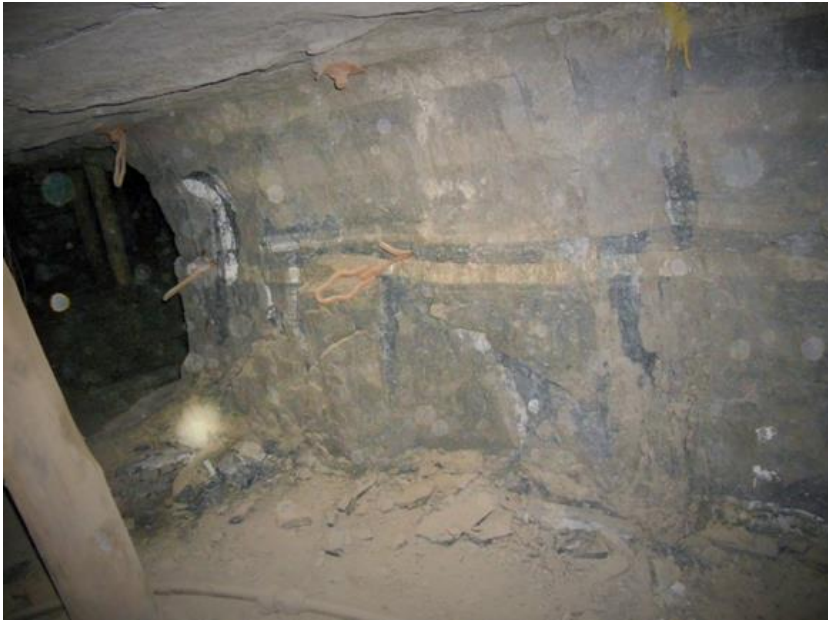
Figure 42: Damage to the superimposed UG2 Reef pillar

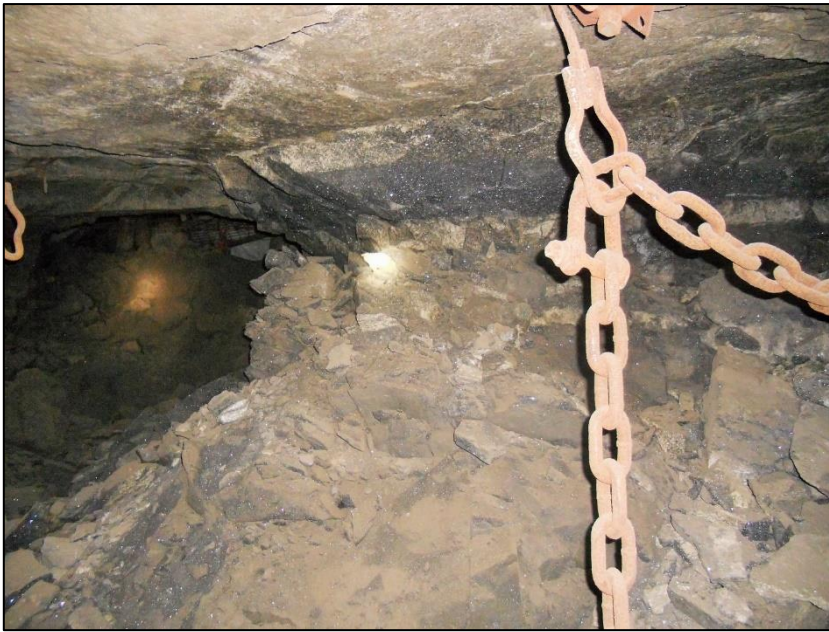
Figure 44: The failed UG2 Reef in-stope pillar

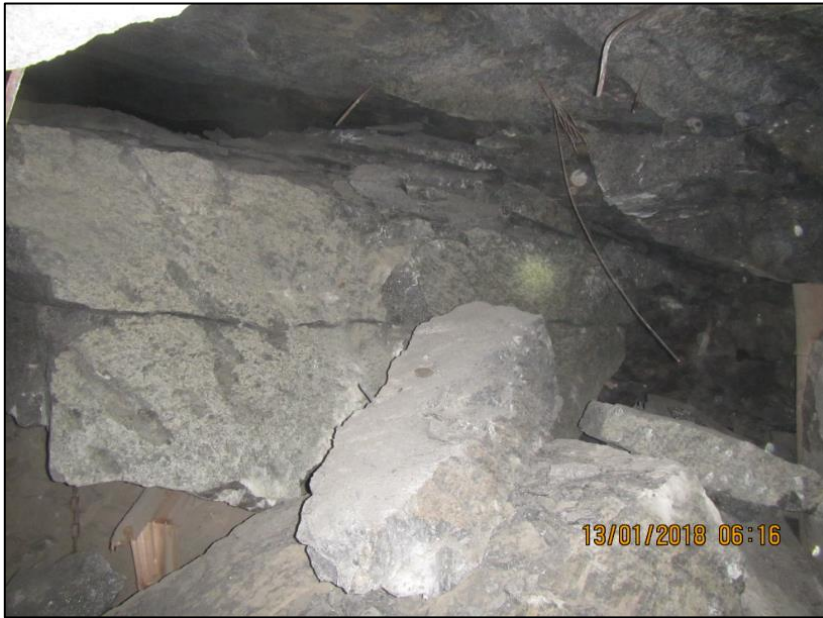
Figure 46: Hangingwall detachment of the Merensky Reef hangingwall

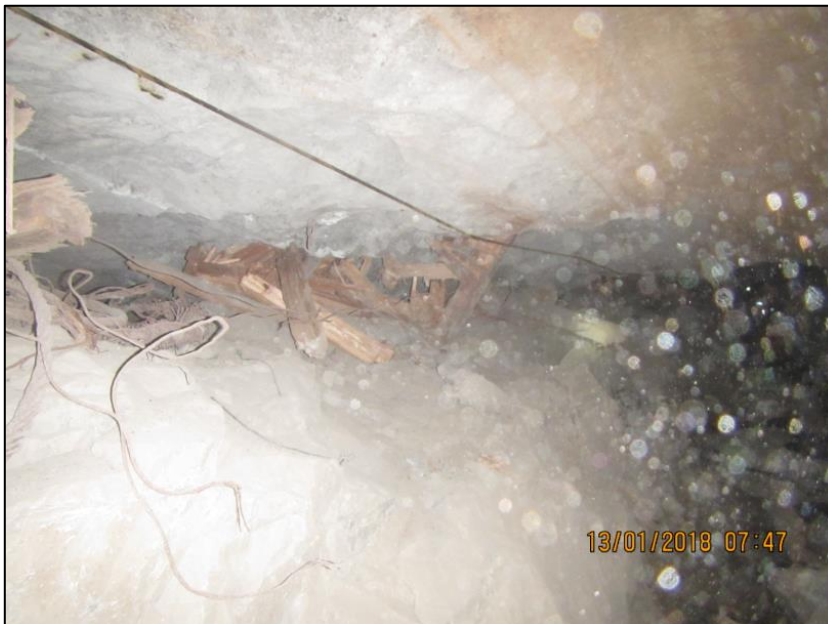
Figure 47: High closure of the Merensky Reef panels. Photo taken in the centre gully

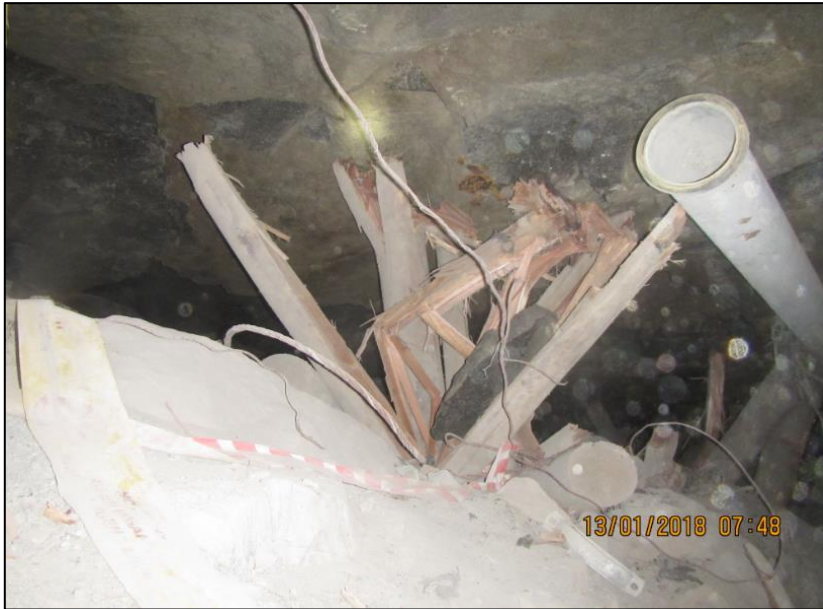
Figure 48: Very high closure of the Merensky Reef panels. Photo taken in the centre gully

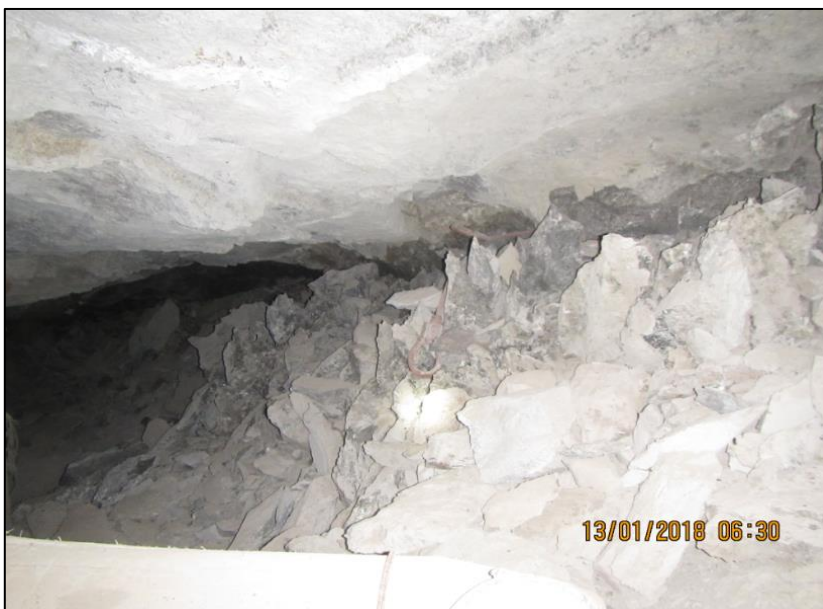
Figure 49: Crushed (completely failed) Merensky Reef pillars

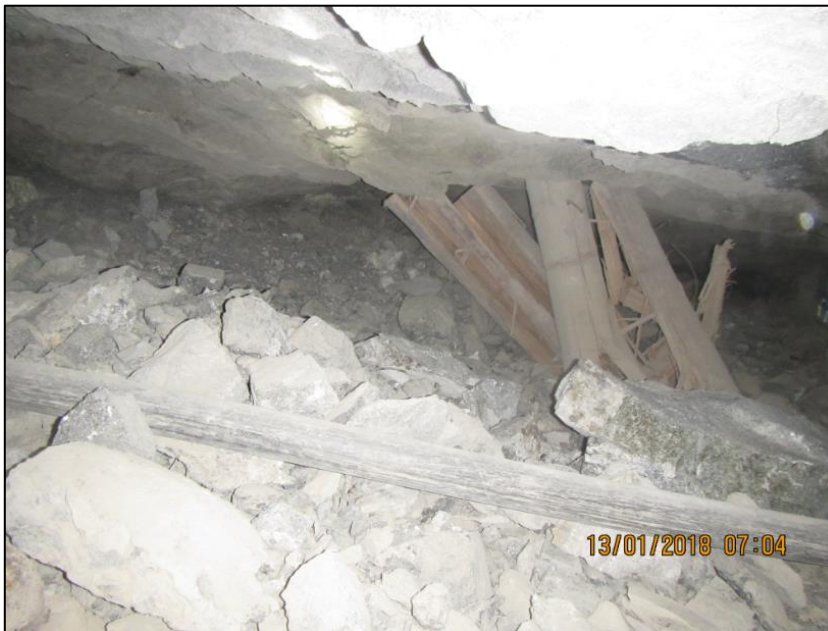
Figure 50: The footwall heave around the failed Merensky Reef pillar

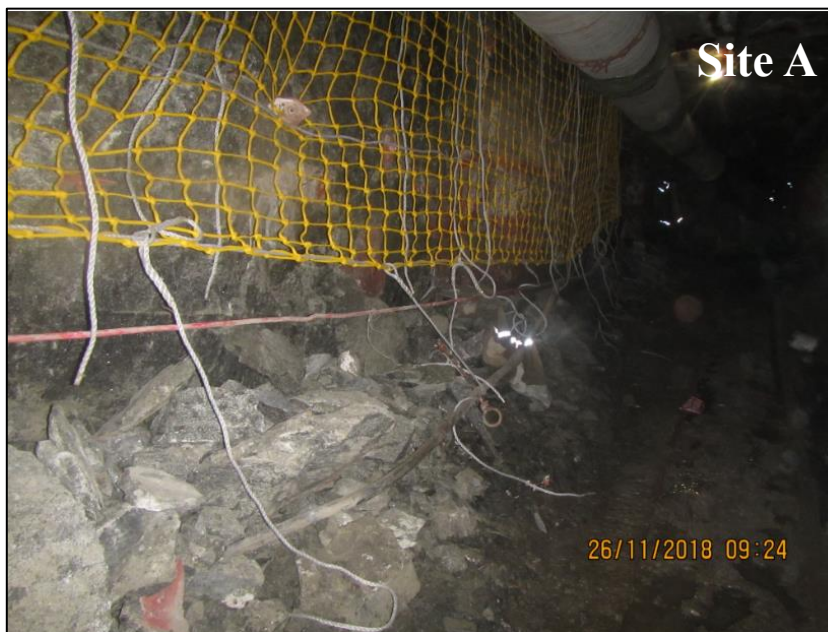
Figure 73: 14-23W UG2 crosscut - western sidewall - Approximately 20 m from travelling way. Shake-down damage. This sidewall was previously reported to be scaling excessively. Net was installed as a remedial measure

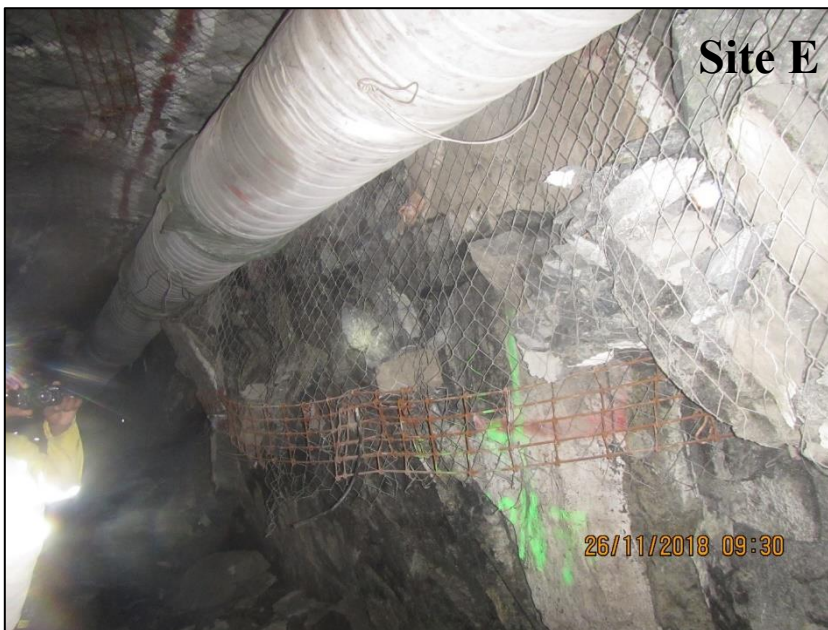
Figure 77: 14-23W UG2 crosscut - western sidewall. The secondary support in this area was highly tensioned as the cable anchors were observed to be pulled into the sidewall. This sidewall was very unstable
