# **GENERATOR PLANT CONDITION ASSESSMENT AT DUVHA POWER STATION**

A research report submitted to the Faculty of Engineering and the Built Environment, of the University of the Witwatersrand, in partial fulfilment of the requirements for the degree of Master of Science in Engineering.

Johannesburg 2010

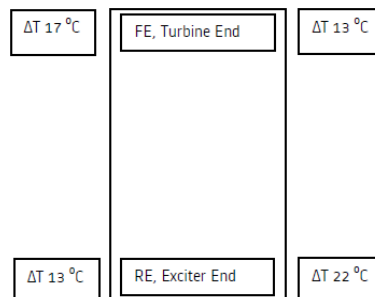
**Figure 15. hydrogen Cooler  $\Delta T$  Analysis**

An analysis of the Hydrogen Cooler performance revealed poor cooling performance, see figure 15.

The left hand (LH) Turbine End (TE) cooler average  $\Delta T$  was 16.56 °C and the Exciter End (EE) average  $\Delta T$  was 13.24 °C. The Right Hand (RH) Exciter End cooler average  $\Delta T$  was 22.19 °C and the TE average  $\Delta T$  was 12.9 °C. The design  $\Delta T$  value across the coolers should be 20 - 29 °C. Only one cooler on unit 1 is performing within specification.

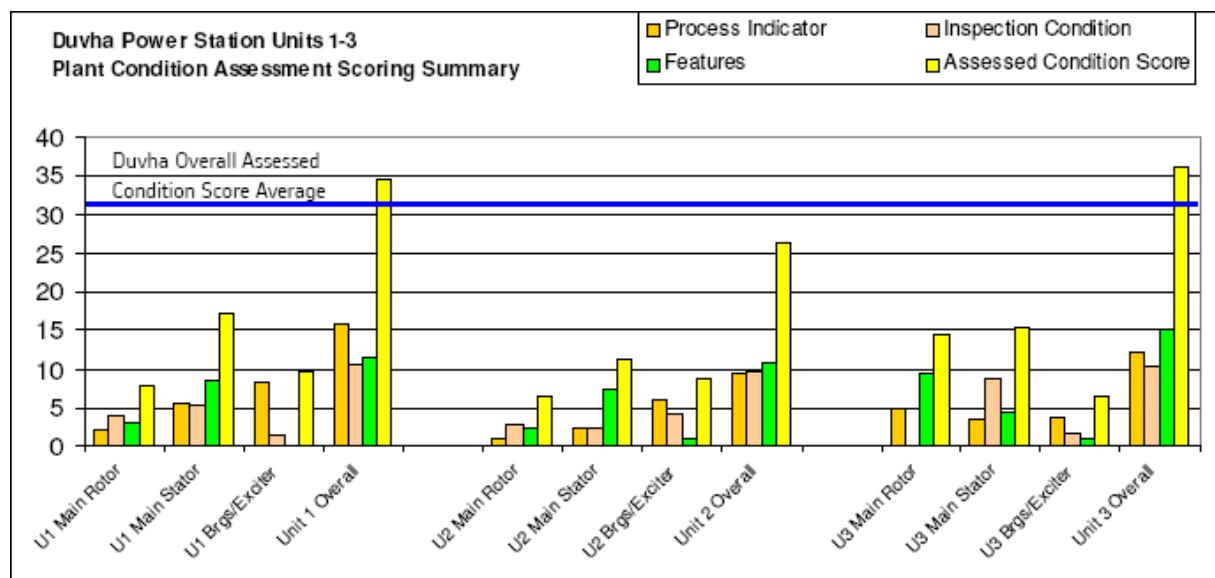
**Figure 16. Duvha Power Station Units 1-3 Plant Condition Assessment Scoring [17]**

Figures 16 and 17 illustrate the subcomponent scores having been grouped into the key component areas of main rotor, main stator and bearing & exciter, with the summation of the unit overall score for each unit. A discussion of figure 16 and 17 is presented below for the individual units:

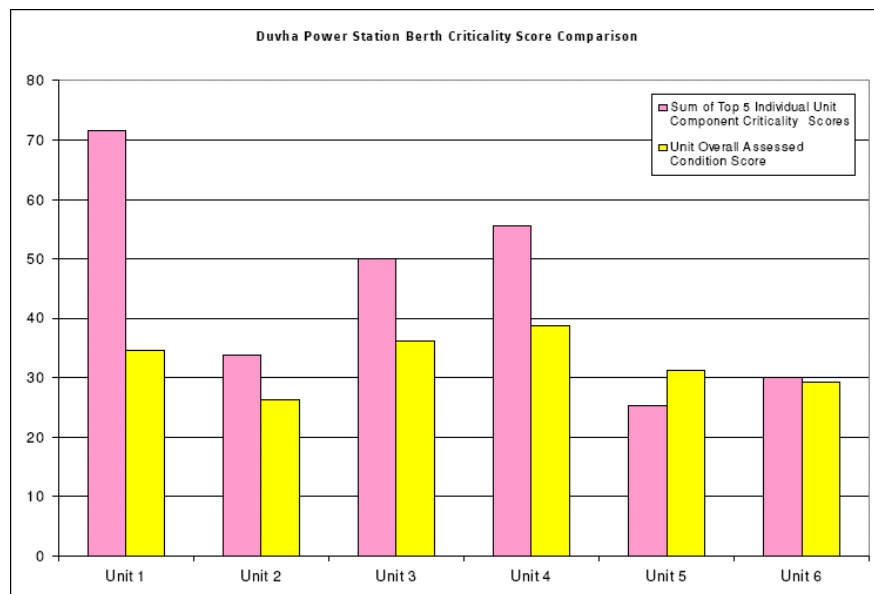
**Figure 18. Duvha Power Station Unit Criticality Score Comparison [17]**

Figure 18, shows the highest unit criticality being unit 1 with its key drivers being the Process Parameters findings. The adverse vibration trend on bearing 11 is also a significant identified operational risk. It is expected that short to medium term actions addressing the key drivers will reduce the overall assessed unit 1 criticality, thus discarding unit 1 as the most critical unit.

The second highest unit criticality is unit 4 (taken as the highest/worst unit). The general outage planned for 2010 will provide an opportunity to reduce the unit criticality. While not the highest main stator criticality assessed condition score, highest being unit 5, unit 4 represents the highest Overall Assessed Condition score.
