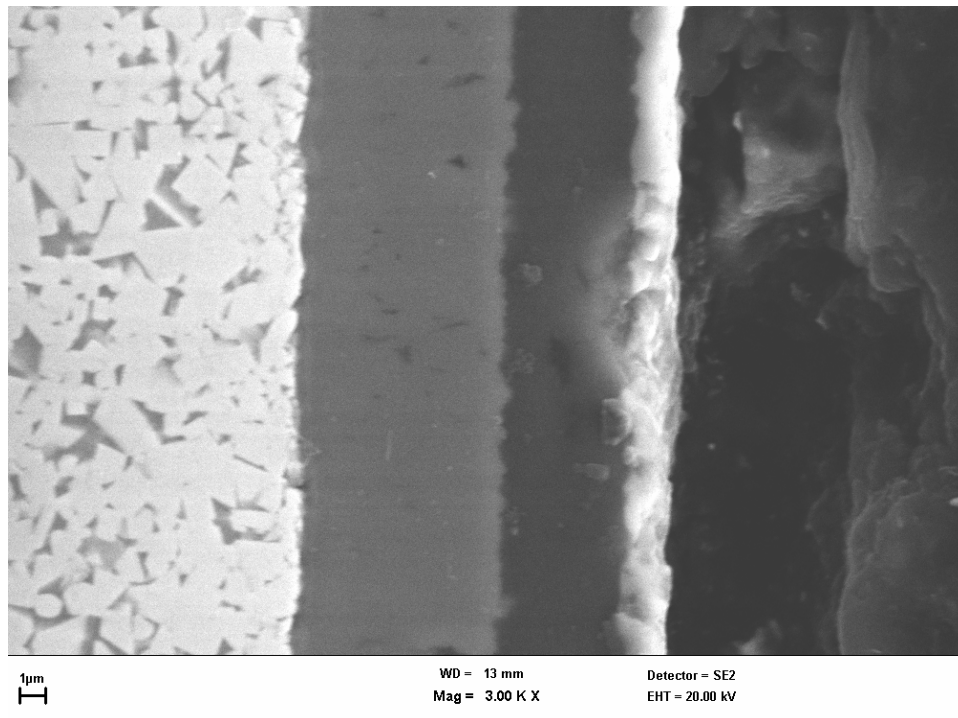
*Fig. 5.89: Interface between substrate and coating of a cutting tool insert from supplier 5*

When comparing the interfaces between the substrate and the coating of all the five suppliers, significant differences were found. The cutting tool insert from supplier 1 had the roughest interface (see Fig. 5.81) with many protruding grains. The cutting tool insert from supplier 2 had a very straight interface. Co pools could often be found along the interface (see Fig. 5.83). The cutting tool inserts from the other three suppliers 3, 4 and 5, showed an intermediate roughness, with the cutting tool insert from supplier 4 the roughest of the three cutting tool inserts. The cutting tool inserts from suppliers 3 and 5 had similar interface roughness. It seemed that in all the cutting tool inserts, except those from supplier 2, the Co was removed from the surface before depositing the coating.

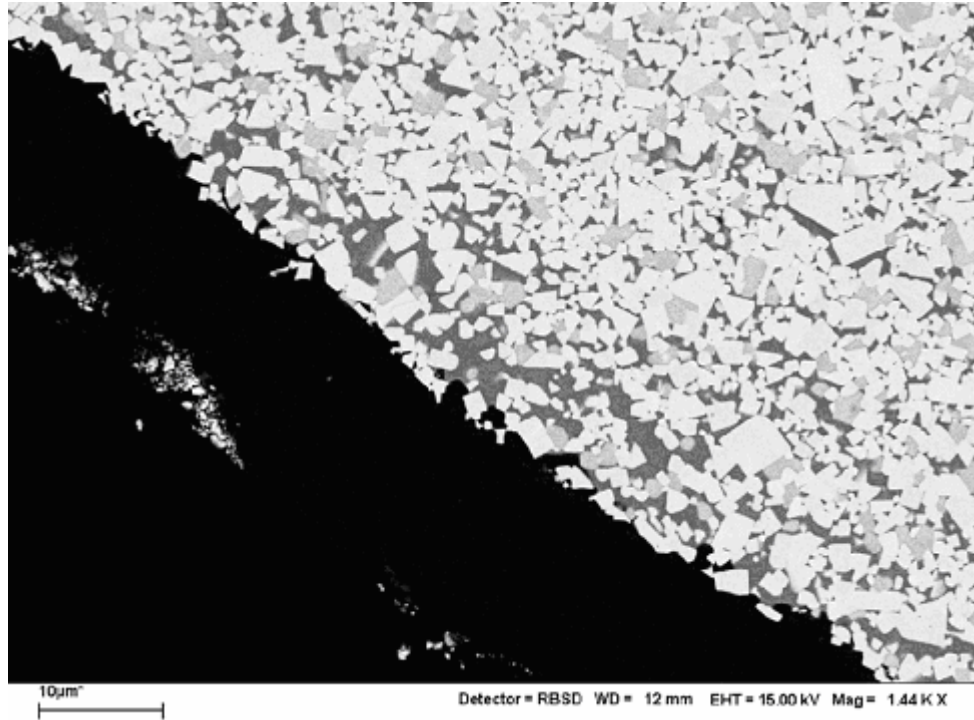
An additional interesting feature in the cutting tool insert from supplier 1 can be seen in Fig. 5.90 which shows that near the surface of the substrate there is more Co than away from the surface and the grains appear more rounded than in the rest of the substrate. There seemed to be a Co drift towards the interface which

suggests that higher temperatures may have been involved than in the other cutting tool inserts. Note that this coating system does not contain  $\text{Al}_2\text{O}_3$ , as will be reported later.

*Fig. 5.90: Interface of a cutting tool insert from supplier 1*

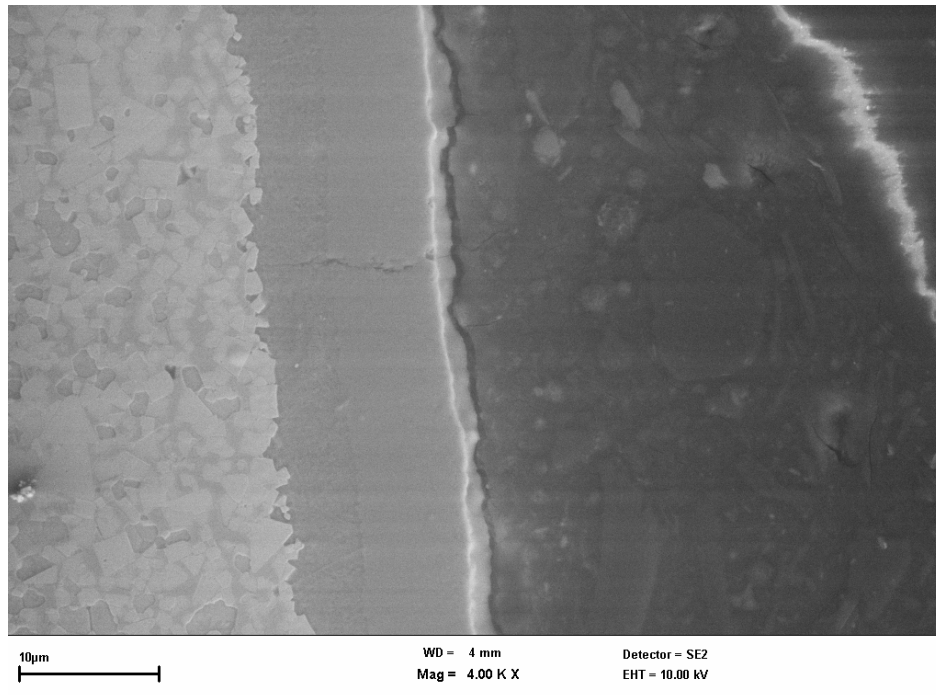
*Fig. 5.91: No porosity in the coating of the cutting tool insert from supplier 1*

In the cutting tool inserts from supplier 2, high porosity was observed in the TiCN layer of the coating, while in the cutting tool inserts from suppliers 1 and 4 hardly any porosity was found in the coatings. The porosity in the cutting tool inserts from supplier 3 was intermediate, i.e. it is higher than in the cutting tool inserts from suppliers 1 and 4 but lower than in the cutting tool inserts from supplier 2. The cutting tool insert from supplier 5 showed only little porosity.

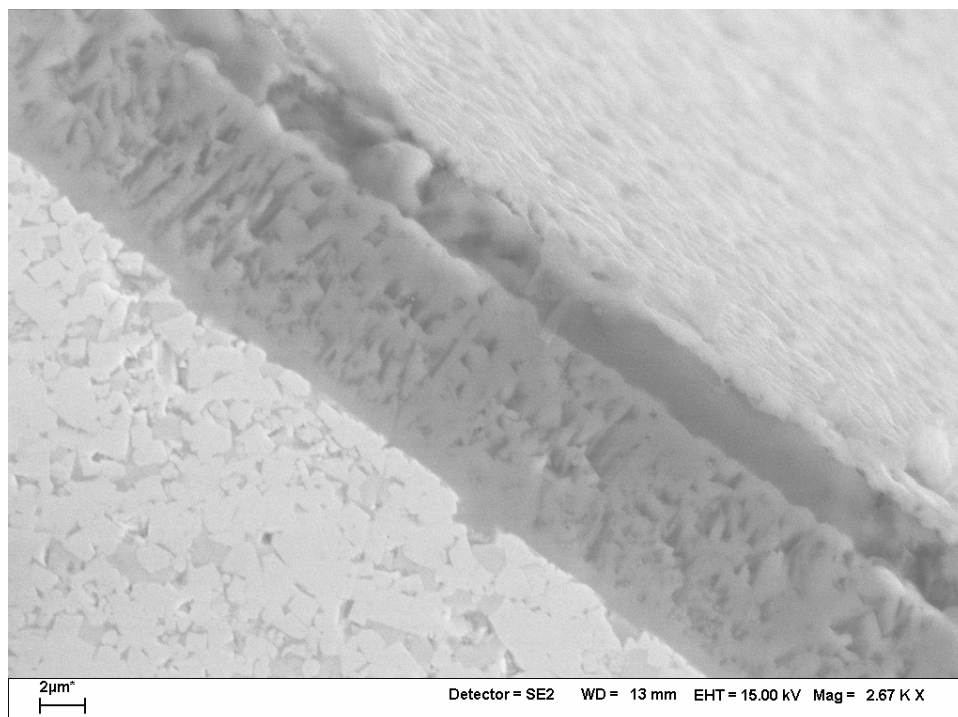
*Fig. 5.92: Porosity in the coating of the cutting tool insert from supplier 2*

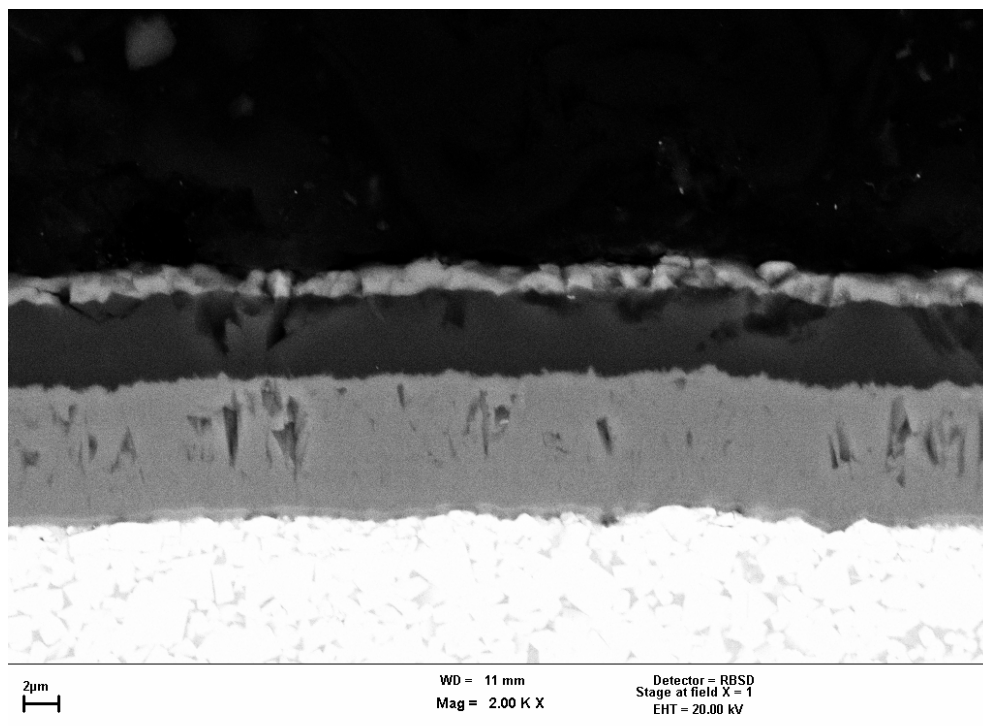
*Fig. 5.93: Porosity in the coating of the cutting tool insert from supplier 3*

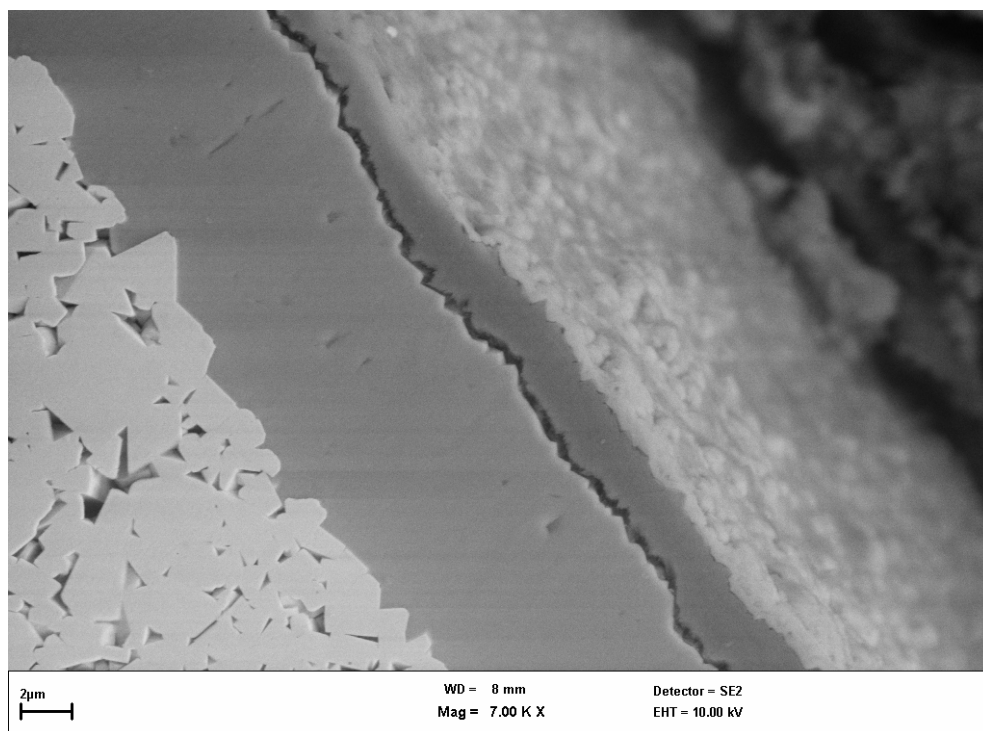
*Fig. 5.94: Rare porosity in the coating of the cutting tool insert from supplier 4*

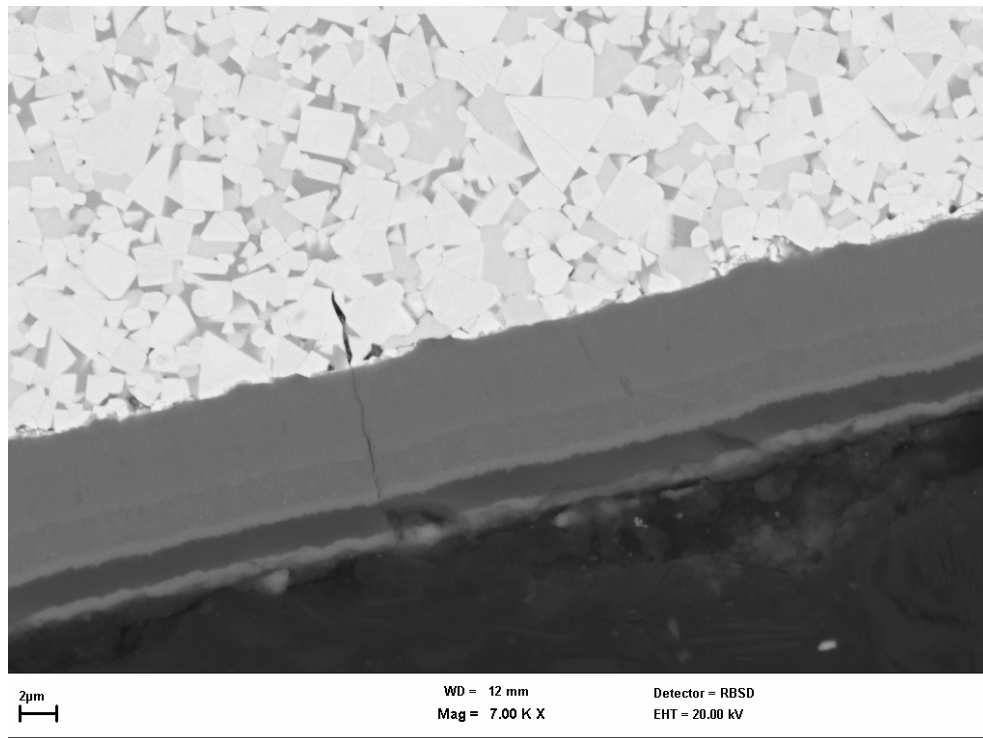
*Fig. 5.95: Low porosity in the coating of the cutting tool insert from supplier 5*
