## CHAPTER 5

### Root cause for fireside boiler tube failures

The extent and causes of fireside boiler tube failures/deterioration were investigated. The approach was based on research at three Eskom power stations located in the South Eastern Transvaal. The main contributing factors to these failures were identified as deposit-buildup, overheating, thermal fatigue and tube defects.

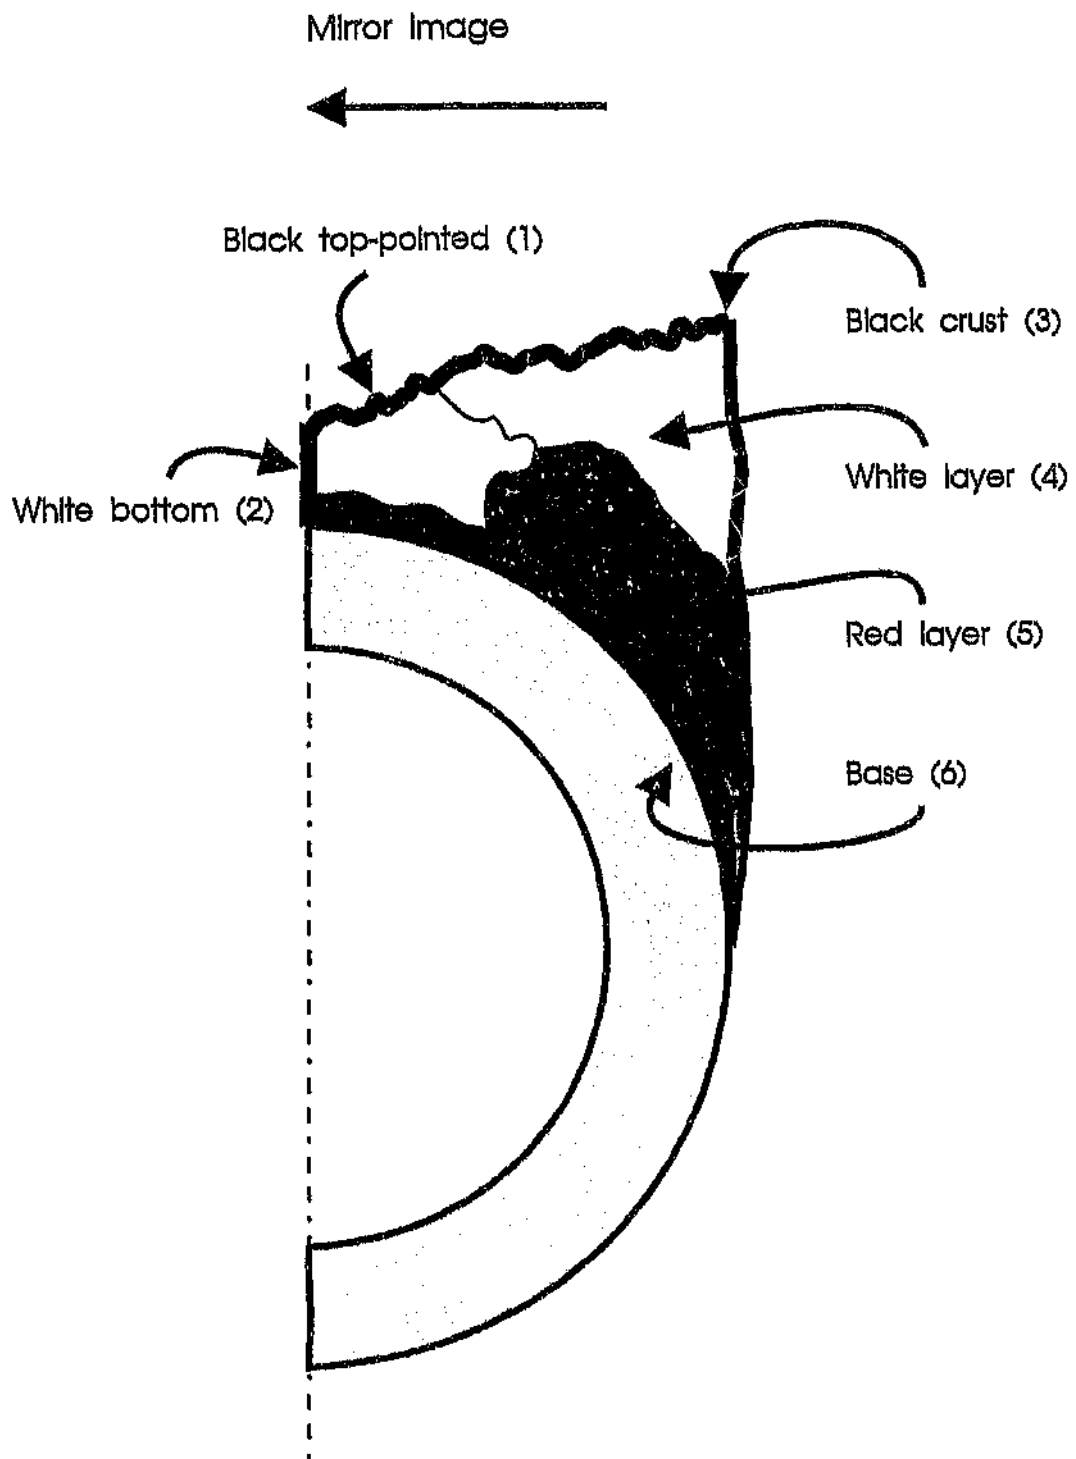
**Figure 1:**  
Secondary Superheater Inlet,  
Element 45, Row 33

a 10 mm thick ash deposit, lightly adherent and friable with no hard or glassy phase present, was observed on the fireside of the tube (Plate 2). A schematic diagram showing the accumulation and structure of the deposit layers on the tube fireside is illustrated in Figure 1.

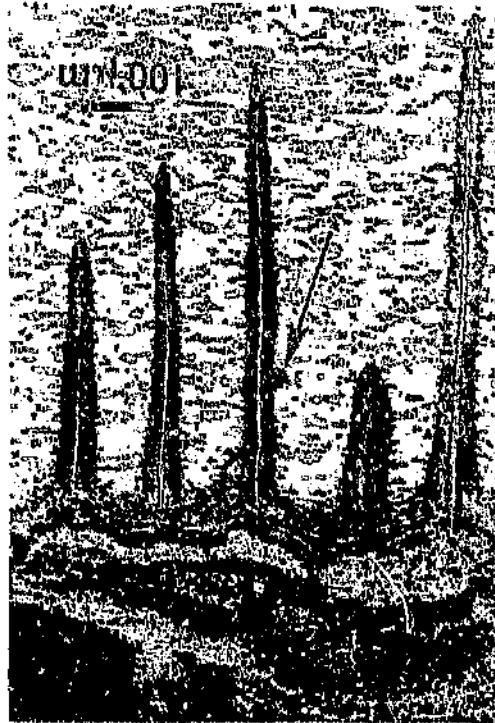
**PLATE 9: Cross-section of a circumferentially  
cracked waterwall tube.**
