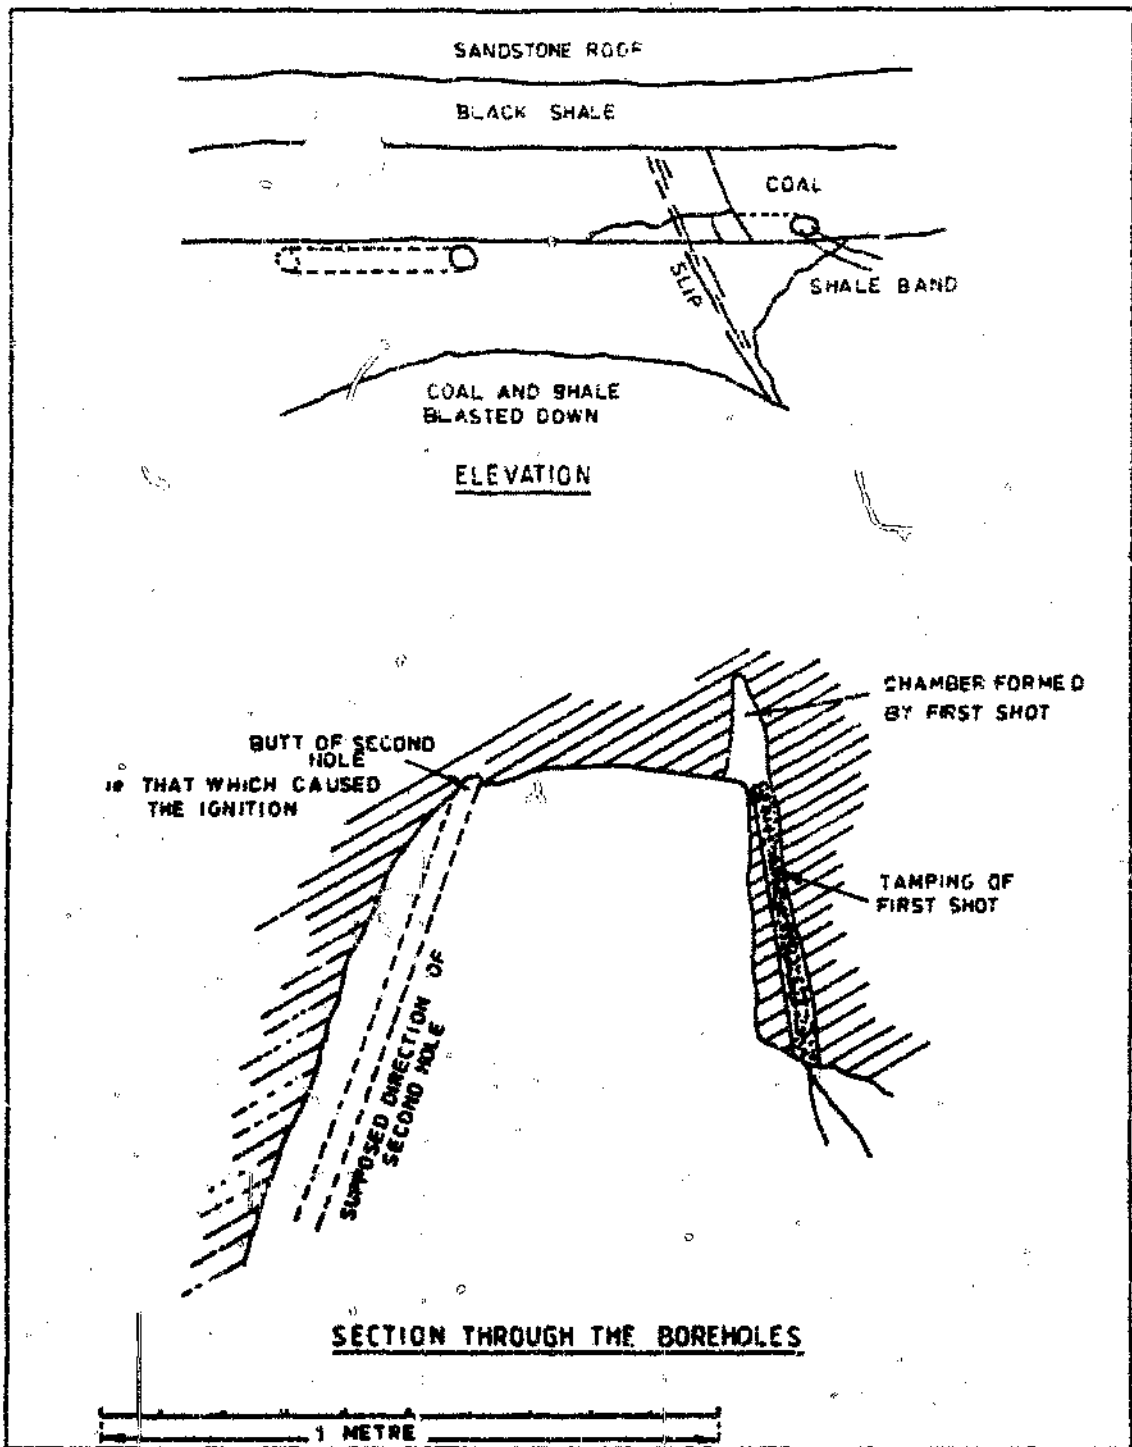
Figure 3

DIAGRAMS SHOWING THE REMAINS OF BOREHOLES  
IN THE NORTH HEADING GLENCOE COLLIERY

"When the end of the north heading was reached (after the disaster), charred timbers and coked coal were found, but it was clear the fire had not been a large one. Strong blowers of firedamp were issuing from the coal face. Observations confirmed the statements previously made by the Miner who fired the shot which commenced the series of explosions, that the shot was near a hole which had previously been fired, but had chambered and not broken the coal.

The entrance to the chambered hole was still standing with the tamping exposed and detonator wires hanging out, but the other shot had broken the coal away so that the chambered portion of the hole was exposed. The butt, about 12 mm deep of the second hole remained. Gas could be felt by the hand to be issuing in some quantity from the remains of each hole, while there was fine coal dust in the chamber of the first. The sketches given will illustrate the conditions as I observed them. According to the Miner three carbonite cartridges were used in the hole which caused the ignition.

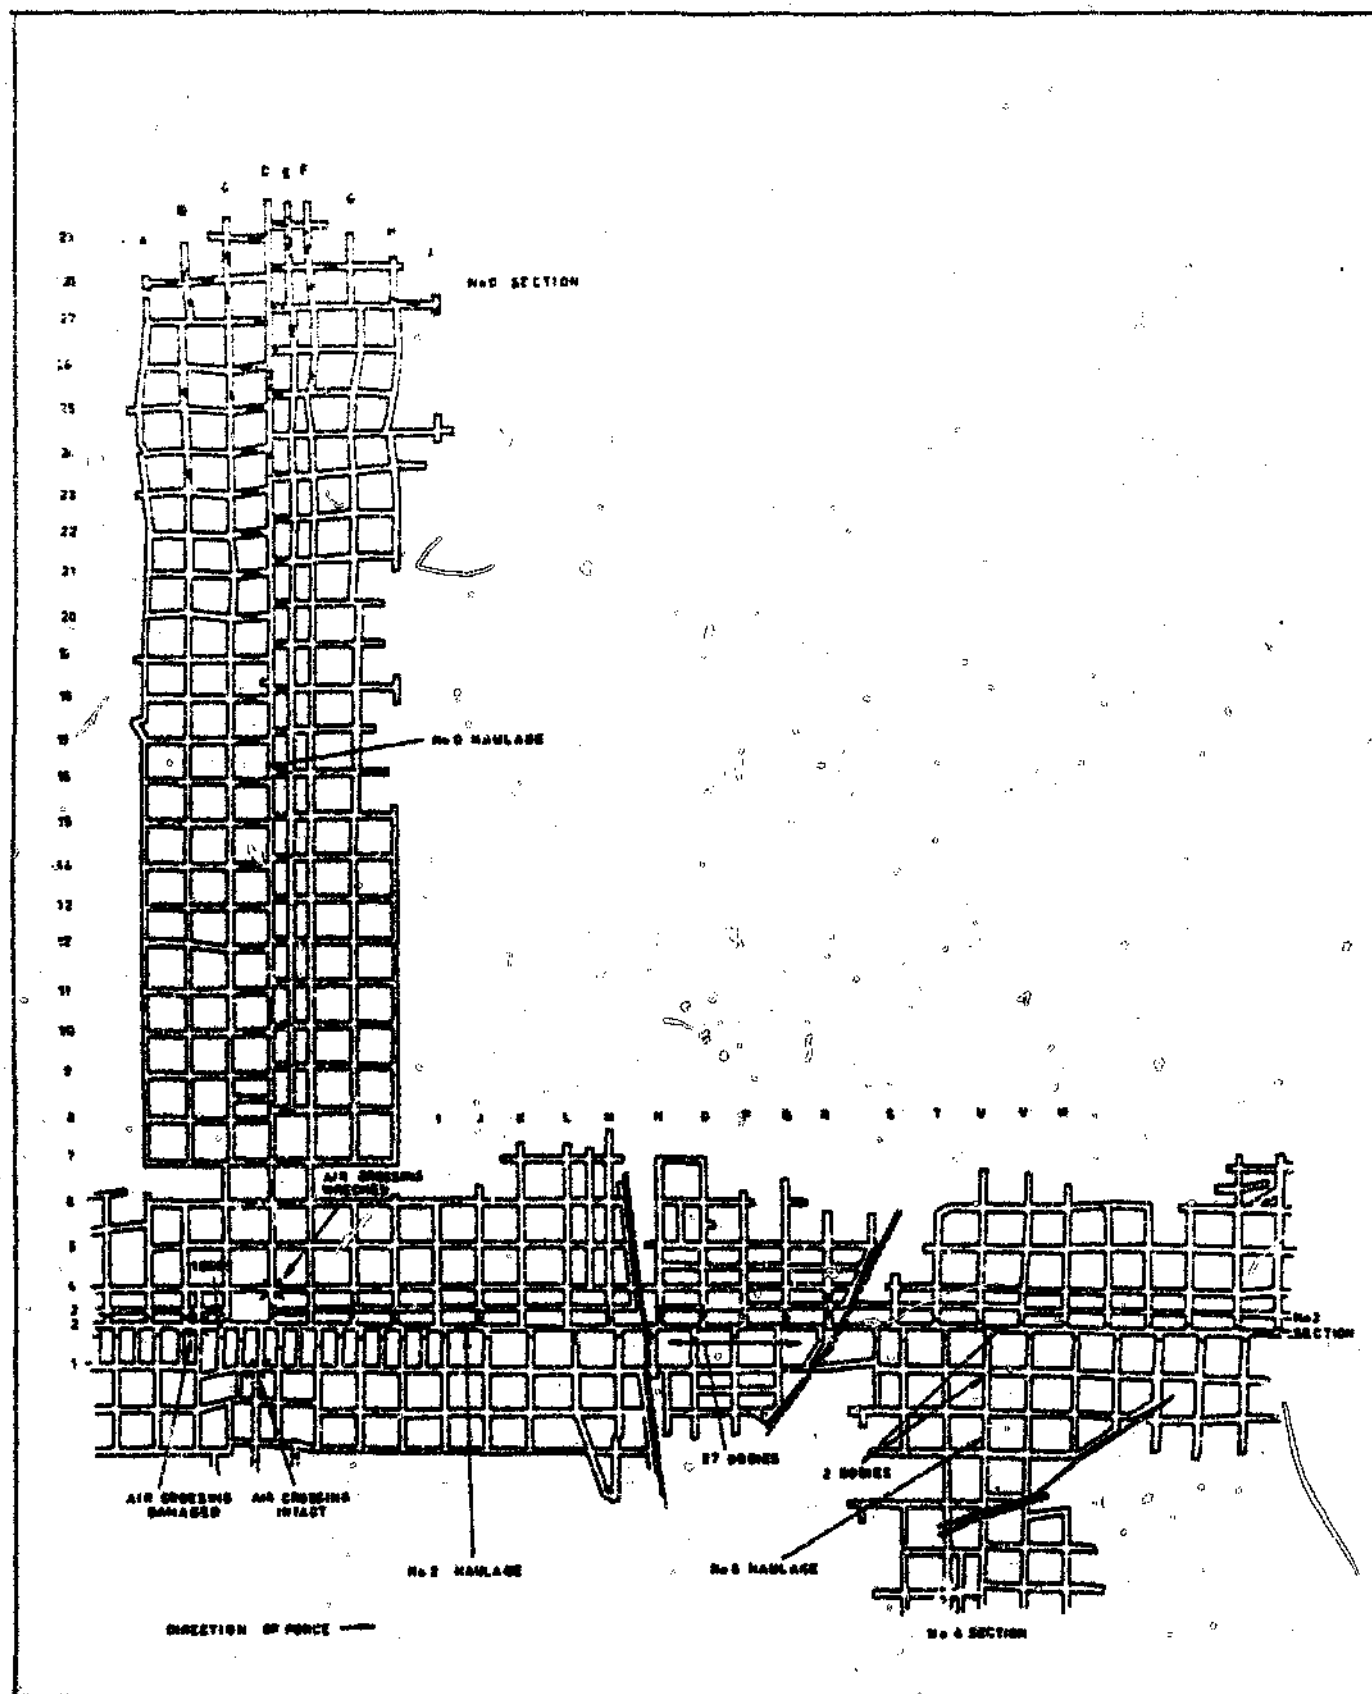
Figure 28

NORTHFIELD - AREA PLAN OF EXPLOSION

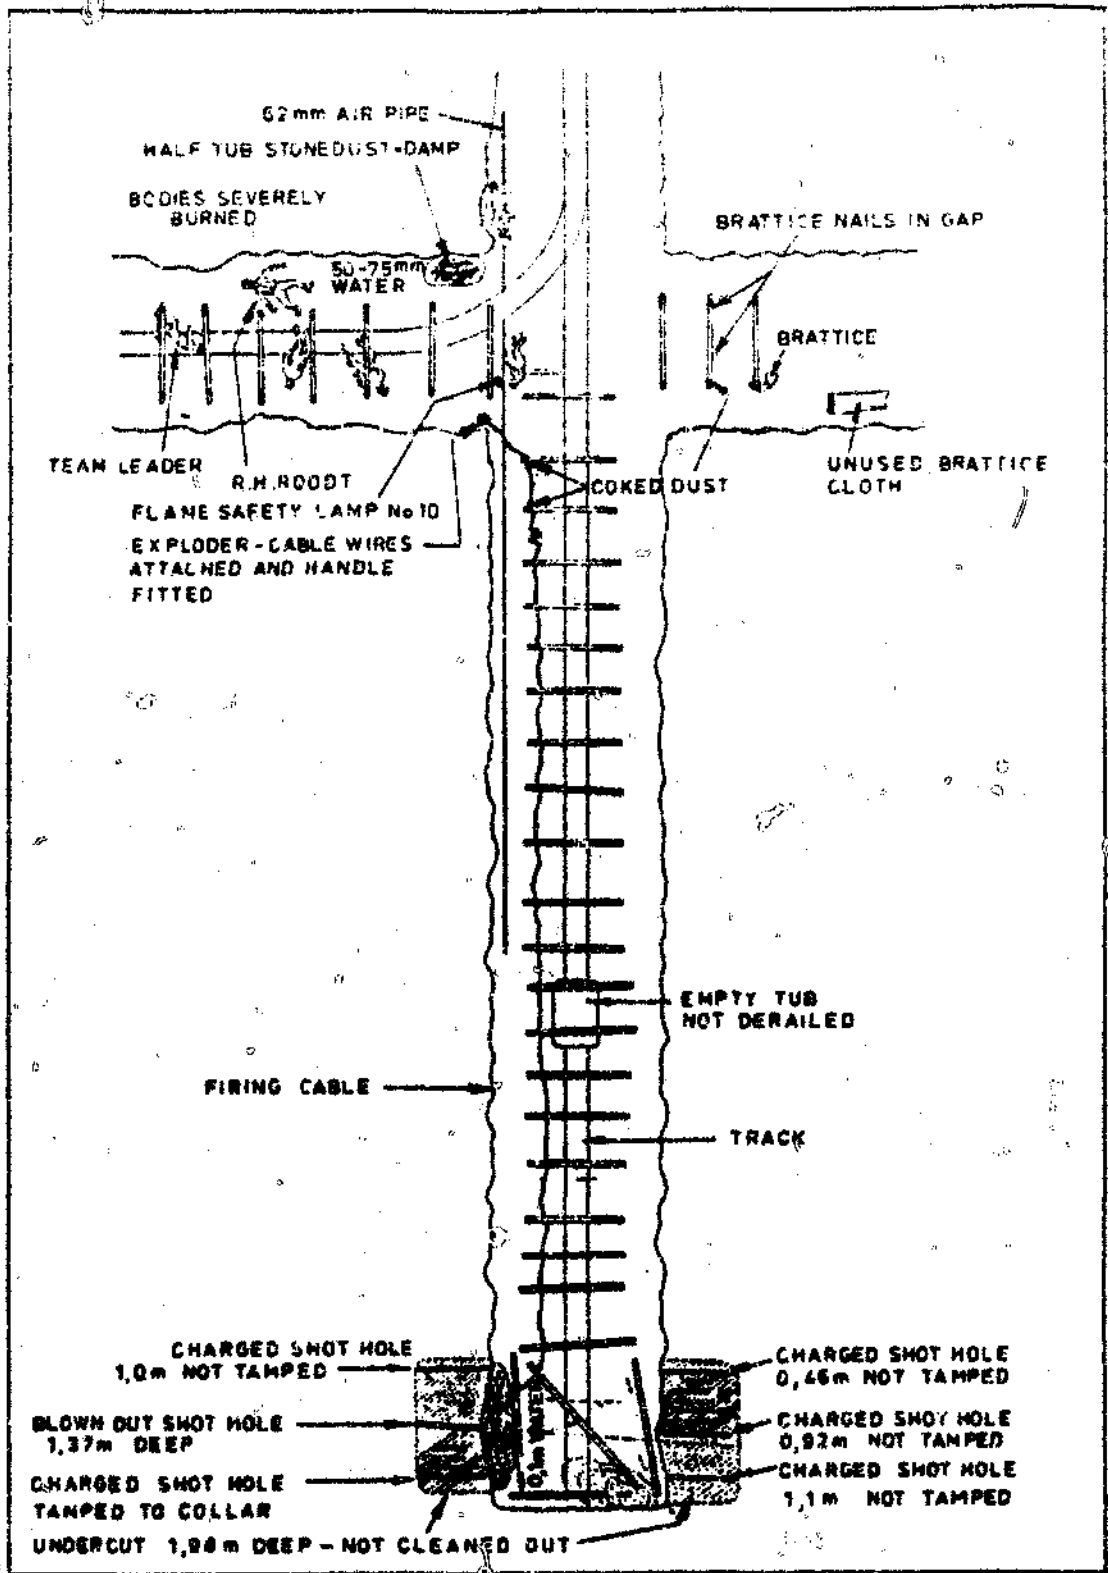
Figure 30  
 NORTHFIELD COLLIERY  
 DETAILED PLAN OF FACE WHERE EXPLOSION OCCURRED

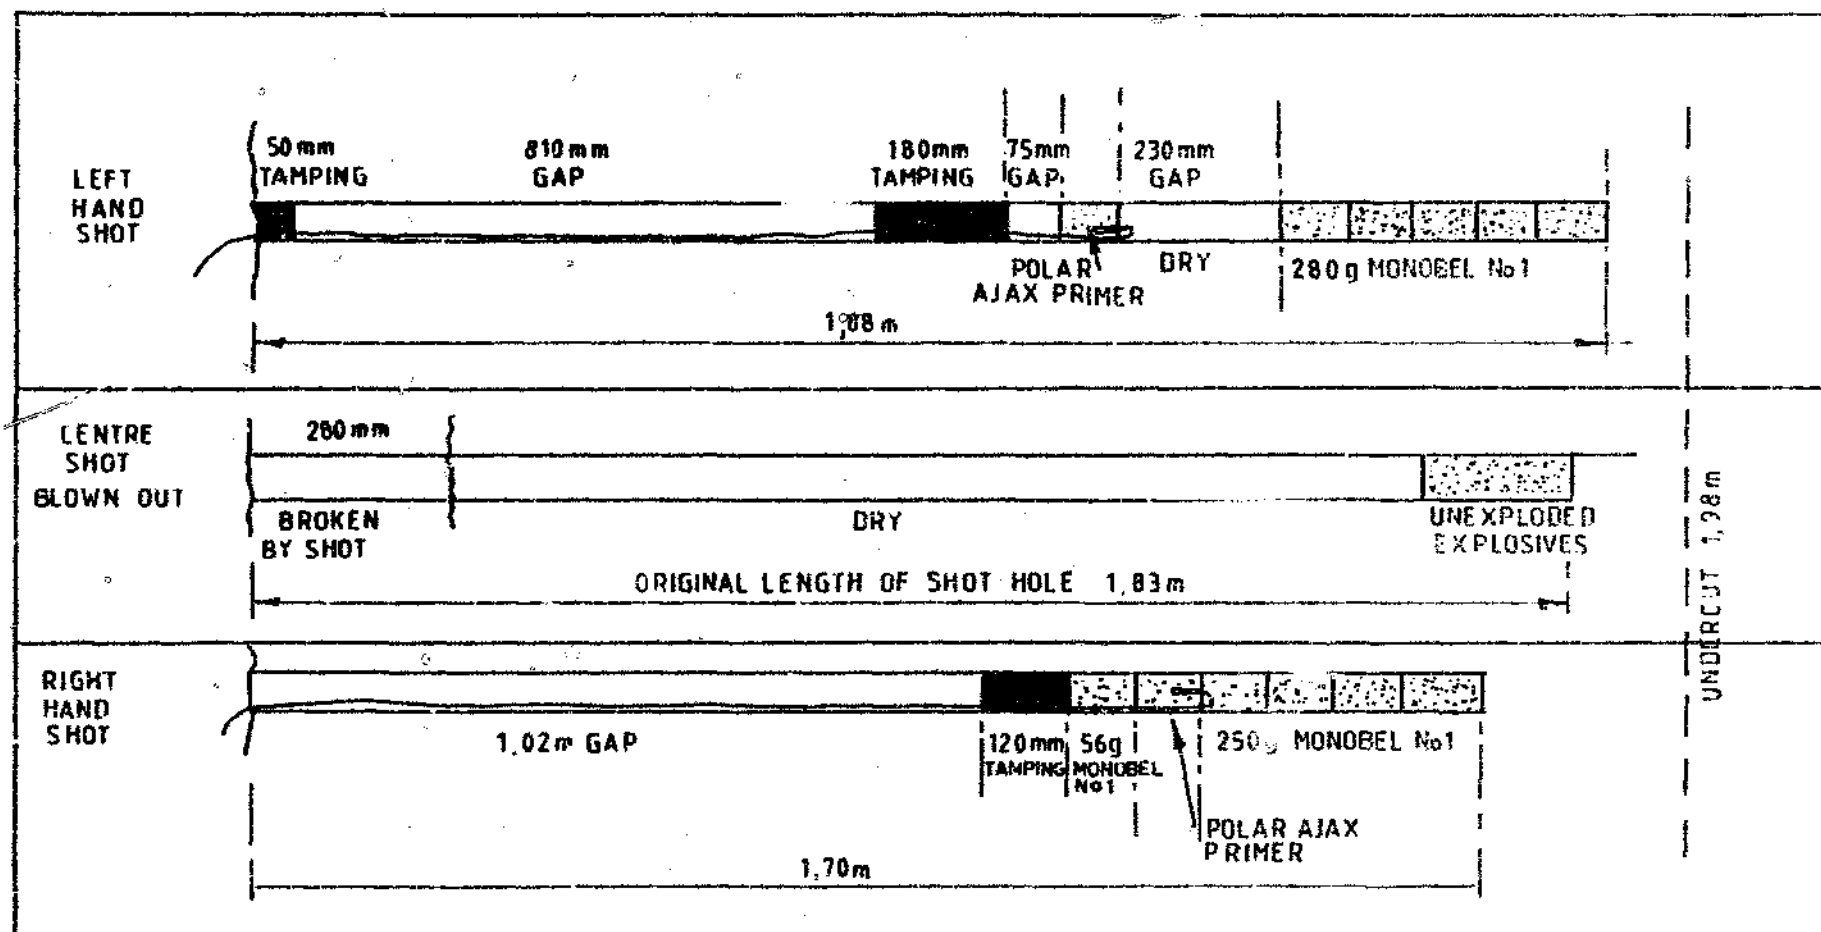
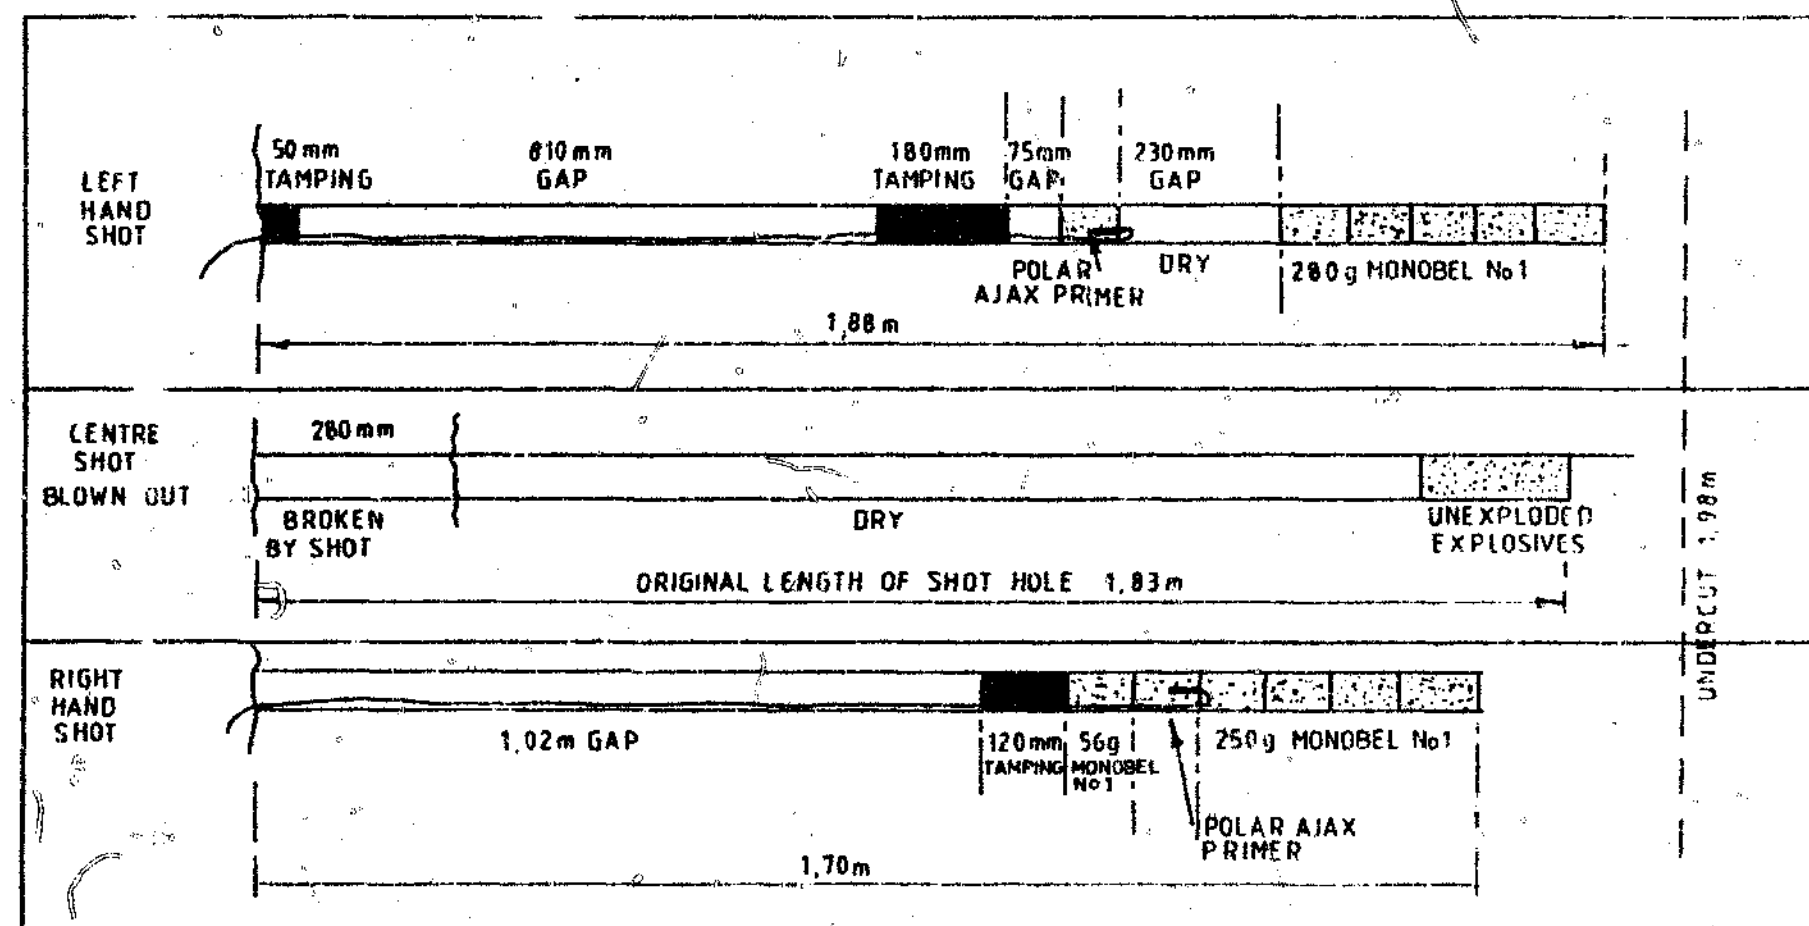
Figure 31  
NORTHFIELD COLLIERY  
DETAILS OF THE THREE SHOTHOLES IN THE FACE WHICH EXPLODED

Figure 31 shows the disposition and amount of explosives and tamping in the shot holes on either side of the blown out shot. The deplorable manner in which these shots were charged would make them extremely liable to blow out if fired, mainly because of the insufficient use of tamping. The Mines and Works Regulations demand that in a fiery mine, shot holes be filled with tamping to the collar of the hole.
