Investigation of the Mechanisms and Control Measures for Fireside Corrosion in Eskom Fossil  
Fuel Boilers

**MSc DISSERTATION**

**Kedimetse Gloria Moloko (9808755G)**

02 October 2019

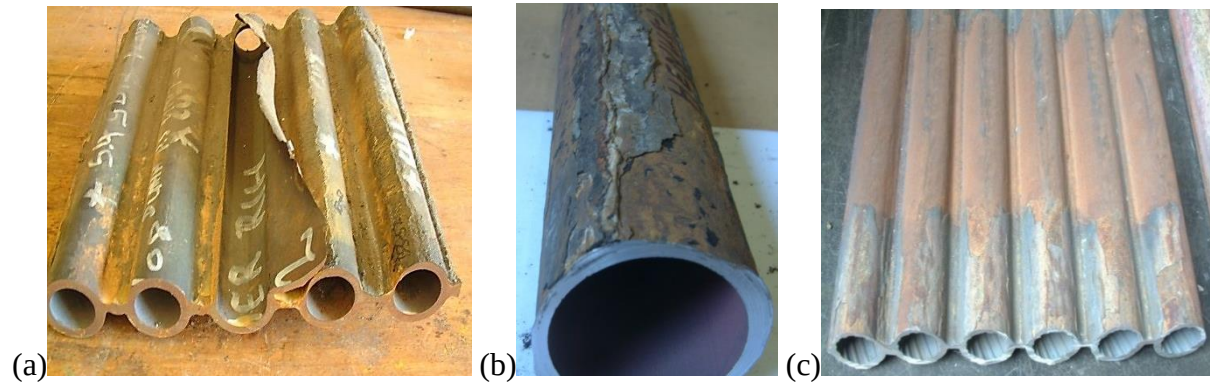
**Figure 4.1: Furnace wall tube from (a) Station A with a ruptured tube, (b) Station B and (c) Station C, showing the fireside deposit.**

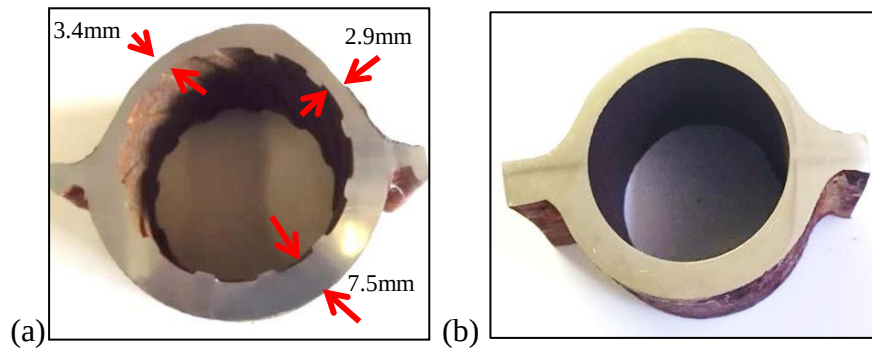
**Figure 4.4: Cross section specimens of tubing from Station A (a) Unit 6 and (b) Unit 4.**

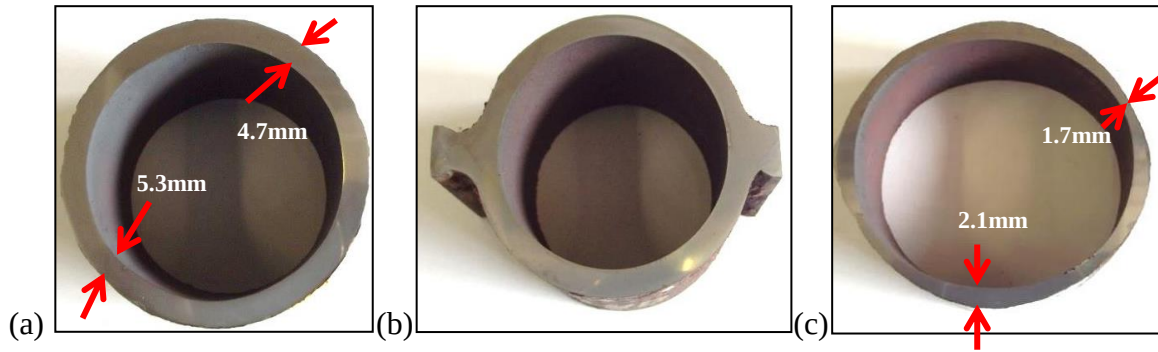
**Figure 4.5: Cross section specimens of Station B tubing showing (a) uniform wall thinning on fireside and coldside of Unit 1, (b) uniform wall thinning on fireside of Unit 8 and (c) uneven wall thinning on fireside and coldside of Unit 3.**

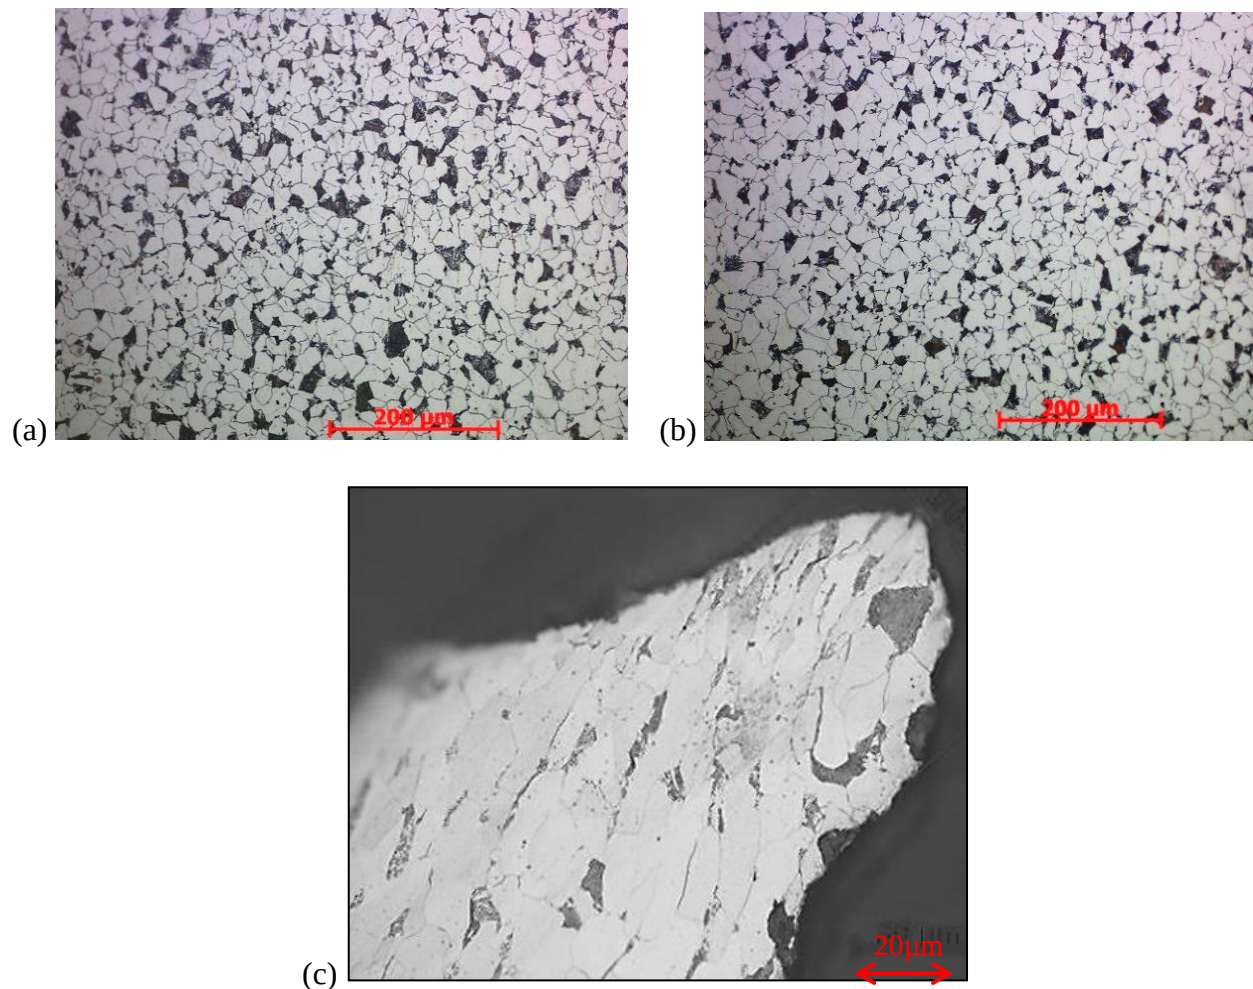
**Figure 4.6: Station A side wall tubing (a) on the fireside, (b) on the coldside and (c) at failure showing deformation.**

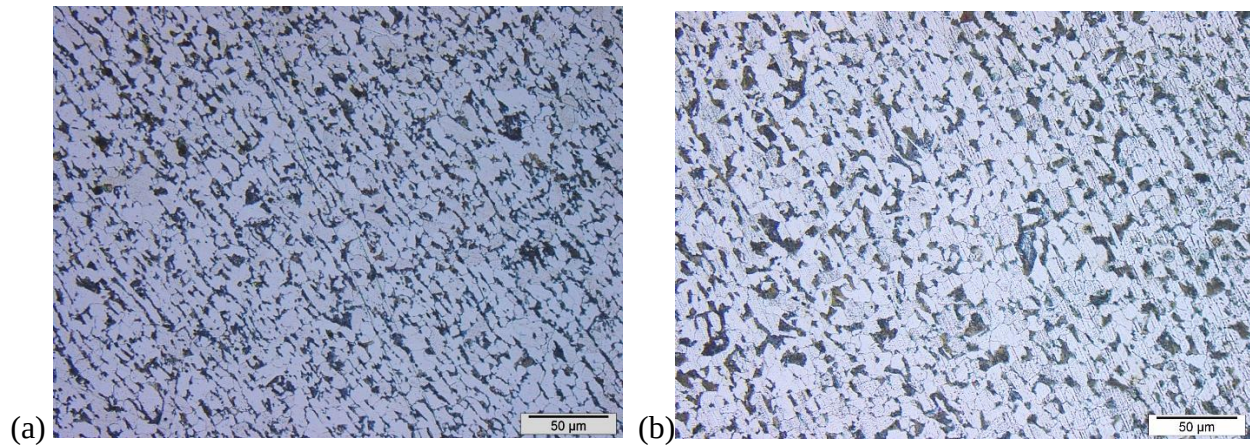
**Figure 4.7: Station B front wall tubing (a) on the fireside and (b) on the coldside.**

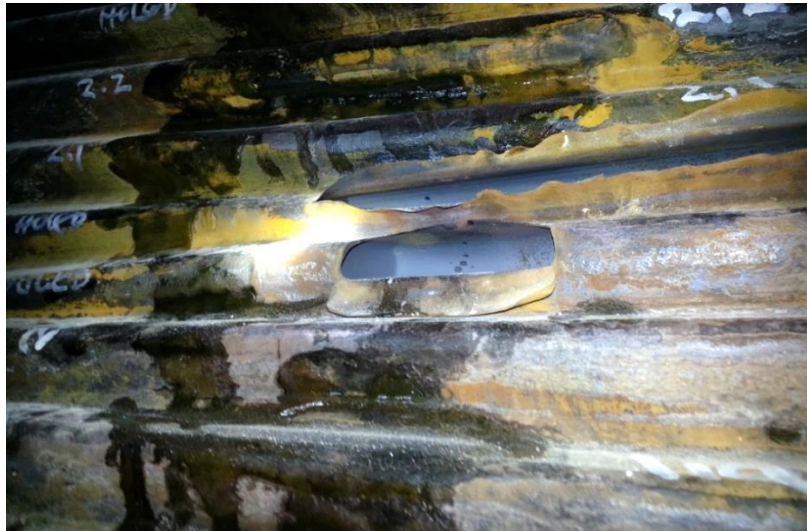
**Figure A.1: Failed tubes on division wall of Unit 2 boiler from station A.**

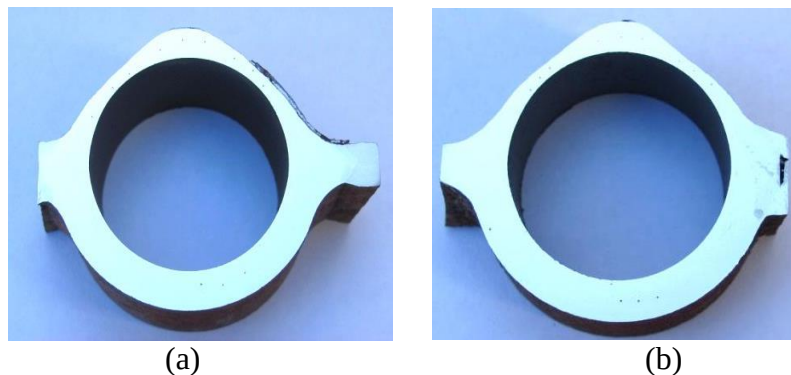
**Figure A.2: Tubing cross sectional samples from Unit 2 non-ruptured tubes of Station A, showing fireside deposit and wall thinning on the fireside.**

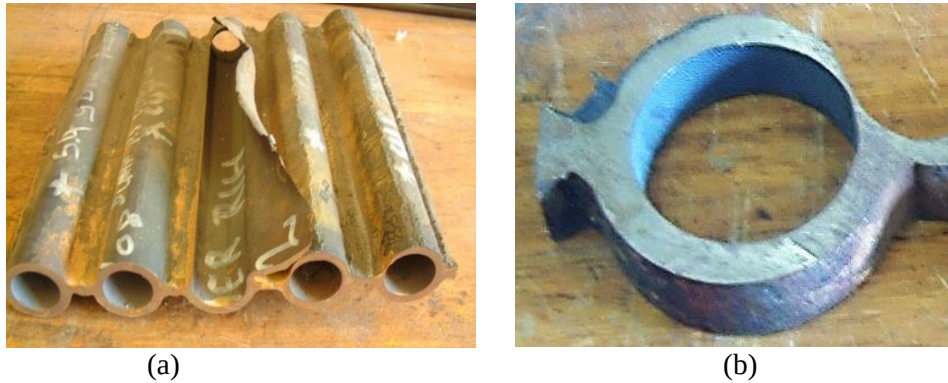
**Figure A.3: Failed tubes on division wall of Unit 2 boiler from station A.**

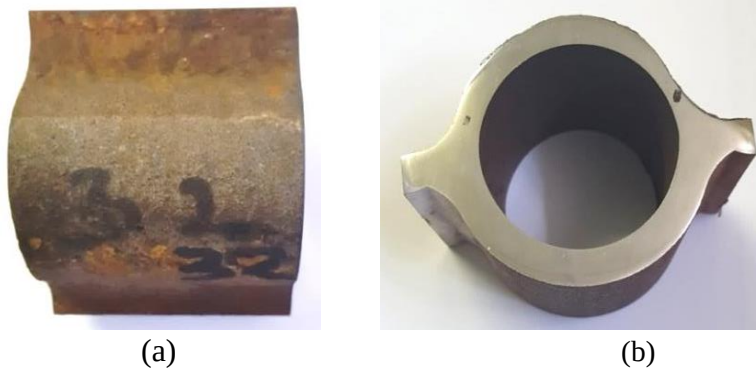
**Figure A.4: Tubing samples from Unit 3 of Station A, showing fireside deposit (a) and wall thinning on the fireside (b).**

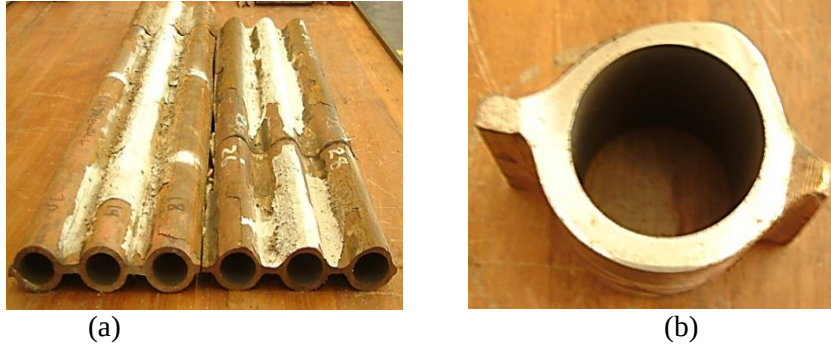
**Figure A.5: Side wall tubing samples from Unit 4 of Station A, showing (a) fireside deposit and (b) wall thinning on the fireside.**

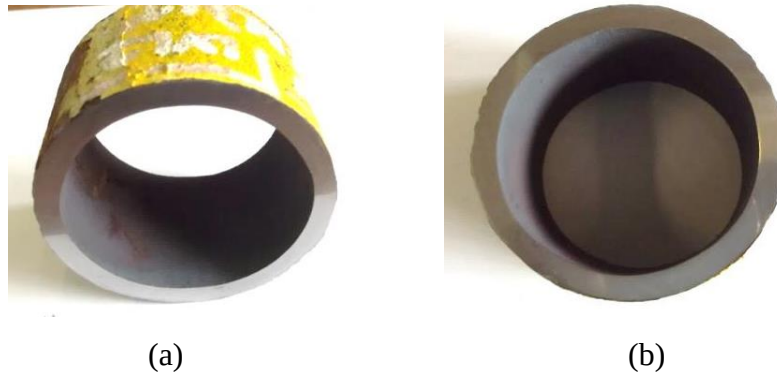
**Figure A.6: Tubing samples from division wall of Unit 1 of Station B, showing (a) fireside deposit and (b) wall thinning on the fireside.**

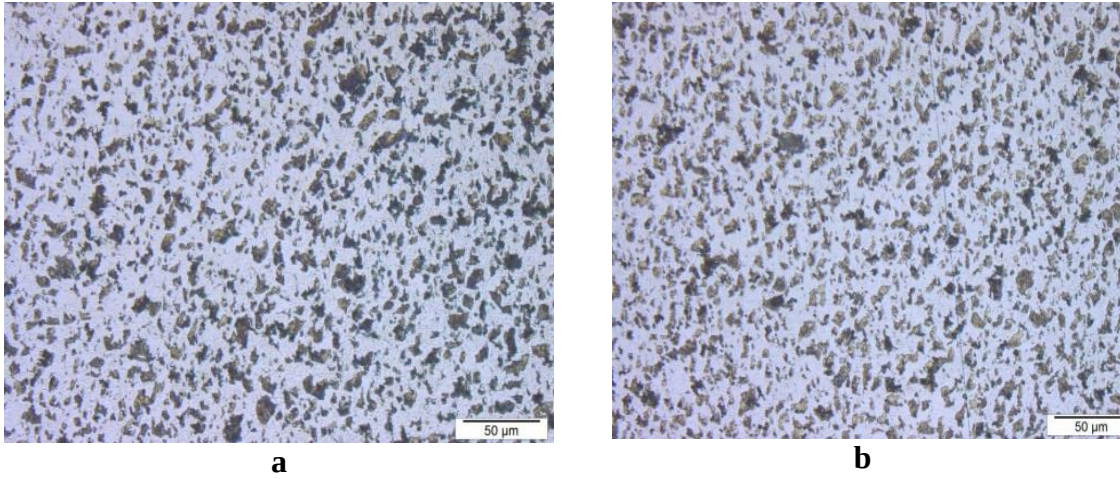
**Figure D.3: Microstructure of Unit 1 front wall tube on the (a) fireside and (b) coldside**

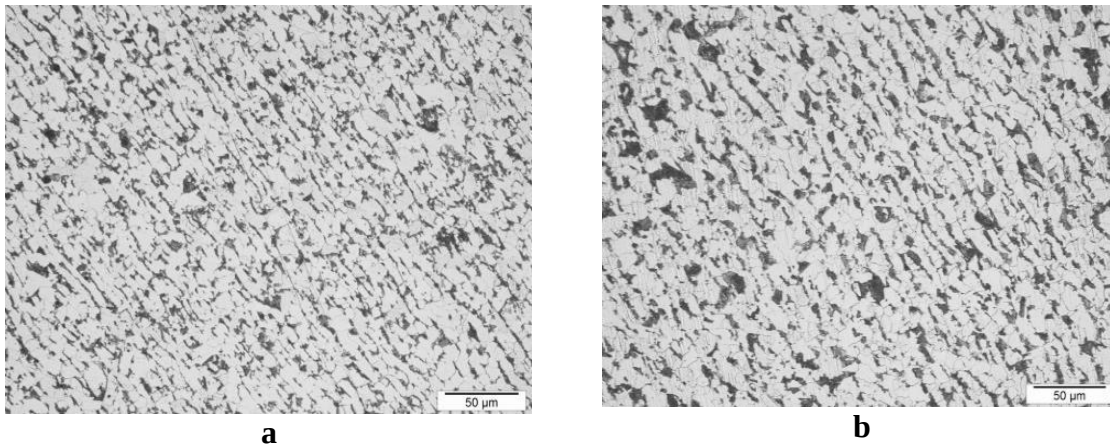
**Figure D.4: Microstructure of Unit 3 division wall tube on the (a) fireside and (b) coldside**

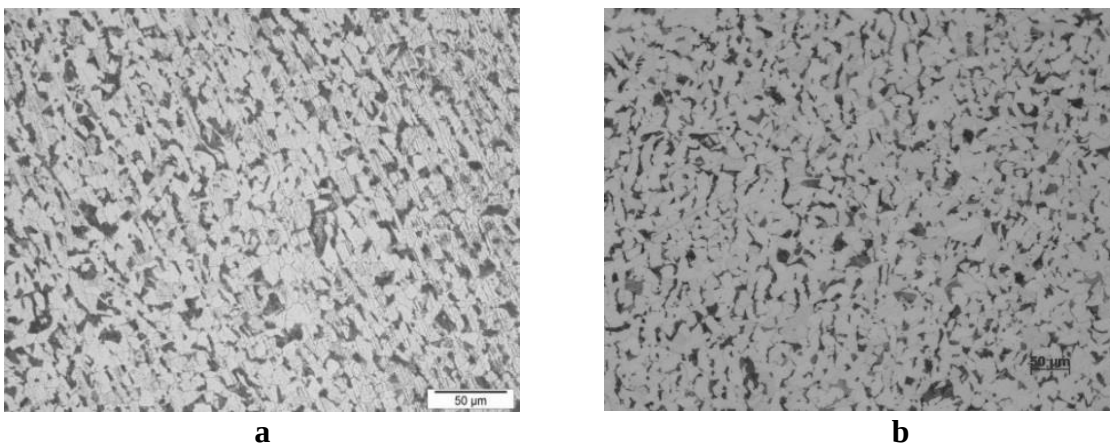
**Figure D.5: Microstructure of Unit 8 division wall tube on the (a) fireside and (b) coldside**

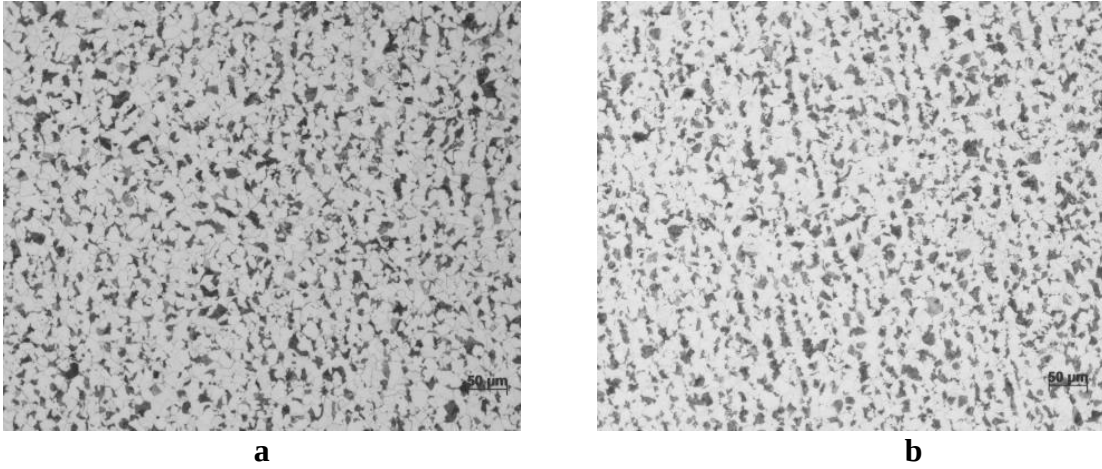
**Figure D.6: Microstructure of Unit 10 division wall tube on the (a) fireside and (b) coldside**

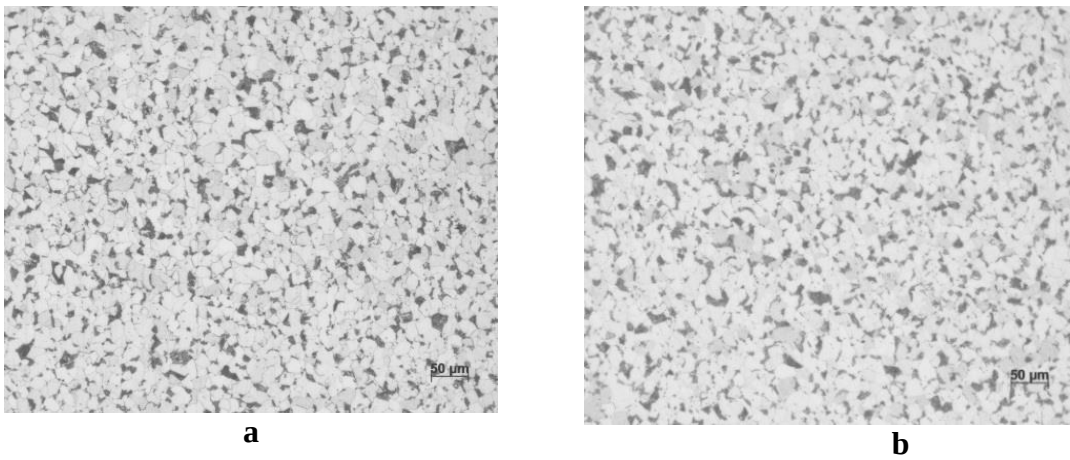
**Figure D.7: Microstructure of Unit 4 side wall tube on the (a) fireside and (b) coldside**

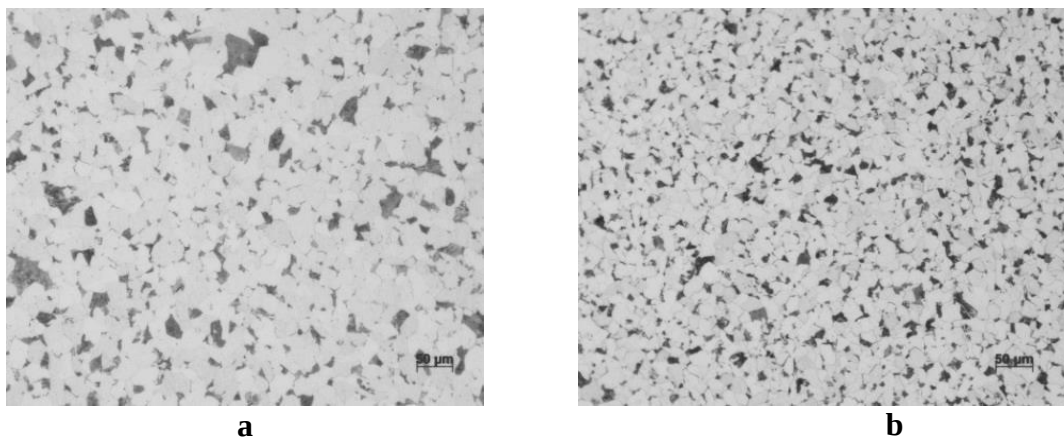
**Figure D.8: Microstructure of Unit 6 side wall tube on the (a) fireside and (b) coldside**
