**Mine gas and coal dust explosions and methane outbursts - their causes and prevention.**

**Flint, John Derek**

**1990**

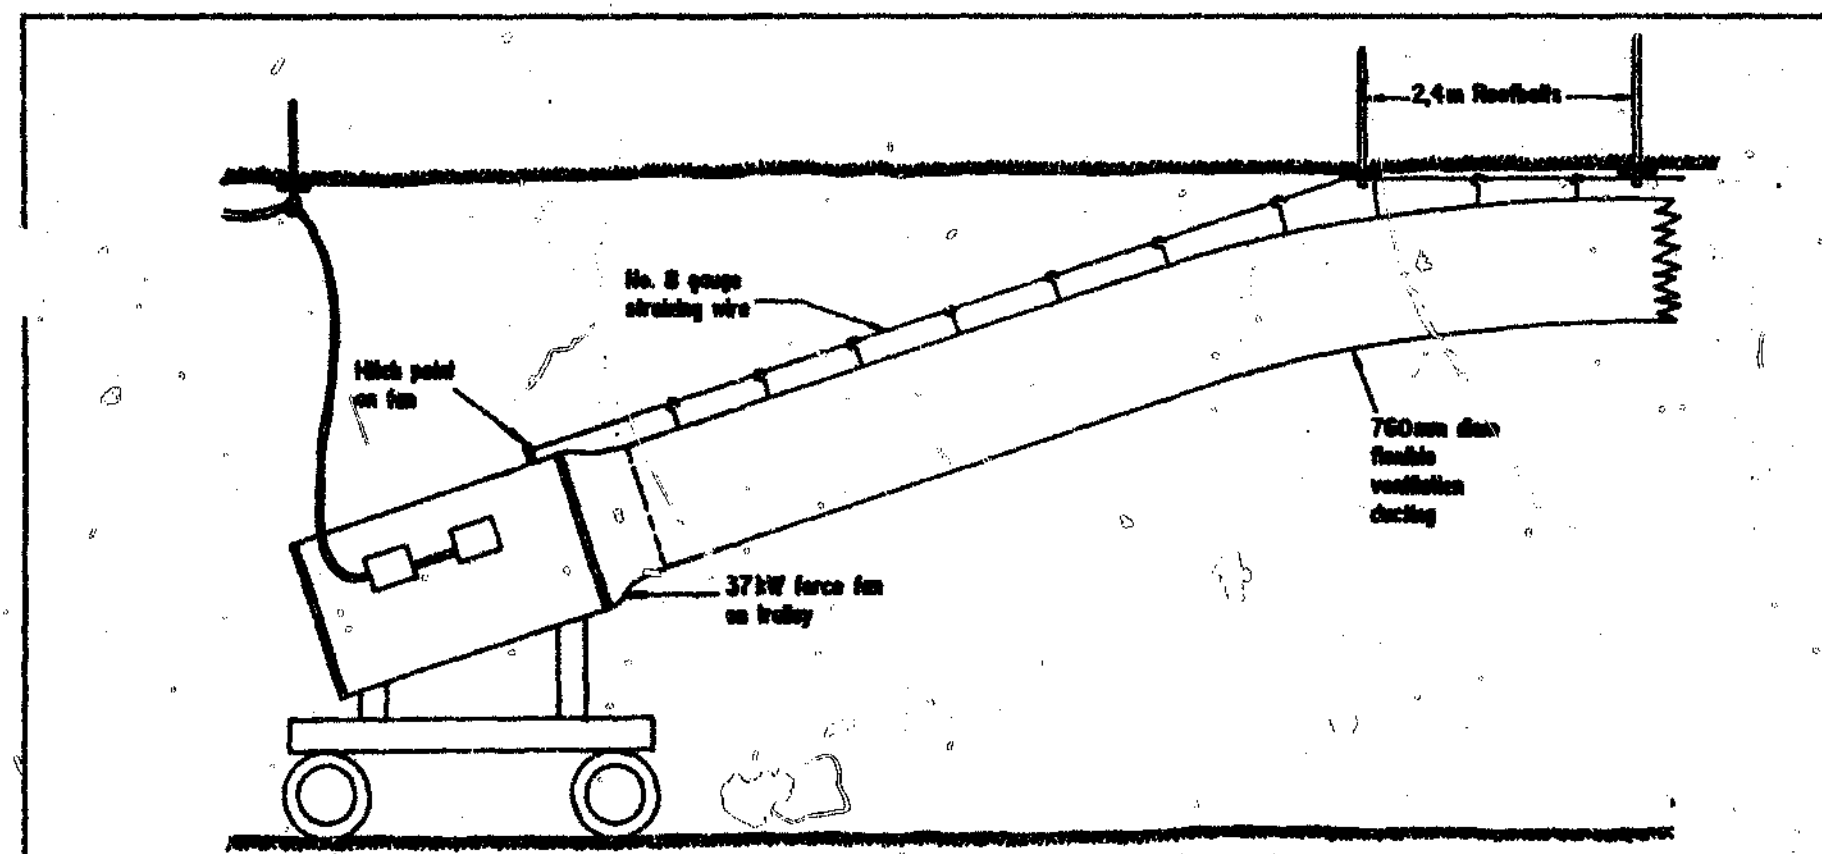
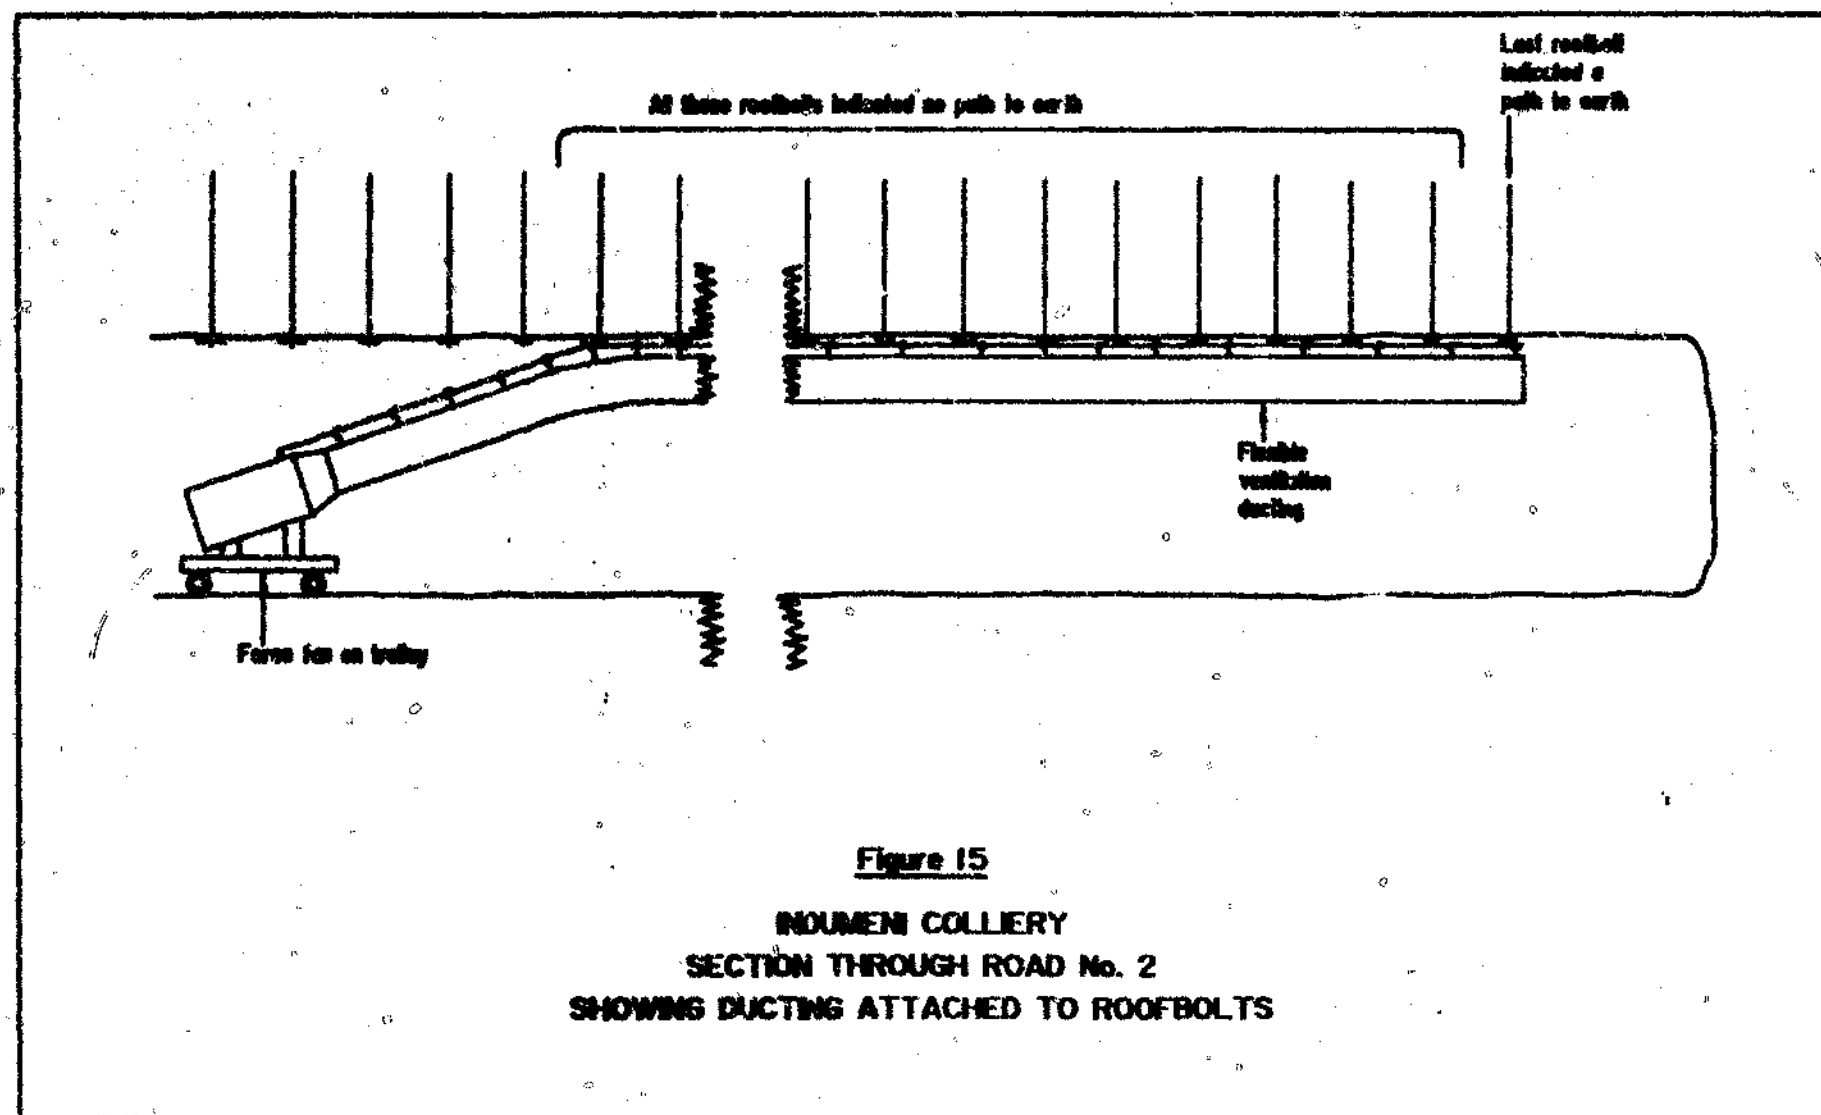
**Figure 14**

**INDUMEN COLLIERY  
SECTION THROUGH ROAD No. 2  
SHOWING FAN AND DUCTING INSTALLATION**

The final conclusion was that when the flash occurred in the fan starter, electricity travelled along the suspended wire and flashed across either at the roofbolt washer or inside the roofbolt hole thus igniting the gas.

When electric equipment and cables are moved the system should be examined for damage particularly to cables and glands.

Strict degassing procedures, as standard practice laid down by the Mine Manager, should be employed when starting a fan where there is an accumulation of methane which stretches back from the face and over the end of the last ventilation pipe in the face. For this specific condition the column should be broken at certain points so that the ventilation pipe can be blown clean especially in the first few lengths from the fan before full degassing commences.

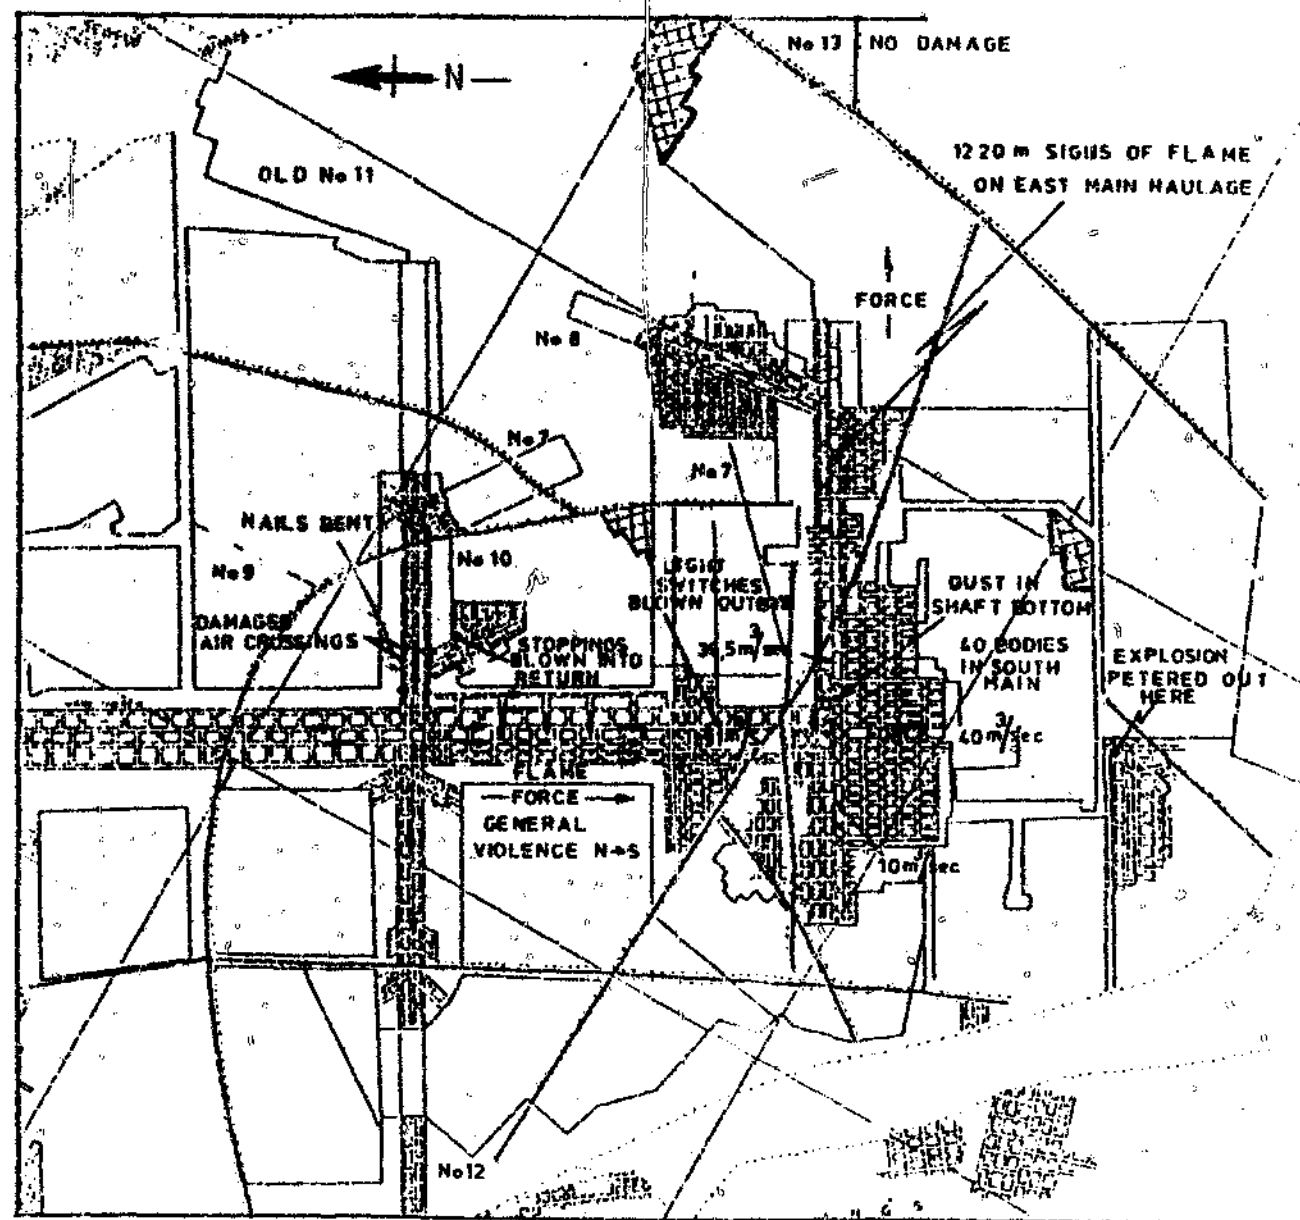
Figure 4  
PLAN OF D.N.C. No. 2 WORKINGS  
1926

1. A methane explosion, caused by a blown-out shot, occurred in Section 10 some 1 300 metres from the shaft bottom (see Figure 4).
2. This explosion developed into a coal dust explosion which traversed the whole mine.
3. The force of the explosion is shown by arrows on Figure 4.
4. The explosion spent itself at the top of the upcast and downcast shafts and in the South main sections.
5. The explosion destroyed the fan drift on the upcast shaft and did considerable damage to the bank of the downcast shaft. The Compound Manager who was about 200 metres from the shaft states in reply to questions at the Official Inquiry:

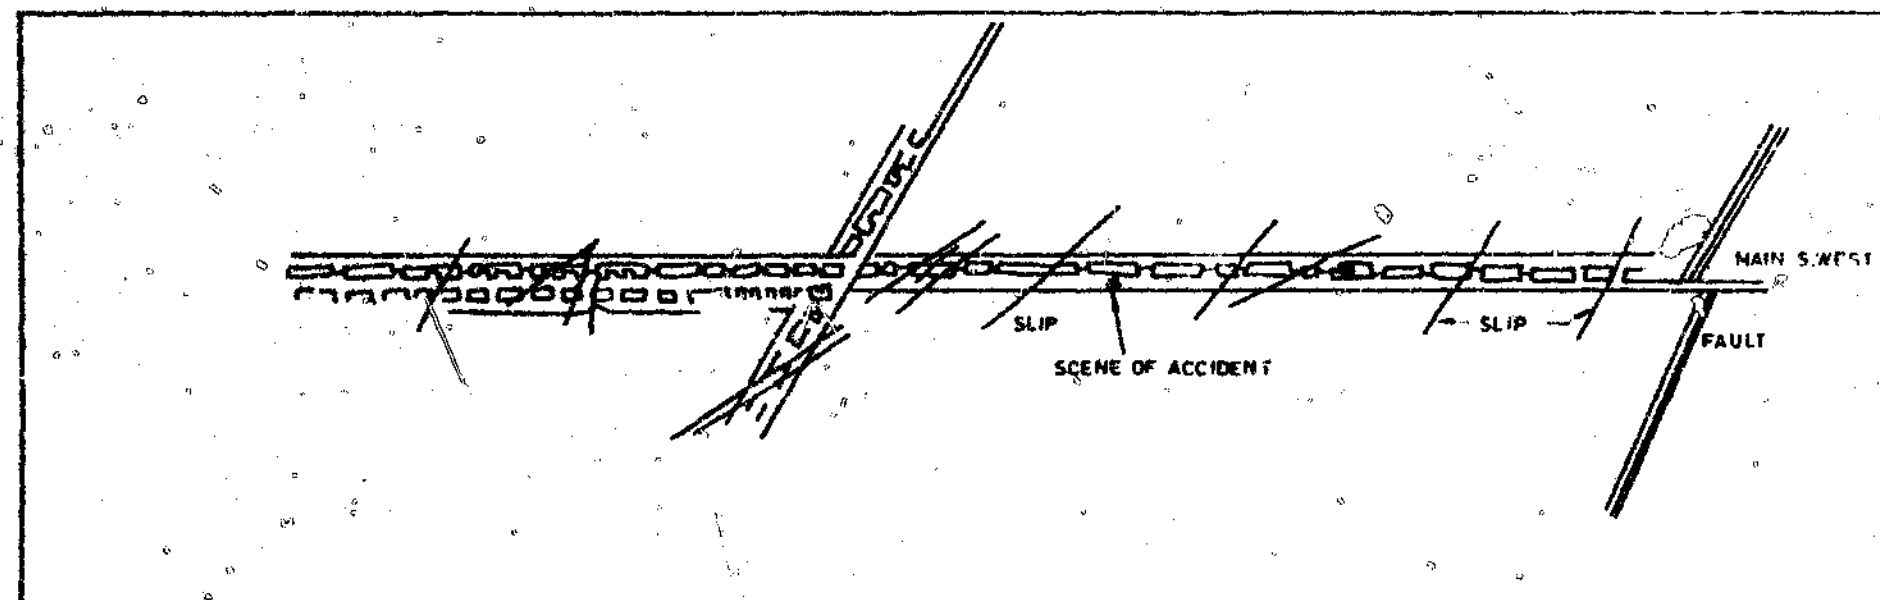
Figure 5  
CONSOLIDATED COLLIERIES  
PLAN OF ACCIDENT SCENE

The colliery is situated in the Ermelo area. The coal seams are found at a depth of between 60 and 85 metres and were known to be gassy. A 2000 volt electric cable was being extended to a new substation site on a Sunday and two Electricians were making a joint in this cable using a blow lamp. The main fan had been stopped for repairs for 3 hours during this period during which time methane built up in the main haulage where the electrical connection was being made. A methane explosion took place seriously injuring the two Electricians.

A Miner was delegated to examine the haulage where the work was to be carried out. Figure 5 shows the Main South West haulage, the various faults and slips and the position of the No. 3 winze together with the scene of the explosion. The Miner examined the haulage between 08h00 and 09h30 and found no gas; the roof and sides were in order and there was a strong air current in the haulage.

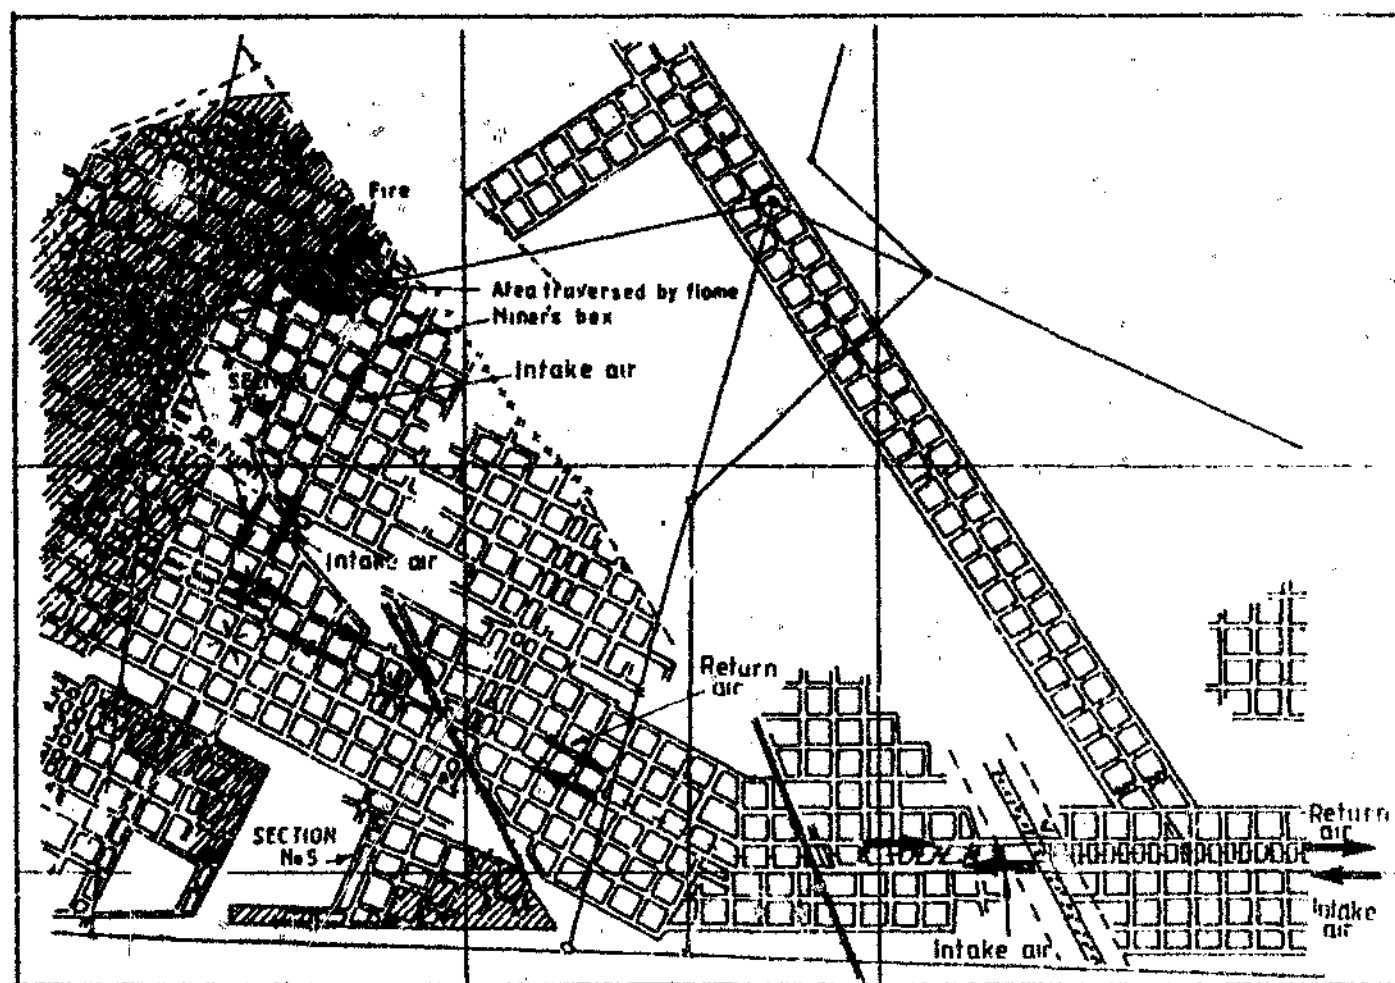
Figure 6  
NORTHFIELD COLLIERY - PLAN OF EXPLOSION

The section in question, Figure 6, was developed during December 1949 on the bord and pillar system. During development, the area was not gassy. There is a large area of ground immediately

beyond the section from which the pillars have been removed. During pillar extraction, for the past few months at least, there had been practically no sign of gas. The Sub Inspector of Mines had visited the section only 12 days before the accident and reported that the ventilation was excellent and no trace of firedamp was found.

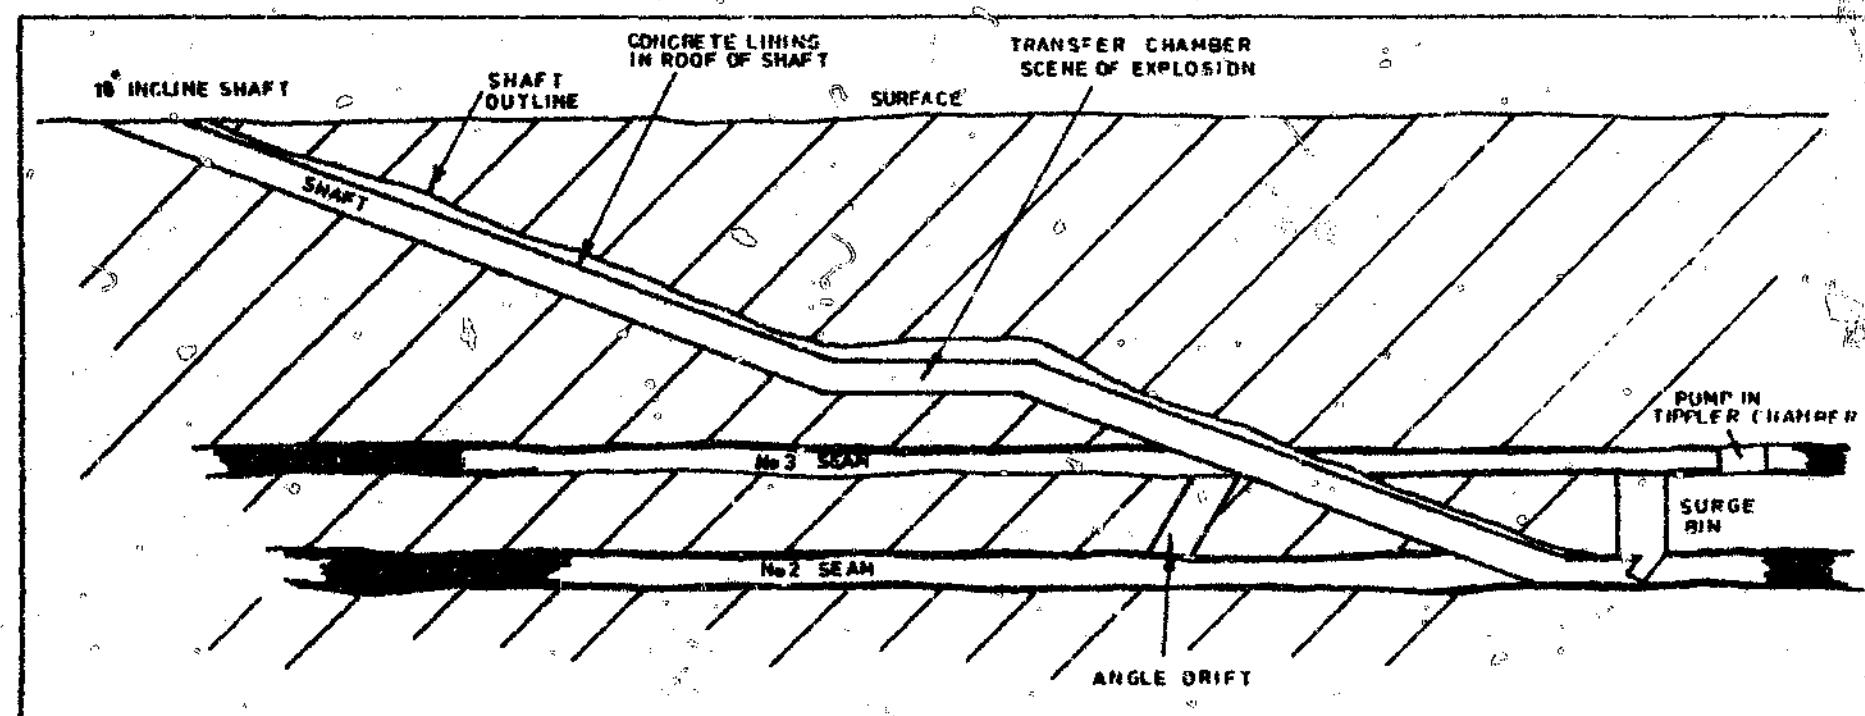
Figure 8  
 COALBROOK COLLIERY  
 SECTION THROUGH INCLINE SHAFT  
 SHOWING SCENE OF EXPLOSION IN TRANSFER CHAMBER

A series of events now took place which finally led to the methane explosion caused by a revolver type igniter or the flame from an acetylene torch used to cut a roof girder in the inclined shaft transfer chamber.

The damage to the incline shaft was great.

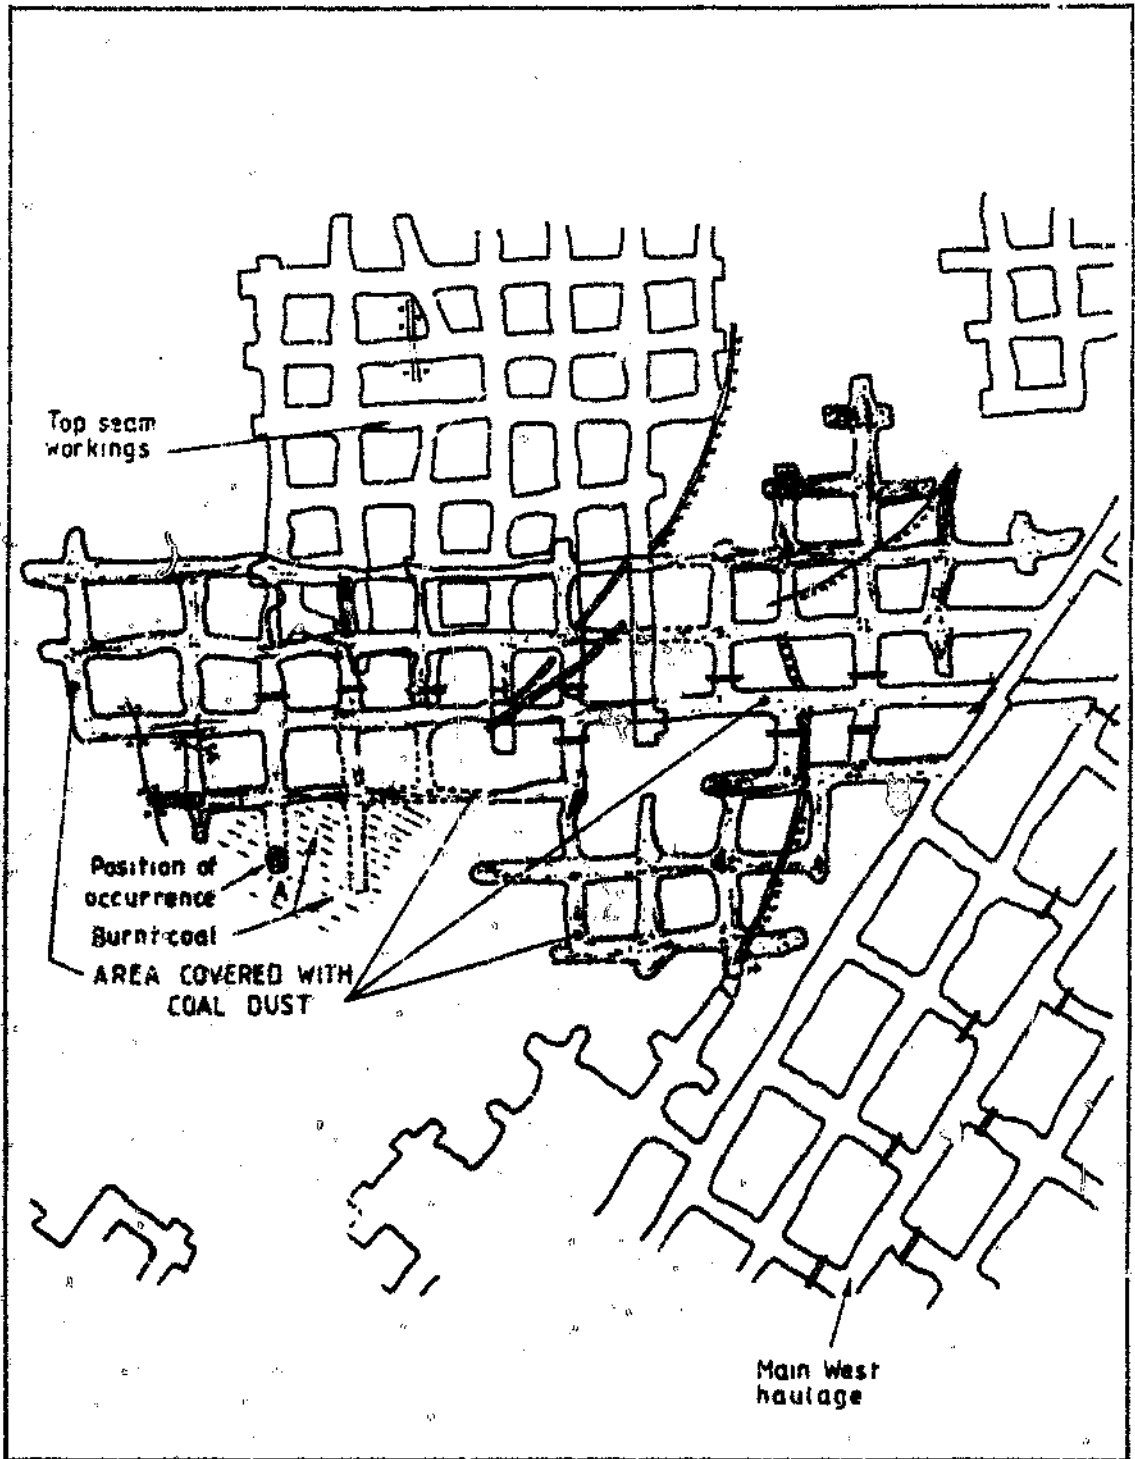
Figure 7

PLAN OF THE SECTION SHOWING THE AREA AFFECTED  
BY FINE COAL DUST AS A RESULT OF AN OUTBURST

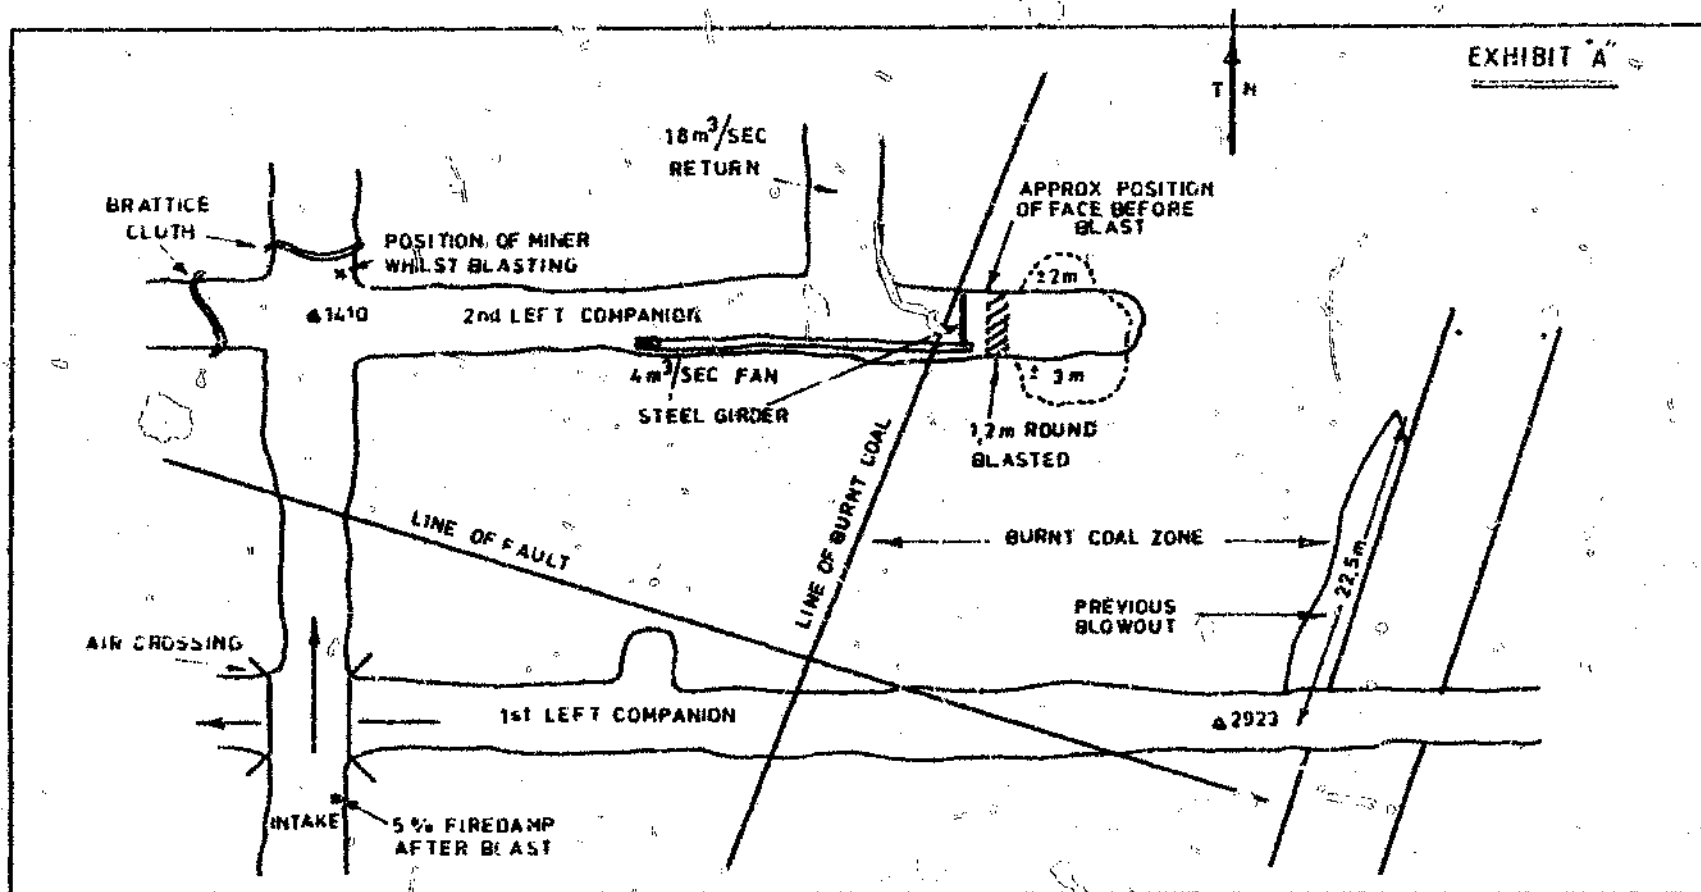
Figure 14  
PLAN SHOWING TWO OUTBURSTS AND VENTILATION ARRANGEMENTS  
IN SECTION 700 OF INDUMANI COLLIERY

In June 1970 an instantaneous methane outburst had occurred in the first left hand companion of section 700. This roadway had developed to within a metre of the dyke shown on Exhibit A. It had become necessary to install a steel girder set in the face one metre beyond the last set since roof conditions were poor in the burnt coal zone. Three slipping holes were drilled on either side of the face as shown in Figure 15 to square off the face in preparation for the girder set installation. The six shotholes were blasted simultaneously and immediately thereafter there was a further blast followed by a large dust cloud and methane gas which enveloped the miner and several of his crew who were standing in the second left hand companion at pag 1410 on Figure 14 Exhibit A. The section ventilation was temporarily reversed and the crew make an attempt to escape eastwards into the intake airway.
