CHAPTER 6ANALYSIS OF CRACK IN BEAM TO COLUMN JOINT6.1 Description of Building and Cracks

**Author** Boardman Vivian Reginald

**Name of thesis** The Effect Of Compressive Stress On The Expansion Of Brickwork And Its Implication In Buildings. 1977

University of the Witwatersrand, Johannesburg

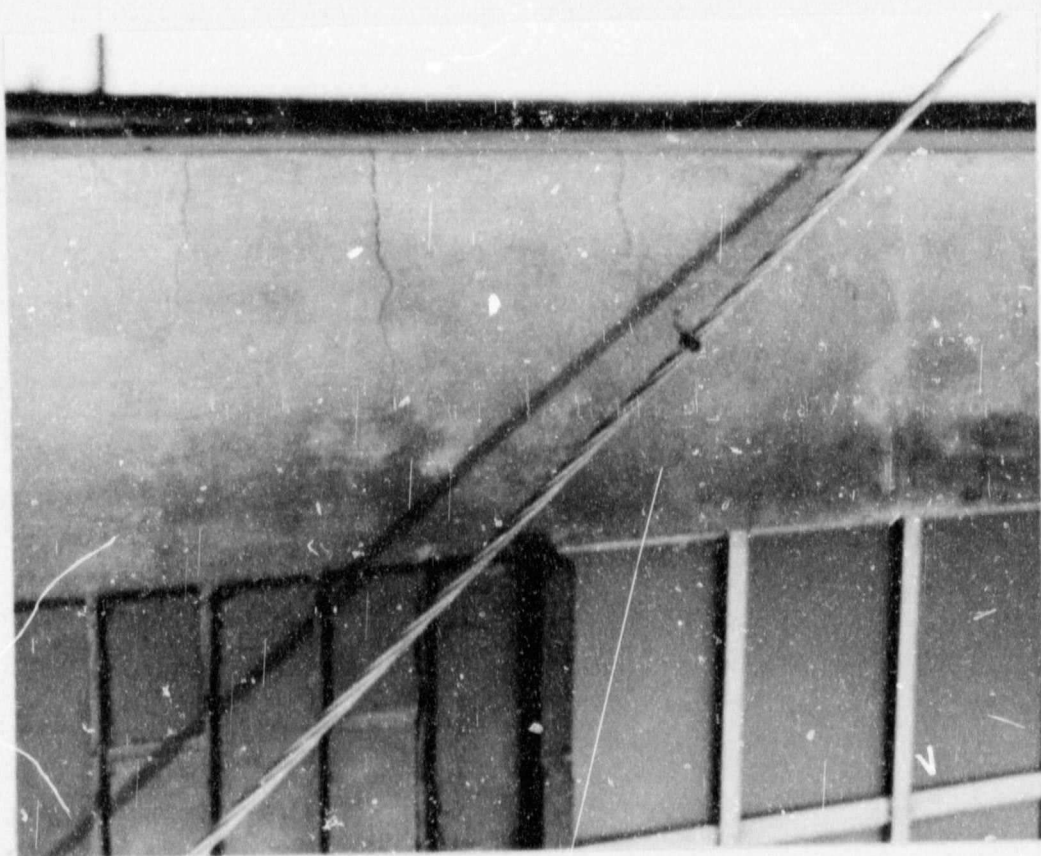
A three-storey industrial building in Cape Town was observed to have cracks at the junction of the corner columns and the beams carried by them. From the cracking patterns shown in Figures 49, 50 and 51, it was assumed that the cracks had been caused by expansion of the brick walls on the beams. It was decided to analyse one beam to column joint.

FIGURE 50. Cracks in column at top of brick wall.

Similar cracks could be seen in column B in the vicinity of the top of the brick walls at the second and third storeys.

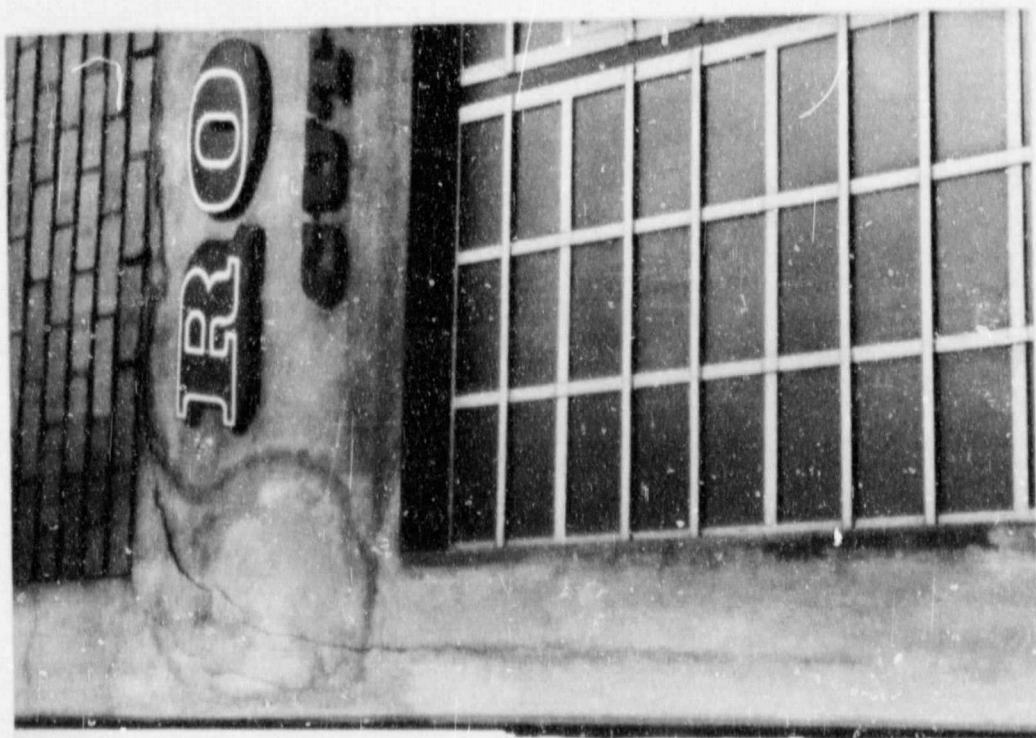
FIGURE 49. Crack at top of ground floor at corner of streets.

The visible cracks at the junction of column B and beam BC are shown in Figure 49. Between the brick wall and the beam a fine crack occurs for most of the distance from column B to column C. This crack starts widening about 2 m from column B at the interface between the brick wall and beam and increases in width as it progresses towards the corner. About 600 mm from the corner, the crack starts curving downwards until it becomes almost a vertical crack in the column just below the bottom of the beam. Similar cracks were observed at other beam to column junctions at corners. The vertical part of the crack tends to be 100 to 130 mm from the corners. A further crack in the concrete

starts at the bottom corner of the brick wall and curves downwards until it is again a vertical crack at about the level of the bottom of the beam or sometimes well above this level. This vertical crack tends to be very close to the external corner of the column, i.e. 15 to 20 mm from the corner. No cracks of any significance could be observed in the brickwork except a horizontal crack below the top course under the windows.

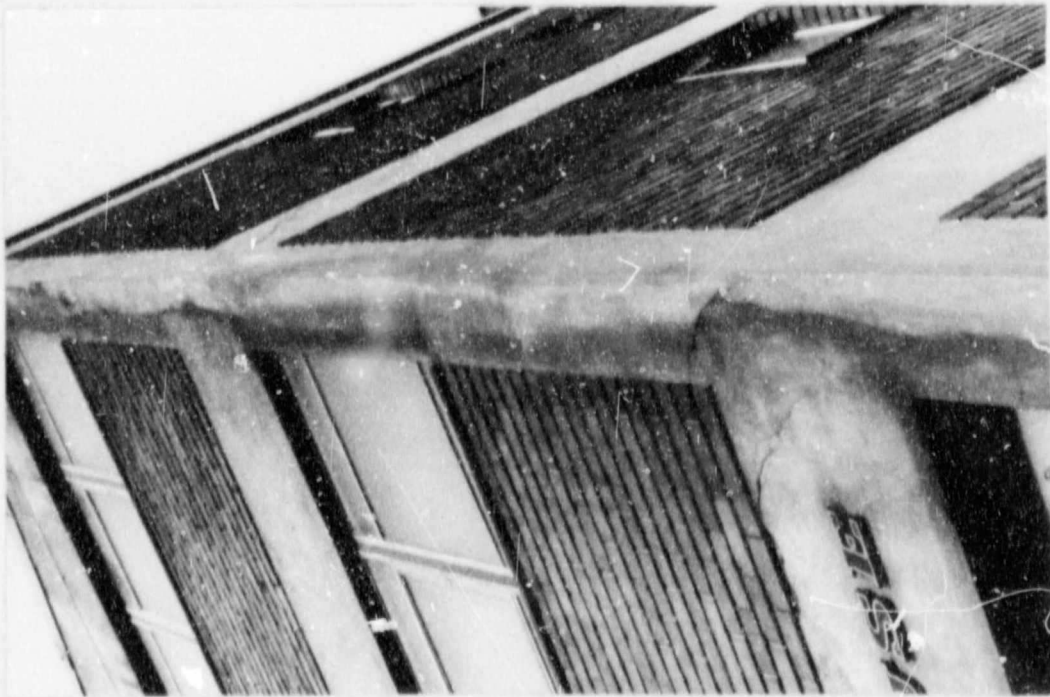
FIGURE 51. Cracks at another corner.
