**THE LOCATION, HAZARD ASSESSMENT AND SEALING OF  
UNSAFE MINE OPENINGS IN THE CENTRAL  
WITWATERSRAND GOLD MINING BASIN**

A dissertation submitted to the Faculty of Engineering and the Built Environment, University of the Witwatersrand, in fulfilment of the requirements for the degree of Master of Science in Engineering by research only

Johannesburg, 2009

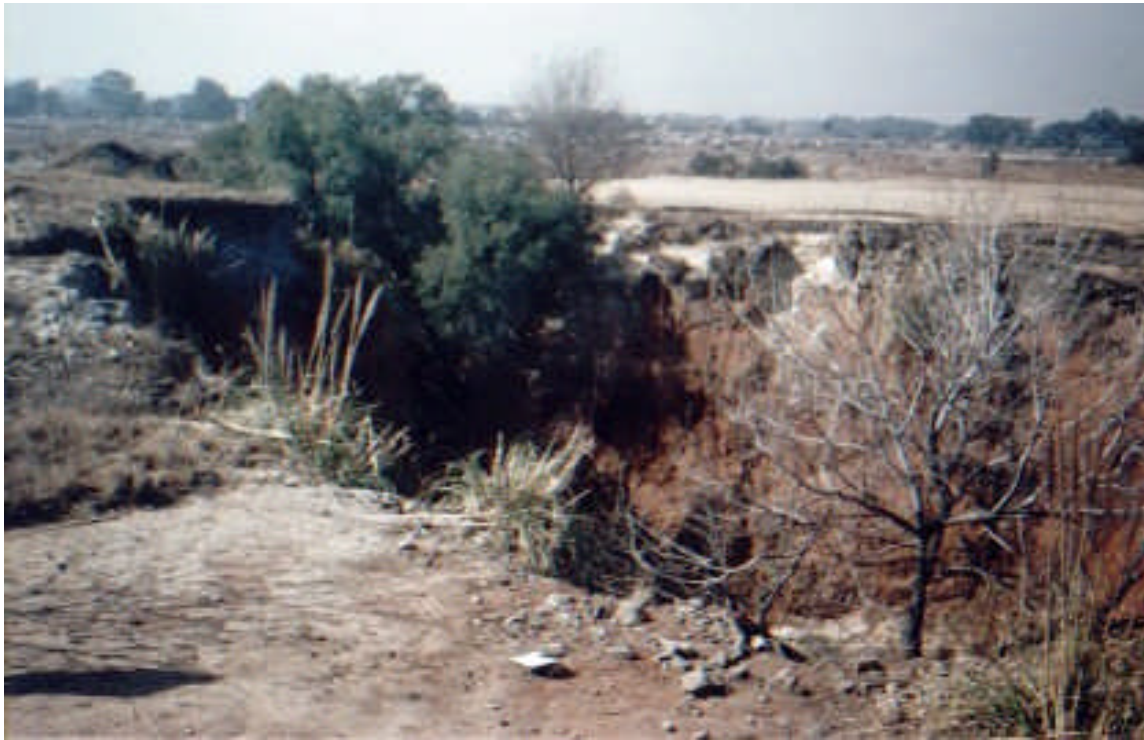
Figure 3.5. Largest subsidence in study area, ERPM 17, Ekurhuleni

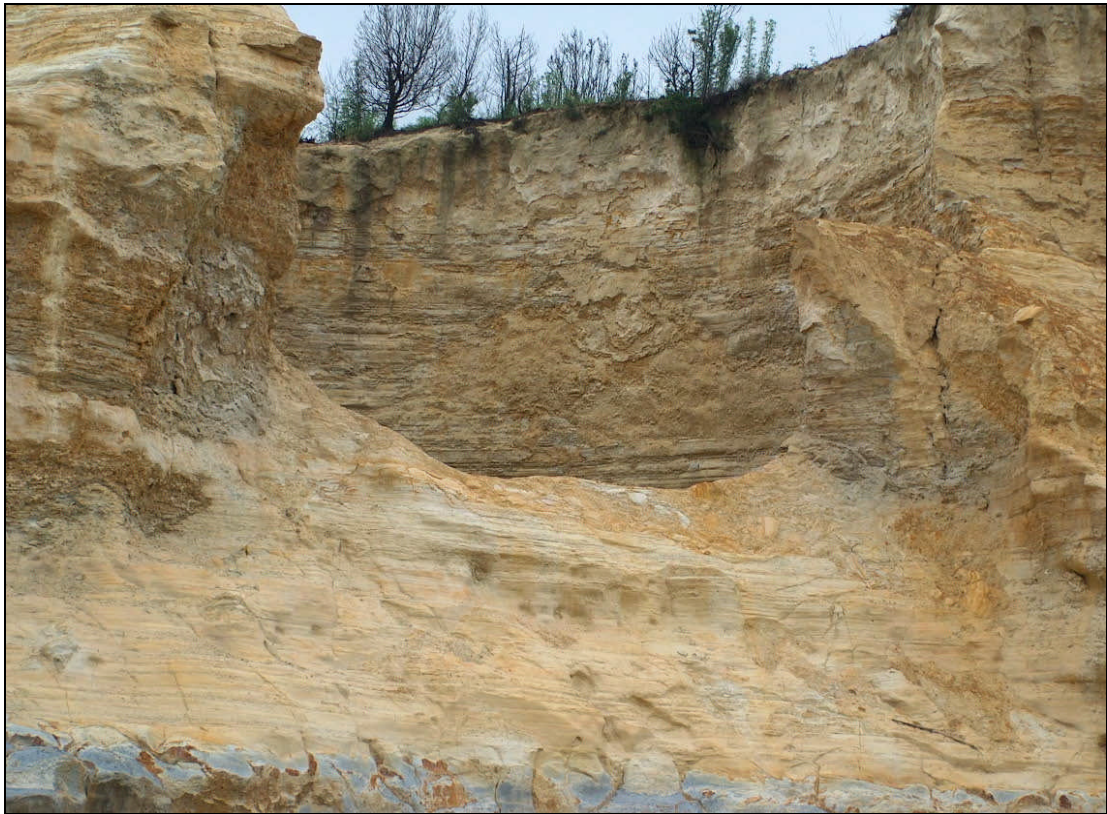
Figure 3.6. ERPM24x, collapse of a slimes dam into an underlying mine opening, Ekurhuleni

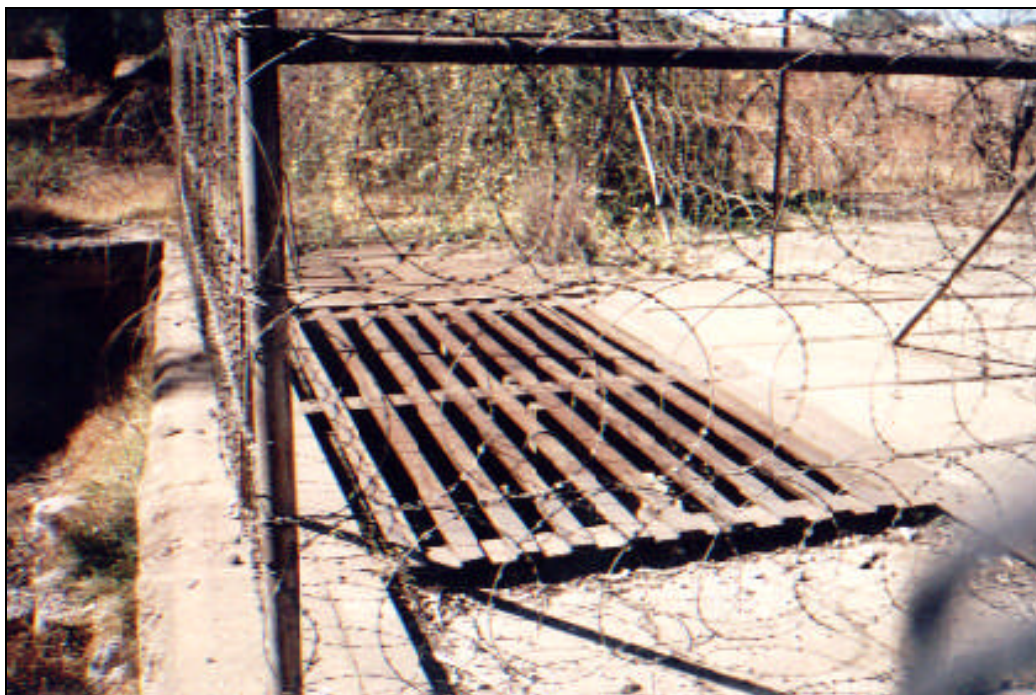
Figure 4.10: Mine opening (S & J 8) sealed with a metal grate and barbed wire fencing, Johannesburg

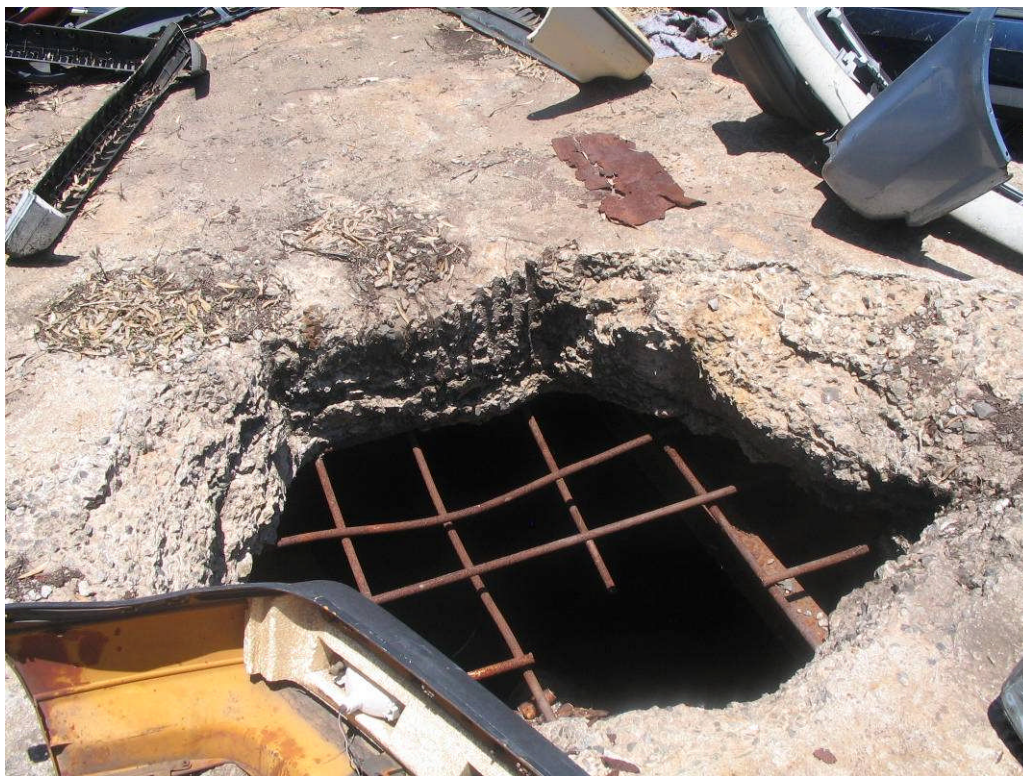
Figure 4.12. Access attempt through reinforced concrete seal, Kleinfontein Mine (Ekurhuleni)

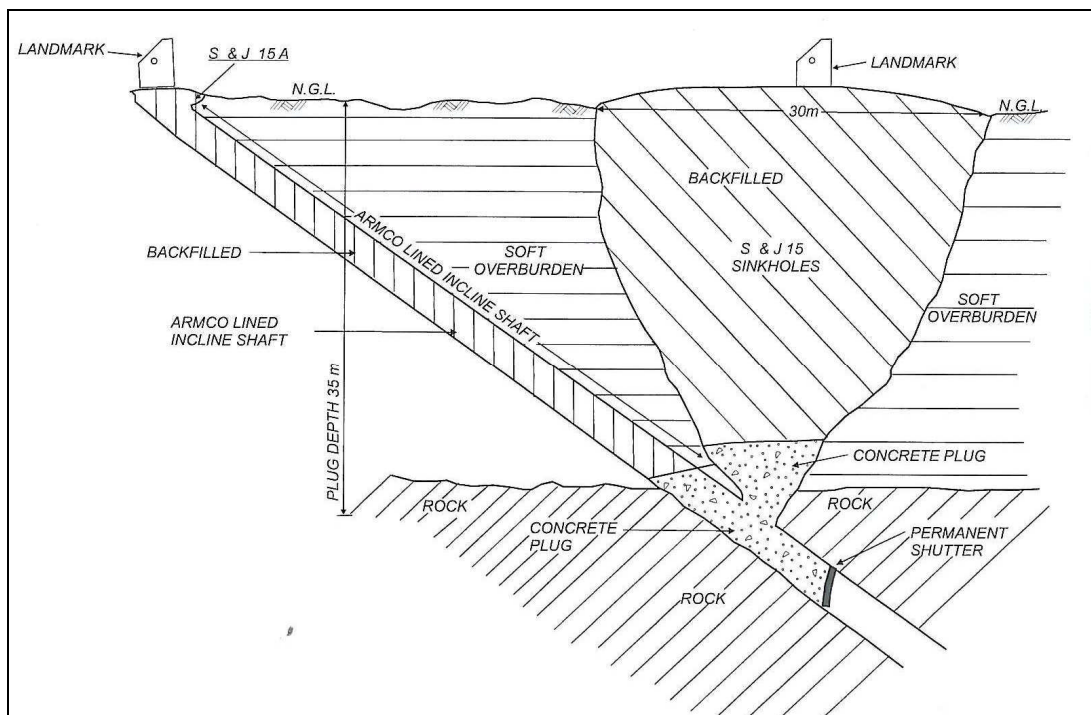
Figure 5.16. Concrete plugs installed in S&J 15 and S&J 15A, Ekurhuleni
