**INDUMEN COLLIERY.
 DETAIL PLAN OF FACES
 WHERE EXPLOSION OCCURRED
 Not to scale**

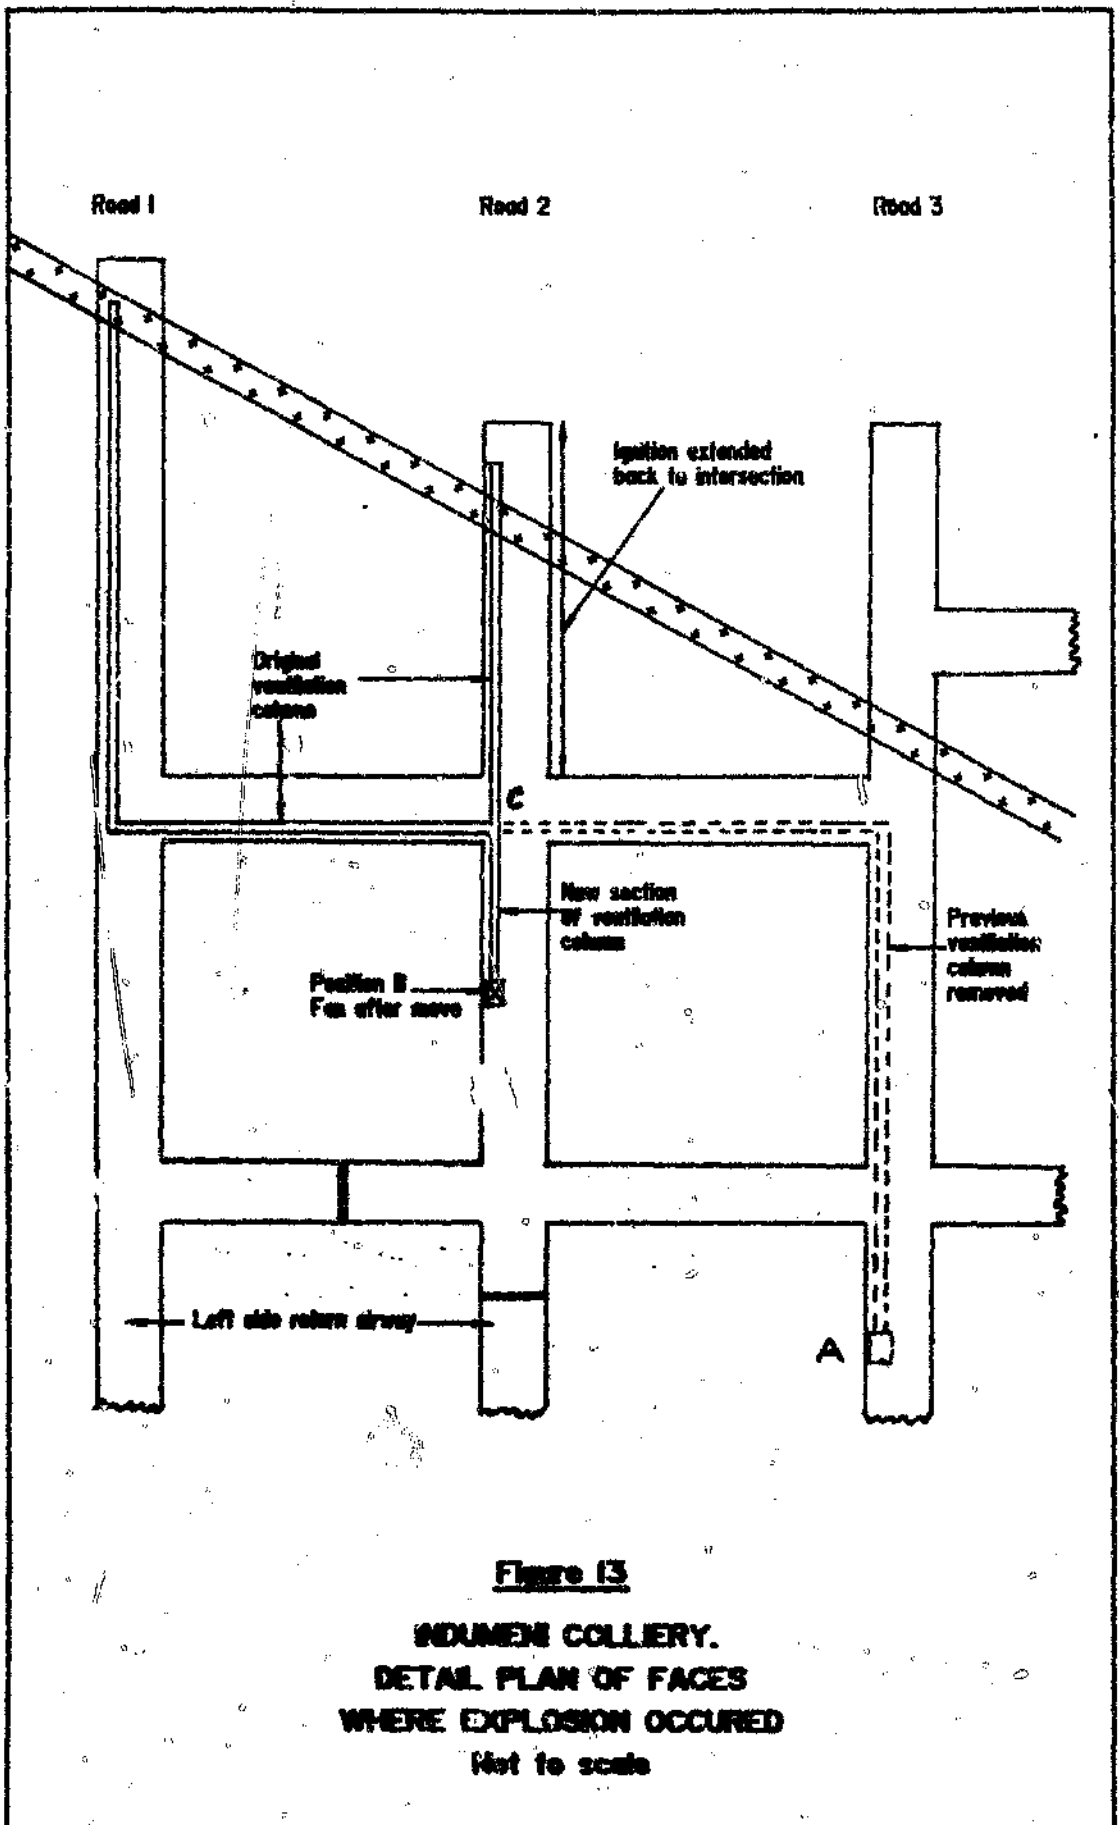
Figure 13

The section was a conventionally mechanised development section working on a double shift basis. A 2.5 m thick dolerite dyke had been encountered and all the roads were through the dyke and in clean coal. Nos. 1 and 2 roads had not yet advanced to a point where a holing could be effected between them in good ground conditions.

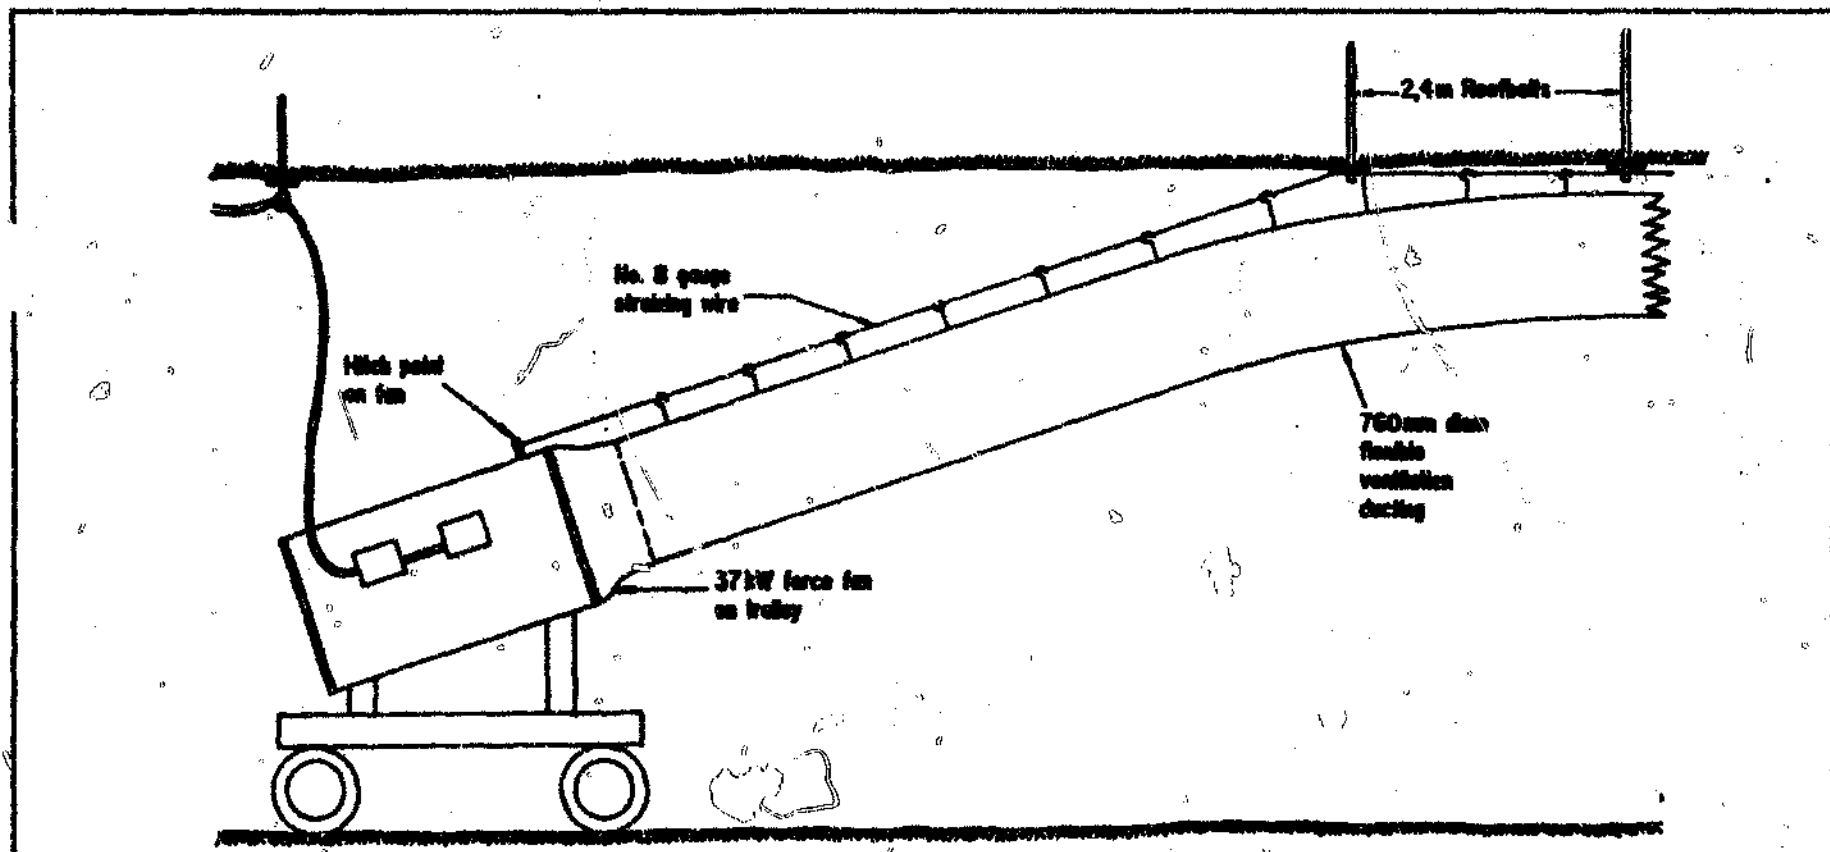
Figure 14
INDUMENI COLLERY
SECTION THROUGH ROAD No. 2
SHOWING FAN AND DUCTING INSTALLATION

The ventilation piping along the original route to the intersection at Point C was taken down and the section from Point C to the fan in its new position was installed. See Figure 13. The Shiftboss checked and found that there was a good flow of air passing the new fan site and that the atmosphere around the fan was clear of methane. He instructed the Electrician to put on the power and then depressed the start button at the same time checking the gland. The fan started but immediately tripped all the power in the section because the Electrician had re-engaged the interlock at the section isolator. He turned to the crew supervisor to send for the Electrician to show him the fault and saw the crew supervisor pointing excitedly towards the face of Road No. 2. The whole face was burning right back along the roof to the intersection.

It was established that the cause of the crackling sound and the smoke from the gland was what was termed a "hot" connection of one of the phases in the starter, and that a flash had occurred to the casing. The only other fault that could be found was that there was a rubber seal missing in the gland where the feed cable entered the starter. An independent specialist in earth faults and stray currents was employed to investigate the set up underground. Figure 15 indicates the set up.

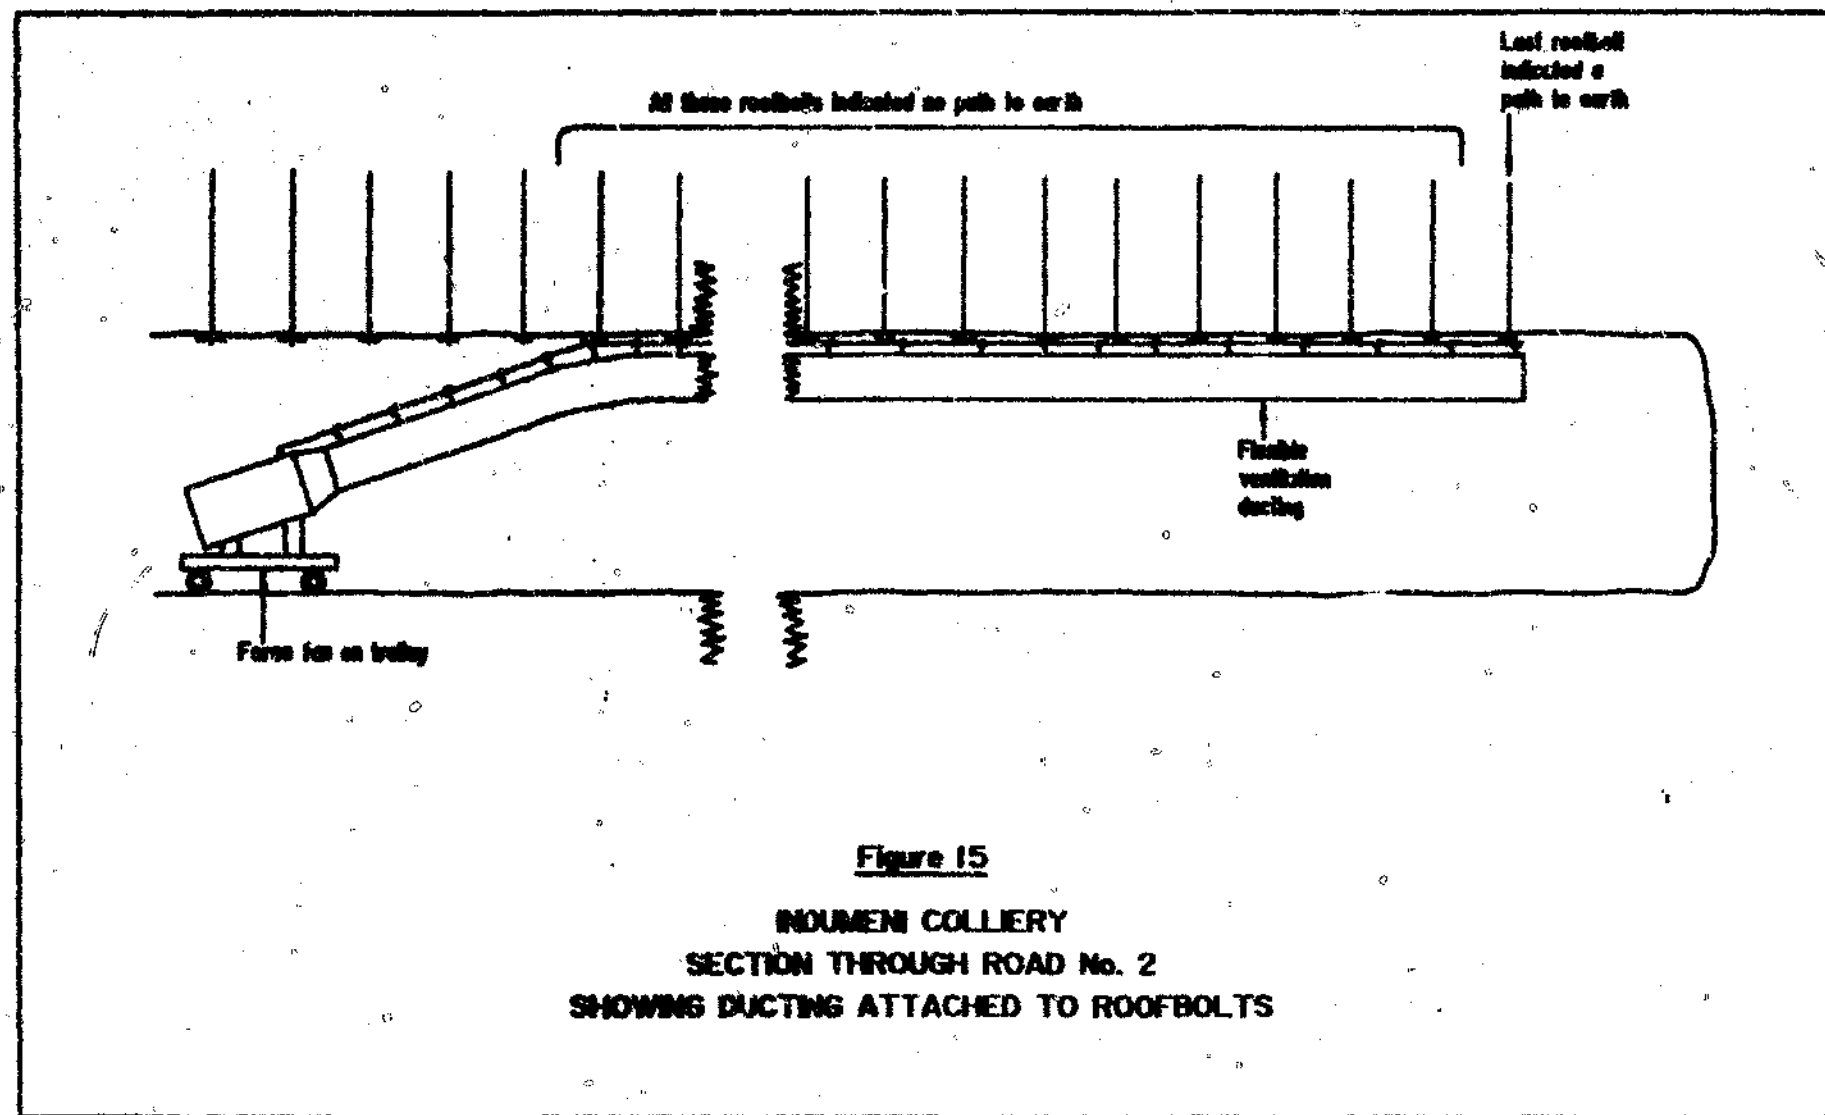
Figure 15
INDUMEN COLLIERY
SECTION THROUGH ROAD No. 2
SHOWING DUCTING ATTACHED TO ROOFBOLTS

All that could be established was that no electrical path to earth could be found at any of the roofbolts to which the wire was suspended except the last one in the face. All the other points were found to be rusty and non-conductive.

The final conclusion was that when the flash occurred in the fan starter, electricity travelled along the suspended wire and flashed across either at the roofbolt washer or inside the roofbolt hole thus igniting the gas.

When electric equipment and cables are moved the system should be examined for damage particularly to cables and glands.

Strict degassing procedures, as standard practice laid down by the Mine Manager, should be employed when starting a fan where there is an accumulation of methane which stretches back from the face and over the end of the last ventilation pipe in the face. For this specific condition the column should be broken at certain points so that the ventilation pipe can be blown clean especially in the first few lengths from the fan before full degassing commences.

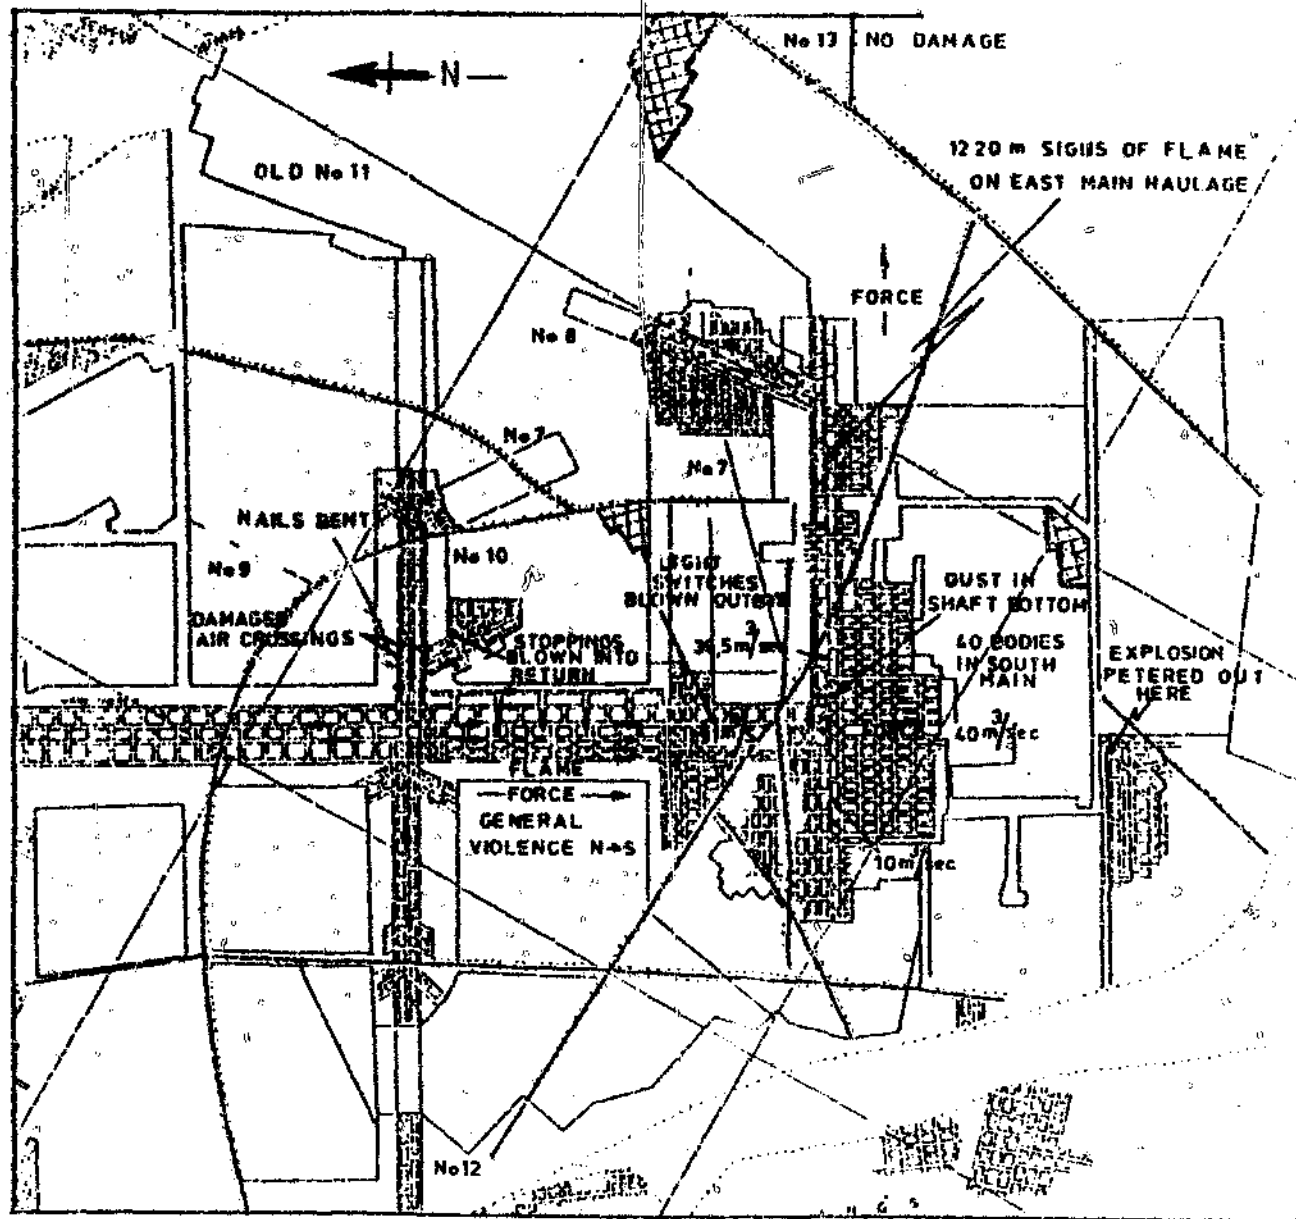
Figure 4
 PLAN OF D.N.C. No 2 WORKINGS
 1926

1. A methane explosion, caused by a blown-out shot, occurred in Section 10 some 1 300 metres from the shaft bottom (see Figure 4).
2. This explosion developed into a coal dust explosion which traversed the whole mine.
3. The force of the explosion is shown by arrows on Figure 4.
4. The explosion spent itself at the top of the upcast and downcast shafts and in the South main sections.
5. The explosion destroyed the fan drift on the upcast shaft and did considerable damage to the bank of the downcast shaft. The Compound Manager who was about 200 metres from the shaft states in reply to questions at the Official Inquiry:

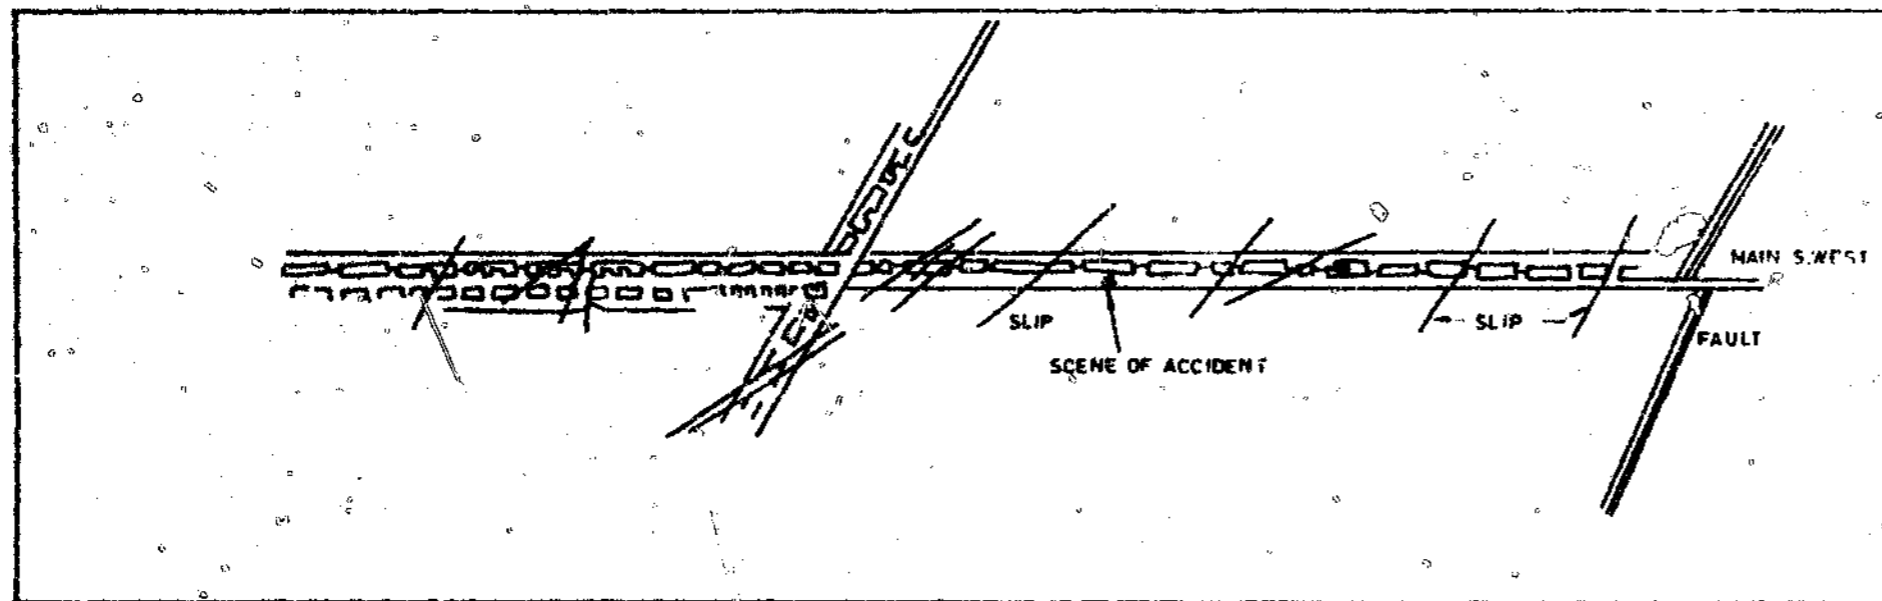
Figure 5
CONSOLIDATED COLLIERIES
PLAN OF ACCIDENT SCENE

The colliery is situated in the Ermelo area. The coal seams are found at a depth of between 60 and 85 metres and were known to be gassy. A 2000 volt electric cable was being extended to a new substation site on a Sunday and two Electricians were making a joint in this cable using a blow lamp. The main fan had been stopped for repairs for 3 hours during this period during which time methane built up in the main haulage where the electrical connection was being made. A methane explosion took place seriously injuring the two Electricians.

The main fan had been stopped for repairs for approximately 2 hours which would have allowed methane to build up in the Main South West haulage.

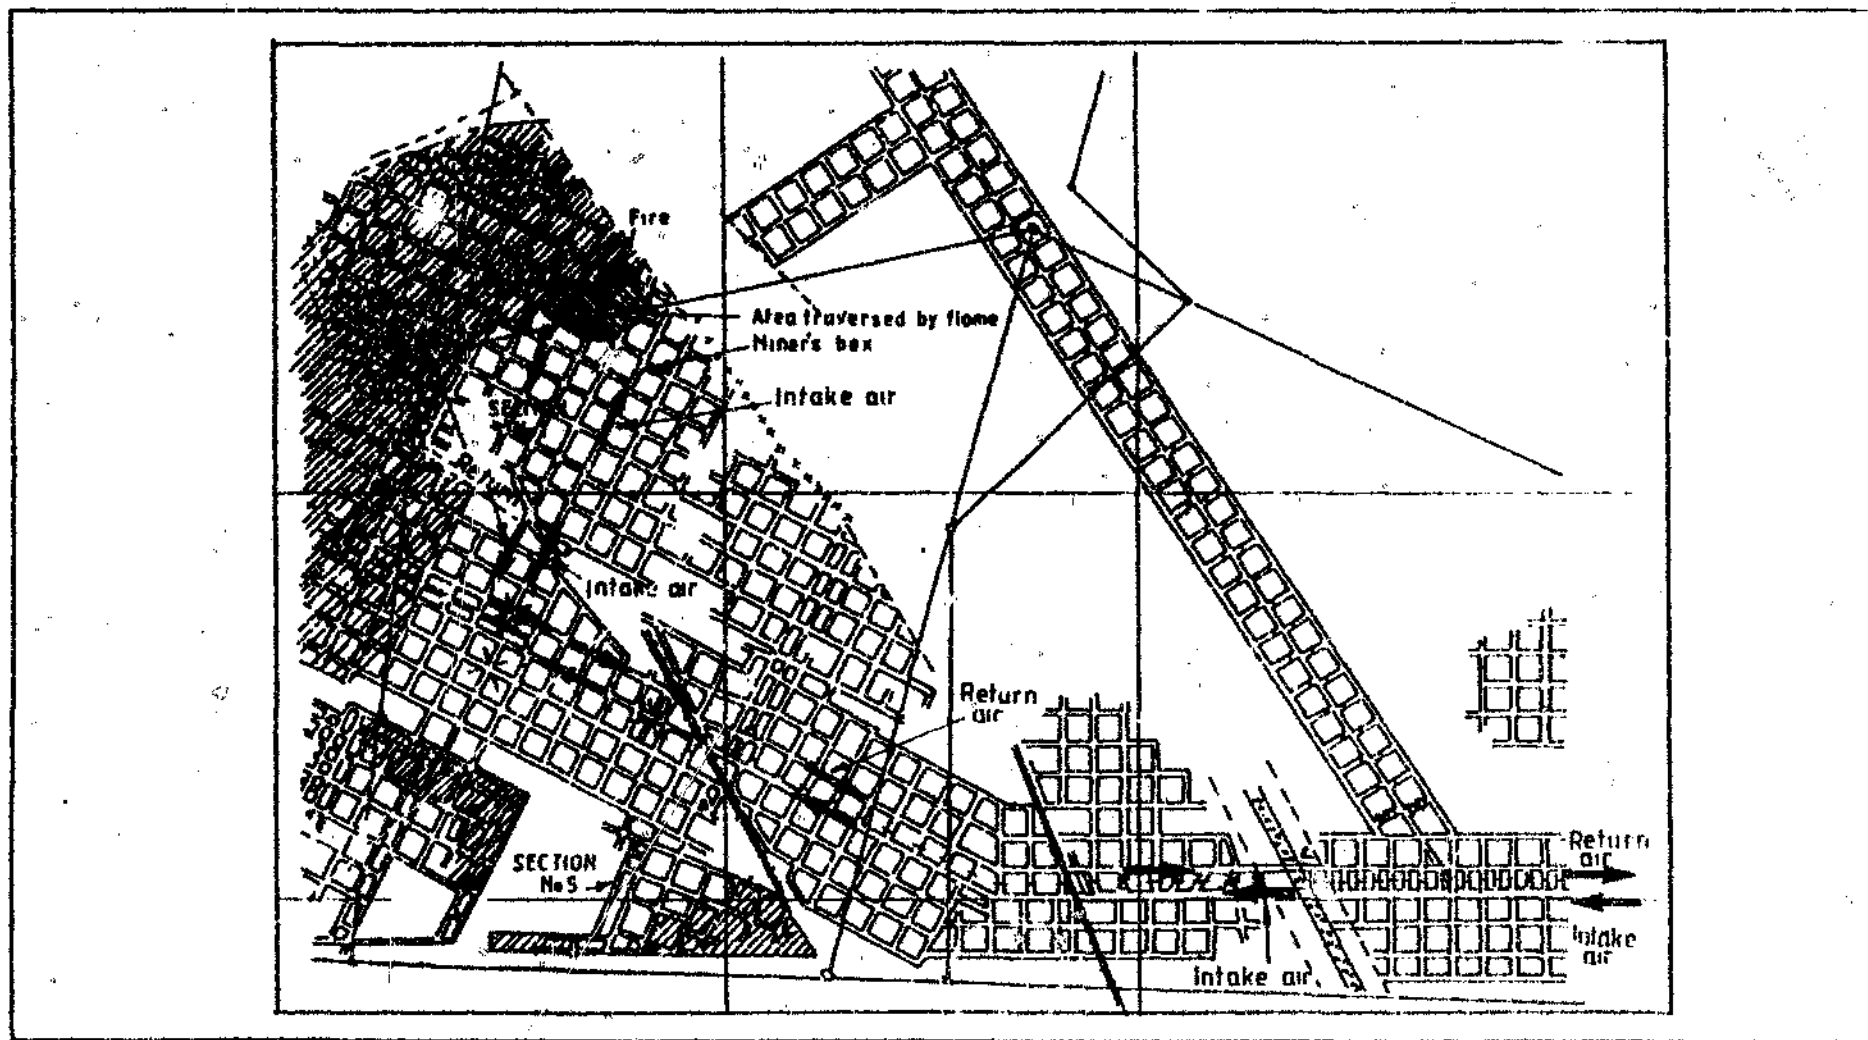
Figure 6
NORTHFIELD COLLIERY - PLAN OF EXPLOSION

The section in question, Figure 6, was developed during December 1949 on the bord and pillar system. During development, the area was not gassy. There is a large area of ground immediately

beyond the section from which the pillars have been removed. During pillar extraction, for the past few months at least, there had been practically no sign of gas. The Sub Inspector of Mines had visited the section only 12 days before the accident and reported that the ventilation was excellent and no trace of firedamp was found.

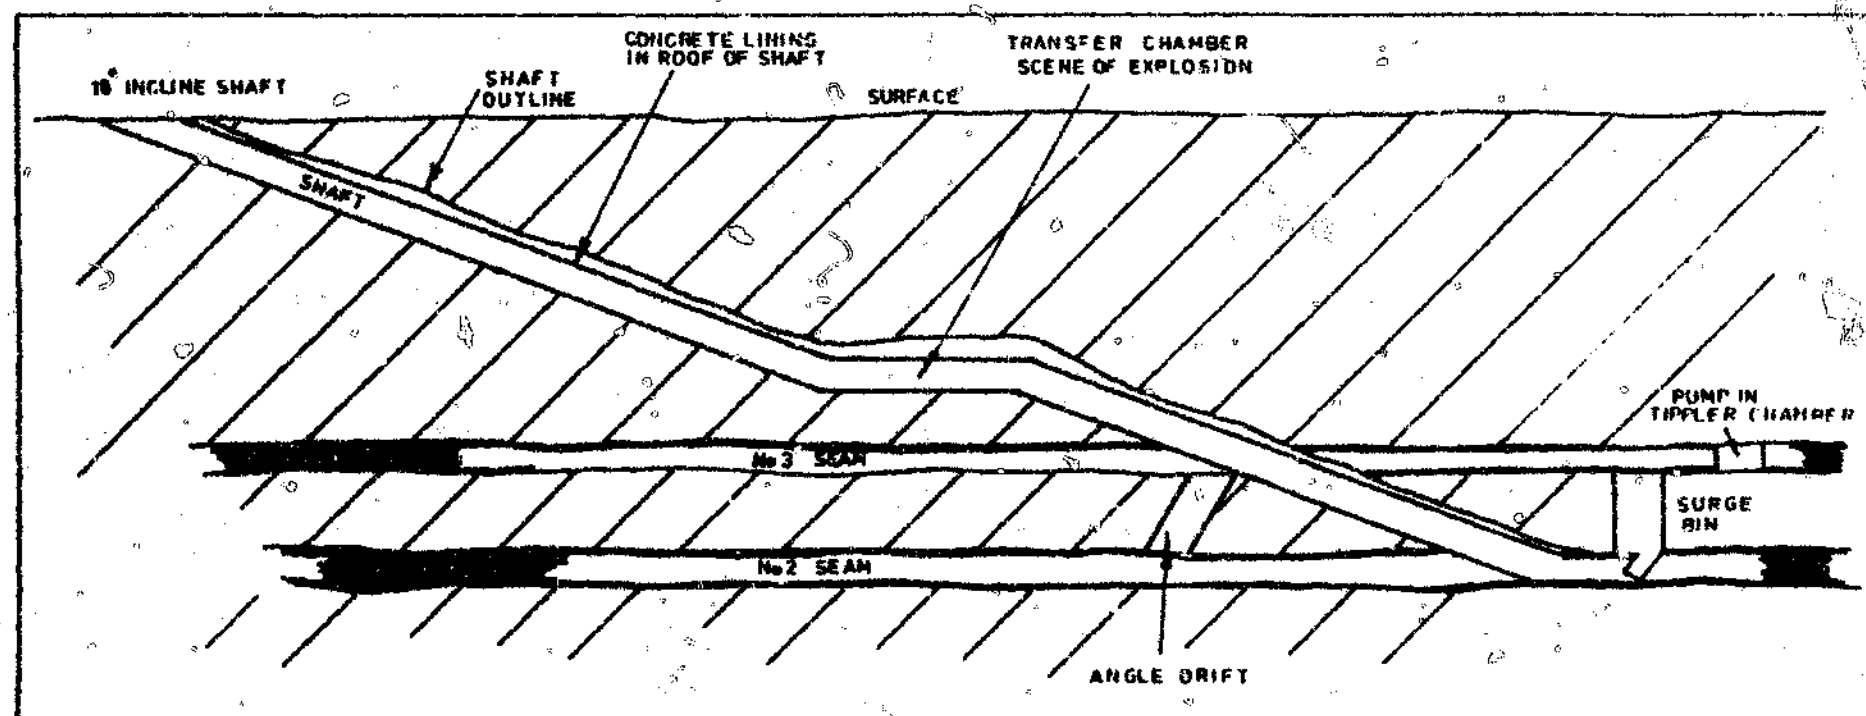
Figure 8
 COALBROOK COLLIERY
 SECTION THROUGH INCLINE SHAFT
 SHOWING SCENE OF EXPLOSION IN TRANSFER CHAMBER

A series of events now took place which finally led to the methane explosion caused by a revolver type igniter or the flame from an acetylene torch used to cut a roof girder in the inclined shaft transfer chamber.

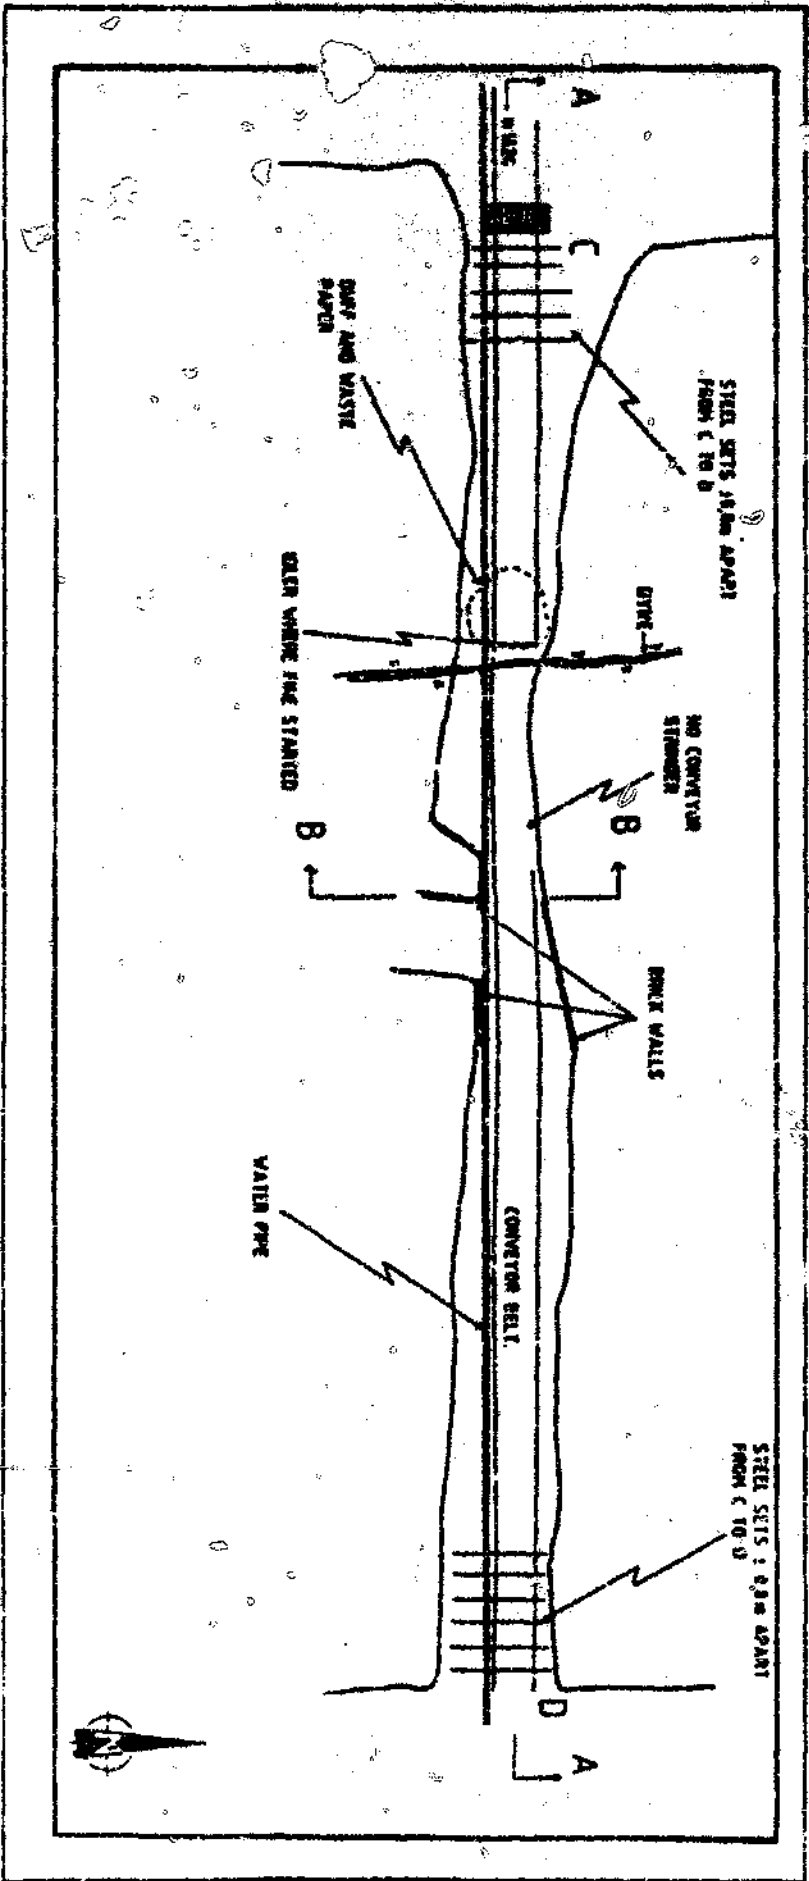
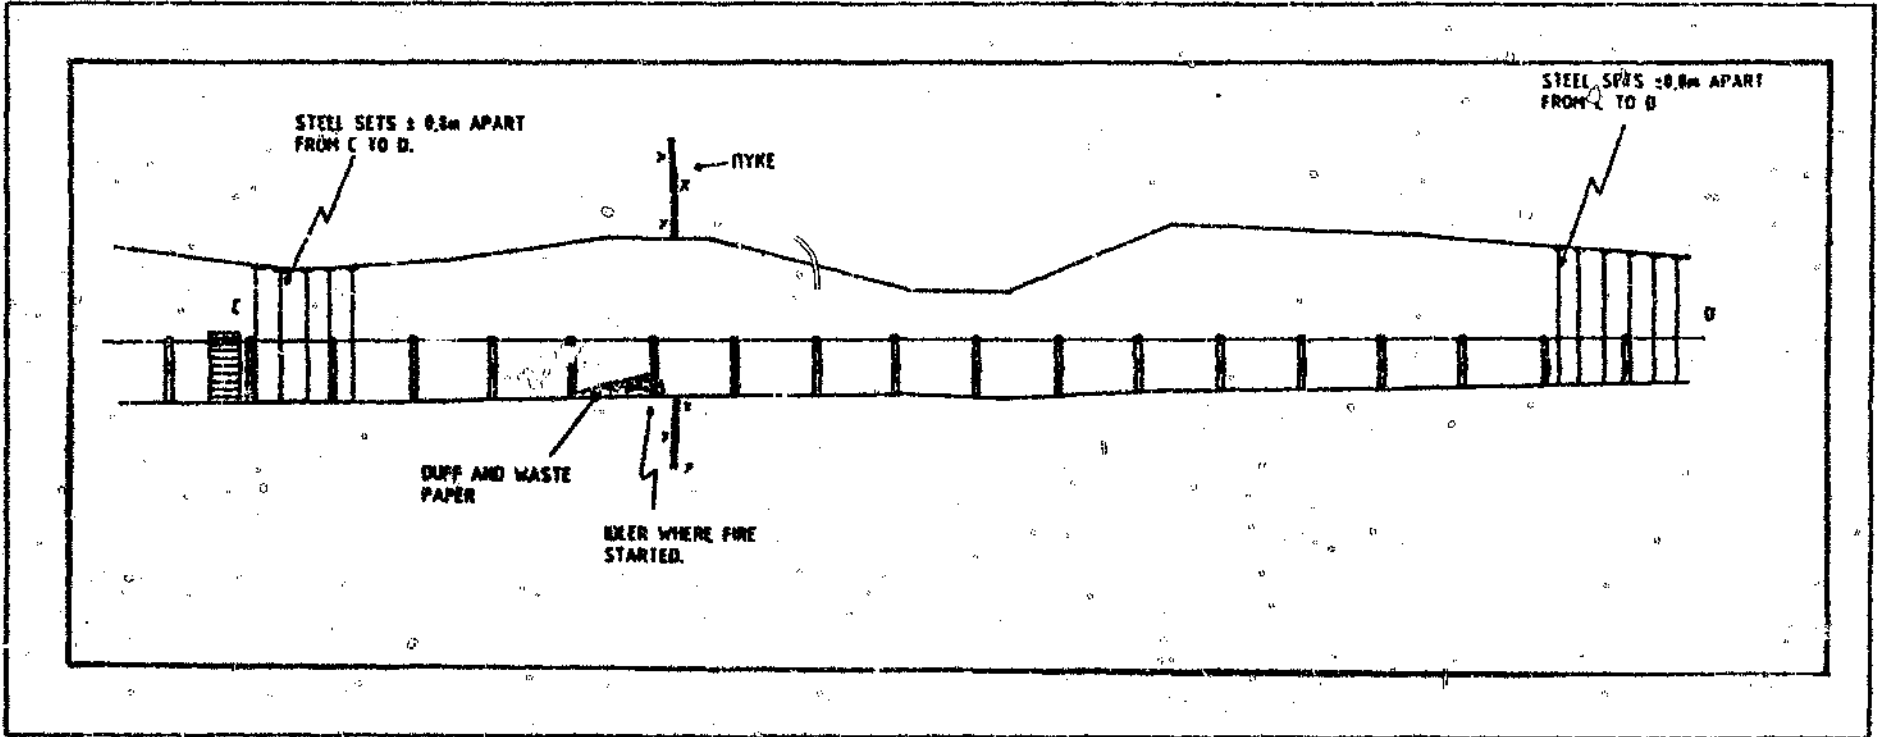
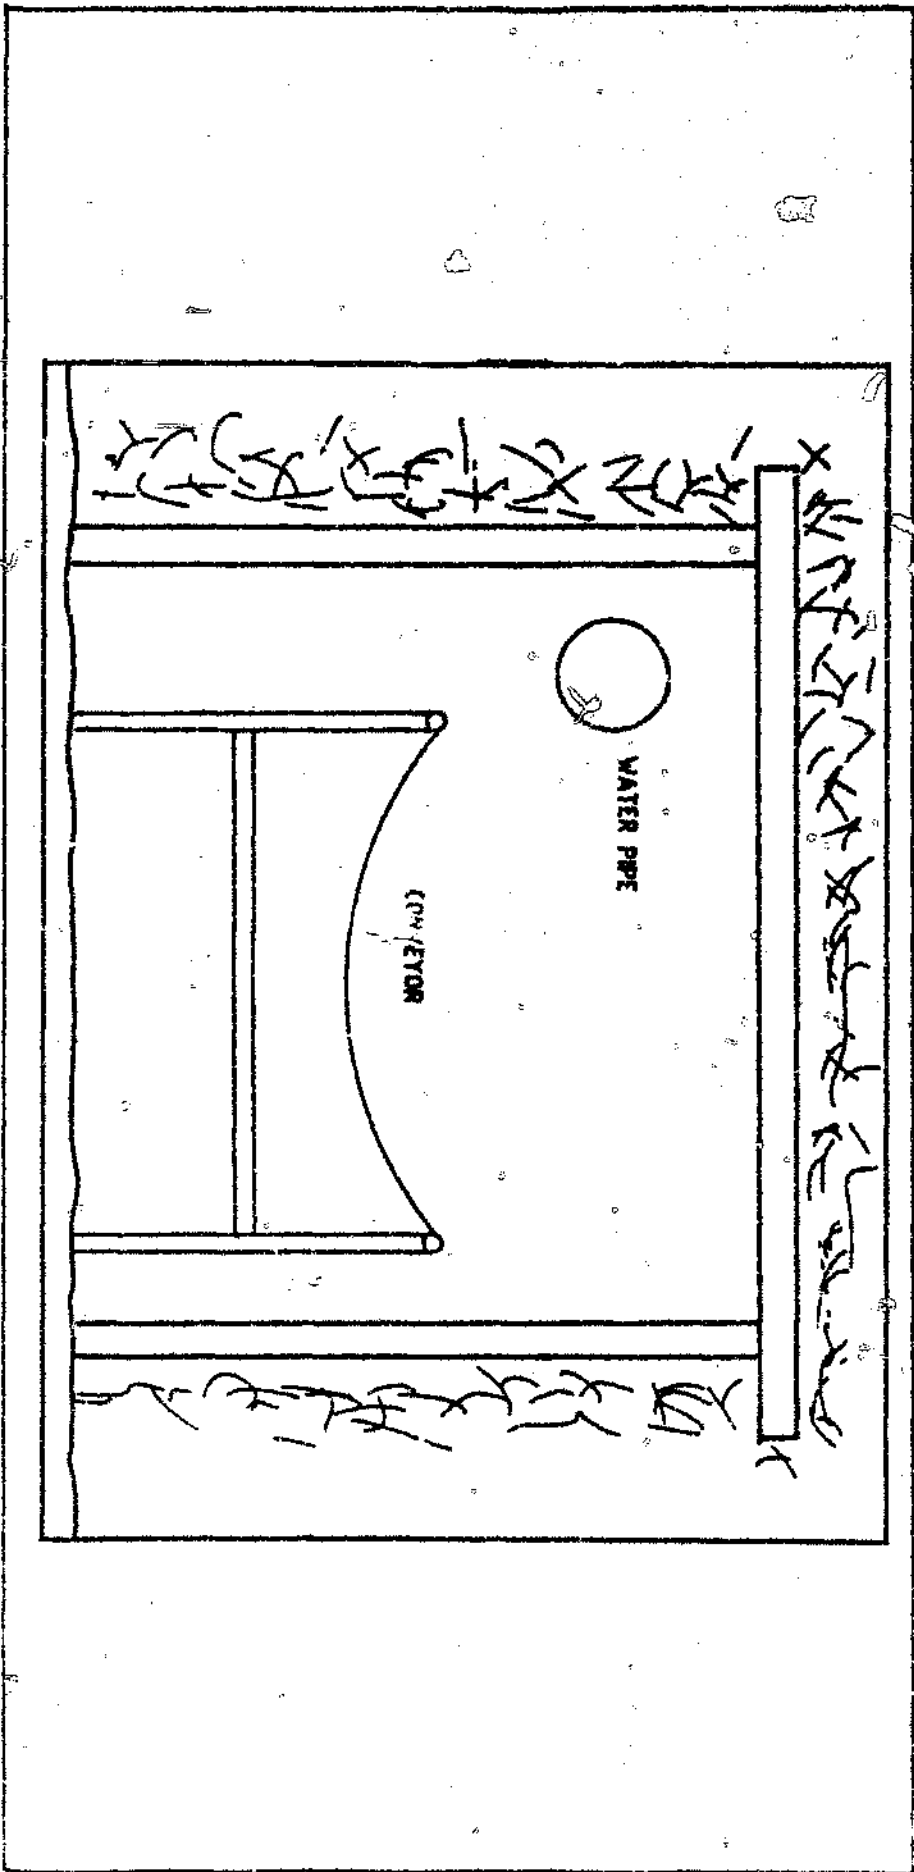
sets on fire. Figures 10, 11 and 12 show details of the affected area.

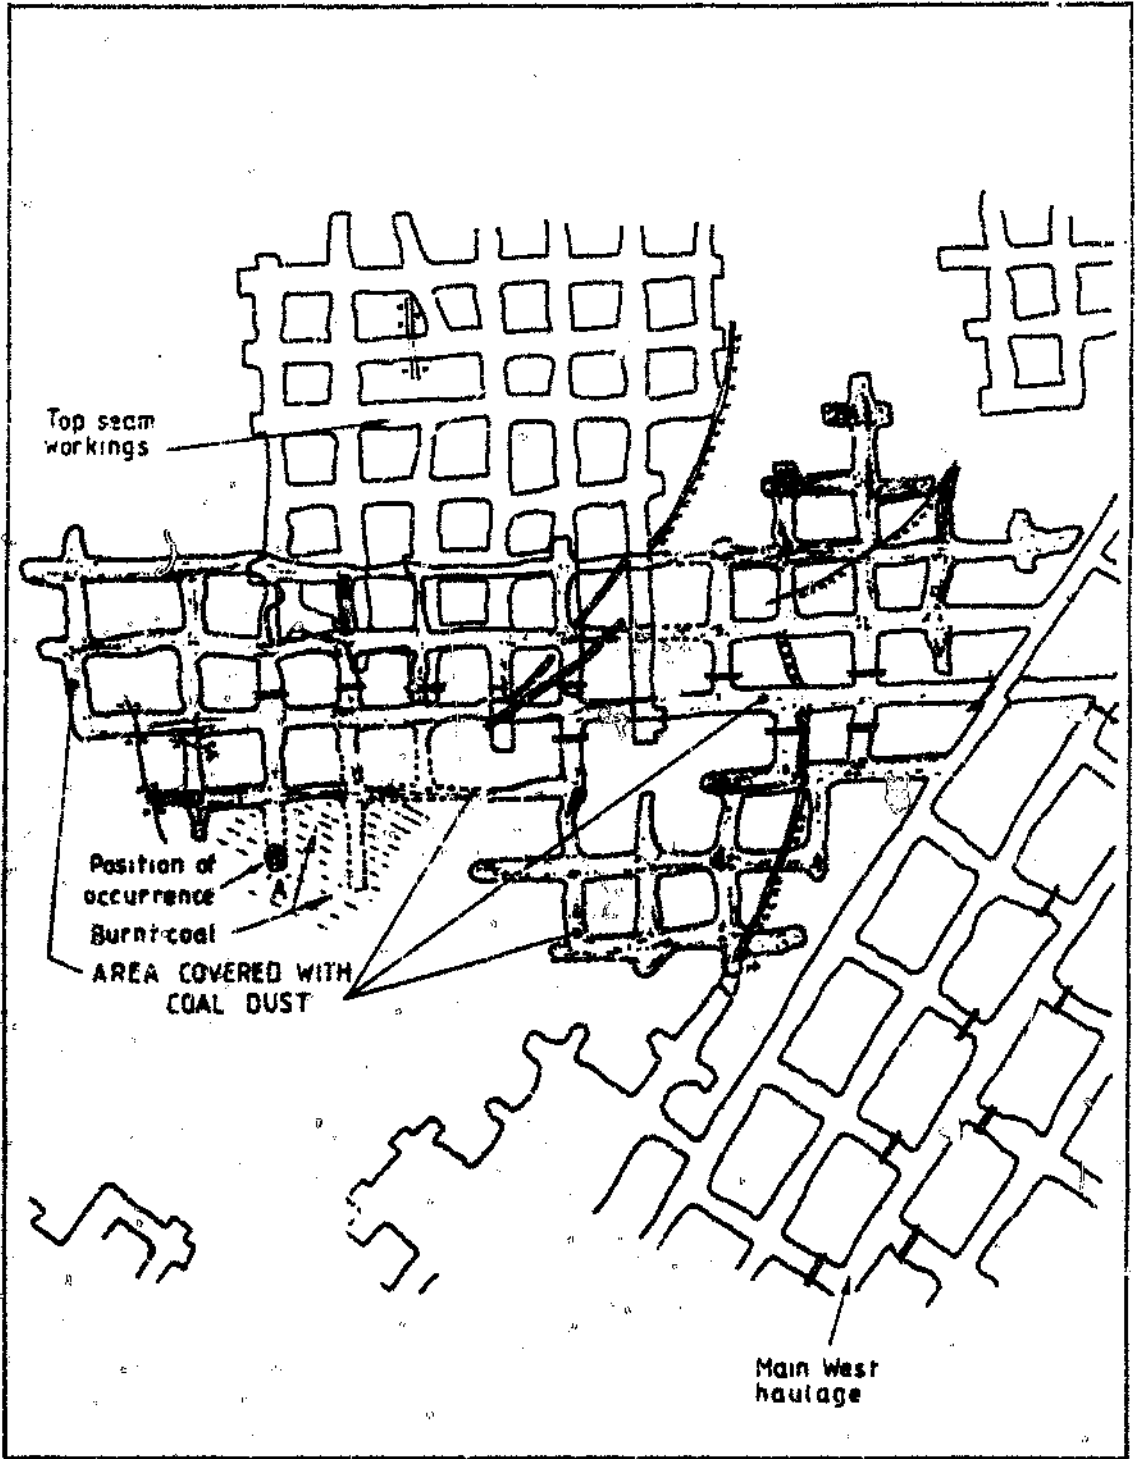
Figure 7

PLAN OF THE SECTION SHOWING THE AREA AFFECTED BY FINE COAL DUST AS A RESULT OF AN OUTBURST

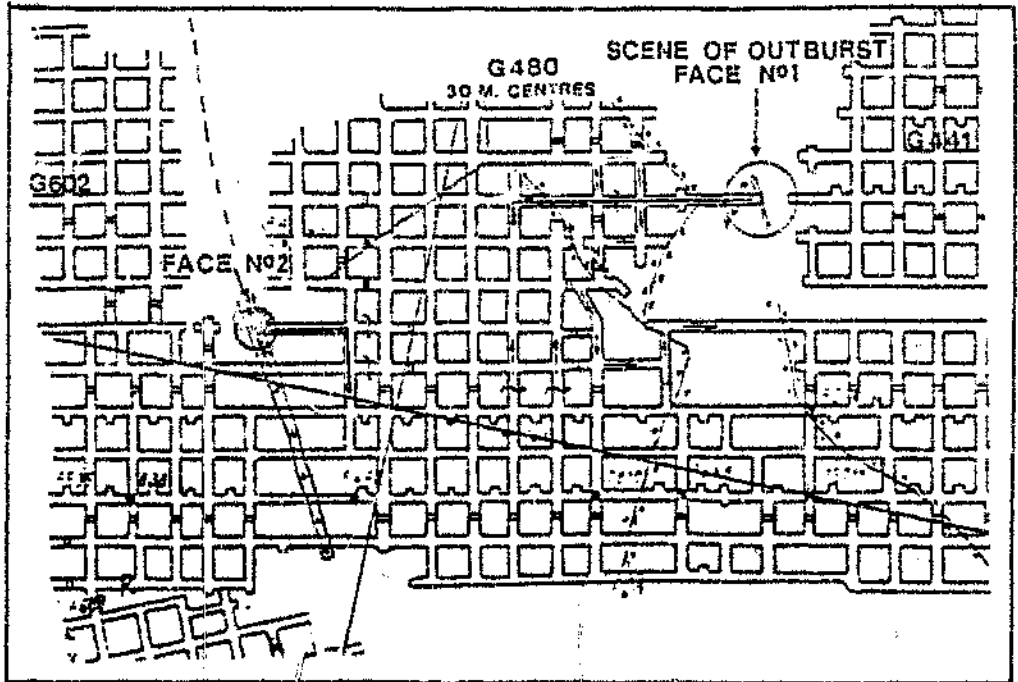
Figure 12

PLAN SHOWING AREA OF MOST RECENT OUTBURST
AT SPRINGFIELD COLLIERY

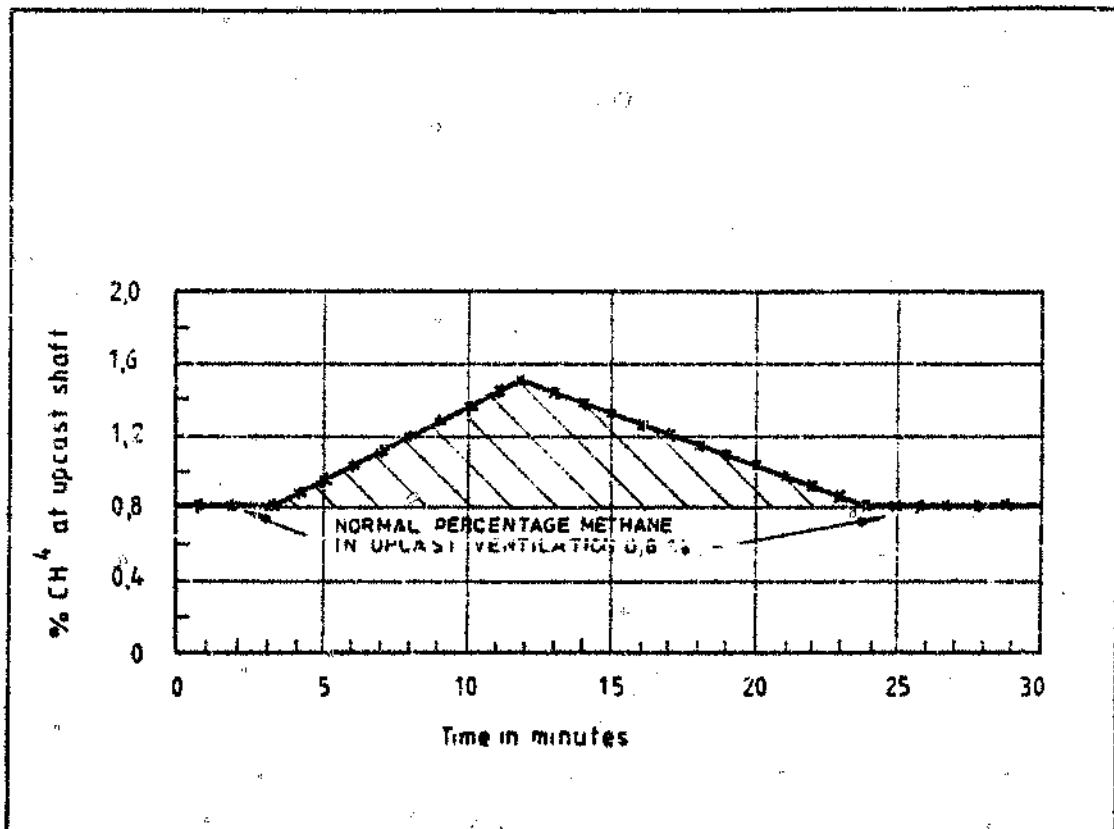
Figure 16 depicts the percentage methane in the upcast shaft prior to and after the outburst. Based on an upcast quantity of $189 \text{ m}^3/\text{second}$ the area shown hatched on the graph indicates the total volume of methane desorbed from the face, roof and sides of the second left hand companion.
