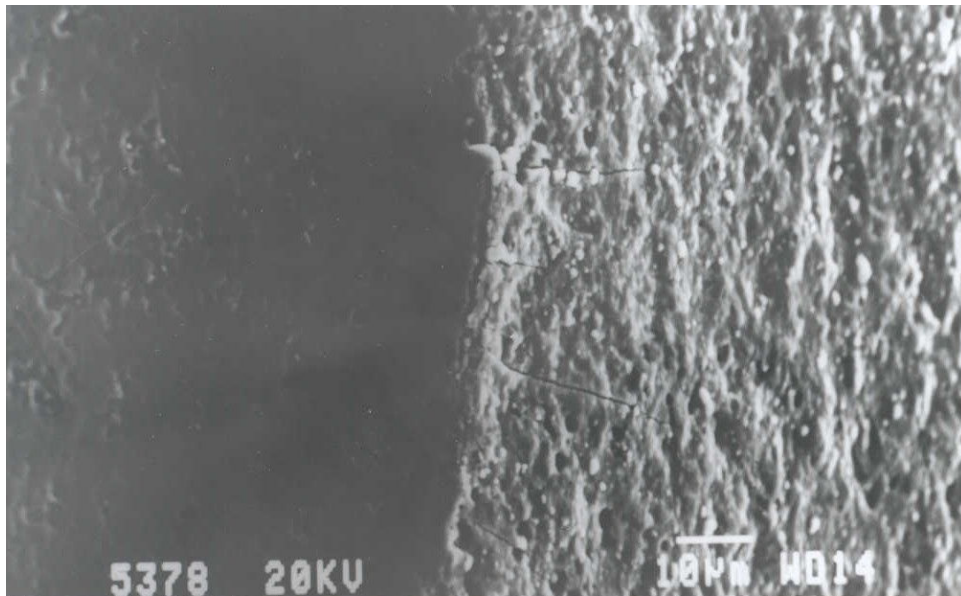
The cracks were homogeneous in length and regular in distance. When the sample was tilted by 45 ° to the electron beam, a small lip around the edge of the indentation could be seen. However, the lip was not prominent. A few cracks could also be found inside the indentation and parallel to the circumference, see Fig. 5.159.

*Fig. 5.159: Cracks due to Rockwell indentation on the coatings from supplier 3*

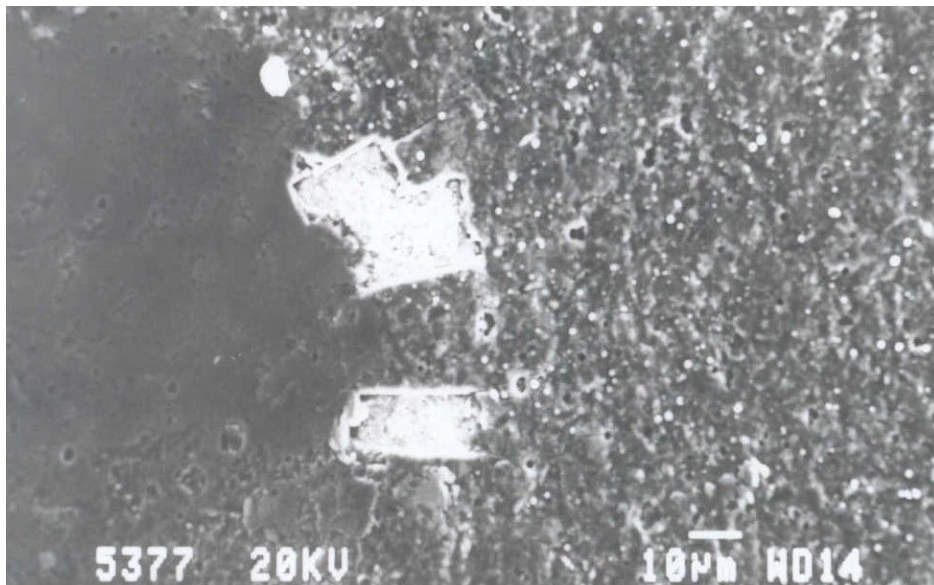
Spectrum (j) from the small region which chipped showed a higher Al peak than spectrum (i) which indicates that Al is exposed. Spectrum (k) was taken at the edge of the indentation where cracks are most likely to occur, but the spectrum is the same as the one from inside the indentation.

The small chipped areas were found between cracks, see Fig. 5.160.

*Fig. 5.160: Chipped areas due to Rockwell indentation on the coatings from supplier 3*

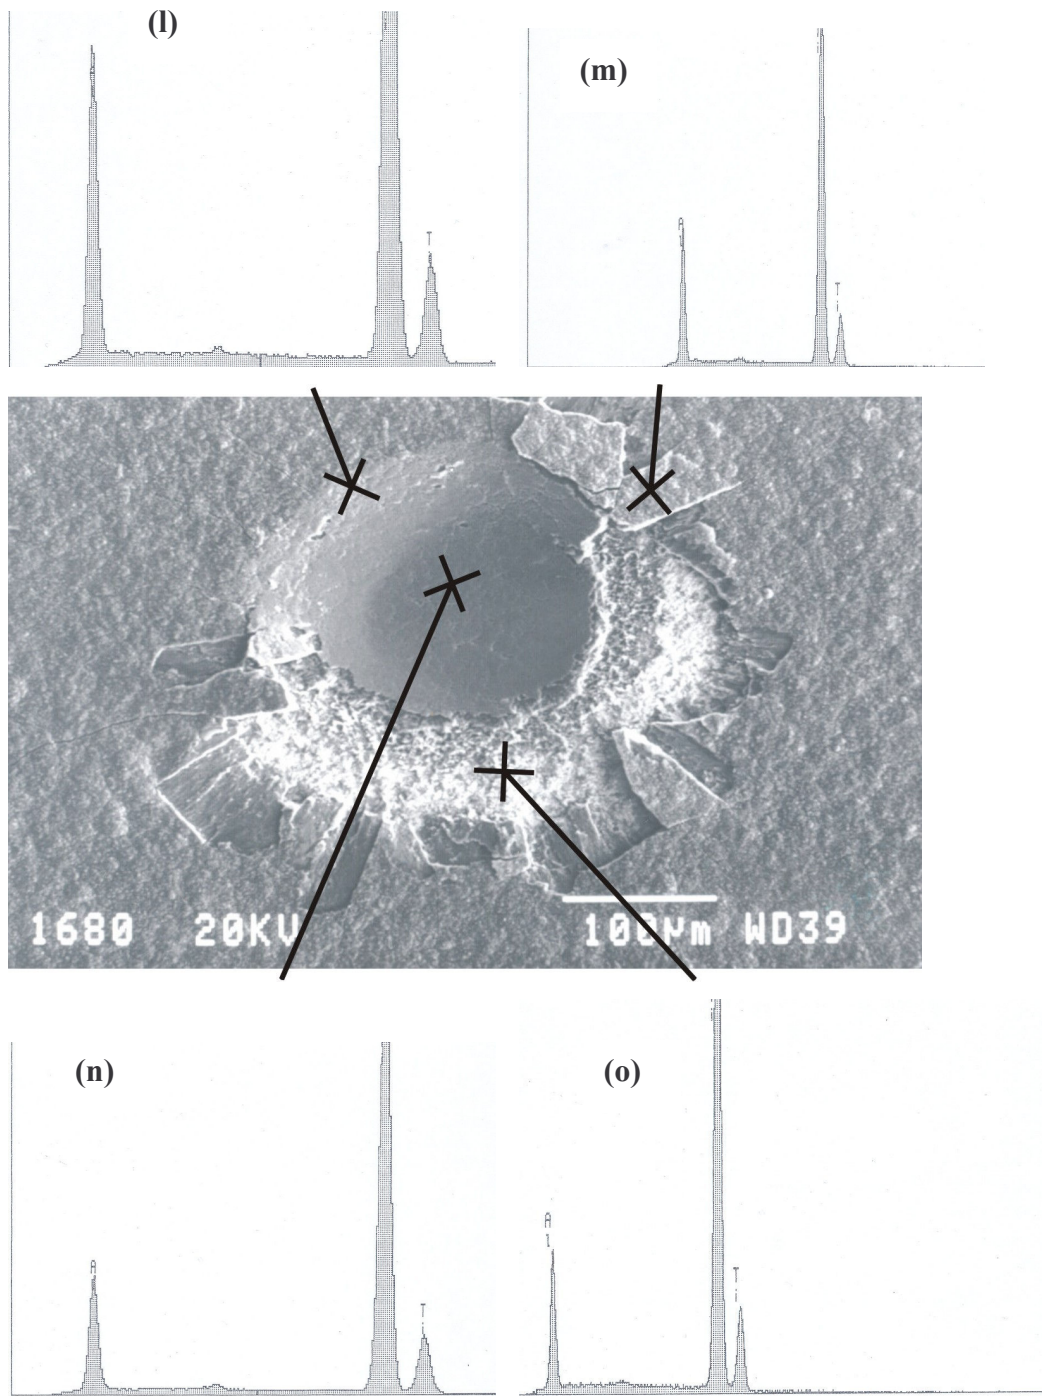
*Fig. 5.161: Rockwell indentation of system "substrate/coating" from a supplier 4's insert and EDS spectra from the spots indicated by the crosses*

The annular region in supplier 4's coating consisted of a finely fragmented area around the indentation and an area with radial cracks surrounding the fragmented region. The cracks were parallel and regular and could be seen inside and parallel to the circumference.

Spectrum (l) is taken at the edge of the indentation where the EDS analysis revealed Al. Spectrum (m) is from a spot on the cracked region where the coating was broken but had not fallen off. In spectrum (o) from the finely fragmented annular region, the TiN had probably partly fallen off and uncovering the  $\text{Al}_2\text{O}_3$  and possibly also the TiCN. The centre of the indentation in spectrum (n) showed the TiN coating pushed down with some  $\text{Al}_2\text{O}_3$  detected.

The Al/Ti ratio seems to be minimum in spectrum (n), therefore the Al peak is probably due to the extreme thinness of the TiN coating. In spectra (m) and (o) the Al/Ti is not much higher than in spectrum (n), indicating that despite fragmentation and cracking most of the TiN coating did not fall off. The highest Al/Ti ratio was found in spectrum (l).

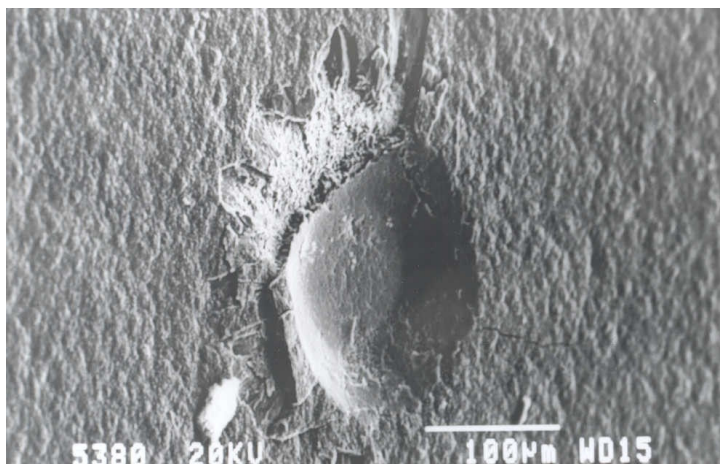
When the sample was tilted by  $45^\circ$  to the electron beam, a lip could be identified which was larger than that of the indentation on the coatings from supplier 3, see Fig. 5.162. (The lip is in focus in Fig. 5.162 while the original surface is out of focus because it is at a lower level.)

*Fig. 5.162: Rockwell indentation on the coatings from supplier 4*

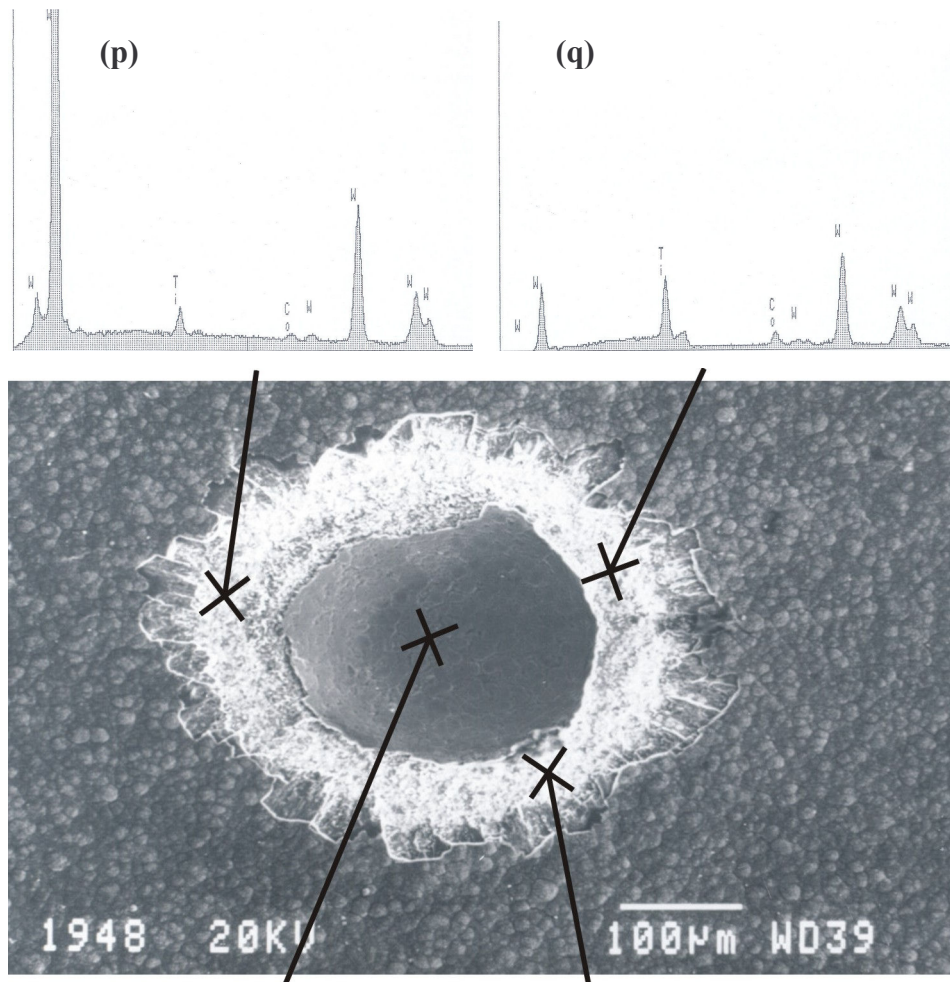
Fig. 5.163: Rockwell indentation of system "substrate/coating" from a supplier 5's insert and EDS spectra from the spots indicated by the crosses

The indentation on a cutting tool insert from supplier 5 showed a thick finely fragmented annular area around the indentation and, around that, a region with radial cracks. Those cracks were not long but many.

The centre of the indentation in spectrum (r) revealed Ti and Al as the TiN was pushed down without removing it, the  $\text{Al}_2\text{O}_3$  layer underneath being revealed probably because of the thinness of the TiN coating. Spectra (p), (q) and (s) showed that the substrate was visible among the coating fragments in larger or smaller amounts depending on the area and that the TiN and  $\text{Al}_2\text{O}_3$  layers were both removed (if  $\text{Al}_2\text{O}_3$  was absent, and thus removed, also TiN must have been removed). Therefore this coating did not adhere to the substrate after cracking.

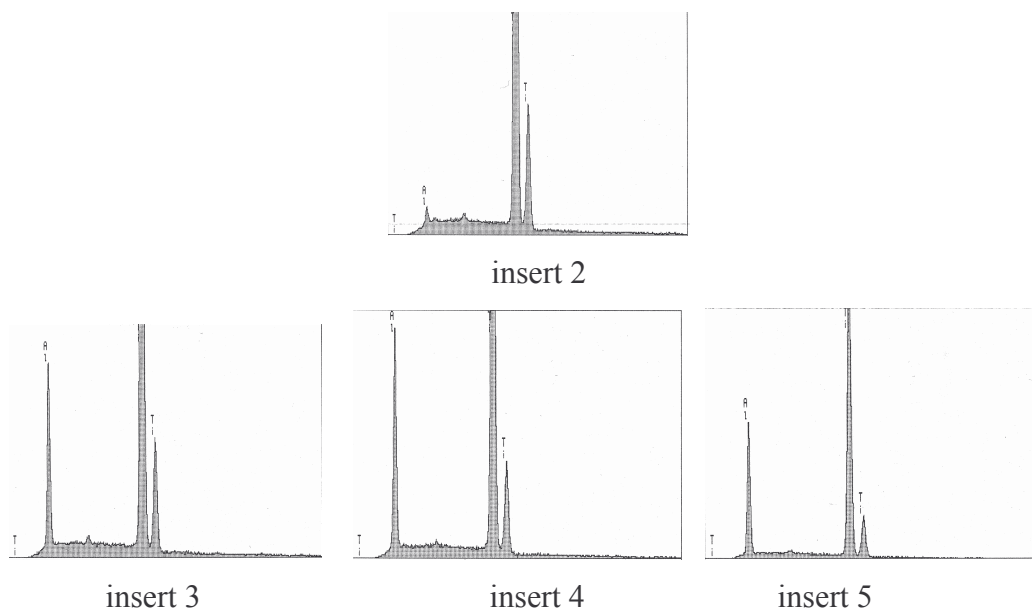
*Fig. 5.164: EDS spectra on the centre of a Rockwell indentation on the coatings from supplier 2 to 5*

The Al detected was much lower in the inserts from supplier 2 compared to the inserts from suppliers 3 to 5 (the inserts from supplier 1 did not contain Al), see the Al/Ti  $K_{\beta}$  peak ratios in Table 5.41.

The Al/Ti  $K_{\beta}$  ratio from the inserts from supplier 2 is below one, while those from the inserts from suppliers 3 to 5 are above one. That phenomenon is still unexplained, although one wonders if the stopping power of the TiCN layer in the coating of the inserts from supplier 2 is related to the adhesion between the TiCN and the  $Al_2O_3$  layers. The adhesion between substrate and whole coating in the inserts from supplier 2 seemed to be good, contrary to the bad adhesion between the TiCN and  $Al_2O_3$  coating layer.

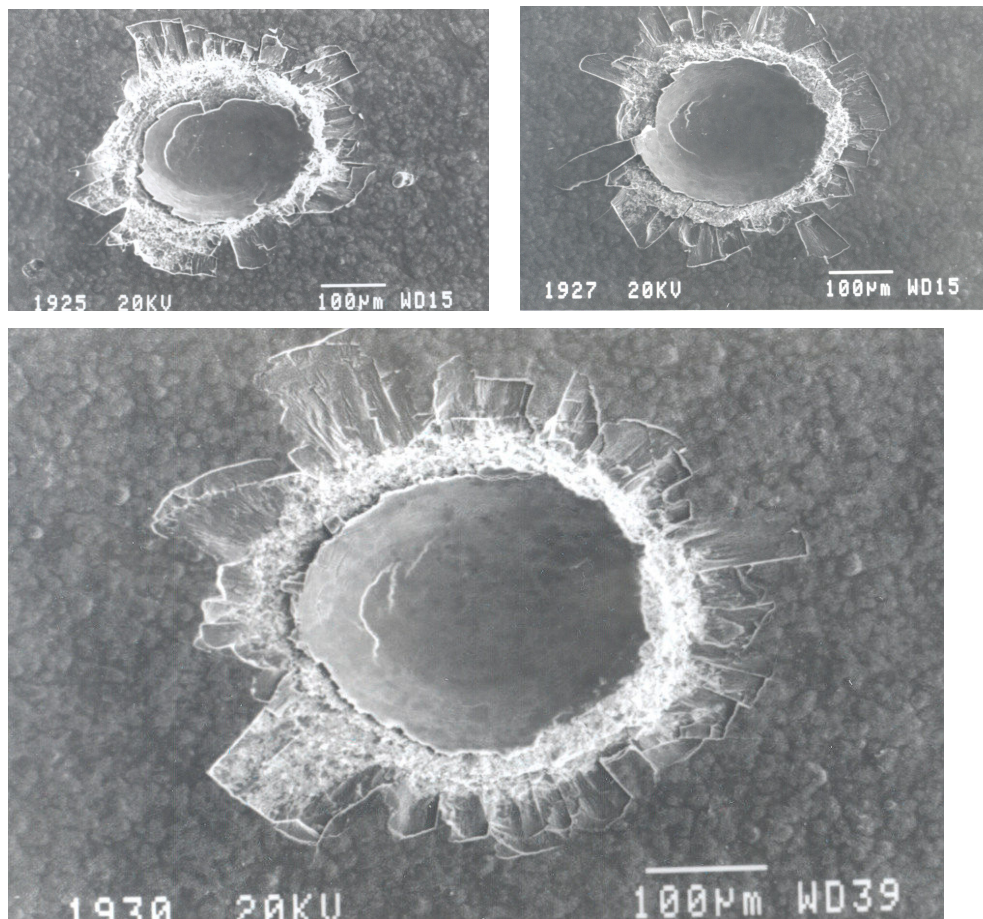
Fig. 5.166: Rockwell indentations on the coating from an insert from supplier 1

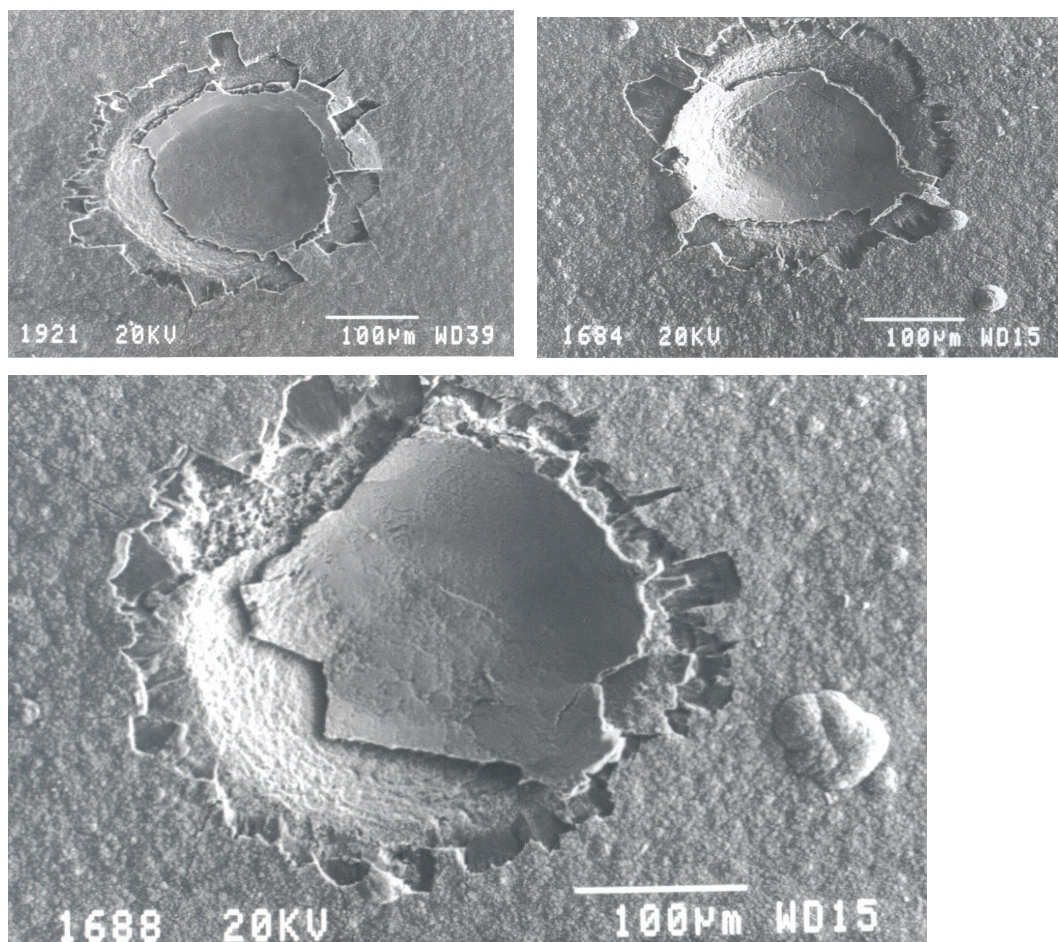
*Fig. 5.167: Rockwell indentations on the coating from an insert from supplier 2*

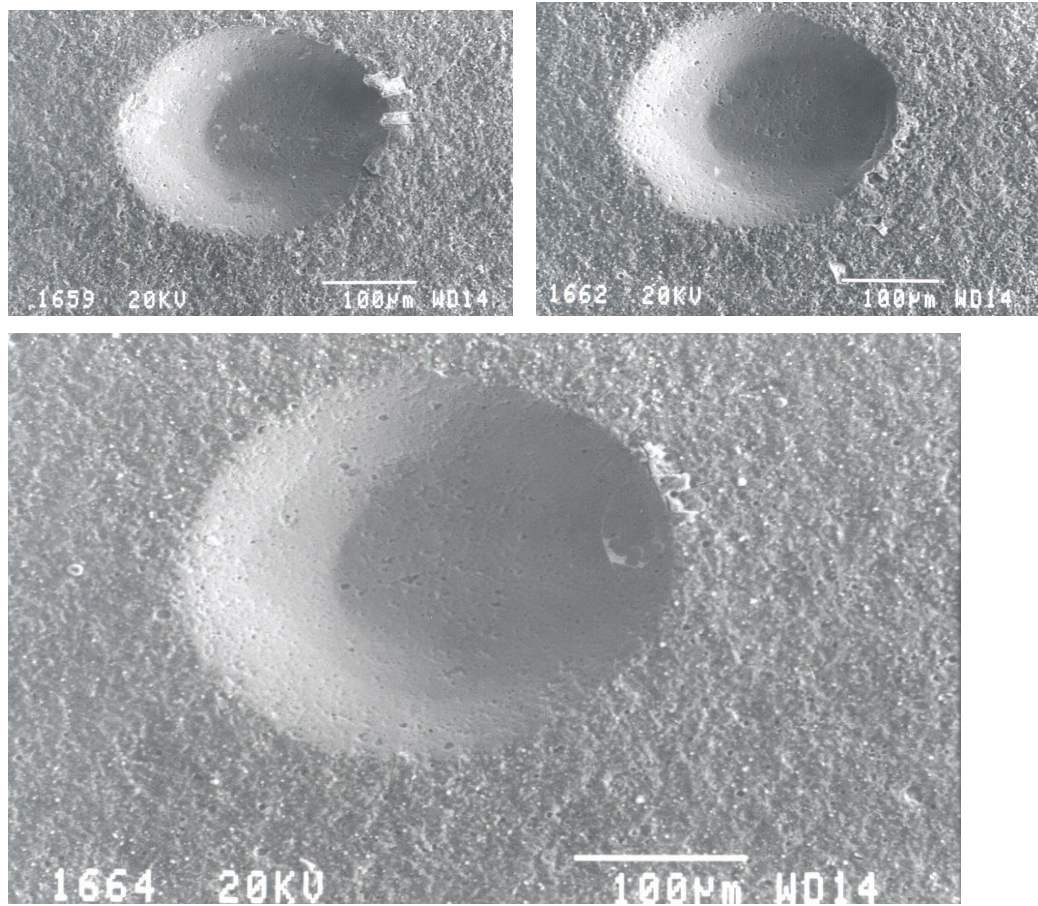
*Fig. 5.168: Rockwell indentations on the coating from an insert from supplier 3*
