Underground observations at a coal mine indicated failure of the immediate roof above the bords while pillars were observed to be intact. To determine the underlying causes of roof failures, careful observations and photographic recording of occurrences of roof failures have been made. Rock samples of the immediate shale roof were collected for laboratory testing to determine the rock strength and deformation properties. Numerical simulations were carried out to analyse stress and strain distributions and also to attempt to explain the guttering process.

Occurrences of roof guttering have recently been observed at a local coal mine in Mpumalanga province. Mapping of occurrences of roof guttering and data collection were carried out at the mine. The following is a summary of the tasks that were carried out:

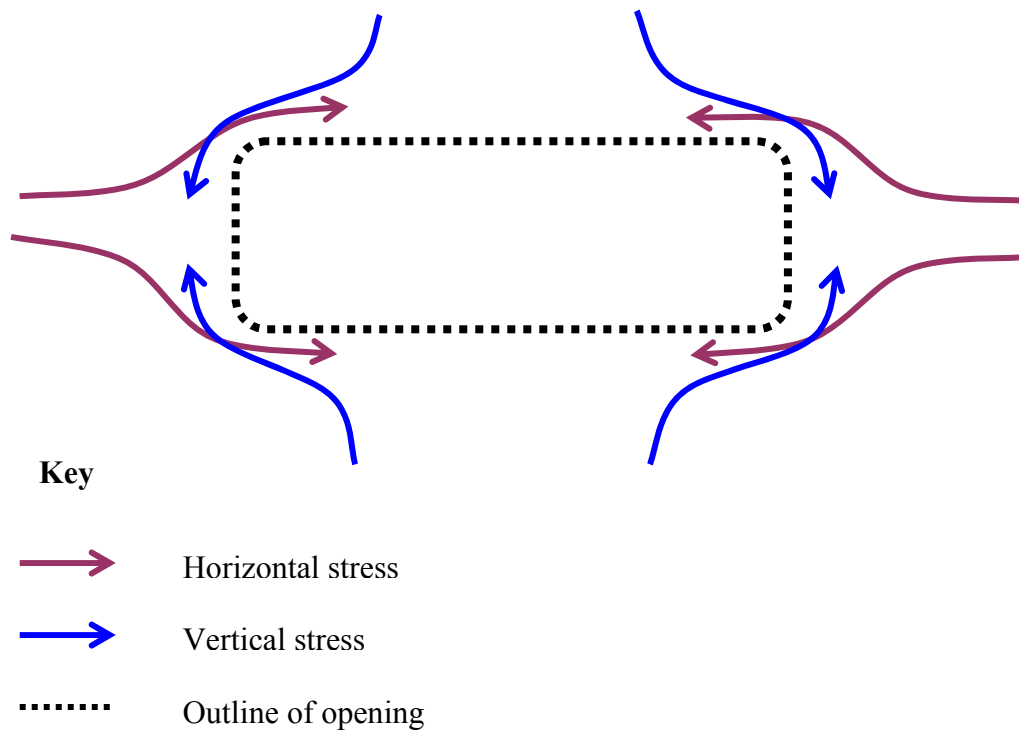
**Figure 2.1: Section through a roadway showing stress redistribution when an opening is created underground**

Prior to the excavation of an underground opening, the rock mass has been shown to be in equilibrium under the action of virgin stresses. When an excavation is created, stresses on the surface of the excavation change and equilibrium is destroyed. In the vicinity of the opening stress redistribution takes place and equilibrium is re-established. This results in horizontal stress concentrations in the roof of an opening while vertical stresses are concentrated at the sides of the opening as shown in Figure 2.1. Part of the rock mass is displaced. Work done during the displacement of the rock mass is usually stored in the surrounding rock mass as strain energy. Part of this strain energy may be dissipated in fracturing of part of the rock mass surrounding the opening (Budavari, 1983).

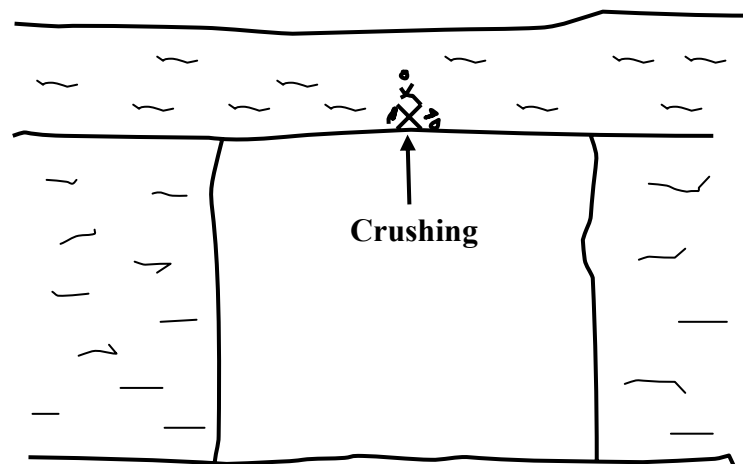
**Figure 2.2: Crushing of the roof (after Parker, 1973)**

Mining in a stress field where the horizontal stress is greater than the vertical stress was also documented by Parker (1973). Earlier “strange” observations of roof failure (i.e., crushing of roof and thrusting as shown in Figure 2.2 and 2.3, respectively) were explained to be a result of the high horizontal stresses.

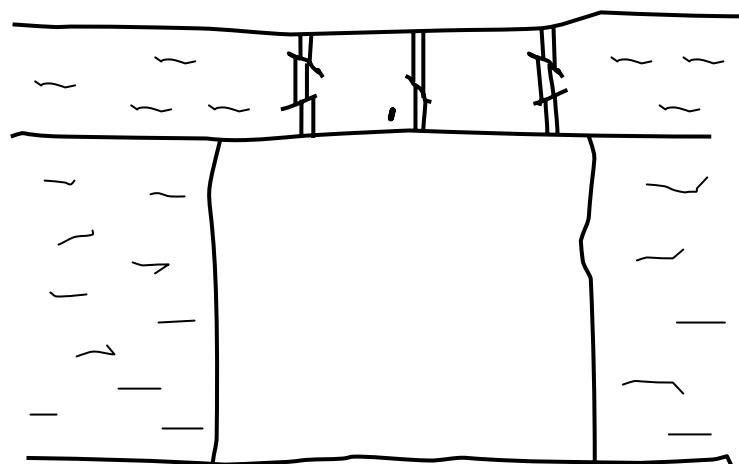
**Figure 2.4: Offsets in empty roof bolt holes (Parker, 1973)**

Strange offsets in empty roof bolt holes, as illustrated in Figure 2.4, were also explained to be a result of high horizontal stresses. Parts of the roof sheared past each other. Thin layers of roof rock under high horizontal stress crumpled and broke. Sometimes a moderately thick layer buckled downward, and when roof bolts were installed and tightened to push the layer back up again, it broke and fell apart. A slightly thicker layer usually buckled upward, and then crushed along the centre line, where deflection and compression were greatest. From these observations, Parker (1973) concluded that the roof was likely to be failing in compression or in shear.

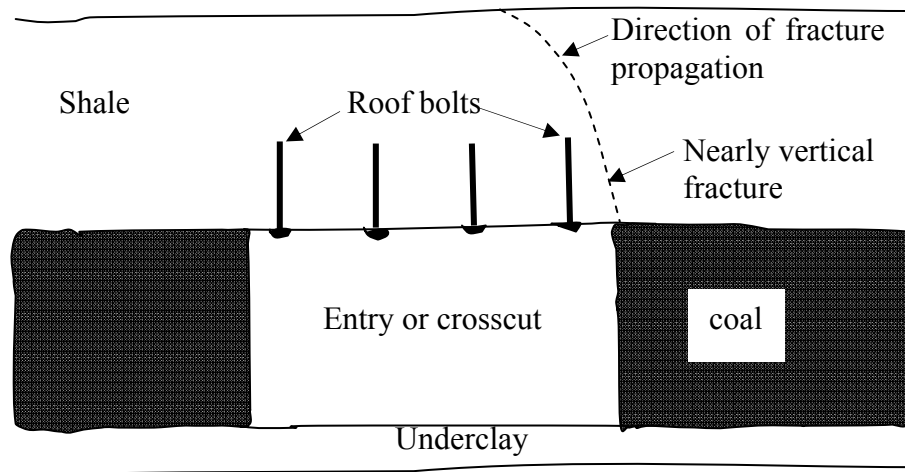
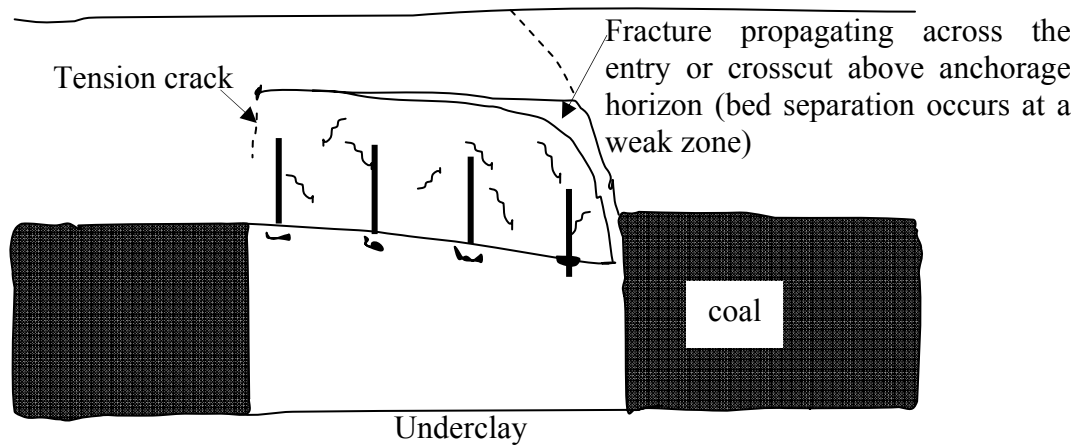
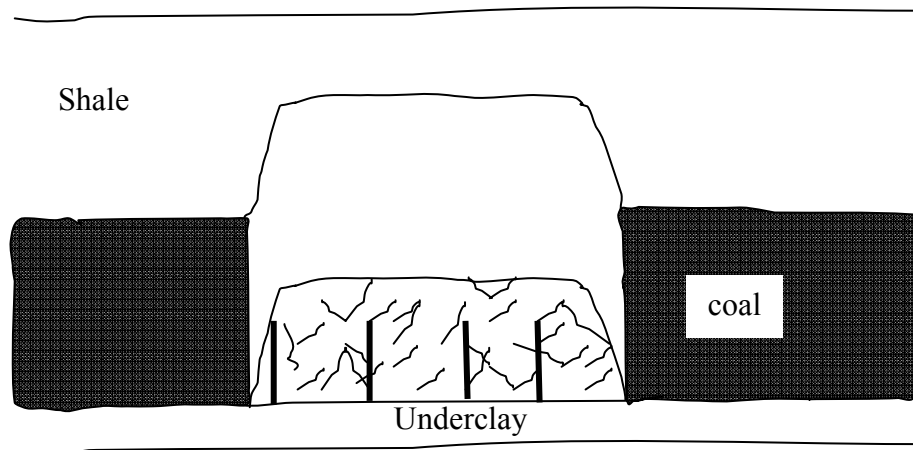
**(a) Initial fracture propagation**

**(b) Propagation of fracture along weak zone (bed separation)**

**(c) Massive roof collapse**

Hill (1986) shared the same views with Peng (1986). Hill defined guttering as a failure process that initially begins as a fracture in the roof rock parallel to, and located at, the roof rib intersection. The fracture propagates upward into the roof and initial failure is confined to the roof-rib intersection. The roof guttering failure sequence according to Hill is illustrated in Figure 2.5 (Hill, 1986). The first stage involves fracture propagation in a nearly vertical direction from the roof-rib intersection as shown in Figure 2.5a. The second stage involves fracture propagation along a weak zone at or above the roof bolt anchorage horizon and is illustrated in Figure 2.5b. Tension cracks develop due to bending of the beam. The tension cracks grow and finally a roof fall occurs (Figure 2.5c). Hill (1986) noted that although theoretical explanations of the causes of roof guttering existed they lacked comprehensive in-mine verification through instrumentation and mapping.

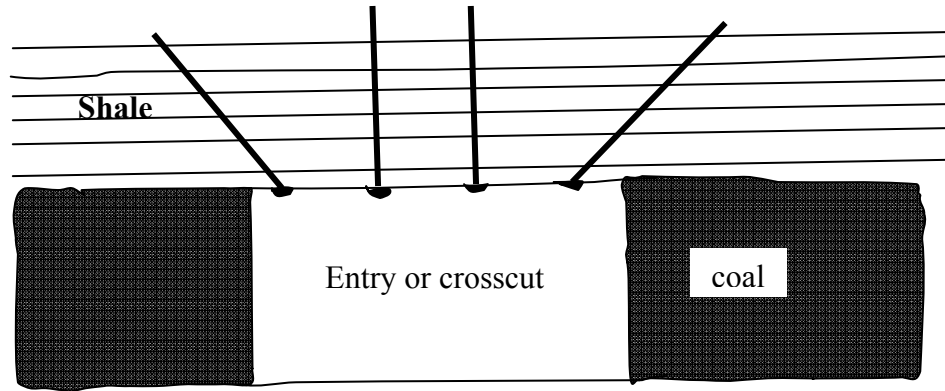
**Figure 2.6: Schematic diagram of angle bolting (Hill, 1986)**

Hill (1986) investigated the factors that influenced the propagation of roof guttering. He found that two critical factors were the stress environment and rock type. A noticeable and most often cited sign of regionally high horizontal stresses in coal mines is that roof guttering occurs in one particular orientation. In addition to artificial support, Hill (1986) discussed mine design changes for controlling or avoiding roof guttering. Artificial support included angle bolting as shown in Figure 2.6 and truss bolting as shown in Figure 2.7.

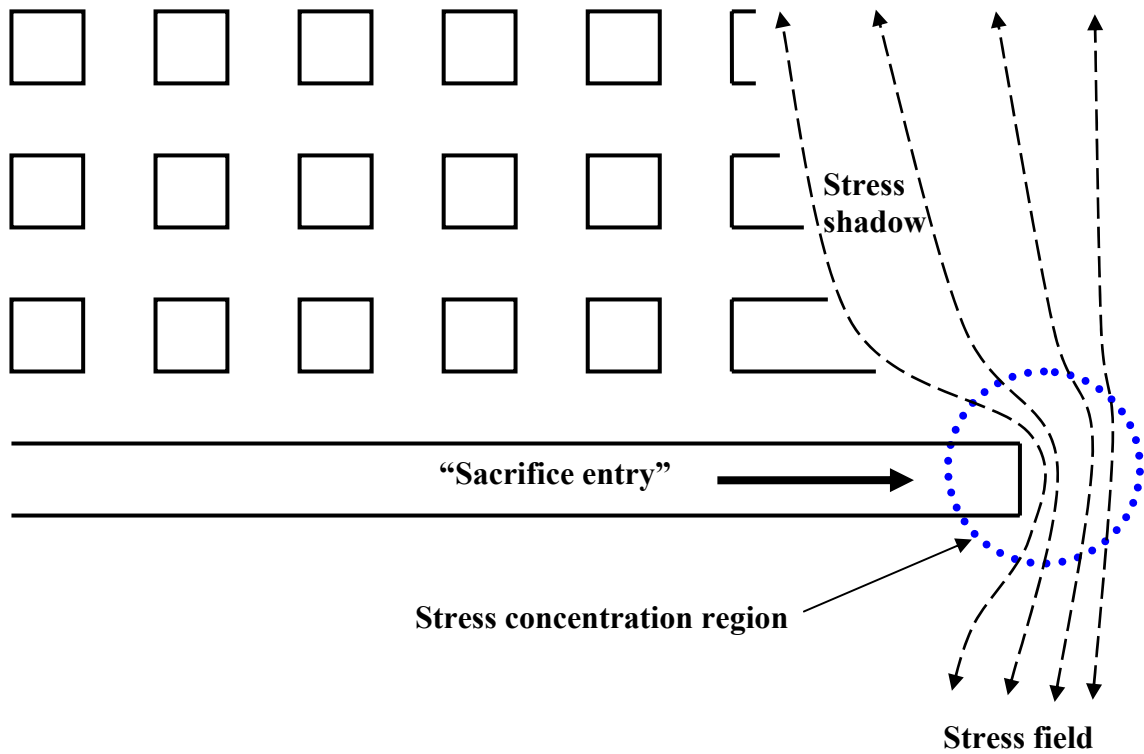
**Figure 2.8: Schematic plan diagram showing the stress shadow created by mining a roadway some distance ahead of other roadways**

Mine design changes included “sacrifice” entries, pillar softening, yield pillars, roof slotting, pillar staggering, reduction in the width of openings, and entry re-orientation. A “sacrifice” entry, shown in Figure 2.8, is a roadway developed ahead of and parallel to future adjacent roadways. Failure is allowed to initiate in “sacrifice” entries thereby relieving in situ stresses to manageable levels in adjacent entries.

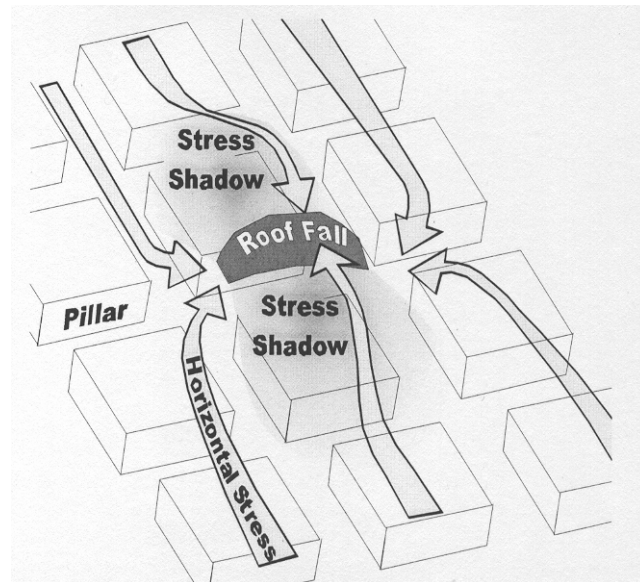
**Figure 2.10: Probable stress redistribution patterns around oval-shaped roof falls, concentrating stress above and along the axial ends and reducing stress (stress shadow) adjacent to the long axis of the roof fall (Iannacchione et al 2001)**

the course of days, weeks, and even years, depending on conditions. Another recognised characteristic of a roof fall caused by high horizontal stress was the zone of reduced stress adjacent to the long axis of an oval shaped roof fall.

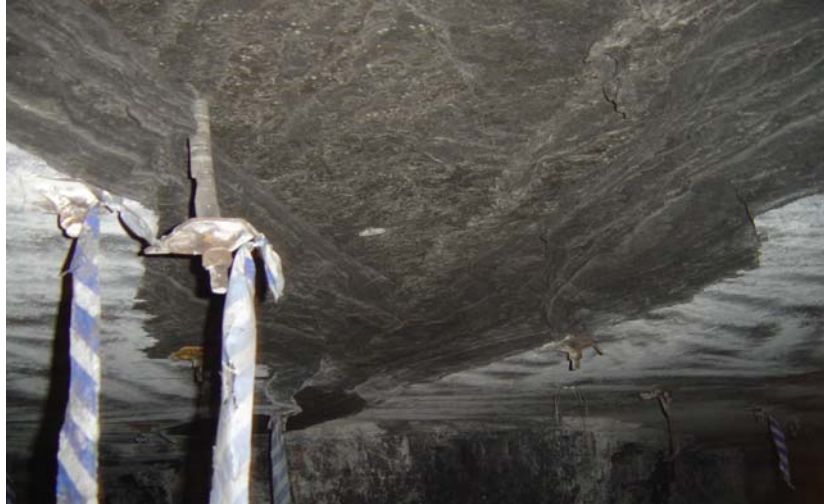
**Figure 2.11: Guttering occurrence in a South African colliery**

Occurrence of guttering in South African collieries has been mentioned in various publications (Altounyan and Taljaard, 2000; van der Merwe, 2000; van der Merwe and Madden, 2002; Frith *et al*, 2002; Munsamy, 2003 and Munsamy and Minney, 2004). These researchers tended to describe the guttering phenomenon in the same way as described in papers reviewed in the previous section for UK mines. Figure 2.11 shows a guttering occurrence observed in one of the South African collieries.

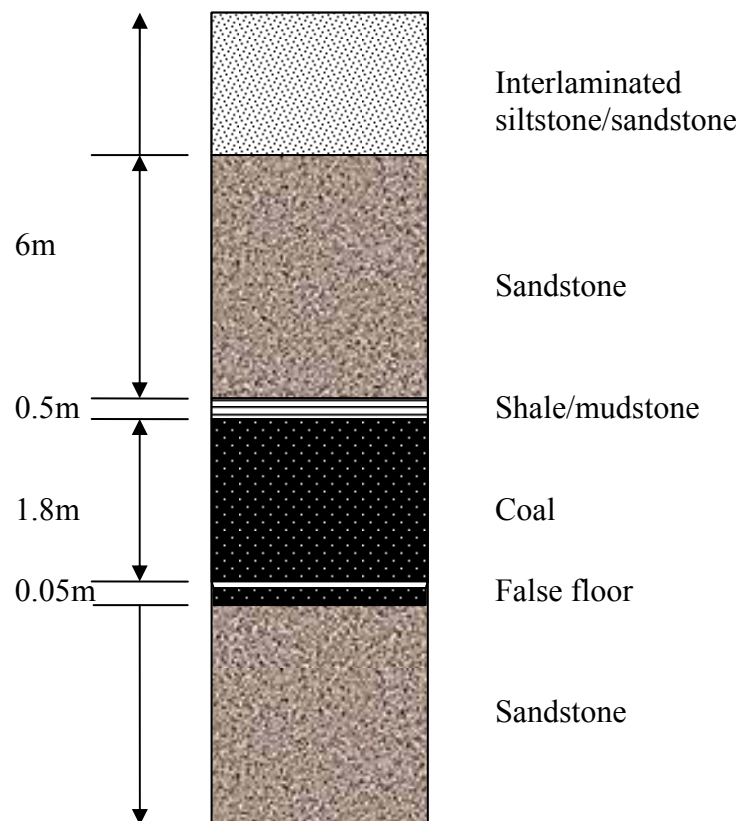
Figure 3.1: Generalised geological log for Nooitgedacht Colliery

Nooitgedacht Colliery is located in the province of Mpumalanga. The coal seam is flat lying with an average dip of less than one degree. The average depth of 5-seam is about 52 m. The coal seam averages 1.8 m in thickness. It is generally undisturbed. In some areas an intensely sheared and broken thin parting is developed towards the base of the seam and forms a false floor to the seam. Below the parting is a thin coal band, averaging 0.05 m. Micaceous mudstone or shale is developed just above the coal seam forming the immediate mining roof.

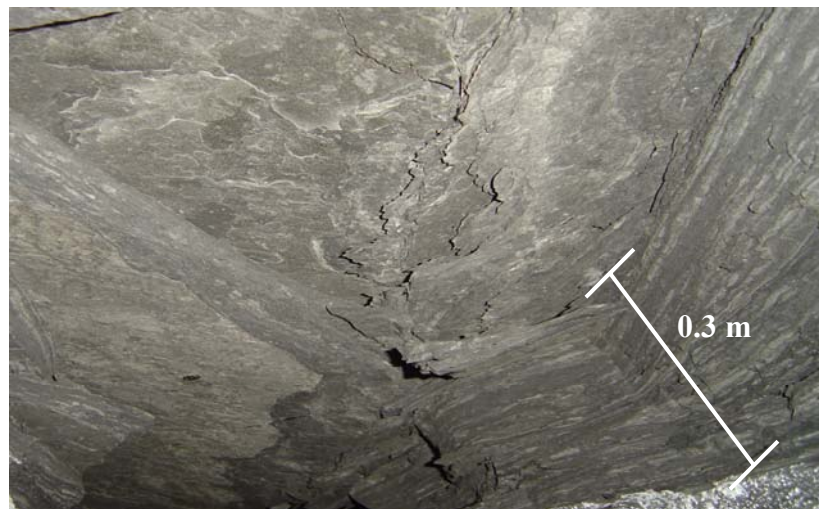
**Figure 3.2: Photograph showing typical depth of gutter (about 0.3 m)**

Guttering was observed to involve the crushing and often violent fall of ground from the roof. Gutters ranged from about 2 m by 0.5 m by 0.1 m to 70 m by 3.5 m by 0.5 m in size. Figures 3.2 and 3.3 illustrate the typical depths of gutters. Figure 3.4 illustrates both the depth and width of a gutter. A few occurrences of guttering covered the whole length of a split, i.e. from one end of the panel to the other. During the process of guttering, noises and “explosions” were heard. The noises and explosions have been explained to be a result of the sudden release of strain energy during the failure process (Martin et al, 1997).

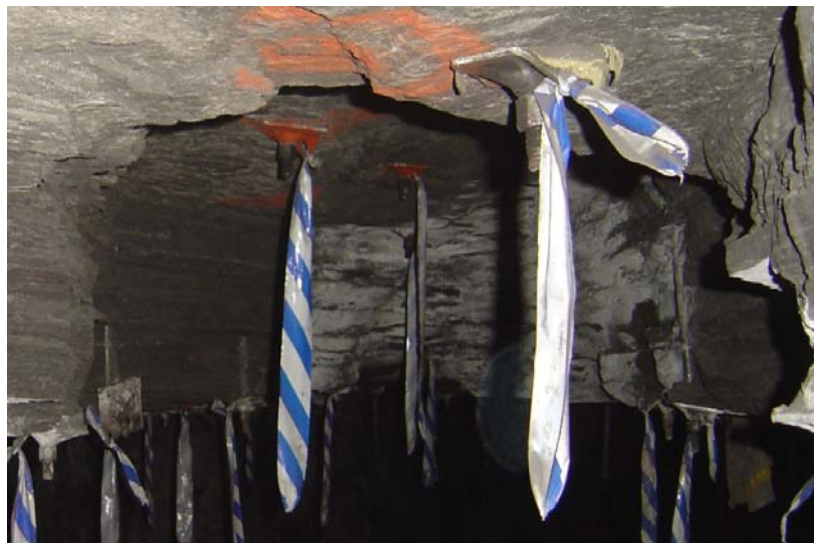
**Figure 3.4: Photograph showing typical depth of gutter (about 0.5 m) and width of gutter (about 1.2 m)**

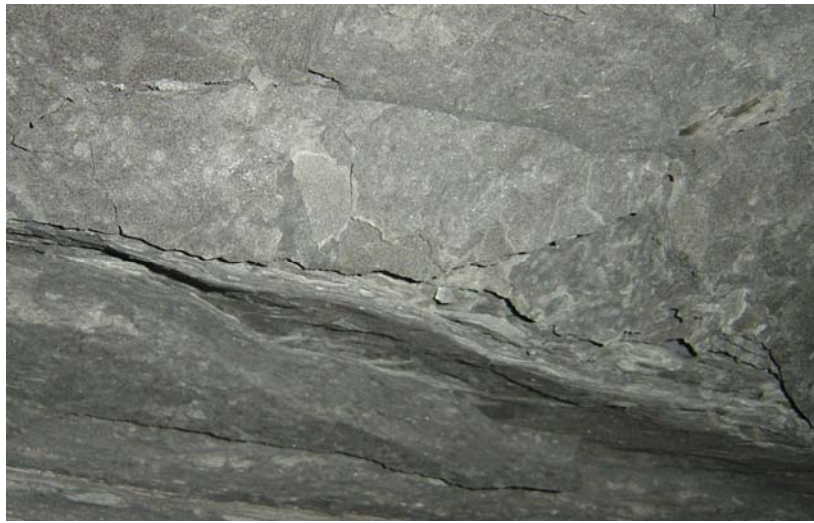
**Figure 3.5: Photograph showing a fractured roof which on scaling results in a gutter**

of the fractured roof can initiate guttering in the roof that is previously observed to be strong and intact.

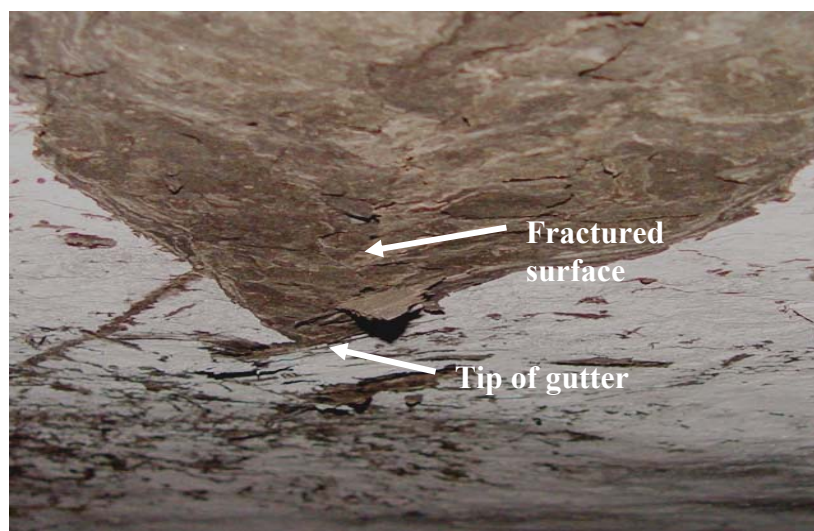
**Figure 3.6: ‘Upturned’ boat-shaped nature of guttering occurrence**

Interesting surface features were observed along a guttering roof. These included ‘upturned’ boat-shaped nature of a gutter, interlocking fracture surfaces towards the centre of a gutter, thin fractured slabs from centre of gutter going outwards and a heavily fractured surface ahead of a gutter. Figure 3.6 illustrates the ‘upturned’ boat-shaped nature of a gutter, the fractured surface and the tip of a gutter. Results of mapping of guttering indicated that a majority of the gutters had this shape. The difference was in their size and orientation.

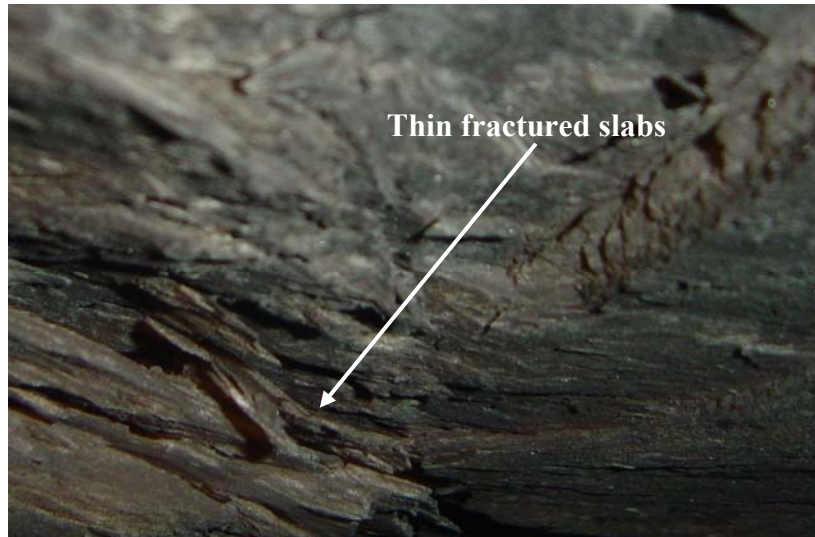
**Figure 3.7: Photograph showing thin slabs associated with roof guttering**

Figure 3.7 illustrates the occurrence of thin fractured slabs emanating from the centre of the gutter going outwards. The thin slabs are more visible at the lower left hand side of the photograph.

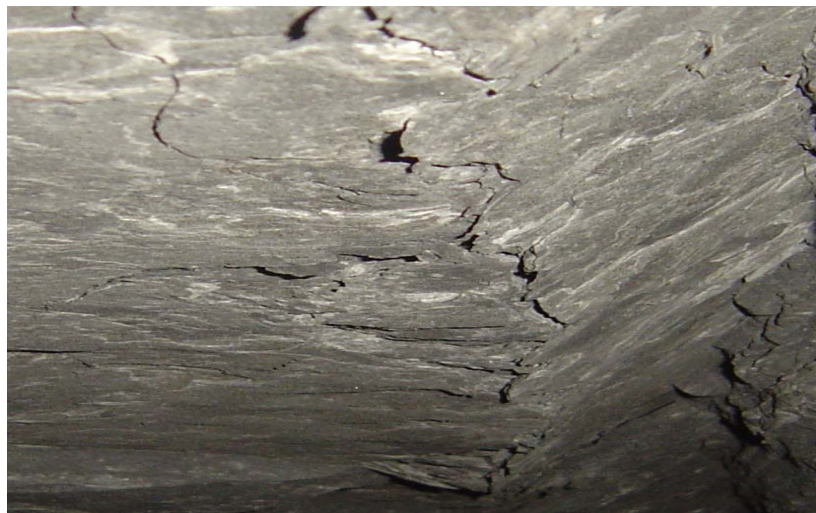
**Figure 3.8: Photograph showing stress induced fracturing associated with roof guttering. The roof gutter occurred towards a pillar edge**

Figure 3.8 illustrates the fracture surface that occurs towards the centre of a roof gutter. On scaling the fractured surface, the roof gutter grows in depth and a new fracture surface may form. If scaling is not done the fractured surface may eventually fall down violently and without warning.

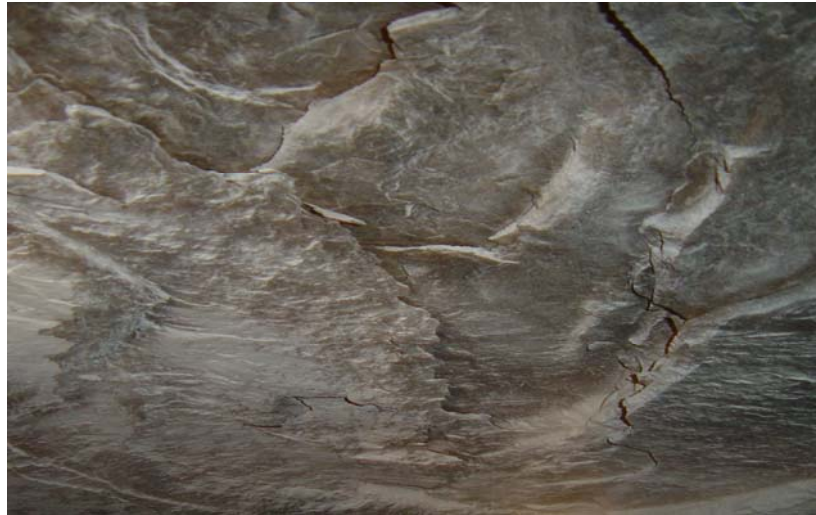
**Figure 3.9: Interlocking nature of surfaces in guttering roof**

Figure 3.9 shows the interlocking nature of fracture surfaces in guttering roof towards the centre of the gutter.

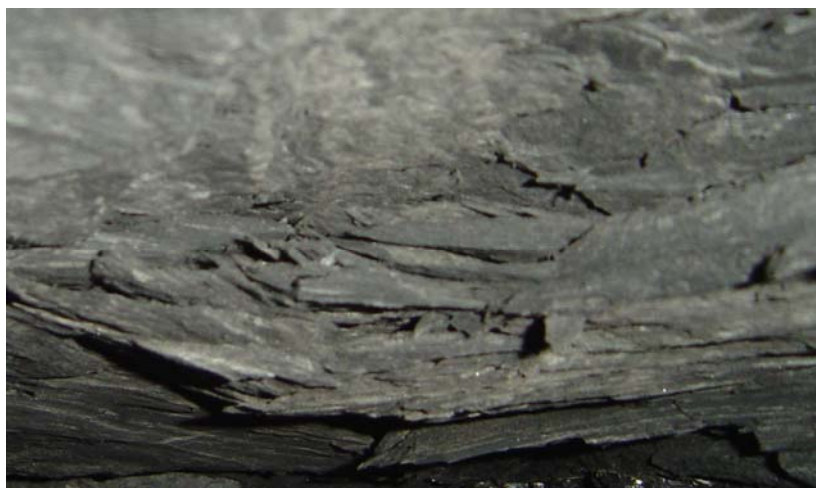
**Figure 3.10: Photograph showing stress induced fracturing ahead of a gutter.  
The roof gutter occurred towards the centre of a roadway**

Figure 3.10 illustrates the fractured surface ahead of a gutter. On scaling down the fracture surface ahead of the gutter, roof falls occurred which led to the gutter developing further longitudinally, laterally and in depth. After a few hours or days another fracture surface may develop ahead of the gutter. The process repeats itself until the gutter stabilises.

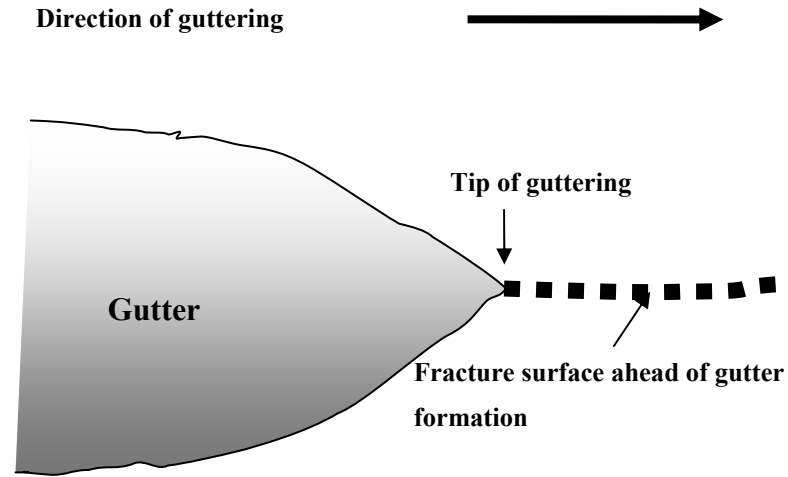
**Figure 3.11: Schematic diagram showing boat-shaped nature of guttering and fracture surface ahead of guttering**

Figure 3.11 below is a schematic diagram illustrating the guttering, showing the plan view looking at the roof.

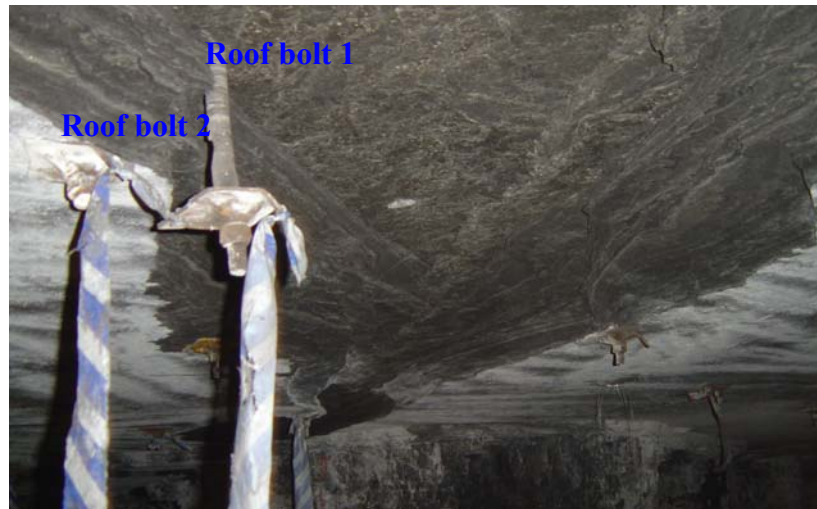
**Figure 3.12: A roof bolt exposed due to guttering is replaced by another one**

In some areas, guttering was observed to develop between roof bolts and between pillars in a direction towards the pillars (Figure 3.13). Roof bolts might be playing a role in arresting lateral development of roof guttering. Additional roof bolts were installed in areas where original roof bolts had been exposed by guttering as shown in Figure 3.12 below. This is also illustrated in the schematic diagram of Figure 3.13. In Figure 3.12 roof bolt number 1 has been exposed due to guttering and roof bolt number 2 was installed as a replacement.

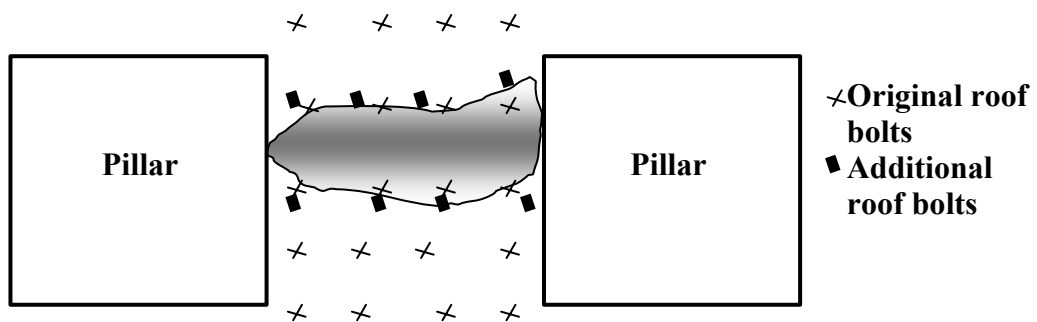
**Figure 3.13: Plan view showing occurrence of guttering between roof bolts. The diagram also shows the guttering occurring between pillars that is stopped by the pillars from developing further longitudinally**

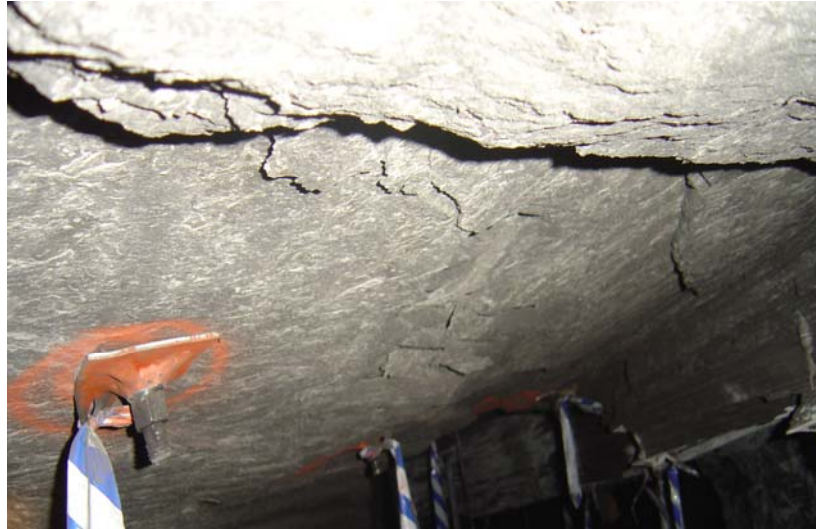
**Figure 3.14: Occurrence of roof guttering along roof bolts**

Occurrences of guttering were also observed to occur along a line of roof bolts as shown in Figure 3.14. In such instances roof bolts were ineffective in preventing occurrences of guttering. Additional roof bolts were installed in such instances. Pillars prevented guttering from developing further longitudinally.

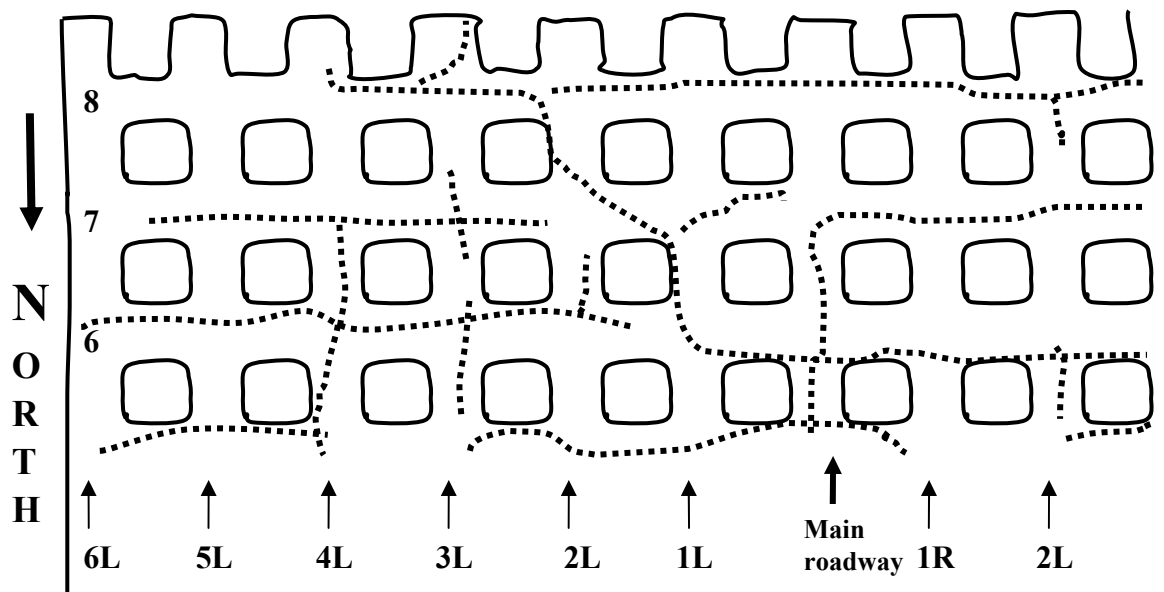
**Figure 3.15: Occurrence of guttering in part of a section. Dotted lines represent the gutters. The numbers 6, 7, and 8 denote split number while 1L, 2L etc denote roadways**

Guttering was observed to occur most commonly towards the centre of the roadways (about 80%), as can be seen in Figure 3.15, which shows the occurrence of guttering as mapped in one section of the mine. This was also observed by mine employees, who mentioned that they felt safer walking along the pillar sides than in the centre of roadways. However, guttering also occurred randomly, as shown in Figure 3.15, moving from centre of roadways to pillar edges and back to centre of roadways. Guttering occurred predominantly in two perpendicular directions.

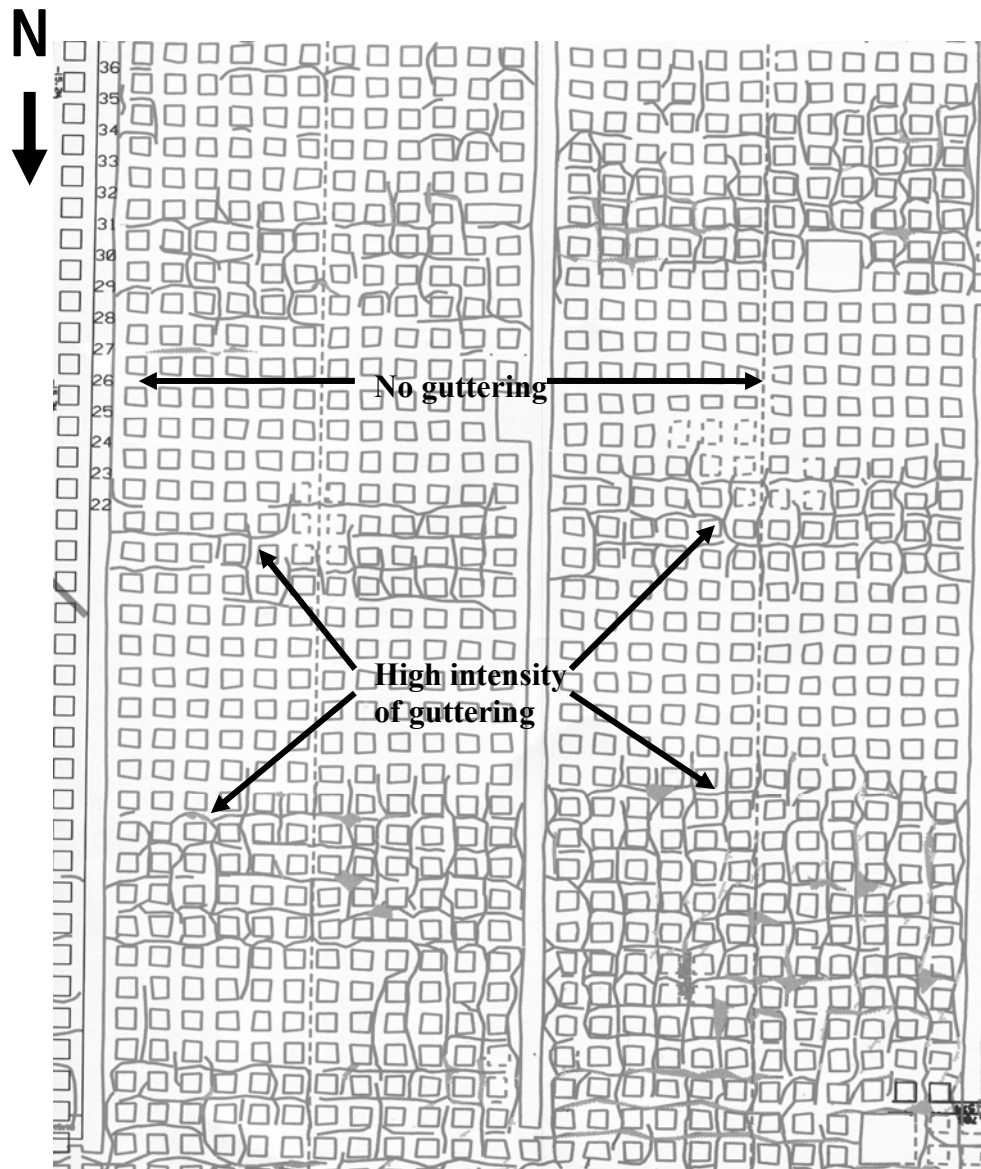
**Figure 3.16: Plan view showing occurrence of guttering in part of two panels. Lines indicate guttering while shaded areas indicate slabbing**

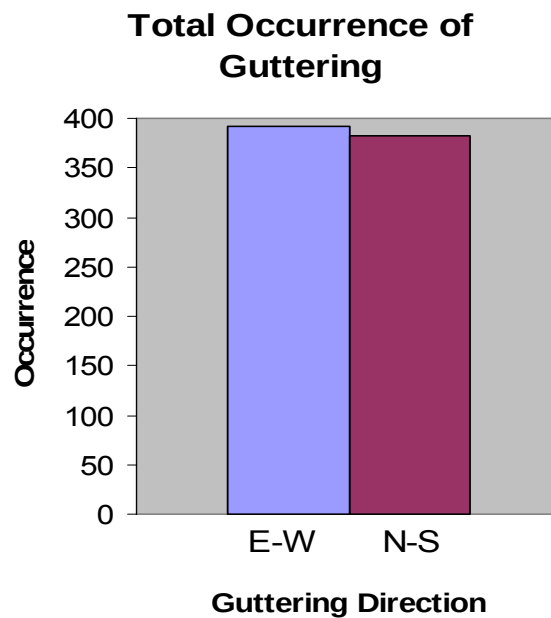
**Figure 3.17 (a): Occurrence of guttering on a mine-wide scale**

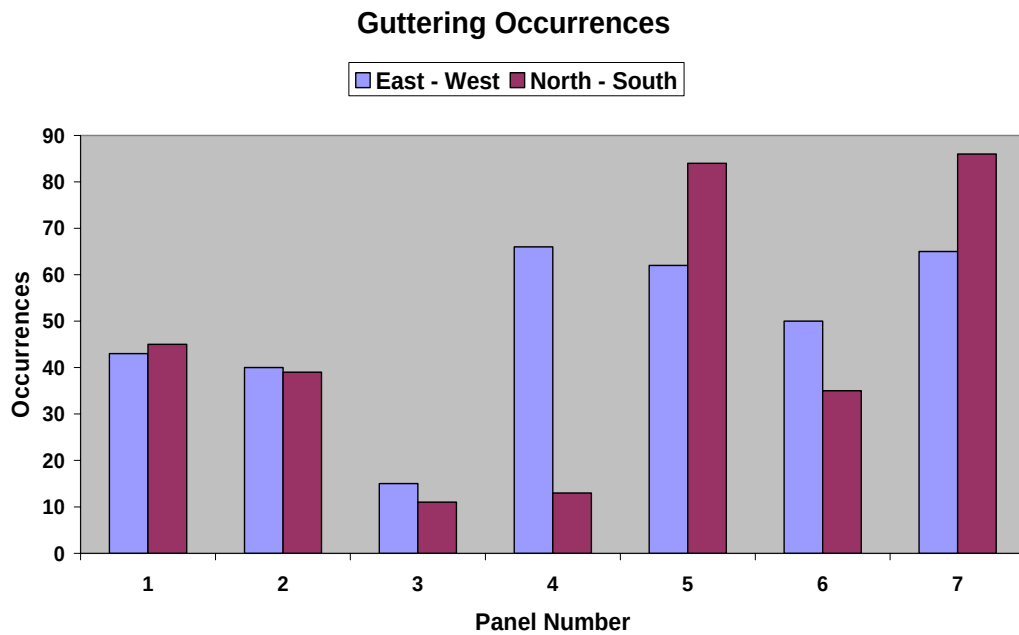
**Figure 3.17(b): Guttering in seven selected panels**

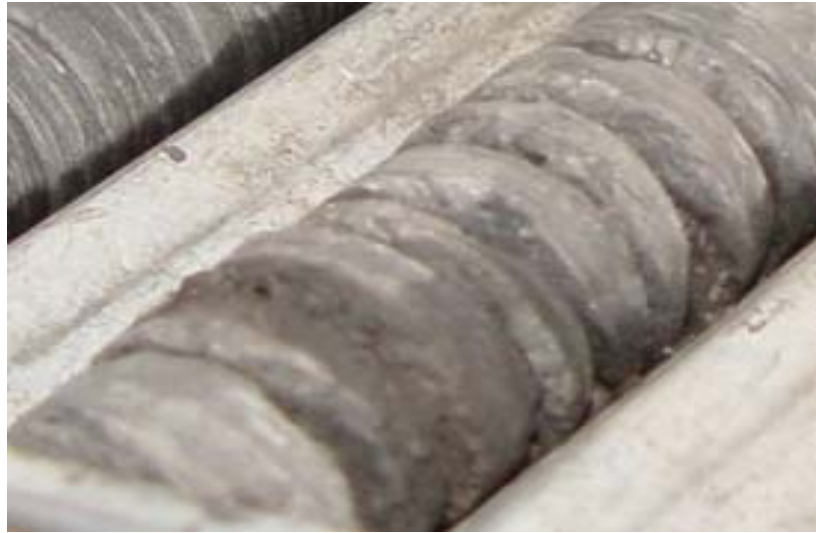
**Figure 3.18: Disced core from one of the guttering sites**

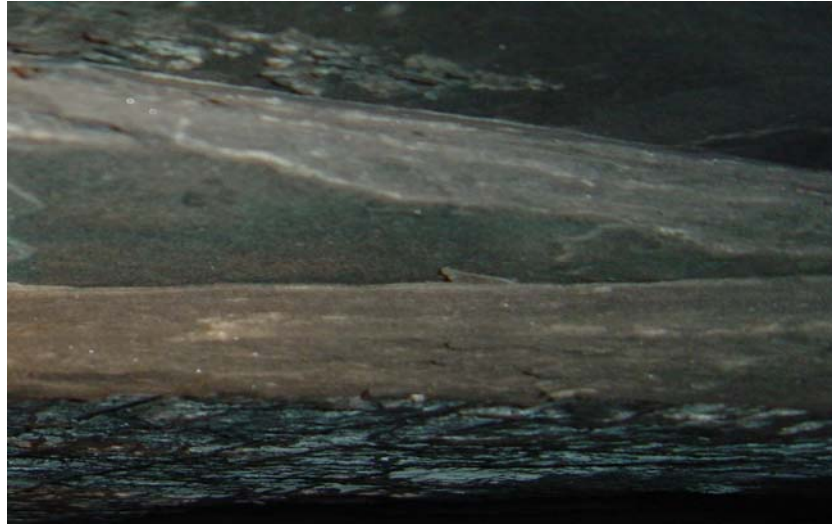
**Figure 3.19: Photograph showing roof slabbing initiated by roof guttering**

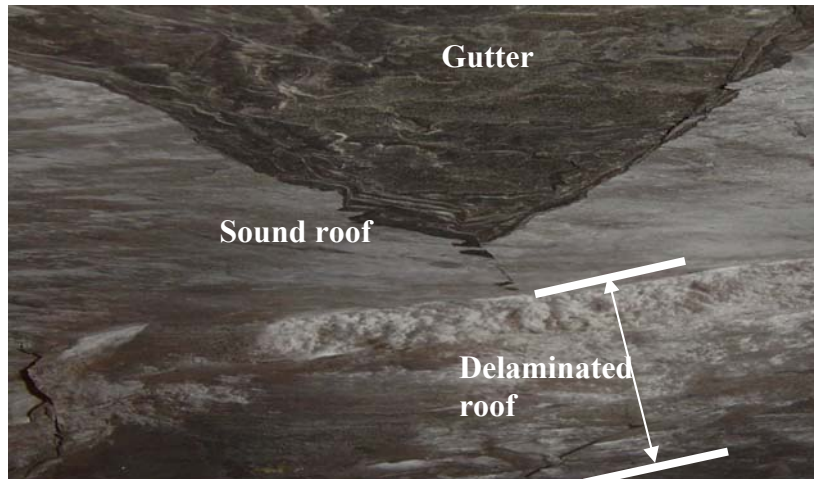
**Figure 3.20: Roof guttering occurring in the solid roof just above a delaminated roof**

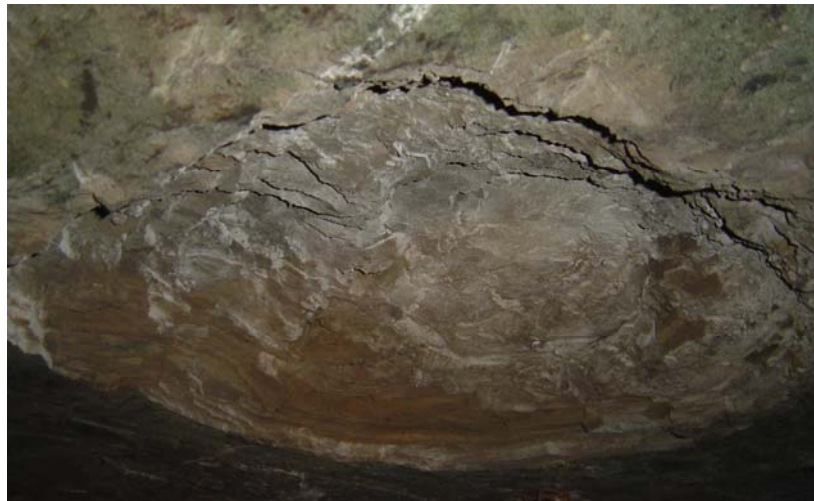
**Figure 3.21: Fall of muddy roof**

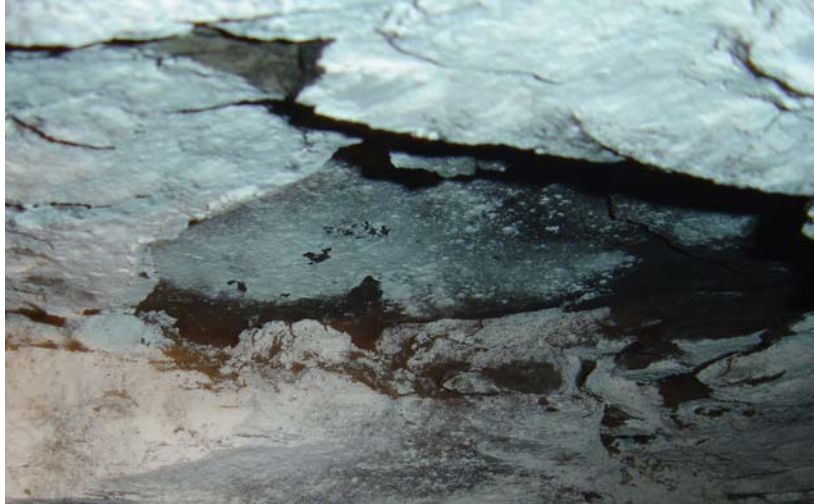
**Figure 3.22: Occurrence of guttering in combination with slabbing was common in muddy roof**

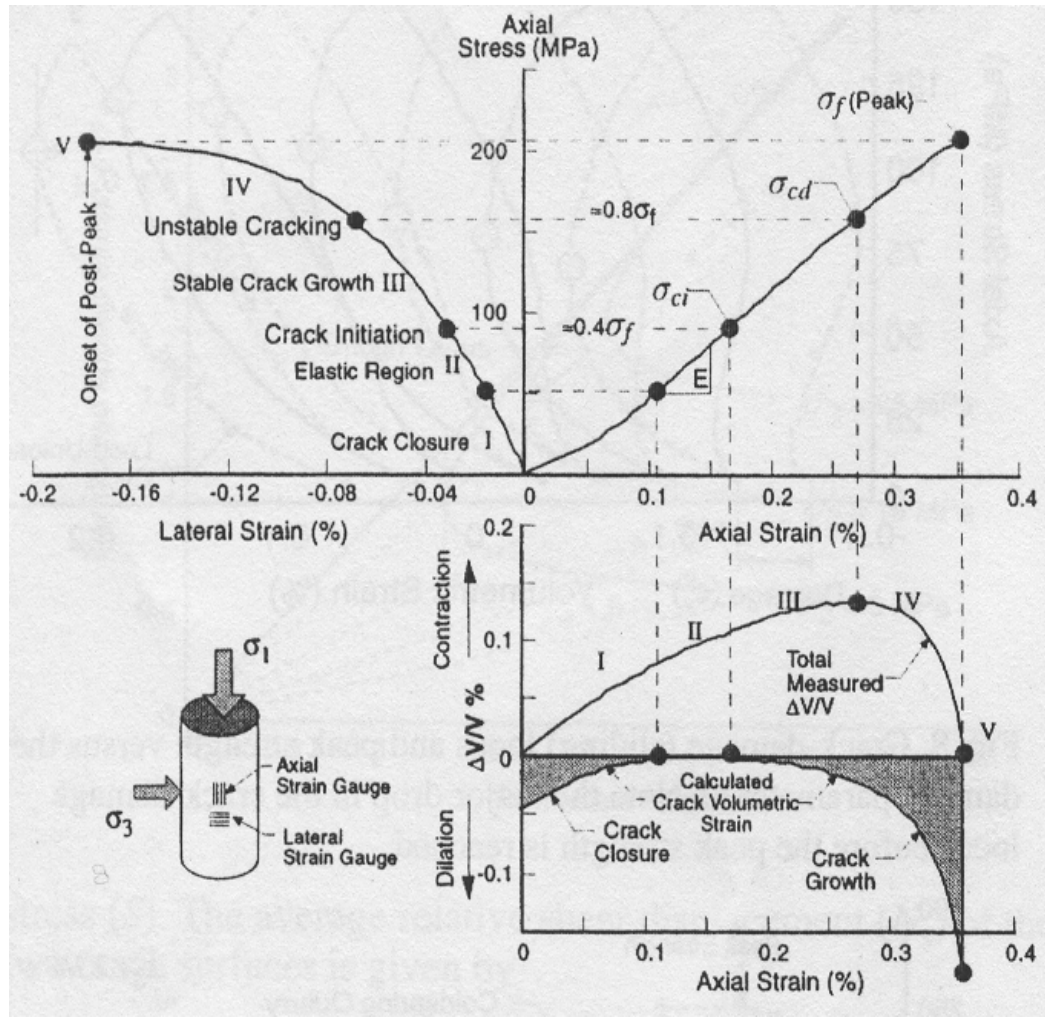
**Figure 3.23: The three parameters determined from laboratory compression test: crack initiation ( $\sigma_{ci}$ ); initiation of sliding ( $\sigma_{cd}$ ), and peak strength ( $\sigma_f$ ).  $\Delta V/V$  is the volumetric strain (Martin, 1997)**

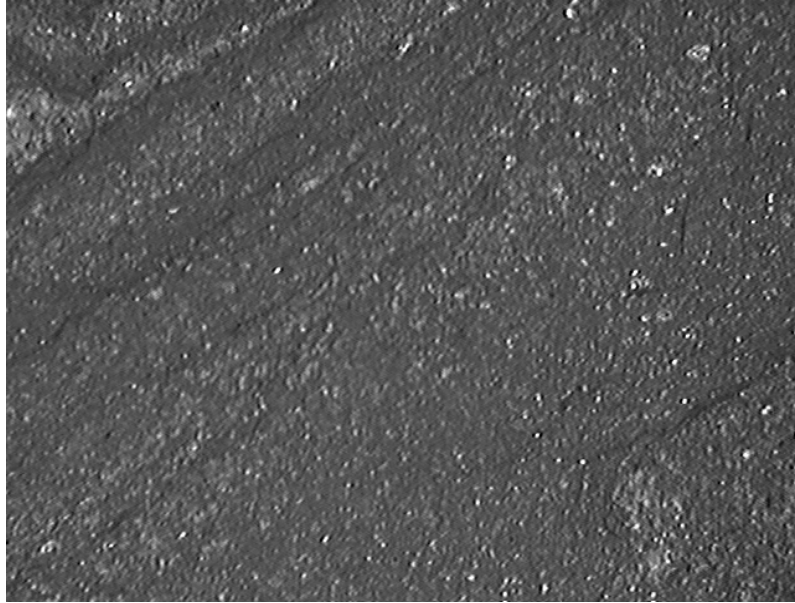
**Figure 3.25a: Photograph of an extension fracture surface**

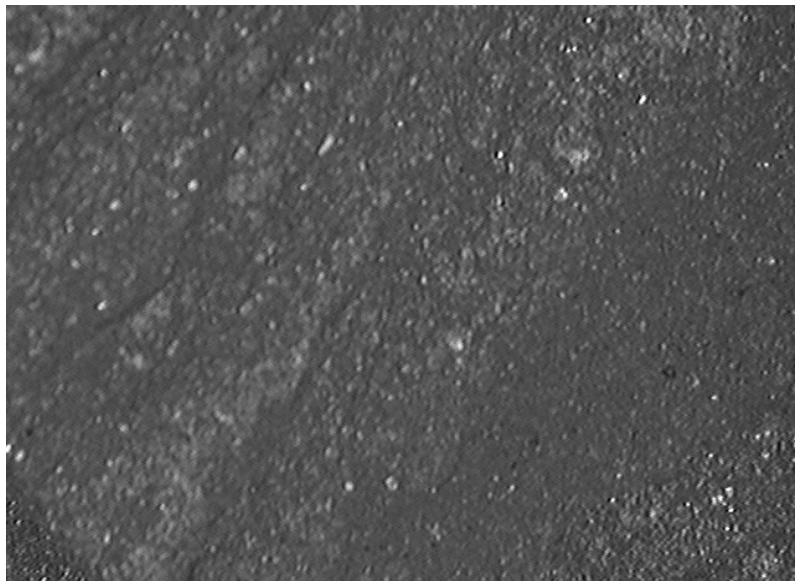
**Figure 3.25b: Photograph of an extension fracture surface**

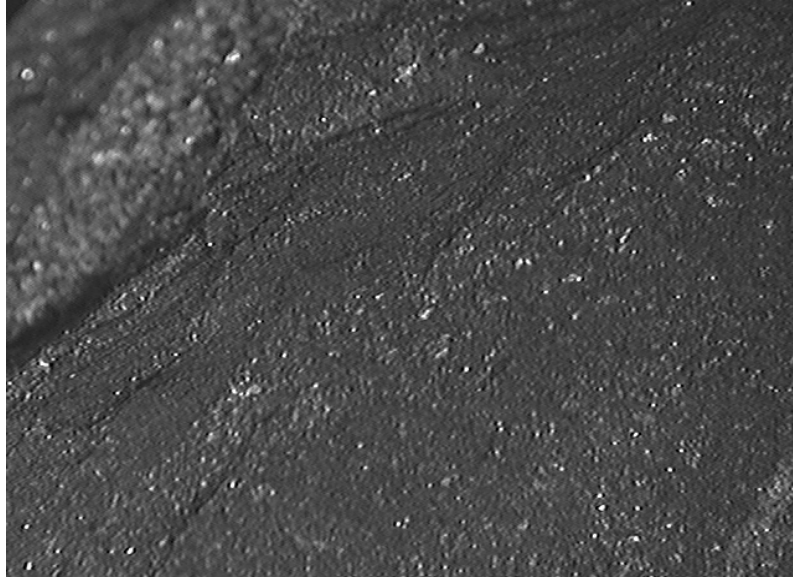
**Figure 3.25c: Photograph of an extension fracture surface**

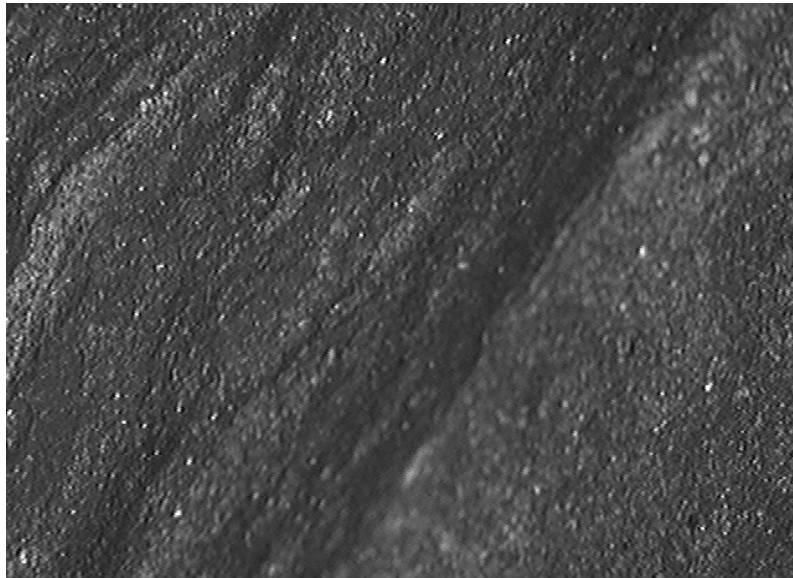
**Figure 3.25d: Photograph of an extension fracture surface**

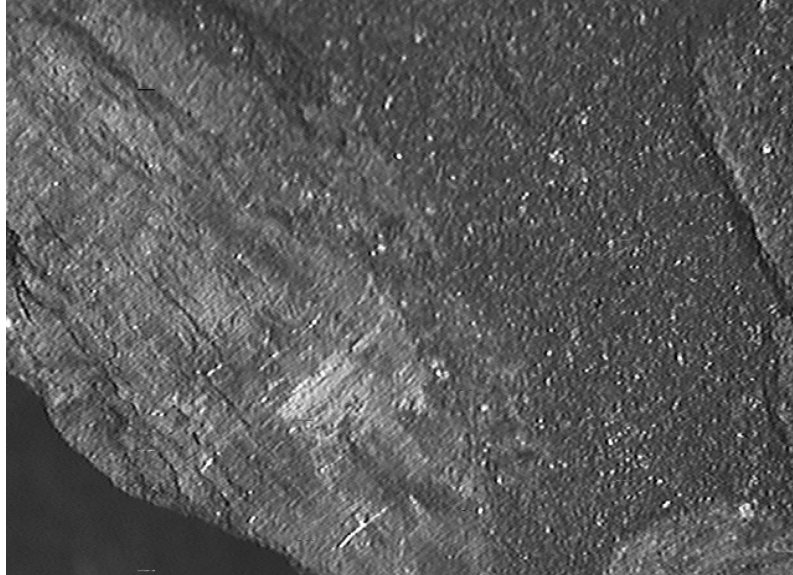
**Figure 3.26a: Photograph of a shear fracture surface**

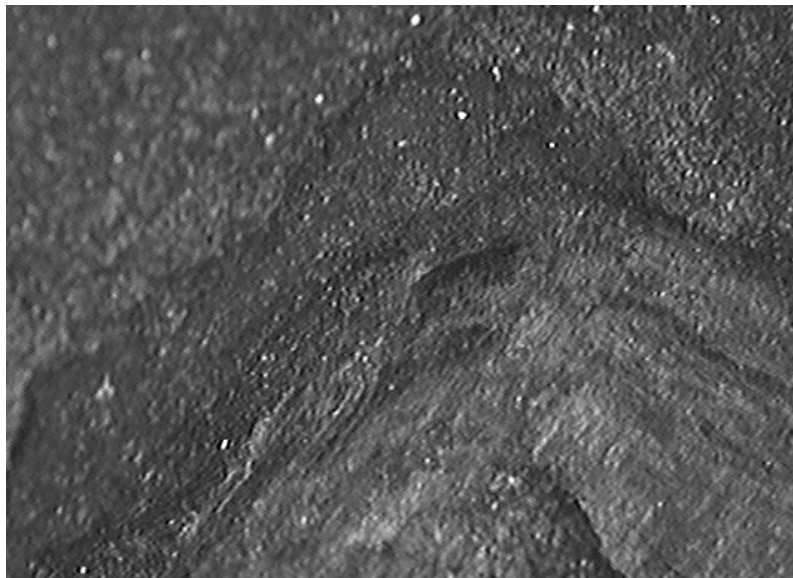
**Figure 3.26b: Photograph of a shear fracture surface**

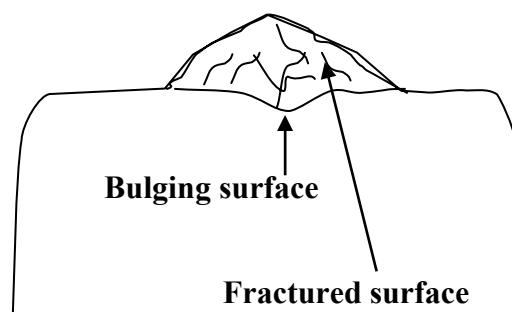
**Figure 3.27a: Schematic diagram of a roadway cross-section showing possible fracturing just before occurrence of guttering**
