Underground observations at a coal mine indicated failure of the immediate roof above the bords while pillars were observed to be intact. To determine the underlying causes of roof failures, careful observations and photographic recording of occurrences of roof failures have been made. Rock samples of the immediate shale roof were collected for laboratory testing to determine the rock strength and deformation properties. Numerical simulations were carried out to analyse stress and strain distributions and also to attempt to explain the guttering process.

Occurrences of roof guttering have recently been observed at a local coal mine in Mpumalanga province. Mapping of occurrences of roof guttering and data collection were carried out at the mine. The following is a summary of the tasks that were carried out:

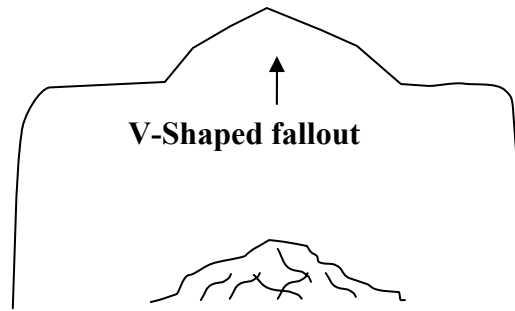
**Figure 3.27b: Schematic diagram of a roadway cross-section showing the fallen rock and the “V-shaped” nature of guttered roof**

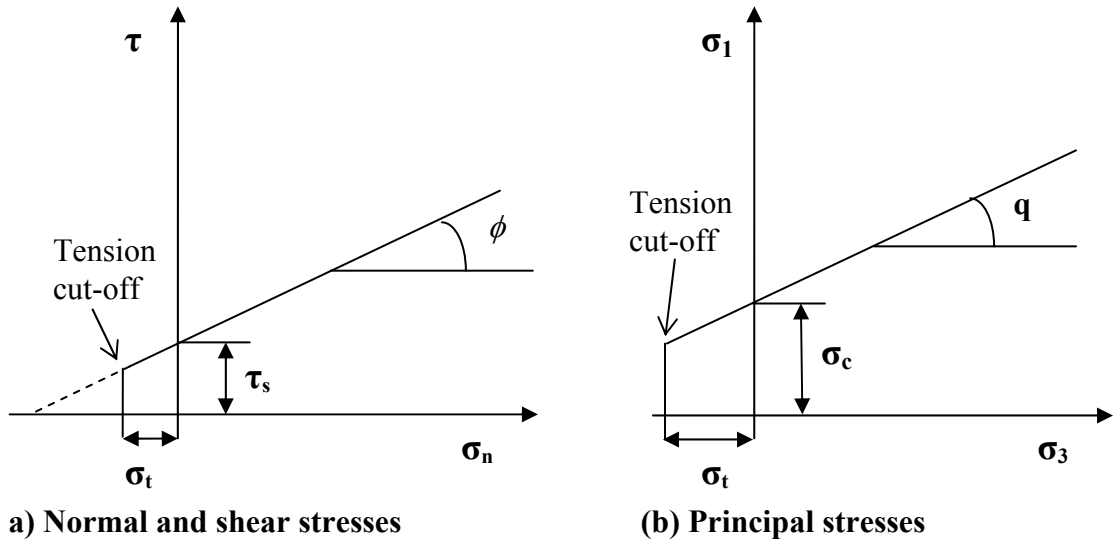
**Figure 5.2: Mohr-Coulomb criterion in terms of (a) principal stresses (b) normal and shear stresses**

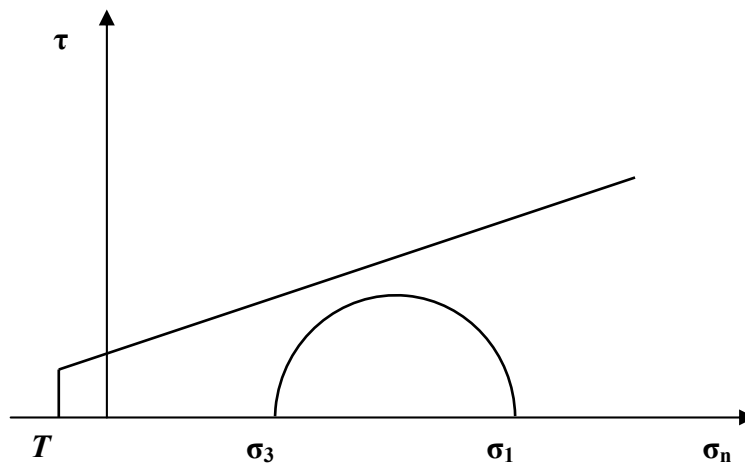
**Figure 5.3a: Mohr circle that lies below the failure envelope and represents a stable stress state**

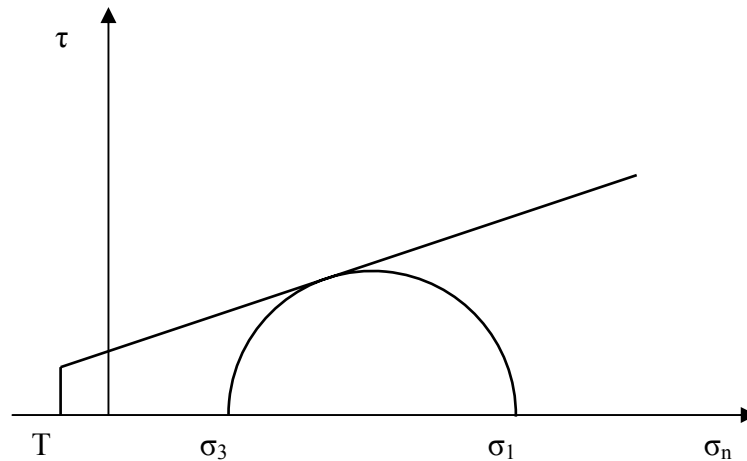
**Figure 5.3b: Mohr circle that is tangent to the failure envelope and represents the state of stress at the instant of failure**

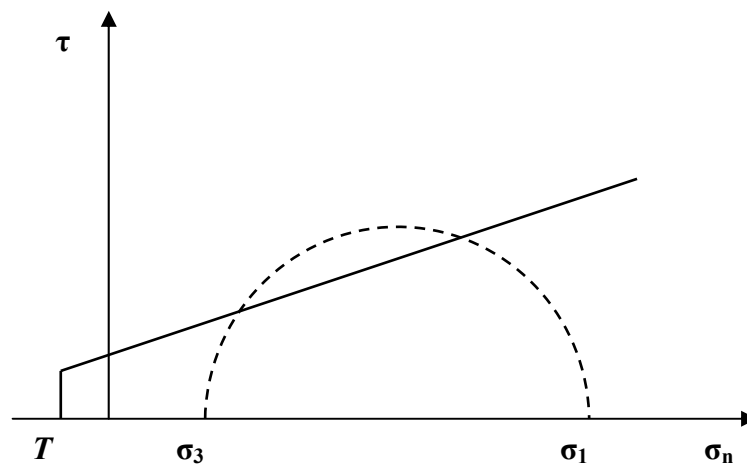
**Figure 5.3c: Mohr circle that intersects the failure envelope and represents an unstable stress state**

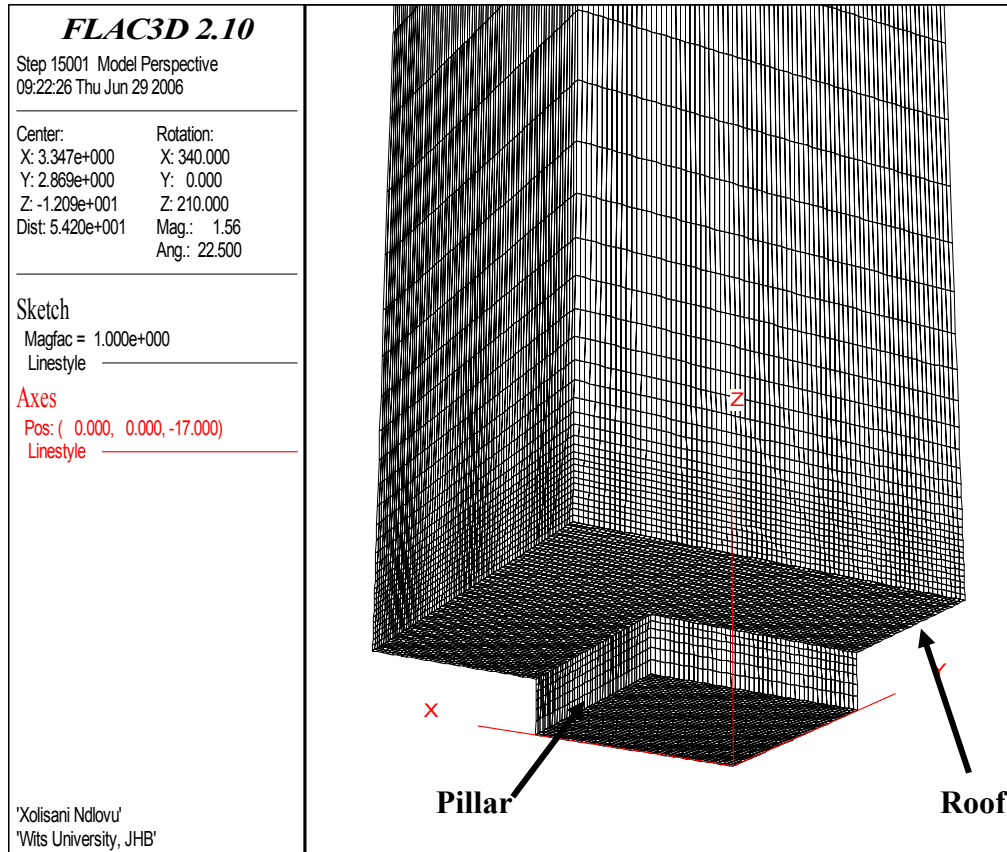
**Figure 6.2: Quarter geometry model grid in three dimensions**

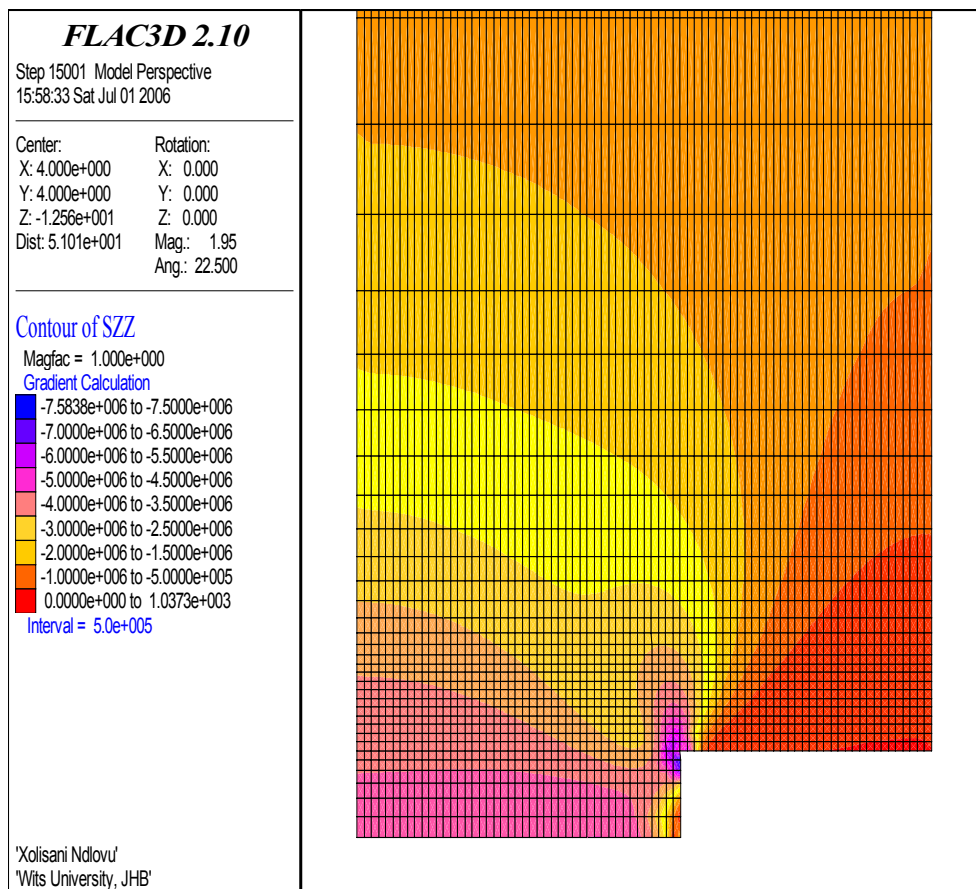
**Figure 6.6: Contour plot of vertical stress distribution for the isotropic model (along Section A, Figure 6.4)**

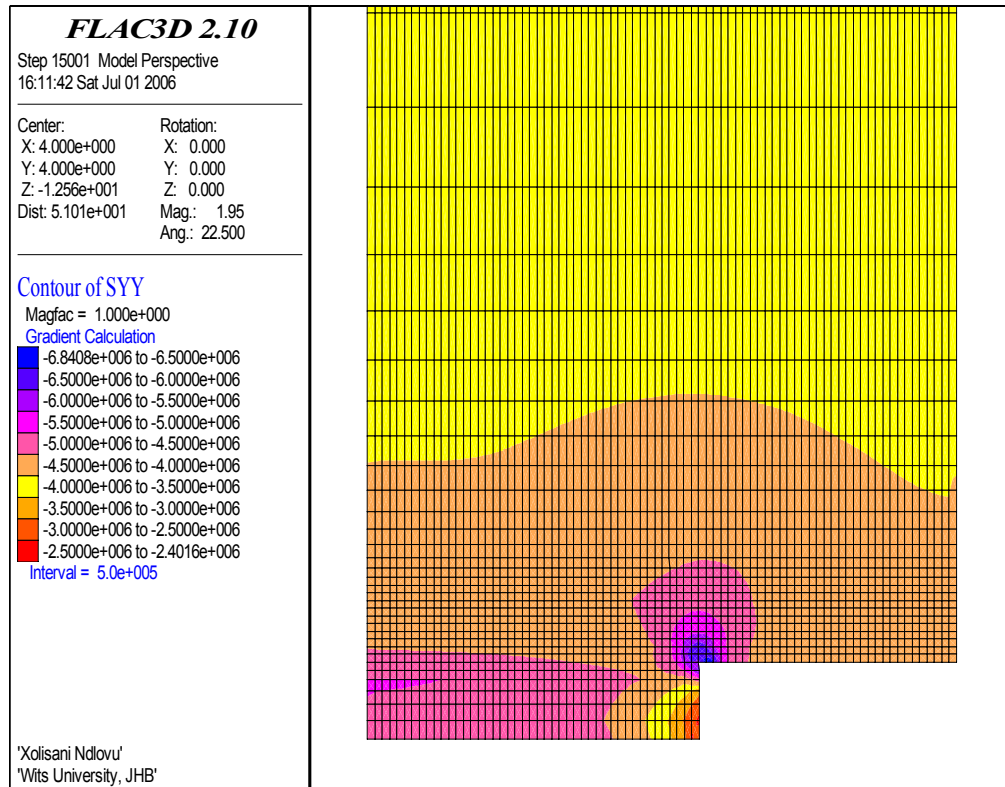
**Figure 6.8: Contour plot of minor horizontal stress distribution along Section A**

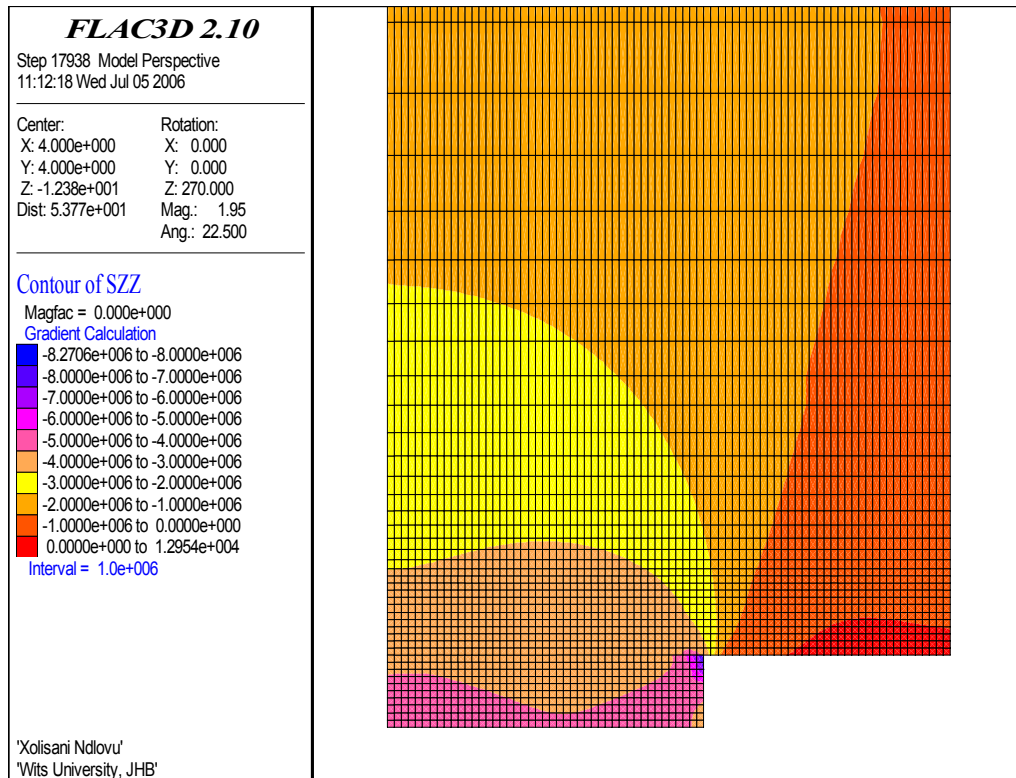
**Figure 6.18: Vertical stress distribution (along Section A, Figure 6.4)**

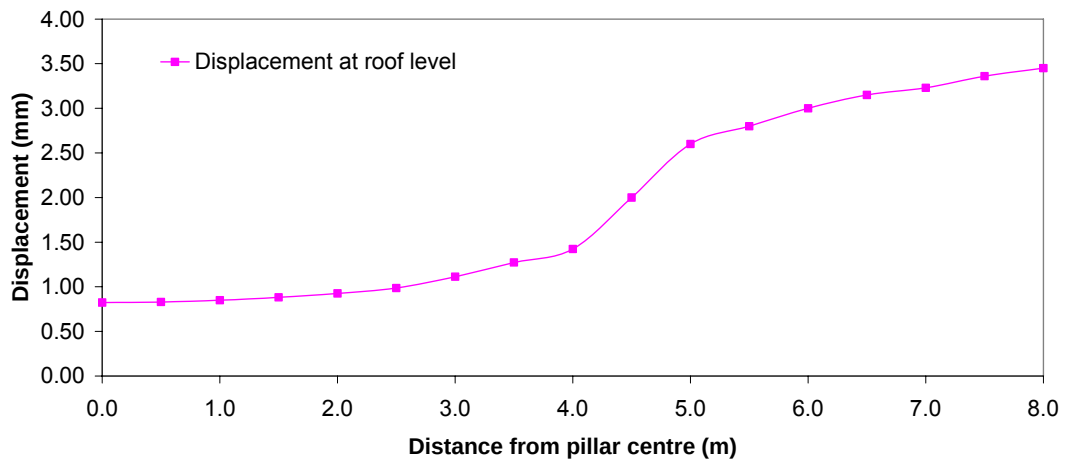
**Figure 6.23: Induced vertical displacements (along Line B, Figure 6.4)**

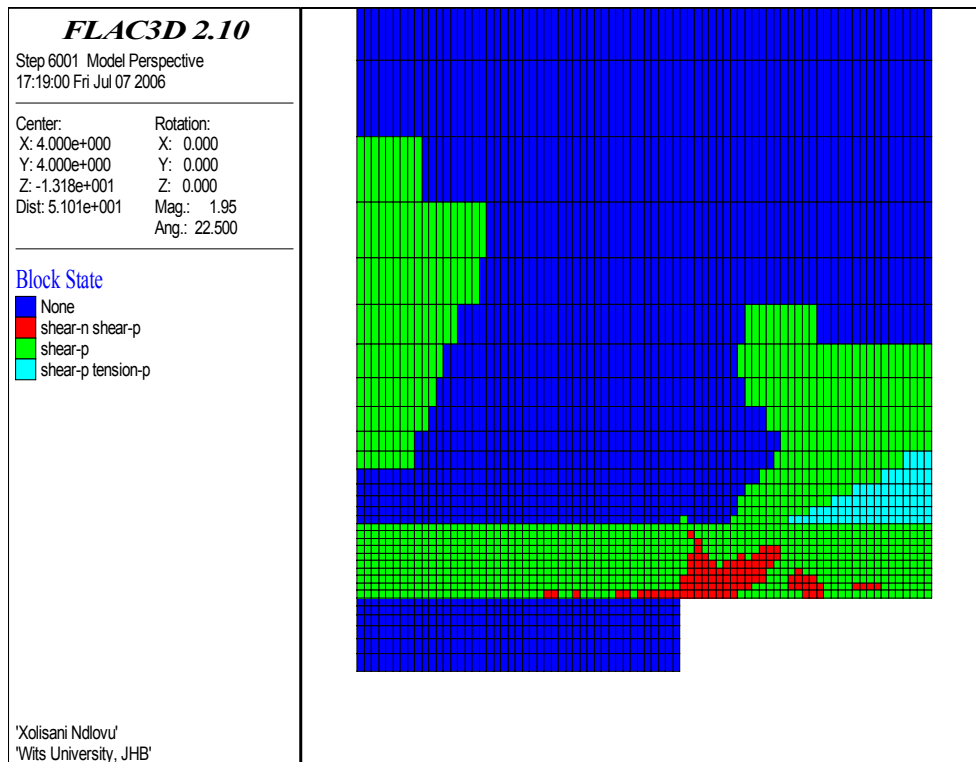
**Figure 6.24: Failure state in the immediate roof (along Section A, Figure 6.4)**

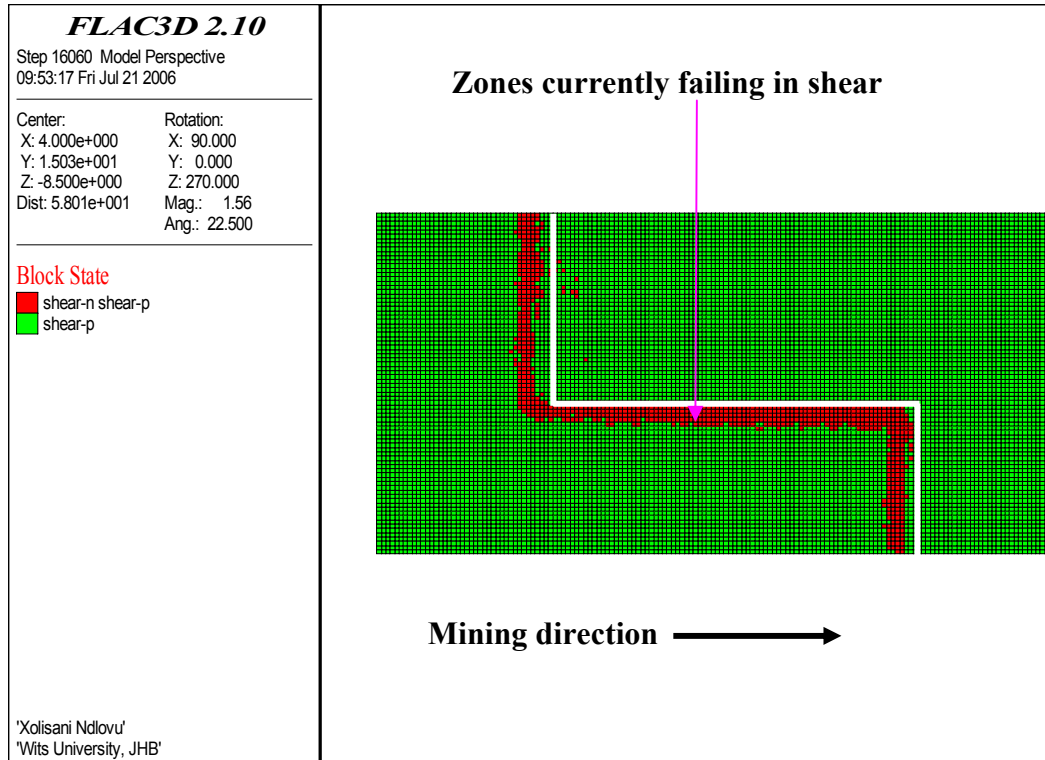
**Figure 6.25: Plan view showing failure zones at the roof level for model with a coal heading**

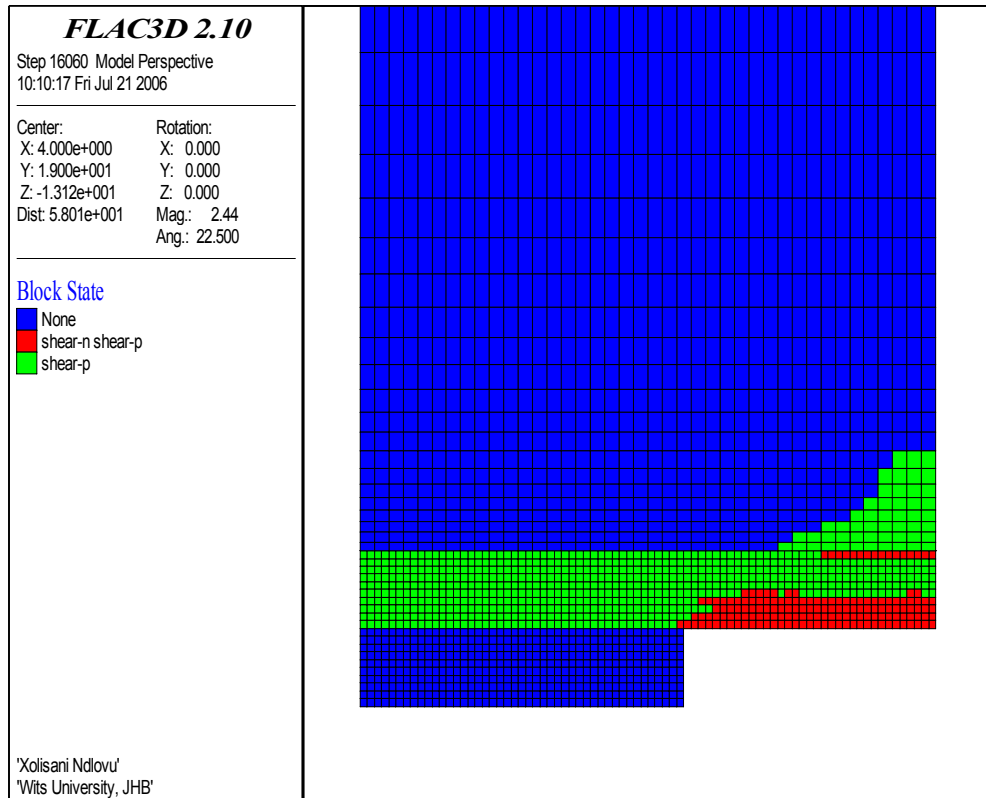
**Figure 6.26: Failure zones 0.2 m behind the coal face (along Section M-M)**

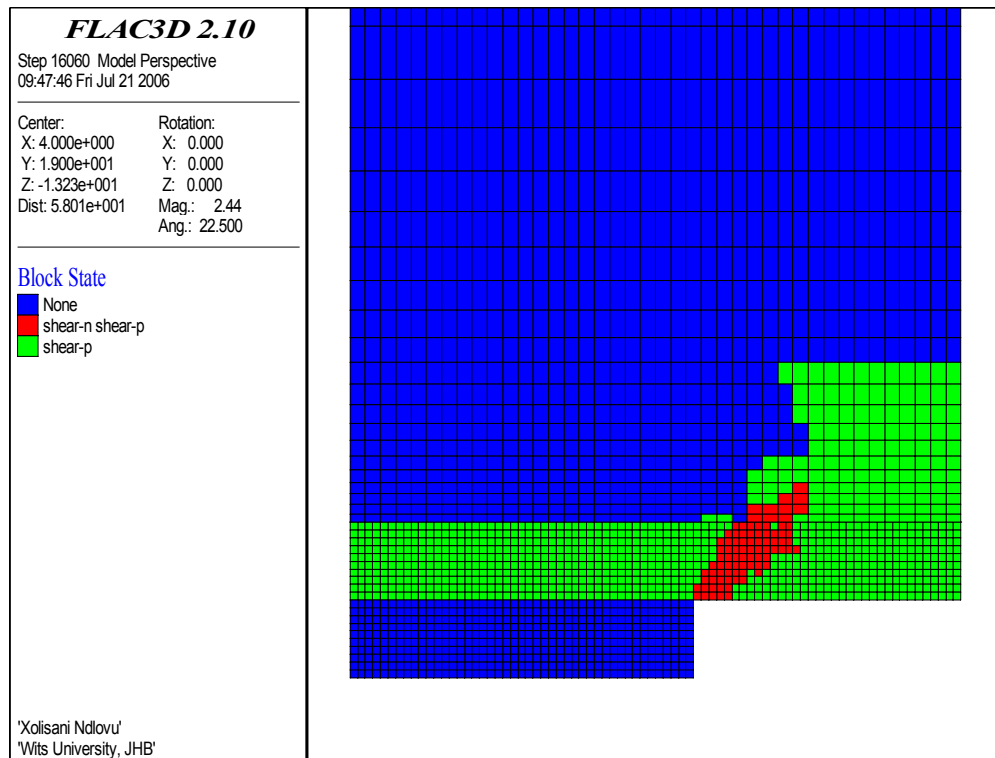
**Figure 6.27: Failure zones 1 m behind the coal face (along Section M-M)**

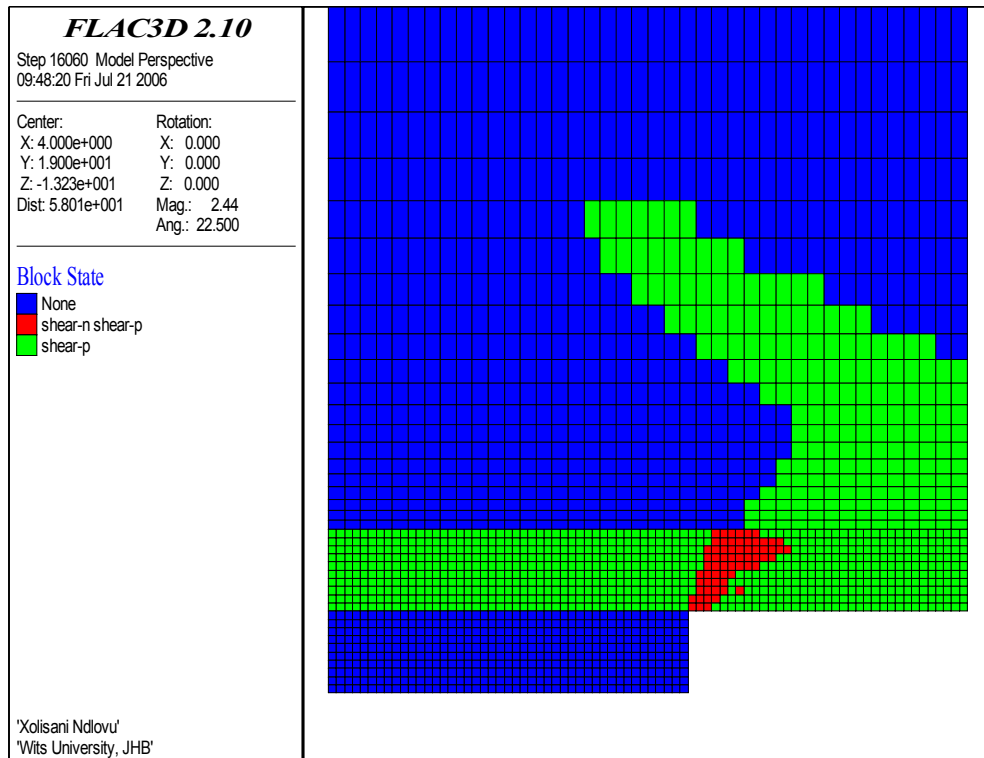
**Figure 6.28: Failure zones 6 m behind the coal face (along Section M-M, Figure 6.3)**

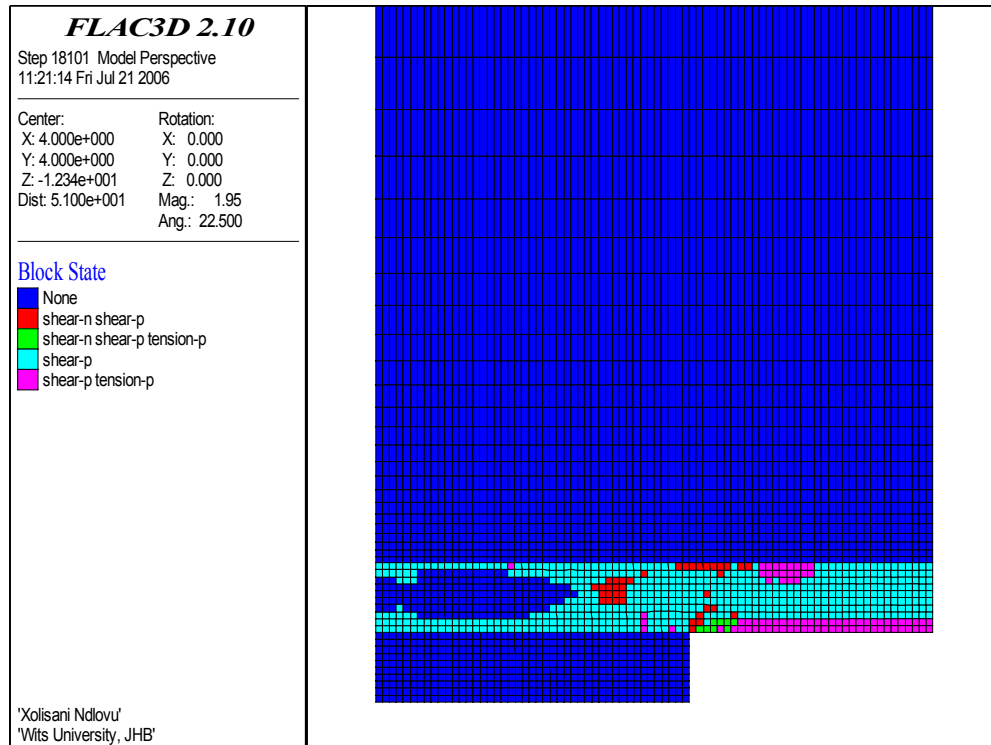
**Figure 6.29: Failure state above immediate roof for strain softening model (along Section A, Figure 6.4)**

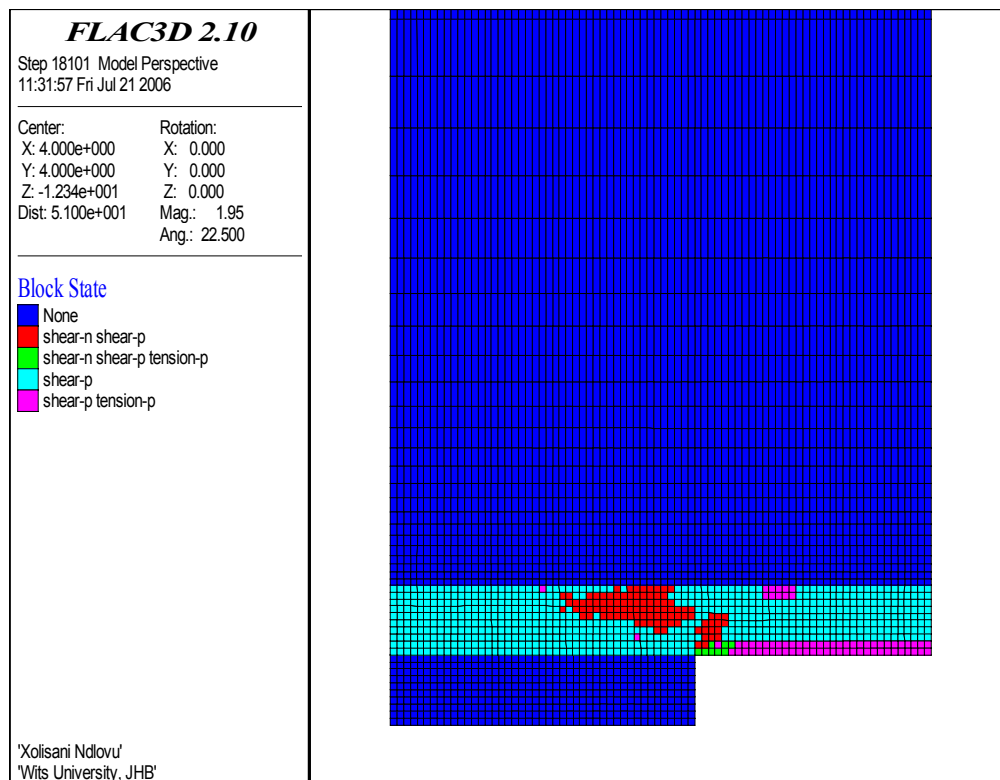
**Figure 6.30: Failure zones 1 m behind the coal face (along Section M-M)**

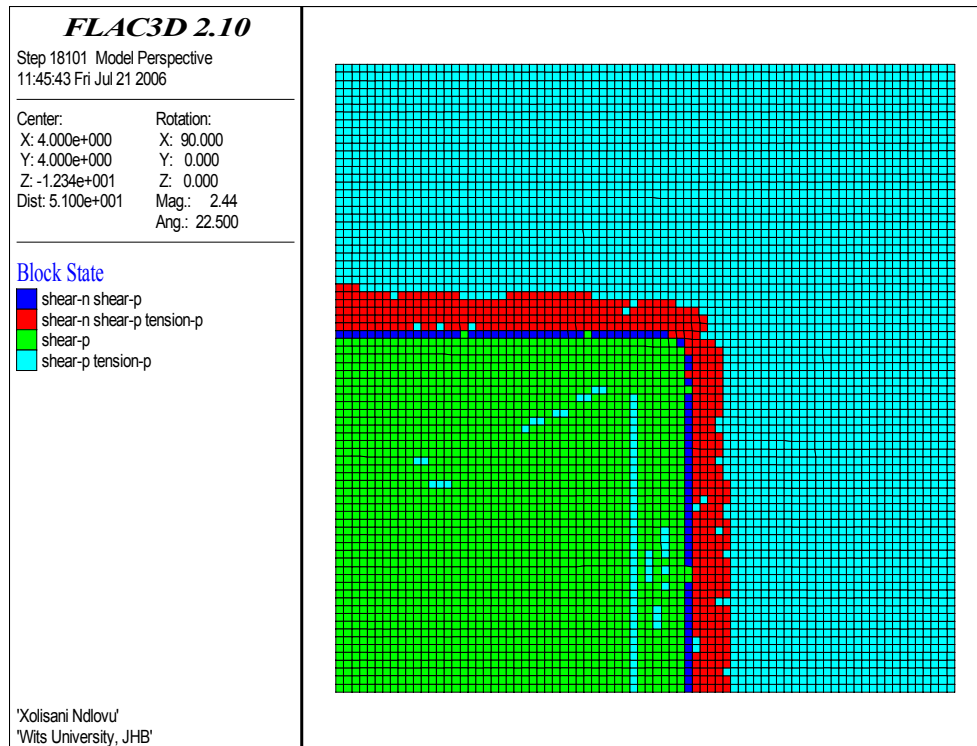
**Figure 6.31: Plan view showing failure state at the roof level for Model 1 geometry with an interface**

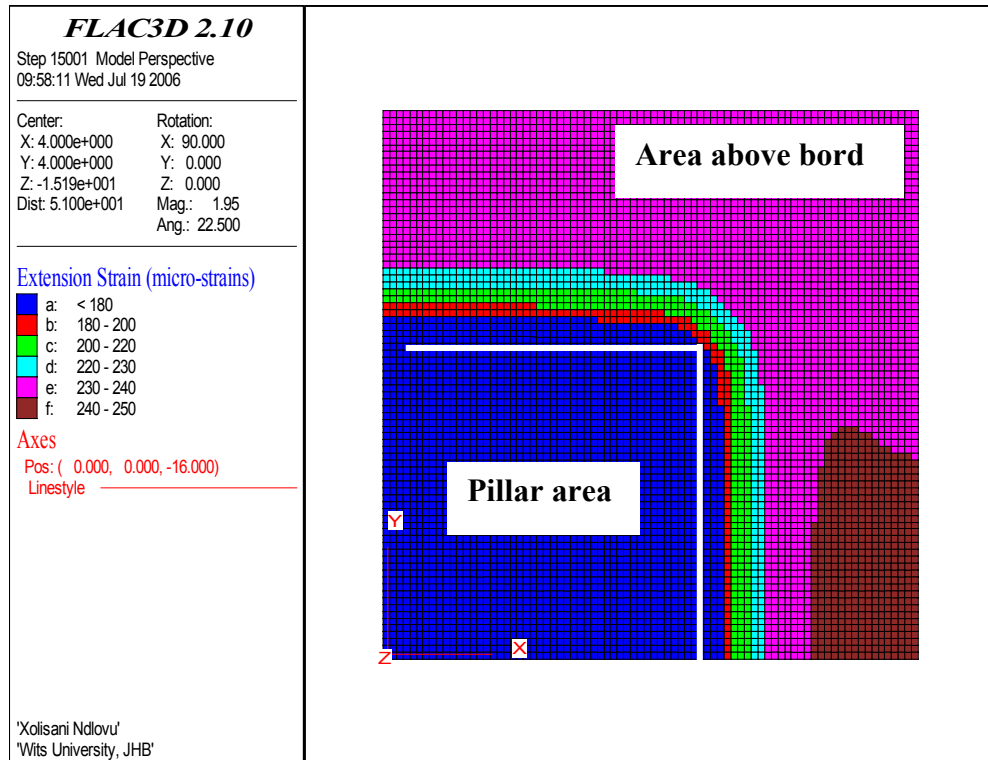
**Figure 6.34: Plan view of extension strain distribution at 1 m above roof level**

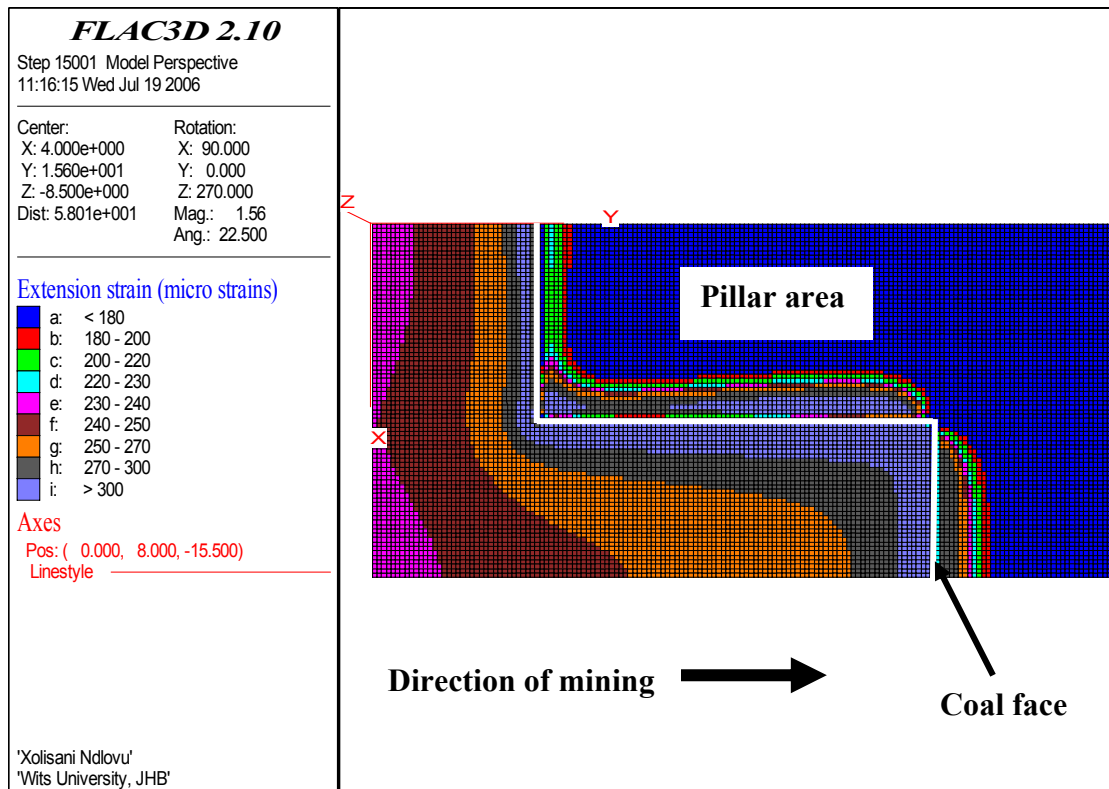
**Figure 6.35: Plan view of extension strain distribution at roof level (based on Model 2 geometry)**

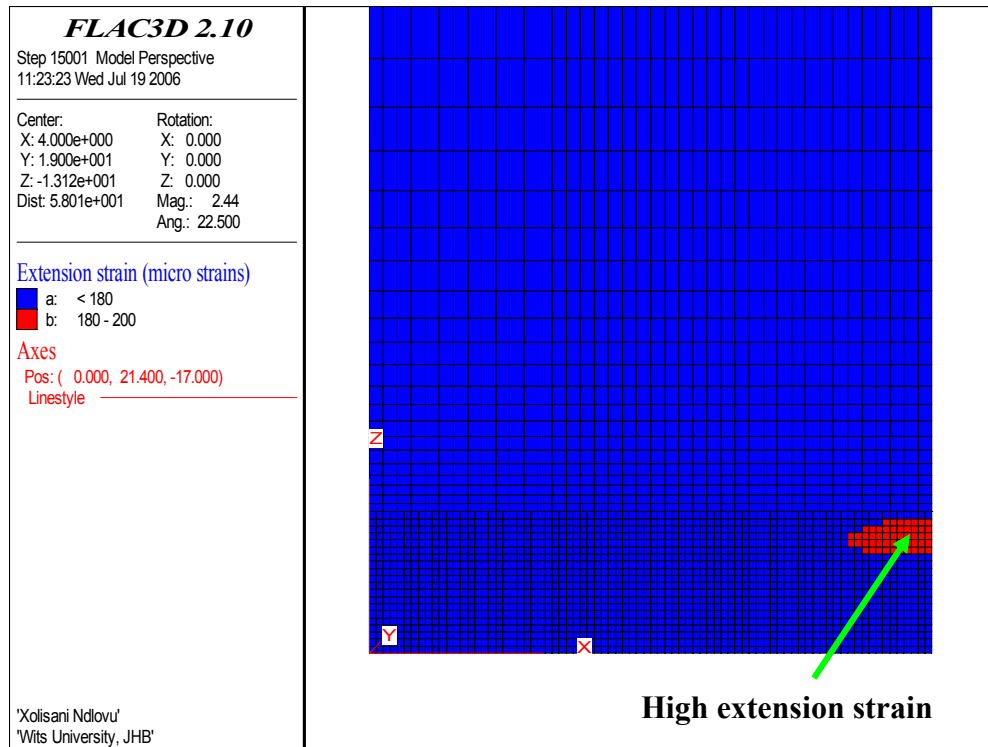
**Figure 6.37: Extension strain distribution at 1.4 m ahead of the coal face (along Section M-M, Figure 6.3)**

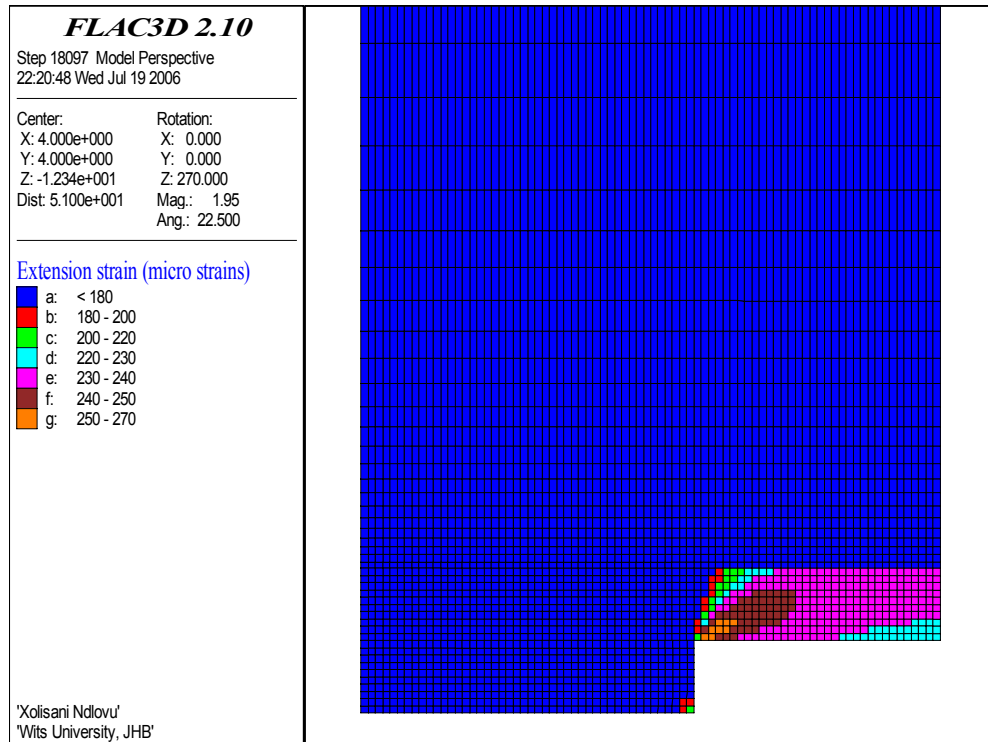
**Figure 6.38: Extension strain distribution (along Section A, Figure 6.4)**

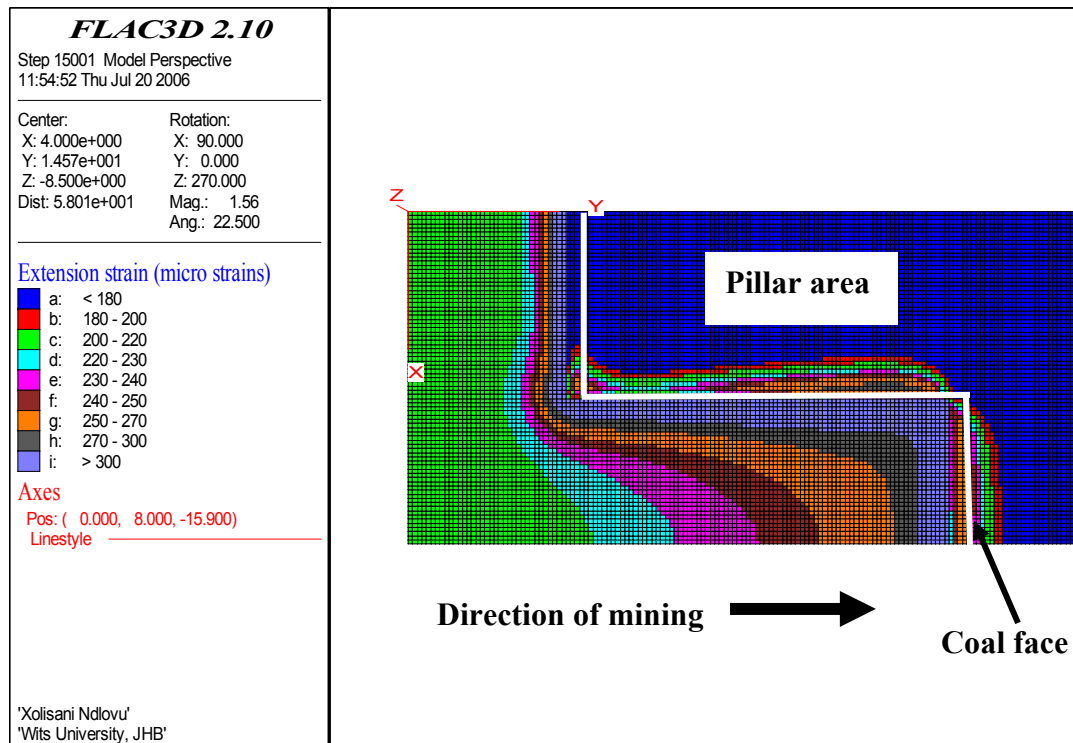
**Figure 6.40: Plan view of extension strain distribution at roof level**

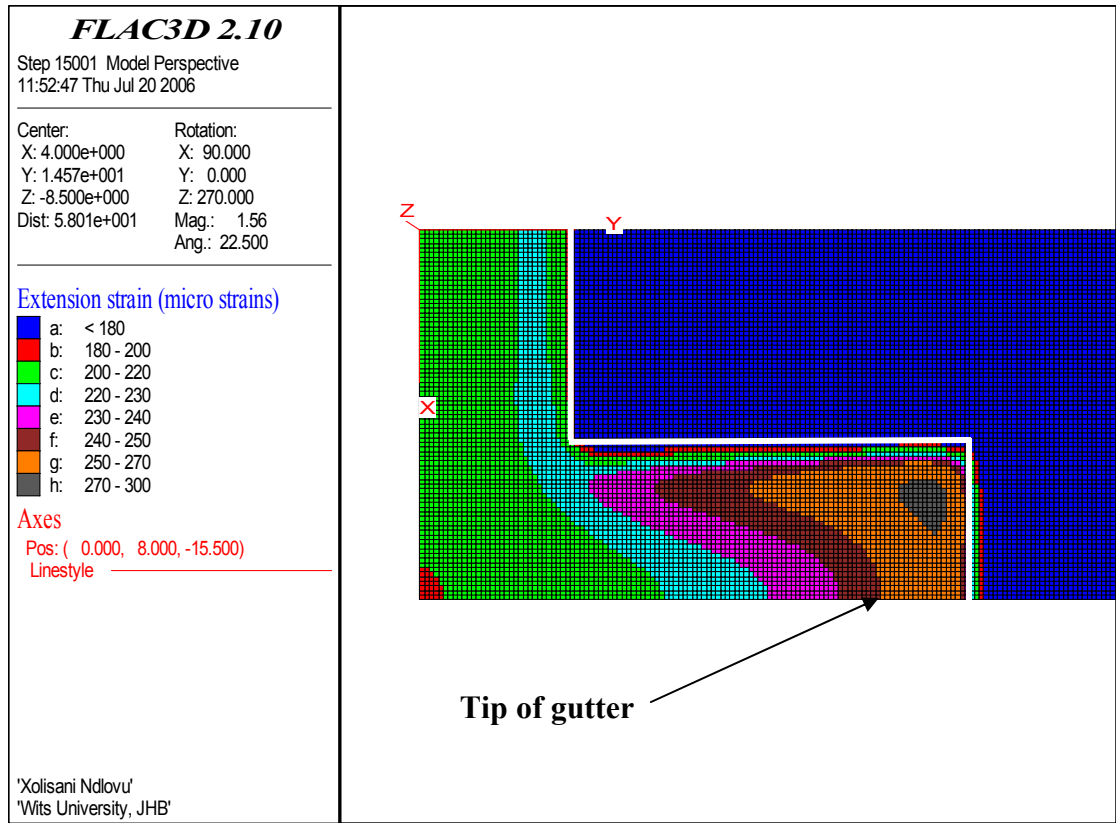
**Figure 6.41: Plan view of extension strain distribution at 0.5 m above the roof level position**

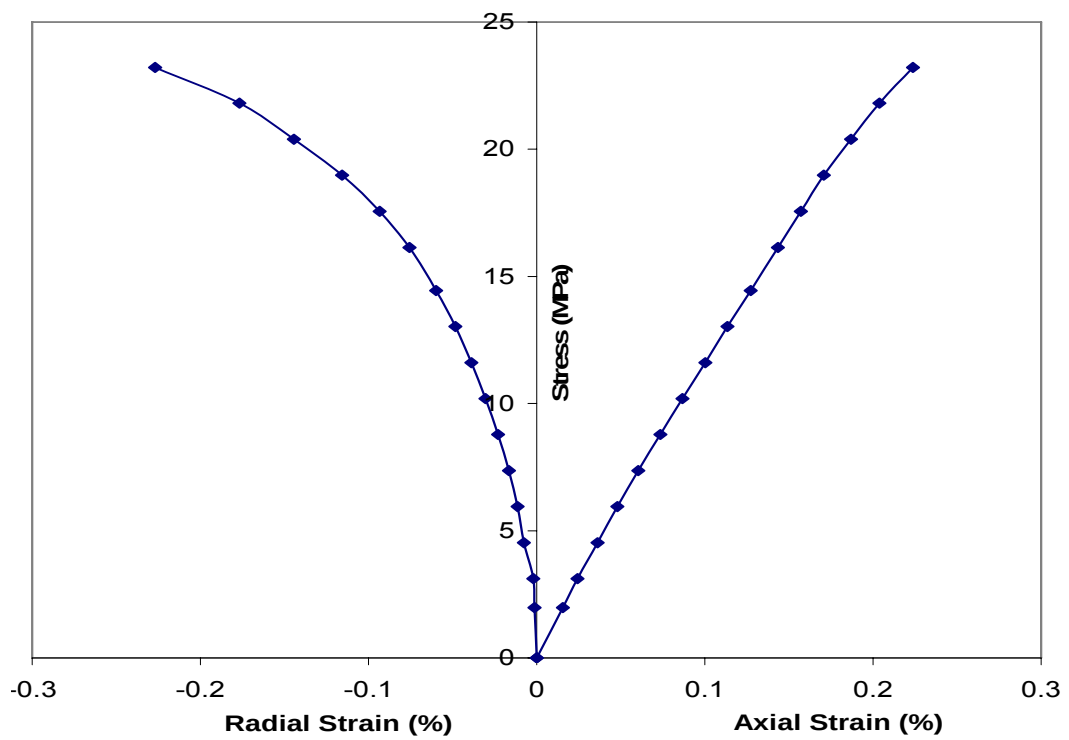
**Figure A1.2: Typical stress – strain graph for a cylindrical sample for loading along bedding**
