Appendix E

Rock mass behaviour

E1 Closure measurements

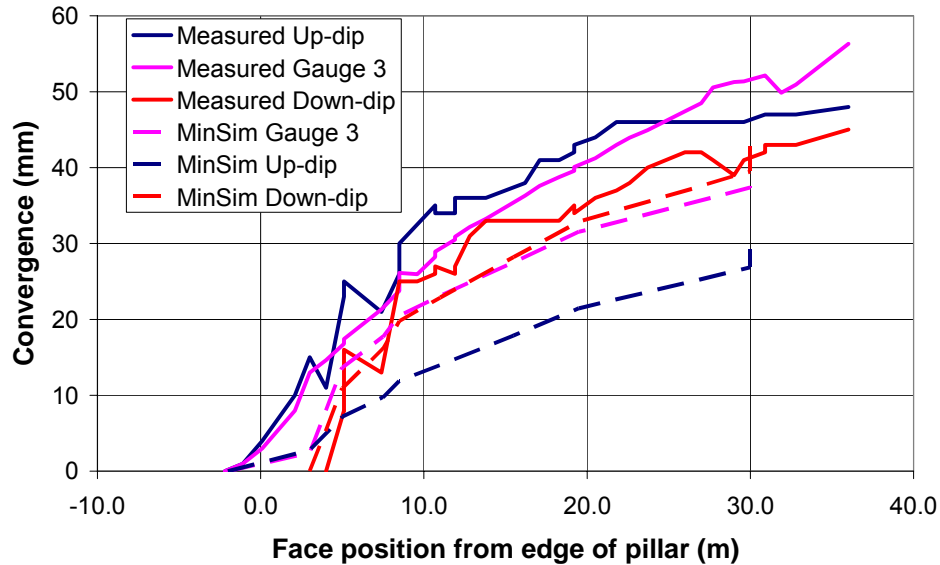
The closure meter on the down-dip side of the P2 was installed about 4 m behind the face and the measurements were similar to the elastic model (Figure E 2). However, on the up-dip side the measurements were significantly larger than the elastic model, particularly during the initial stages of pillar formation. The model assumed that the pillar failed when the face had advanced by about 3 m from the pillar edge, and that the residual strength dropped immediately after failure to 20 MPa. In reality, the pillar failed as it was exposed and the stress dropped to residual strength at a face advance of about 16 m. At least some of the additional measured closure occurred as a result of the mismatch between the model and reality. However, closure measurements made at face advances beyond 16 m still showed higher closure than what was modelled, suggesting an inelastic component of closure on the up-dip side of the pillar. A few open discontinuities were observed in the hangingwall up to a height of 4.25 m above the stope (in a

Figure E 2 Measured closure and elastic convergence at the Amandelbult site

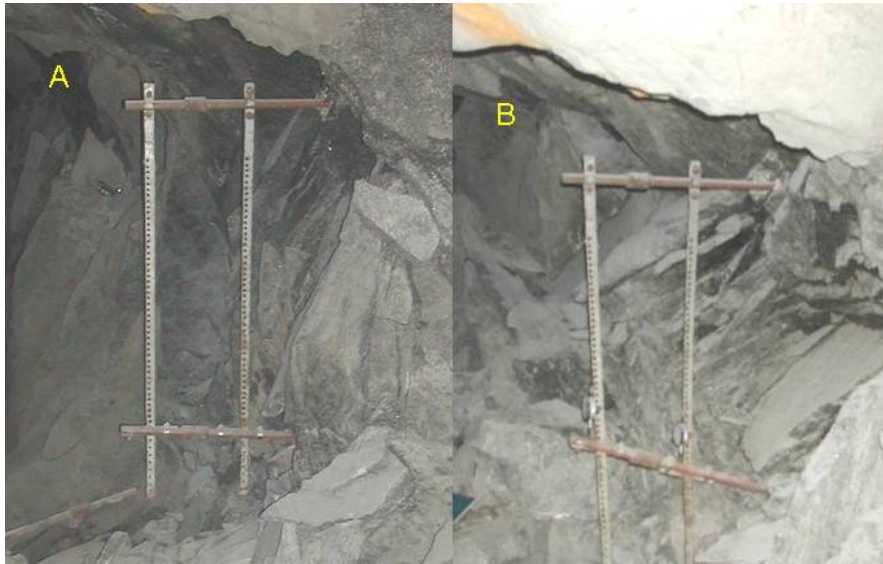
1.8 m long jumpers were cemented into the centre of both the instrumented pillars, near the top edge of the pillars and about 1 m vertically below this position as shown in Figure E 3A. A slow but perpetual upwards rotation was observed on the lower bar on both pillars as shown in Figure E 3B. This rotation could have resulted from sliding wedges in the pillar, but is more likely to be caused by a relatively larger downwards deformation of the more solid pillar centres than near the edge of the pillars. Also in both instances very little or no rotation occurred on the top bar and the direction of rotation on the lower bar was the same. The rotation of the bars and the additional measured closure suggest that the pillars were punching into the footwall with a flow of damaged footwall rocks into the gully on the up-dip side of the pillars. The measurements on Gauge 3 suggest that some of the inelastic deformation was occurring deeper than 0.5 m below the level of the ASG.

Figure E 3 *Rotation of jumpers cemented into the centre of P2 near the top edge of the pillar and about 1 m vertically below. A = pillar failure, B = three months after pillar failure*

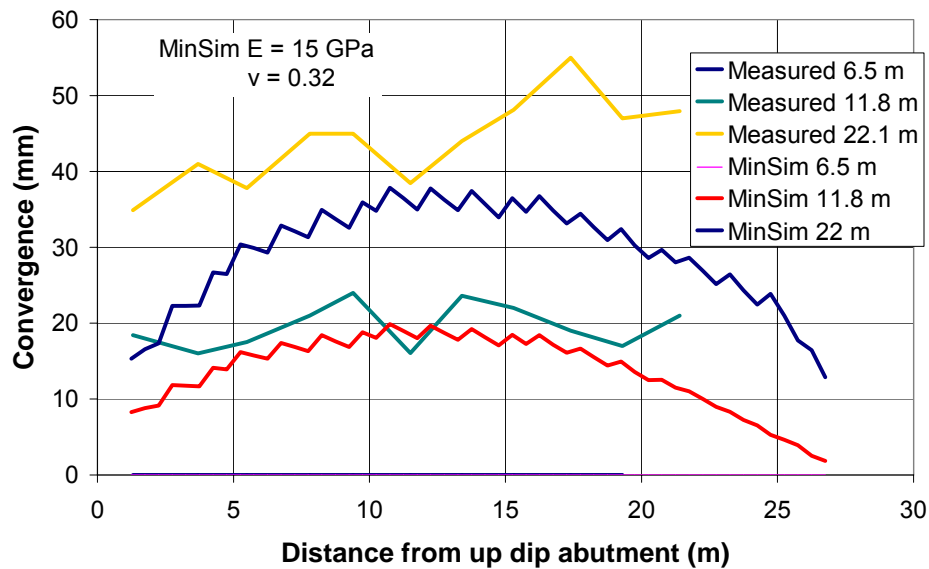
Figure E 5 Comparison between the measured closure and MinSim convergence for the isolated 7s panel at Impala 10-Shaft

The almost linear closure across the panel in Figure E 5 suggests bulking, possibly due to the fracturing of the footwall at the face. Figure E 7 shows that about 40 mm less closure actually occurred within 6 m of the face than predicted by the elastic model (with a Young's Modulus of 15 GPa and a Poisson's Ratio of 0.32). An explanation for the comparatively small deformation actually measured near the face is the affect on closure of the material above the face which is not microfractured. The model only accounts for a single modulus and therefore predicts more convergence near the face. As the closure was probably affected by linear elastic and microfractured rock above the panel, it is probable that some inelastic deformation is hidden in the low modulus used in the model. Thus some extension fracturing and bulking due to the drop in the vertical confining stress is possible, but is unlikely to be significant unless shear fractures developed ahead of the face, i.e. prior to the installation of the closure meter. These types of fractures were not observed in the hangingwall or footwall and the face also appeared unfractured when the panel was isolated. The closure that was measured at the centre of the panel from about 6 m face advance was almost elastic during the isolated stope conditions as shown by the dashed line in Figure E 7.

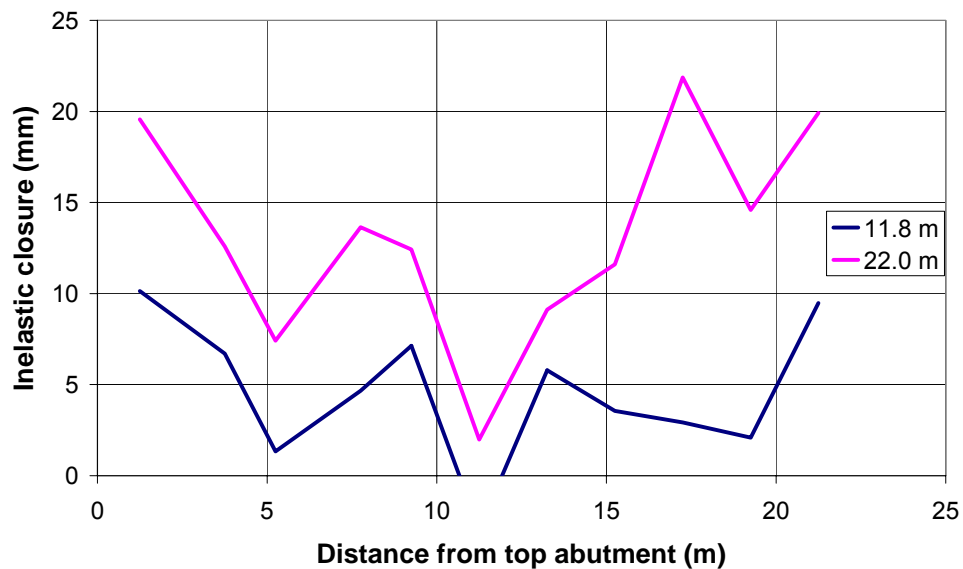
Figure E 6 Inelastic component of the measured closure for various face advances (assuming E=15 GPa)

York et al (1998) shows that the heave near the abutments in Figure E 6 could be associated with buckling. In the scenario shown in Figure E 8, York et al (1998) suggests that the initial heave results from discontinuities or fractures closer than 1 m to the excavation. The secondary buckling at higher face advance may have occurred at deeper levels.

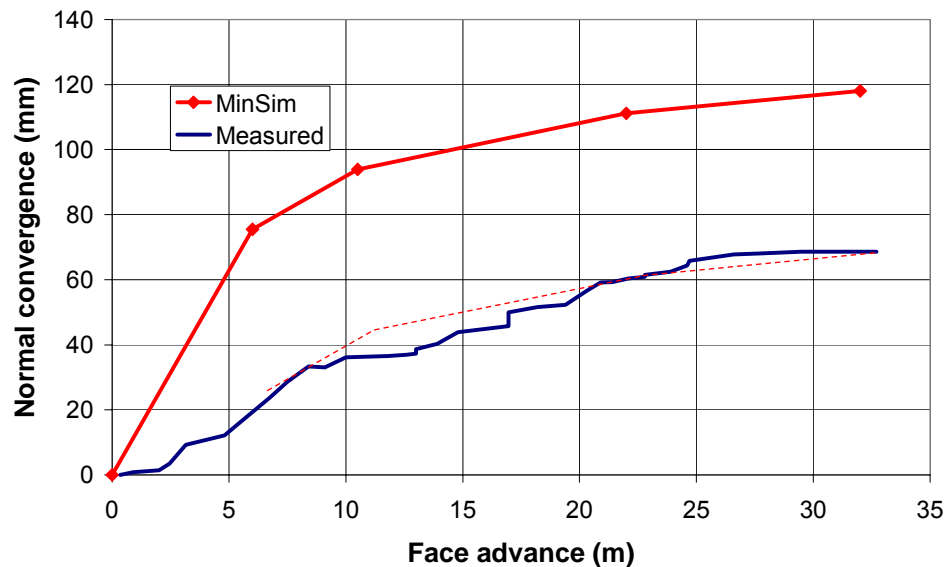
Figure E 7 Measured closure and elastic convergence at the centre of the panel

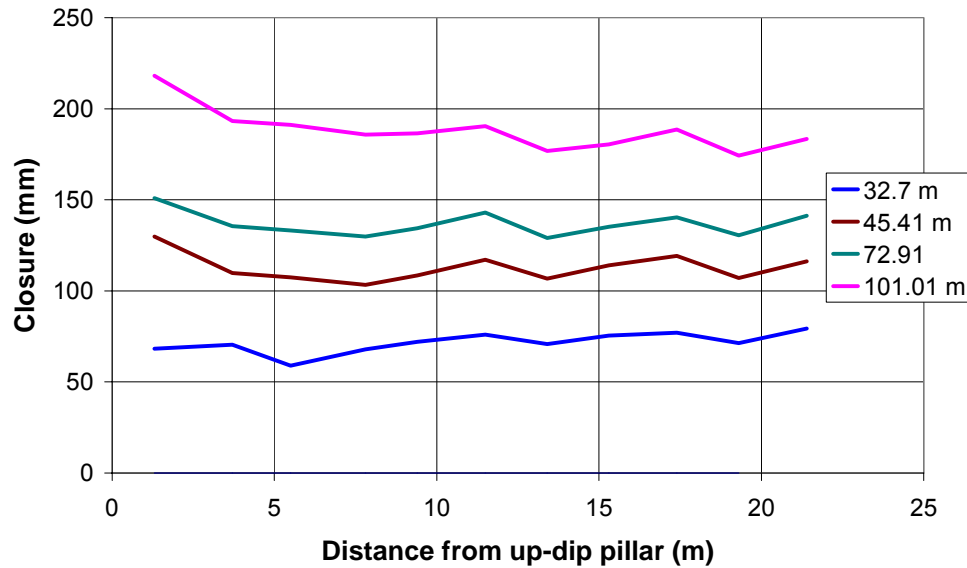
Figure E 8 Closure measured at various face advances of Panel 7s. Pillar formation occurred between face advances of 32.7 m and 101.01 m

The closures represented in Figure E 8 were plotted against time in Figure E 9. The first 33 m face advance in Figure E 6 and Figure E 8 shows the closure in the isolated panel. Face advance was temporarily halted in Panel 7s between 9 December 2005 and 31 March 2006. During this time mining commenced in Panel 8s and the face in Panel 6s was also advanced as shown by the yellow in Figure E 4. This mining resulted in a comparatively lower closure rate than the isolated panel, due in part to the reduction in elastic convergence. The closure rate gradually increased as the up-dip and down-dip faces approached the closure meter stations and the pillars in the vicinity of the closure meter stations failed. At the end of March 2006, the face in Panel 8s was temporarily halted in line with the closure meters in Panel 7s. Failure was also initiated on the pillars in line with the closure meters, which resulted in comparatively more closure immediately down-dip of the pillar between Panels 7s and 8s as shown by the pink line in Figure E 9. Mining was subsequently resumed in Panel 7s, which was mined together with Panel 6s until 14 June 2006, where mining was again temporarily halted in Panel 7s and resumed in Panel 8s. Panel 8s reached its final position on 25 August 2006, which coincided with a significant drop in the closure rate in Figure E 9. Subsequent mining in Panel 7s had a relatively small impact on closure.

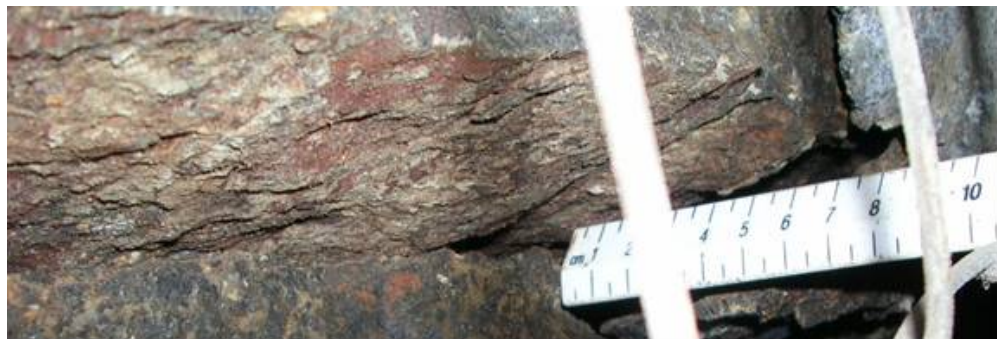
Figure E 11 Movement on a structure in the footwall during the mining of Panel 8s

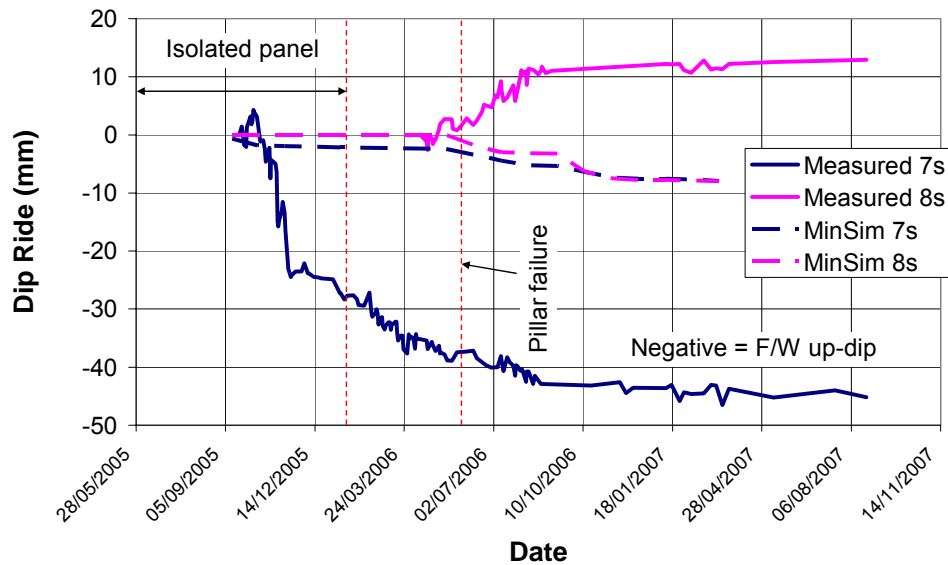
The dip ride measurements in Panel 7s showed an initial down-dip and a subsequent much stronger up-dip movement of the footwall relative to the hangingwall (Figure E 12). However, the footwall of the more highly stressed 8s panel only moved down-dip at the measurement point (which was installed about 0.5 m from the face). The elastic model shows an up-dip movement for both panels. The strong up-dip movements in Panel 7s are suspected to be the results of micro-cracking in the rock mass or from the development of the fractures that were later observed in the footwall (Section E3). The down-dip movement of the footwall in Panel 8s is suspected to have resulted from an overriding footwall punching affect of the large pillar at the top of panel 8s (Figure E 4). Once mining was initiated in panel 8s, an almost elastic ride response was observed in Panel 7s (Figure E 12). At this stage the face position in Panel 7s was far advanced and face advances were not made in the panel for several months. It appears that the original mechanism for the large-scale inelastic footwall ride in Panel 7s had been reduced or terminated.

Figure E 12 Dip ride measurements at the centre of Panels 7s and 8s

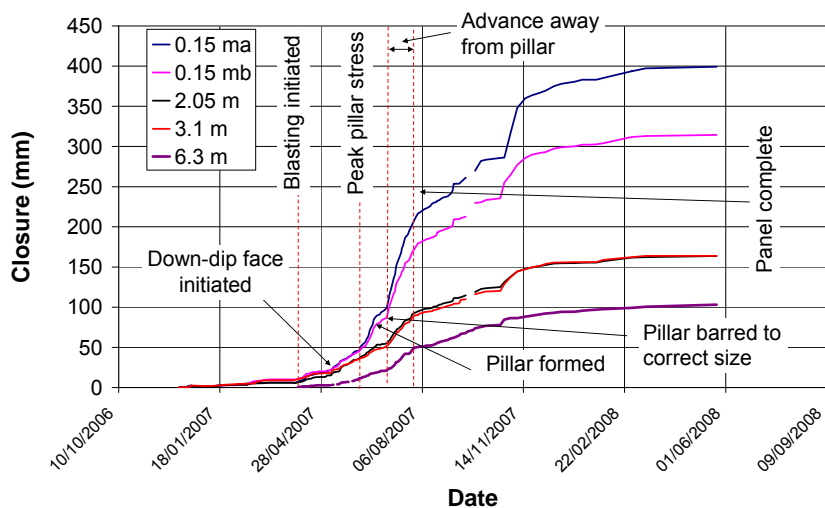
Figure E 14 Closure measurements made at various distances from the edge of the monitored pillar (towards the north)

The closure results in Figure E 14 show that a similar amount of closure (~8 mm) was measured by the four stations in the ledge adjacent to the proposed pillar for a period of four months prior to mining. The stations were located at 0.15 m, 2.05 m and 3.10 m from the proposed pillar edge. Since all the stations showed a similar change, the closure is suspected to be the product of deeper level foundation failure, bulking and possibly buckling with a small elastic component due to external mining. The core from an extensometer hole adjacent to the closure meter station on the north side of the centre raise (6.3 m) showed that the footwall was highly fractured to a depth of about 3 m below the stope (2 m in Figure E 15). This suggests that some inelastic closure had already occurred prior to the closure meter installations. The initial mining on the up-dip side of the pillar resulted in an increase in the closure rate particularly near the pillar, i.e. a profile of decreasing closure rate with distance from the pillar (Figure E 16). This profile could not be replicated with an elastic model (Figure E 17) (Young's modulus of 30 GPa and Poisson's Ratio of 0.32 were used in the model), and suggests inelastic behaviour due to pillar punching. The profiles in Figure E 17 suggest that a significant proportion of the inelastic deformations were occurring in the footwall at depths less than 5.5 m below the stope during this period (above the anchor in closure station 6.3 m). However, it is apparent from the initial measurements made on closure station 6.3 m that the modulus was too low, i.e. an exaggerated convergence is shown in Figure E 17.

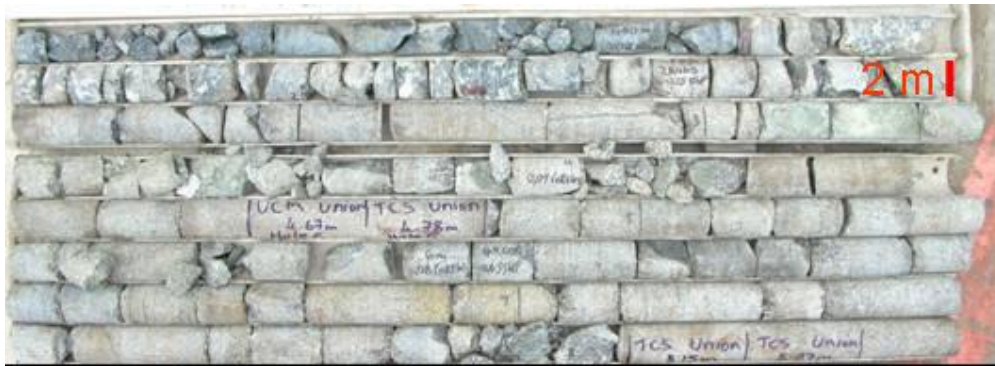
Figure E 15 Core from the footwall extensometer

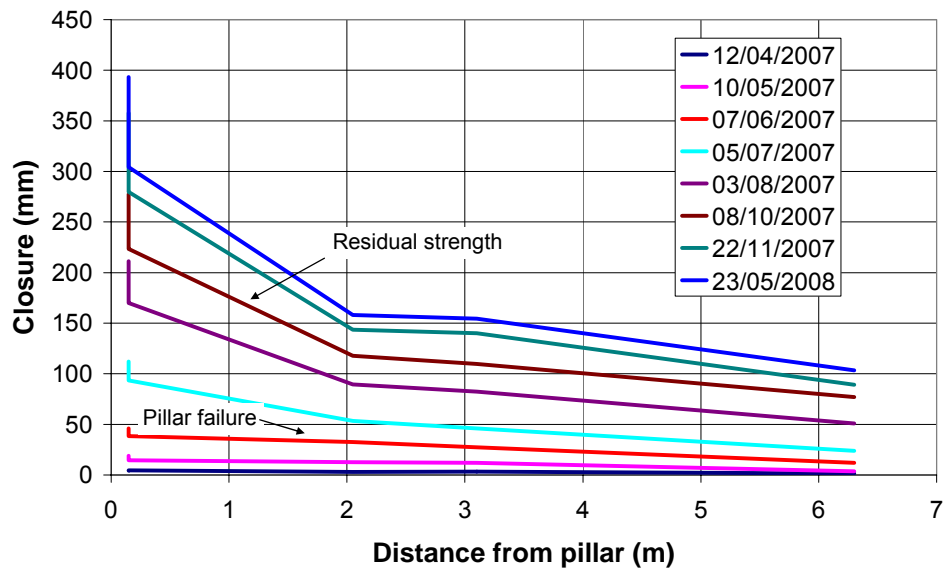
Figure E 16 Closure in the ledge with distance from the pillar edge

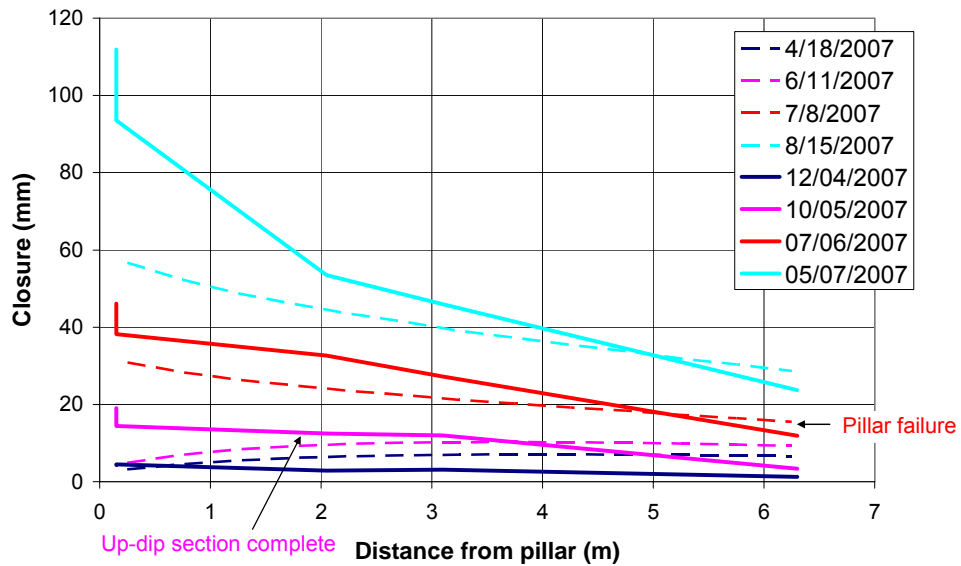
Figure E 17 Closure (solid lines) and elastic convergence (dashed lines) with distance from pillar edge

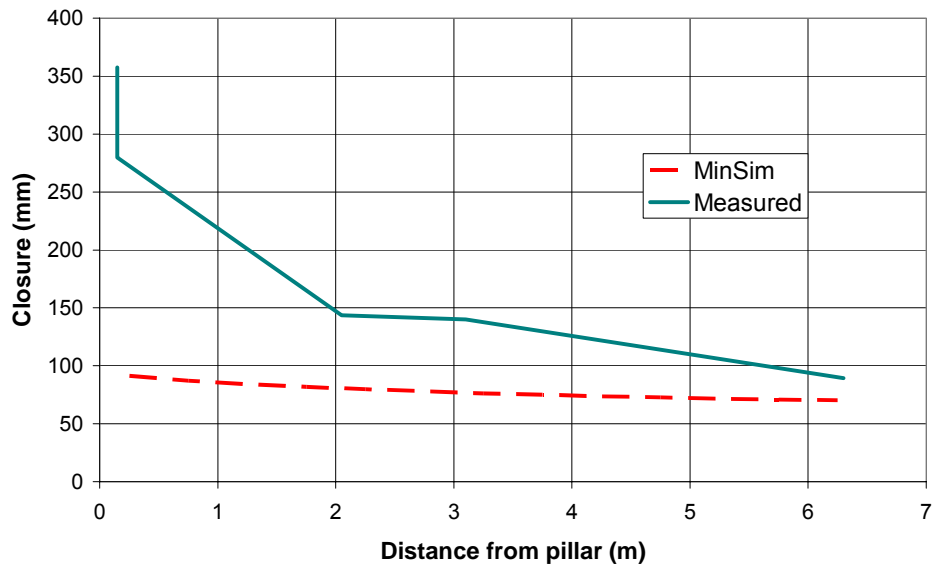
Figure E 19 Closure and elastic convergence at the edge of the monitored pillar from the start of mining in Panel 3S to completion of mining in Panel 3N

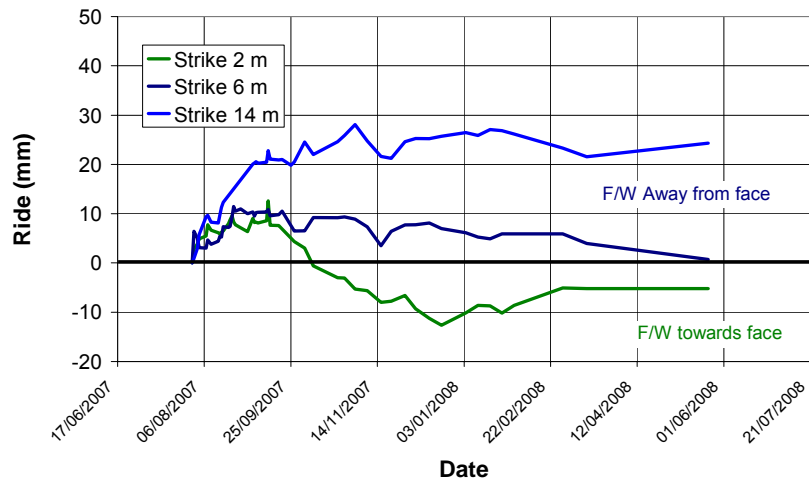
Figure E 21 shows the strike ride measurements at 2 m, 6 m and 14 m from the pillar edge. The station at 14 m was 6 m from the final position of the face and measurements were initiated when this station was 4 m from the face. During the mining of the 3S and 2S panels, the footwall moved away from the 3S face. However, after this mining was terminated there was a reversal in the direction of movement in the two stations closest to the pillar (Stations 2 m and 6 m). The shape of the closure profiles in Figure E 22 suggest that the pillar and probably the face were punching into the foundation rocks, and this is likely to be the

Figure E 21 Strike ride measurements in Panel 3S

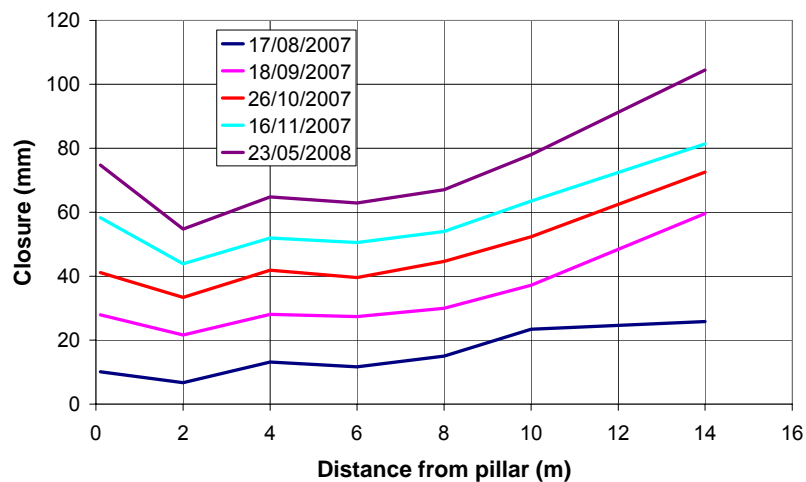
reason for the ride. It appears that the effects of the crushed pillar were overridden by the face during the initial mining but subsequent mining of the 3N and down-dip panels caused sufficient pillar punching to reverse the direction of the ride on stations 2 m and 6 m. The residual pillar stress was reached before 26/10/2007 but the ride continued on the station at 2 m. Further steepening at the pillar edge of subsequent closure curves in Figure E 22 is evidence of the pillar influence on stope behaviour.

Figure E 22 Closure with distance from pillar edge

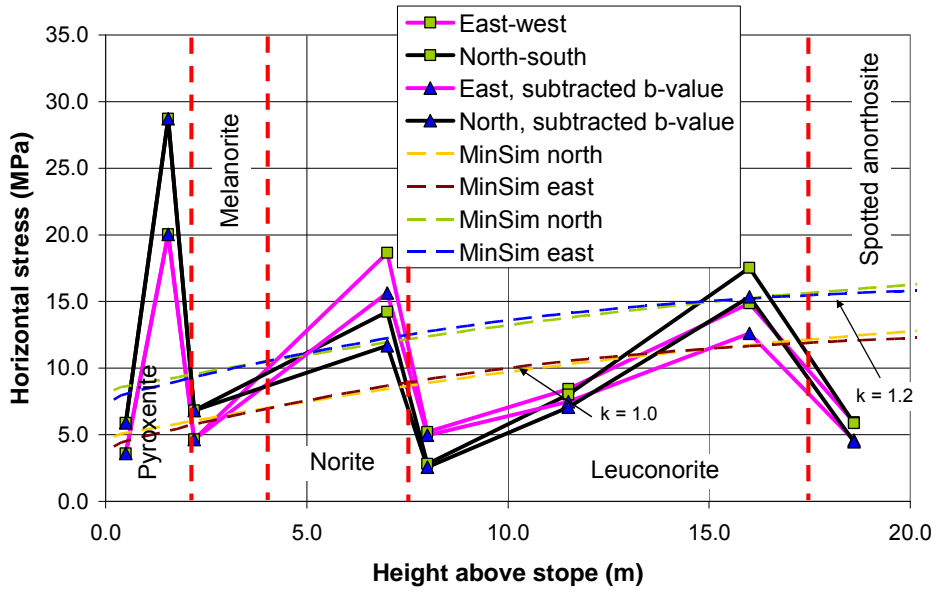
Figure E 25 Horizontal stresses in the North and East directions evaluated using biaxial test results, elastic model dotted

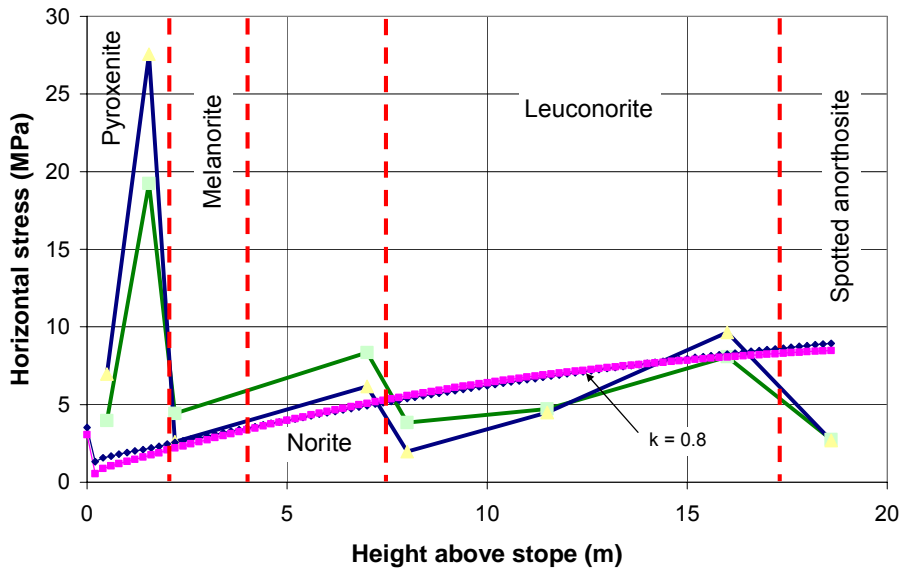
Figure E 26 Horizontal stresses in the North and East directions evaluated using the nonlinear evaluation technique, elastic model dotted

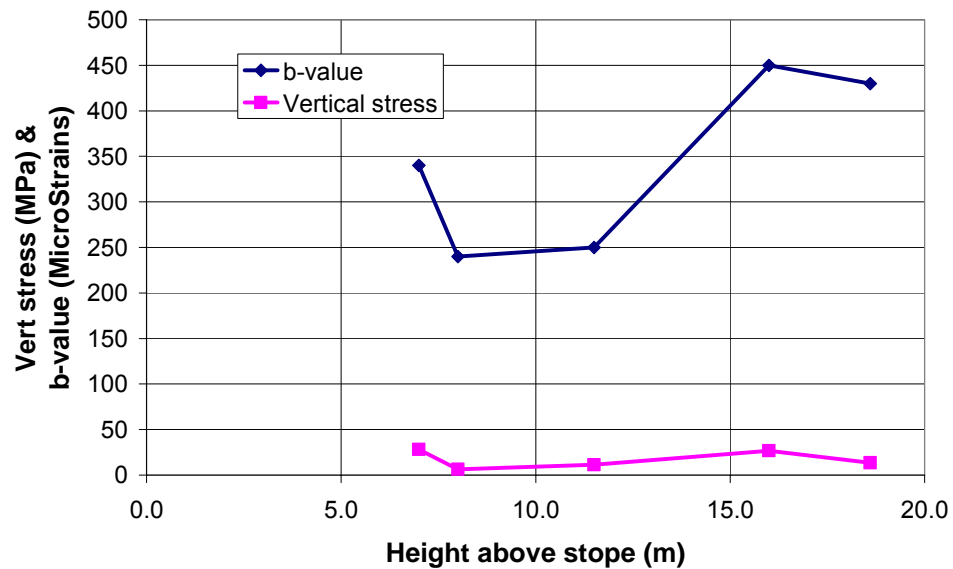
Figure E 27 Comparison between the measured vertical apparent stress (strain) and a measure of nonlinearity (b-value)

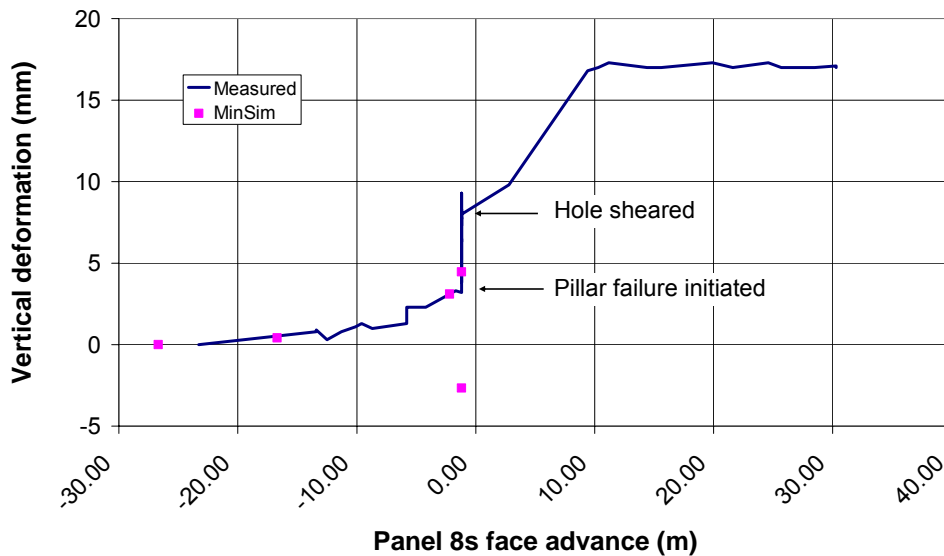
Three extensometers were installed in the hangingwall to measure horizontal and vertical deformations. A vertical extensometer was installed through the centre of Pillar 2 (CSIRO1 in Figure E 28) ahead of the up-dip and down-dip panels and measured the vertical deformation that occurred between the top of the pillar and 4.18 m above the pillar (Figure E 30). Positive deformation represents compression. Pillar failure occurred about 1 m ahead of the lagging up-dip face and the deformation up to failure initiation was shown to be elastic (Figure E 30), using the 'matrix' constants for spotted anorthosite. After failure initiation, the elastic deformations were followed by significant inelastic compressive

deformations before the borehole was sheared. These results suggest that the pillar was punching into the hangingwall. The tensile deformations that occurred after pillar failure may have been the result of borehole shearing or relaxing of the strata. The compressive measurements that occurred after shearing are likely to represent at least some of the hangingwall punching that occurred at the centre of the pillar. The flattening of the curve at 11 m face advance in Figure E 30 coincided with the beginning of the steady state residual strength shown by the pillar stress measurements. However, all hangingwall deformations measured after pillar failure are suspect as the hole appears to have sheared during pillar failure.

Figure E 30 Hangingwall deformations above the centre of Pillar 2, between the pillar top contact and 4.18 m above the Pillar. Elastic $E = 83 \text{ GPa}$ and $\nu = 0.32$

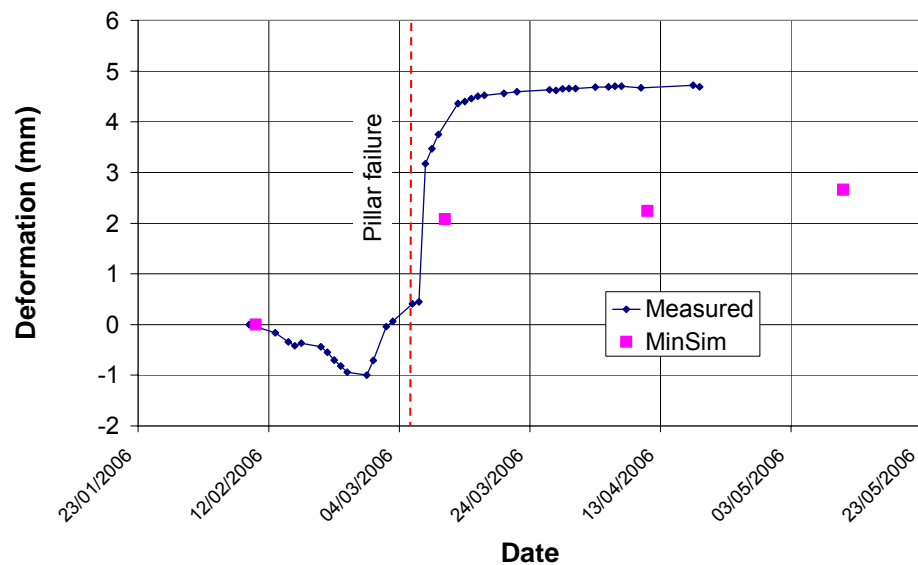
Figure E 33 Horizontal deformation in the hangingwall across a panel at vertical heights between 1.5 m and 5.5 m above the stope. Measurements performed in Borehole CSIRO2

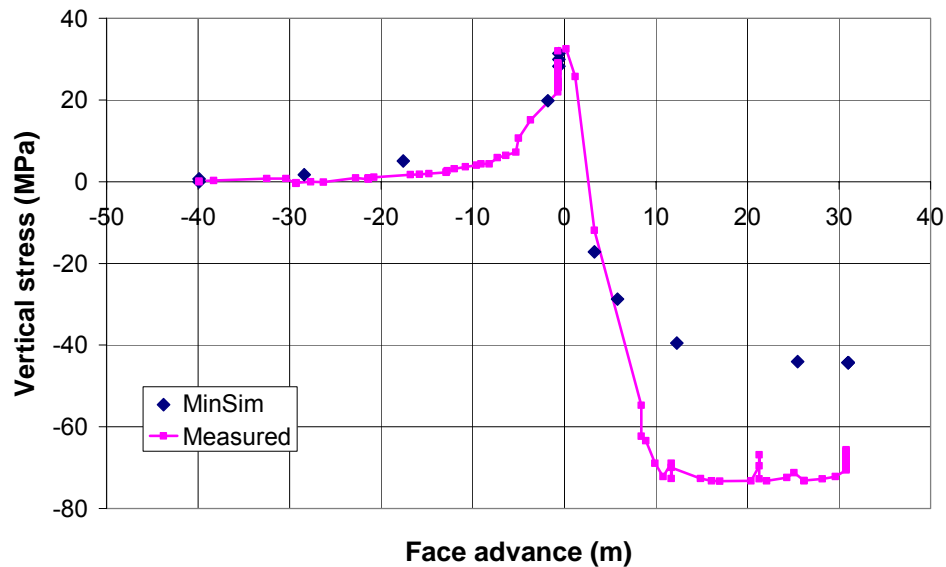
Measurements were conducted over Panel 8s in Borehole CSIRO2 to determine the stress change in the hangingwall during the mining of this panel. The vertical stress results are provided as a function of face advance and compared to an elastic model in Figure E 34. The good correlation between the measurements and the elastic model up to a face advance of about 8 m confirms the matrix elastic constants used in the evaluation of the stress measurements. Good comparisons between the extensometers and elastic models were also achieved during elastic loading conditions when these constants were applied to the models.

Figure E 34 Vertical stress change 4.7 m above the centre of Panel 8s in Borehole CSIRO2. Negative face positions are behind the cell

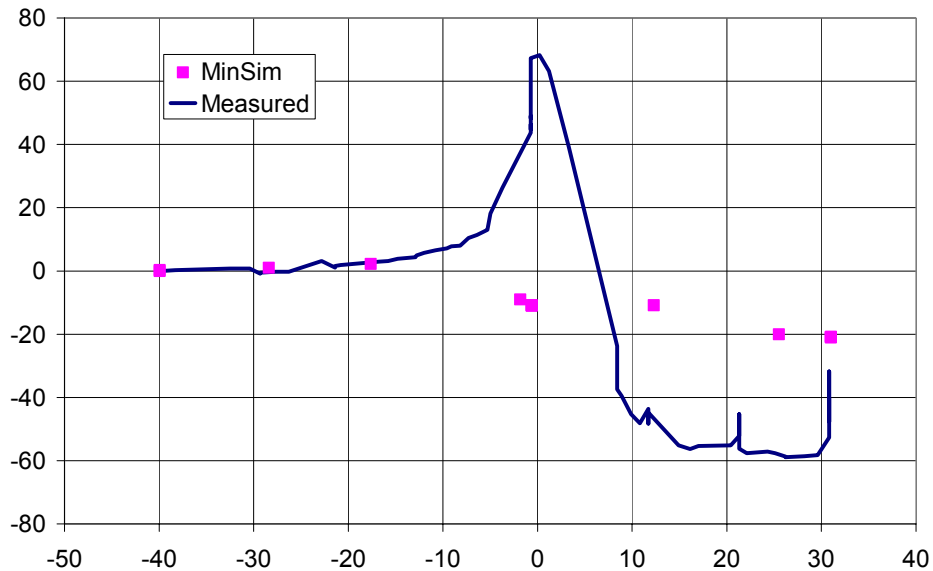
The match between the horizontal stress in the strike direction (North) is less convincing than the vertical correlation (Figure E 35). A 2D DIGS model (Napier and Hildyard, 1992) was run to observe the possible effects of beam development on horizontal stress. The model showed that high horizontal stresses can be generated near the front of a fracture that develops with the face advance due to the induced shear stresses. The profile shown in Figure E 35 is described if such a parting develops just below the measurement point.

Figure E 35 Horizontal stress change in the strike direction, 4.7 m above the centre of Panel 8s in Borehole CSIRO2. Negative face positions are behind the cell

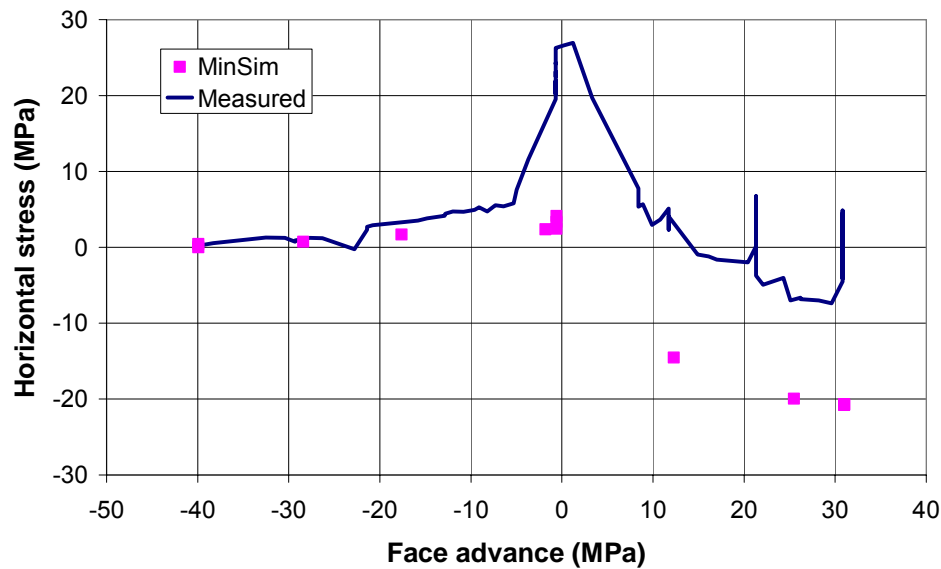
If the advancing fracture and associated shear stress is the reason for the relatively high horizontal stress measured in the strike direction, the stress change in the dip direction would not be directly affected by the assumed shear stress. However, there is a Poisson effect that could explain the higher measured than modelled stresses shown in Figure E 36. The reason for the relatively small drop after the peak stress is not understood. However, the slopes of the unload portion of the measured and modelled curves are similar.

Figure E 36 Horizontal stress change in the dip direction, 4.7 m above the centre of Panel 8s in Borehole CSIRO2. Negative face positions are behind the cell

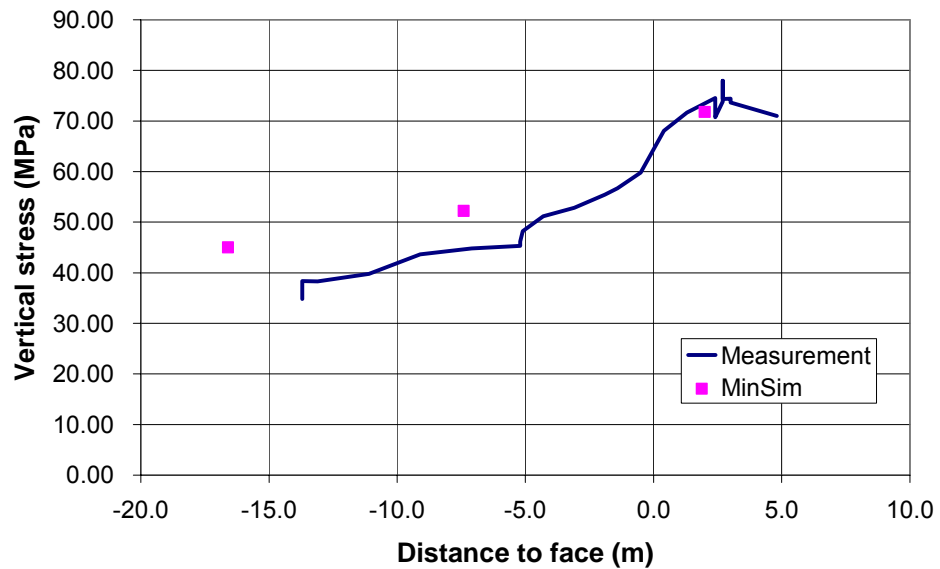
Figure E 38 Vertical stress change 5.28 m above the pillar in Borehole P1. Negative face positions are behind the cell

Stress change measurements were also conducted in the hangingwall over three pillars in Boreholes: CSIRO1, P1 and P3. The pre-failure vertical stresses are shown in Figure E 37, Figure E 38 and Figure E 39. In every case there is a reasonably good correlation with the elastic models when the measurements were evaluated using the matrix elastic moduli of the rock in which the cells were located. The horizontal stresses measured on the down-dip side of the pillars (P1 and P2) also correlated well with elastic models (Figure E 40 and Figure E 41). However, this was not true of the measurements in Borehole CSIRO1 (Figure E 42). A better match was achieved when the measurements were compared to modelled stresses that were closer to the pillar. The horizontal stress at this position appears to be sensitive to the stress condition of adjacent pillars and the mismatch may be an artefact of incorrectly assigning these stresses in the model. The stress condition over the pillar may also have been affected by vertical discontinuities and fractures as shown by the stress channelling effects of these discontinuities in an ELFEN model (Figure E 43). Vertical stress fractures were observed in shallow dipping boreholes drilled closer than 1.2 m above the pillars, but no evidence of stress fractures were found higher than this.

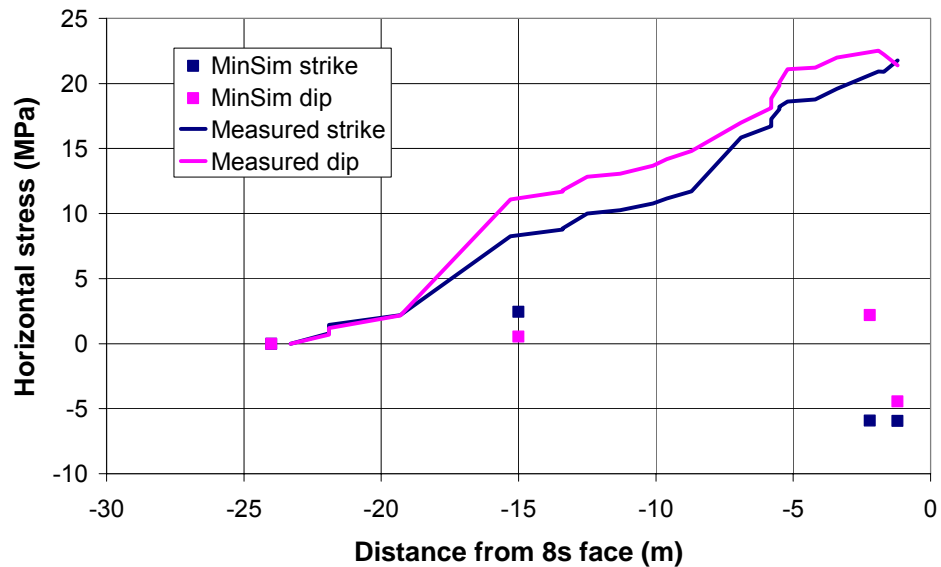
Figure E 42 Horizontal stress change 4.2 m above Pillar 2 in Borehole CSIRO1. Negative face positions are behind the cell

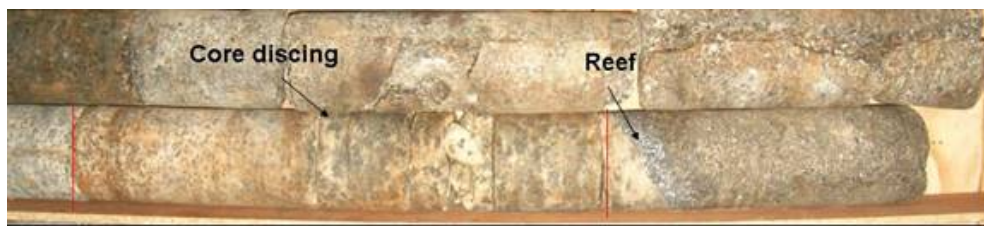
Only one steeply dipping discontinuity was observed in the footwall core of Borehole CSIRO1, at about 1.3 m below the stope. High horizontal stresses were evident from core discing in the immediate footwall (spotted anorthosite) and mottled anorthosite in the stope area (Figure E 57). A k-ratio of about 1.4 was estimated from sockets in the drive. Approximately 30 m to the south, where the 17 and 17A south drives converged, significant gothic arching was observed (Figure E 58), suggesting a k-ratio of at least 1.4 on this elevation.

Figure E 57 Core discing observed in the F/W anorthosites

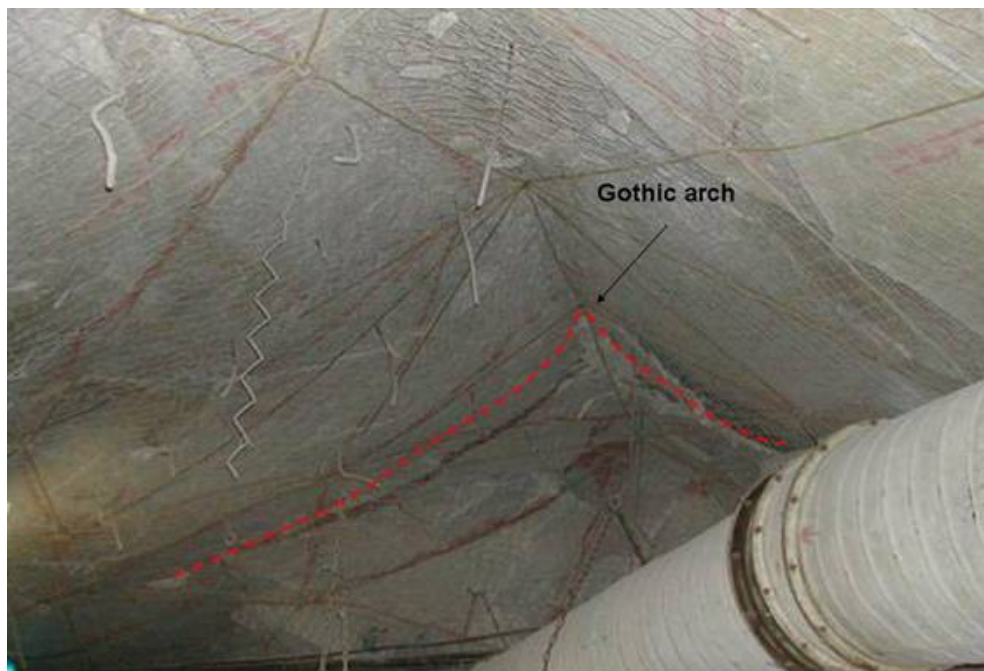
Figure E 58 Gothic arching in the 17 South Drive

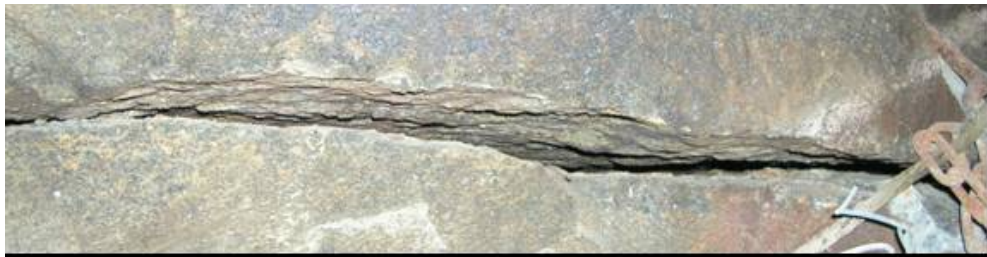
Figure E 59 Open discontinuity observed in the travelling way 1.3 m below Panel 8s

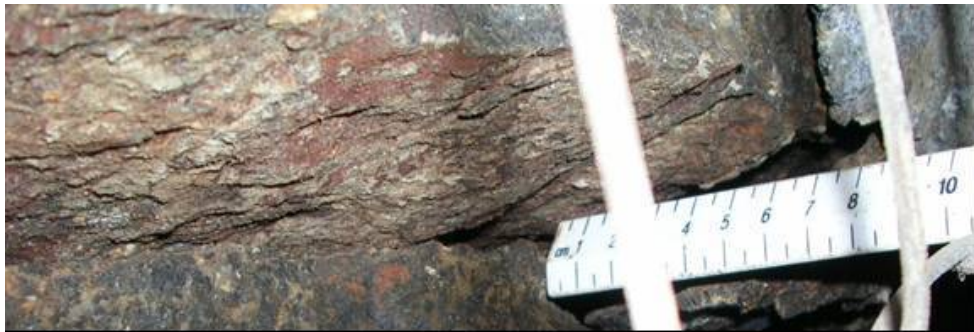
Figure E 60 Striations on the discontinuity surface, indicating a fault

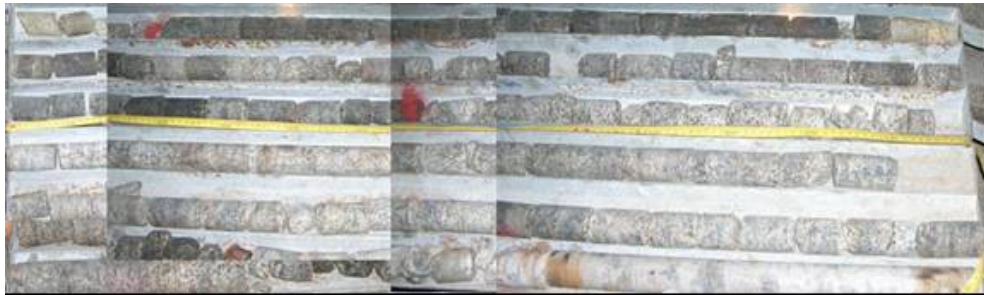
due to a worn core-spring but may have been discing, indicating high horizontal stress. Water losses were recorded during drilling, showing that there were open discontinuities prior to drilling the hole. A sudden change in lithology was observed at 1.37 m below the stope. No geological discontinuities were visible in the first 9 m and only one steeply dipping joint between 9 m and 10 m.

Figure E 61 Core from F/W1 (Figure E 56)

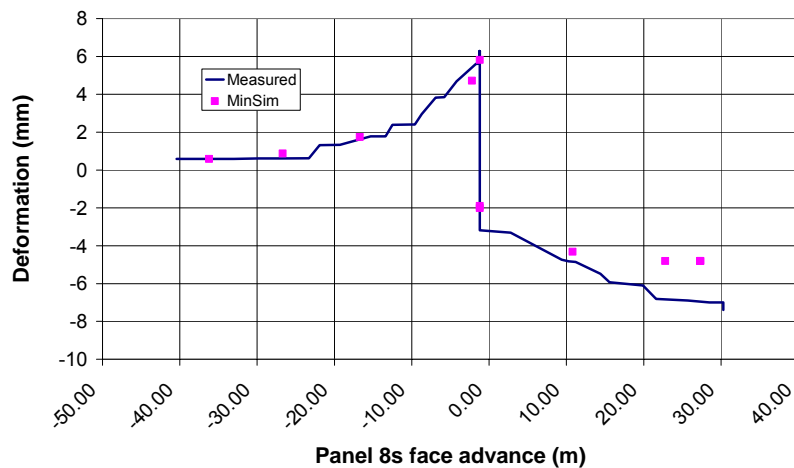
Figure E 62 Footwall extensometer below the centre of Pillar 2, plotted against the advance of the 8s face. Negative face advances represent the face position behind the instrument

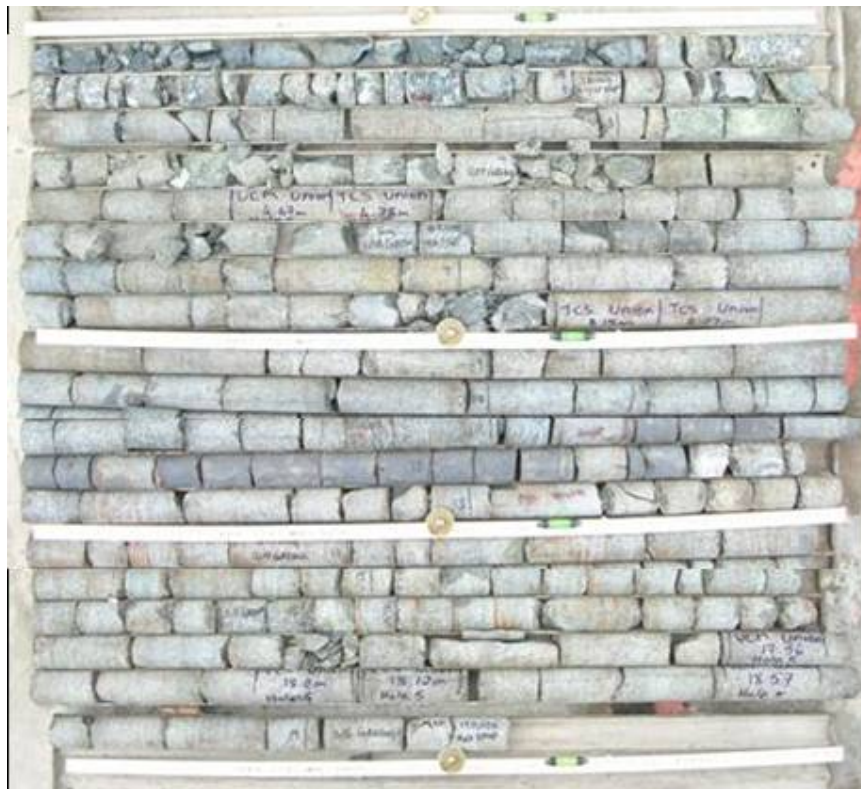
Figure E 65 Borehole core retrieved from Union Spud shaft F/W1

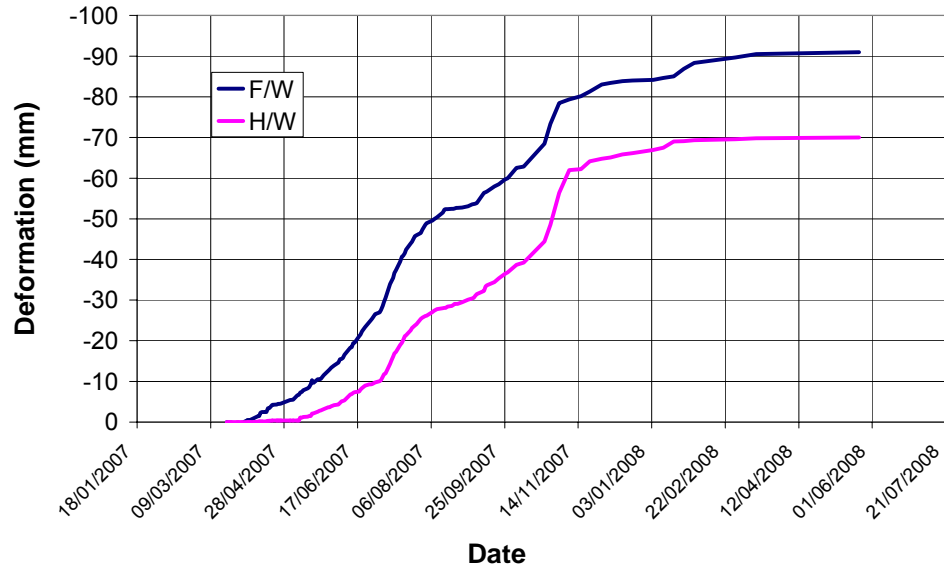
Figure E 67 Comparison between the footwall and hangingwall extensometer results
