Appendix G

Pillar behaviour

G1 Peak pillar strength evaluation procedures

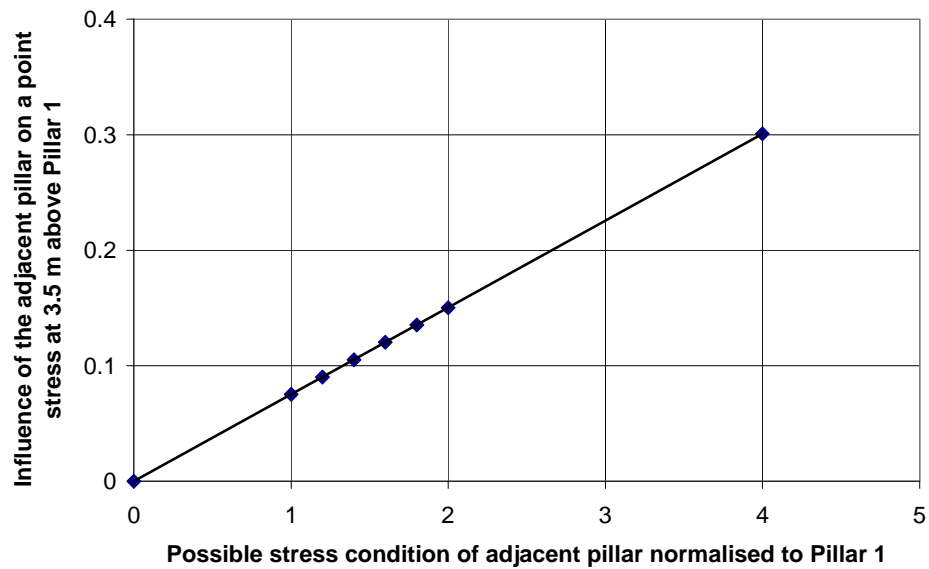
Figure G 4 Effect of adjacent pillars on P1 measurements

shown in Figure G 4. The likely error if the adjacent pillar has not failed is about 15% and this would only affect post-peak results, i.e. the slope of the stress-strain curve. The influences of these pillars were subtracted from the results using the procedure described in Figure G 2. The relative closeness of the measurement point above Amandelbul P1 (3.5 m above the pillar) introduces other errors though, associated with potential stress profiles across the pillar. A range of between an overestimate of 25 per cent before failure to an underestimation of 49 per cent in the post failure region is shown in Table G 1 and Figure G 5. Some of the investigated scenarios are extreme and unlikely and a more probable range is between 12 per cent and 24 per cent for the pre and post failure scenarios respectively. The likely errors in the post failure measurements are shown between the dashed lines in Figure G 5. Note that the pre-failure measurement is likely to be overestimated while the post-failure results could be underestimated.

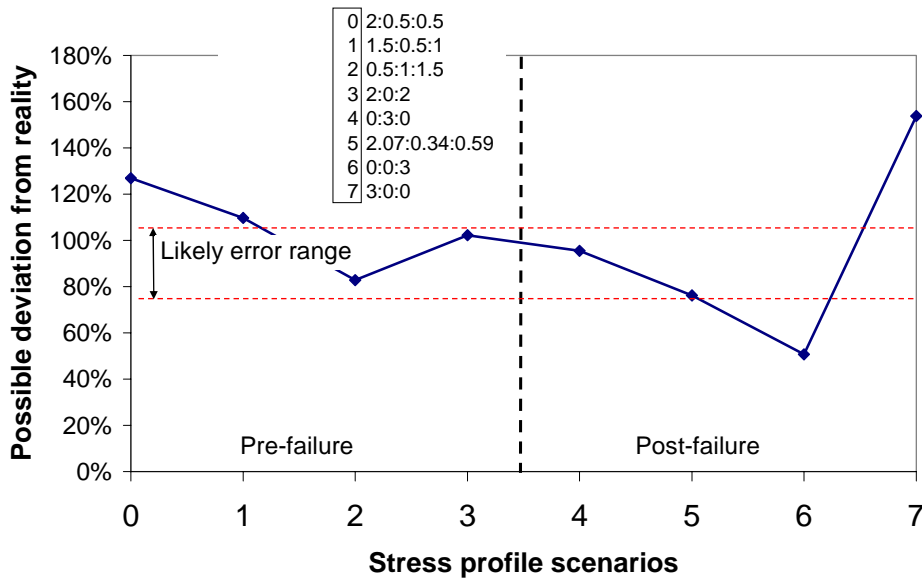
Figure G 5 Synopsis of potential errors associated with stress profiles across P1

Table G 1 Errors associated with possible stress profiles across P1

Stress condition	Profile number (used in Error! Reference source not found.)	Stress profile across Pillar 1 normalised to APS (wide to narrow end)	Percentage error
Pre-fail worst	0	1.5:1.5:0	-25%
Pre-fail likely	1	1.25:1.25:0.5	-12%
Pre-fail normal	2	2:0:2	-2%
Post-peak normal	3	0:3:0	4%
Post-peak measured	4	2.07:0.34:0.59	24%
Post-peak worst	5	0:0:3	49%

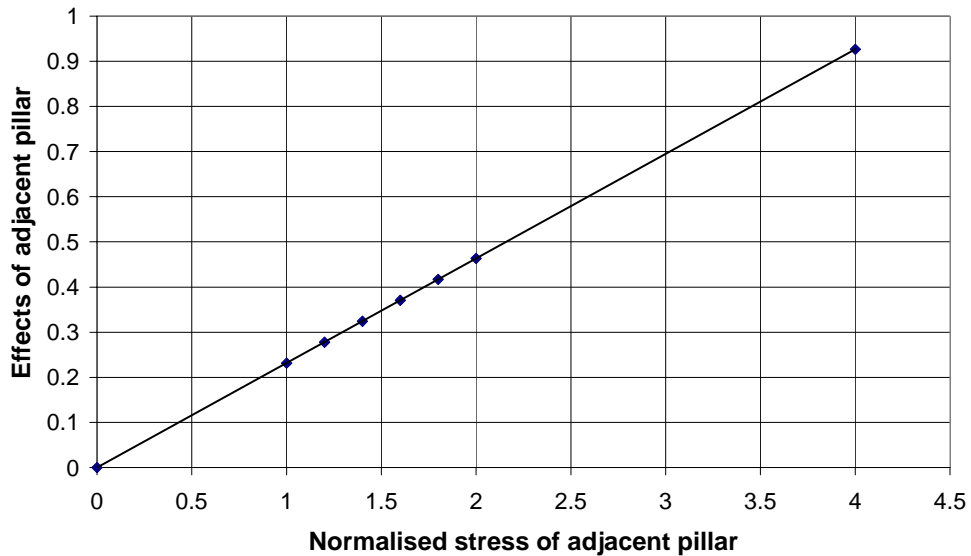
Figure G 6 Effect of adjacent pillars on P2 measurements

The evaluations conducted on Amandelbult P2 at a height of 6.5 m showed that the effects of adjacent pillars on the measurements were significant as illustrated in Figure G 6. A sensitivity analysis indicated errors of up to 43 per cent if it is assumed that an adjacent pillar was carrying double the stress of the monitored pillar. The procedure described in Figure G 2 allowed the identification and removal of the face effects and therefore the analysis of the peak strength. However, the post failure stress drop results are uncertain and the analyses of the data assume equal residual strength on the adjacent pillars. This assumption appears reasonable as visually the pillars were similar and about the same size and shape. The errors associated with the possible stress profiles across the pillar (Table G 2) were much less than for Pillar 1, and the likely range shown in Figure G 7 indicates a possible overestimate of about 6 per cent.

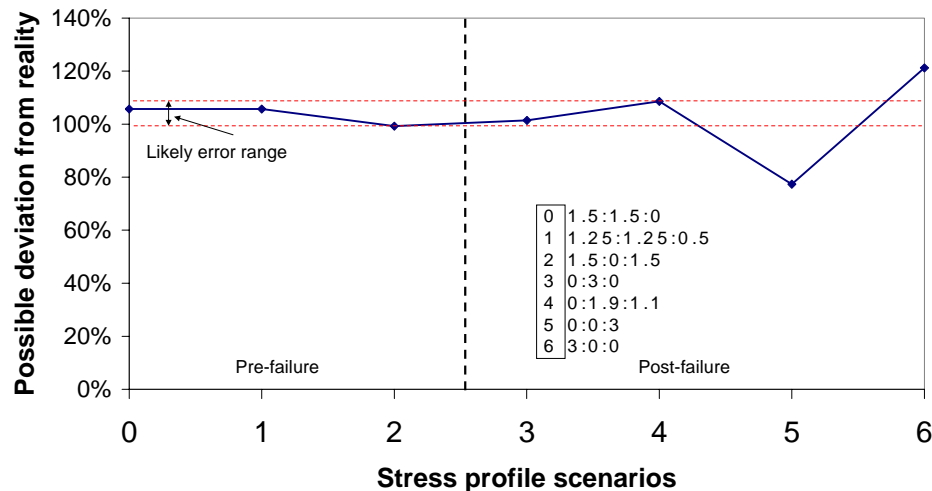
Figure G 7 Synopsis of potential errors associated with stress profiles across P2

Table G 2 Errors associated with possible stress profiles across P2

Stress condition	Profile number (used in Error! Reference source not found.)	Stress profile across Pillar 2 normalised to APS (wide to narrow end)	Percentage error
Pre-fail worst	0	1.5:1.5:0	106
Likely	1	1.25:1.25:0.5	106
Pre-failure	2	1.5:0:1.5	99
Peak middle	3	0:3:0	101
Measured	4	0:1.9:1.1	109
Peak wide end	5	0:0:3	77
Peak narrow end	6	3:0:0	121

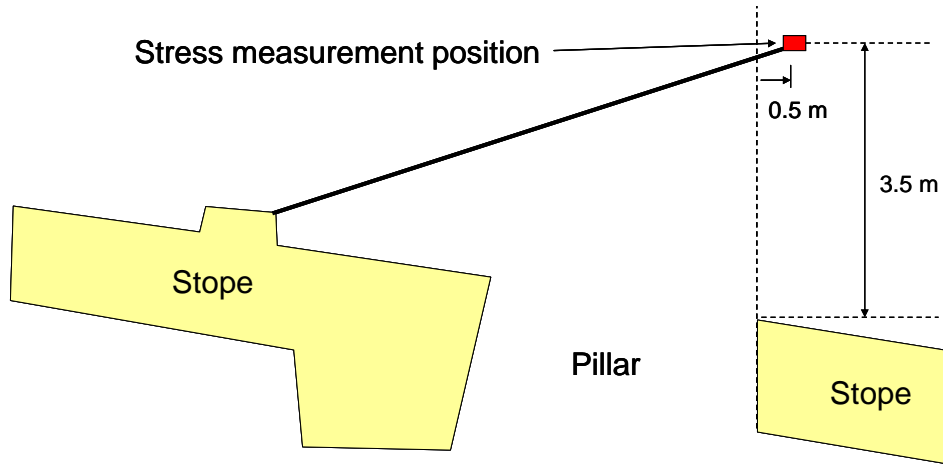
Figure G 10 Section showing the instrumentation position above Amandelbult P1

A section and plan view showing the orientation of the instrument installed over P1 is shown in Figure G 10 and Figure G 11, respectively.

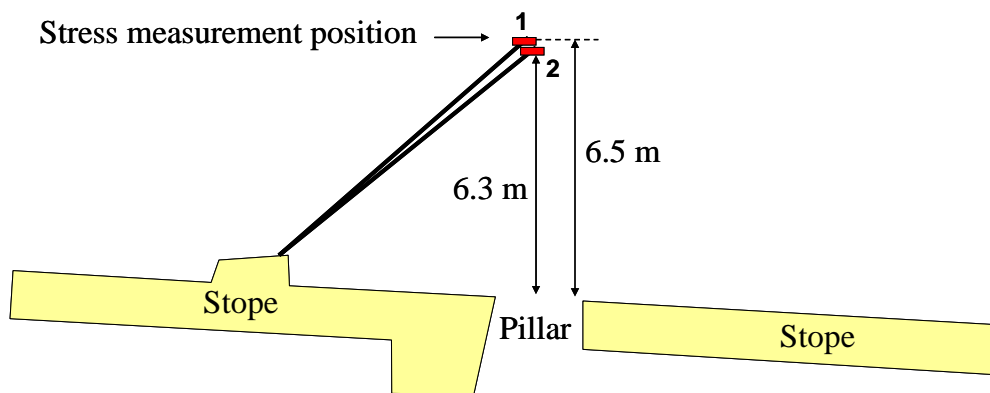
Figure G 14 Section showing the instrumentation position above P2

Two stress change cells were installed above P2. A 3D CSIRO cell was mounted at a height of 6.5 m (1 in Figure G 14 and Figure G 15) and 1.3 m ahead of the down-dip face, i.e. prior to pillar formation (Figure G 15). The other instrument was a 2D doorstopper, mounted at a height of 6.3 m above the pillar, and 0.82 m behind the down-dip face (2 in Figure G 14 and Figure G 15). The face position at the installation of this cell is shown by the dotted line in Figure G 15. A 2D field stress measurement was performed just behind the final cell position and this result was used in the back analysis of the P2 average pillar stress (APS).

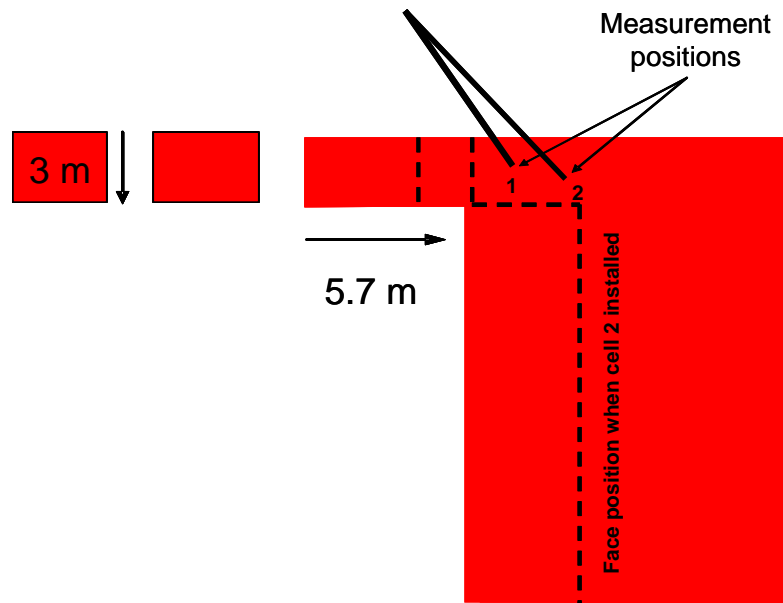
Figure G 15 Plan view of the cell installations over P2

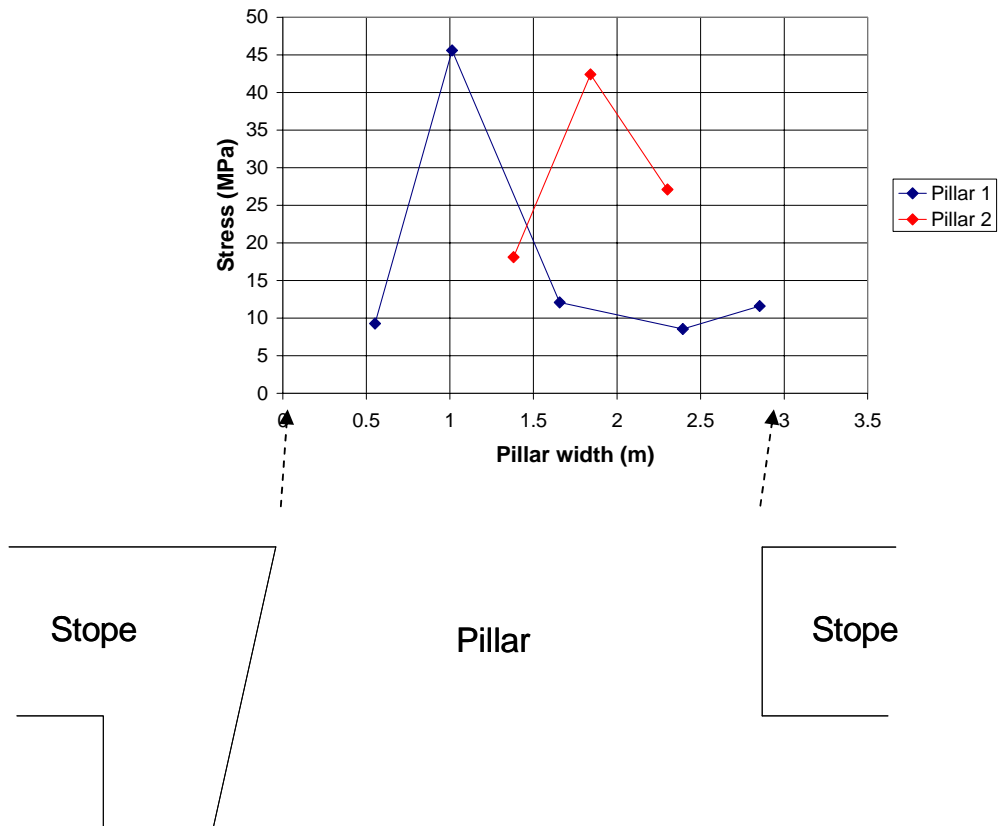
Figure G 19 Stress profile across two failed pillars (not corrected for measurement height) and a sketch of a 3 m wide pillar

Most of the residual stress measurements were made using 2D doorstopper instruments. The results reflect stresses in the plane of the pillar long-axis in the sub-vertical and horizontal directions (Figure G 18). Only the sub-vertical stresses are shown in Figure G 19.

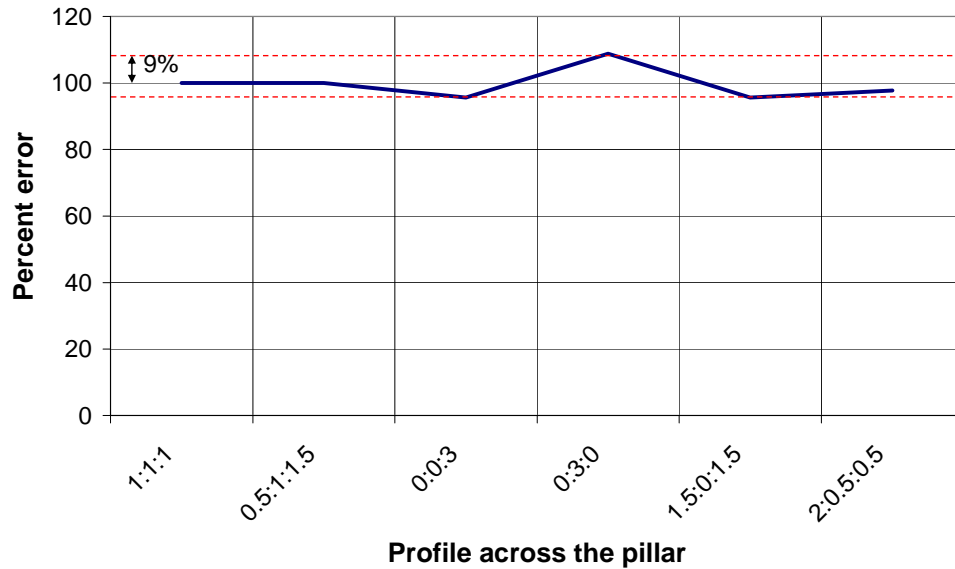
Figure G 26 Synopsis of potential errors associated with stress profiles across Impala P2

The errors due to the most likely stress profiles across the pillar on the measurement point are shown in Figure G 26. A maximum error of 9% is indicated.

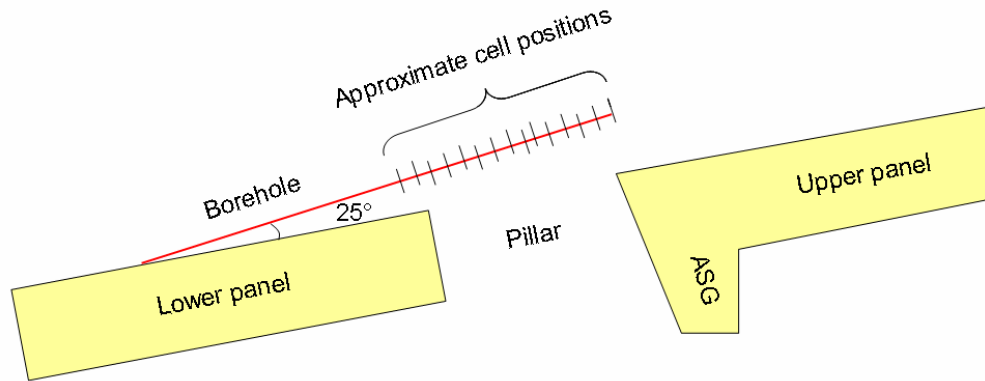
Figure G 28 Section showing the asymmetric shape of Impala P1 and the approximate stress cell positions in Borehole P1a (not to scale)

The final pillar size was approximately 4.8 m long and 5.2 m wide with a narrow, highly fractured strip on one side. A series of field stress measurements were conducted in two shallow dipping boreholes (~15° steeper than the reef) drilled about 1.9 m and 3.6 m above the centre of the pillar. A section through the pillar is provided in Figure G 28 to show the approximate measurement positions of the lower borehole. The upper borehole had a similar dip but was collared further back from the pillar.

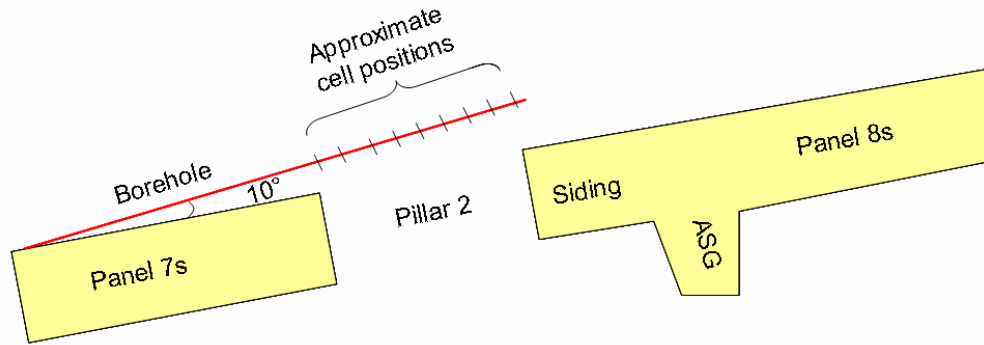
Figure G 30 Section showing Impala P2 with the approximate stress cell positions in Borehole P1a (not to scale). P2b was parallel to P2A

Two parallel boreholes were drilled at 10° to the strata to measure the field stress conditions at close intervals (Figure G 30). The boreholes collared at the same distance from the pillar, spaced approximately 0.5 m apart. Most of the instruments measured 2D stress but a triaxial cell was installed in P2b to determine the axial stress. A third borehole was drilled at 15° to the strata and a series of eight triaxial cells were installed.

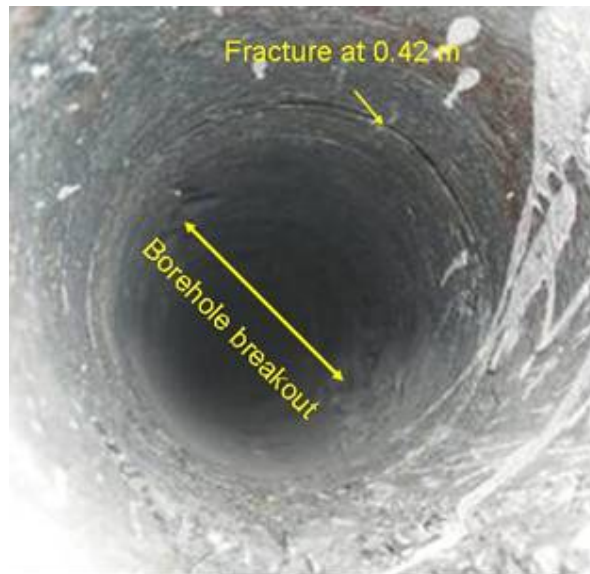
Figure G 41 Fracturing and slight borehole breakout observed in the Union P1 sidewall inspection borehole, drilled adjacent to the extensometer

The borehole breakout shown in Figure G 41 was observed in the inspection hole prior to any mining in the stope (Figure G 35). The high angle of 42° suggests an unexpected orientation of the major principal stress in the plane normal to the borehole axis. The orientation of the breakout in the extensometer borehole, located 0.42 m down-dip of the inspection hole, was oriented at 26° in the opposite direction, i.e. 68° to each other. The borehole breakout in the extensometer borehole suggested that the major stress was almost normal to the reef at this position. The abrupt change in orientation of the major stress

highlights the difficulties of determining the pillar stress from stress measurements at the Union site.
