# **The environmentally assisted cracking of Ru enriched laser alloyed surface layers on 304L stainless steel**

A dissertation submitted to the Faculty of Engineering, University of the Witwatersrand, Johannesburg, in fulfilment of the requirements for the degree of Master of Science in Engineering

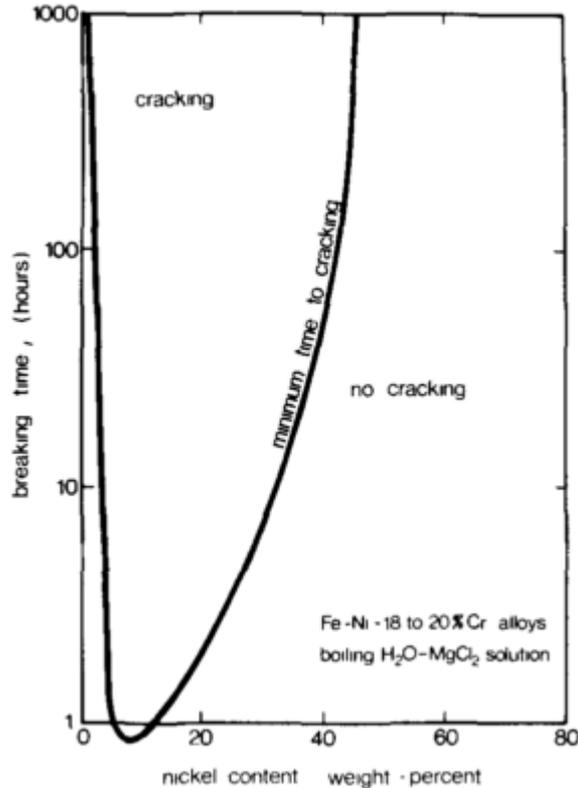
Figure 2.1: Copson's curve showing the effect of Ni on the SCC susceptibility of stainless steels in boiling 45% magnesium chloride solution (Speidel, 1981).

Nickel was first discovered in 1751 by Axel Fredrick (Cunat, 2004). The element does not play a major role in the passivation of austenitic stainless steel, but has beneficial effects in sulphuric acid environments. Nickel increases mechanical properties such as ductility, toughness and hardness. It is also used in martensitic stainless steels to improve weldability. At elevated temperatures nickel can develop oxide and precipitation hardening phases which are essential for high temperature alloys (Tabolt and Tabolt, 1998). The other benefit of Ni as an alloying element is that it does not form carbides. Nickel is primarily good for mechanical properties than corrosion resistance, it stabilises the ductile austenitic phase. According to Copson's curve (Figure 2.1), the alloys with higher Ni content are not susceptible to cracking.

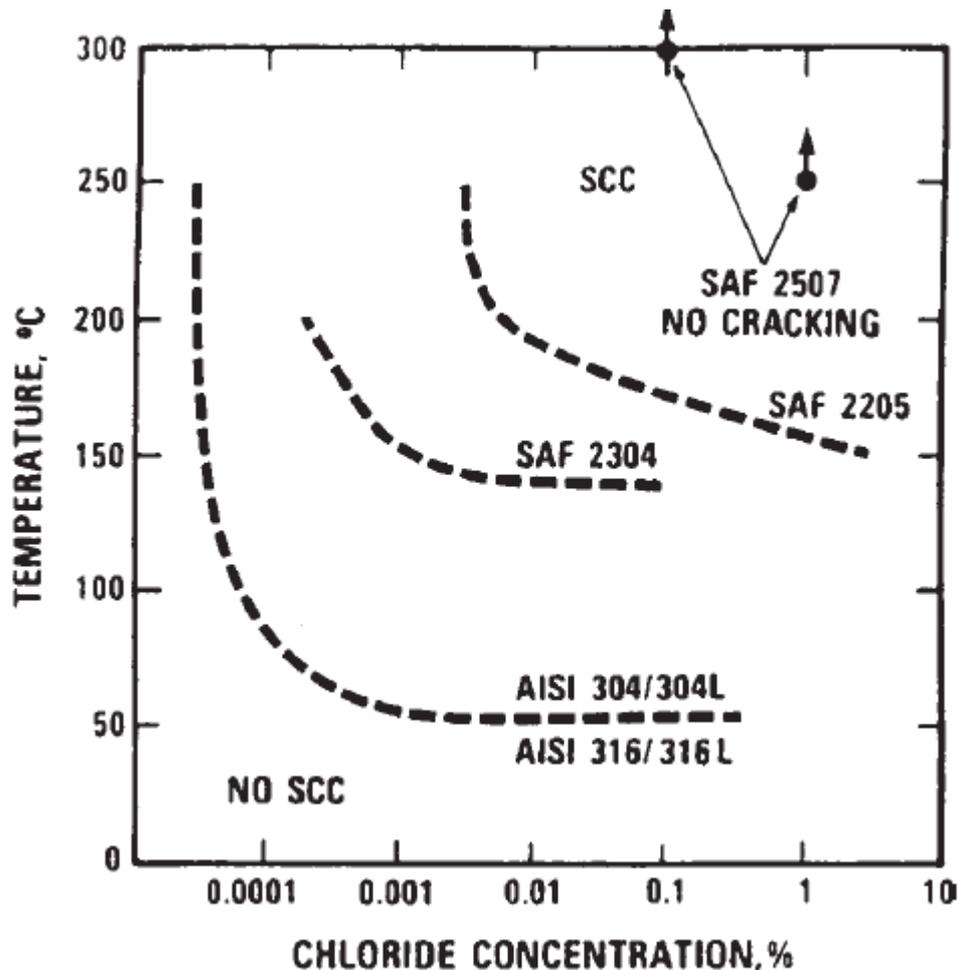
Figure 2.4: The relationship of temperature and chloride ion concentration of austenitic and duplex stainless steels (Kaneko, 2007).

The presence of chloride ions in aqueous solutions promotes SCC of austenitic stainless steels. An increase in chloride concentration will require shorter times to initiate SCC cracks (Nishimura and Maeda, 2004). It is evident that the alloys shown in Figure 2.4 will crack at higher chloride concentrations and temperatures.

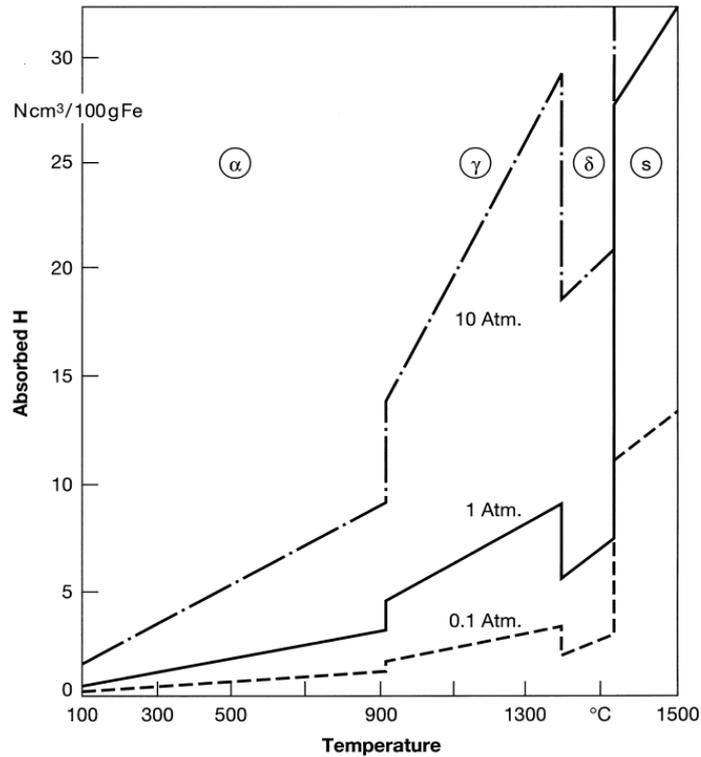
Figure 2.5: Solubility of hydrogen as a function of temperature and pressure (Woodtli and Kieselbach, 2000).

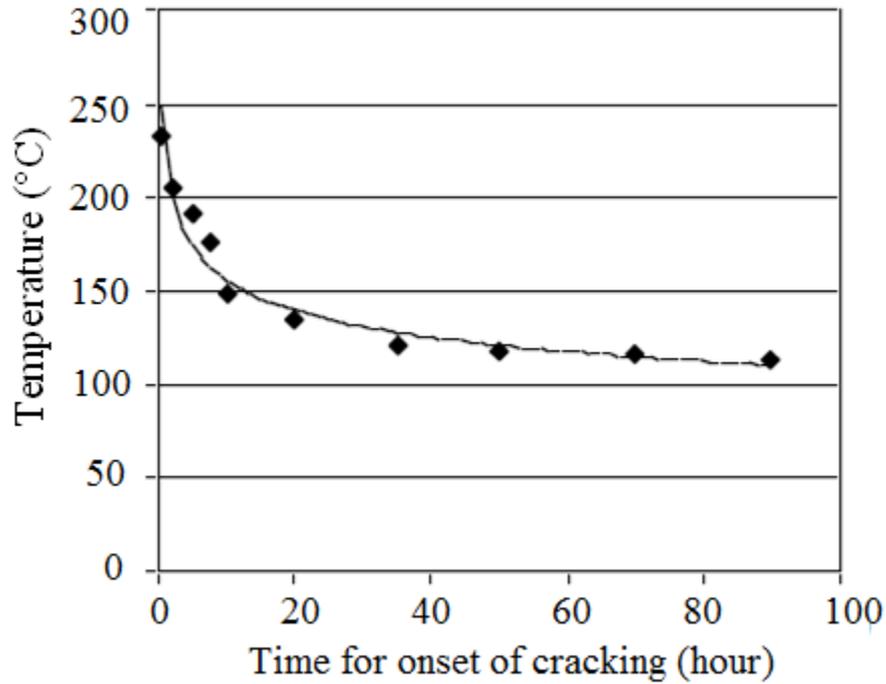
Figure 2.6: Effect of temperature on SCC of stainless steel (Fontana, 2005).

Previously it has been shown that SCC is more likely to occur at temperatures above 25°C. Zhong et al. (2017) reported increased severity (22.3%) in SCC when the temperature was increased from 40 to 60°C for austenitic stainless steels. Increased temperature also lead to fracture transformation from ductile to brittle (Zhong et al., 2017). This correlated to the study conducted by Huang et al. (2015) where both ductile and brittle fracture was observed. The other effect of temperature on SCC is that it reduces the tensile strength and elongation of the material. However, the study conducted by Alyousif and Nishimura (2006) revealed fracture transformation from TGSCC to IGSCC when temperature was decreased on austenitic stainless steels. This was due to the formation of martensite at grain boundaries. Type 304L stainless steel is susceptible to hydrogen embrittlement at temperatures below 140°C and prone to SCC at temperatures above 140°C (Alyousif and Nishimura, 2006). The crack initiation of stainless steels due to SCC occurs at approximate less than an hour at temperatures above 160°C as shown in Figure 2.6. At lower temperatures, a crack will take longer time to initiate.

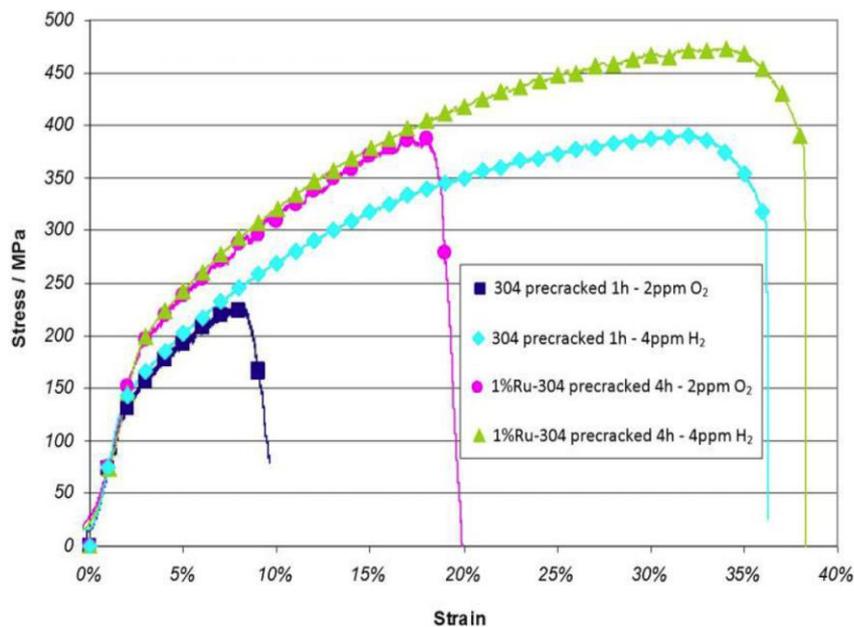
Figure 2.7: SSRT curves of 304 stainless steel in oxygenated water (Scenini et al., 2012).

The dominance of SCC in the elastic region can be confirmed by the small differences in stress-strain behaviour as shown in Figure 2.7. This was illustrated by slow strain rate tests (SSRT) and the susceptibility of alloys to SCC was reported based on the crack growth rate.

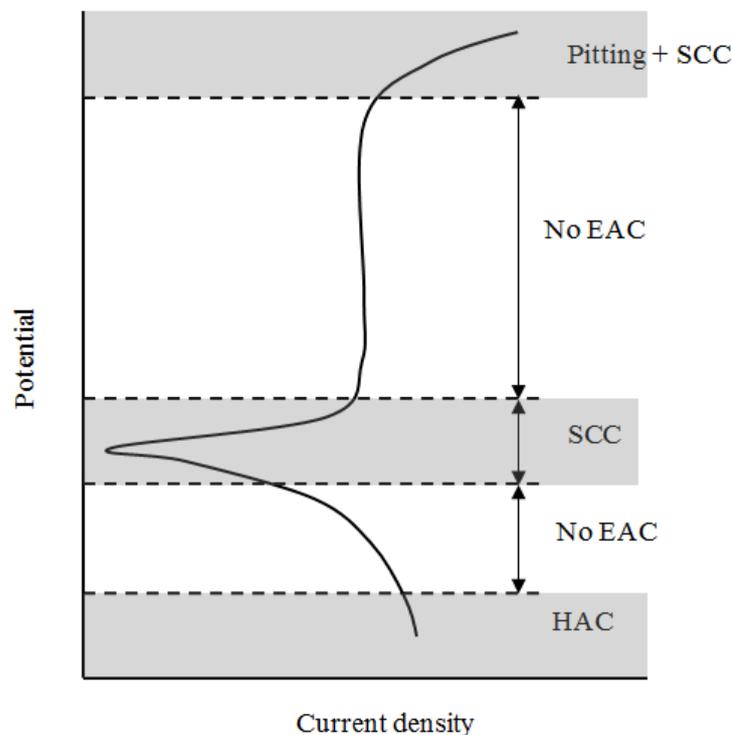
Figure 2.8: The effect of potential on EAC susceptibility of stainless steels (Redrawn from Tsai and Chou, 2000).

The susceptibility of alloys to EAC such as SCC and HE depend on the electrochemical potential. More negative potential will increase the level of hydrogen absorbed and subsequently leading to HE. The positive potentials will also increase hydrogen entry than the free corrosion potentials (Schweitzer, 2013). SCC often occurs between the active and passive regions as shown in Figure 2.8. This correlated with the work performed by Tsai and Chou (2000) where SCC of alloys was above the pitting corrosion potential. It is common that the alloy surface will be in the passive region where its crack tip is in the active or pitting region (NPL, 2016).

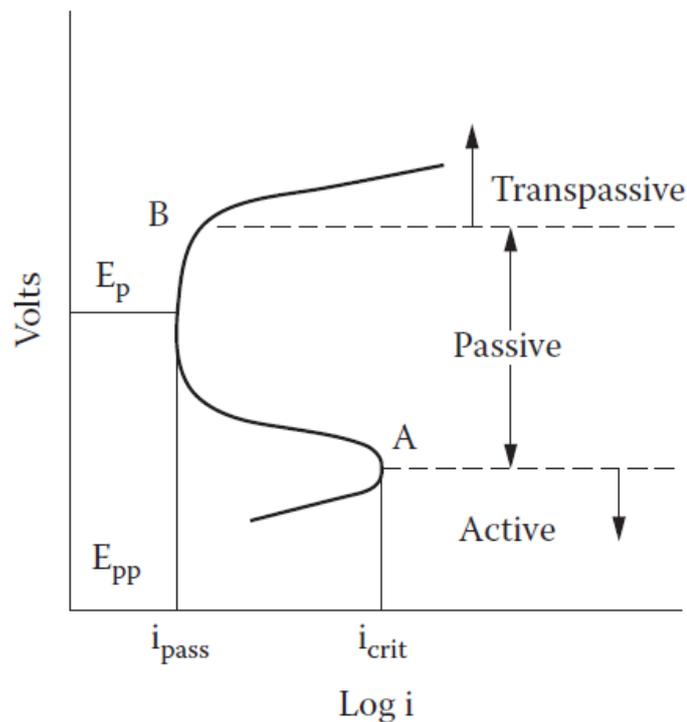
Figure 2.9: Anodic polarization characteristics of stainless steels (Schweitzer, 2013).

When the metal is freely corroding, the electrons generated at anodic areas will flow through the metal to react at cathodic areas (Tabolt and Tabolt, 1998). Corrosion of metals take place mainly due to reduction-oxidation reactions where the electrons are exchanged explicitly (Ahmad, 2006). The electrochemical reaction is often associated with the chemical transformation that implies the transfer of charges across the interface between the electrode and the electrolyte (Landolt, 2007). Polarisation characteristics can be determined experimentally by using a potentiostat and specialised computer software to acquire data and a polarisation curve as shown in Figure 2.9.

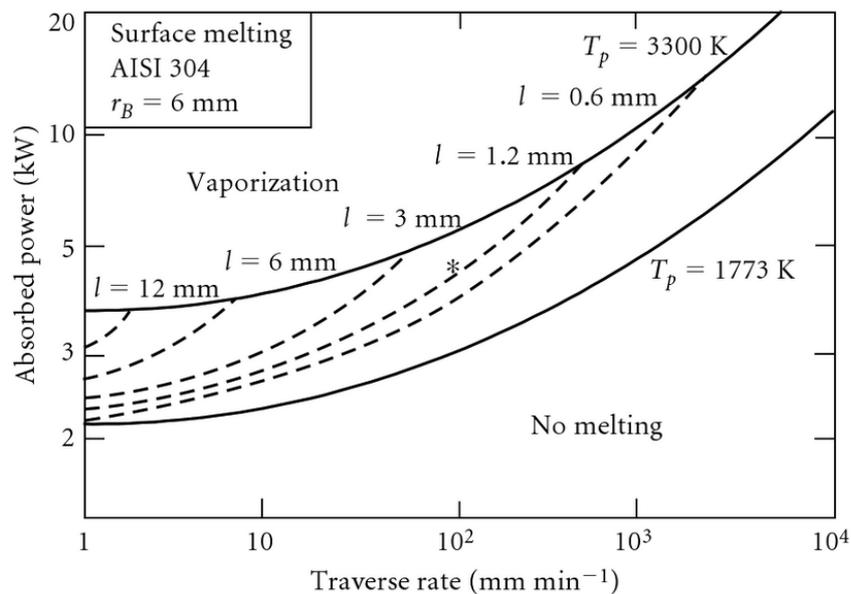
Figure 2.11: Calibrated model based of laser surface melting of AISI 304 using a beam of width 12 mm (Ion, 2005).

The important LSA parameters which can be altered are laser power, beam radius and scan speed (Kwok and Wong, 2010; Ion, 2005; Draper and Poate, 1985; Pawlowski, 1999). LSA diagrams such as the one shown in Figure 2.11 are usually used to select the parameters for the laser alloying procedure. Other parameters which cannot be controlled during laser surface process is the interaction time and cooling rate.

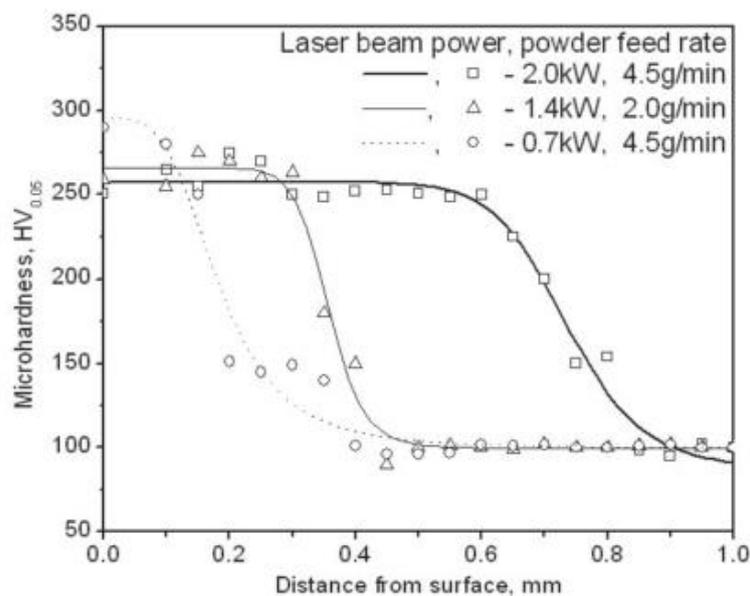
Figure 2.13: Microhardness of Cr laser alloyed 316 stainless steel at various laser beam power and powder feed rate(Brytan et al., 2010).

The work (Zhang et al., 2014; Lekala et al., 2012; Brytan et al., 2010; Kwok and Wong, 2010; Tjong et al., 1996) conducted previously has shown a significant improvement of microhardness of laser alloyed layer alloys. Figure 2.13 shows the microhardness of laser alloyed austenitic stainless steel with Cr at different laser alloying conditions of laser power and powder feed rate. The unstable data points can be attributed to various microstructures in different local areas in the alloyed layers (Tjong et al., 1996).

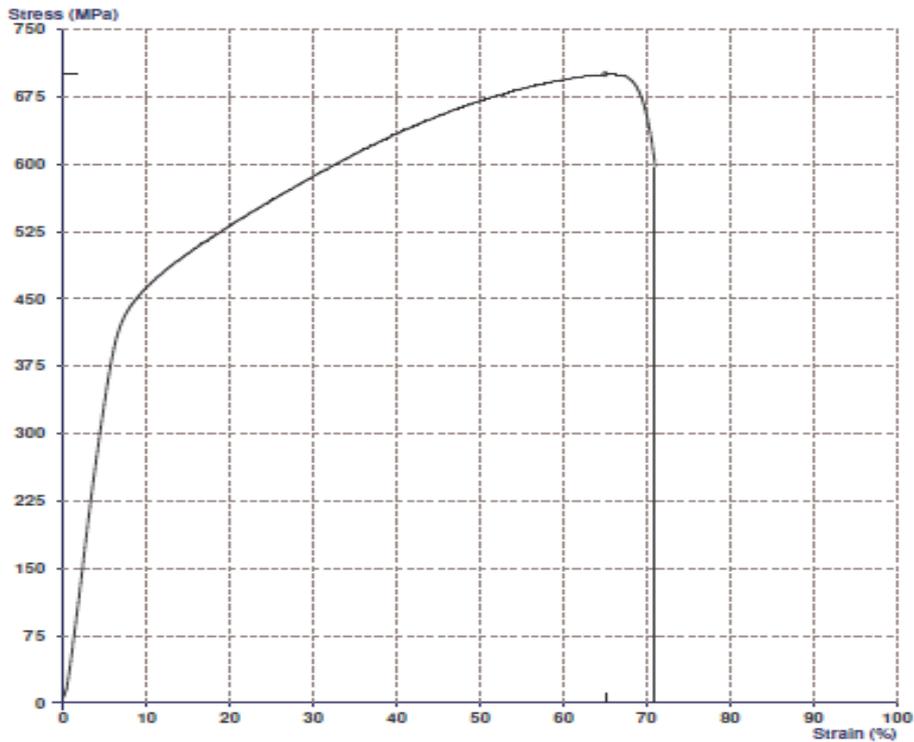
Figure 3.4: Stress- strain curve of as-received 304L stainless steel.

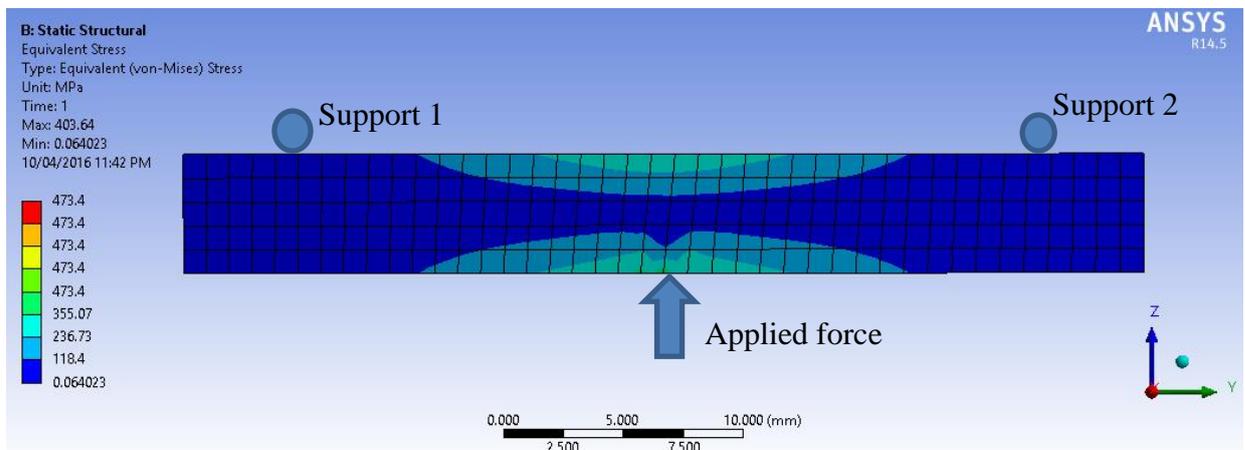
Figure 3.5: Stress distribution of 304L stainless steel stressed on a three point bend rig.

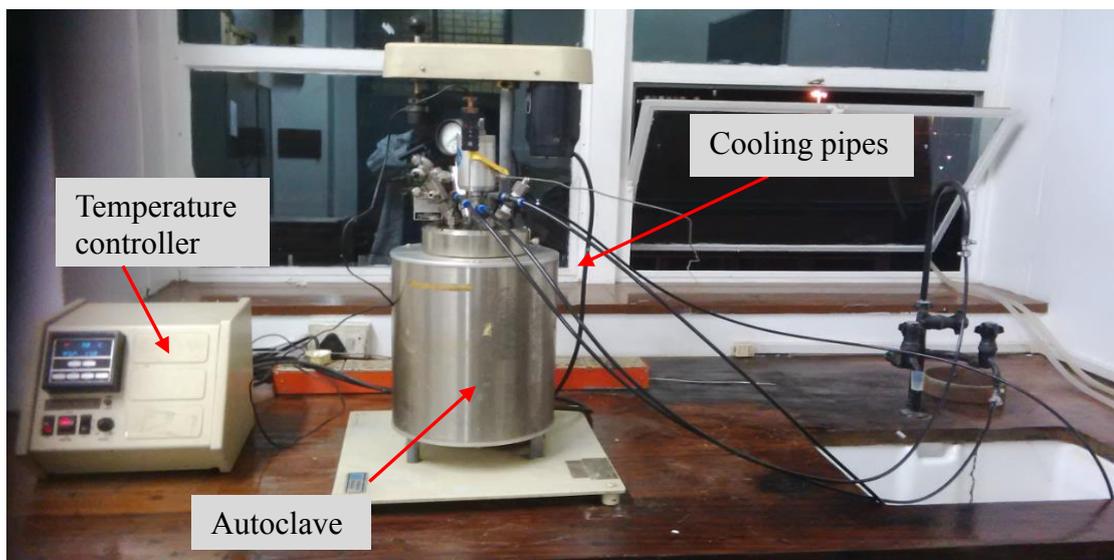
Figure 3.7: SCC Testing setup.

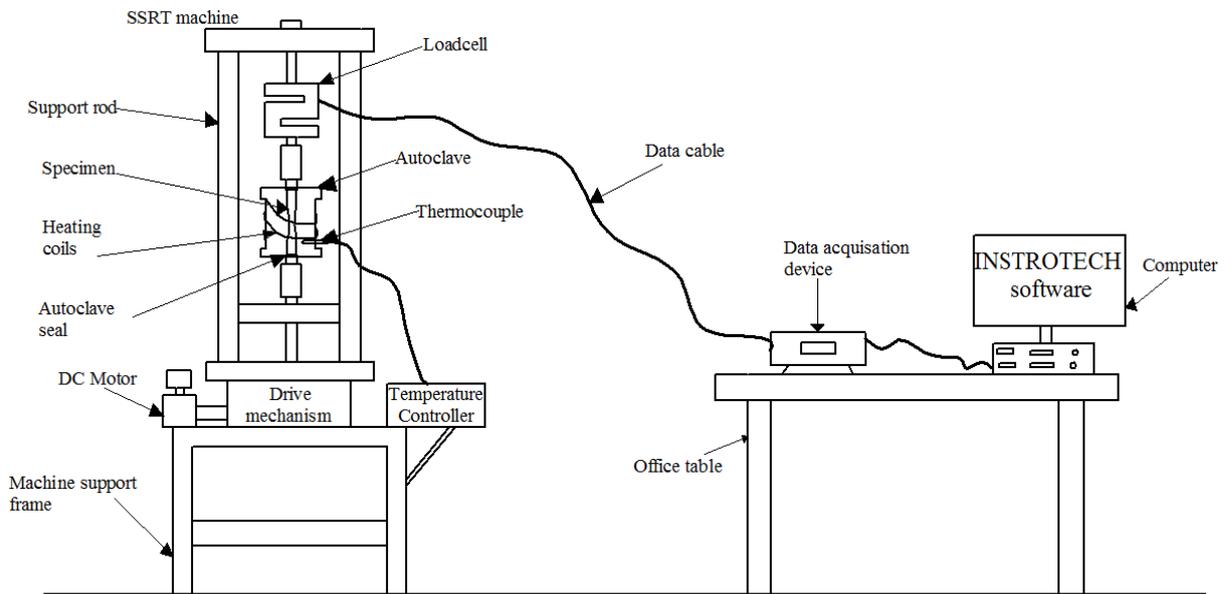
Figure 3.9: SSRT experimental setup.

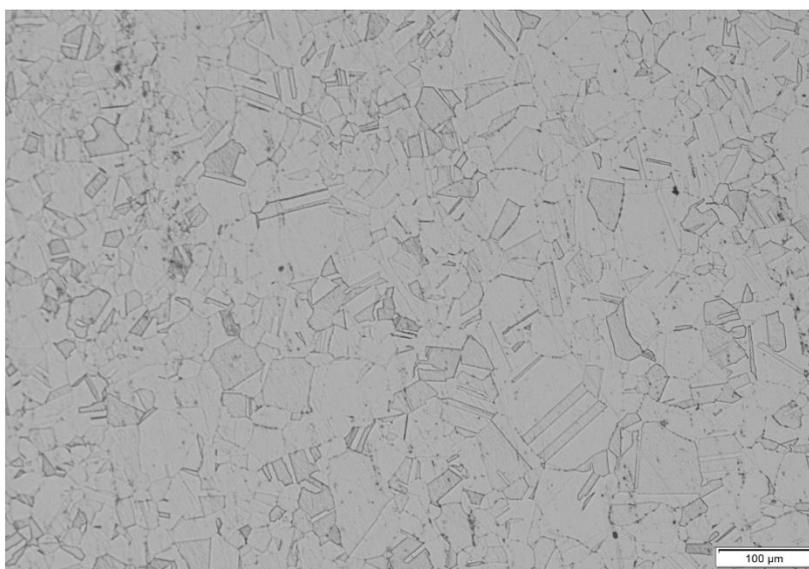
Figure 4.1: Microstructure of the as-received 304L SS etched electrochemically with 10% oxalic acid at 8 V for 60 seconds.

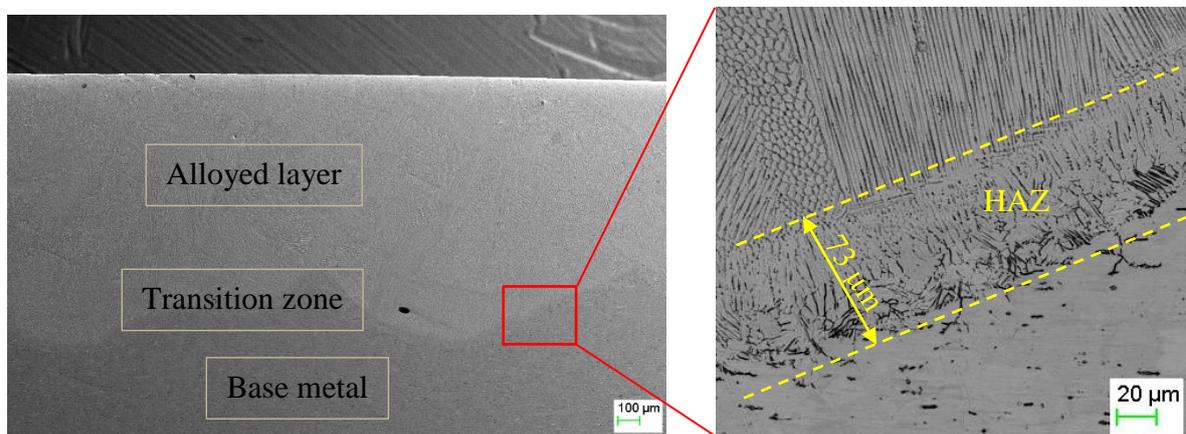
Figure 4.2: Microstructure of laser alloyed 304L stainless steel with 0 wt% Ru etched with marble's reagent and 10% oxalic acid.

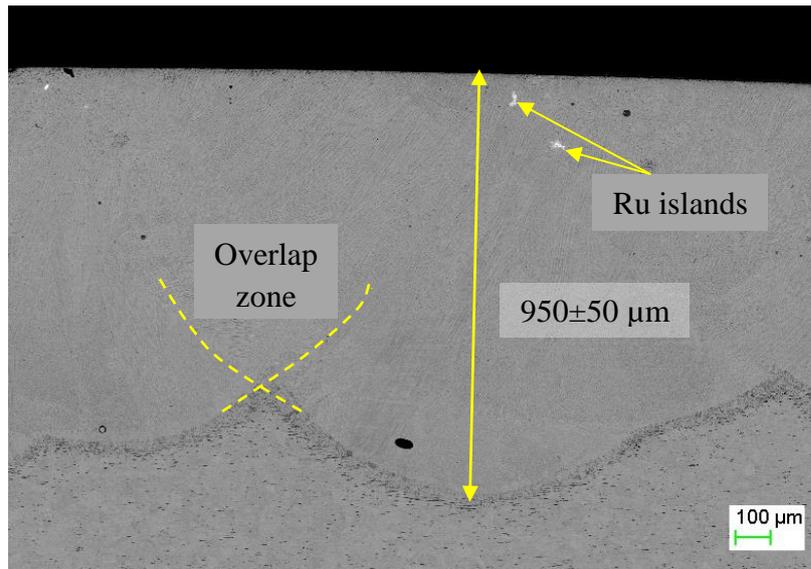
Figure 4.3: Cross-section of laser alloyed 304L stainless steel with 4.74 wt% Ru etched with marble's reagent and 10% oxalic acid.

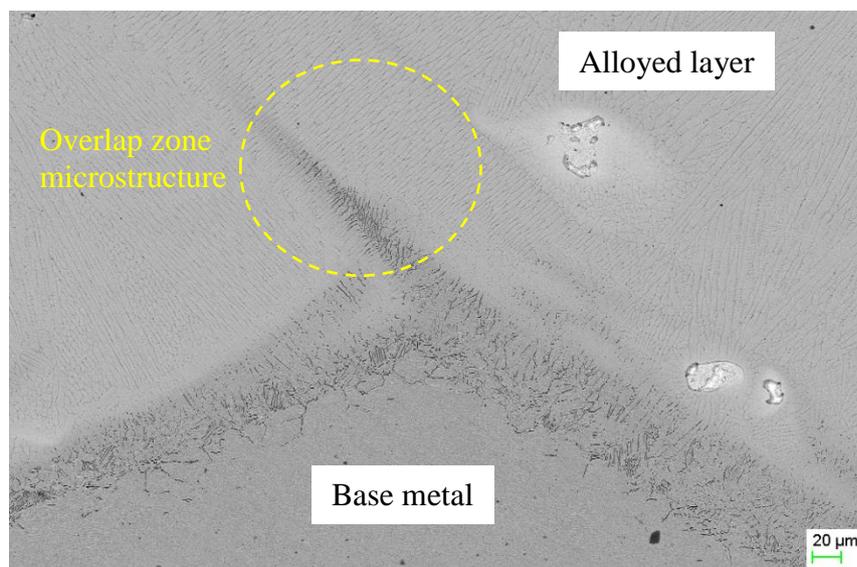
Figure 4.4: Microstructure of overlap zone of laser alloyed 304L stainless steel with 9.2 wt% Ru and etched with marble's reagent and 10% oxalic acid.

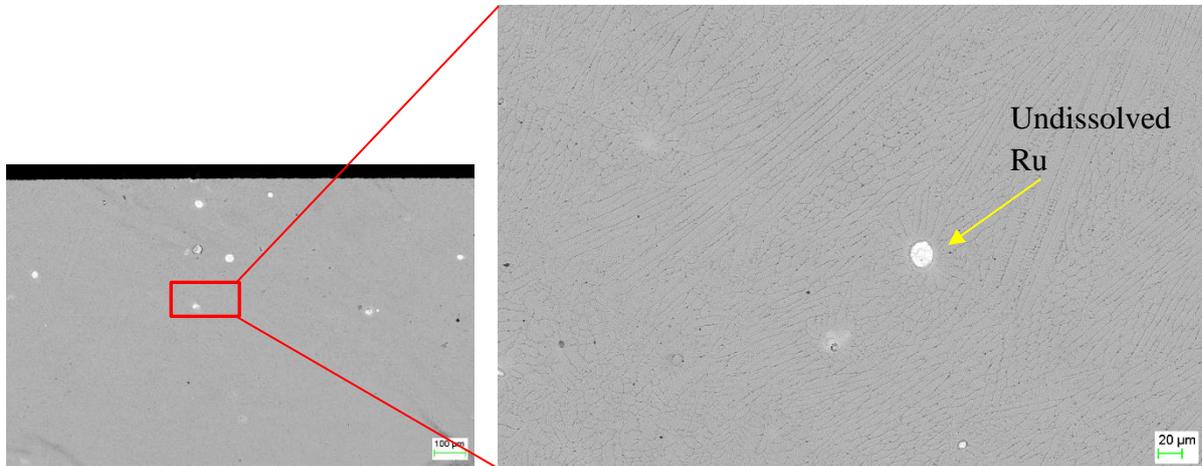
Figure 4.5: Ru islands formed on 304L SS laser alloyed layer with 9.2 wt% Ru.

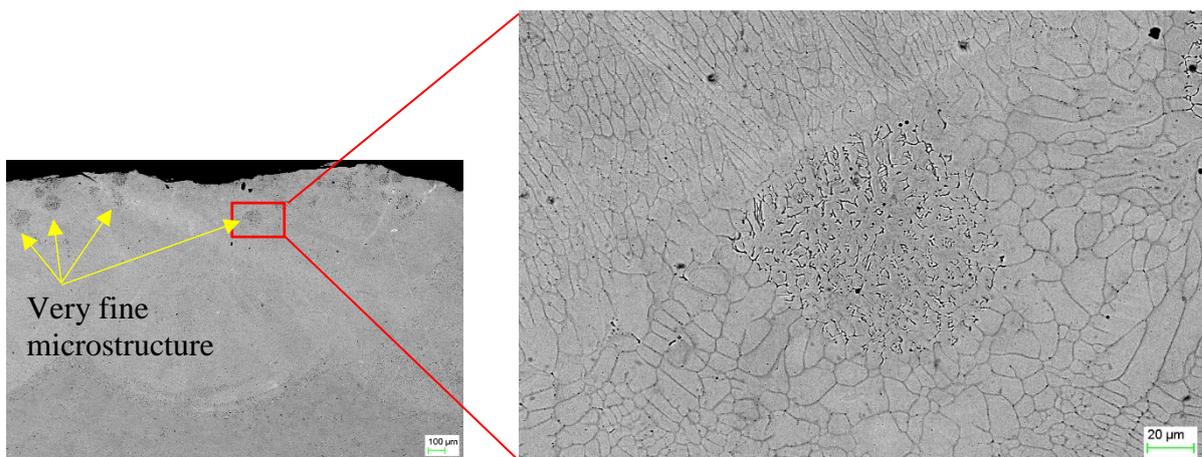
Figure 4.6: A very fine grained regions towards the top surface of laser surface alloyed 304L SS with 0.98 wt% Ru and etched with marble's reagent and 10% oxalic acid.

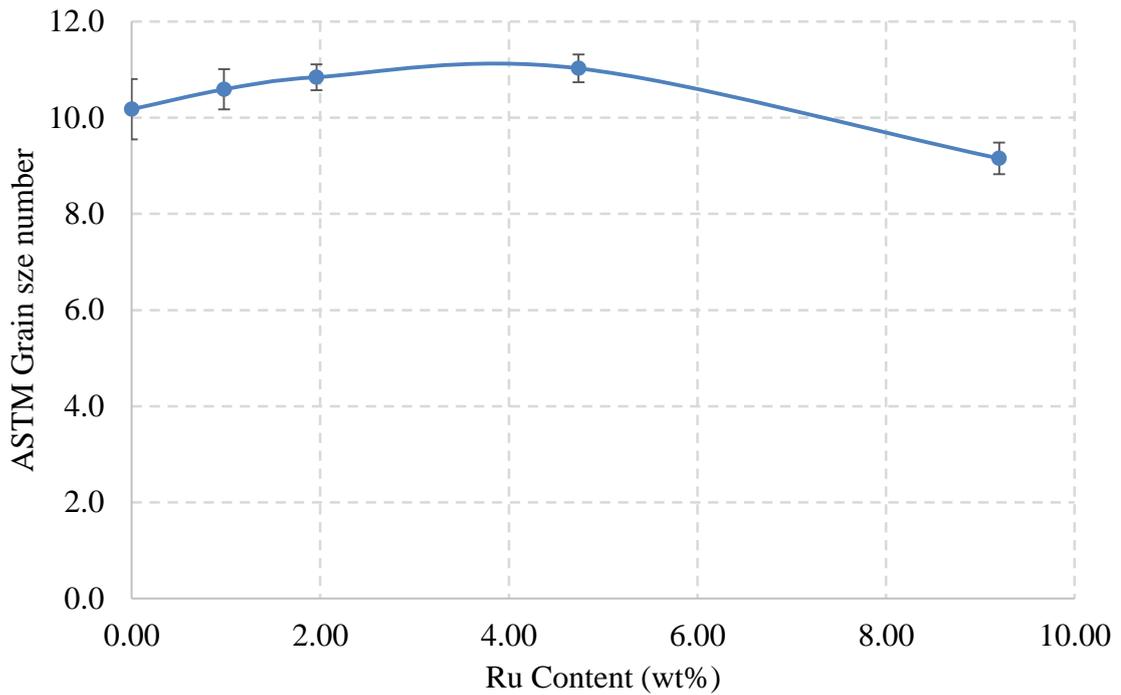
Figure 4.13: Relationship of grain size number and Ru additions on 304L stainless steel samples prepared using LSA technique.

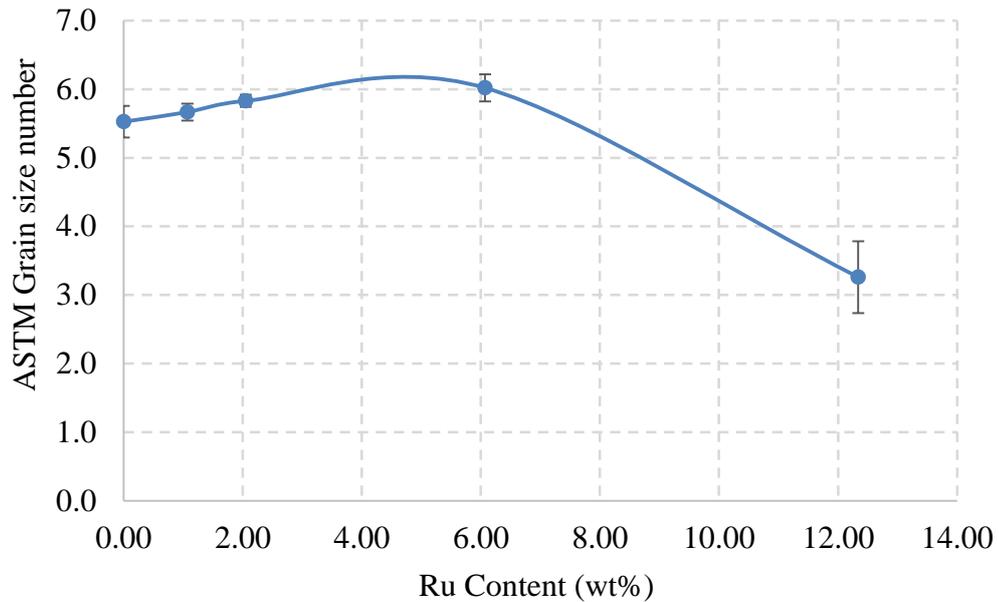
Figure 4.14: Relationship of grain size number and Ru additions on 304L stainless steel samples prepared using VAR technique.

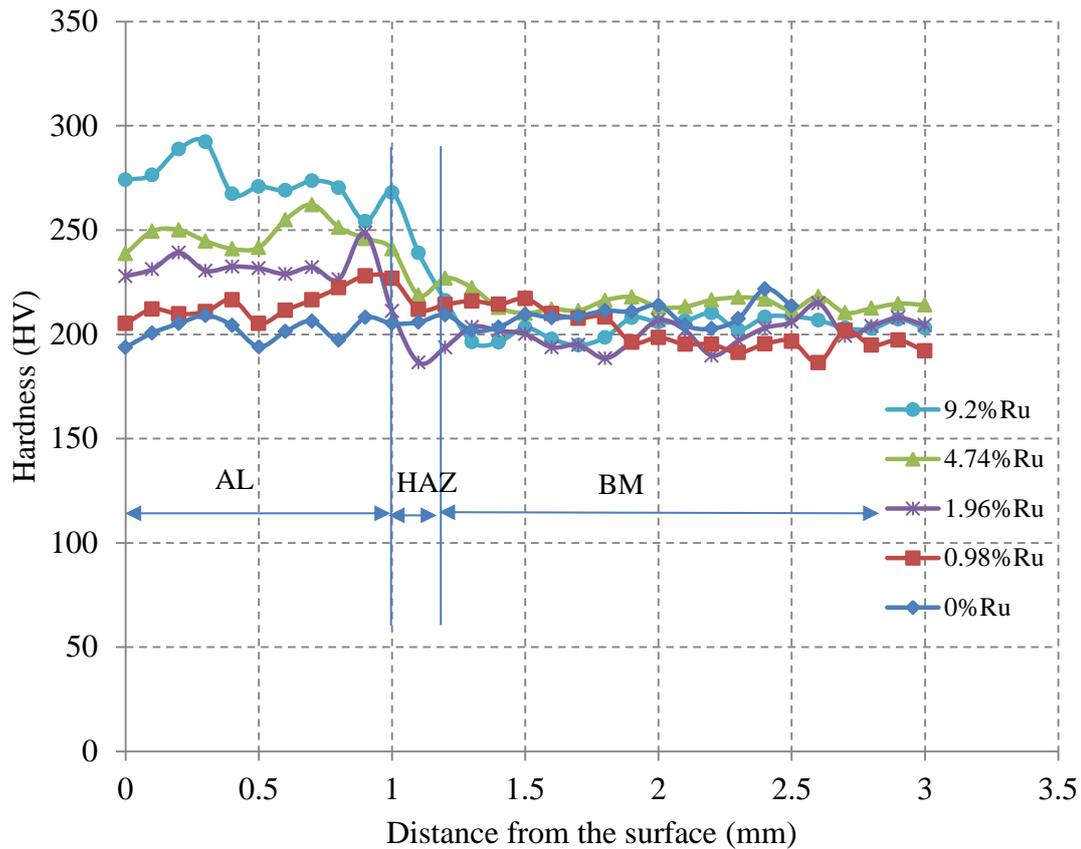
Figure 4.15: Vickers hardness profile of laser surface alloyed 304L stainless steel with Ru.

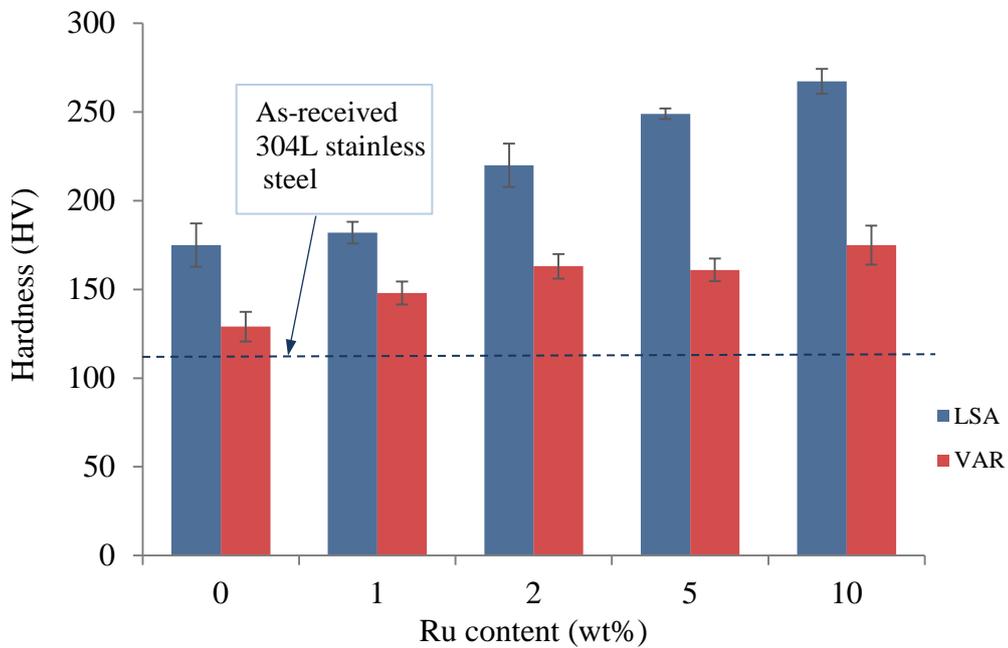
Figure 4.16: Comparison of Vickers microhardness values of alloyed 304L stainless steel with Ru.

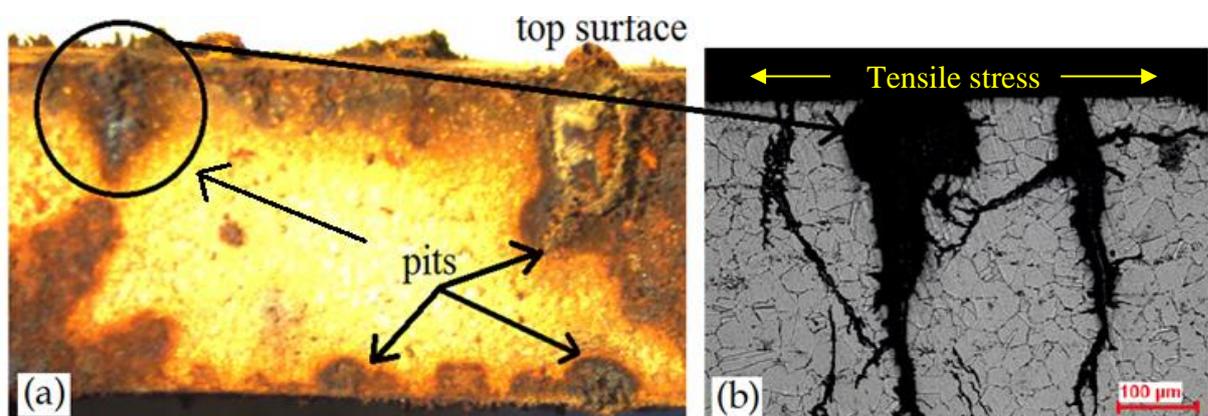
Figure 4.17: SCC cracks initiated from pits of untreated 304L stainless steel exposed in 5000 ppm NaCl solution at 160°C for 172 hours; (a) before etching (b) after etching.

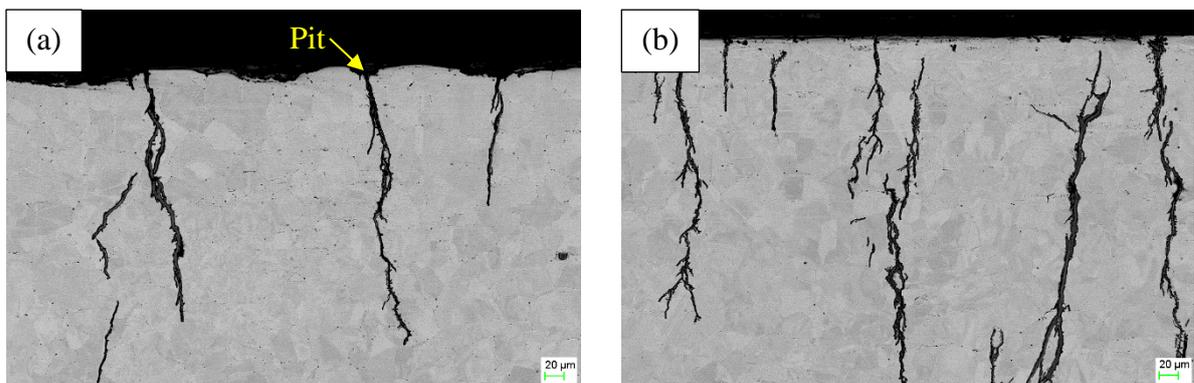
Figure 4.18: Transgranular SCC of as-received 304L stainless steel exposed to NaCl solution containing 3 ppm DO at  $160^\circ\text{C}$  for 172 hours; (a) 100 ppm  $\text{Cl}^-$  concentration (b) 500 ppm  $\text{Cl}^-$  concentration.

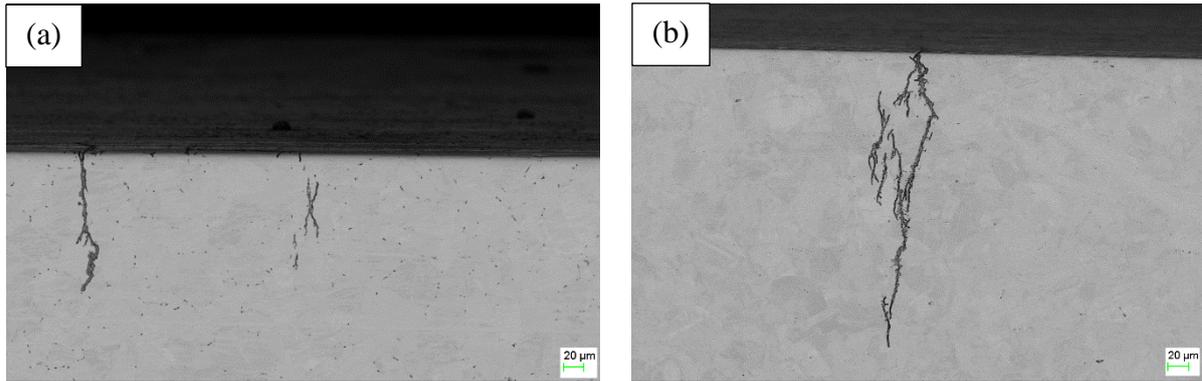
Figure 4.19: Transgranular SCC of as-received 304L SS after exposure to 10 ppm NaCl solution at 200°C for 172 hours (a) 0 ppm DO (b) 10 ppm DO.

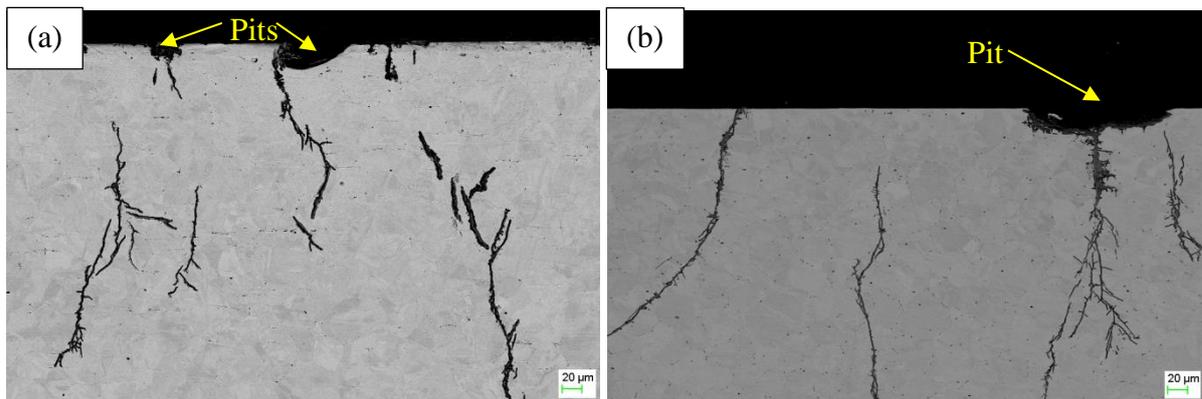
Figure 4.20: Transgranular SCC of as-received 304L SS after exposure to 50 ppm NaCl solution and 10 ppm DO for 172 hours (a) 80°C (b) 160°C.

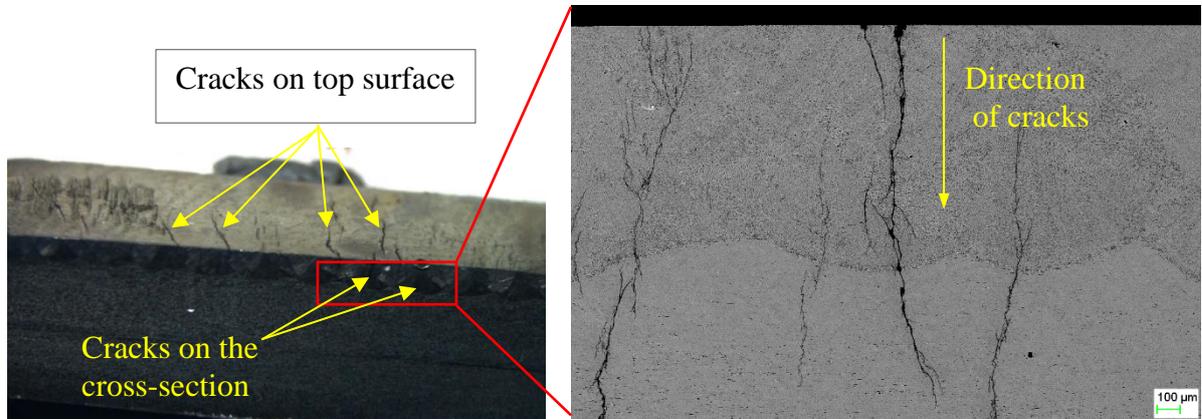
Figure 4.21: SCC cracks on the cross-section of laser alloyed 304L SS with 0 wt% Ru after exposure to 50 ppm NaCl containing 10 ppm DO at 160°C for 172 hours.

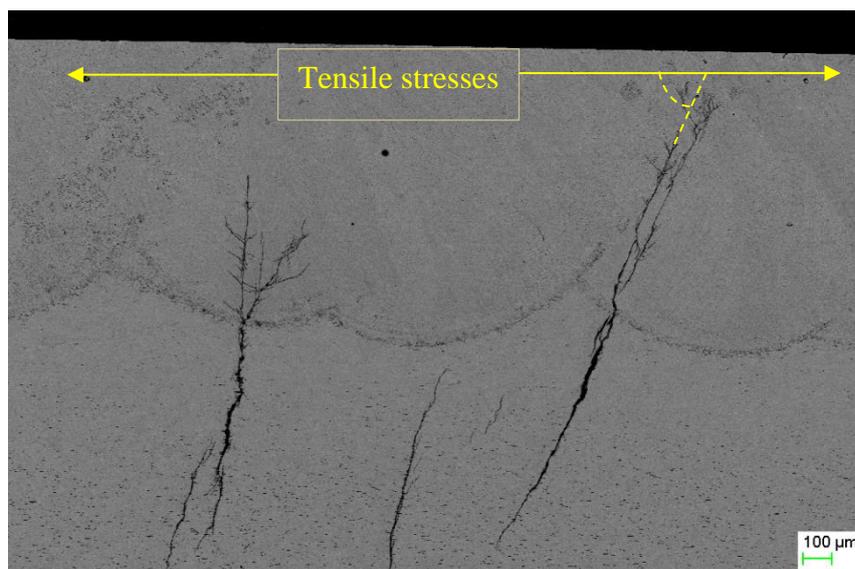
Figure 4.22: Transgranular SCC of laser alloyed 304L SS with 0.98 wt% Ru after exposure to 50 ppm NaCl containing 10 ppm DO at 160°C for 172 hours.

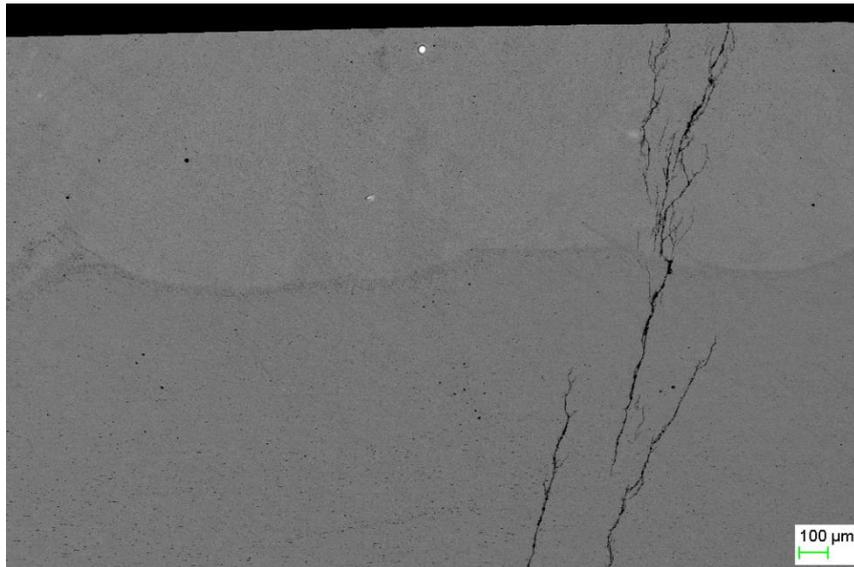
Figure 4.23: Transgranular SCC of laser alloyed 304L SS with 1.96 wt% Ru after exposure to 50 ppm NaCl containing 10 ppm DO at 160°C for 172 hours.

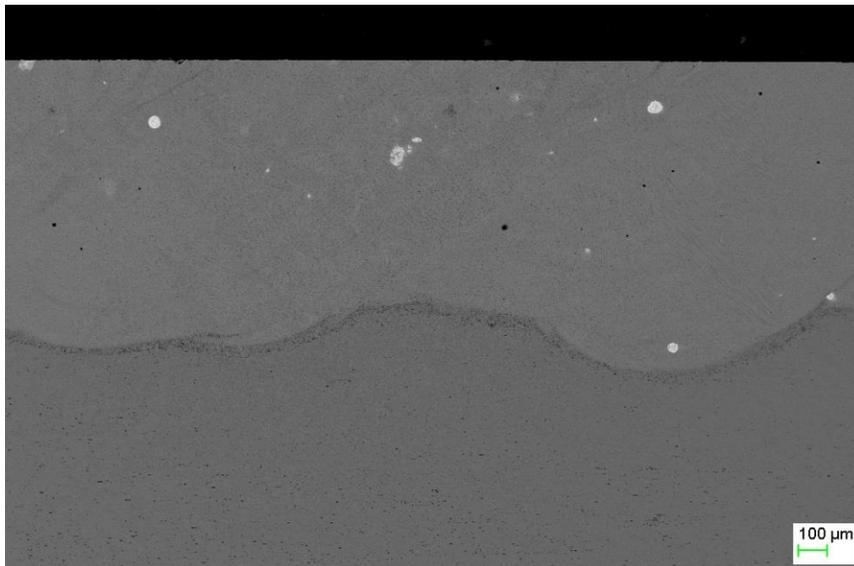
Figure 4.24: Cross-section of laser alloyed 304L SS with 4.74 wt% Ru after exposure to 50 ppm NaCl containing 10 ppm DO at 160°C for 172 hours.

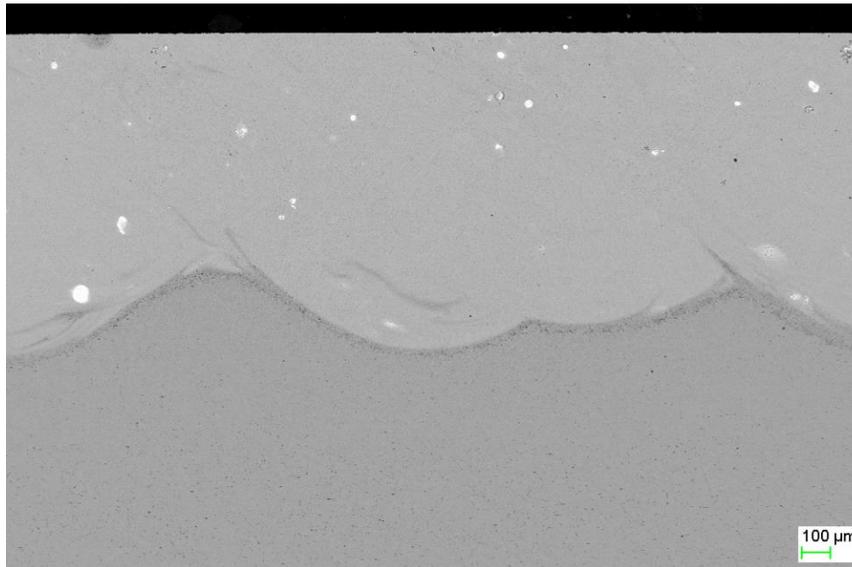
Figure 4.25: Cross-section of laser alloyed 304L SS with 9.2wt% Ru after exposure to 50 ppm NaCl containing 10 ppm DO at 160°C for 172 hours.

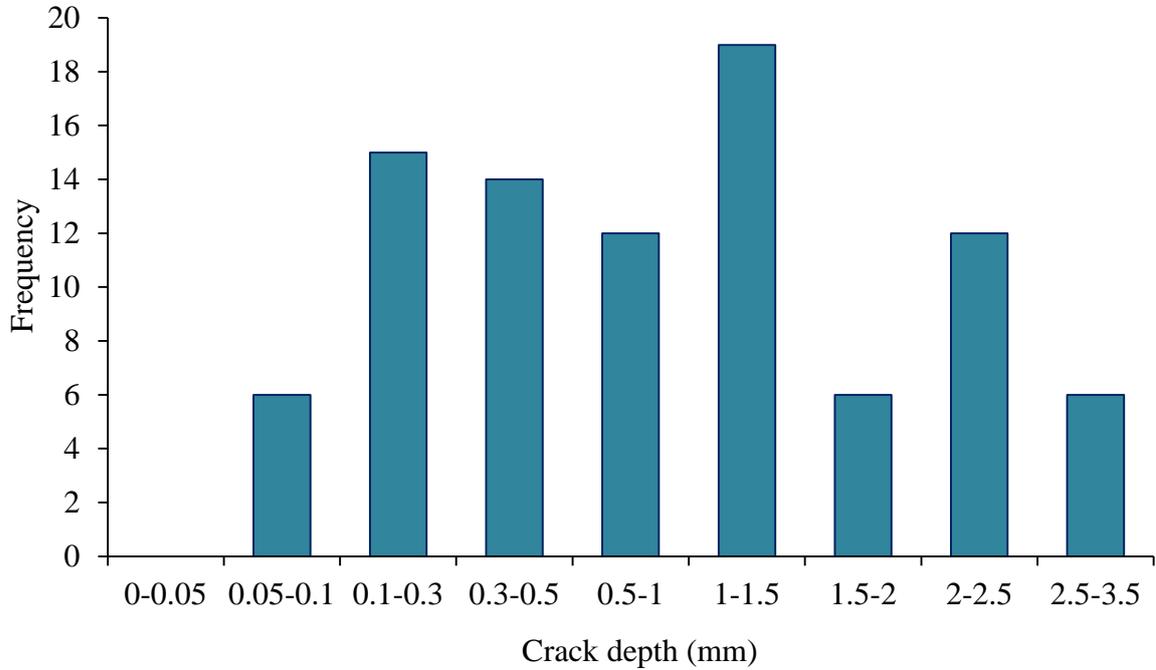
Figure 4.27: Distribution of crack lengths of polished as-received 304L stainless steel after exposure to 50 ppm NaCl containing 10 ppm DO at 160°C for 172 hours.

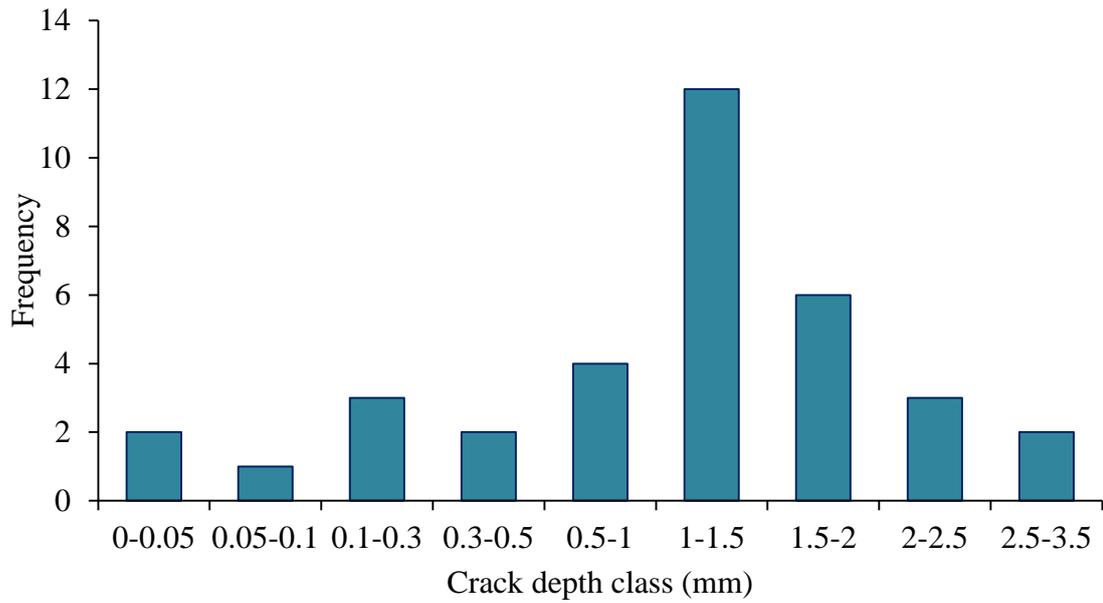
Figure 4.28: Distribution of crack lengths of polished laser alloyed 304L SS with 0 wt% Ru after exposure to 50 ppm NaCl containing 10 ppm DO at 160°C for 172 hours.

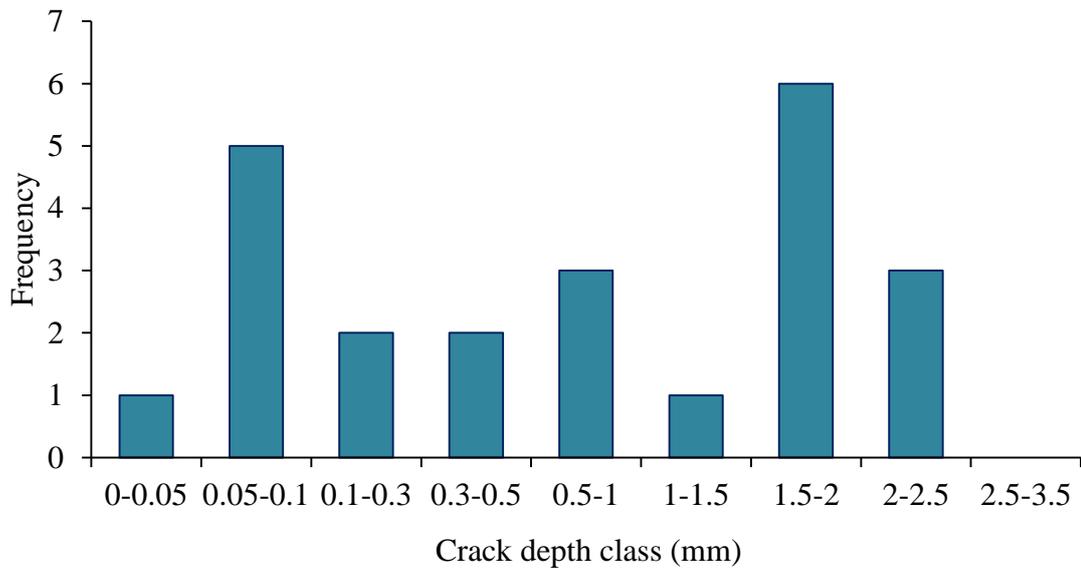
Figure 4.29: Distribution of crack lengths of polished laser alloyed 304L SS with 0.98 wt% Ru after exposure to 50 ppm NaCl containing 10 ppm DO at 160°C for 172 hours.
