# **The environmentally assisted cracking of Ru enriched laser alloyed surface layers on 304L stainless steel**

A dissertation submitted to the Faculty of Engineering, University of the Witwatersrand, Johannesburg, in fulfilment of the requirements for the degree of Master of Science in Engineering

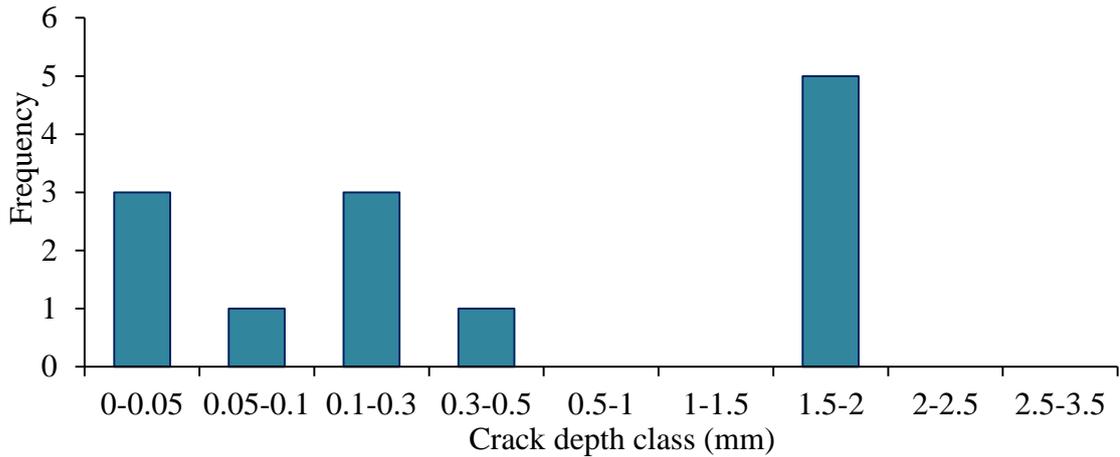
Figure 4.30: Distribution of crack lengths of polished laser alloyed 304L SS with 1.96 wt% Ru after exposure to 50 ppm NaCl containing 10 ppm DO at 160°C for 172 hours.

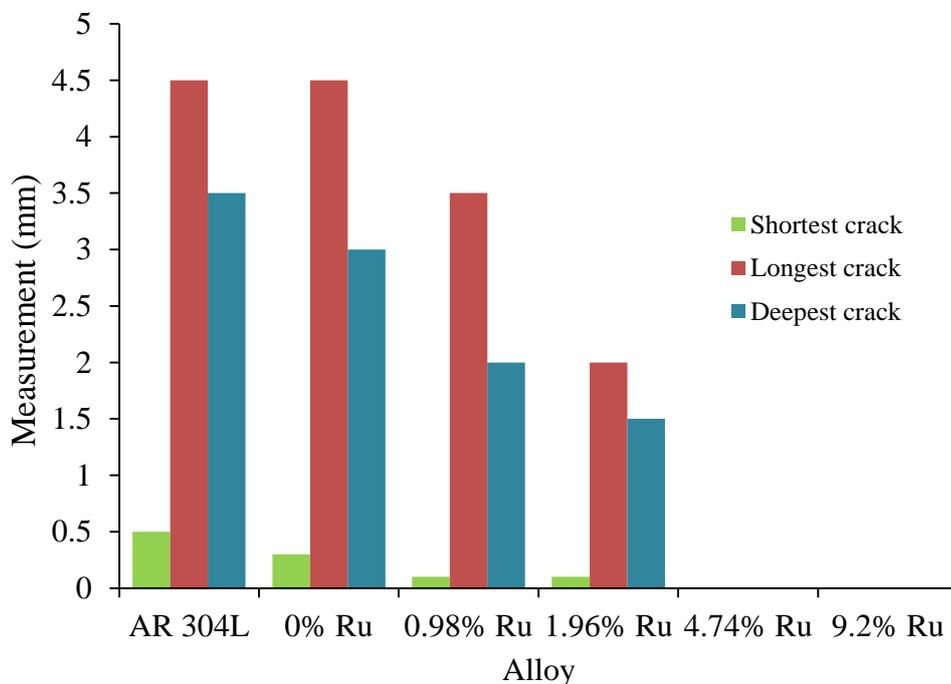
Figure 4.31: Comparison of crack depth and length of polished samples after exposure to 50 ppm NaCl solution with 10 ppm DO at 160°C for 172 hours.

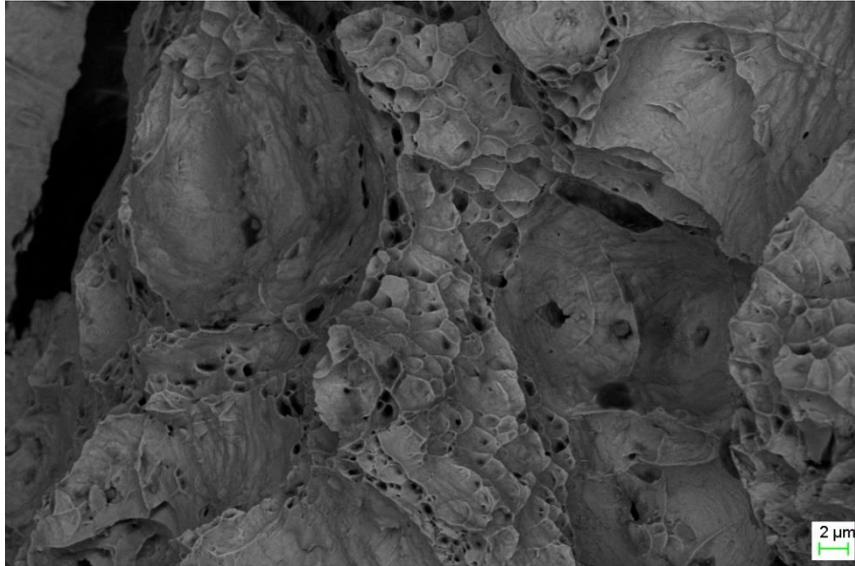
Figure 4.32: Fractured surface of as-received 304L SS in 50 ppm NaCl solution containing 10 ppm DO at 160°C.

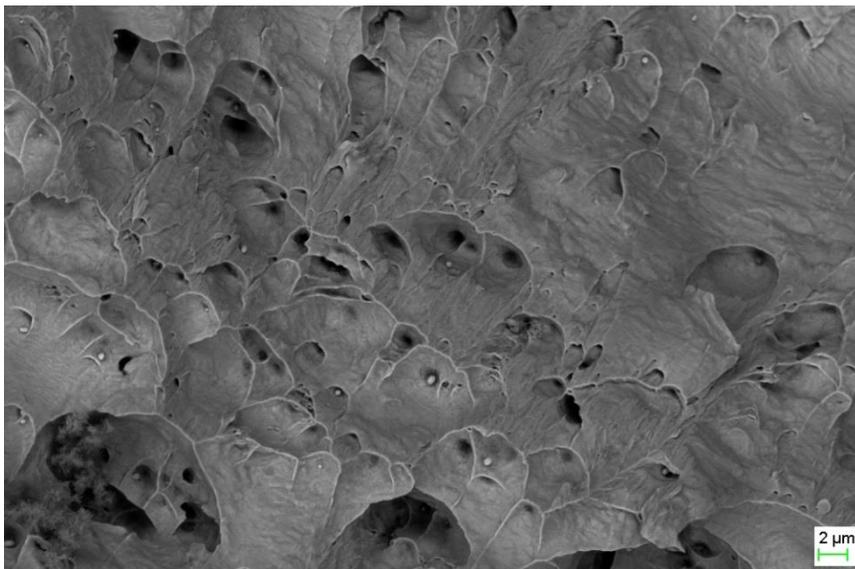
Figure 4.33: Fractured surface of vacuum remelted 304L SS with 0 wt% Ru in 50 ppm NaCl solution containing 10 ppm DO at 160°C.

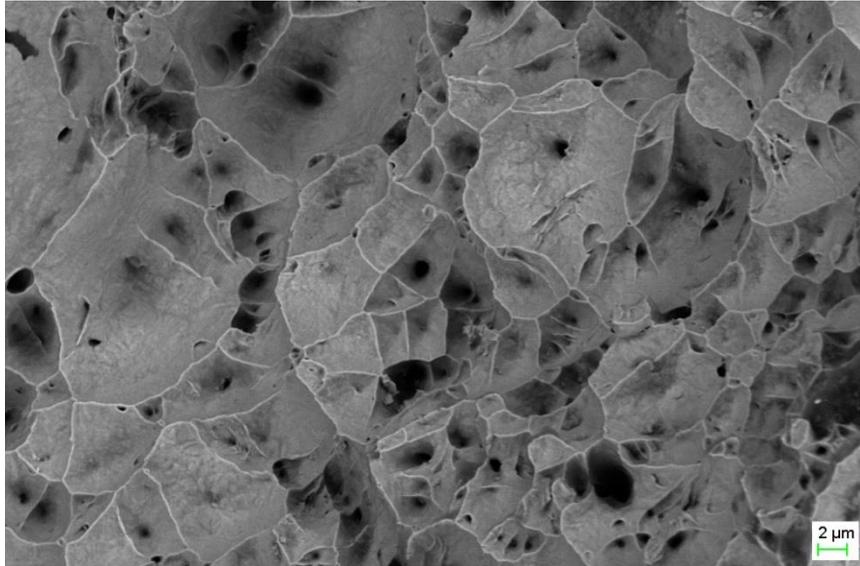
Figure 4.34: Fractured surface of vacuum remelted 304L SS with 1.07 wt% Ru in 50 ppm NaCl solution containing 10 ppm DO at 160°C.

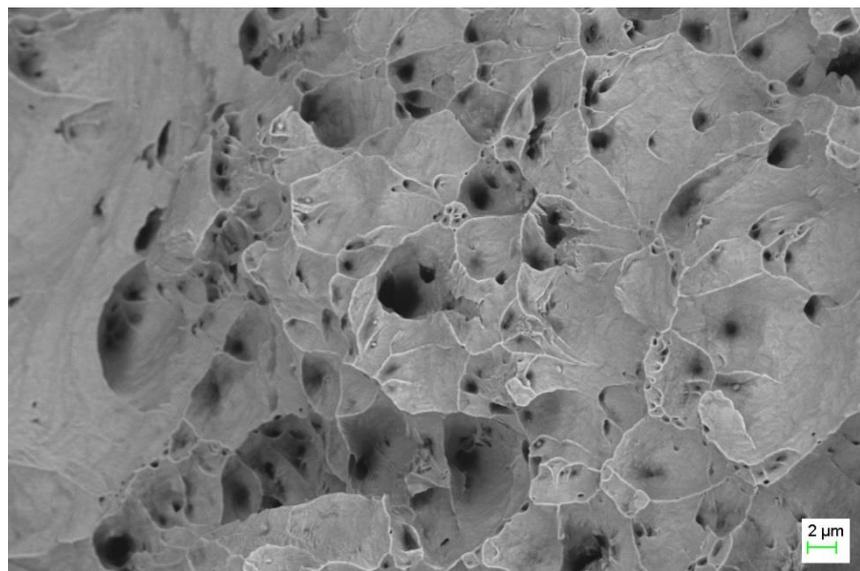
Figure 4.35: Fractured surface of vacuum remelted 304L SS with 2.05 wt% Ru in 50 ppm NaCl solution containing 10 ppm DO at 160°C.

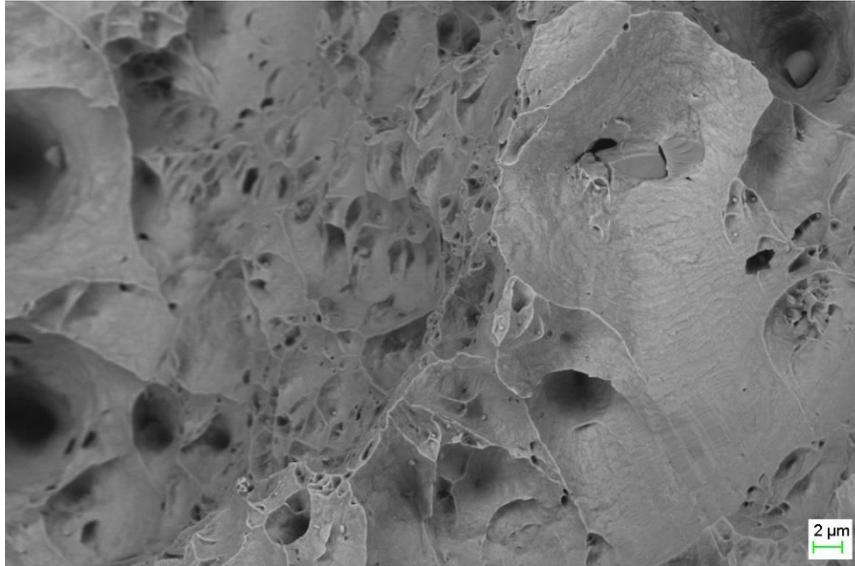
Figure 4.36: Fractured surface of vacuum remelted 304L SS with 6.07 wt% Ru in 50 ppm NaCl solution containing 10 ppm DO at 160°C.

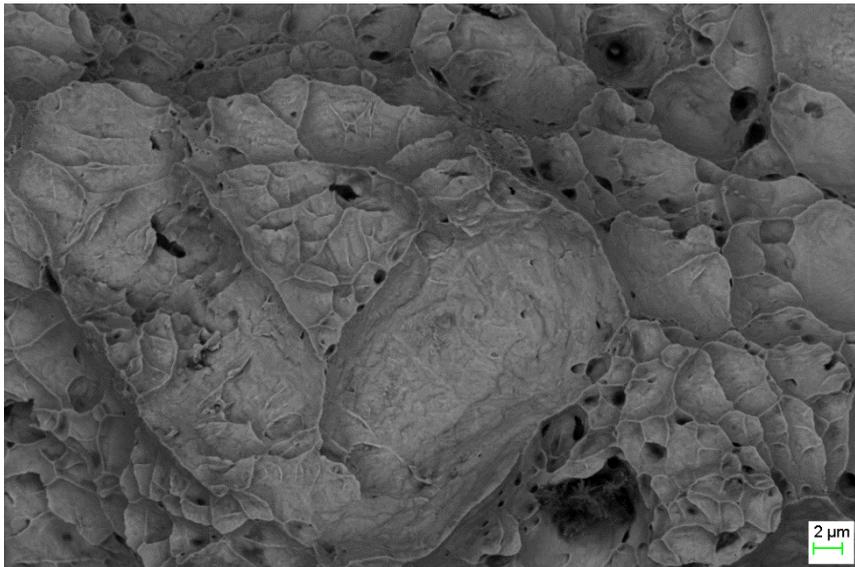
Figure 4.37: Fractured surface of vacuum remelted 304L SS with 12.34 wt% Ru in 50 ppm NaCl solution containing 10 ppm DO at 160°C.

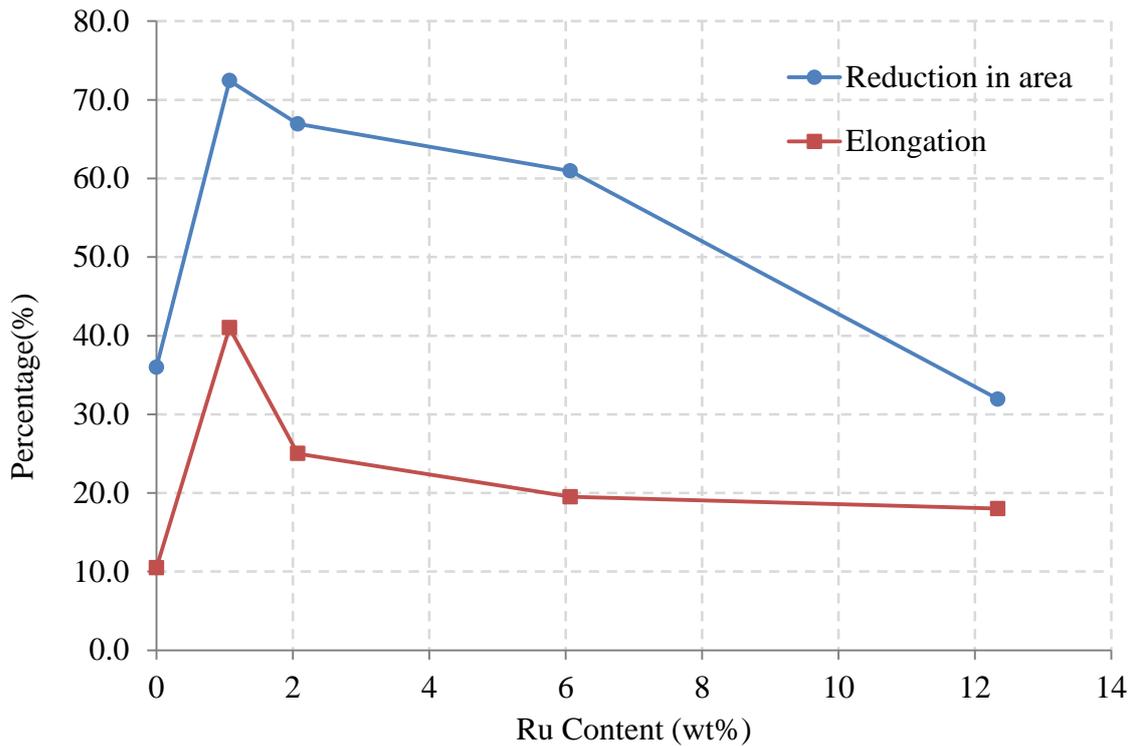
Figure 4.38: Elongation and reduction in area of vacuum remelted 304L stainless steel with Ru after exposure to 50 ppm NaCl solution and 10 ppm DO at 160°C.

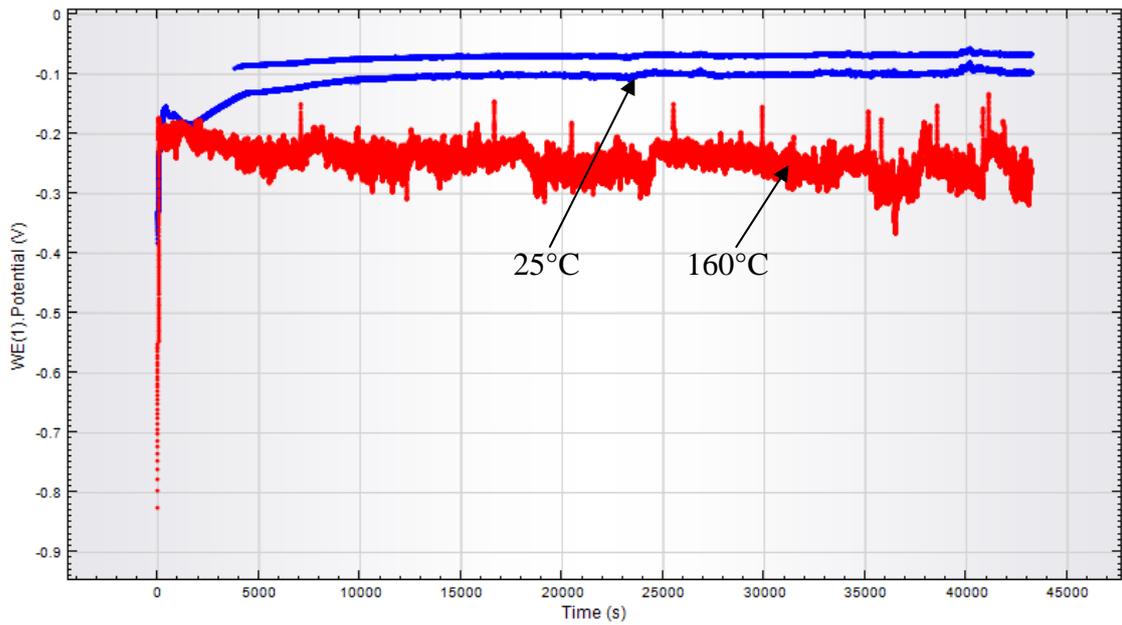
Figure 4.39: The OCP of as-received 304L SS in 50 ppm NaCl solution containing 10 ppm DO at 25°C and 160°C.

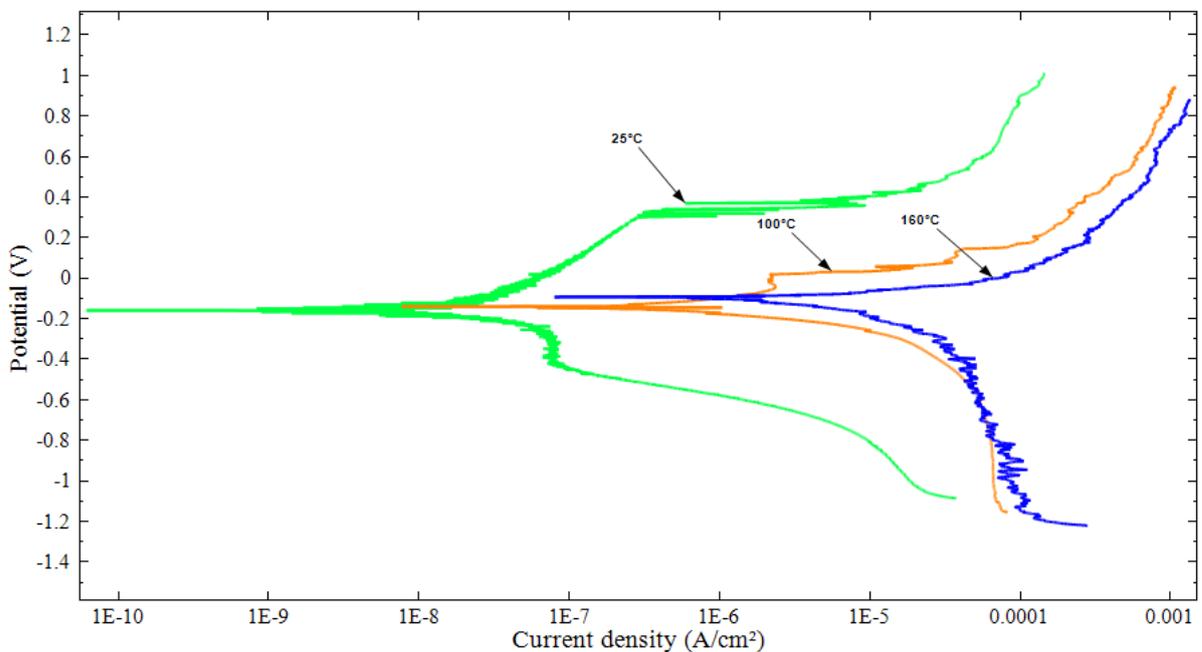
Figure 4.40: Potentiodynamic polarisation curve of as-received 304L SS in 50 ppm NaCl containing 10 ppm DO.

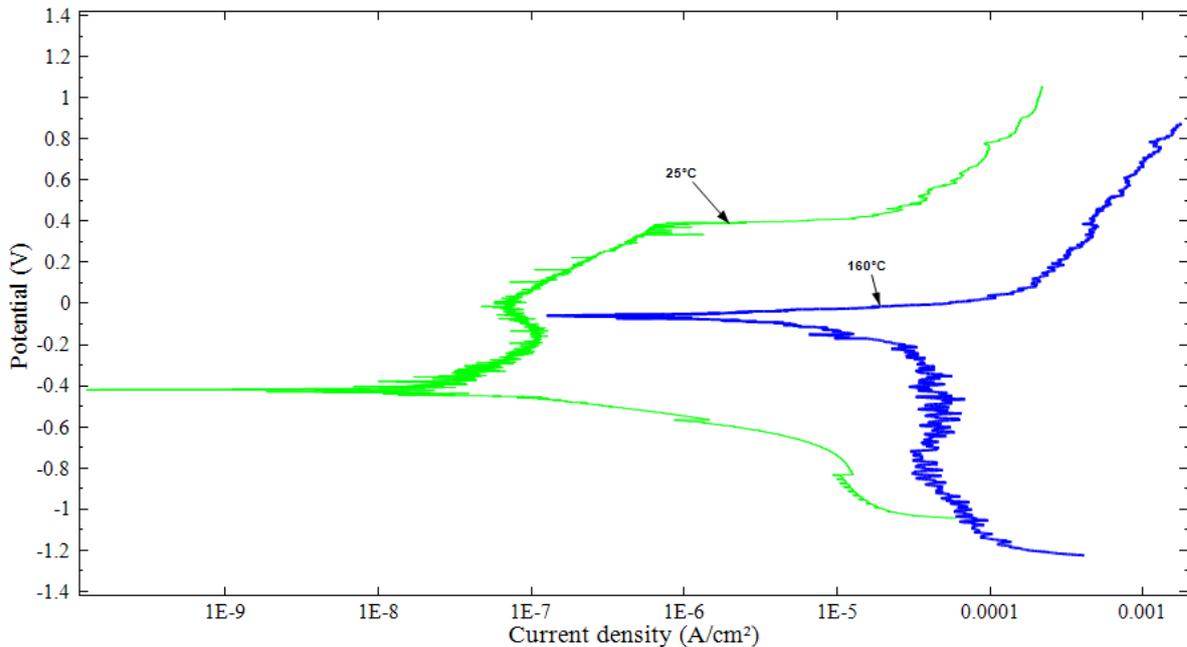
Figure 4.41: Potentiodynamic polarisation curve of laser alloyed 304L SS with 0 wt% Ru in 50 ppm NaCl containing 10 ppm DO.

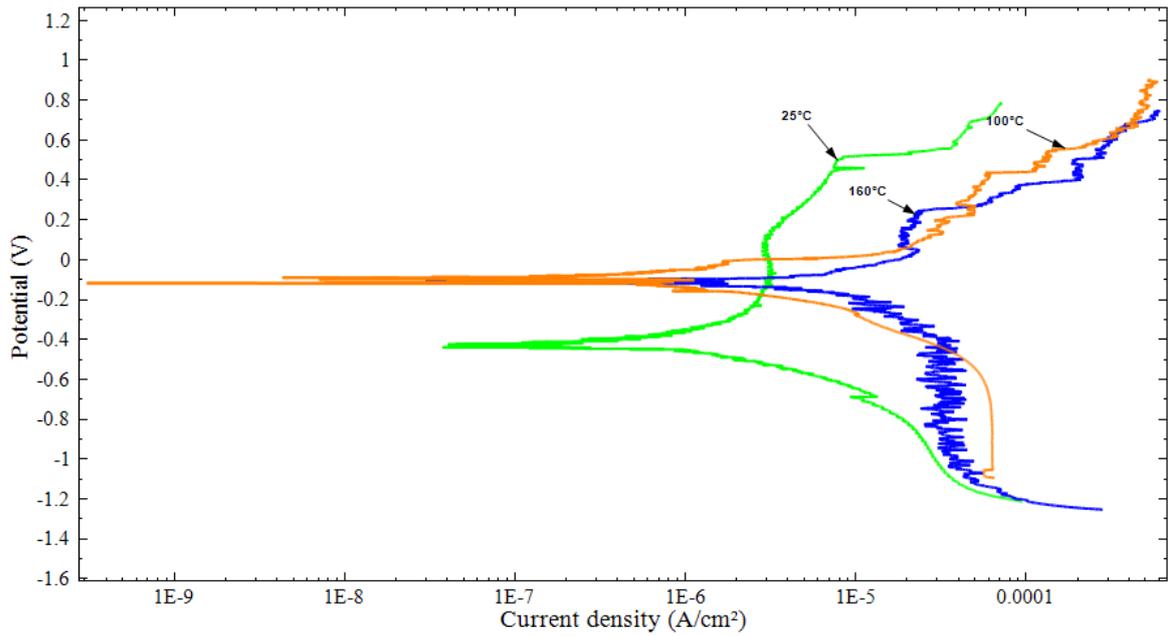
Figure 4.42: Potentiodynamic polarisation curve of laser alloyed 304L SS with 0.98 wt% Ru in 50 ppm NaCl containing 10 ppm DO.

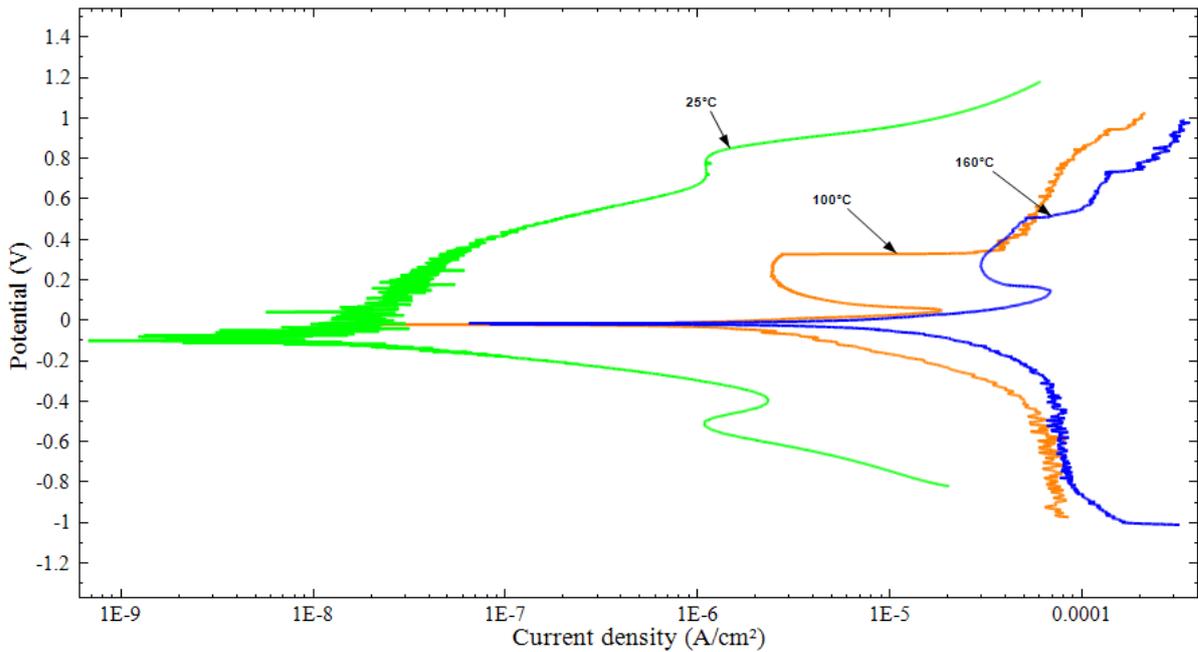
Figure 4.45: Potentiodynamic polarisation curve of laser alloyed 304L SS with 9.2 wt% Ru in 50 ppm NaCl containing 10 ppm DO.

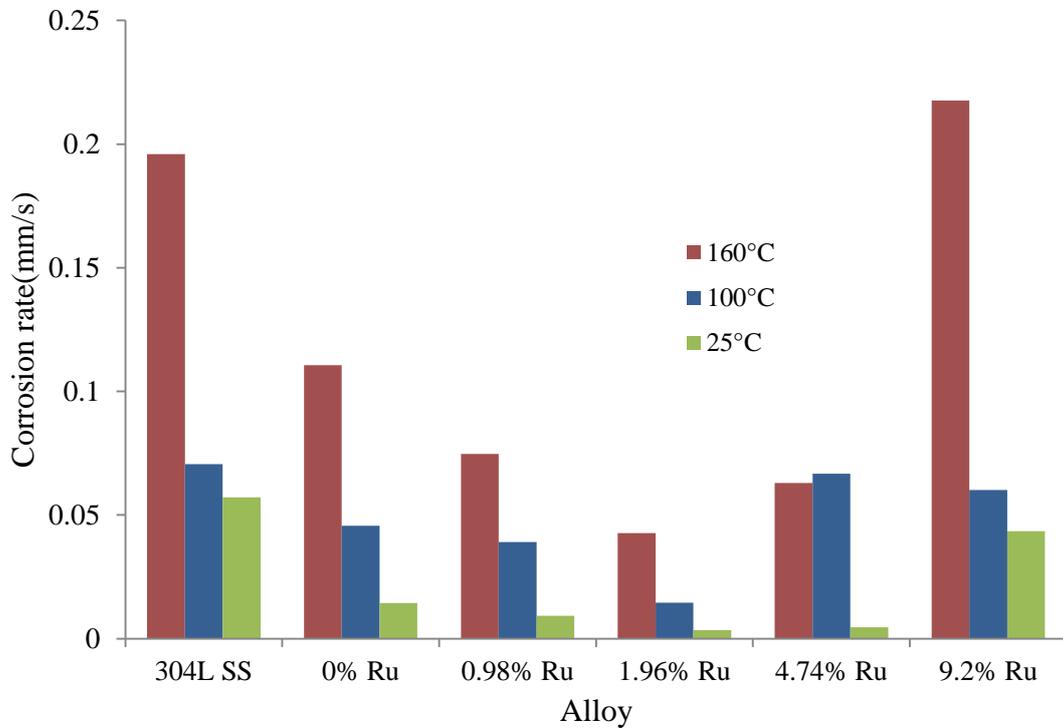
Figure 4.46: Corrosion rate of samples in an oxygenated (10 ppm DO) sodium chloride solution (50 ppm) at different temperatures.

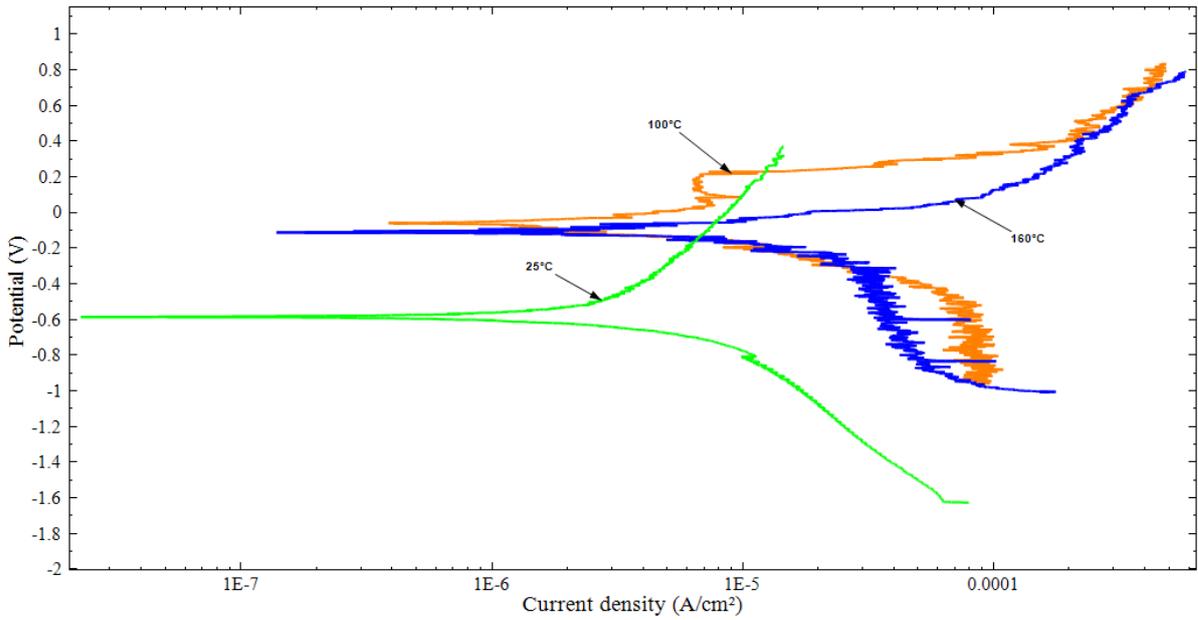
Figure 4.47: Potentiodynamic polarisation curve of vacuum remelted 304L SS with 0 wt% Ru in 50 ppm NaCl containing 10 ppm DO.

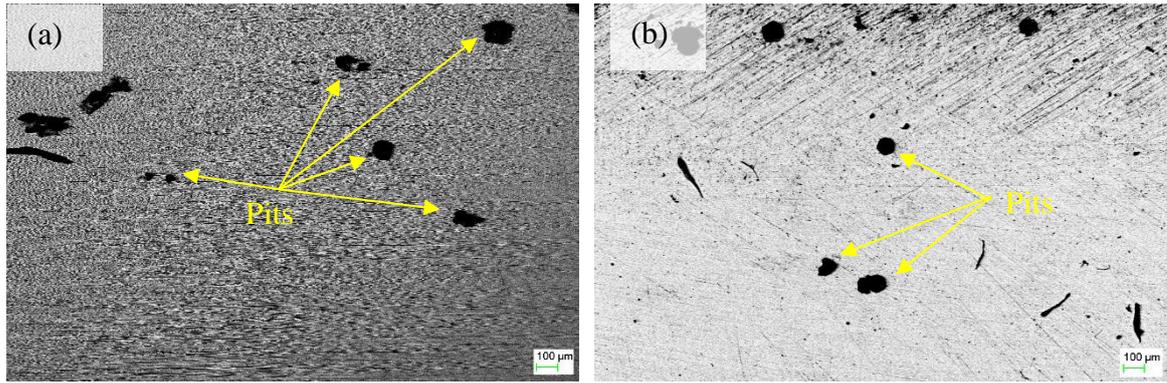
Figure 4.52: Pitting observed after electrochemical test exposure in 50 ppm NaCl with 10 ppm DO at 160°C (a) As-received 304L SS (b) 0 wt% Ru.

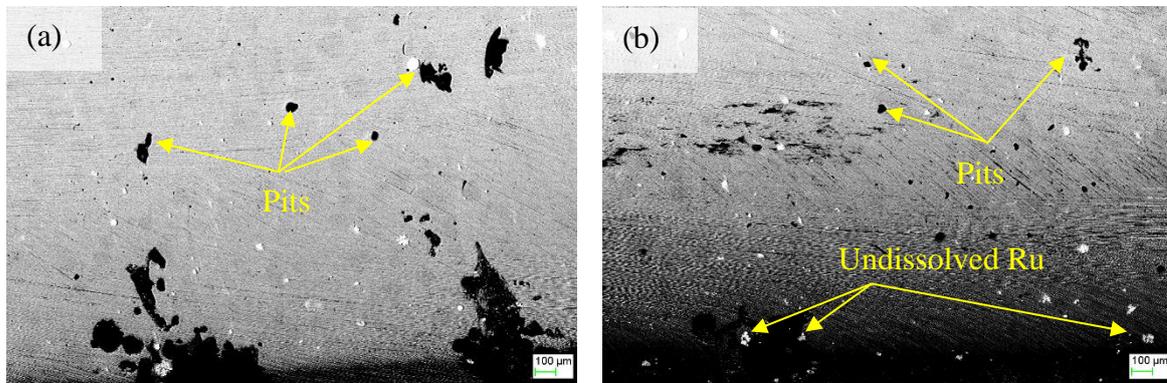
Figure 4.53: Pitting observed after electrochemical test exposure of VAR samples in 50 ppm NaCl with 10 ppm DO at 160°C (a) 0.98 wt% Ru (b) 1.96 wt% Ru.

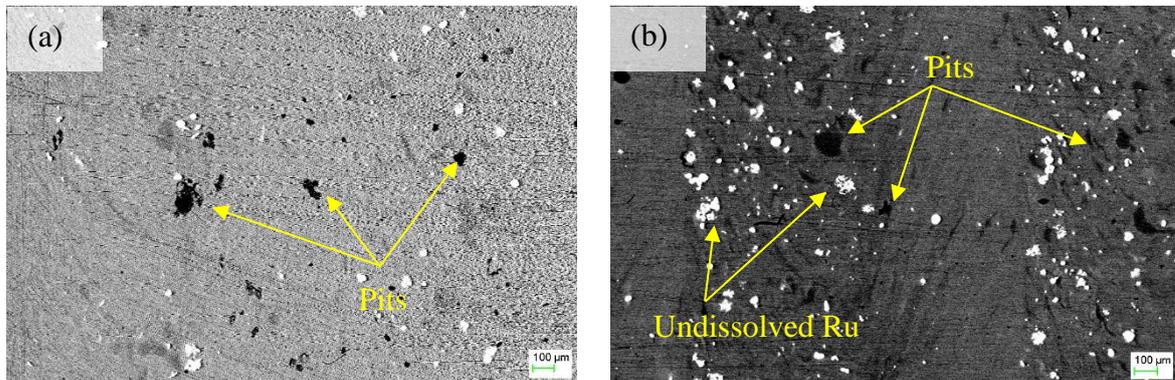
Figure 4.54: Pitting observed after electrochemical test exposure of VAR samples in 50 ppm NaCl with 10 ppm DO at 160°C (a) 4.74 wt% (b) 9.20 wt% Ru.

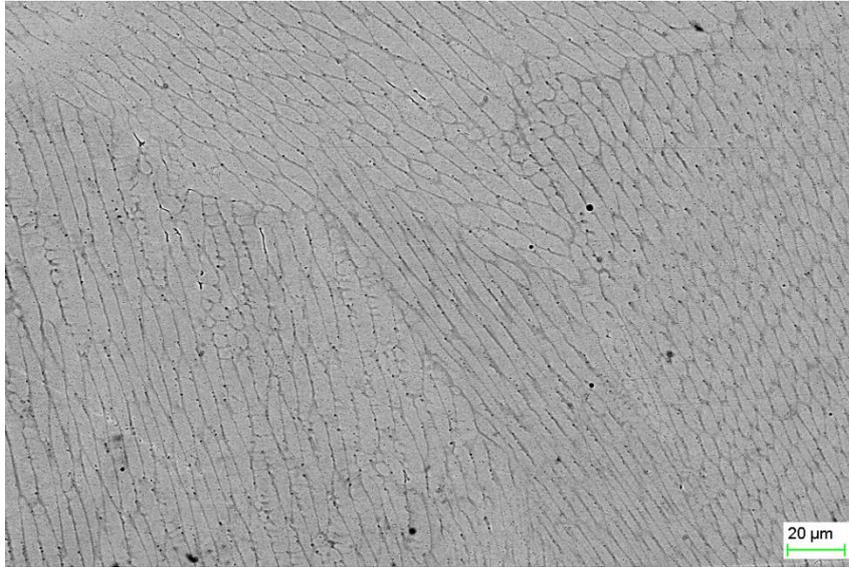
Figure 5.1: Cross-section microstructure of alloyed layer of LSA 304L SS with 0.98 wt% Ru.

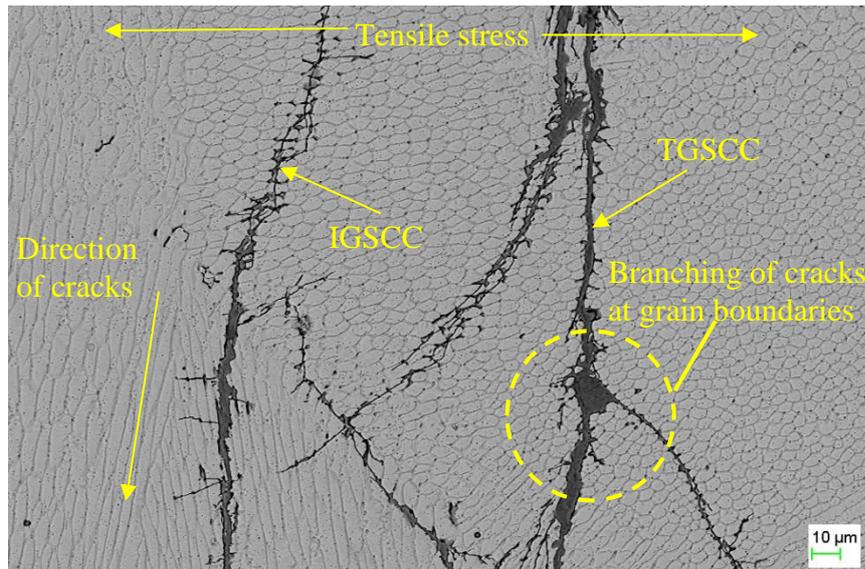
Figure 5.2: IGSCC and TGSCC of Ru (0.98 wt%) enriched laser alloyed layer on 304L SS after exposure to 50 ppm NaCl containing 10 ppm DO at 160°C for 172 hours.

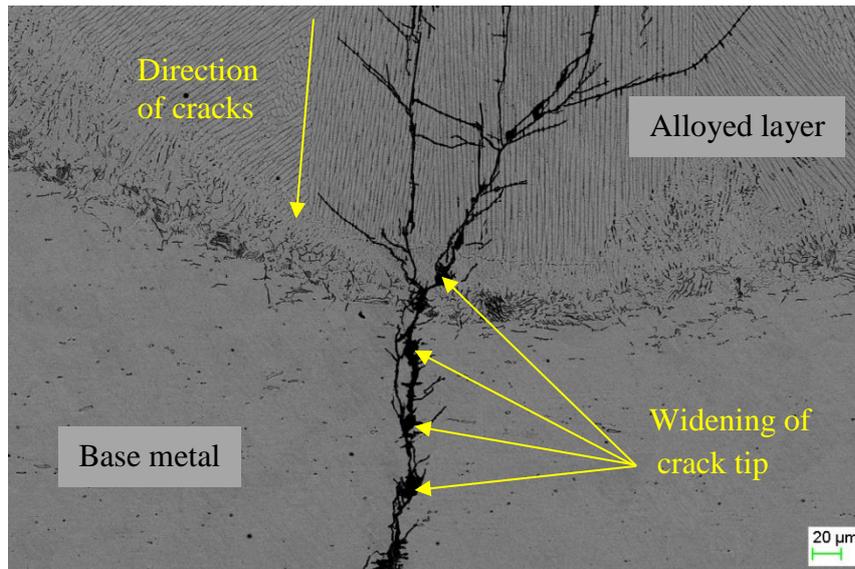
Figure 5.3: Coalescence of SCC cracks of laser surface alloyed 304L SS with 1.96 wt% Ru after exposure to 50 ppm NaCl and DO at 160°C for 172 hours.

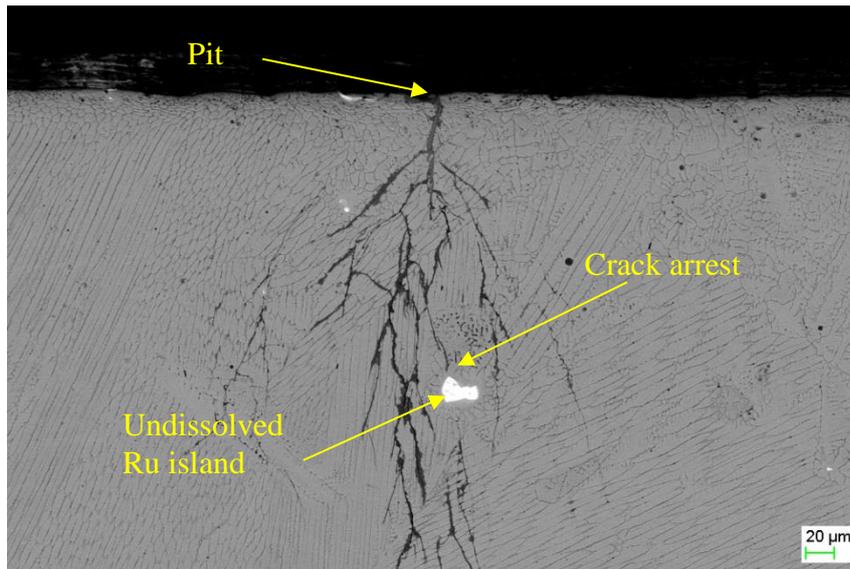
Figure 5.4: Crack arrest of 1.96 wt% Ru enriched laser alloyed layer on 304L SS after exposure to 50 ppm NaCl solution with 10 ppm DO at 160°C for 172 hours.

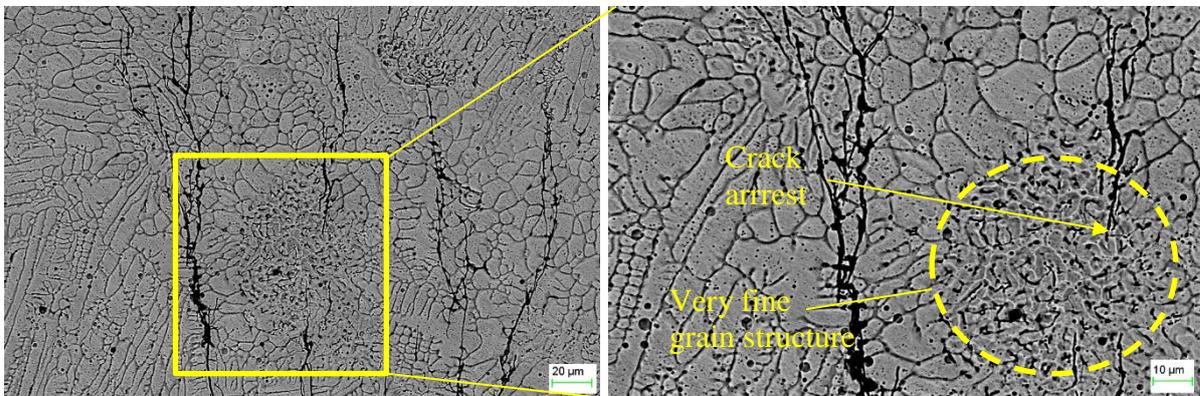
Figure 5.5: Crack arrest of very fine structure of 0.98 wt% Ru enriched laser alloyed layer on 304L SS after exposure to 50 ppm NaCl solution with 10 ppm DO at 160°C for 172 hours.

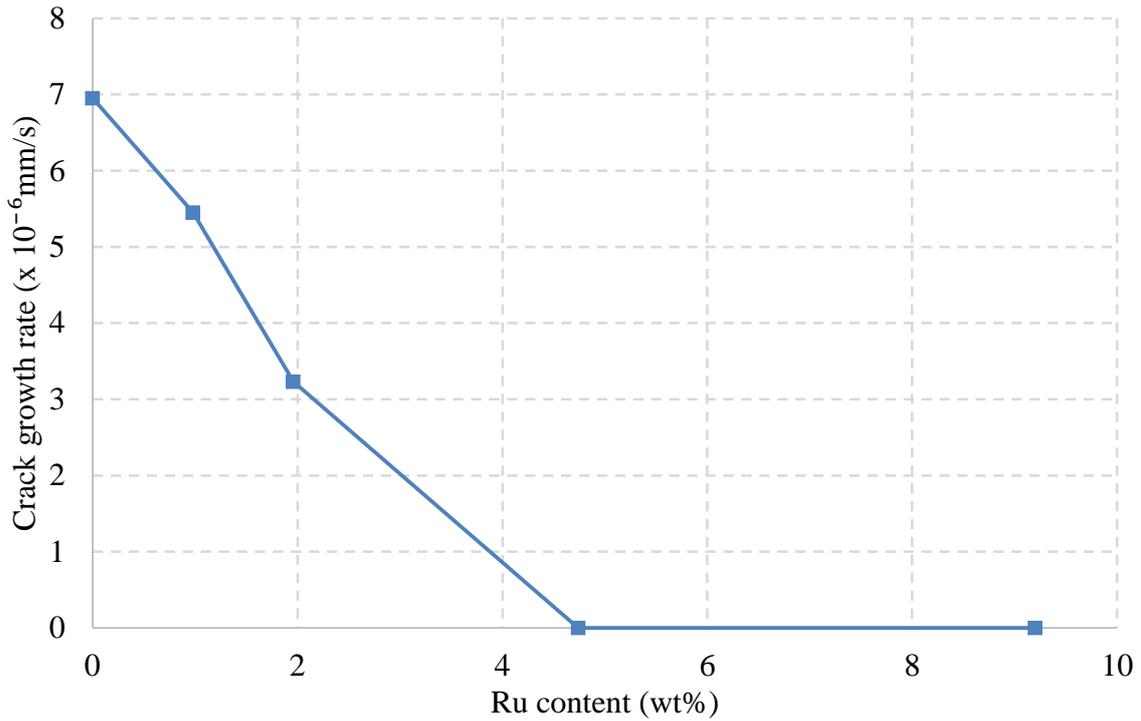
Figure 5.8: Effect of Ru content on crack growth rate after exposure to 50 ppm NaCl solution with 10 ppm DO at 160°C for 172 hours.

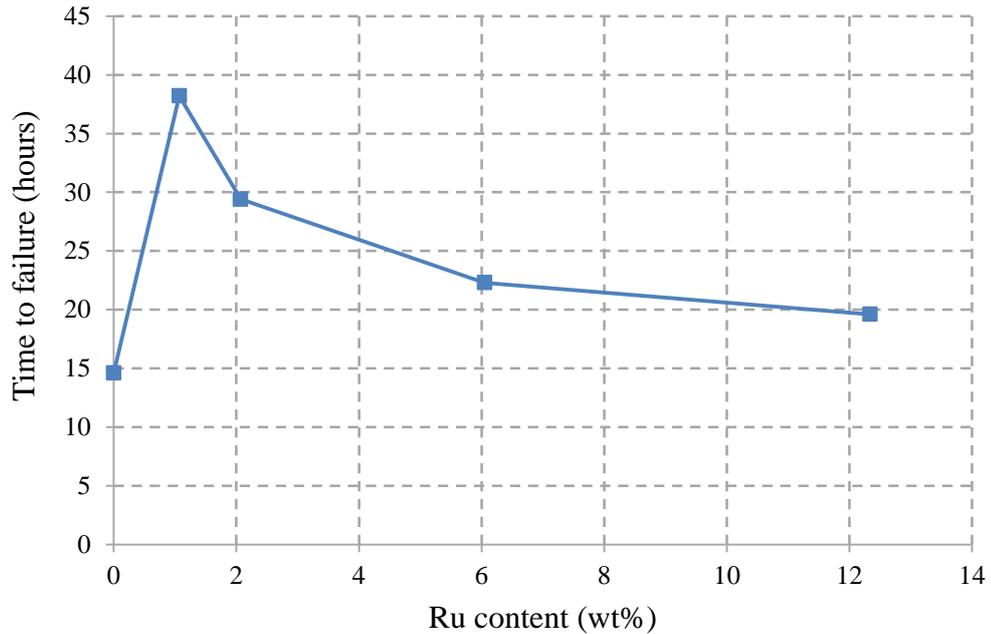
Figure 5.9: Effect of Ru on SCC time to failure in 50 ppm NaCl solution and 10 ppm DO at 160°C.

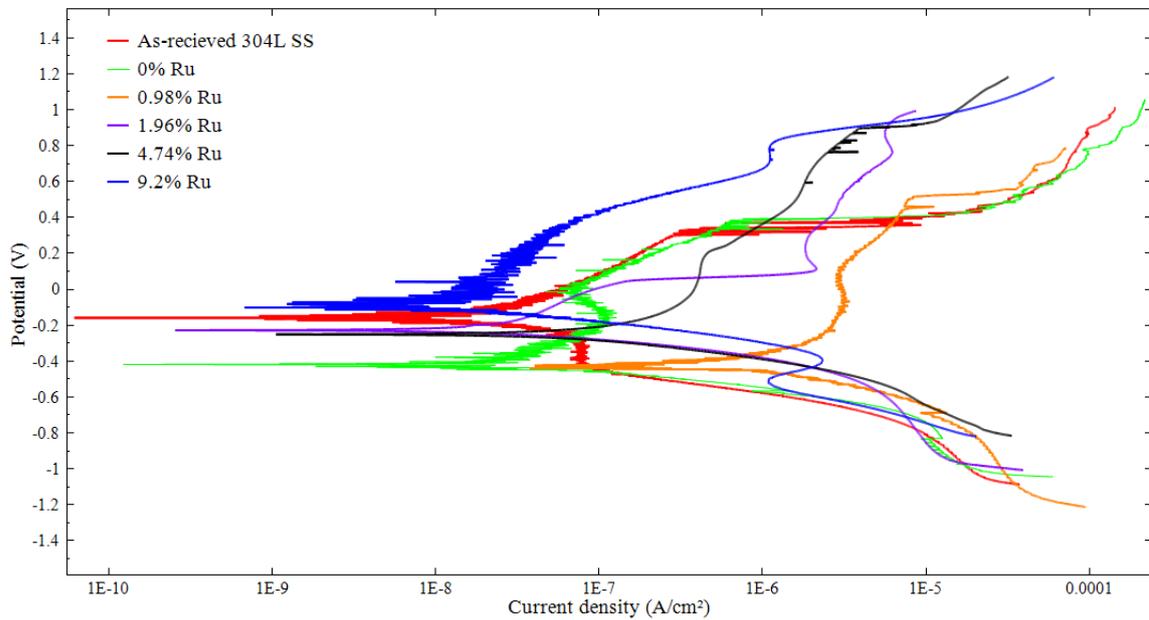
Figure 5.10: Potentiodynamic polarisation curve at samples at various Ru content in 50 ppm NaCl and 10 ppm DO at 25°C.

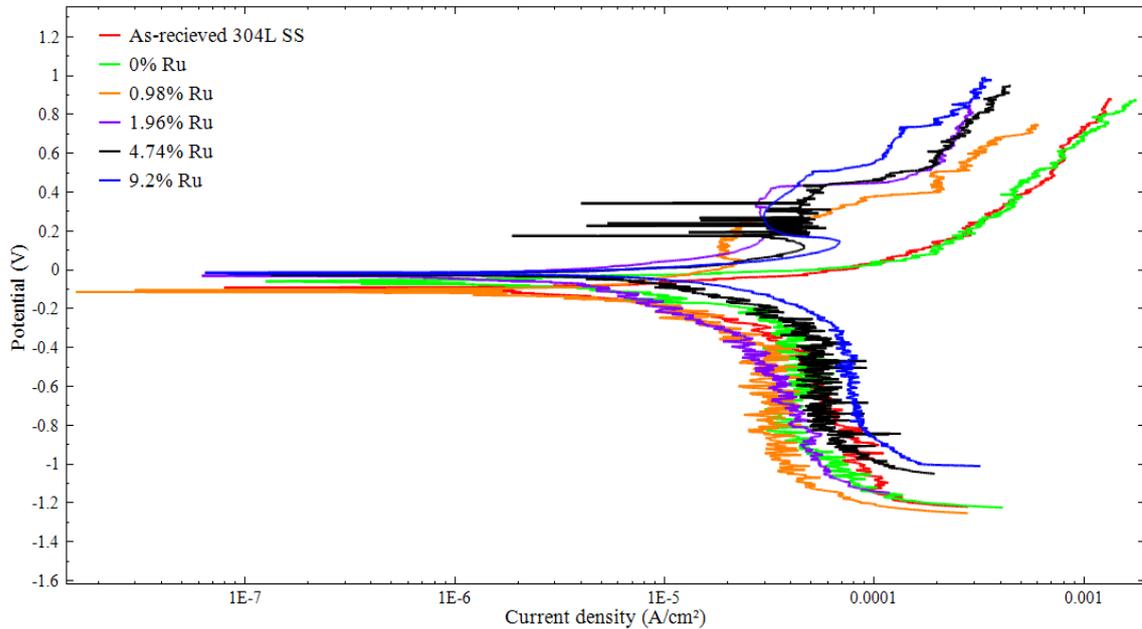
Figure 5.11: Potentiodynamic polarisation curve of laser alloyed samples at different Ru content in 50 ppm NaCl and 10 ppm DO at 160°C.

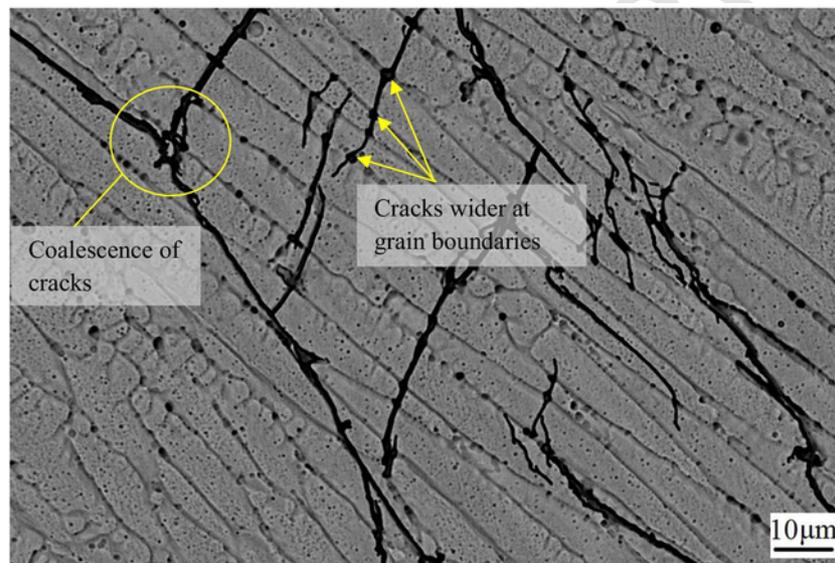
Fig. 9. Transgranular SCC of 304L stainless steel laser alloyed layer with 1% Ru after exposure in 100 ppm NaCl and 8 ppm DO at 200 °C for 172h.

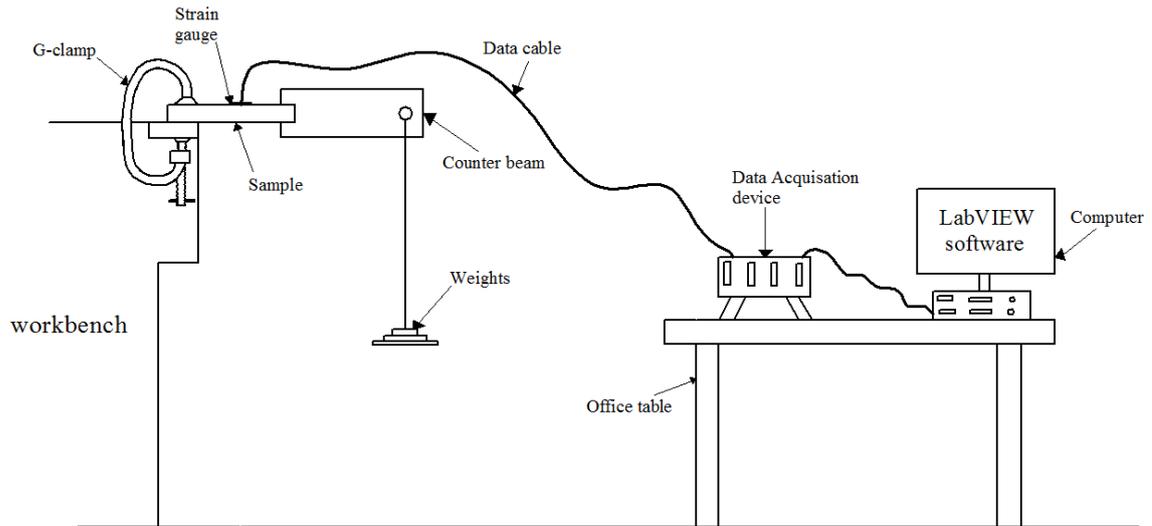
Figure C-2: Experimental set-up for calibrating the samples.

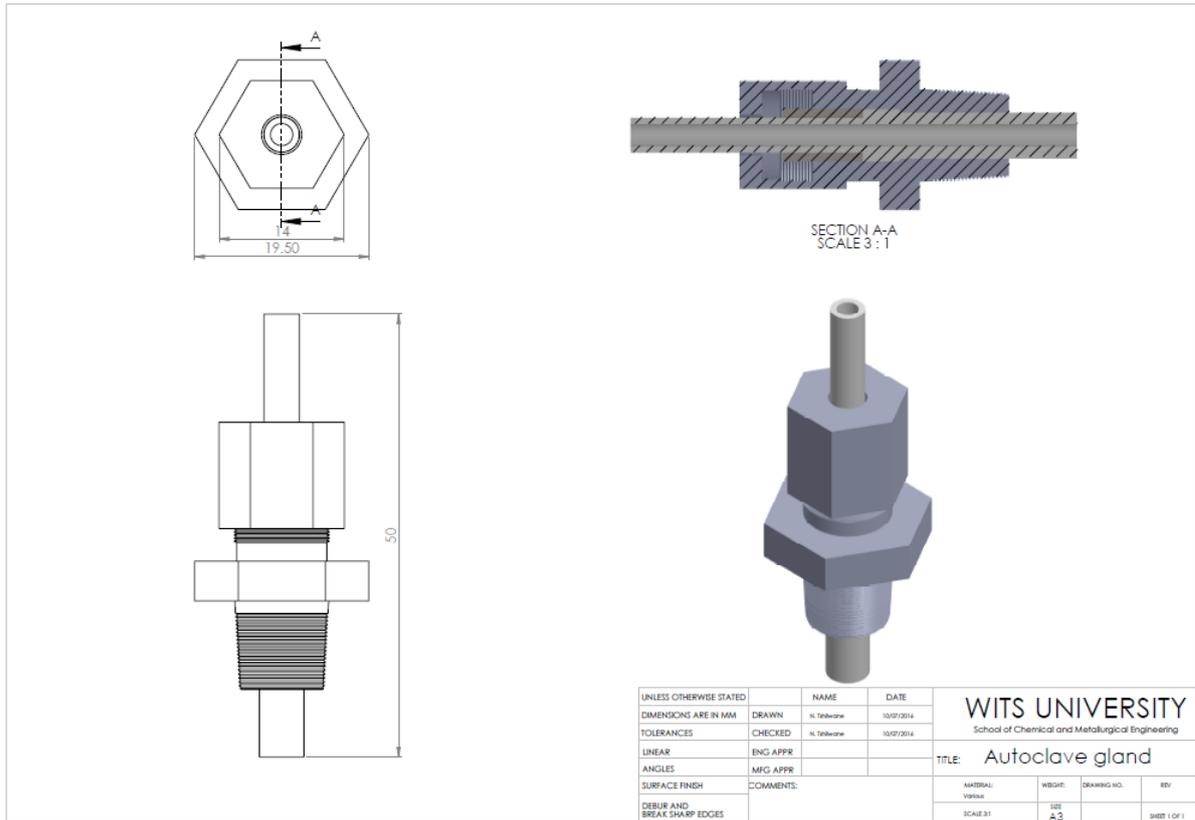
Figure D-1: Autoclave gland fabricated from 316 stainless steel and Teflon.

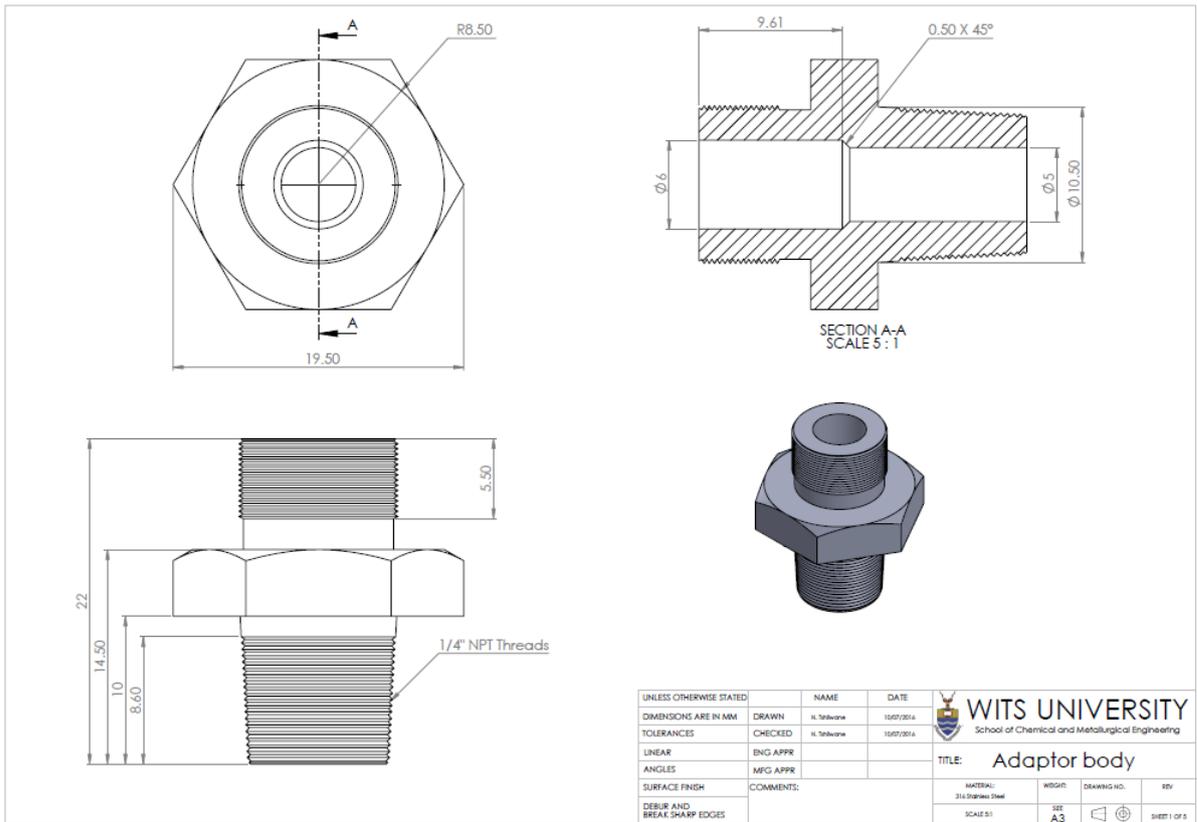
Figure D-2: 316 stainless steel adaptor fitting.

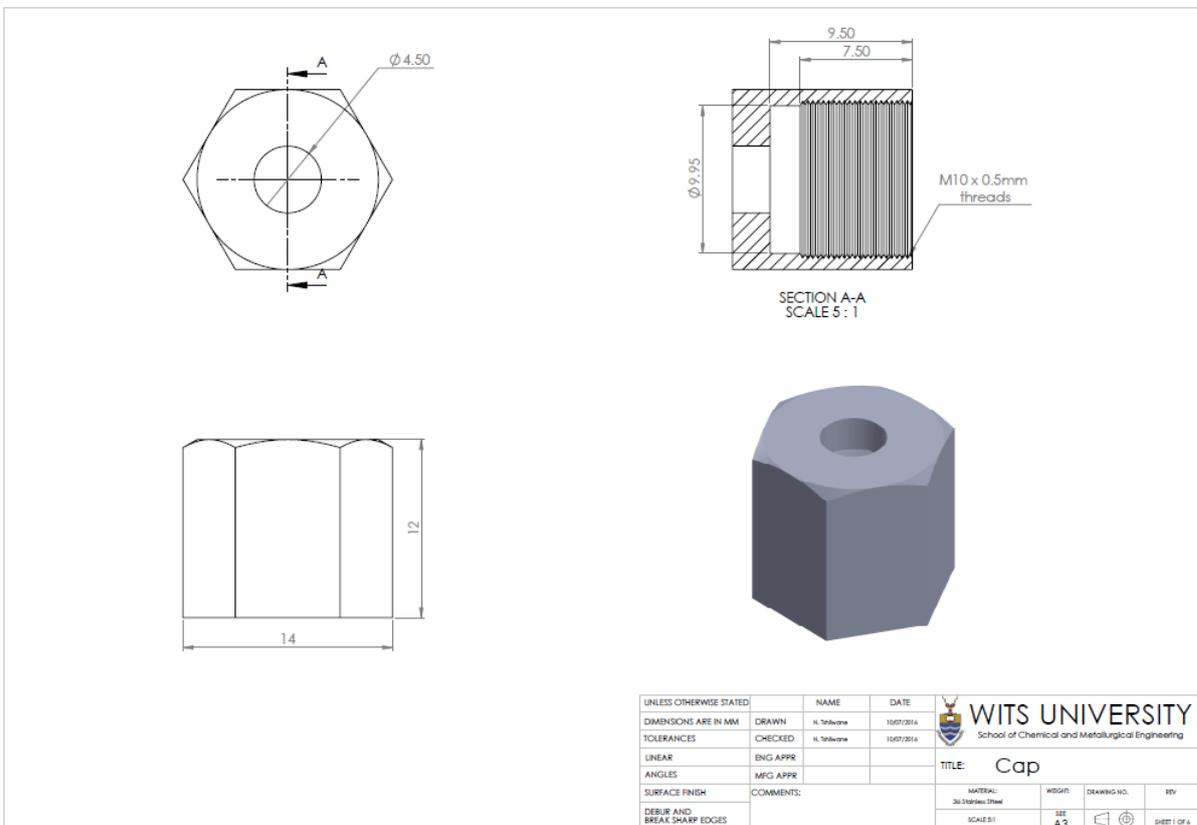
Figure D-3: 316 stainless steel cap for adaptor body

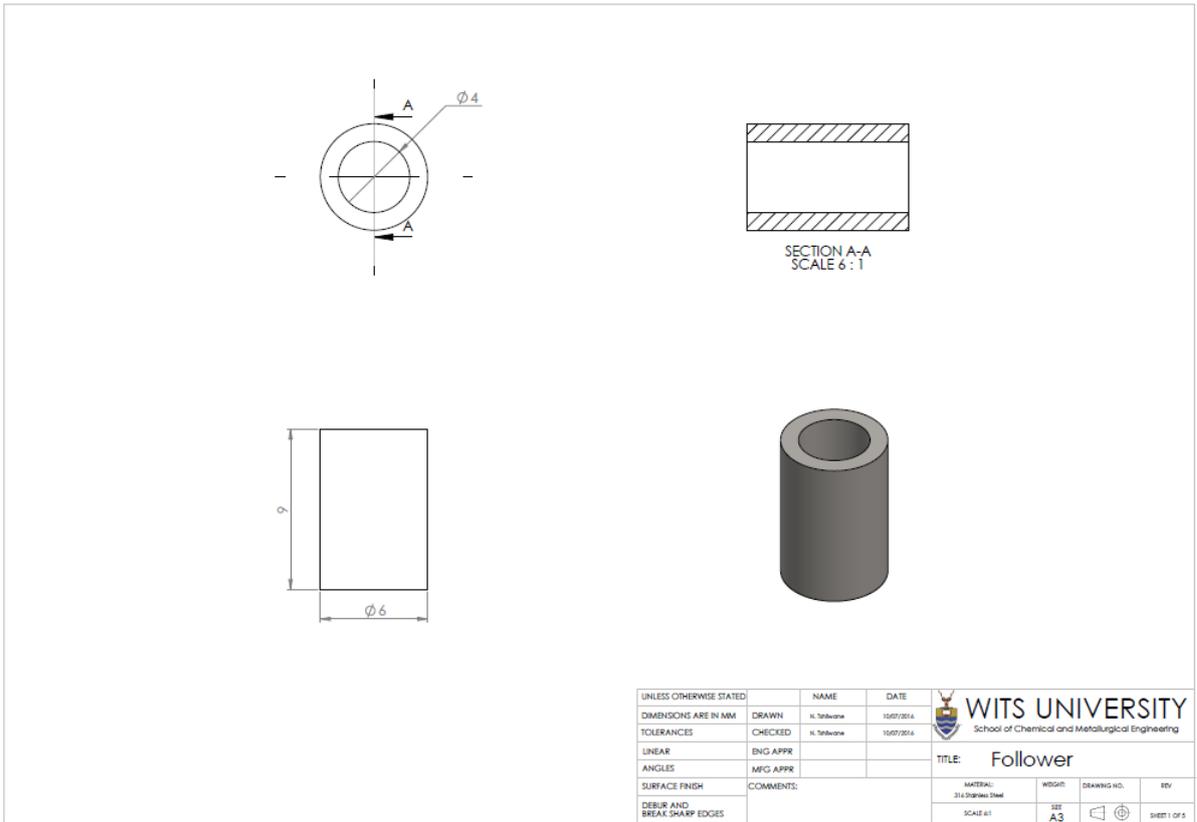
Figure D-4: Teflon follower to fit in the autoclave gland.
