THE INVESTIGATION AND PRACTICAL APPLICATION OF
VIBRATION THEORIES TO DETECT CUP NICKS ON
TAPERED ROLLER BEARINGS

A research report submitted to the Faculty of Engineering and the Built Environment,
University of the Witwatersrand, in partial fulfillment of the requirements for the degree
of Master of Science in Engineering.

Johannesburg, 2013

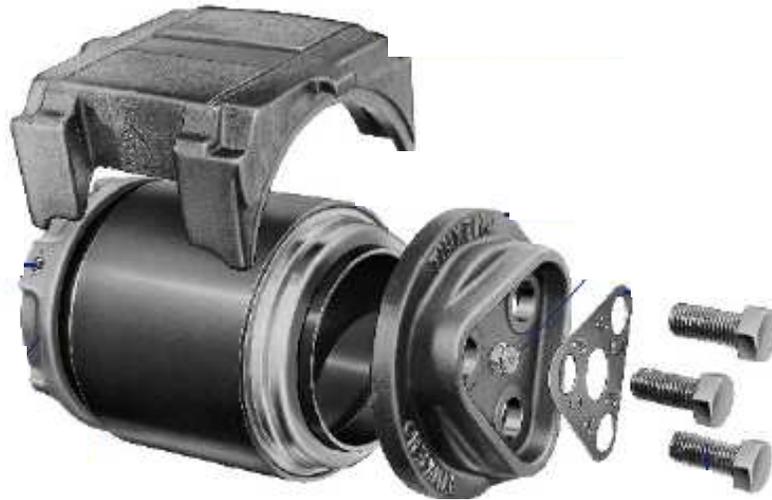
Figure 2-1 – General bearing arrangement (The Timken Company)

The assembled bearing consists of an outer ring (cup) on which two sets of taper rollers act. Two inner races (cones) transmit radial and axial loads through the taper rollers to the outer race or vice versa. A spacer separates the two cones in such a manner that the desired mounted end-play can be achieved within the assembly. Assembled bearings also have seals and ancillary components to retain grease and prevent environmental contamination within the application.

Figure 2-1 shows a general arrangement of an AP (All Purpose) bearing. This is a pre-lubricated, preassembled package bearing. AP Bearings are mostly used for rail wheel journals and also in some industrial applications. Timken South Africa manufactures class B, C, D and E bearings (between four and six inch bores), but assembles most of the other sizes (bore up to seven inches).

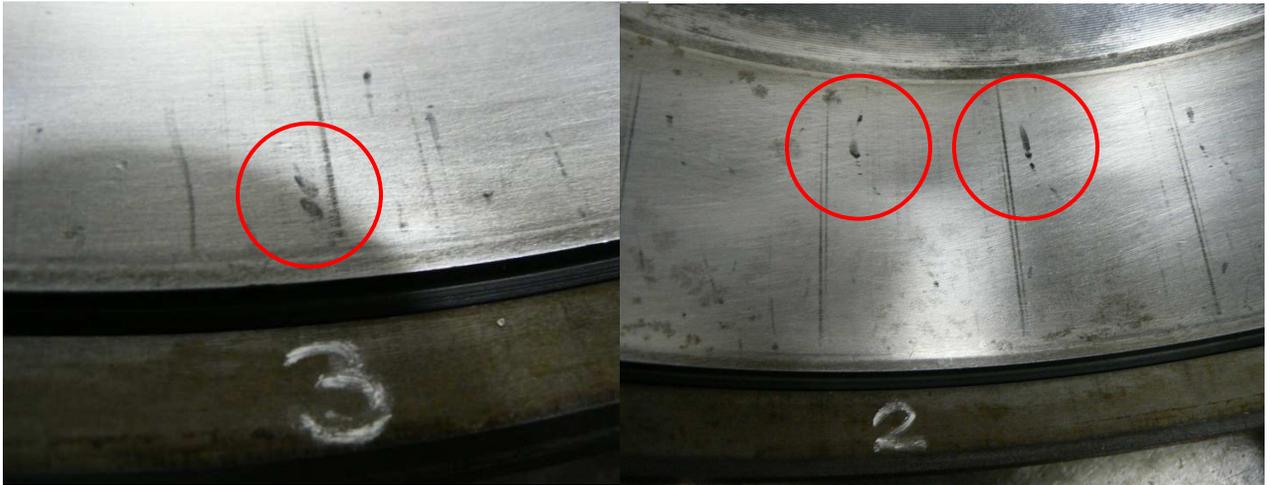
Figure 2-4 – Nicks in two different cup raceways

Figure 2-4 shows typical examples of raceway nicks. This particular bearing was returned from a customer, opened, washed and cleaned and inspected. Large nicks have been encircled and these particular nicks have been stained as well. Nicks are not always this dark. The lines in the photograph are not as a result of grease smearing but due to another damage mode which is not in the project scope.

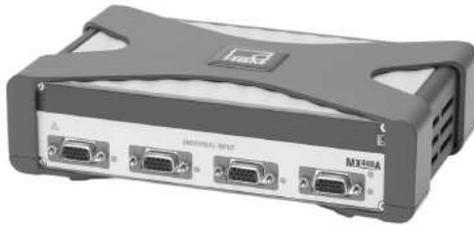
Universal amplifier

- 4 individually configurable inputs (electrically isolated)
- Connection of more than 12 transducers technologies
- Data rate: up to 19,200 Hz
- 24-bit A/D converter per channel for synchronous, parallel measurements
- Active low pass filter
- TEDS support
- Supply voltage (DC): 10 V ... 30 V
- Supply voltage for active transducers (DC): 5 V ... 24 V
