AN INVESTIGATION INTO THE SEPARATION OF SOLDERED CONNECTIONS  
FROM GOLD PLATED ELECTRONIC CIRCUIT BOARDS.

A dissertation submitted to the Faculty of Engineering, University of  
the Witwatersrand, in fulfillment of the requirements for the degree of  
Master of Science in Engineering, by J. D'A. Kirkman B.Sc. (Eng.)

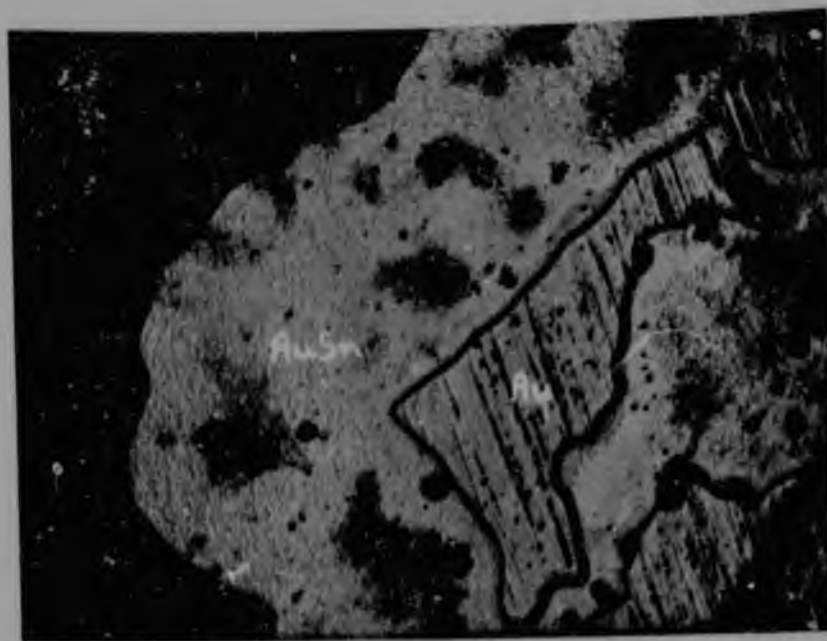
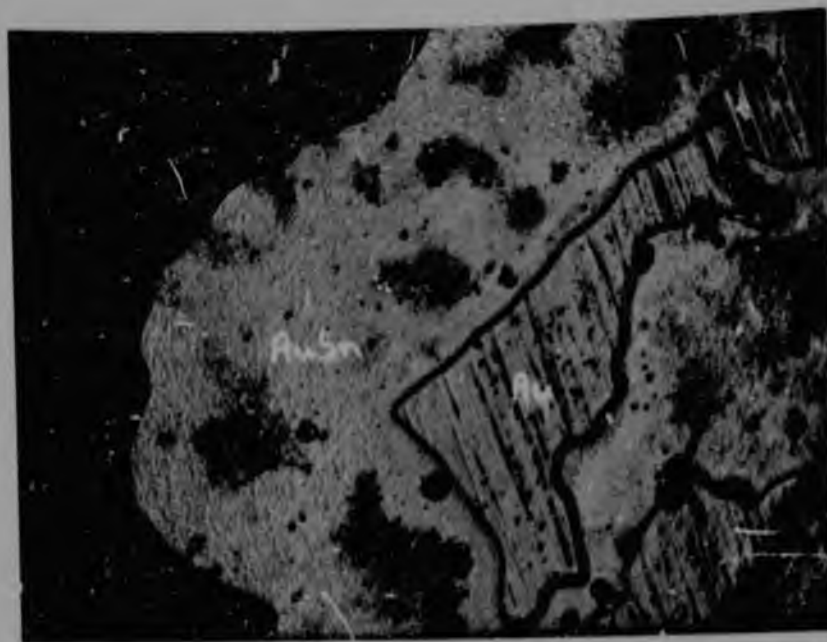
Plate 1(X 33)

Gold soldered at high temperature. The gold has been severely attacked, with resultant massive formation of AuSn. Unetched.

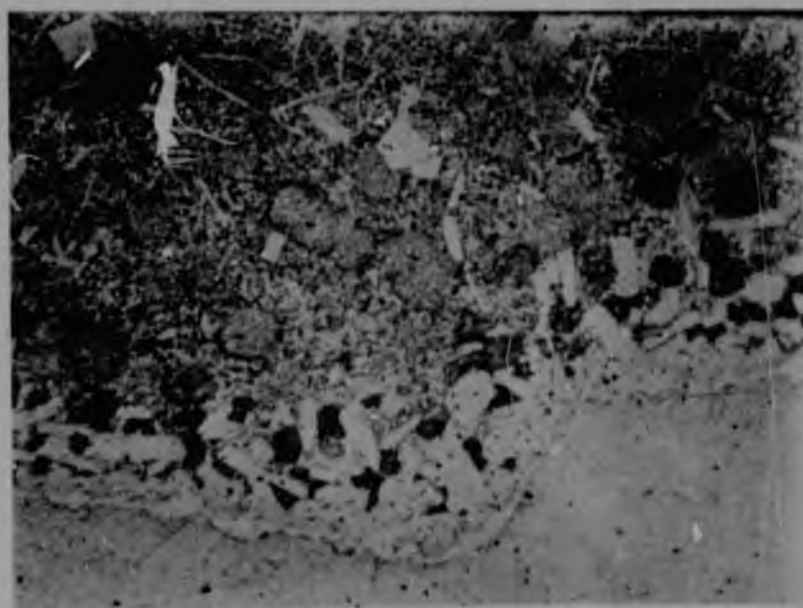
Plate 6(X 350)

Plate 5 at higher magnification. Note the duplex  
compound layer and the free lead adjacent to it.  
Etched with  $\text{HNO}_3/\text{CH}_3\text{COOH}$  in glycerine.

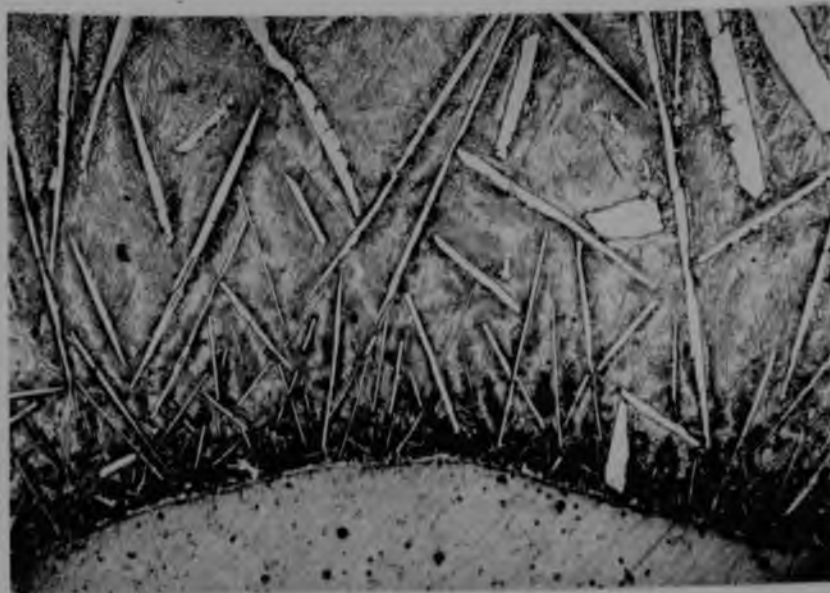
Plate 7

Specimen 1. Needles of  $\text{AuSn}_4$  radiating outwards from the surface of the gold bead. The matrix consists of the  $\text{AuSn}_4$ -Sn eutectic. Etched with  $\text{HNO}_3/\text{CH}_3\text{COOH}$  in glycerine.

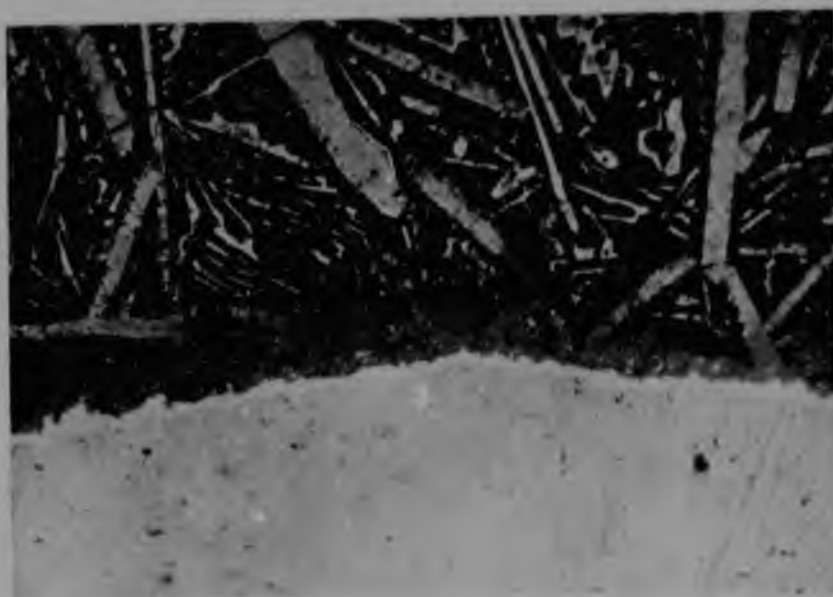
(X 70)

In this specimen gold and tin were reacted together at  $245^{\circ}\text{C}$  for five minutes, and then cooled in air. Reference to the gold-tin equilibrium diagram (Figure 2) will indicate that  $\text{AuSn}_4$  is the stable phase at this temperature. It was noted that the alloy remained liquid at all stages during the reaction and this indicates that less than 10% of gold could have been present in the tin otherwise the alloy would have solidified. Thus the structure could be expected to consist of primary  $\text{AuSn}_4$  and the  $\text{AuSn}_4$ -Sn eutectic. This was in fact the case, with acicular needles of  $\text{AuSn}_4$  radiating outwards from the gold bead, in an  $\text{AuSn}_4$ -Sn eutectic matrix. There was a duplex compound layer at the interface, consisting of  $\text{AuSn}_2$  adjacent to the gold and  $\text{AuSn}_4$  adjacent to the tin. The  $\text{AuSn}_2$  must have formed initially as a solid layer at this temperature and then reacted with the molten tin to form  $\text{AuSn}_4$ . Thus the formation of compounds at the interface is controlled by the concentration gradient of gold in the liquid tin. The dissolution reaction can be visualised as the reaction

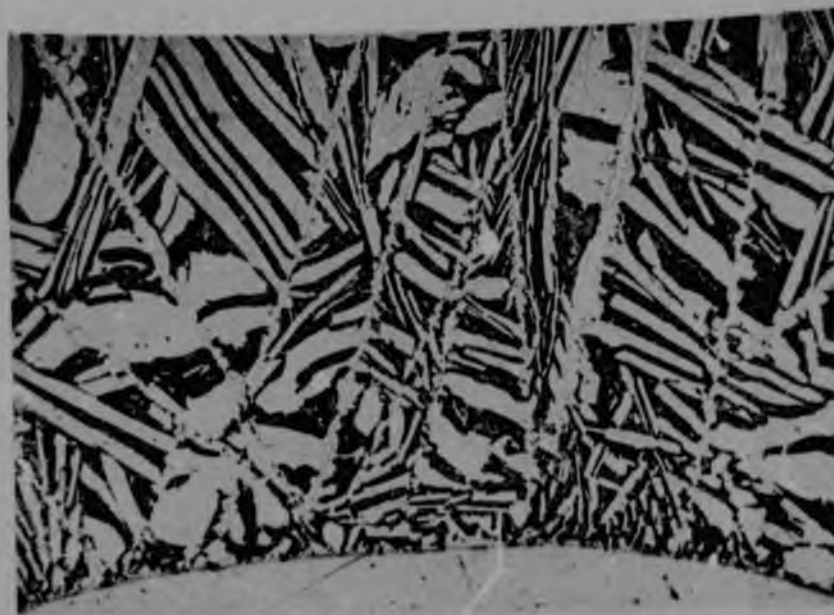
Plate 9

Specimen 2. The thin duplex needles are  $\text{AuSn}_2$  surrounded by  $\text{AuSn}_4$ . The thicker grey needles are primary  $\text{AuSn}_4$  and the black matrix is the  $\text{AuSn}_4$ -Sn eutectic. Etched with  $\text{HNO}_3/\text{CH}_3\text{COOH}$  in glycerine.

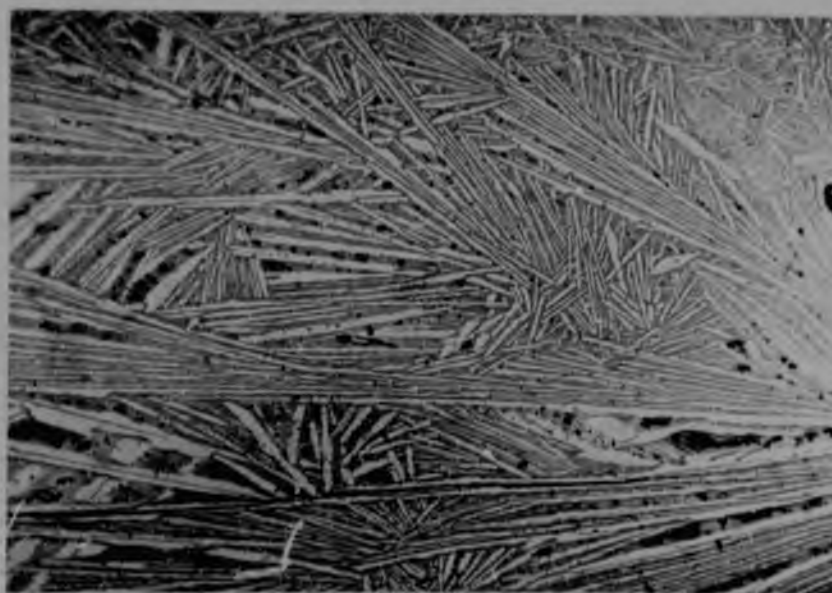
(X 140)

Specimen 4. Duplex AuSn/AuSn<sub>2</sub> dendrites in an AuSn<sub>4</sub> matrix. Etched with 50% HNO<sub>3</sub>.

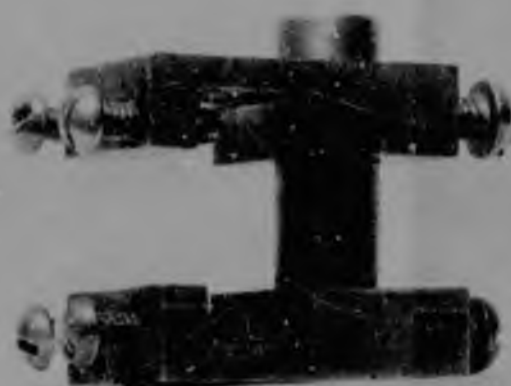
Plate 15

The brass clamp constructed to ensure accurate joint spacing.

To prevent this, a new clamp was constructed (see Plate 15). In this clamp, the two halves of the lap joint were held by cantilever arms which were located on a vertical column. No wire spacers were necessary since no force was applied across the joint, and thus the joint spacing was controlled by the thickness of the solder pre-form. Plate 16 shows a clamped joint assembly ready for soldering. The new clamp produced consistently spaced joints, and due to the higher proportion of solder in these joints, no continuous lead-rich zone was present in the centre.

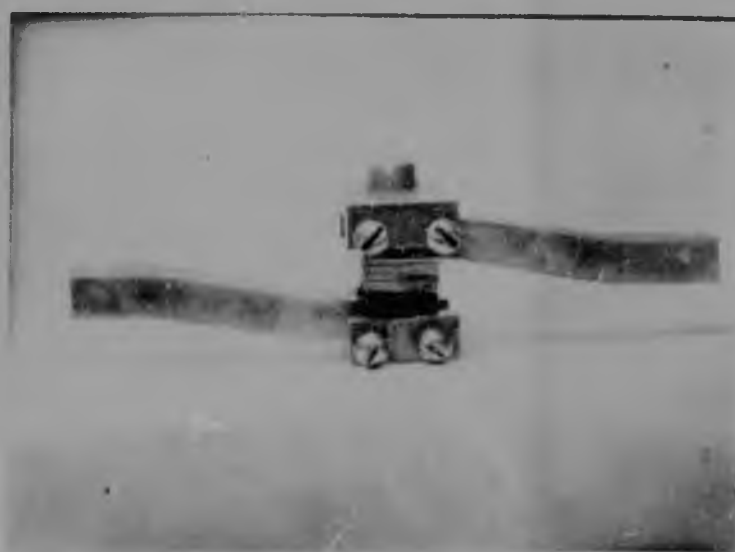
Plate 16

Clamped joint assembly prior to soldering

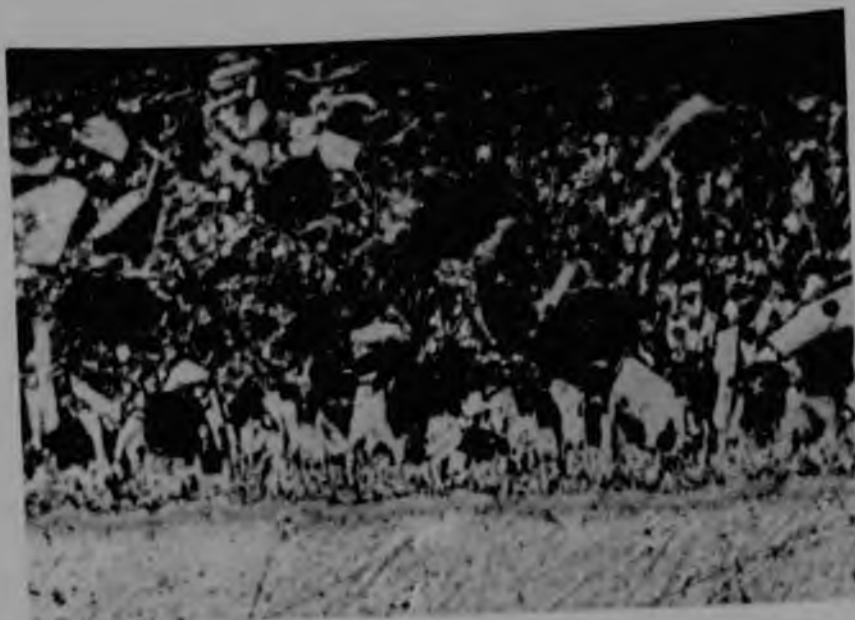
Plate 17

Fractured specimen showing duplex compound layer, with  $\text{AuSn}_2$  adjacent to the gold and columnar  $\text{AuSn}_4$  adjacent to the solder.

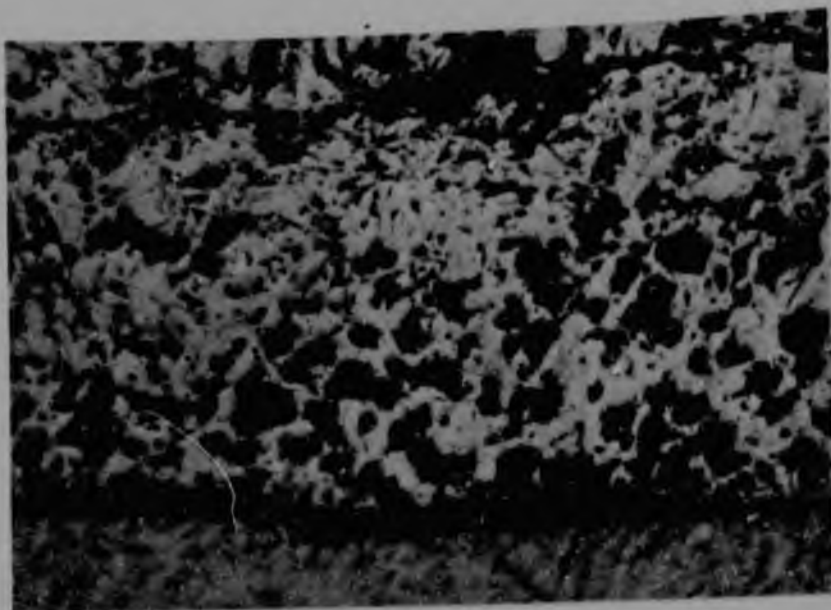
Plate 21(X 700)

Joint soldered at 240°C. The continuous compound layer at the interface is  $\text{AuSn}_2$ .

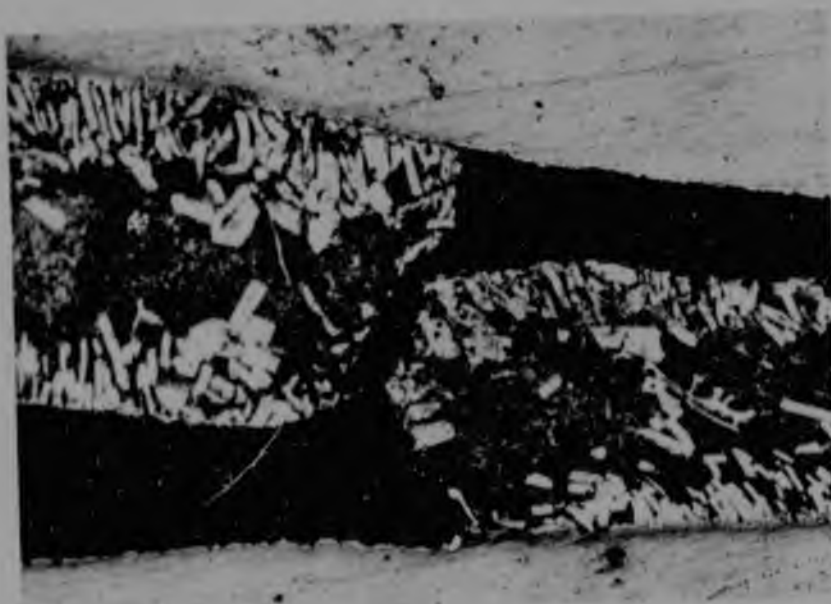
Plate 24

Joint soldered at  $220^{\circ}\text{C}$ . The fracture has travelled at the  $\text{AuSn}_2/\text{AuSn}_4$  interface in this area. Note the residual  $\text{AuSn}_2$  on the gold surface.

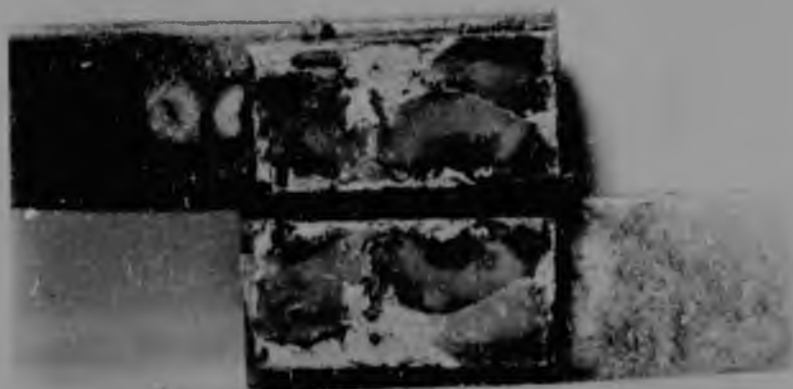
Plate 25

Joint soldered at 220°C and aged at 100°C for 30 days.  
Almost complete low strength, dark Au/AuSn<sub>2</sub> interface fracture.

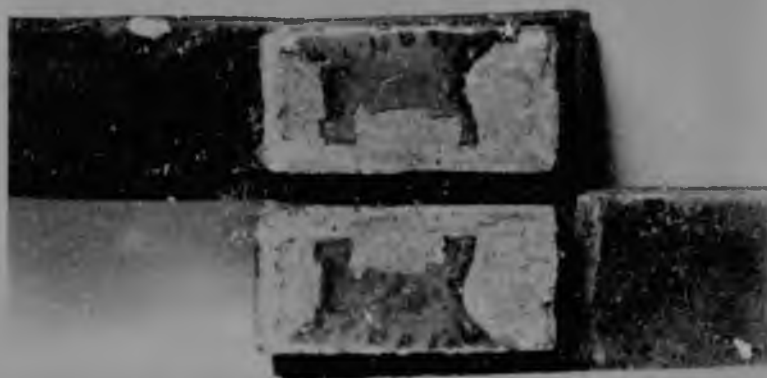
Plate 27

Joint soldered at  $200^{\circ}\text{C}$  and aged for 30 days. The dark fracture surface covers approximately 40% of the total area.

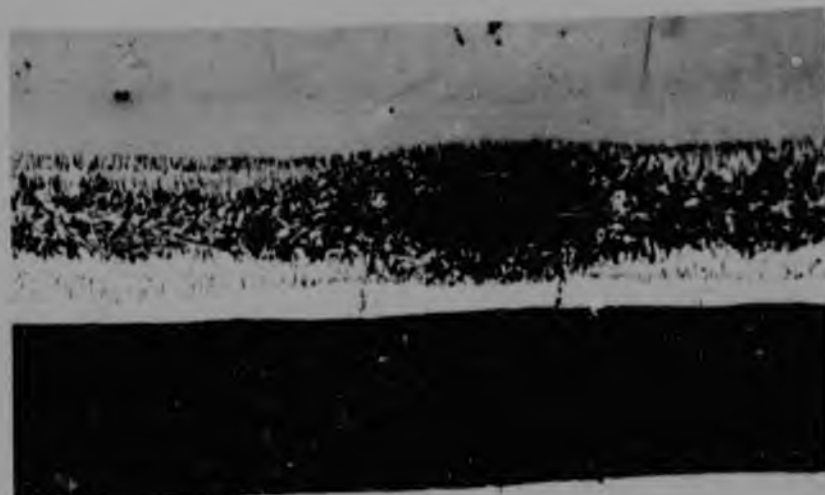
Plate 29

Soldered at  $220^{\circ}\text{C}$  and aged for 30 days. Growth of the compounds has occurred, leading to separation at the  $\text{Au}/\text{AuSn}_2$  interface. This area corresponds to the dark fracture surface.

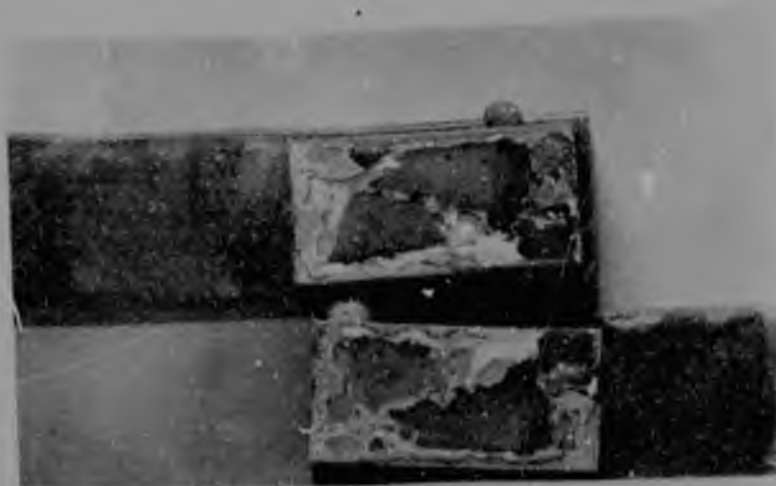
Plate 31

Soldered at 200°C and aged for 60 days. Note increased proportion of dark Au/AuSn<sub>2</sub> interface fracture.

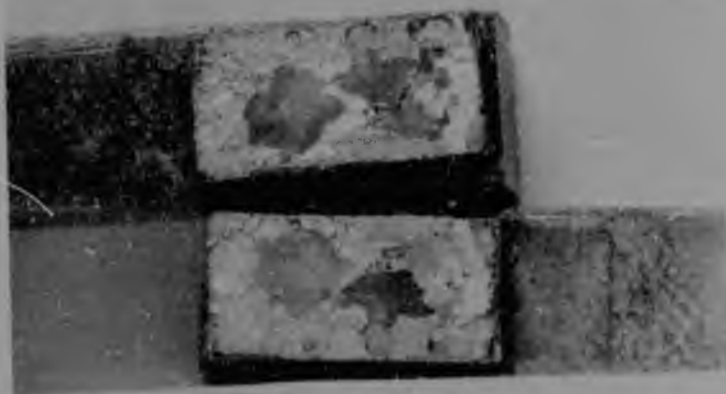
Plate 33

Soldered at  $240^{\circ}\text{C}$  and aged for 60 days. The proportion of dark fracture surface has increased in comparison with plate 28.

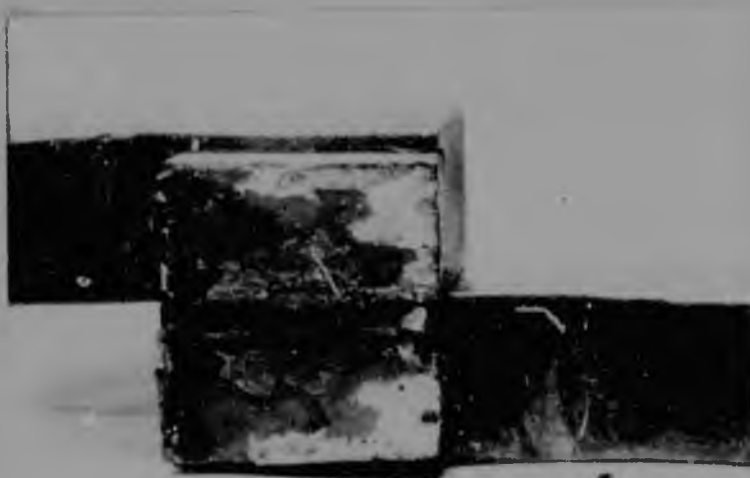
Plate 34

Soldered at  $200^{\circ}\text{C}$  and aged for 90 days. Note increased proportion of dark fracture surface.

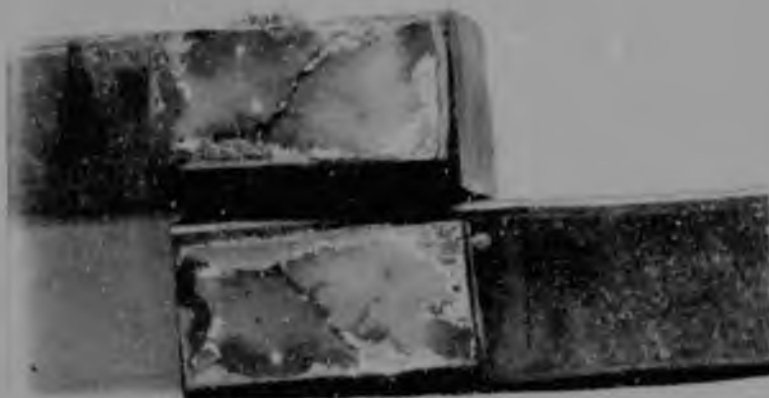
Plate 35

Soldered at  $220^{\circ}\text{C}$  and aged for 90 days. Total separation at the  $\text{Au}/\text{AuSn}_2$  interface has occurred.

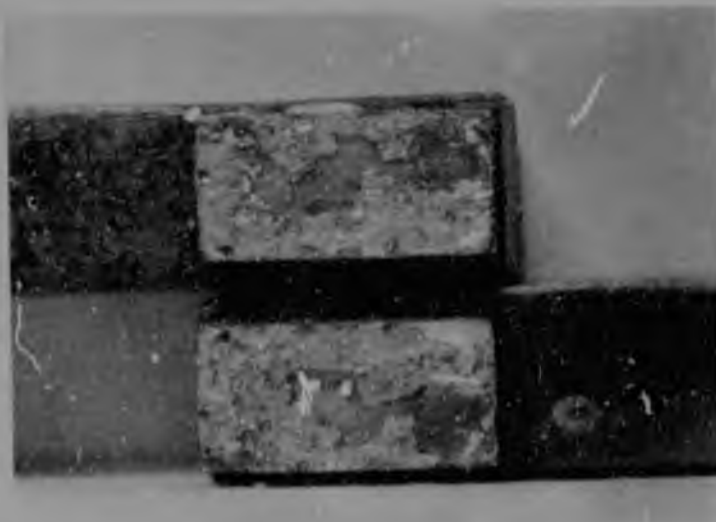
Plate 36

Soldered at  $240^{\circ}\text{C}$  and aged for 90 days. Once again the proportion of dark fracture has increased.

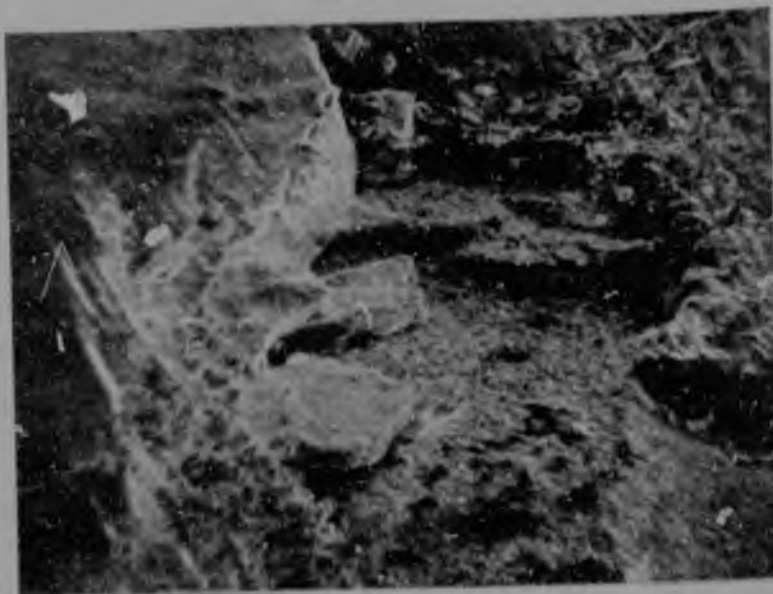
Plate 37

(X 130)

S.E.M. photograph showing an area where the fracture had jumped from the  $\text{AuSn}_4/\text{AuSn}_2$  interface (left hand side) to the  $\text{Au}/\text{AuSn}_2$  interface (centre).

The first specimen studied was one which had been soldered at  $200^{\circ}\text{C}$  and aged for 30 days at  $100^{\circ}\text{C}$ . The area of interest was a dark, smooth area at the centre of the specimen. At low magnification this was seen to be a flat area surrounded by steep walls rising to another flat, plateau-like surface (see Plate 37). Analysis of the lower surface revealed this to be gold, while the plateau area gave strong responses for both gold and tin. Unfortunately the analysis was not quantitative, but the smoothness of this surface indicates that it is the top of the  $\text{AuSn}_2$  compound layer. Thus this was an area where the fracture had

travelled along the  $\text{AuSn}_4/\text{AuSn}_2$  interface and then crossed the  $\text{AuSn}_2$  interface. A view of this step at high magnification is shown in Plate 38. The brittle nature of the  $\text{AuSn}_2$  layer can be seen from the many cracks in it, and the clean separation between the  $\text{AuSn}_2$  and the gold is also apparent.

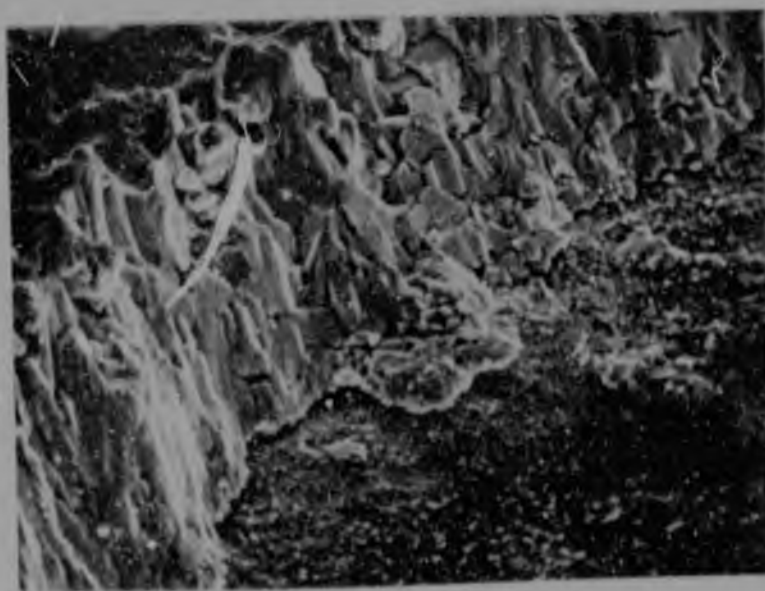
Plate 38

(X 1200)

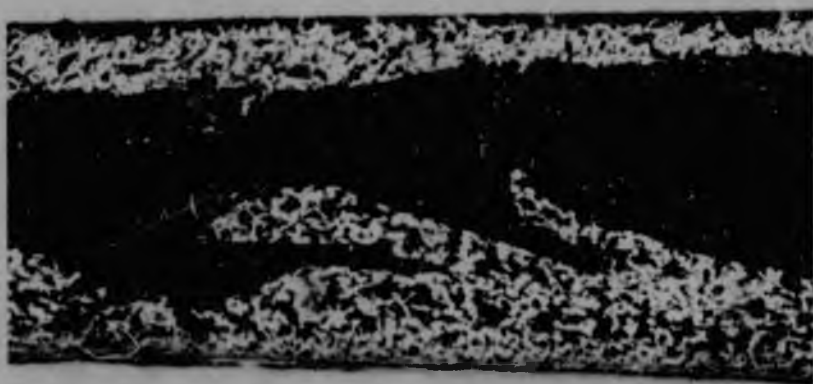
Plate 40

(X 200)

Specimen no. 1, showing failure in the centre of the joint.

The first five specimens in this group exhibited shiny, granular fracture surfaces and were found to have failed in the centre of the joint (see Plate 40). Most of the gold-plate had dissolved during soldering and therefore compound growth during ageing was limited. Some growth did take place however, (see Plates 41 and 42) and the specimen

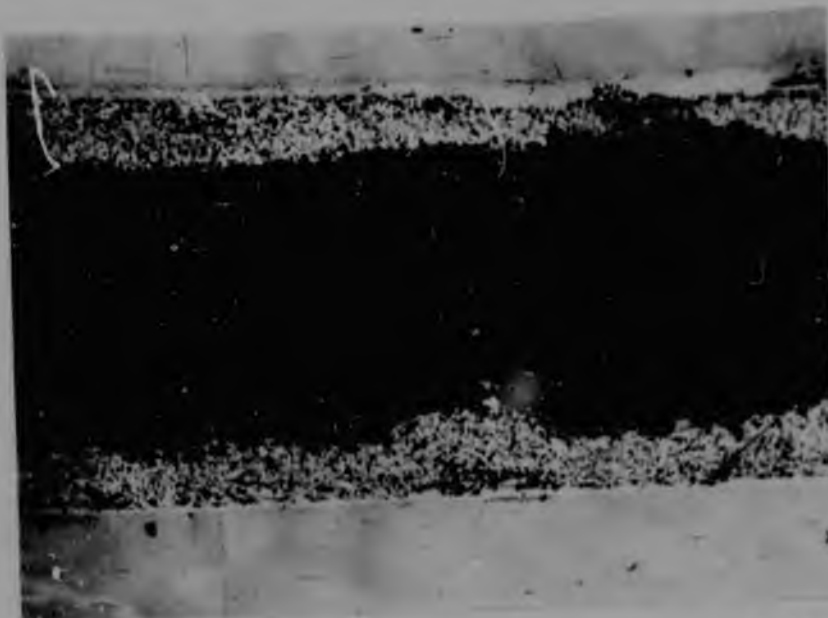
Plate 41

(X 170)

Specimen no. 2. Note the growth of the  $\text{AuSn}_2$  layer after ageing for 30 days.

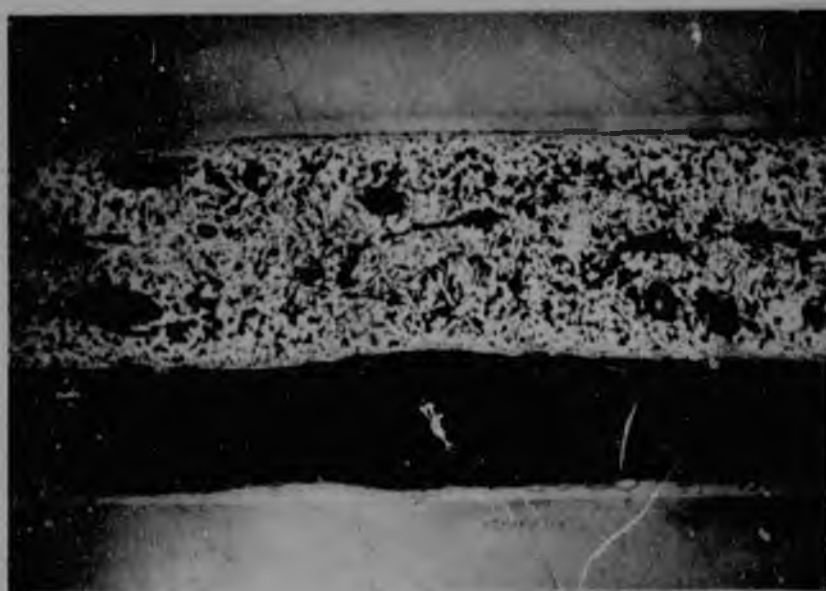
Plate 44

(X 250)

Specimen no. 6. Complete separation between the  $\text{AuSn}_2$  layer and the residual gold.

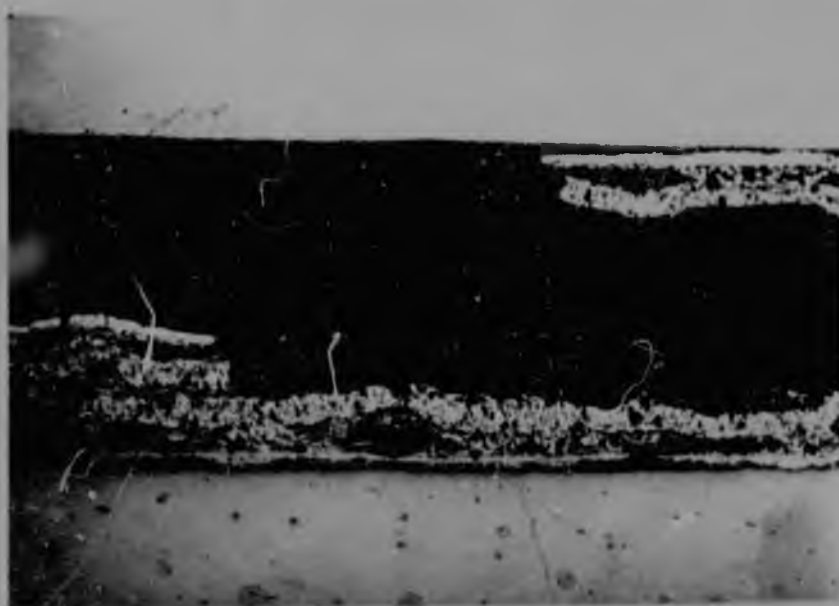
Plate 45

(X 130)

Specimen no. 7, showing both fracture in the centre of the joint and separation at the Au, AuSn<sub>2</sub> interface.

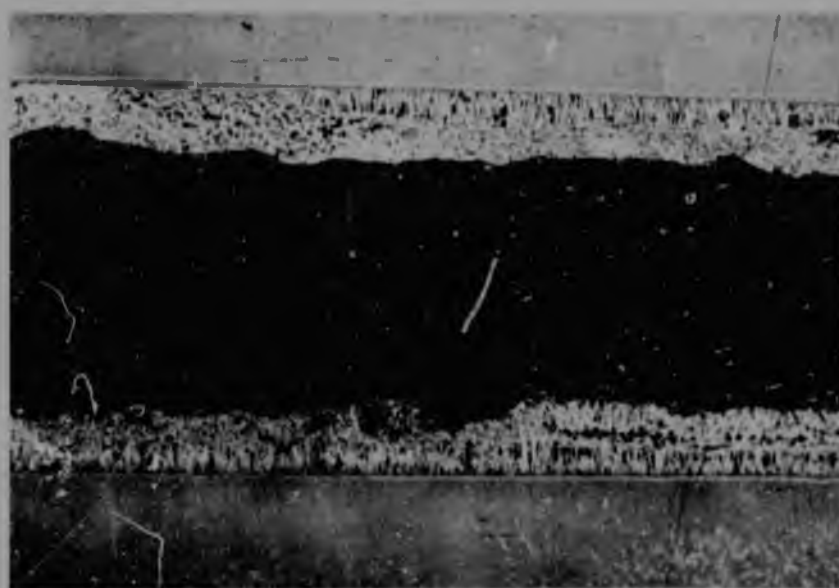
Plate 46

(X 120)

Specimen no. 11. Note the columnar AuSn<sub>4</sub> crystals from each surface and fracture in the zone between them. The nickel underlayer is visible between the copper substrate and the AuSn<sub>4</sub> crystals.

Specimens 11 to 15 correspond to numbers 1 to 5 except that they had a 5 to 7 micron nickel under-layer. These joints also produced bright fracture surfaces and separation was found to have occurred in the centre of the joint (see Plate 46). All of the gold had dissolved and there was a layer of columnar  $\text{AuSn}_4$  crystals adjacent to the nickel surface. The aged specimens revealed small areas where fracture had occurred between the nickel and the  $\text{AuSn}_4$  layer.

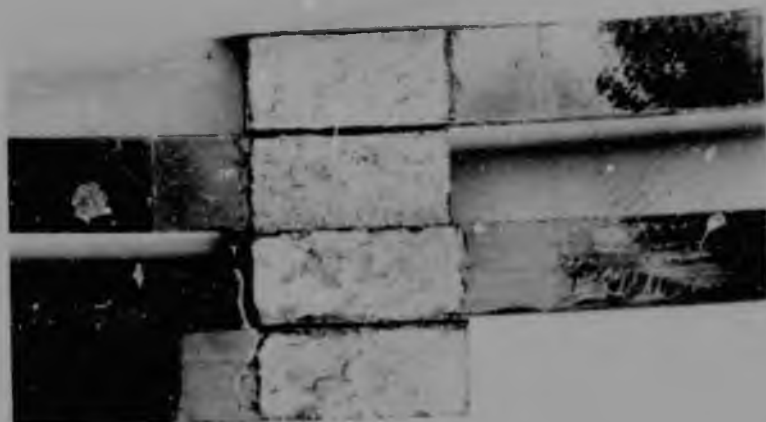
Plate 49

Specimens 22 (top) and 23 (bottom). Bright fracture surfaces of high strength joints.

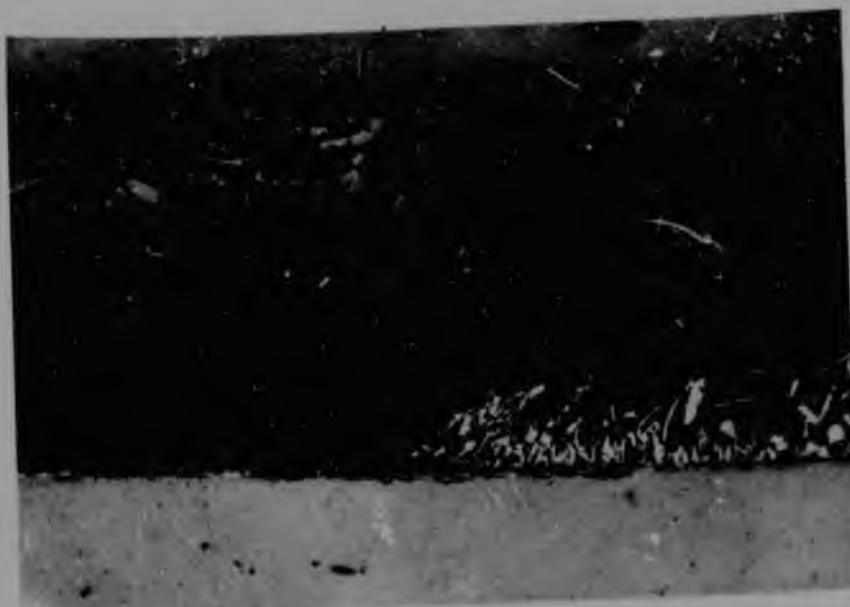
Plate 52

(X 100)

Specimen no. 33. Separation has occurred in the centre of the joint and at the  $\text{AuSn}_4/\text{AuSn}_2$  interface.

Specimens 31 to 35 all exhibited a bright fracture surface, and separation was found to have occurred both in the centre of the joint and at the  $\text{AuSn}_4/\text{AuSn}_2$  interface (see Plate 52).

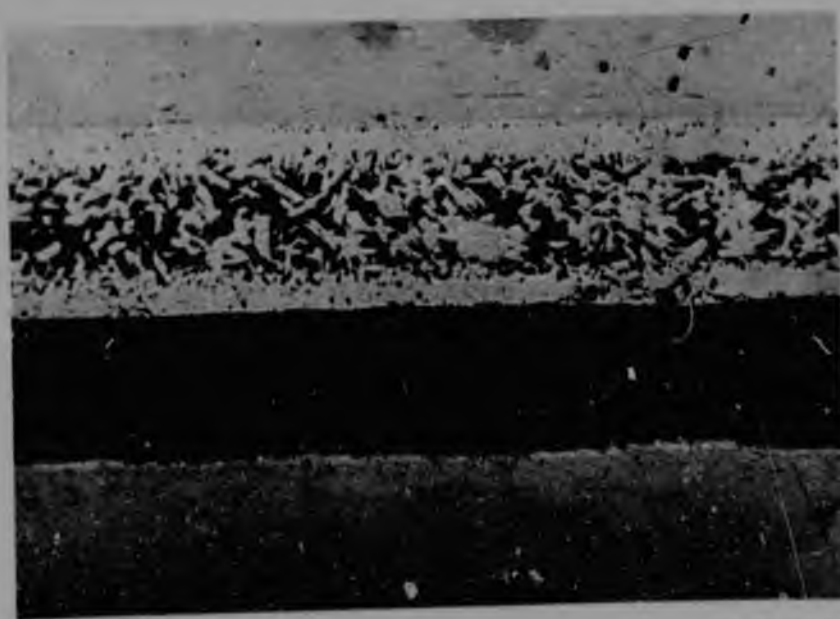
Plate 53

(X 250)

Specimen no. 39. The presence of residual gold has enabled growth of the  $\text{AuSn}_2$  layer to occur, causing separation at the  $\text{Au}/\text{AuSn}_2$  interface.

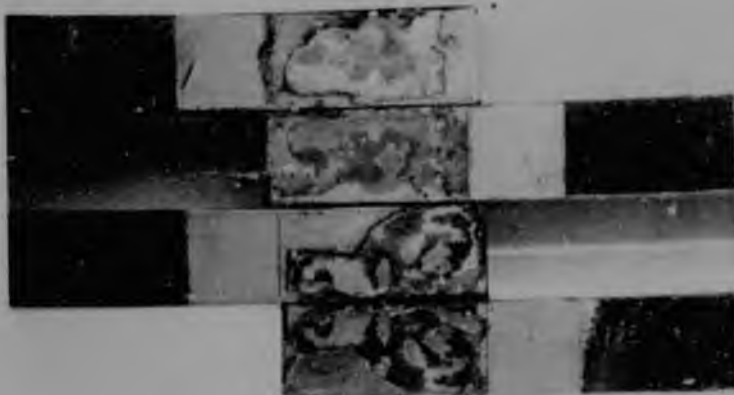
Plate 54

Specimens 42 (top) and 43 (bottom). Low strength, dark fractures at the AuSn<sub>2</sub>/Ni interface. Note also the incomplete wetting of the gold by the solder.

The shear strength of specimen 41 was high, and the fracture was found to have occurred either at the  $\text{AuSn}_4/\text{AuSn}_2$  interface, or adjacent to the columnar  $\text{AuSn}_4$  layer, giving a bright fracture surface. The strength was lower than that of specimen 31, which had the same thickness (3 microns) of alkaline cyanide gold, but was without a layer of nickel beneath the gold. The joints in this category which had been aged, however, yielded low shear strengths, and produced dark, smooth fractures at the  $\text{AuSn}_2/\text{Ni}$  interface, shown in Plates 54 and 55. The lack of complete wetting of the gold surface can also be seen in these photographs.
