# Microscope observations of ART excavated cavities and restorations

ES Grossman, S Mickenautsch

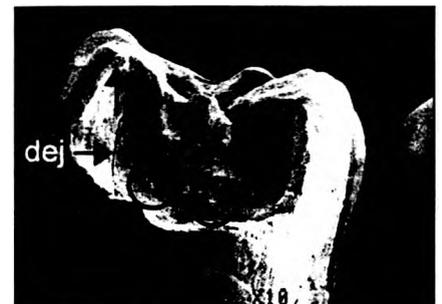
Fig. 2. This cavity surface shows pocketing, grooving, crevicing, ridging and furrowing on both enamel and dentine surfaces. Unsupported enamel is evident ( $\leftarrow$ ). Note the chunks of surface debris (circled) and dehydration crack indicating the dentino-enamel junction (dej).

lesion. From the specimens examined it was not possible to define a typical cavity configuration; however all cavities examined in this study encompassed both enamel and dentine (Fig. 2). Crests of unsupported enamel were evident (Fig. 2). The cavity margins did not form a right angle to the tooth surfaces but were generally chipped and indented and followed an irregular course (Fig. 3). Fractured enamel surfaces were evident but generally enamel surfaces were smeared and debris covered, obscuring the enamel prism structure. Cavity shape varied tremendously between specimens and it was not possible to determine the point at which the cavity wall became the cavity floor. At low magnification the excavated cavity surface had a complex surface arrangement: pocketing was evident, as well as grooving, crevicing, ridging and furrowing on both enamel and dentine (Fig. 2). All dentine surfaces were covered or smeared with debris but in some areas the underlying dentine structure was visible showing occluded dentinal

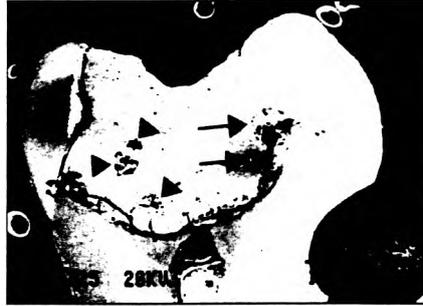
Fig. 6. Voids are apparent within the GIC (arrow heads) and at the GIC-tooth interface (arrows) in this specimen. Such interfacial voids account for 16% of the tooth-GIC interface.

The most striking feature of the restored cavities were the numerous voids, both large and small, within the GIC and at the tooth-restoration margin. Ten of the 22 restored specimens had large voids both within the restorative material and at the cavity-GIC margin (Figs 5 and 6). Such voids were spherical or irregular with smooth inner margins which indicated that they had formed because of air entrapment (Fig. 5). Interfacial voids prevented adaptation along considerable lengths of the tooth-GIC interface (Figs 5 - 7). All sectioned specimens had bubbles within the GIC which were  $<50\ \mu\text{m}$  in diameter. Concentrations of bubbles ranged between 100 and 200 within a surface area of  $500\ \mu\text{m}^2$ . Irregular-shaped voids and inclusions within the GIC were frequently seen. One of the inclusions was identified as strands of cotton wool (Fig. 7); in another specimen a blue thread was seen. The origin of irregular inclusions in other specimens was more obscure (Fig. 8).

to the cavity surface despite specimen preparation (Fig. 8 - 10) whereas in other specimens adaptation was poor (Fig. 5) or hampered by voids (Fig. 6). It was necessary to define good and poor GIC adaptation to the cavity wall and distinguish it from the effects of specimen dehydration which caused the GIC to shrink, pulling away from the cavity wall in all specimens. Good adaptation was easily recognised in that the GIC margin ran parallel to and replicated exactly the contours of the irregular cavity margin. If adaptation was poor the GIC margin followed a different course to the cavity margin (Fig. 5). There were no obvious differences between the features of novice and skilled prepared ART cavities.

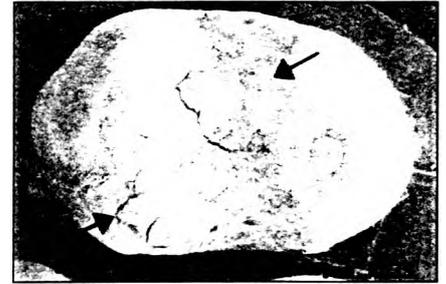
Fig. 11. Low power view of the ART restored occlusal tooth surface showing the rough 'press finger' surface. Note that the GIC margin is difficult to follow with ditching (top arrow) and raised ledges (bottom arrow). The cracks in the GIC are dehydration artefacts.

All ART restoration surfaces were rough. Gross roughness took the form of grooves and pits presumably caused by carving. Banked margins, peaks of GIC and rippled surfaces (Fig. 11) were also seen. At magnifications higher than X500 scratches, pits, porosities, chipping and voids were evident (Fig. 12). Restoration margins were not always readily apparent as the 'press finger' technique was able to merge the GIC to a fine edge on the occlusal surface. In other specimens the GIC formed a ridge at the restoration periphery.
