UNIVERSITY OF THE  
WITWATERSRAND,  
JOHANNESBURG

**EFFECT OF REHABILITATION ACTIVITIES ON  
ECOLOGICAL INTEGRITY AND FLOW REGULATION  
FUNCTION OF WETLANDS IN A GAUGED CATCHMENT**

Research Report submitted in partial fulfilment of the requirements  
for a Masters Degree in Environmental Sciences

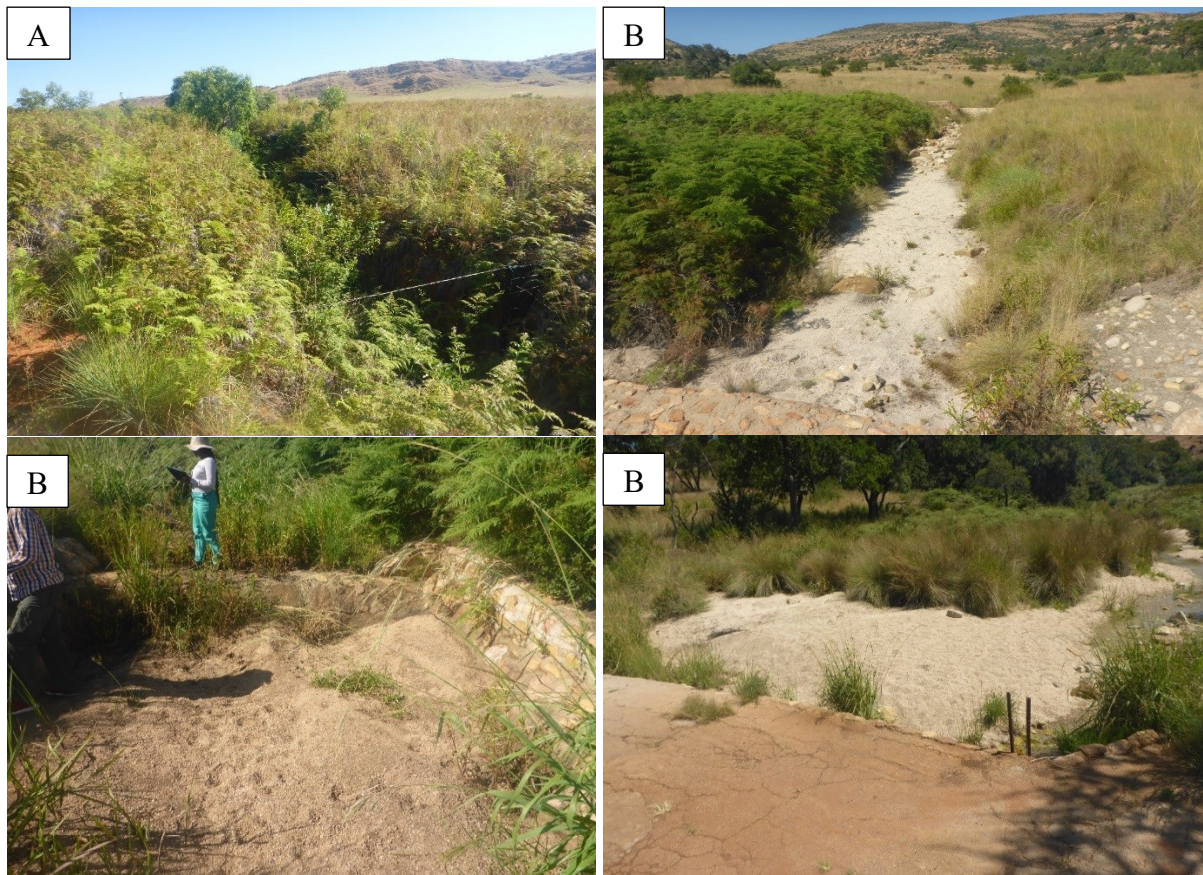
**Figure 8:** Channel incision and sediment fences (A) within side slopes of UCVB1, exposed sediment bars upstream and downstream of the flow impeding structures (B) within CVB1 within the Kgaswane Nature Reserve.

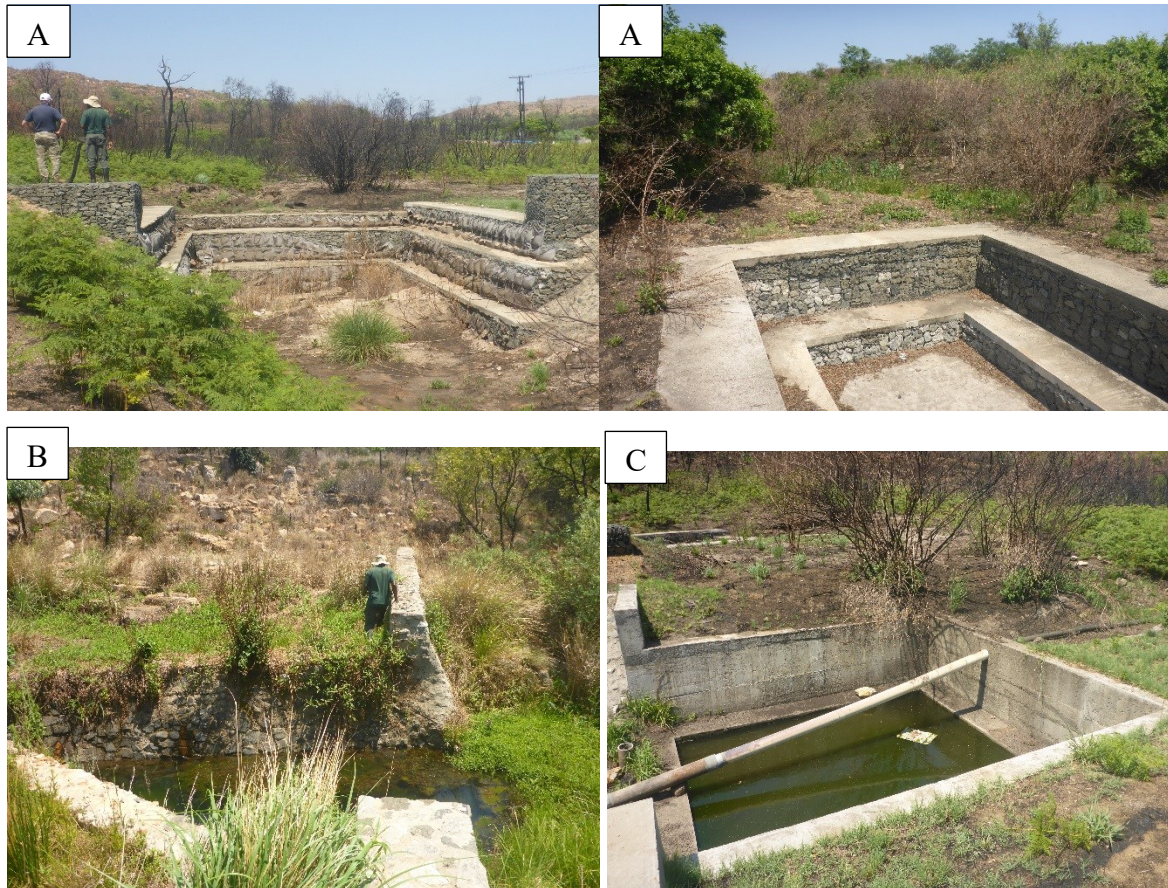
**Figure 11:** Erosion control and stabilisation interventions recorded on a wetland on site. (A) – gabion concrete cast weirs, (B) – rock masonry and (C) – concrete drop inlet weir.

An assessment of the Rietfontein Wetland indicated that attempts to restore the ecological function of the wetland had been implemented on site. Various wetland rehabilitation interventions at specific areas had been implemented on site. These interventions were aimed

at controlling and stabilising erosion (mainly headcut erosion) and raising the water table to promote flow distribution and diffuse flow in the wetland system. The implemented structure consisted of gabion concrete cast and rock masonry weir structures at various key points within the wetland system, as indicated in Figure 11.

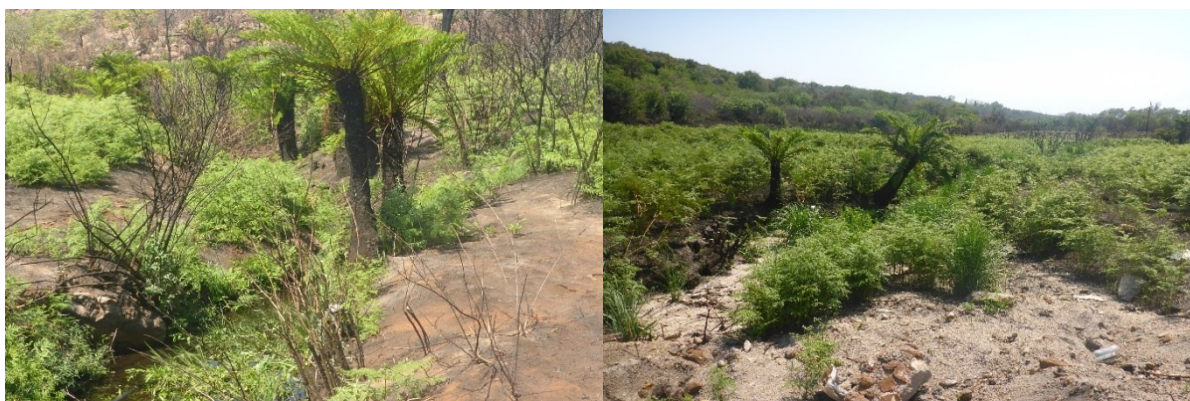
**Figure 12:** Prominent species within the wetland included tree ferns *Alsophila dregei* (tall plants) and bracken *Pteridium aquilinum* (short plants).

There were, however, persisting impacts on the wetland recorded on-site and this included erosion (gully erosion, channel incision, headcut erosion, and excessive water abstraction to meet the water demand for irrigation of the orchards around the wetland area). A section of the wetland was burnt during the site visit, which consisted of *Gunnera purpensa*, *Alsophila dregei* and *Pteridium aquilinum*, the dominant species (Figure 12).

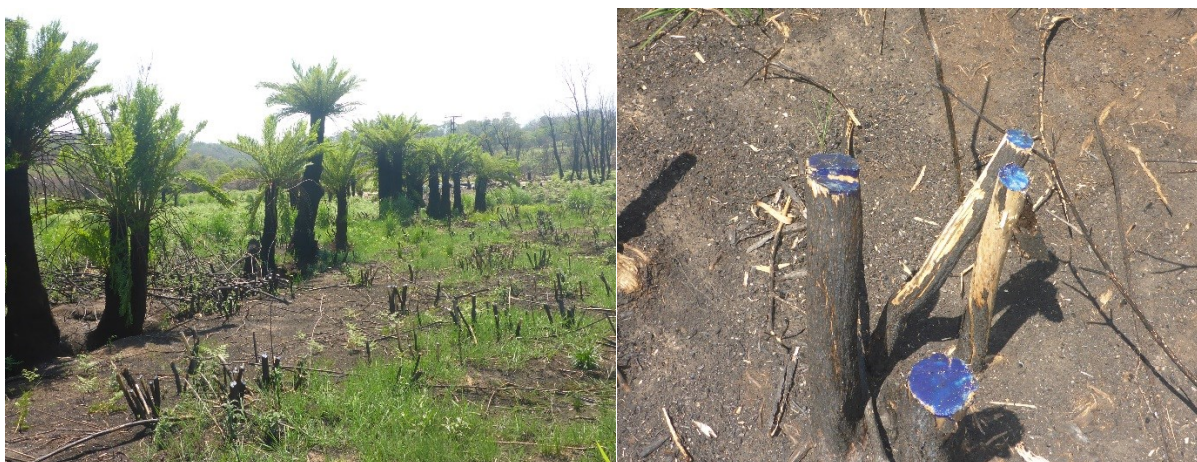
**Figure 13:** Cut tree stumps of trees that had been burnt within the wetland system.

It appeared that dead wood from the fire was presumably from alien vegetation, especially around the fern-dominated wetland section that had been cut and cleared; however, not all invasive species had been removed within the wetland area. Figure 13 below illustrate the cut stumps of trees that had been burnt within the wetland system.
