School of Mining Engineering

**A REVIEW OF THE STOPE SUPPORT SYSTEM  
AT IMPALA BAFOKENG NORTH SHAFT  
OWING TO STOPE CLOSURE AT SHALLOW  
MINING DEPTHS**

A research report submitted to the Faculty of Engineering and the Built Environment, University of the Witwatersrand, Johannesburg, in partial fulfillment of the requirements for the degree of Master of Science

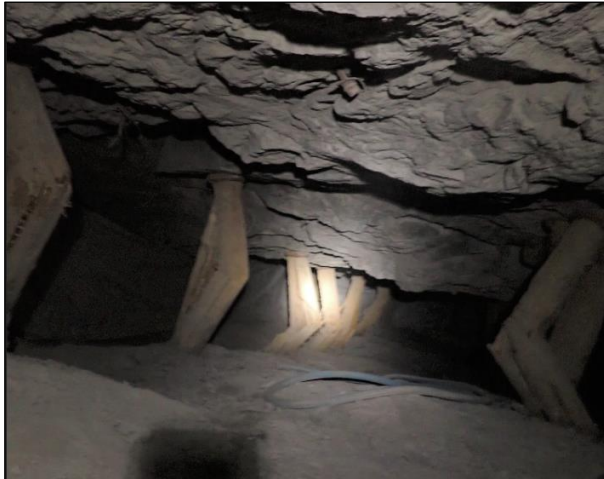
The stope panel support system at North Shaft is designed to carry the deadweight up to the tensile zone. At shallow mining depth, little to no closure is expected (Jager & Ryder, 1999). The support system is designed to be stiff and active. The design is consistent with shallow mining support requirements of depths of less than 1000 m. The mine pole support was found to be splitting and buckling in the back areas of the panel from as little as 20 m away from the face (Figure 1.4). This led to the finding that the closure rate had increased rapidly from previously mined stopes. This study was aimed at adapting the support design for the new conditions encountered.

*Figure 1.4: Failed mine poles in the back area of stopes.*

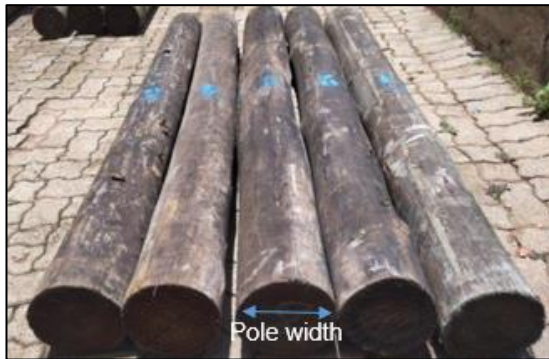
The support design of North Shaft relies heavily on mine poles. A mine pole refers to an unturned elongate; mine poles are generally grown from a eucalyptus tree (Figure 1.6). The width of the mine pole is measured diametrically across the end of the pole. The mine poles are cheap compared to hydraulic props. The mine poles are readily available and simple to install. At shallow depth, mines generally have a low dynamic support requirement which makes the mine pole a suitable choice due to its stiff nature. The mine poles are installed in combination with a pre-stressing device. The mine pole becomes an active support unit which is ideal for mining at shallow depths.

Figure 1.6: Mine poles (Khosa, 2022).

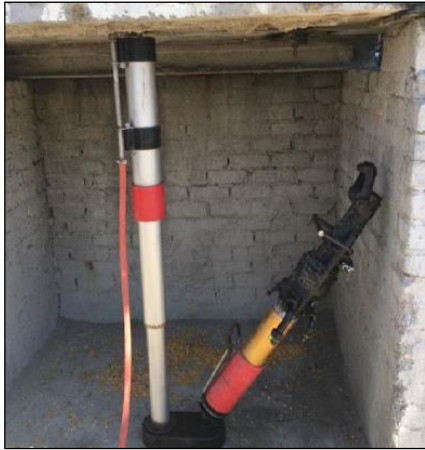
In-stope bolts are utilised that are 1.2 m in length. The bolts are 16 mm Secura Bolts and are installed with resin. A specially designed, telescopic drill rig with a stinger was utilized. The stinger assists with stabilizing the rig to reduce risk to the rock drill operator whilst drilling (Figure 1.8).

Figure 1.8: Telescopic drill rig and stabilizer.

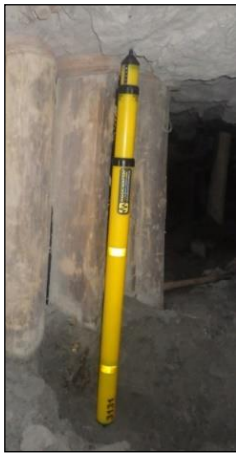
Observational methods such as closure logging can be used during mining. The analysis of the ground-support interaction is the only way to verify the excavation designs that were based on empirical and analytical methods (Swart, 2005). Closure measurement data was recorded with closure loggers (Figure 2.10). The data can be used as a predictor for large collapses in mines. Closure data can also be used for improving support designs through the inclusion of the effect of the mining rate (Malan & Napier, 2021). The data can be used to define ground control districts with specific support strategies.

*Figure 2.10: Closure logger installed in a stope panel.*

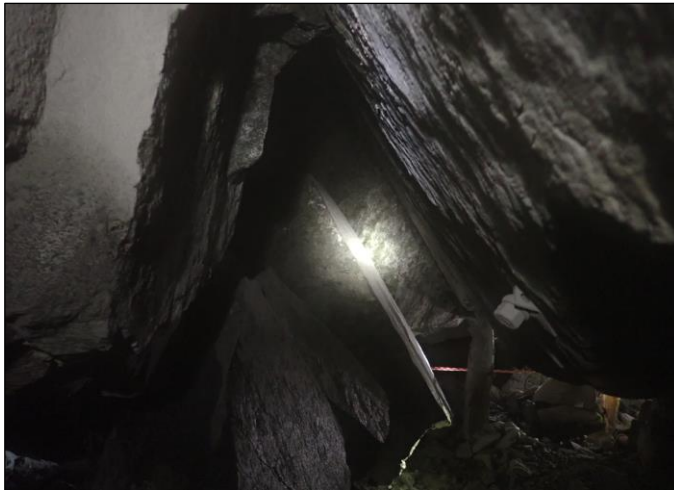
The stability of the panels is influenced by the geological discontinuities present. The discontinuity spacing, infilling, orientation, dip and persistence all factor into the overall stability. A typical wedge failure is presented in Figure 2.13 below. Dome structures or curved ramp structures occur randomly and have been observed to extend from as little as 2 m to as much as 30 m across a panel. Investigations of numerous FOG's by York et al. (1998) found that almost all the FOG events were linked to major geological discontinuities and not due to span alone. They found that there was a correlation between a reduction in span and improvement of hangingwall conditions where shallow dipping discontinuities were present.

*Figure 2.13: Wedge failure between joint sets.*

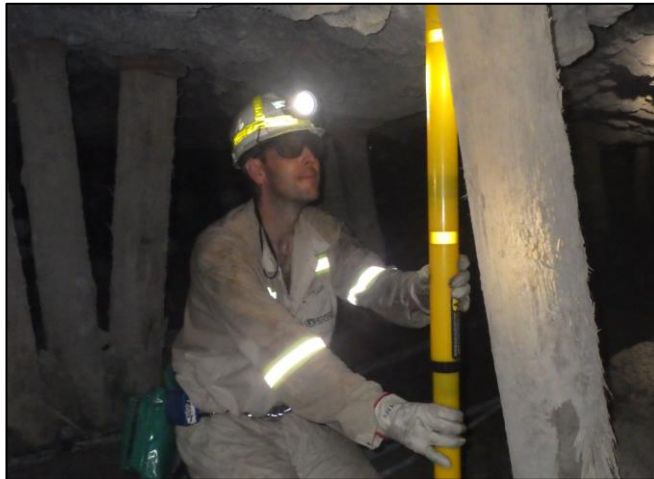
*Figure 3.2: Closure logger installation by the author.*

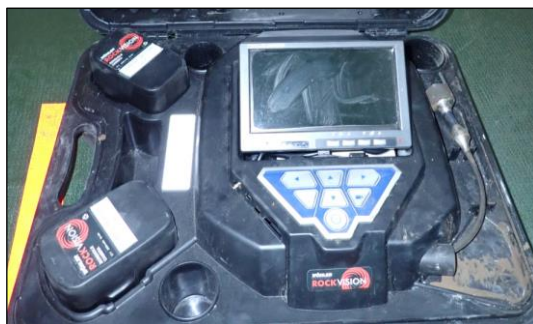
Figure 3.4: Rock Engineering Department borehole camera.

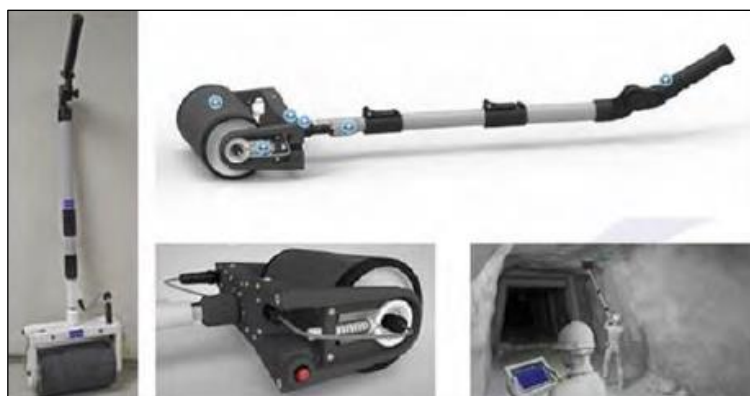
Figure 3.7: Sub Surface Profiler used for GPR analysis (Andrews, et al., 2019).

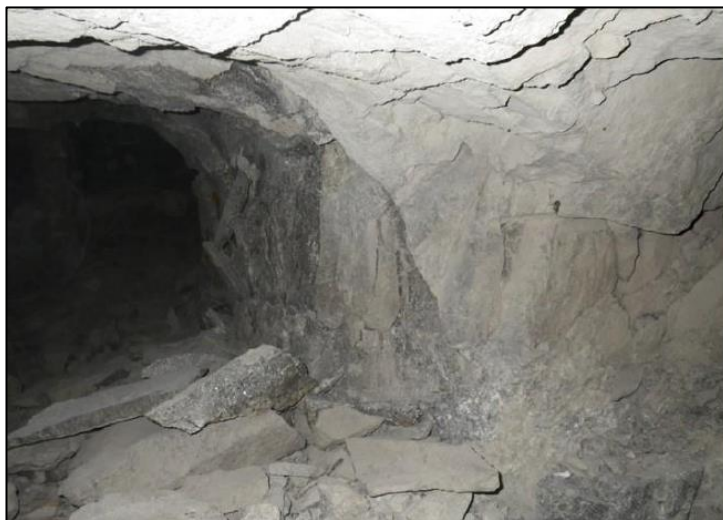
Visual observations were conducted for the in-stope pillars to determine whether they were behaving as expected according to the crush pillar design (Figure 3.8). Observations were conducted to inspect the footwall and hangingwall for fracturing. Panels were identified on plan with various spans and then visited to assess the support behaviour in the workplaces identified. The spans ranged from 24 m to 30 m. Back analysis of falls of ground were conducted to verify the failure mechanisms involved.

*Figure 3.8: Crush pillar scaling at N15 Level.*

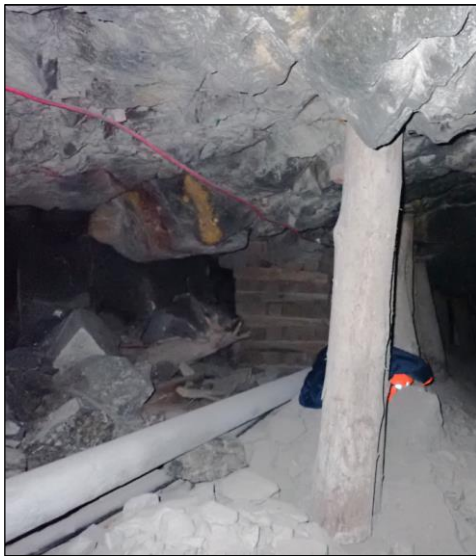
The failure mechanism of the FOG's that have occurred in the section were analysed. The dead weight fallout of keyblocks or wedges was the main mechanism observed. Unravelling was observed but would occur after the elongate failure had taken place and the required support resistance was no longer provided. The C-Packs would prevent unravelling and compartmentalise the falls (Figure 4.1).

*Figure 4.1: FOG along C-packs prevented further unravelling.*

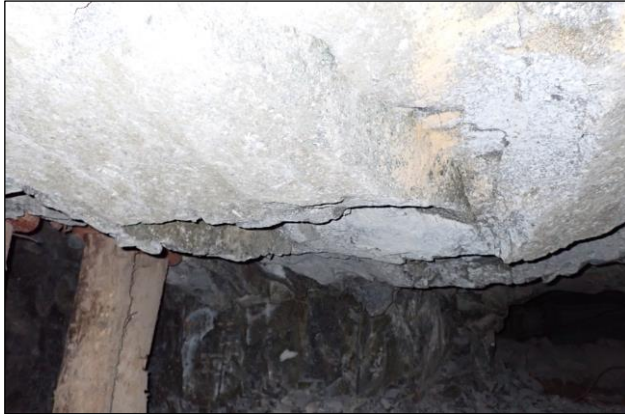
The hangingwall around the pillars was observed to be competent and no fractures were present (Figure 4.6). Hangingwall conditions were stable.

*Figure 4.6: Hangingwall condition around the crush pillar.*

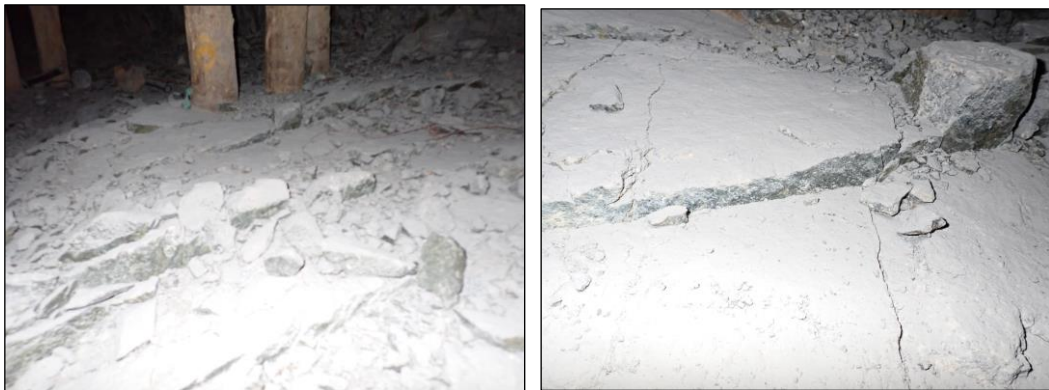
*Figure 4.7: Footwall fracturing and heave around a crush pillar footwall.*

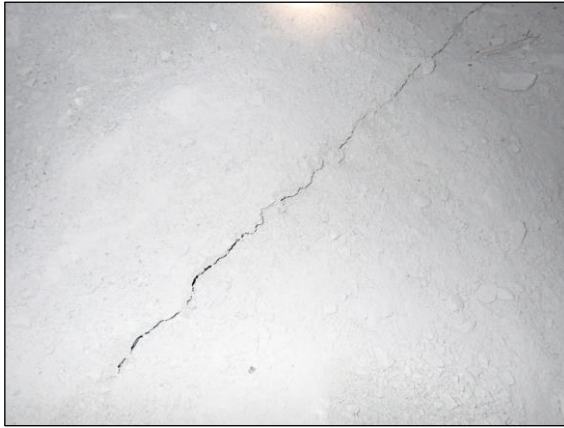
*Figure 4.8: Tensile cracks in the footwall.*

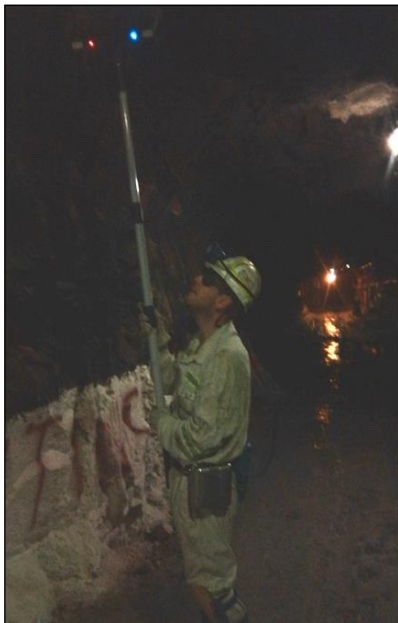
GPR scans were conducted on both 14 Level and 15 Level Roadways as they are on reef excavations and located on either side of the closure areas. The GPR was used to correlate the findings of the borehole camera work conducted (Figure 4.9). The profiles are recorded directly to the tablet and then transferred to the server via Bluetooth. Additional scans were conducted along the 15 Level north 02 raise line.

*Figure 4.9: The author conducting GPR scans along the Roadway.*

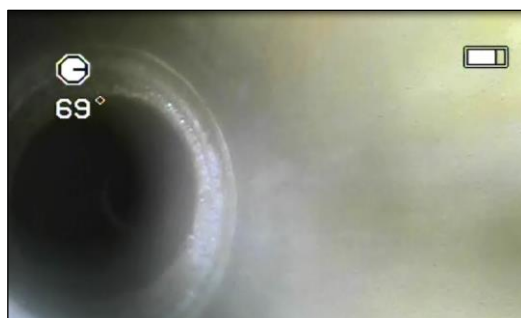
Figure 4.14: Contact from Merensky hangingwall to Norite.

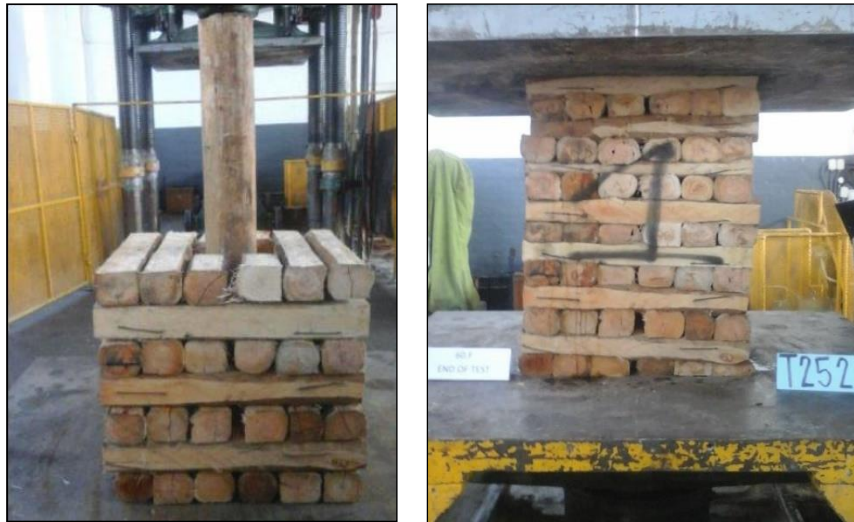
Figure 4.17: C-pack construction and testing at the CSIR Laboratory in Johannesburg.

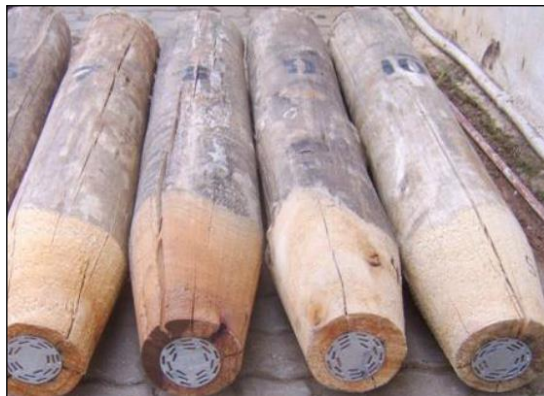
Figure 4.19: Pencil sticks selected for load deformation testing (Mabitsela, 2023).

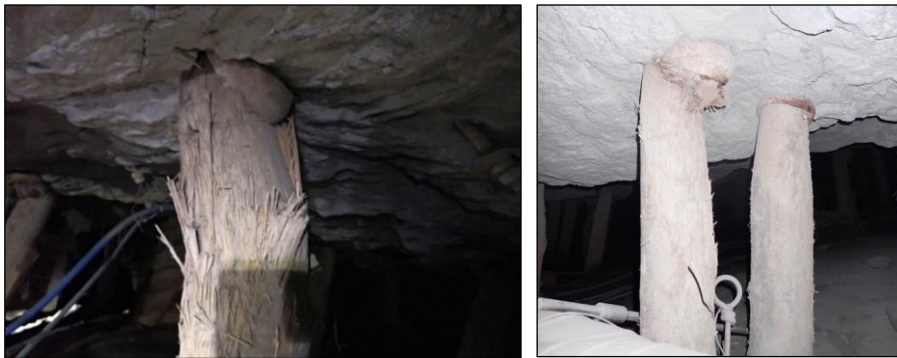
Figure 4.22: Pencil sticks showing rapid yielding.

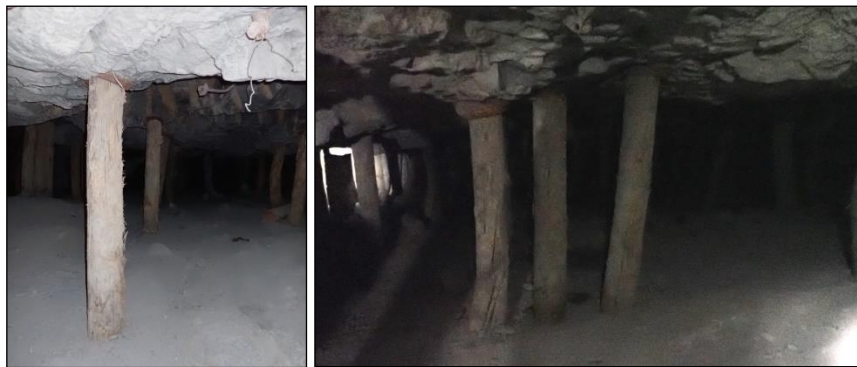
*Figure 4.24: Mine pole support in short panel.*
