## CHAPTER 11:

## THE RIDGED AND HIPPED ROOF

**Name of thesis** The Development Of Rural Vernacular Architecture In Southern Africa. 1980

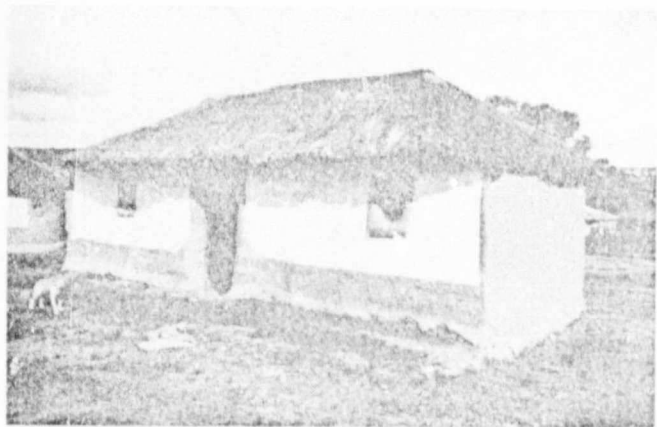
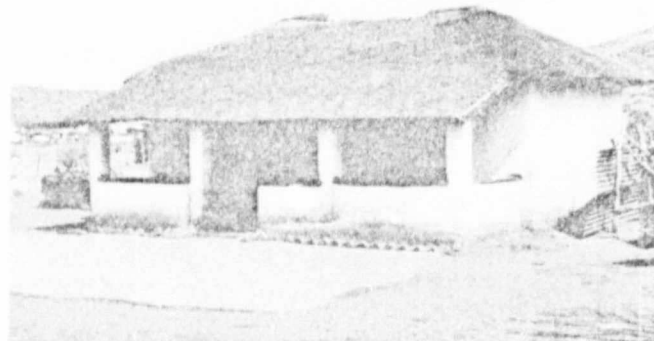
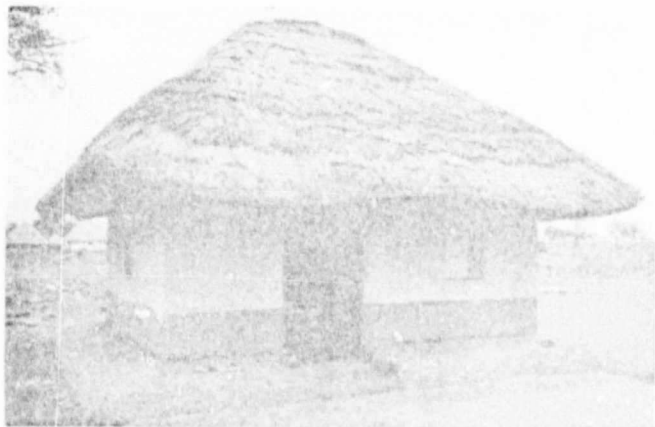
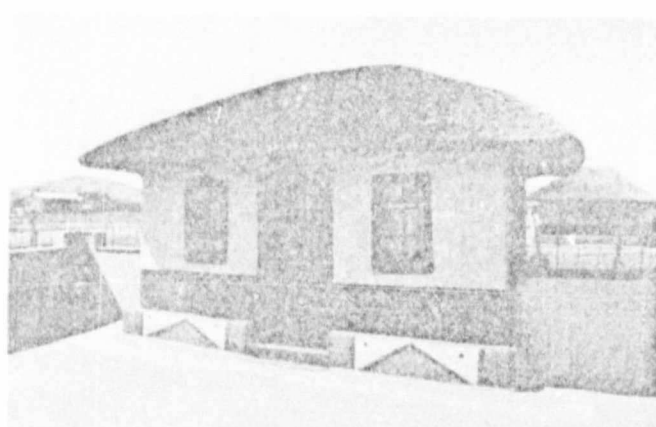
- a. Dwelling: Alice, Ciskei.
- b. Dwelling with front verandah: Moruleng, Bophuthatswana.
- c. Dwelling: Xigalo, Gazankulu.
- d. Dwelling: Mogongwa, Lebowa.

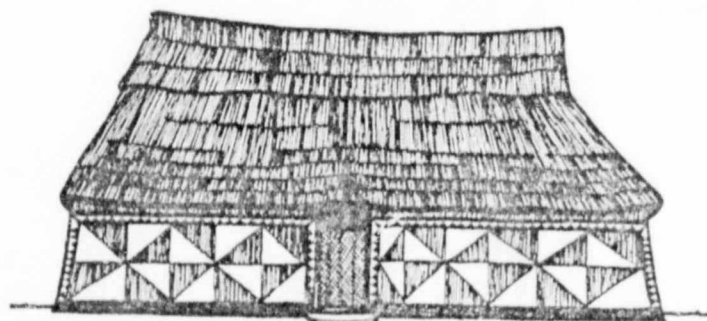
Ridged and hipped roof: Units  
23 and 24.

- CLASSIFICATION: RIDGED & HIPPED ROOF.
- LOCATION: UNIT 23: STANDERTON.  
UNIT 24: MARIKANA.
- CONSTRUCTION: UNIT 23: THE WALLS ARE BUILT UP IN LOAD-BEARING, SUN-DRIED EARTH BLOCKS BONDED IN EARTH & PLASTERED WITH DACA. THE WALLS ARE LIGHTLY BUTTRESSED TO ACCOUNT FOR THE LATERAL THRUST OF THE ROOF STRUCTURE. THE ROOF TRUSSES ARE TIED IN THE SHALLOW THIRD OF THE ROOF VOID. THATCH LAID SEED-END UP.  
UNIT 24: UNDRESSED FLINTSTONE IS BONDED IN EARTH. THE ROOF TRUSSES ARE TIED AT EAVES LEVEL AND EACH BEAM IS TIED TO THE TIE BEAM BY A STRUT. THATCH LAID SEED-END UP & SHINGLED.

- SOCIAL GROUPING: NEITHER UNIT BELONGED TO A SETTLEMENT OR HOUSEHOLD OF DISCERNIBLE PATTERN. UNIT 23 FUNCTIONED AS A LIVING/SLEEPING AREA; UNIT 24 FUNCTIONED AS A CHURCH.

- GENERAL: SMALL WINDOW OPENINGS, TIMBER SHUTTERED IN BOTH CASES. CONDITION OF BOTH UNITS IS GOOD ALTHOUGH UNIT 24 SHOWED THE BEGINNINGS OF WALL CRACKING.

Figure 87. Unit 23.

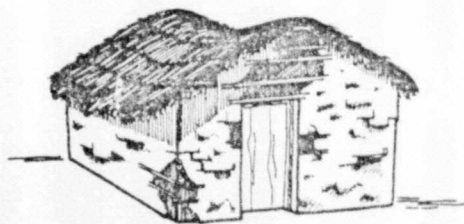
Unit 25

Gabled roof: Units 25 and 26.

- CLASSIFICATION: GABLED ROOF.
- LOCATION: UNIT 25 : MELMOTH.  
UNIT 26 : GREYTOWN.
- CONSTRUCTION: TIMBER POSTS ARE SET INTO THE GROUND AT 1200 mm INTERVALS. SAPLINGS ARE FIXED TO THE INTERNAL & EXTERNAL PERIMETERS OF THE WALL, SPANNING FROM COLUMN TO COLUMN PARALLEL TO THE GROUND SPACED APPROX. 300 mm APART. THE CAVITY THUS FORMED IS PACKED WITH EARTH & THE WALLS ARE PLASTERED OVER WITH DAGA. IN UNIT 25 TIMBER BEAMS SPAN FROM CABLE TO CABLE & TAKE THE THATCH LOAD DIRECTLY RESULTING IN SAGGING OF THE ROOF RIDGE. IN UNIT 26 THE BEAMS ARE SHALLOWLY TIED INTO TRUSSES WHICH SPAN FROM WALL TO WALL PARALLEL TO THE CABLE ENDS. SAPLING BATTENS CARRY THE THATCH COVER. THE RIDGE IS RESOLVED BY SEWING THATCH BUNDLES ACROSS IT THUS GIVING IT A ROUNDED APPEARANCE.

- SOCIAL GROUPING: ZULU HOMESTEAD WITH A CATTLE ENCLOSURE AT ITS FOCUS FOR UNIT 25 WHILE IN THE CASE OF UNIT 26 NO DEFINITE PATTERN WAS DISCERNIBLE.
- GENERAL: BOTH UNITS FUNCTIONED AS LIVING/SLEEPING AREAS. CONDITION OF UNIT 25 - POOR; UNIT 26 - GOOD. BOTH UNITS AVERAGE TO RESPECTIVE HOUSEHOLDS.

Figure 90. Unit 25.

A few variants to this structure of some import were recorded. One unit, near Melmoth, was a timber framed cavity wall structure, the cavity being packed with earth and plastered both internally and externally with daga. Timber beams ran the length of the dwelling from gable to gable with cross-beams being placed over them. The whole was then thatched over. As the gable beams were of little substance and no central supports were used to prop the roof structure up internally, considerable sagging of the roof had occurred. A similar structure near Greytown showed signs of roof trussing although the end walls were not brought over the roof into full gables.

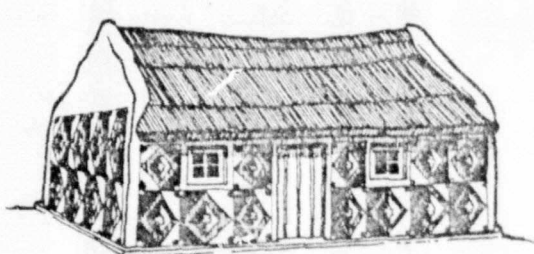
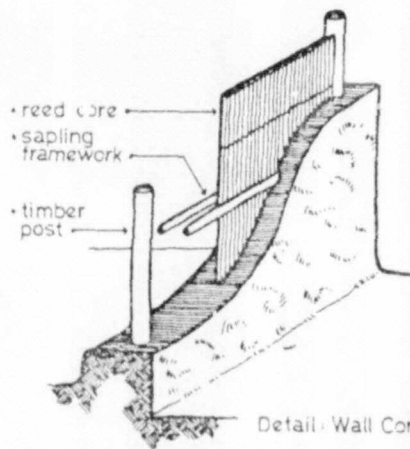
Gabled roof: Unit 27.

- CLASSIFICATION : CABLED ROOF.
- LOCATION : BALFOUR.
- CONSTRUCTION : TIMBER POSTS ARE SET INTO THE GROUND. A REED SCREEN LAID VERTICALLY IS SANDWICHED BETWEEN SAPLINGS LAID TO THE TOP & BOTTOM OF THE PANEL & PROTRUDING ON EITHER SIDE. THE PANEL IS FASTENED TO THE TIMBER POSTS AND AN EARTH PACKING & DAGA PLASTER IS APPLIED BOTH INTERNALLY & EXTERNALLY. A SLIGHT BUTTRESSING OF THE WALLS HAS OCCURRED TO COMPENSATE FOR THE LATERAL THRUST OF THE ROOF. THE ROOF BEAMS ARE TIED AT EAVES LEVEL BUT THE EAVES BEING ONLY 1,600 m HIGH, THE FLOOR HAS BEEN EXCAVATED BY 200 mm TO INCREASE THE INTERNAL HEAD ROOM. THE THATCH IS LAID SEED-END UP.

- SOCIAL GROUPING: NO SETTLEMENT PATTERN WAS EVIDENT IN THE HOUSEHOLD. UNIT FUNCTIONED AS LIVING/SLEEPING AREA.
- GENERAL : WINDOW OPENINGS SMALL. SASHES IN TIMBER & GLAZED. A SMALL OPENING TO REAR OF UNIT HAS BEEN GLAZED BY SETTING THE GLASS INTO THE WALL. CONDITION OF UNIT GOOD BUT ABOVE AVERAGE FOR THE SETTLEMENT.

One of the few examples which showed any signs of forming the roof frame out of triangulated trusses was recorded on white farmland in the district of Balfour. A monolithic sun-dried earth brick wall carried a roof structure formed of beams brought to a central ridge and having a tie-beam set at approximately one-third of the depth of the roof void. Battens were run at right-angles to the trusses and the whole was then thatched over. The shallow truss of the roof was due to the need for head-room within the dwelling. This however placed some stress upon the walls which

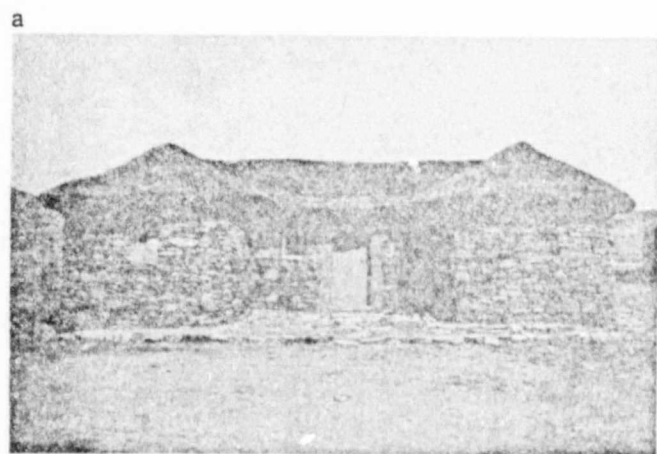
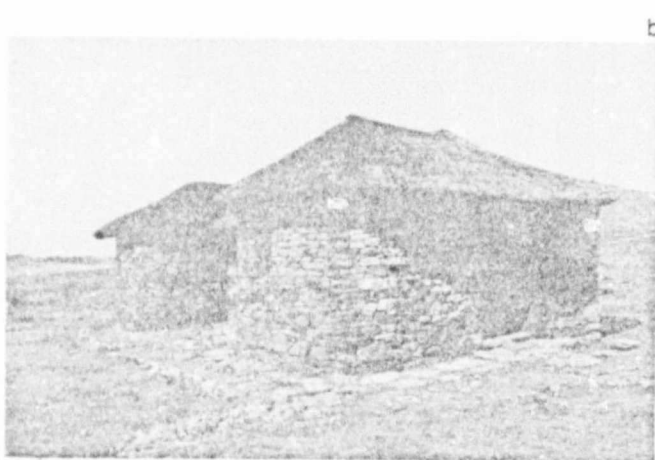
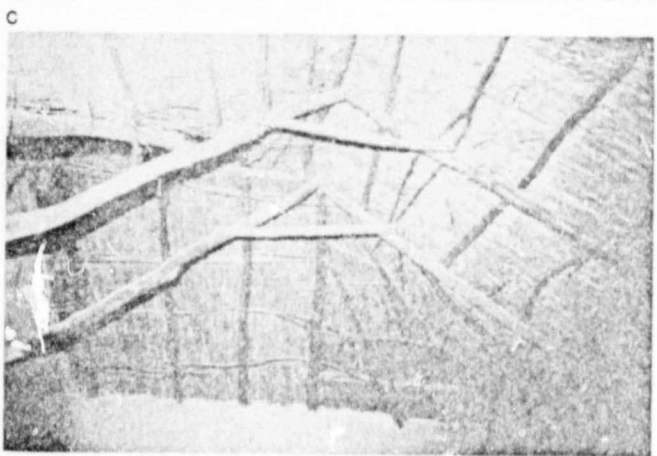
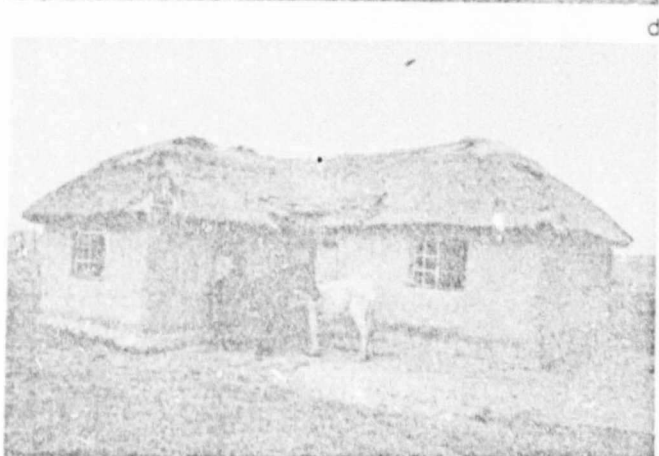
- a. Front elevation: "U-plan" dwelling, Thaba 'Nchu, Bophuthatswana.
- b. Side view of same.
- c. Internal detail of roof of same.
- d. "L-plan" dwelling: Loskop, KwaZulu.

Figures 94 a. b. c.

The walls were in dressed stone with considerable skill being shown in turning the right-angled corners. Although the thatching technique coped with the problems in the valley, the roof framework in this area showed evidence of being in its early stages of development. The wings and the main body of the house each had trussed roof structures independent of each other being linked only the battens. No valley beams or jack rafters were used. The inhabitants were of Sotho stock although this region is predominantly Tswana.

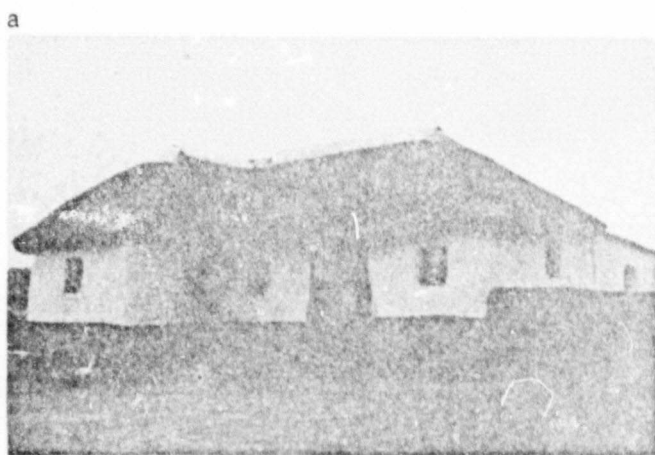
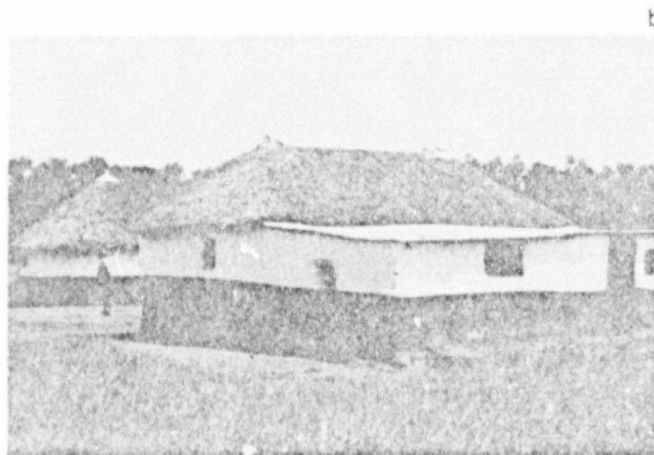
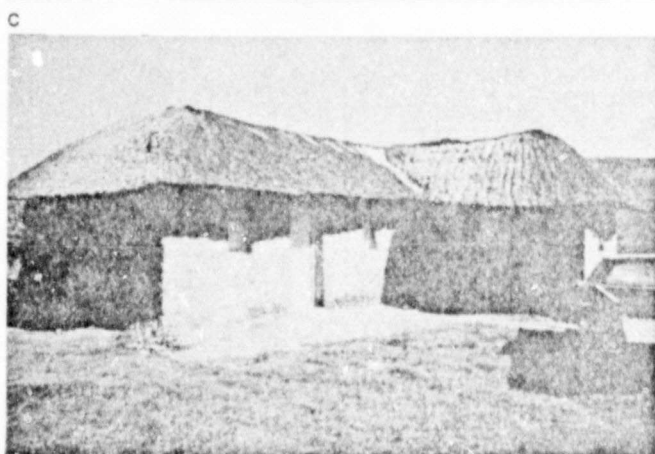
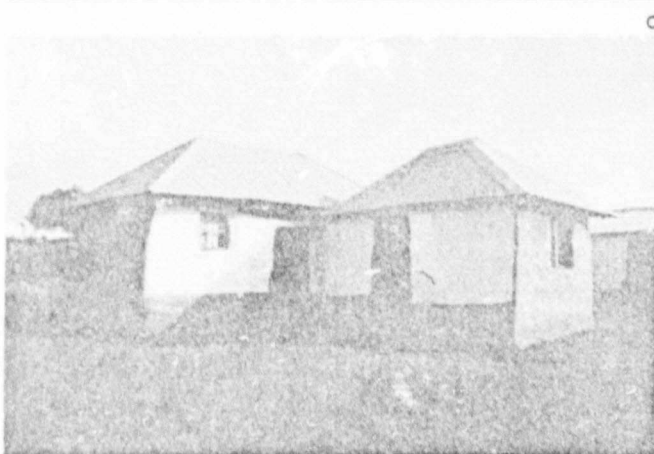
- a. Front view: "L-plan" dwelling, Redoubt, Transkei.
- b. Rear view of same.
- c. Front view: "L-plan" dwelling, Witsieshoek, Qwa Qwa.
- d. Front view: "L-plan" hybrid dwelling, Keiskammahoek, Ciskei.

A comparatively large number of L-planned dwellings were recorded in such geographically disparate regions as Transkei, Qwa Qwa and KwaZulu. In most cases the roof structure made use of valley beams but not of jack rafters. The example recorded at Loskop, in the Bergville district, seemed to have experienced some trouble in the thatching of the valley, although this might also have been the result of the building being in a poor state of maintenance. Similar problems were experienced in the

dwelling recorded at Witsieshoek, Qwa Qwa, where the valley, once thatched, was plastered over in cement.

The two examples recorded in the Transkei were probably of the greater relevance to this study. In both cases the main dwelling consisted of two rooms with a third room projecting forward to form the wing. In the first example however, the dwelling had also been extended to the rear by yet another two rooms roofed over with corrugated iron tucked underneath the thatch eaves. In the second a room, similarly roofed, had been added to the front of the house alongside the thatched wing.

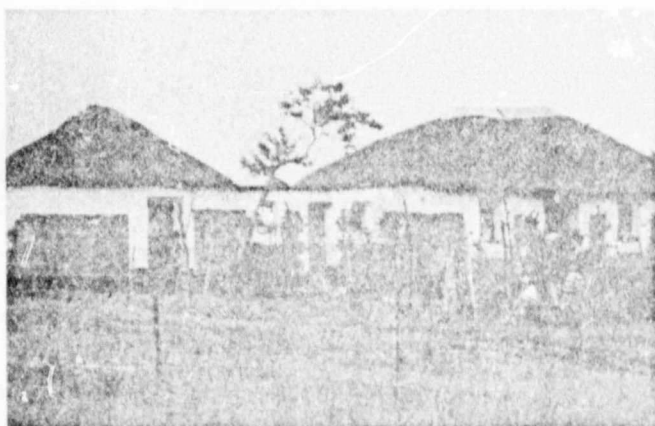
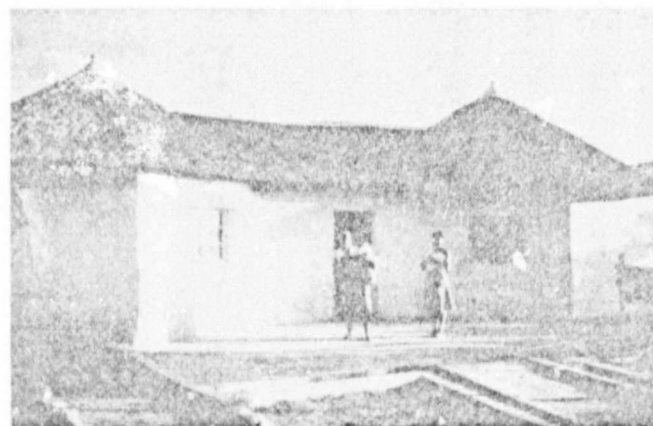
a. Hybrid dwelling: Kinira Drift, Transkei.  
b. Hybrid dwelling: Qamata, Transkei.

On an average most hybrid forms recorded consisted of two cone on cylinders linked by a flat-roofed room, although several five-unit structures were also observed.

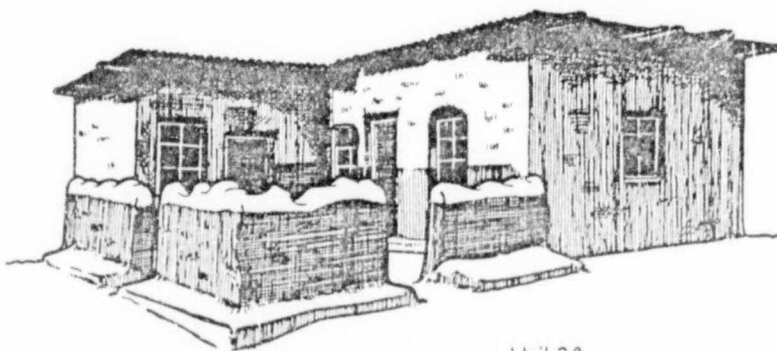
Unit 28

Highveld house: Units 28 and 29.

- CLASSIFICATION : HIGHVELD HOUSE.
- LOCATION : UNIT 28 : BUSSUCKRIDGE, LEBOWA.  
UNIT 29 : GA-RANKUWA, BOPHUTHATSWANA.
- CONSTRUCTION : MONOLITHIC SUN-DRIED EARTH BRICKS BONDED IN EARTH & PLASTERED OVER WITH DAGA. IN UNIT 28 THE ROOF BEAMS ARE TIED INTO THE WALL, THE CORRUGATED IRON IS LAID DOWN & SECURED BY A SECOND SET OF TIMBER BEAMS LAID EXTERNALLY & TIED TO THE FIRST BY WIRE HOOPS. IN UNIT 29 THE CORRUGATED IRON SHEETING IS SECURED BY MEANS OF WEIGHTS LAID OVER THE ROOF.

- SOCIAL GROUPING : UNIT 28 HAD BEEN BUILT IN TWO STAGES TO FORM A THREE-ROOMED L-PLAN DWELLING, GIVING ONTO A COURT. UNIT 29 EXTENDED INTO TWO ROOMS GIVING ONTO A CENTRAL COURT SHARED WITH TWO OTHER UNITS & GIVING ONTO ANOTHER REAR COOKING COURT. BOTH UNITS FUNCTIONED AS LIVING/SLEEPING AREAS.

- GENERAL : BOTH UNITS MADE USE OF COMMERCIALY AVAILABLE DOOR & WINDOW FRAMES. CONDITION OF BOTH UNITS GOOD & AVERAGE FOR THEIR RESPECTIVE AREAS. UNIT 29 MADE USE OF COMMERCIALY AVAILABLE P.V.A. COLOURS.

Figure 103. Unit 28.

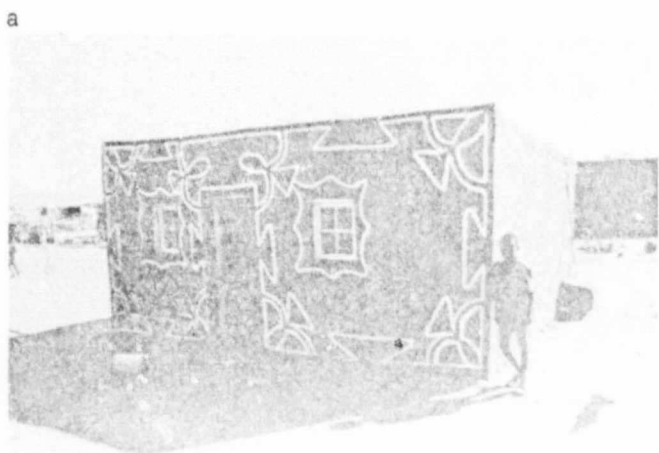
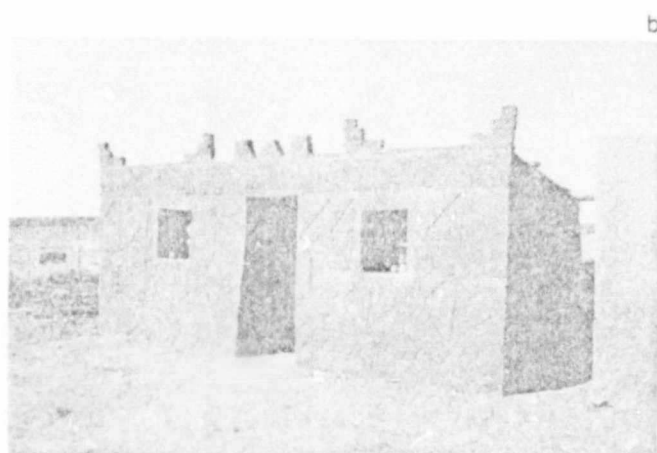
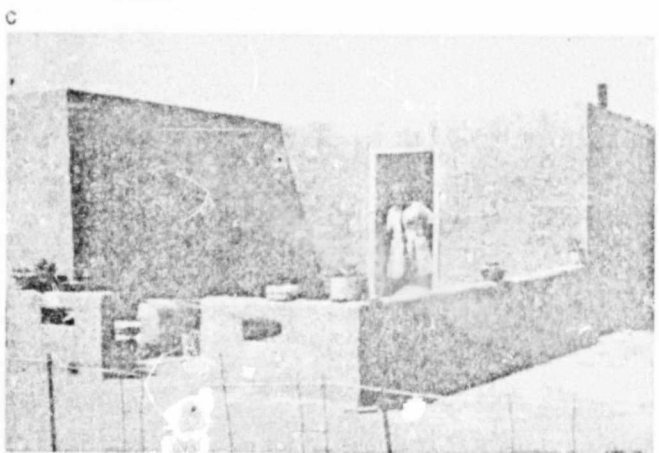
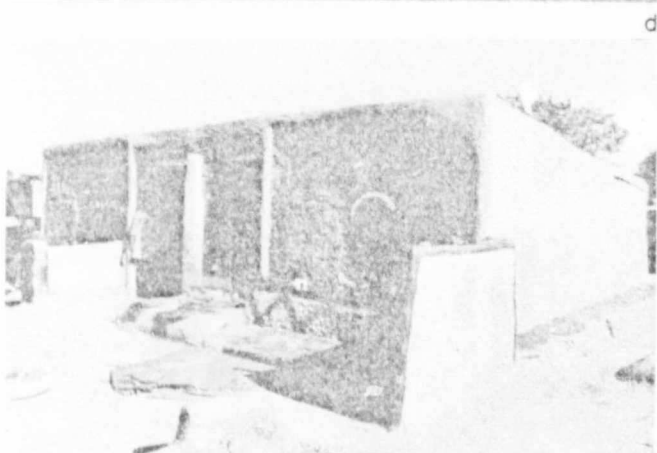
- a. Single-roomed dwelling: Kromdraai, Thaba 'Nchu, Bophuthatswana.
- b. Two-roomed dwelling: road Bethlehem to Paul Roux, O.F.S.
- c. Three-roomed dwelling: Winterveld, Bophuthatswana.
- d. Five-roomed dwelling: Winterveld, Bophuthatswana.

Figures 104 a. b. c. d.

Perhaps the most notable achievement of the highveld house lies in its ability to expand. Up to now the greatest restraint upon the development of the floor plan in rural architecture has been the inability of the roof to cater for anything more complex than the basic rectangle. With the introduction of galvanized iron sheeting, the floor plan is suddenly liberated and is now able to indulge the demands of the rural family to an extent made possible by current thatch technology. The use of the flat leaf roof also provides the rural dweller with a house form which is now able to respond to his financial realities as well as his spacial needs. The basic one-roomed highveld house represents a module which is able to expand as the family's spacial needs grow and according to their budget. The principle of lean-to shelter combining as it does with the parapet wall, ensures that the rural builder is able, through judicious placing of his roofs, to keep on expanding his dwelling almost ad infinitum.

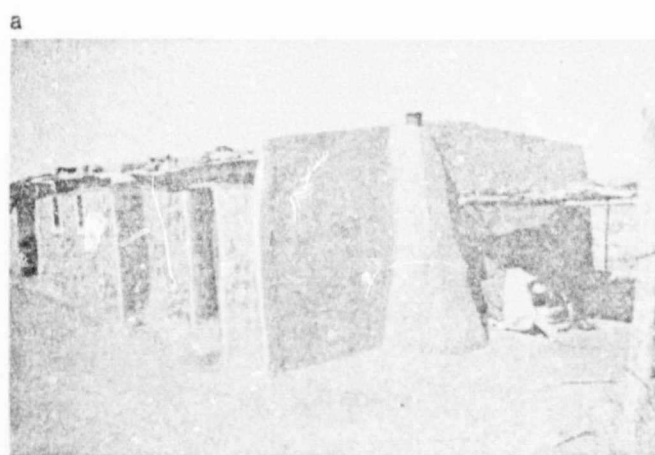
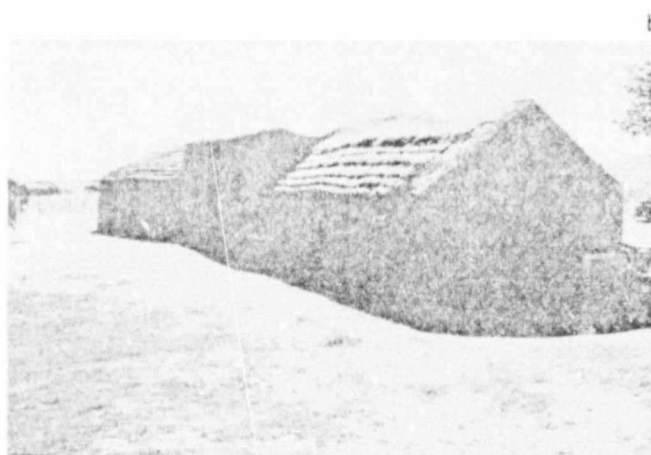
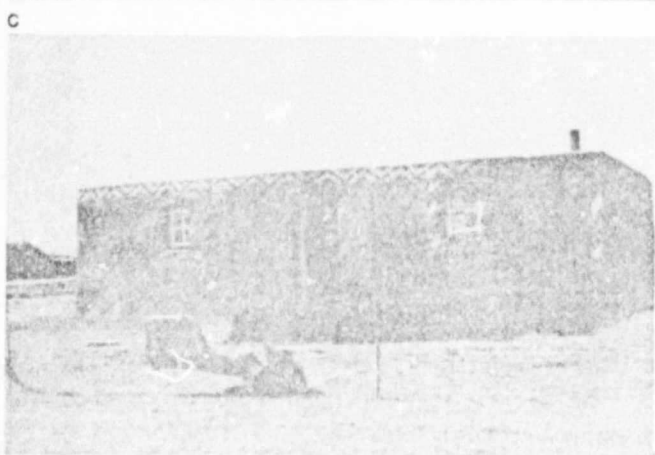
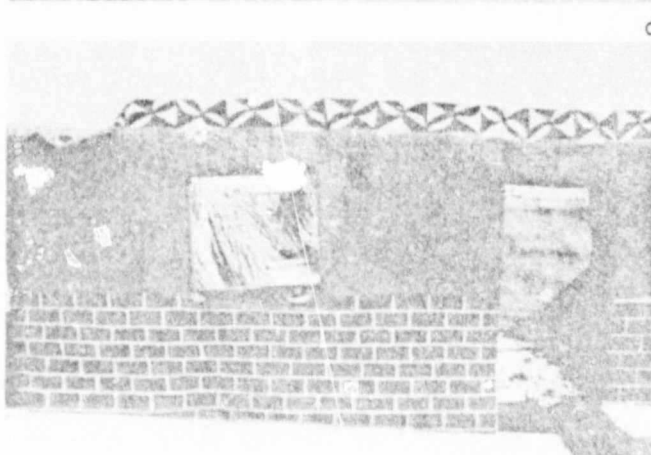
- a. Linear house development: road Heidelberg to Villiers, Transvaal.
- b. Linear house development: Warden, O.F.S.
- c. Two-roomed dwelling undergoing expansion: Greylingstad, Transvaal.
- d. Abandoned dwelling: road Warden to Harrismith, O.F.S.

Two dwellings which did seem to make full use of the extension possibilities of a gabled roof were recorded on the Orange Free State highveld. In the first example near Villiers, a central gabled and thatched structure was bracketed on either side by two rooms roofed over with corrugated iron. In this case the three rooms appeared to have been built simultaneously and as a whole thus negating the expansion possibilities of a gabled structure. The central part, being thatched, functioned as a kitchen/living space, an aspect of highveld settlements which will be discussed in a later chapter.

Figure 106 d.

floors have made use of a daga plastering, a mixture of mud and cow-dung, this has had the effect of allowing insects, many of them harmful to man to breed within them. Thus we find that the lifespan of the rural house, which in some of the recorded examples was as long as 40 years plus, has in this case now been reduced to less than ten, and whereas before the walls and roof frame were retained and the thatch cover renewed, it is now the walls which are discarded as the family moves to a fresh site taking their roof with them.
