**ESTABLISHING EFFECTIVE, APPROPRIATE AND APPLICABLE  
TECHNOLOGIES IN TREATING CONTAMINATED SURFACE  
WATER AS PART OF A REHABILITATION STRATEGY FOR THE  
PRINCESS DUMP IN ROODEPORT, WEST OF JOHANNESBURG.**

**A Research Project submitted to the Faculty of Science, at the University of the  
Witwatersrand in partial fulfilment of the requirements for the degree of**

**Master of Science**

**Environmental Science.**

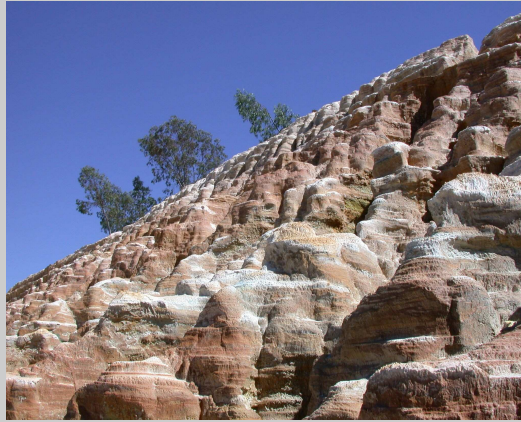
Position A facing south – Showing the impact of erosion on the unprotected slopes.

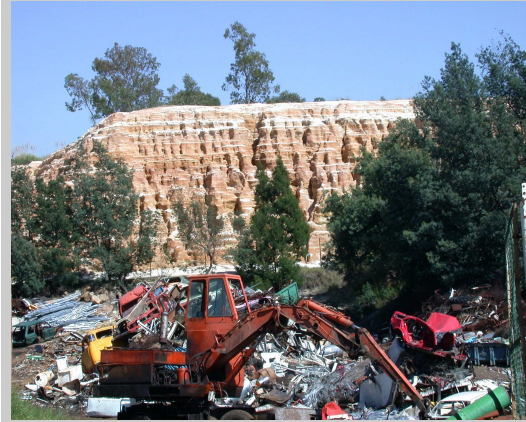
Position B facing west – shows metal waste disposed on the TSF

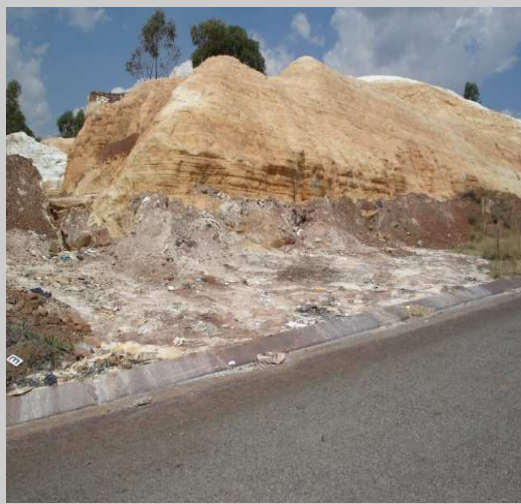
Position C facing east – shows eroded tailings leaving the TSF.

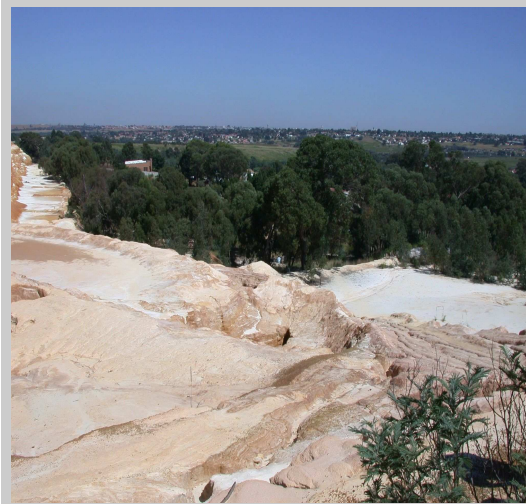
Position D facing west – shows eroded tailings leaving the TSF.

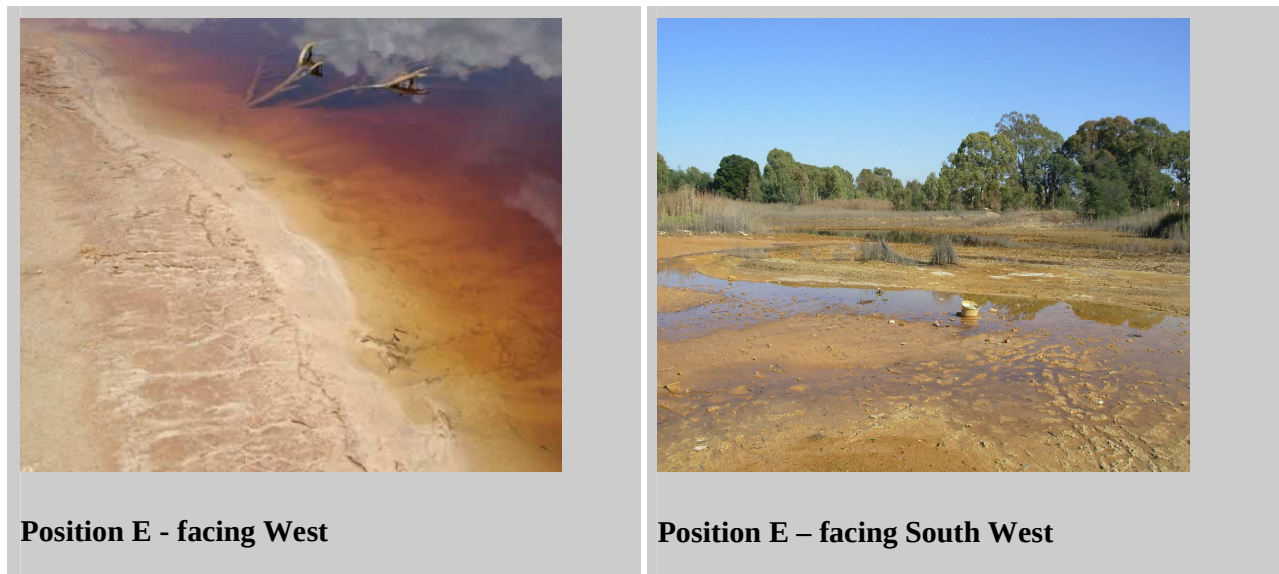
There is a manmade wetland that has developed to the west of the TSF as a result of the previous mining activities, seepage and municipal discharge. Tailings sediments that leave the TSF have contaminated the artificial streams, manmade wetland and other riparian zones around the site as shown in the Figure 4 below.

**Figure 4: The sedimentation of eroded tailings into nearby water bodies.**

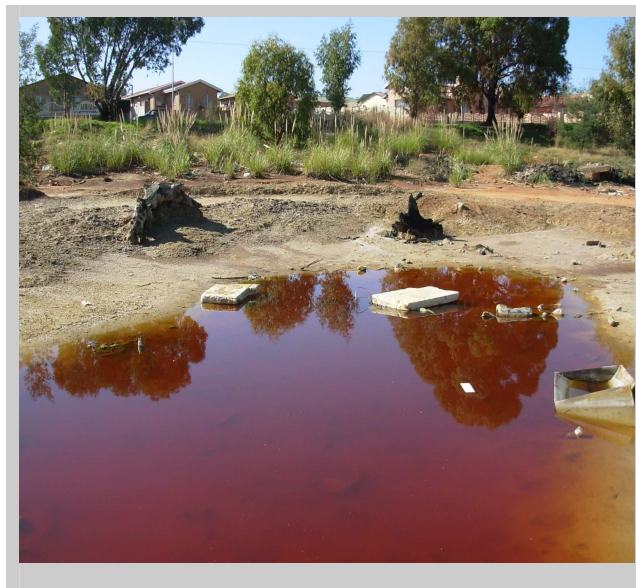
The water in the vicinity of the TSF is visually observed to have a “yellow boy” colouration which is an indication that the water has come into contact with pyrite.

**Figure 5: The “yellow boy” colouration of the water in the wetland.**

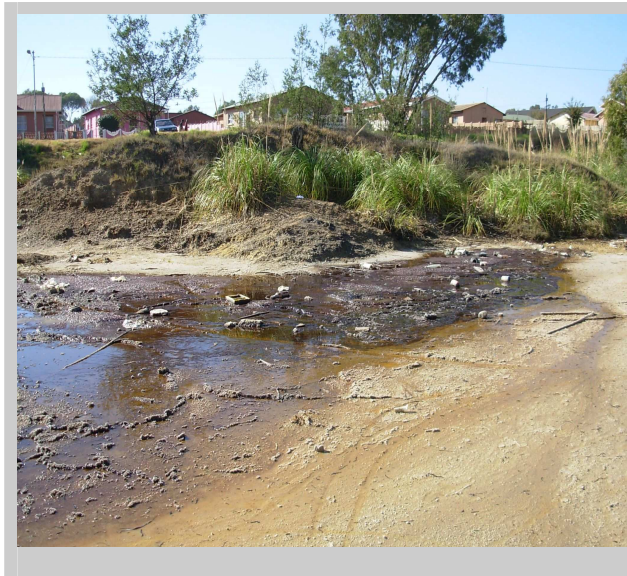
**Figure 6: Contaminated seepage from the TSF near the wetland.**

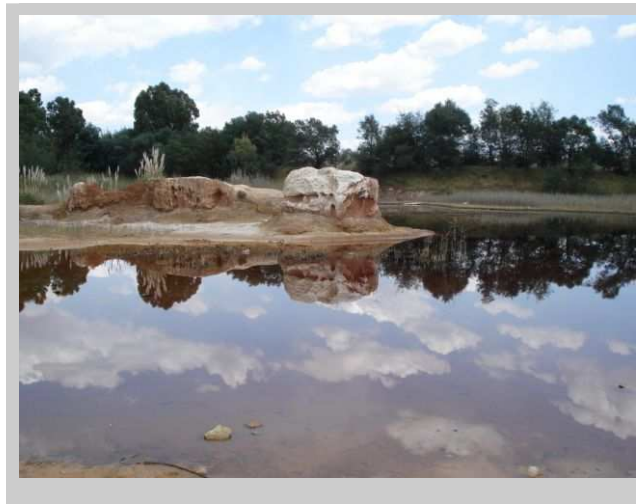
The ecological integrity of the watercourse and manmade wetland adjacent to the TSF has been severely compromised by the polluted runoff, seepage and deposition of eroded tailings. Also there are small tailings heaps deposited around the manmade wetland that are an additional source of pollution.

**Figure 7: A tailings heap in the manmade wetland area.**

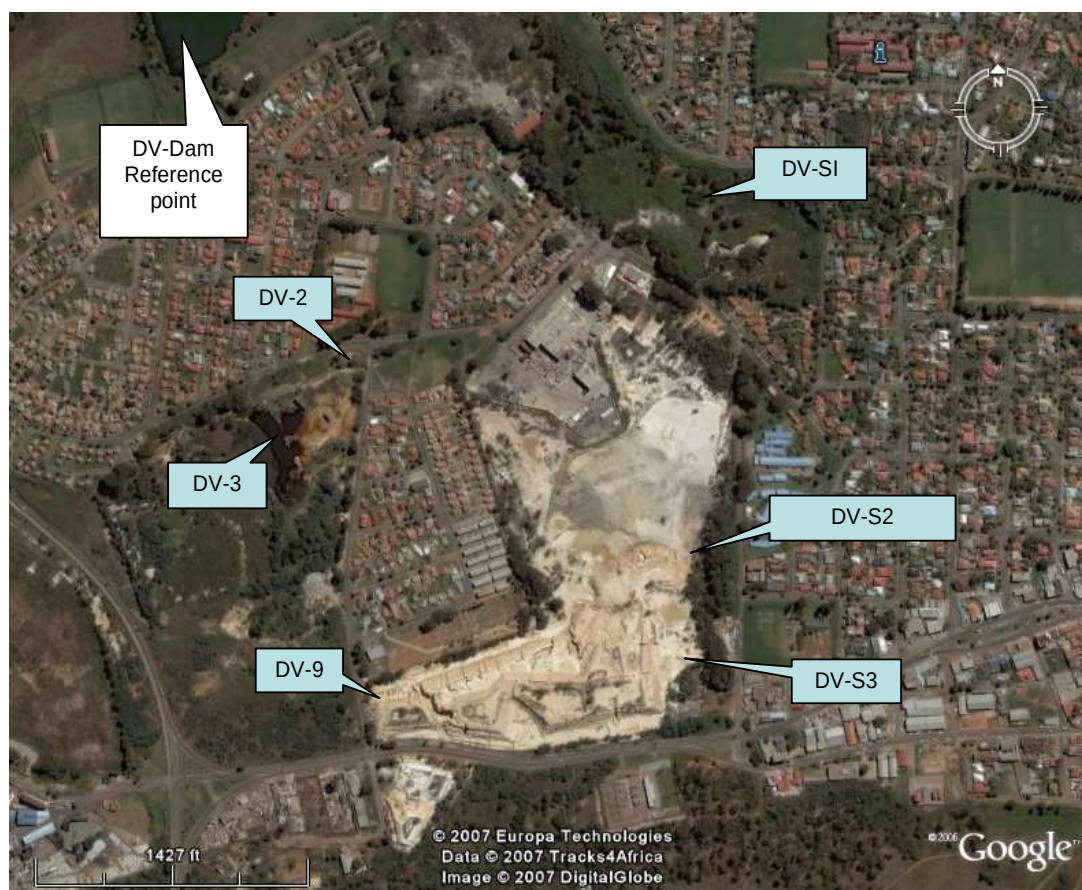
**Figure 12: Princess Dump monitoring points sampled by DWAF.**

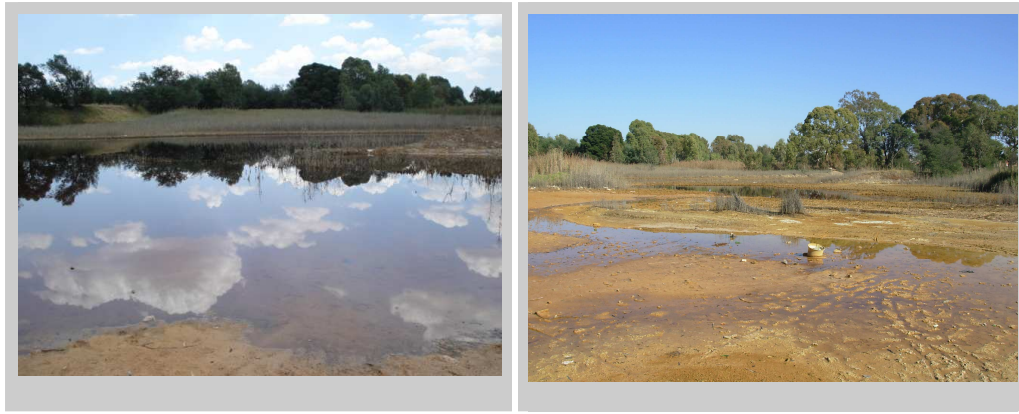
**Figure 14: Showing the wetland during the summer (January 2007) (left), and autumn (April 2007) months (right).**
