Investigation of the micro- and macroscopic wear properties  
of cemented tungsten carbide for the wear lining material  
selection of chutes

A dissertation submitted to the Faculty of Engineering and the Built Environment, University of the Witwatersrand, Johannesburg, in fulfilment of the requirements for the degree of Master of Science in Engineering.

Johannesburg, 2021

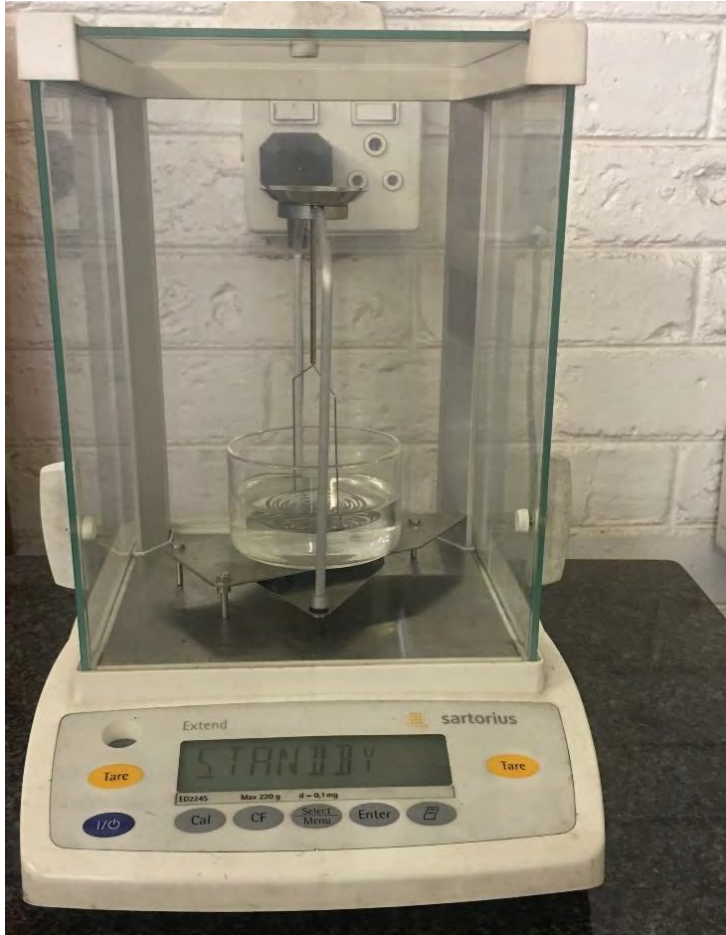
**Figure 3.1: Macrograph of the densimeter used to measure the density of the investigated samples.**
