**THE VIABILITY OF MANUALLY PRODUCING AND  
USING CONCRETE ROOF TILES FOR LOW COST  
HOUSING IN SOUTH AFRICA**

**ROBERT MICHAEL BATHKE**

A dissertation submitted to the faculty of Architecture,  
University of the Witwatersrand, Johannesburg, in fulfilment  
of the requirements for the degree Master of Science in  
Building Management.

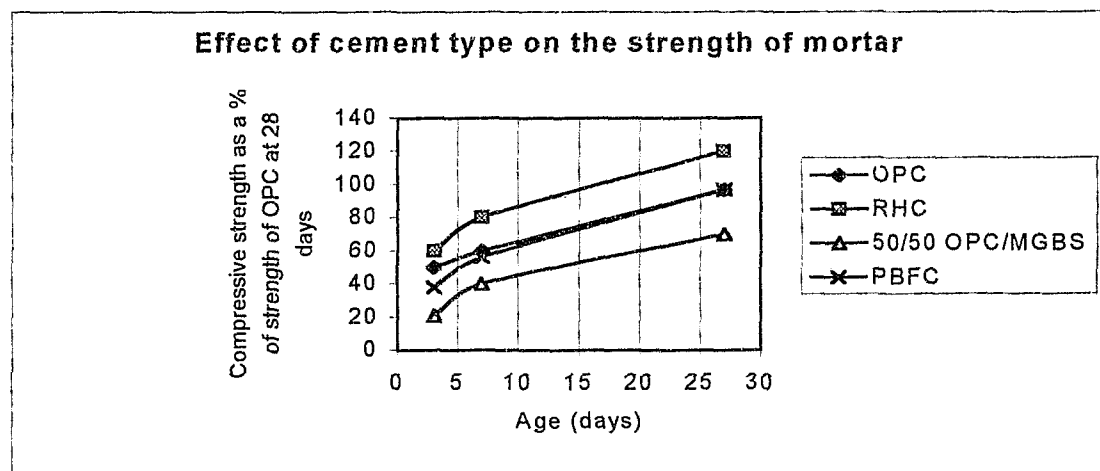
Graph A: (Addis B 1995 Cement concrete and mortar Portland Cement Institute Midrand)

Graph A. shows the compressive strength as a percentage of strength at 28 days for 3 types of cement that all utilise the same water to cement ratio. Analysis of the graph shows that RHC has a 20% greater strength than OPC at 7 days and at 28 days RHC has attained the greatest strength of all the concretes.

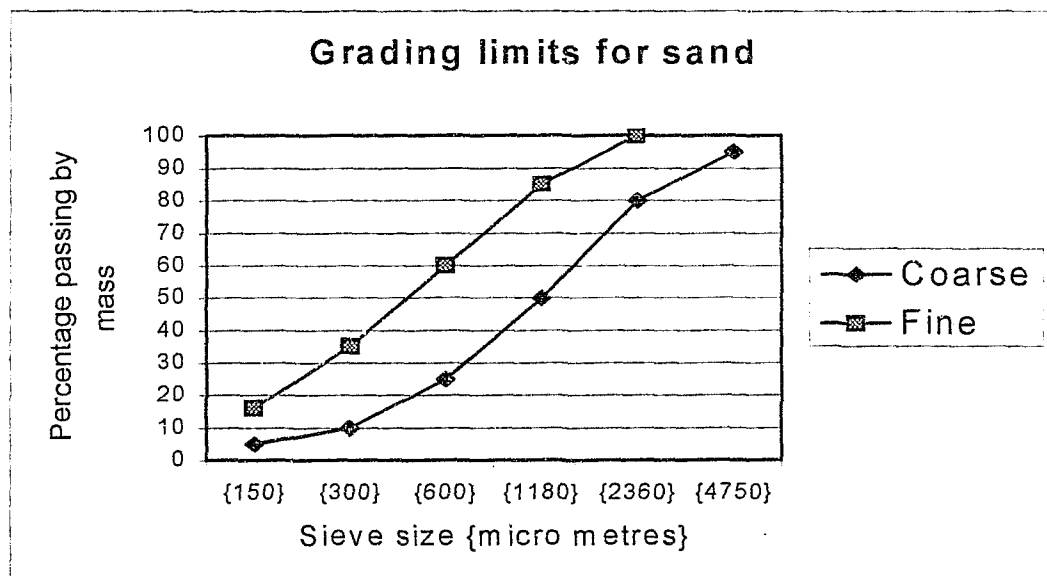
Graph B: Grading limits for sand (supplied by the Portland Cement Institute)

However the grading profile range into which the Portland Cement Institute suggests a fine aggregates grading profile should fall (shown in graph.B) for it to be suitable for the production of concrete does not necessarily apply to the aggregate used to produce micro concrete tiles such as Agri-Tiles. From the case studies conducted in chapter 3 (and table F below) it can be seen that the sand grading profile range recommended by SKAT and used by Grupo Sofonias not only differs from the recommendation of the Portland Cement Institute, but varies according to the thickness of tile produced.

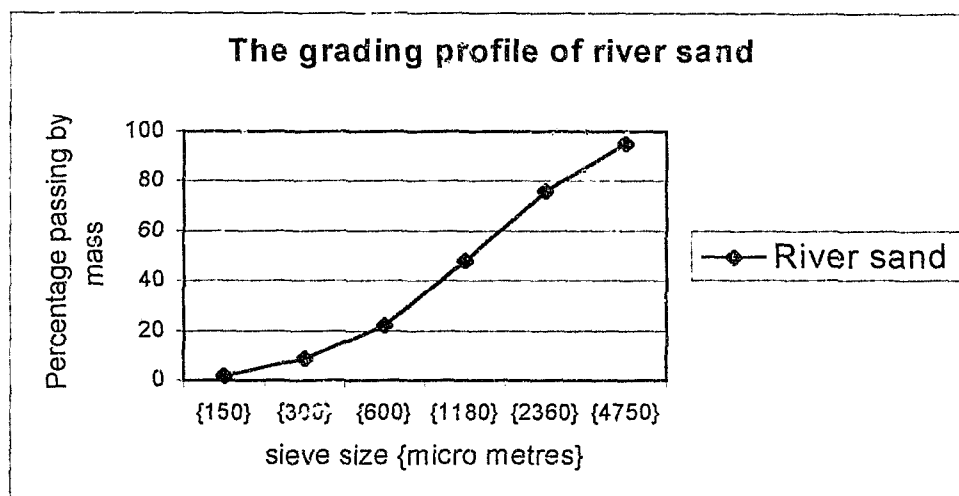
Graph.C: The natural grading profile of river sand

The river sand's natural grading profile was established according to the method in SABS 1083. The sieve analysis of river sand can be seen in graph.C

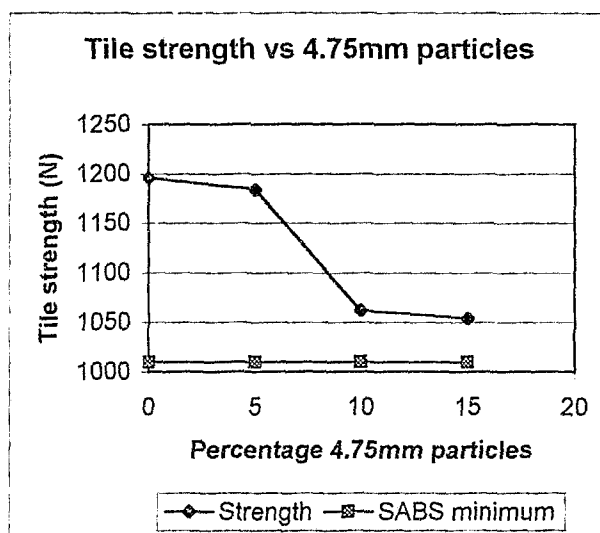
**GRAPH D: Tile strengths relative to concentrations of 4750 $\mu$ m particles in river sand**

Examining graph.D reveals that an increase in this particle size leads to a reduction in the strength of the tiles. The loss of strength is relatively low until 5% of the sand consists of 4750 $\mu$ m particles. The majority of the 11.5% loss of tile strength takes place when the percentage of 4750 $\mu$ m particles is increased to between 5 and 10%, after which the strength loss becomes more gradual. When the river sand's volume is composed of 15% 4750 $\mu$ m particles the strength of the tiles is still in excess of the minimum strength recommended by the SABS.

Graph.D on page 90 shows strengths of tiles produced with river sand containing the specified percentages of particles 4750 $\mu\text{m}$  or greater in size.

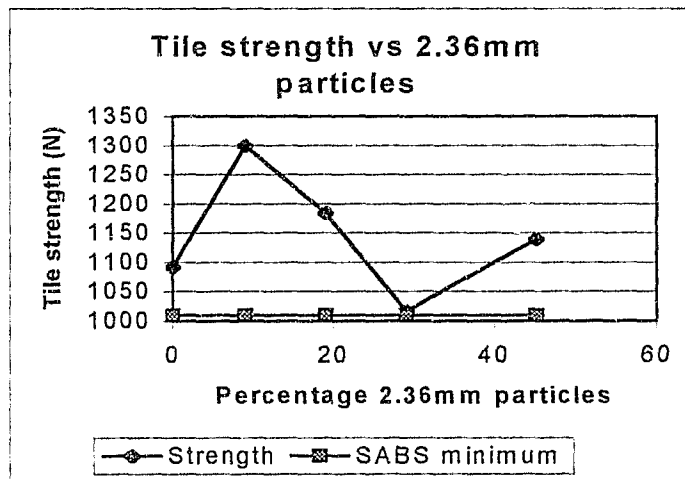
**GRAPH E: Tile strengths relative to concentrations of 2360 $\mu$ m particles in river sand**

From Graph.E it can be seen that when the percentage of 2360 $\mu$ m particles in the river sand ranges between 0 and 45 percent of the volume tiles can be produced which meet the minimum strength requirement of the SABS. The addition of this particle size increases the strength of the tiles until the optimum strength is reached when the 2360 $\mu$ m particles make up 9% of the sand volume. There is a 21.8% reduction in the strength of the tiles, which takes place when the sand is composed of between 9 and 29% of 2360 $\mu$ m particles. A surprising increase in the strength of the tiles takes place when the composition of the sand is made up of between 29 and 45% of particles retained on the 2360 $\mu$ m sieve.

The increase in the strength of the tiles that takes place with the addition of between 0 and 9% of 2360 $\mu$ m particles can be attributed to the optimisation of the grading profile of the sand. Once this optimum profile has been reached the further addition of 2360 $\mu$ m particles degenerates the grading profile resulting in the loss of strength experienced by the tiles when the 2360 $\mu$ m particles comprise between 9 and 29% of the volume of the sand.

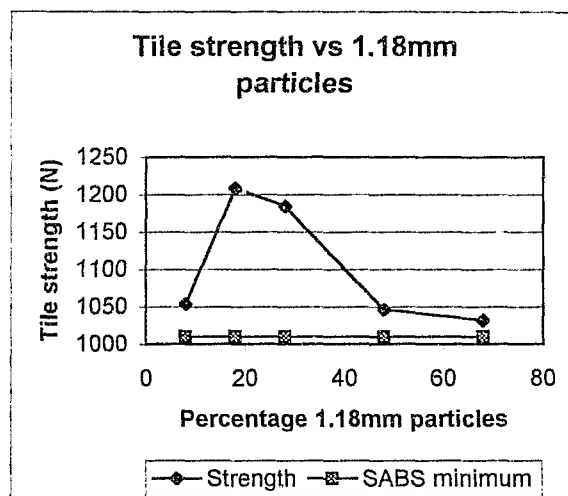
#### Graph F: Tile strengths relative to concentrations of 1180 $\mu$ m particles in river sand

The parabolic shape of graph.F shows that the initial addition of 1180 $\mu$ m particles improved the grading profile of the sand, and thus improved the density and compatibility of the mortar. This improved the strength of the tiles. When the sand volume consists of 18% 1180 $\mu$ m particles the sand grading profile is optimum and the further addition of these particles decreases the strength of the tiles. The content of 1180 $\mu$ m particles in the sand tested varied from 8 to 68% of the sand volume and, while percentages above 18% reduced the strength of the tiles, all of the tiles had flexural strengths in excess of the minimum strength required by the SABS.

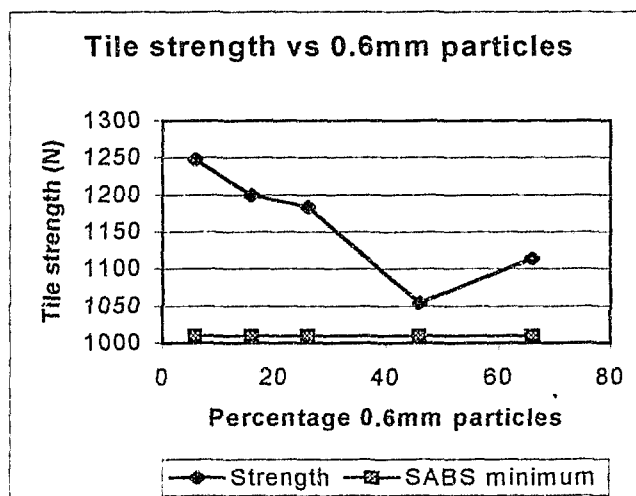
**GRAPH G: Tile strengths relative to concentrations of 600 $\mu$ m particles in river sand**

From graph.G it can be seen that the tiles achieved the highest recorded strength when only 6% of the volume of the sand was composed of 600 $\mu$ m particles. Any further addition of this particle

size resulted in a decrease in the strength of the tiles. This loss of strength can be attributed to an increase in the water requirement of the mortar, the increase in the amount of air that was trapped in the tile and the decrease in the workability of the mortar. The increase in the strength of the tiles that occurred when the volume of the river sand was made up of between 46 and 66% of the particles retained by the 600 $\mu$ m sieve could not be explained.

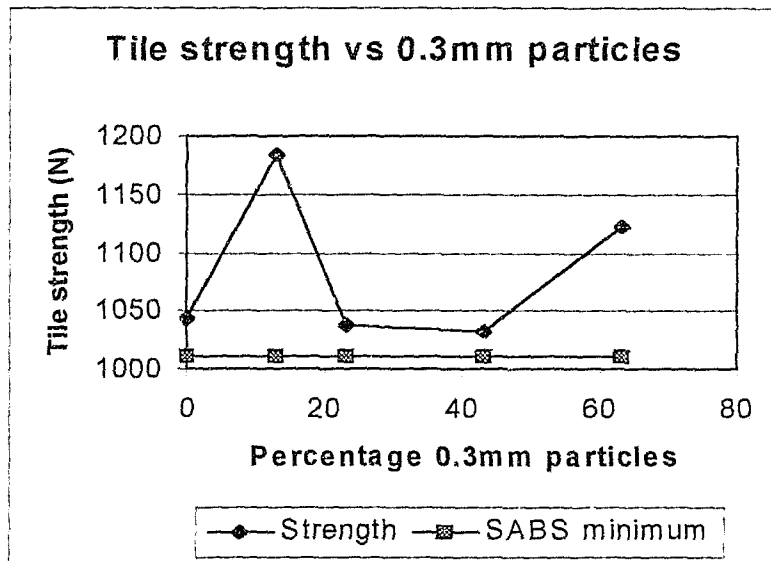
**GRAPH H: Tile strengths relative to concentrations of 300 $\mu$ m particles in river sand**

The absence of 300 $\mu$ m particles in the sand resulted in tiles that met the SABS minimum strength requirement by a slender margin. Graph.H shows that the initial increase to 13% 300 $\mu$ m particles produced a significant increase in the strength of the tiles due to the optimisation of the grading profile of the river sand. The further increase in the percentage of 300 $\mu$ m particles moved the grading profile from the optimum and decreased the strength of the tiles produced with the reconstituted sand. A surprising increase in the strength of the tiles occurs when the volume of the sand is composed of more than 43% 300 $\mu$ m particles. This is a similar trend to that found when working with the 2360 and 600 $\mu$ m particles

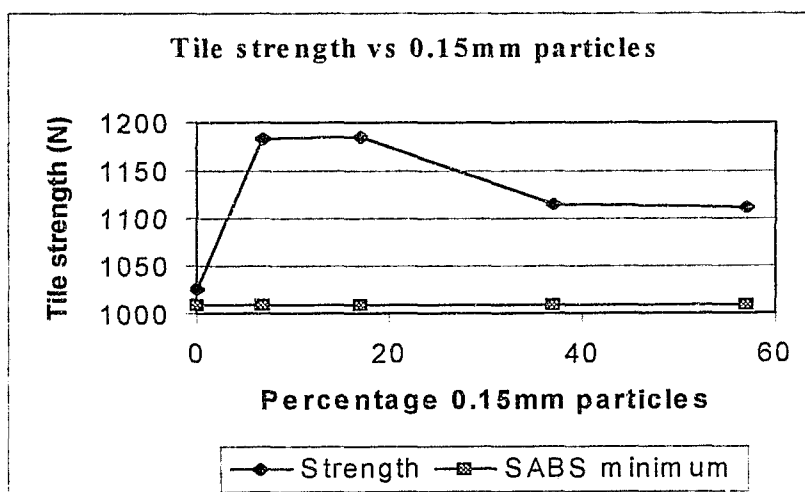
### GRAPH I: Tile strengths relative to concentrations of 150 $\mu$ m particles in river sand

As with the 300 $\mu$ m particles the initial increase to 7 percent of 150 $\mu$ m particles had a significant effect on the strength of the tiles. Once the percentage of the 150 $\mu$ m particles was above 7% of the volume of the river sand only a slight increase in the strength of the tiles could be seen in graph.1. The grading profile of the river sand produced maximum tile strength when the 150 $\mu$ m particles composed 17% of the volume of the river sand. The further addition of these particles reduced the strength of the tiles. The trends seen in the 2360, 600 and 300 $\mu$ m particle sizes, where exceptionally high concentrations of these particles caused a surprising increase in tile strength was not continued with the 150 $\mu$ m particle size. However the increase in the volume of 150 $\mu$ m particles of between 37 and 57% reduced the rate of strength loss of the tiles, with a further loss of only 2 Newtons.

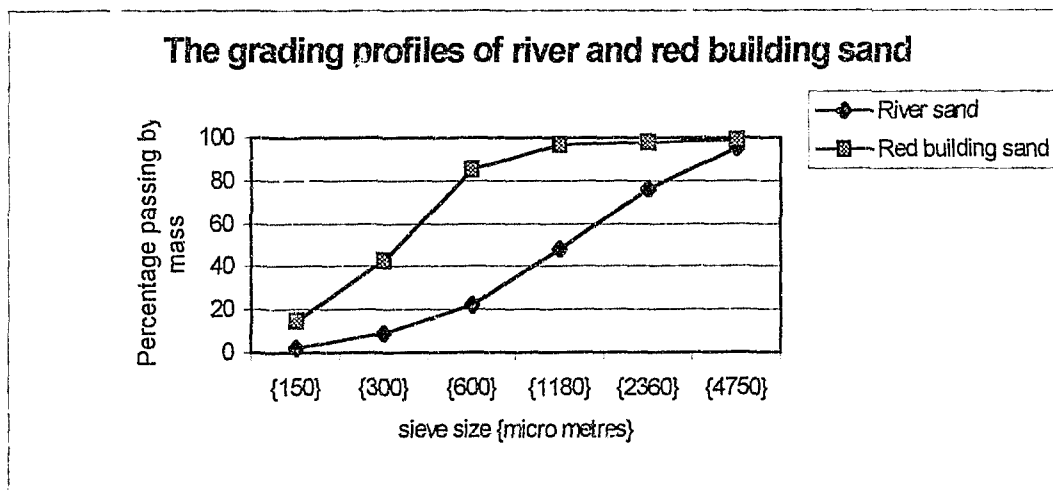
Graph J:

The tiles produced using red building sand had an average strength of 4.04 N/mm of tile width and the weakest tiles had individual strengths of 3.76 N/mm of tile width and thus met the minimum strength requirements of the SABS.

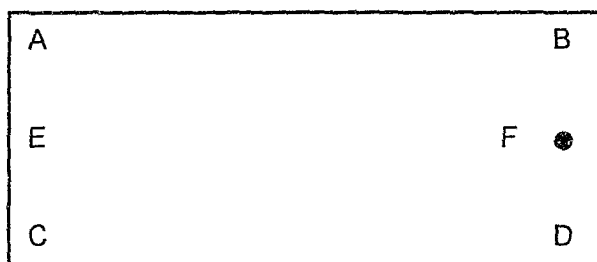
#### Designated areas at which the tile thickness was measured

Tile viewed from above (smooth side facing upward) with nail hole to the right.

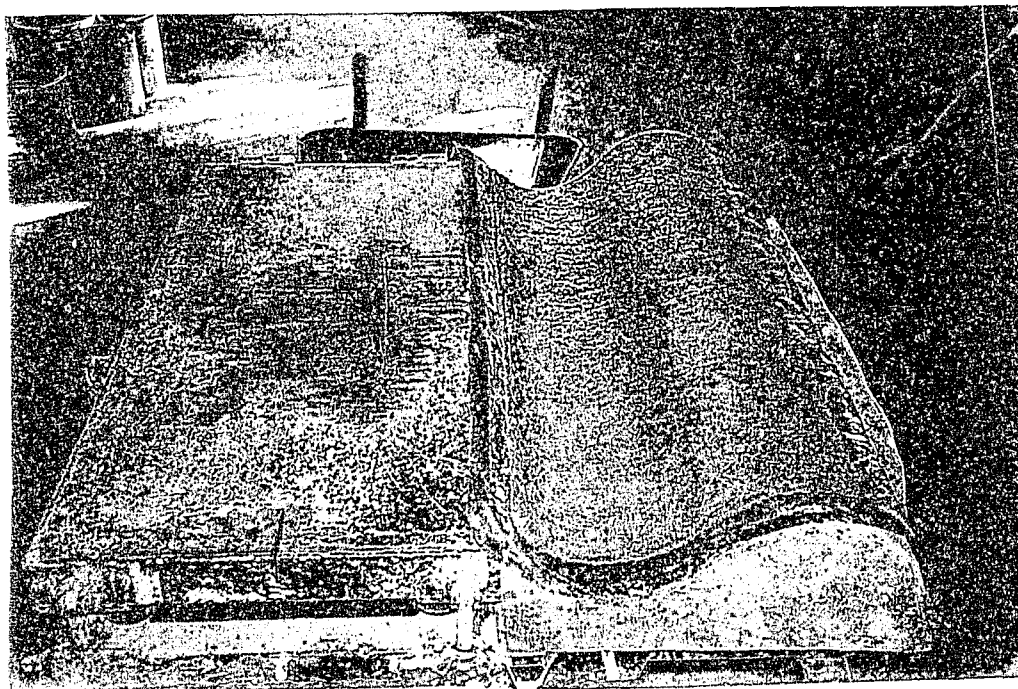
Figure 2: Moulding the original Agri-Tile

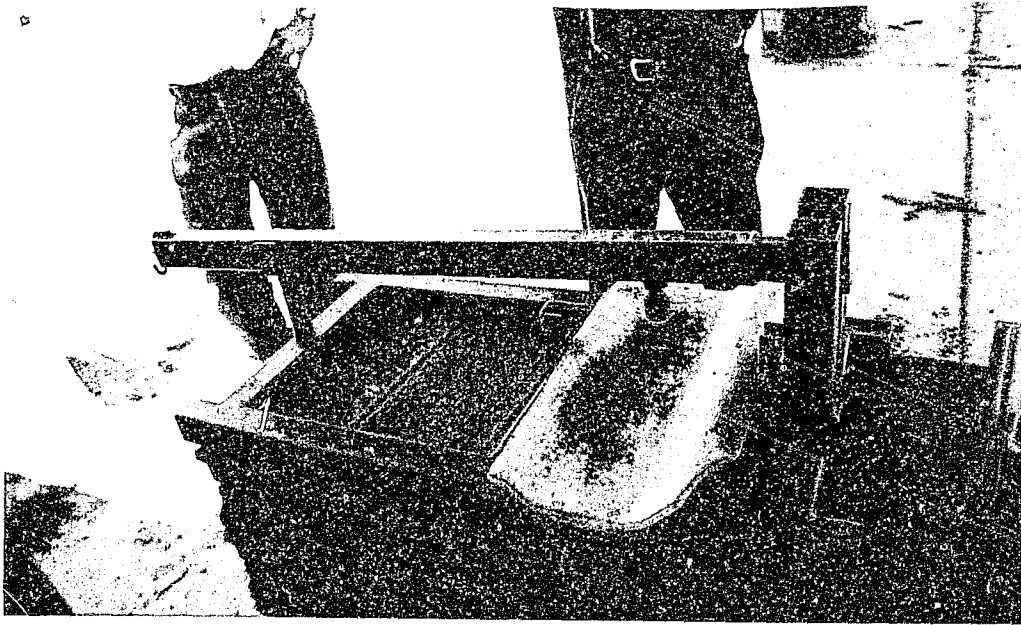
Figure 1: The apparatus used to test the transverse strength of tiles produced by Grupo Sofonias. Unfortunately the third bearer was not available at the time of taking the photo.

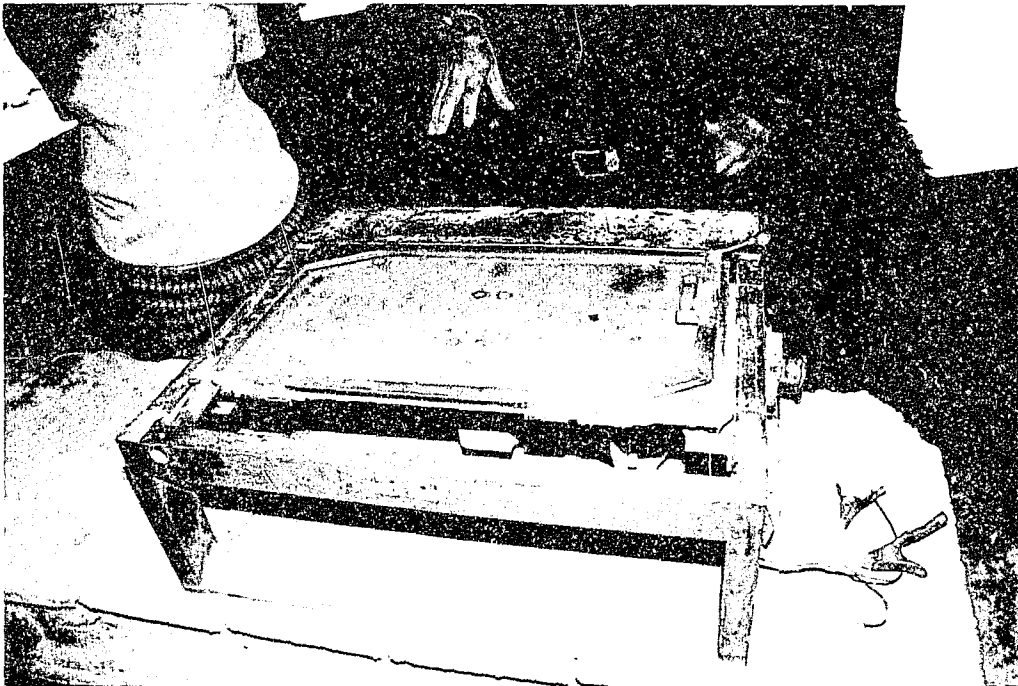
Figure 2: The vibrating table used by Grupo Sofonias (note the mitres on the diagonally opposite corners and the box mould used to form the nib on the tile)

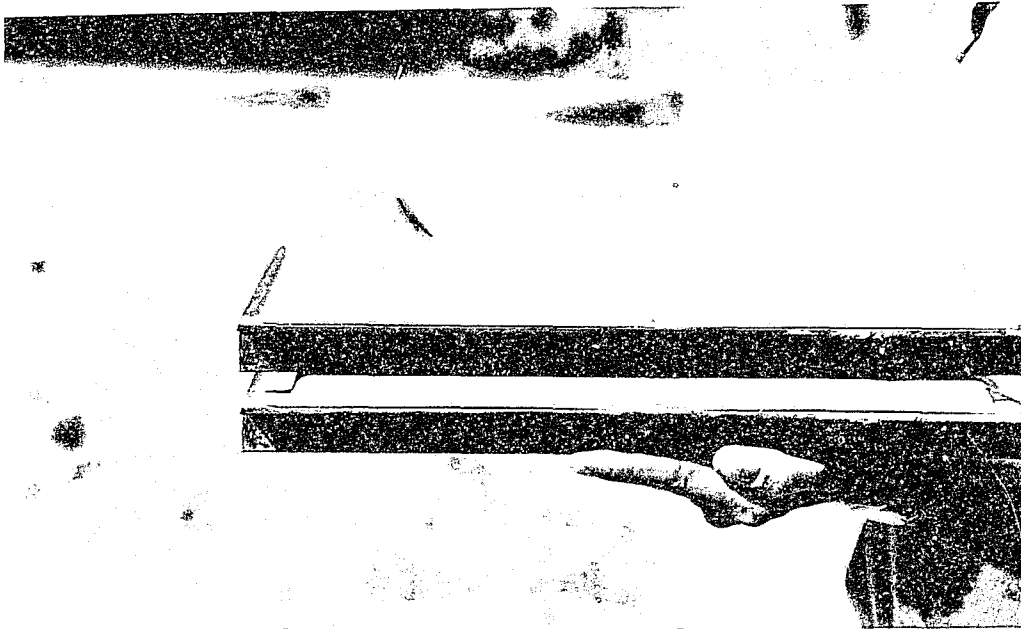
Figure 1: Examples of the high quality injection moulded polypropylene moulds used by Grupo Sofonias

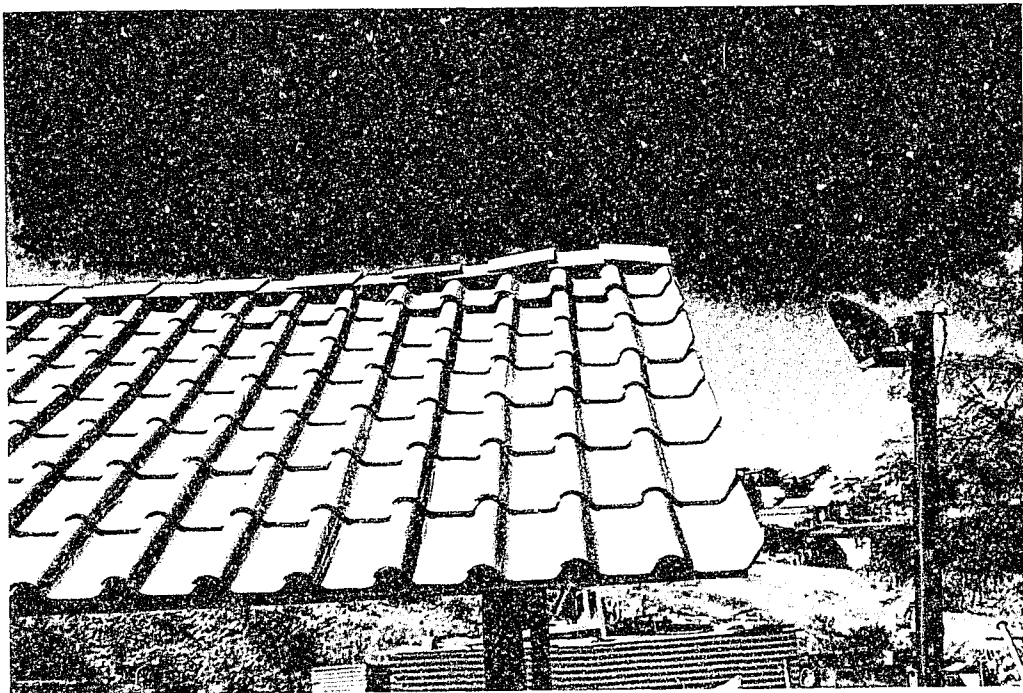
Figure 2: An example of a roof covered with tiles produced by Grupo Sofonias

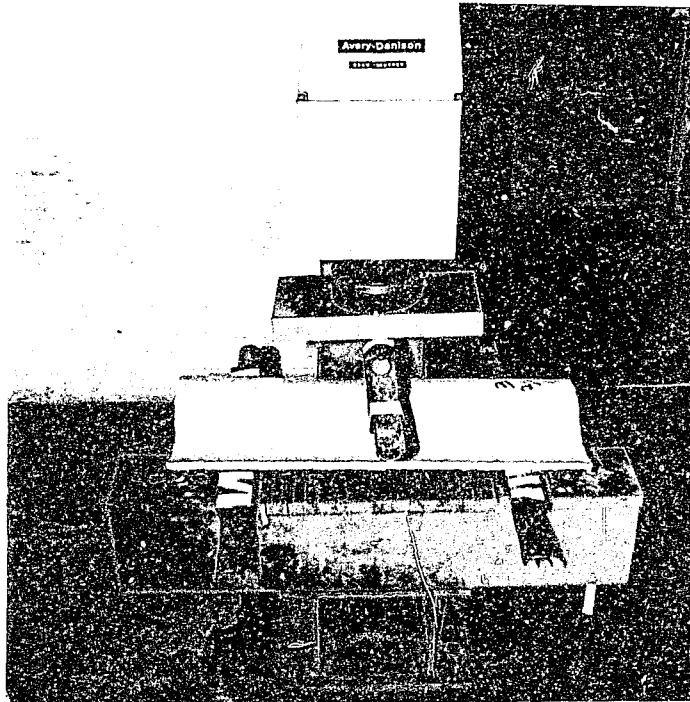
Figure 1: The beam crusher used to establish the transverse strength of the tiles

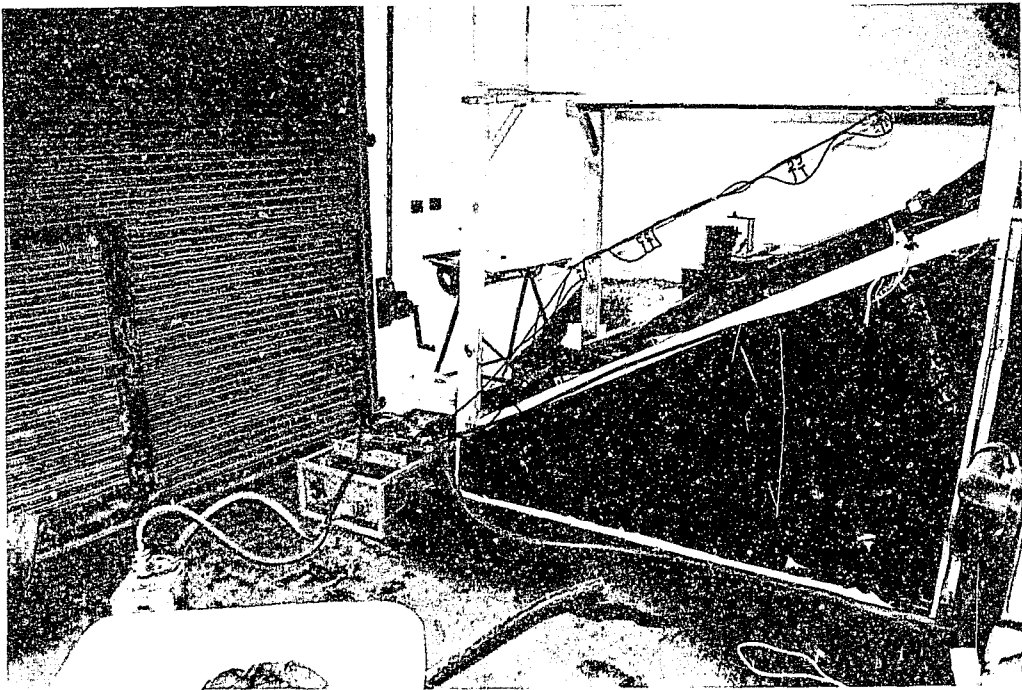
Figure 2: The specially constructed rain penetration test rig

- 9) The combined volume of water supplied to the test roof was then caught for a period of one minute. The combined flow rate of the sprays and the sparge pipe equalled 7.632l/m which was the required combined flow rate. The slight drop in pressure resulting from simultaneously opening the tap that supplied the sprays and the tap that supplied the sparge pipe did not affect the flow rate of either the sprays or the sparge pipe.

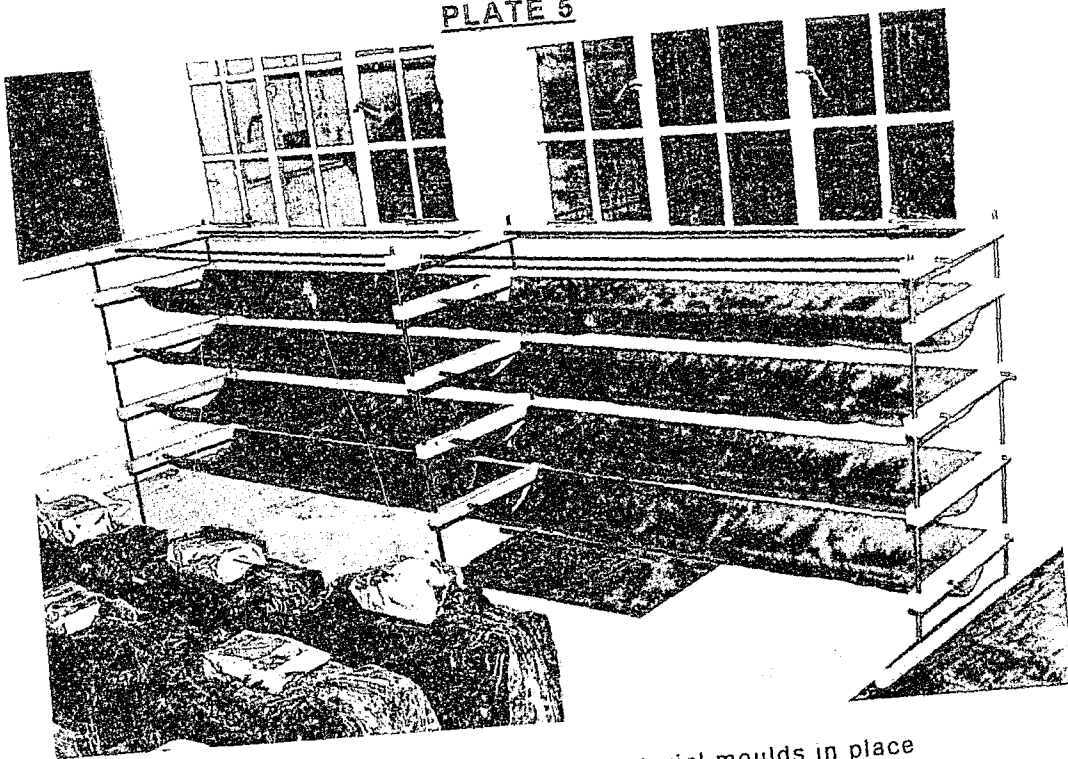
Figure 1: The first frame with material moulds in place

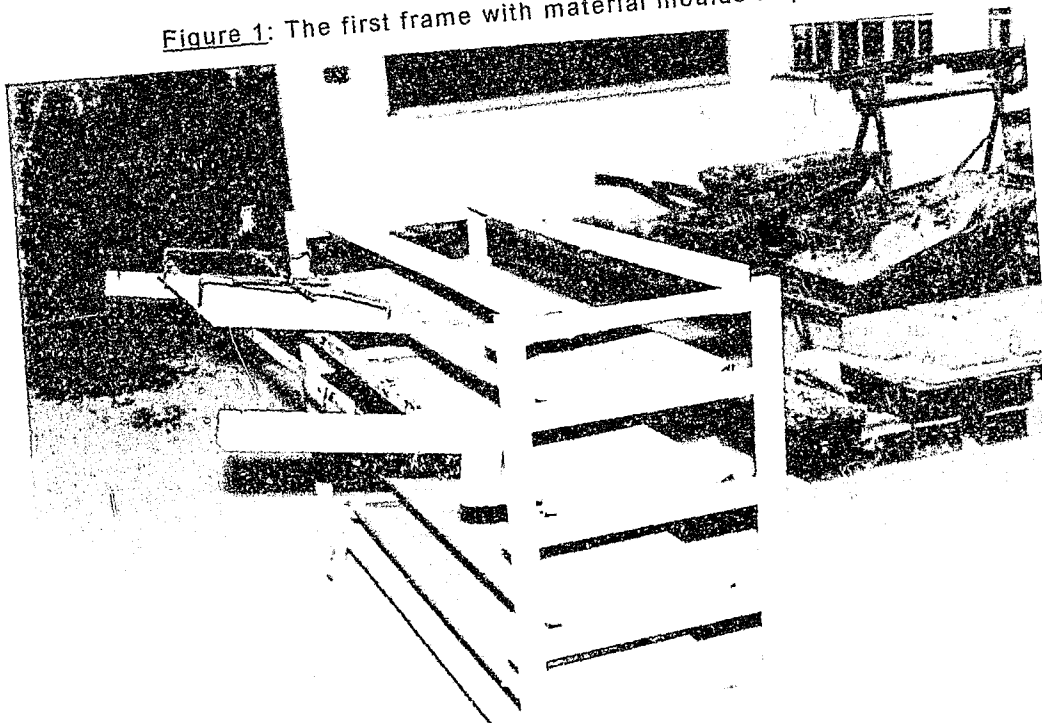
Figure 2: The second frame with material moulds in place. The clamps and angle iron supports, supporting the steel sheet used to transport the tile, can be seen on the side of the frame

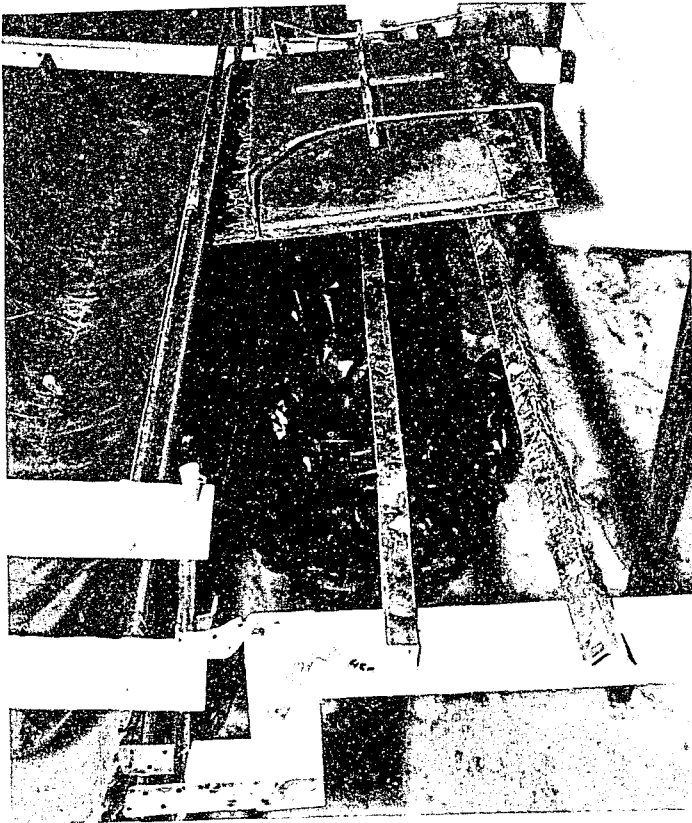
Figure 1: The clamps on the side of the frame supporting the steel sheet on which a green tile waits to be pulled onto the material mould

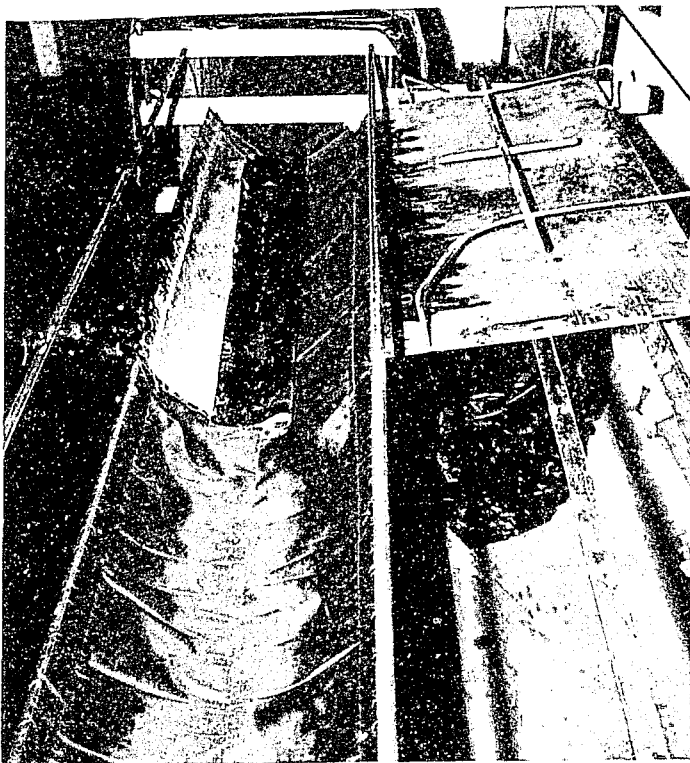
Figure 2: An example of the folding problem experienced with the first frame. This was cured in the second frame by allowing the material mould to be pulled taut, before pulling the tile on to it. The material mould would then be lowered into position with the green tiles in place.

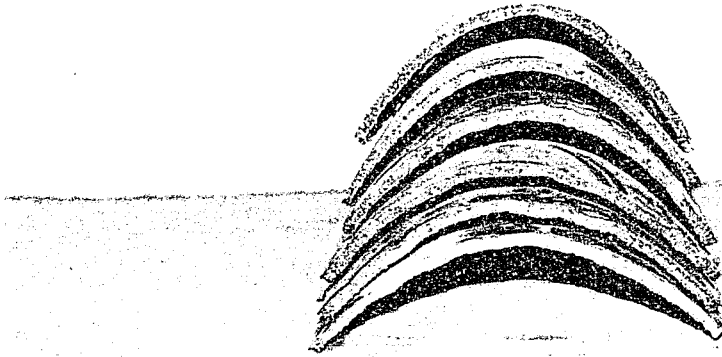
Figure 1: The various tile profiles tested. Profiles are from the bottom Aa, a, b, c, d and e

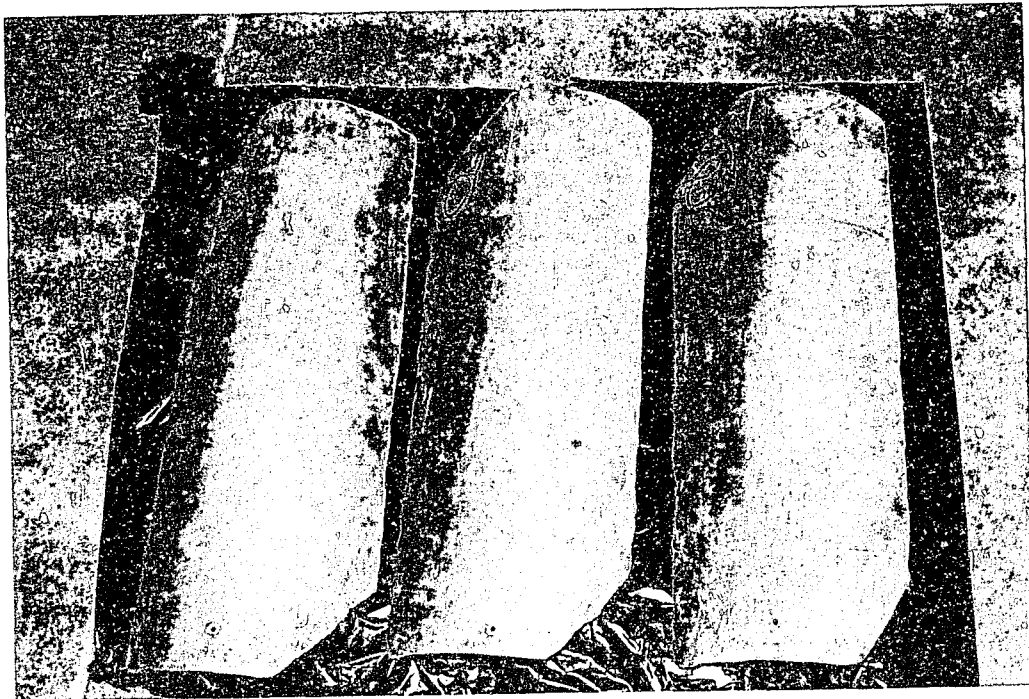
Figure 2: The new parabolic "b" profiled Agri-Tile

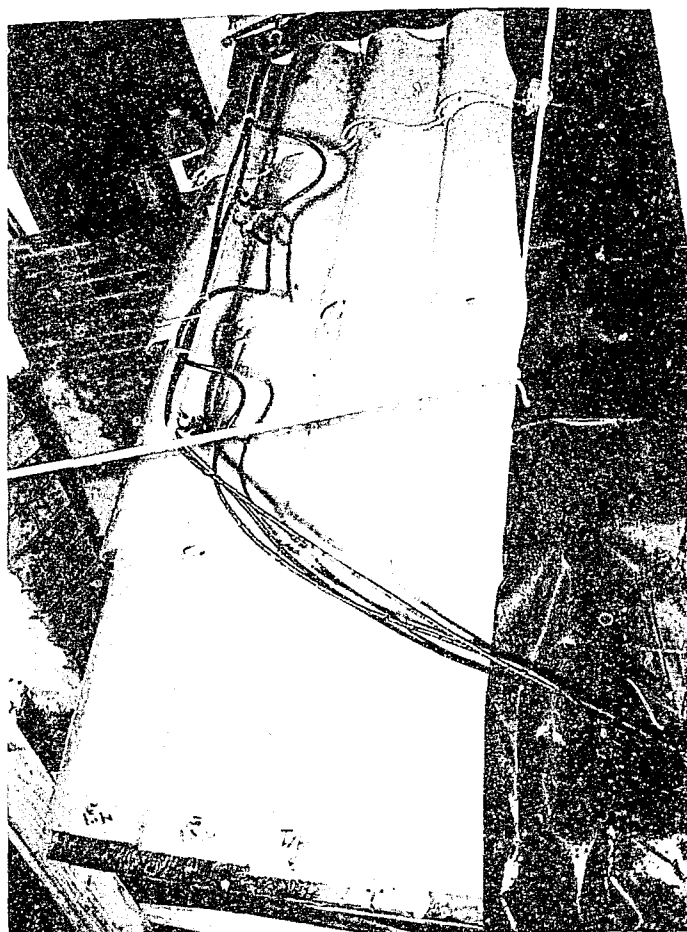
Figure 1: The original Agri-Tiles undergo the rain penetration test

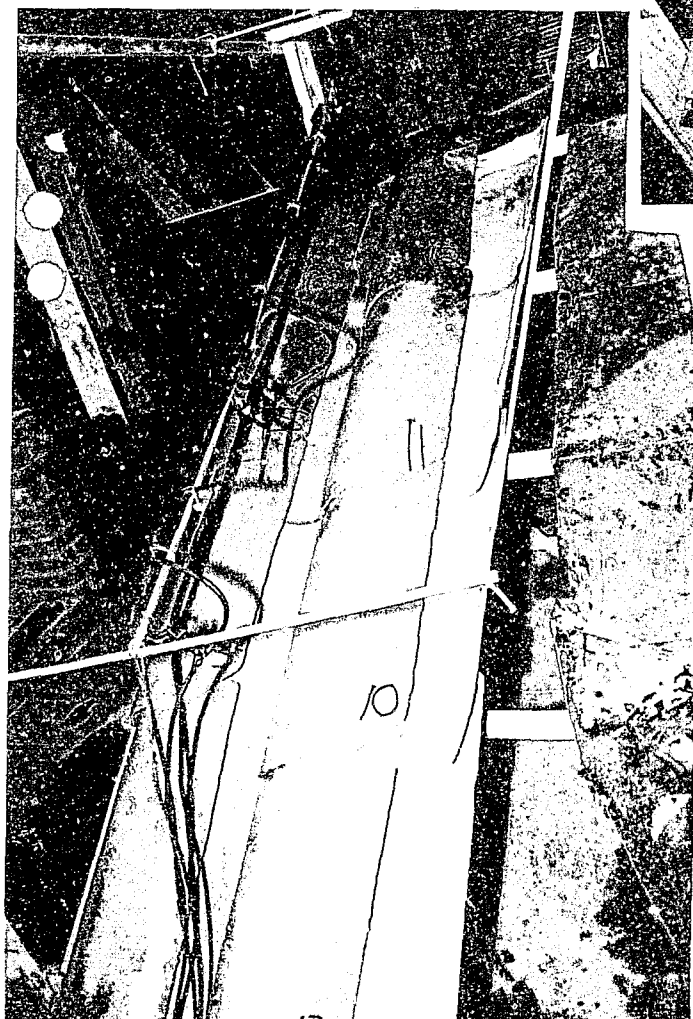
Figure 2: The modified Agri-tiles undergo the rain penetration test

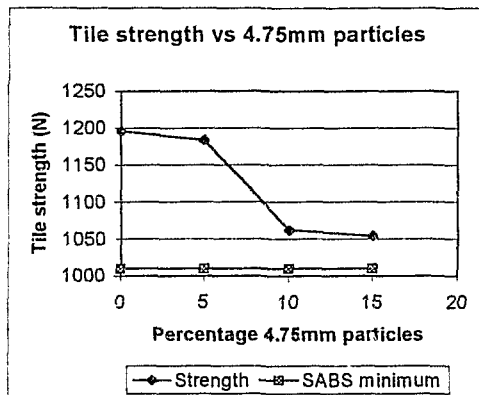
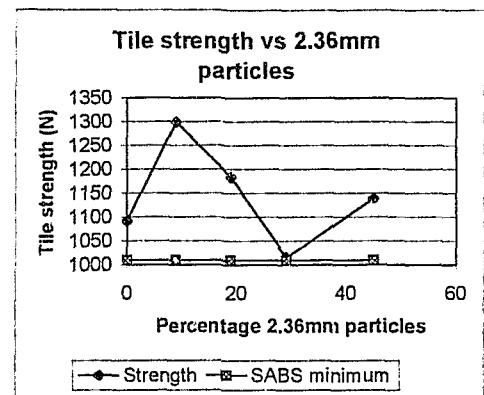
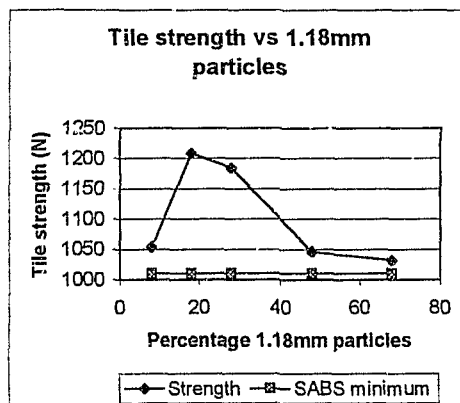
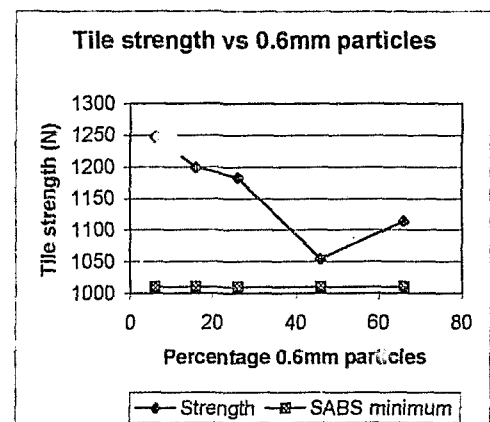
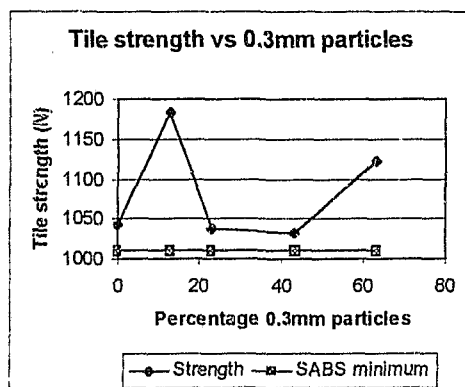
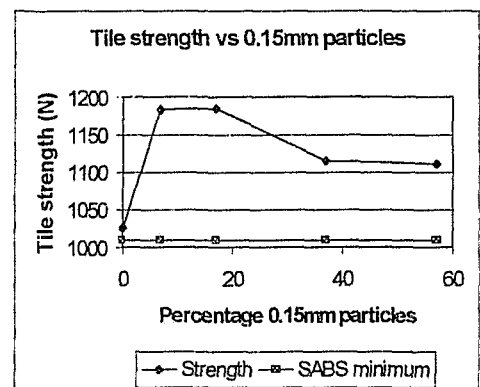
**PLATE 9**

A summary of graphs 6D to 6I
