## 6.2 Closure and Ride Tests:

**Name of thesis** An appraisal of the pillar support system at the St Helena gold mine. 1968

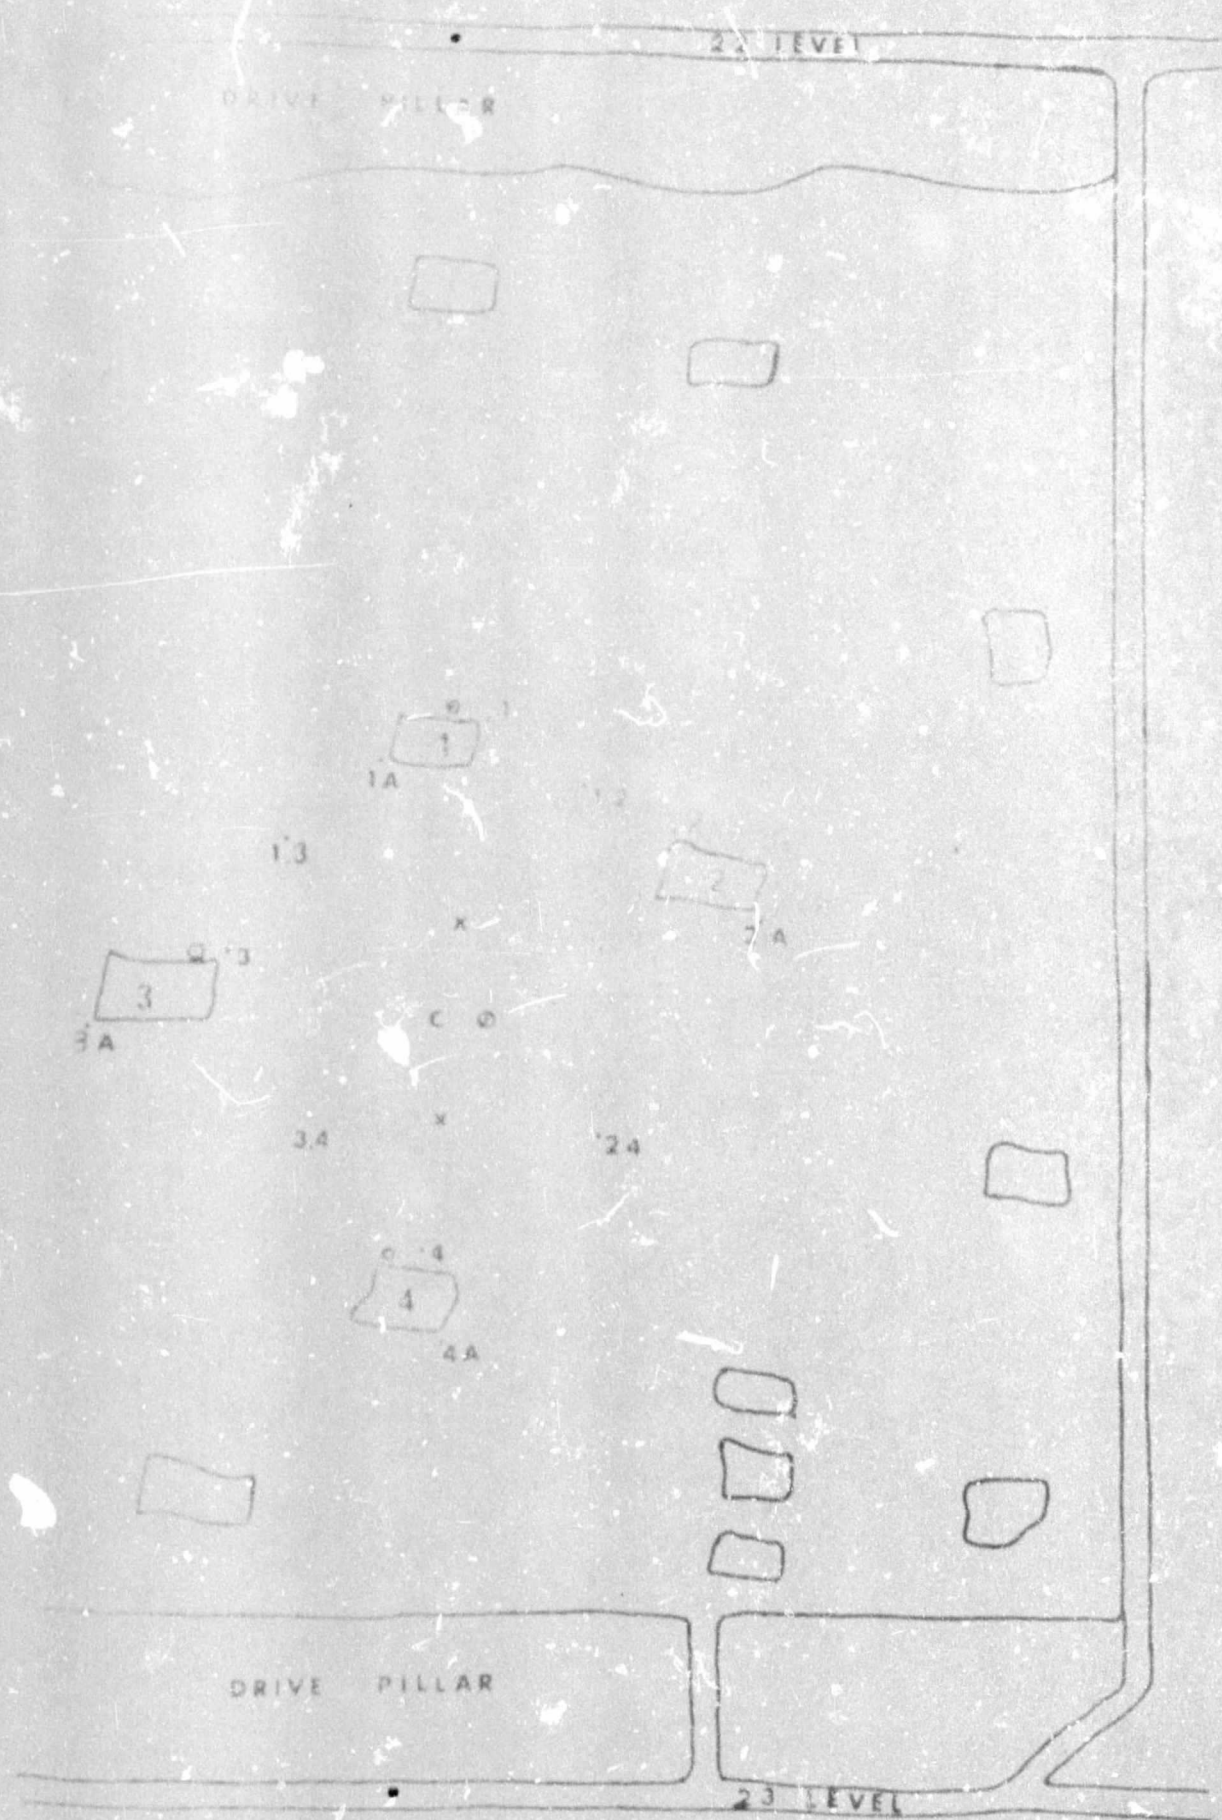
FIG 39

- Closure-Ride Stations
- ⊙ Bed Separation Meters
- x Ride Meters

Sketch Showing Positions of Stations

2323 Slope

22 and 23 Level drives is shown in FIG. 39 in plan, and FIG. 41 in section. This layout consisted of nineteen measuring stations, and tests were conducted during the three months required for pillar removal, and then for a further twelve months after all work had ceased.
