School of Mining Engineering

**SLOPE FAILURE PREDICTION AT HUSAB OPEN  
PIT MINE IN NAMIBIA**

A research report submitted to the Faculty of Engineering and the Built Environment, University of the Witwatersrand, Johannesburg, in partial fulfilment of the requirements for the degree of Master of Science in Engineering.

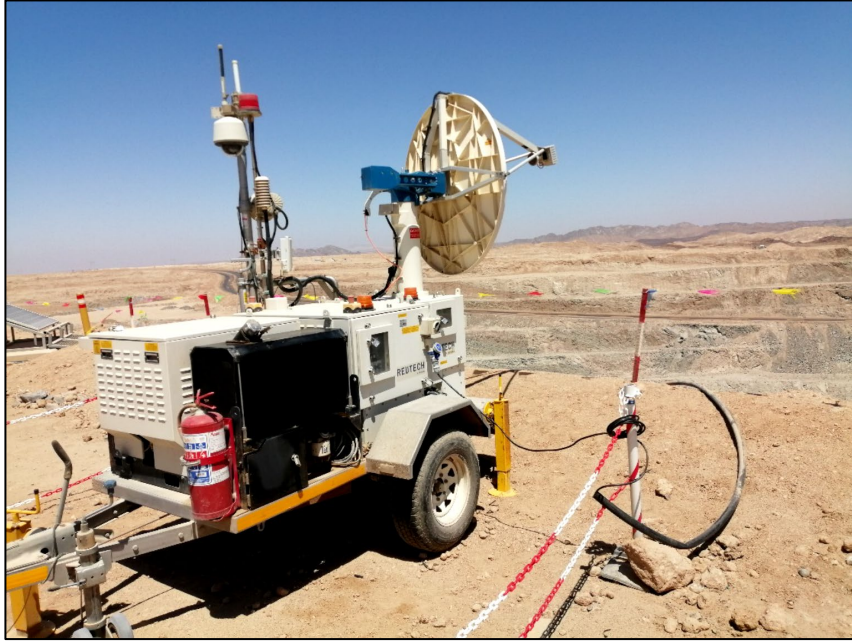
periods, as they introduce instantaneous velocity and noise, leading to frequent radar alarms. The usage of longer time periods is recommended, as it provides clean data for assessing deformation over a longer time period (Shellam and Coggan, 2020). Figure 2 -10 shows a RAR in use at Husab mine in Namibia.

*Figure 2-10: Reutech MSR series RAR radar, photograph taken at Husab Mine (Namibia)*

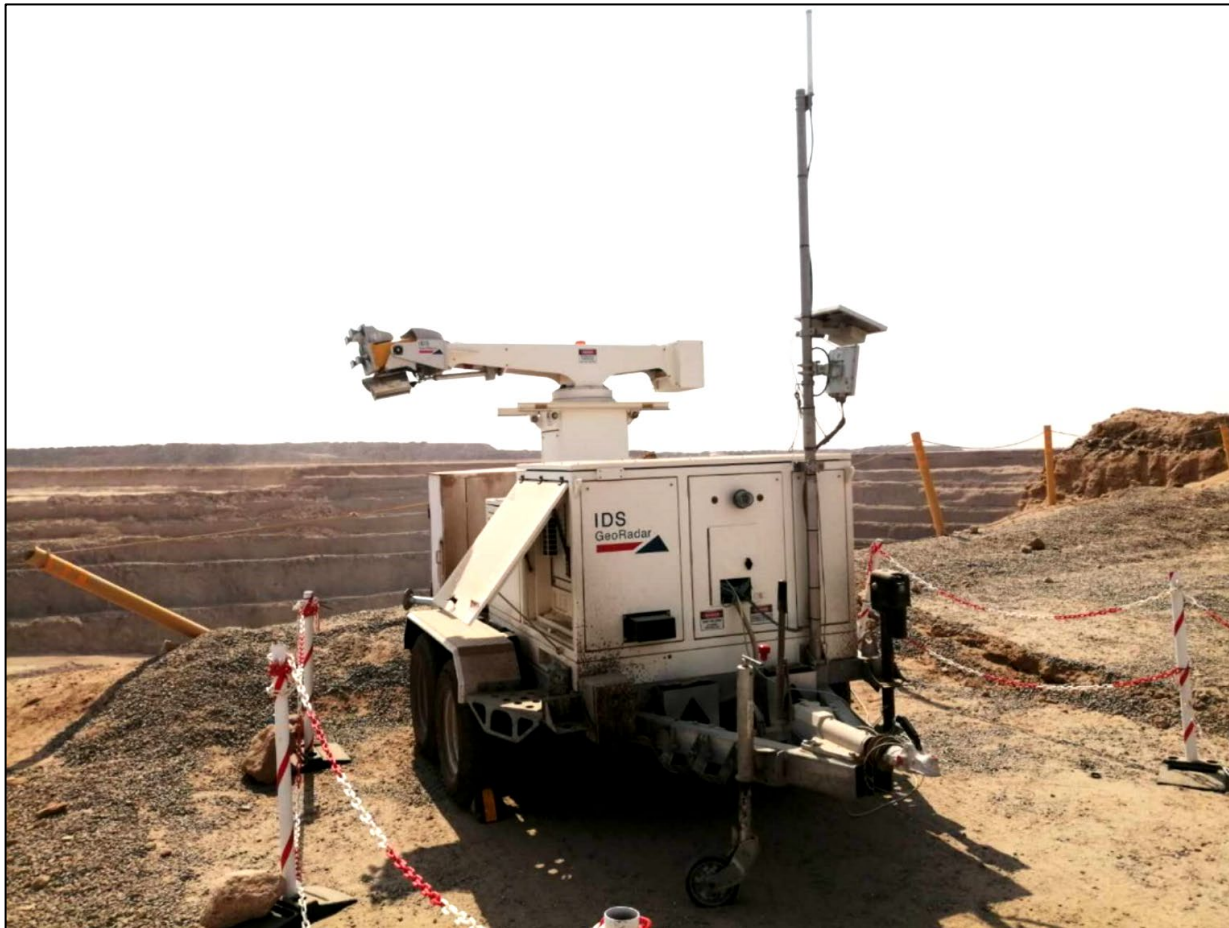
An example of the GBInSAR is the IDS (Ingegneria Dei Sistemi) IBIS system developed in 1980 (IDS GeoRadar, 2022). Figure 2 - 11 shows an example of an IDS GBInSAR radar utilised at Husab mine in Namibia.

*Figure 2-11: IBIS-ArcSAR radar deployed in an open pit operation, photograph taken at Husab mine (Namibia)*

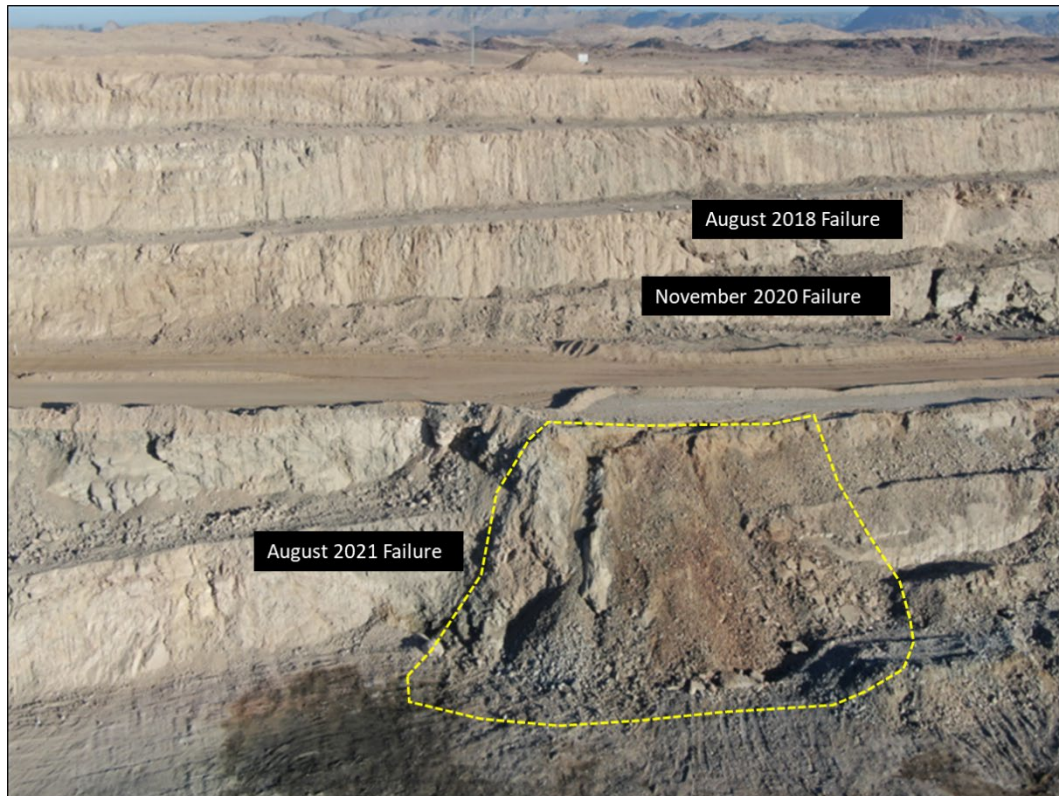
*Figure 4-3: August 2021 failure taken with the DJI Mavic Air 2 Drone*

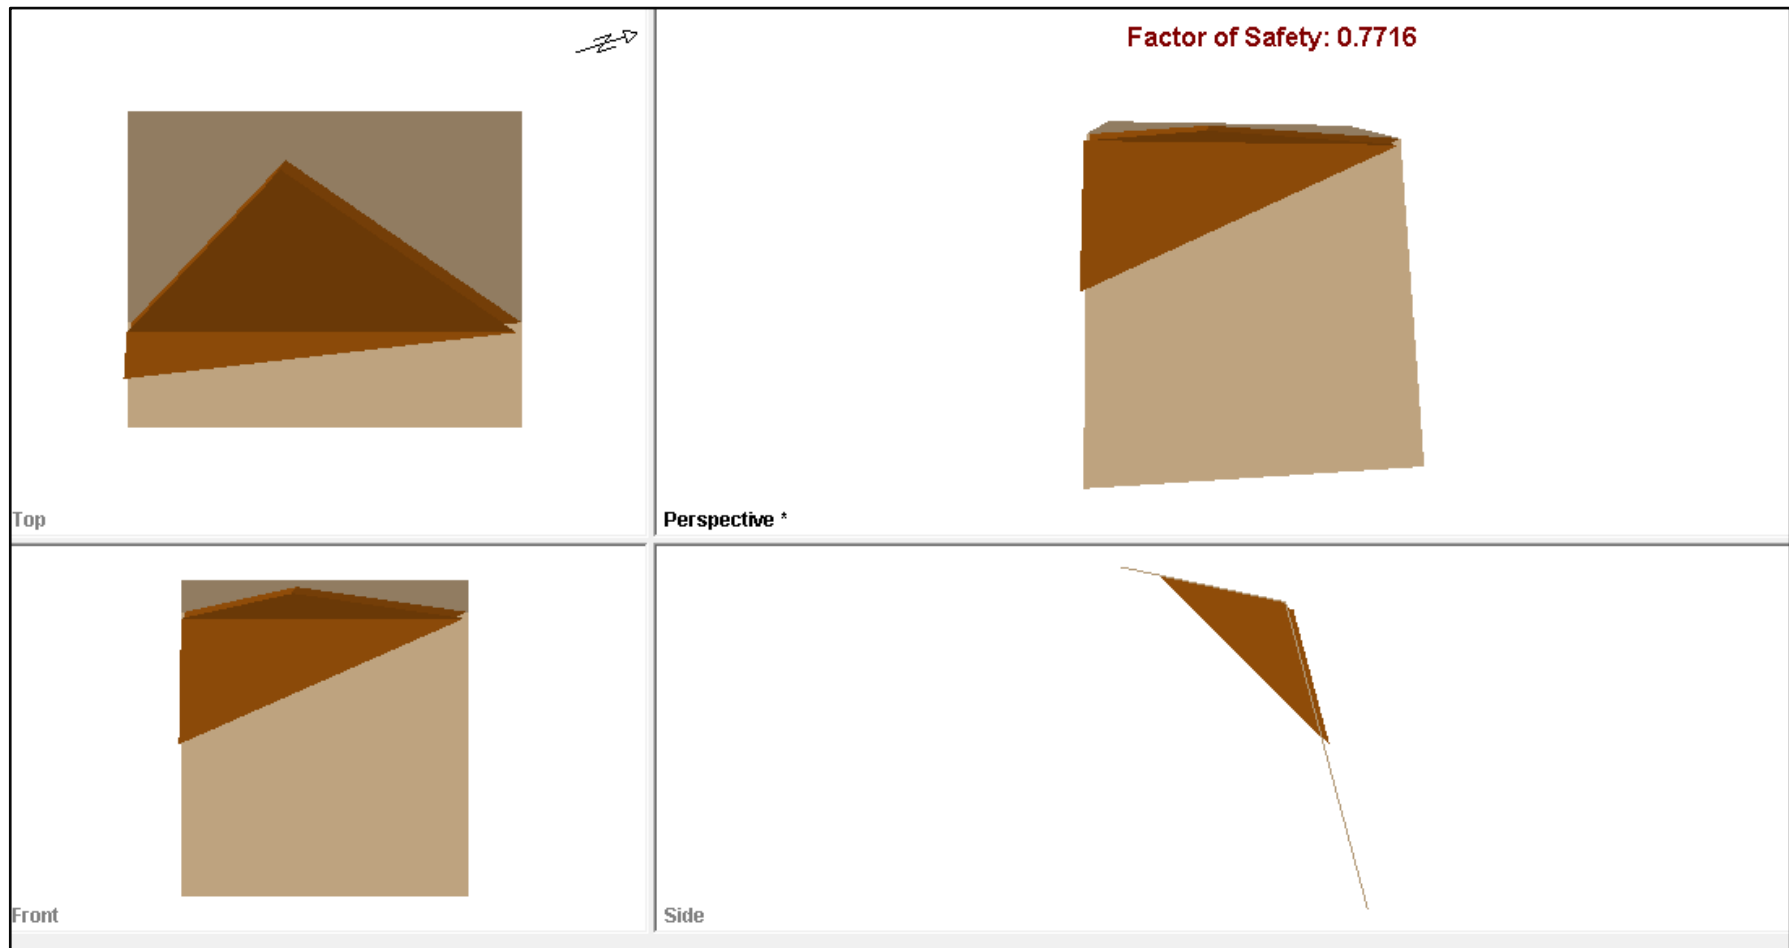
The wedge failure was analysed in the Rocscience Swedge software to determine the Factor of Safety (FOS) (Figure 4-7), a design acceptance criterion in engineering. FOS refers to the ratio of the shear strength of the material of a slope and the shear stress that develops along a potential failure surface (Read and Stacey, 2009). The following input parameters were used to carry out the analysis; cohesion 0 KPa, friction angle of  $32^{\circ}$ . The joints in the rock are cohesionless, as a result of blasting and opening up of foliation planes, therefore loss of shear strength along joint surfaces. Joint 1 orientation dip ( $39^{\circ}$ ), dip-direction ( $134^{\circ}$ ), Joint 2 orientation dip ( $80^{\circ}$ ) and dip – direction ( $63^{\circ}$ ), Slope orientation (Dip/Dip Direction)  $75^{\circ}/108^{\circ}$ . From the analysis, the FOS is 0.772. Limit Equilibrium is achieved when the FOS is 1. A FOS of less than 1, satisfies the condition for failure (Read and Stacey, 2009).

Figure 4-7: Swedge analysis carried out in Rocscience Swedge software, FOS is 0.772

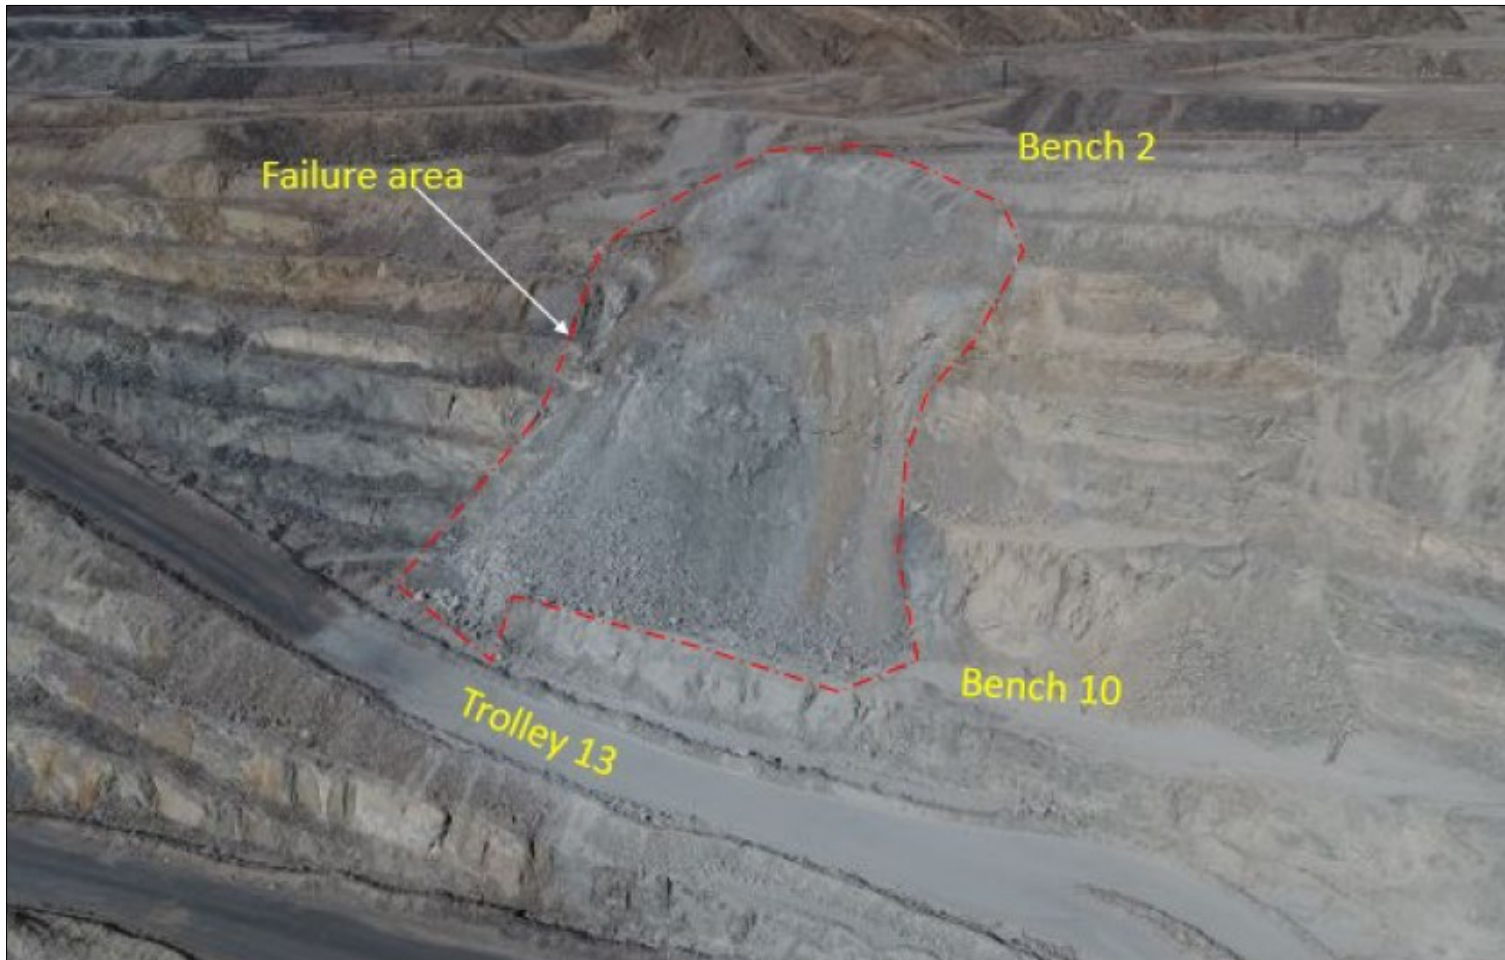
*Figure 4-21: Failure in the Rössing Uranium Mine Open Pit – 31 July 2020*
