### 5.2.3 P.W.R.(2a), (2b) and AIR (40R) orientation tests

5.2.4 P.W.R. (3a) and (3b) tests

#### 5.2.5 P.W.R. (4a), (4b) and AIR(2) tests

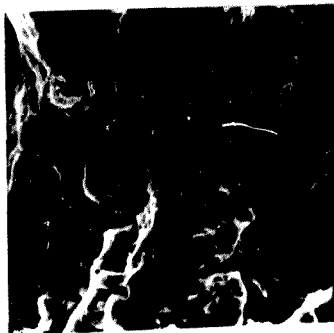
PLATE 5.23: General fracture surface. Ductile striated growth (enlarged region of above plate).  
(Mag. x 3000)

Crack growth direction ↑

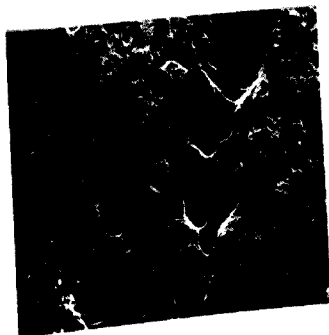
PLATE 5.41: (Mag. x 100)

PLATE 5.41 - 5.45: Whole MnS inclusions seen at the base of fast fan shaped regions of crack growth.

Plates 5.37 - 5.45 clearly show that the fracture surface is 'rid-died' with MnS inclusions which have assisted rapid crack growth. Large regions are linked together to provide a rapid crack growth path. Both the broken-up MnS and the 'whole' MnS's were seen to have the same effect on crack growth i.e. both creating fan shaped, fast crack growth regions.

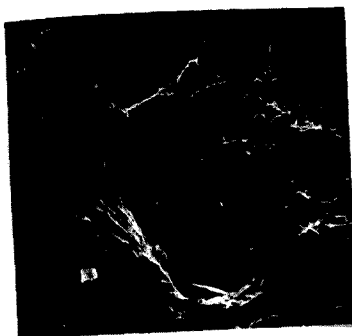
PLATE 5.49: (Mag. x 5000)

MnS inclusions resulting in fan shaped regions of fast crack growth

Specimen P.W.R. (2b) does, however, not show these large MnS inclusion areas, but MnS alignment in the direction of crack growth is still evident (plates 5.49 - 5.52) which enhances crack growth above that observed for specimen P.W.R. (1b) where manganese sulphides are orientated normal to the crack growth direction.

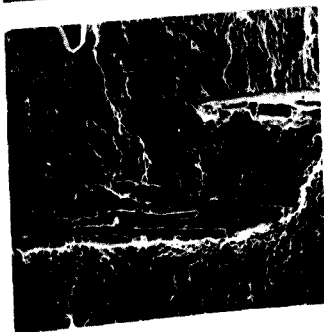
PLATE 5.65: Faster crack growth region extending slightly past the final MnS inclusion.  
(Mag. x 300)

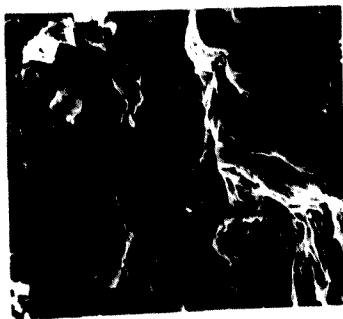
Plate 5.72: Close-up of the above fracture surface.  
(Mag. x 3000)

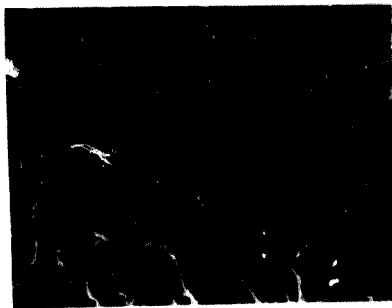
PLATES 5.76 - 5.78: MnS inclusions  
found towards the end  
of crack growth explain  
why crack growth rates  
increased dramatically  
for the 10 Hz test.

PLATE 5.77: Note fanned region  
originating from an  
inclusion site.  
(Mag. x 1000)

Test P.W.R. (4a) resulted in an initial ductile striation crack advancement process but, at  $\Delta K = \pm 15 \text{ MPa} / \text{m}$  cleavage facets were observed (Plates 5.73 to 5.75) and a small region of intergranular failure occurred. As both specimens, P.W.R. (4a) and (4b) showed these features at approximately the same  $\Delta K$ , and were cut from the same section of material, it can be assumed that these regions are heavily segregated. This, in itself, could cause the fractographic features, but hydrogen embrittlement could certainly have contributed to the intergranular cracking. For  $\Delta K > 15 \text{ MPa} / \text{m}$  inclusions were found to influence crack growth (a) fan-shaped regions of environmentally assisted crack growth after the inclusions (Plate 5.76); (b) fan originating from an inclusion site (Plate 5.77); (c) 'fast'-ductile-striated growth related to an inclusion (Plate 5.78).

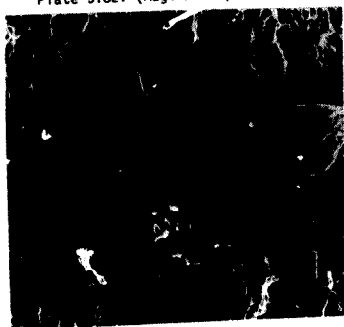
PLATES 5.82 and 5.83: MnS inclusions appear to have no influence on the crack growth mechanism in the adjacent matrix. Photographs were taken 1 mm from the final fracture surface.

Plate 5.83: Small regions of fan-shaped growth after the MnS inclusions.  
Mag. x 400
