#### **4.2.4 Summary of preconditioning activity**

#### **4.2.5 Analysis of preconditioning blasts**

#### **4.2.6 Quantitative analysis of the effects of preconditioning**

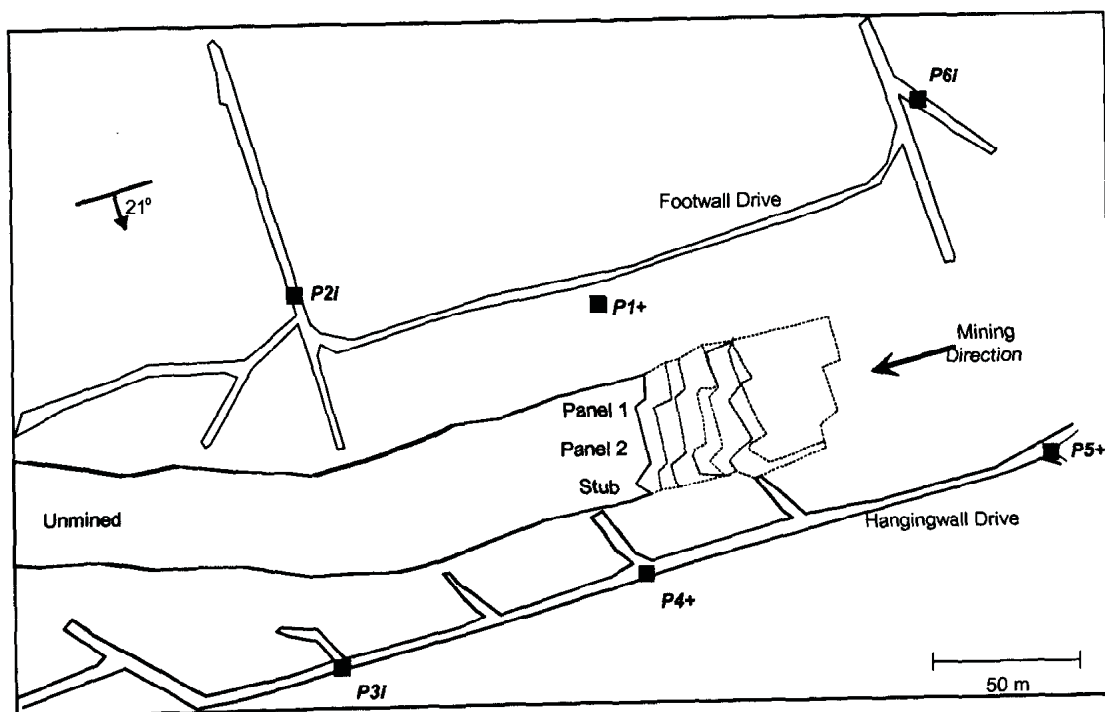
**Figure 4.2.3 Plan of the preconditioning test site, showing the geophone positions for the PSS network**

The PSS network had a fairly good location accuracy ( $5.4 \pm 3.0$  metres) for seismic events that originated from the preconditioning site. This location accuracy provided a high degree of confidence to studies of migratory patterns of microseismic event locations ahead of the mining faces. These migratory patterns were related to the stress redistribution that took place in the rockmass during mining and preconditioning activity. This formed an important part of the analysis of the effectiveness of preconditioning.

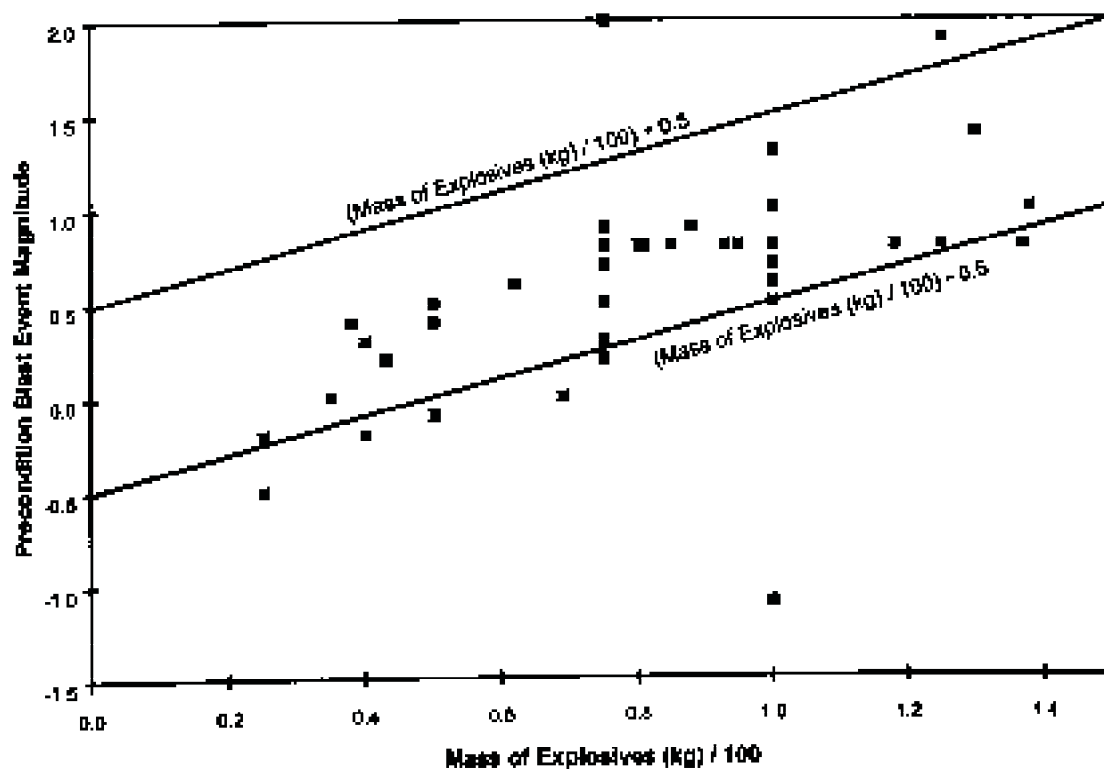
**Figure 4.2.4 Comparison of the recorded preconditioning blast event magnitudes with the amount of explosive used for each blast**

where "mass of explosive" used for the blast is given in kilograms (Figure 4.2.4). This gives a seismic efficiency of about one percent. Two of the recorded

preconditioning blasts had magnitudes above this range, indicating a release of stored strain energy from the rockmass in addition to that would arise from the normal interaction of the explosive with the rock. The rockmass in the vicinity of these two blasts had clearly been carrying excess load, which was relieved by the preconditioning. Eight of the recorded preconditioning blasts had magnitudes below the range given above. These were mostly blasts from short holes with small quantities of explosive, or blasts from incorrectly laid-out holes or holes that had proved difficult to drill and that had not been drilled to the planned length.

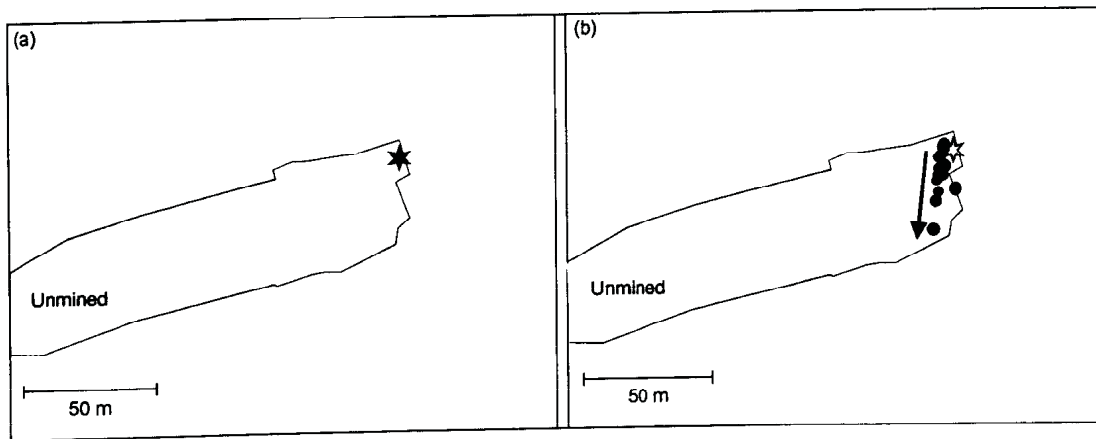
**Figure 4.2.5 Seismic data recorded during and following a preconditioning blast at the test site on 26 November 1992**

**Case 1:** The recorded microseismicity following effective preconditioning blasts exhibits spatial migration away from the vicinity of the preconditioning blasts, indicating the transfer of stress further ahead of the face of the preconditioned panel and towards unpreconditioned ground. Figure 4.2.5 shows an example of the effects of a preconditioning blast that took place on 26 November 1992. The star in Figure 4.2.5 (a) shows the location of the blast event ( $M = 0.7$ ) as recorded by the PSS. The arrow in Figure 4.2.5 (b) indicates the spatial migration of microseismicity (circles) recorded by the PSS in the 24 hours following the blast. This seismicity showed a clear migratory trend away from the top panel towards the panels below, indicating the transfer of stress away from the panel after the preconditioning blast.

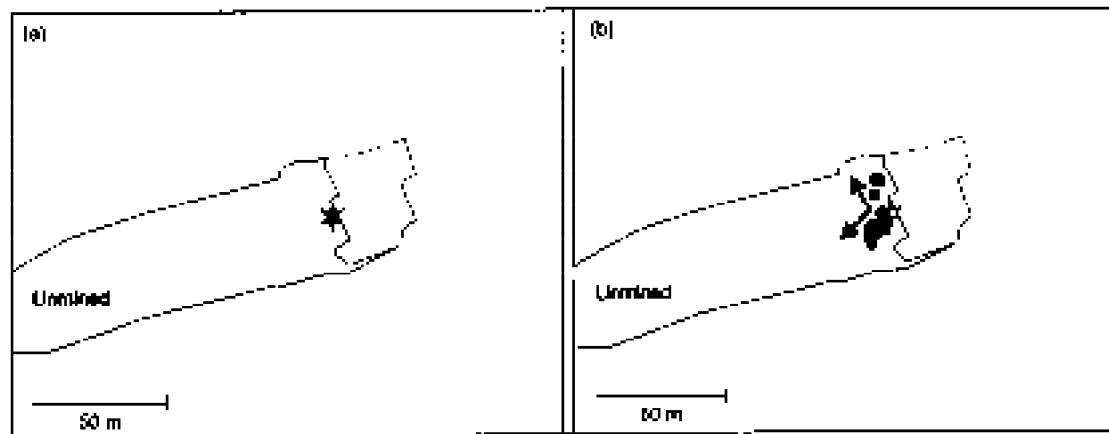
**Figure 4.2.8 Seismic data recorded during and following a preconditioning blast at the test site on 22 December 1993**

**Case 2:** Figure 4.2.6 shows an example similar to that shown in Case 1. The star in Figure 4.2.6 (a) shows the location of the blast event ( $M = 1.0$ ) as recorded by the PSS. In Figure 4.2.6 (b) the arrows indicate the spatial migration of microseismicity recorded by the PSS in the 24 hours following the blast. This seismicity concentrated further ahead of the preconditioned panel (i.e. away from the working areas), as well as in the adjacent panel above, indicating the transfer of stress away from the vicinity of the preconditioning blast. This example illustrates the need for a correct sequencing of the preconditioning of adjacent panels. Since the preconditioning blast in this panel transferred some of the stress onto the panel above, it was thus important that the panel above had been

preconditioned (destressed) prior to this panel, or the stress transfer might have loaded the rockmass ahead of panel above and led it to failure.

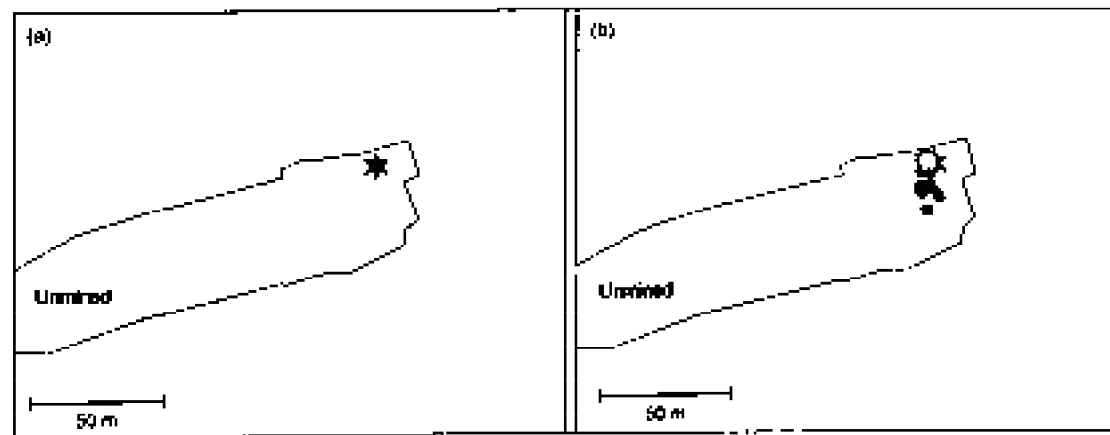
**Figure 4.2.7 Seismic data recorded during and following a preconditioning blast at the test site on 31 March 1993**

There was a three-month production stoppage from July to September 1994, and it was decided to precondition all three faces before restarting the production

activity at the site. The first of those blasts, on 20 September 1994 in the top panel, went according to plan and was effective in preconditioning the rockmass ahead of the panel face. But, due to some drilling difficulties, neither of the preconditioning blasts, in the middle panel on 26 September and in the stub on 29 September, produced a discernible preconditioning effect. Thus, the top panel preconditioning blast on 28 October 1994 took place at a time when neither the middle panel nor the stub had been effectively destressed.

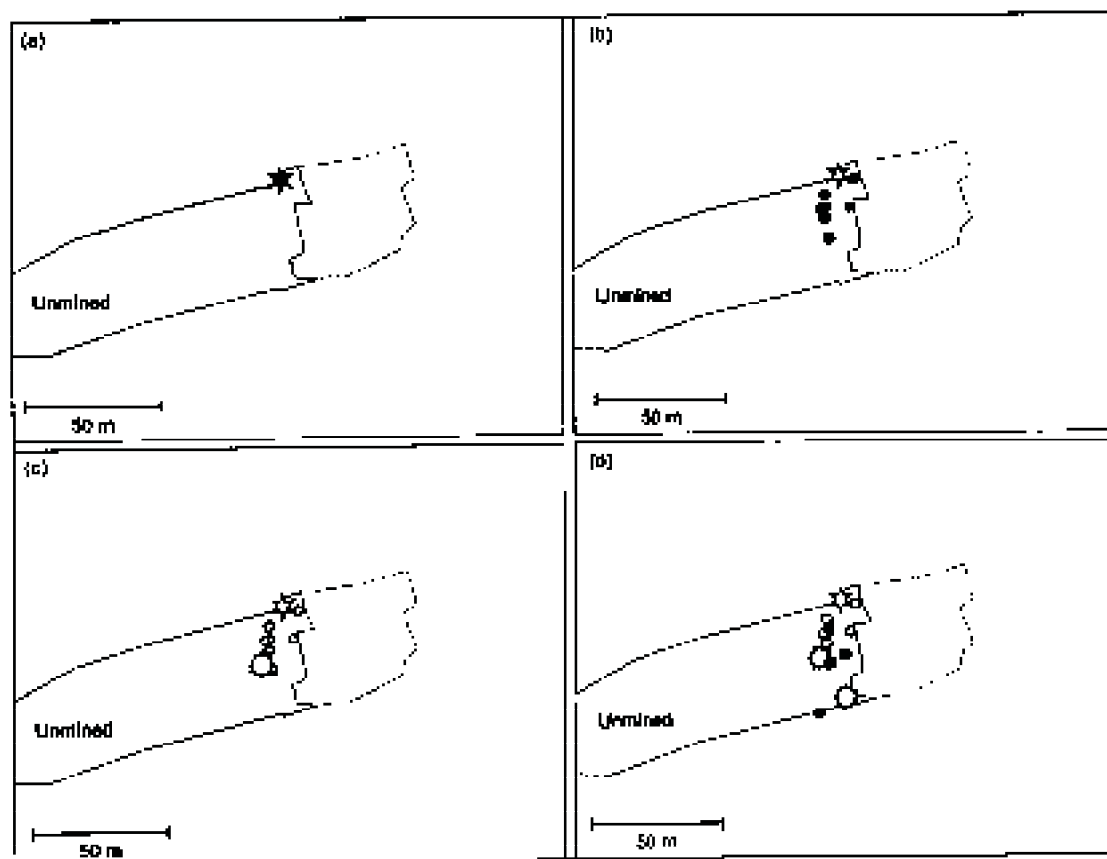
**Figure 4.2.8 Seismic data recorded during and following a preconditioning blast at the test site on 28 October 1994**

The preconditioning blast on 28 October 1994 was recorded as an  $M = 0.9$  seismic event by the PSS. The star in Figure 4.2.8 (a) shows the location of this event. The subsequent microseismicity (circles in Figure 4.2.8 (b)) migrated down-dip, indicating the transfer of stress away from the preconditioned panel. The addition of load to the rockmass ahead of the panel below then triggered a large ( $M = 2.1$ ) seismic event in that area, releasing the strain energy that had accumulated there. The white star in Figure 4.2.8 (c) indicates the location of this triggered event. The destressing of both panels in sequence suggests that additional load was then being carried by the rockmass ahead of the stub face, a supposition borne out by the subsequent triggering of a large ( $M = 1.5$ ) seismic event in that area by the production blast in the stub face. The white star in Figure 4.2.8 (d) shows the location of this triggered event. All of the mining faces were thus effectively destressed by the one preconditioning blast in the top panel, on that occasion.

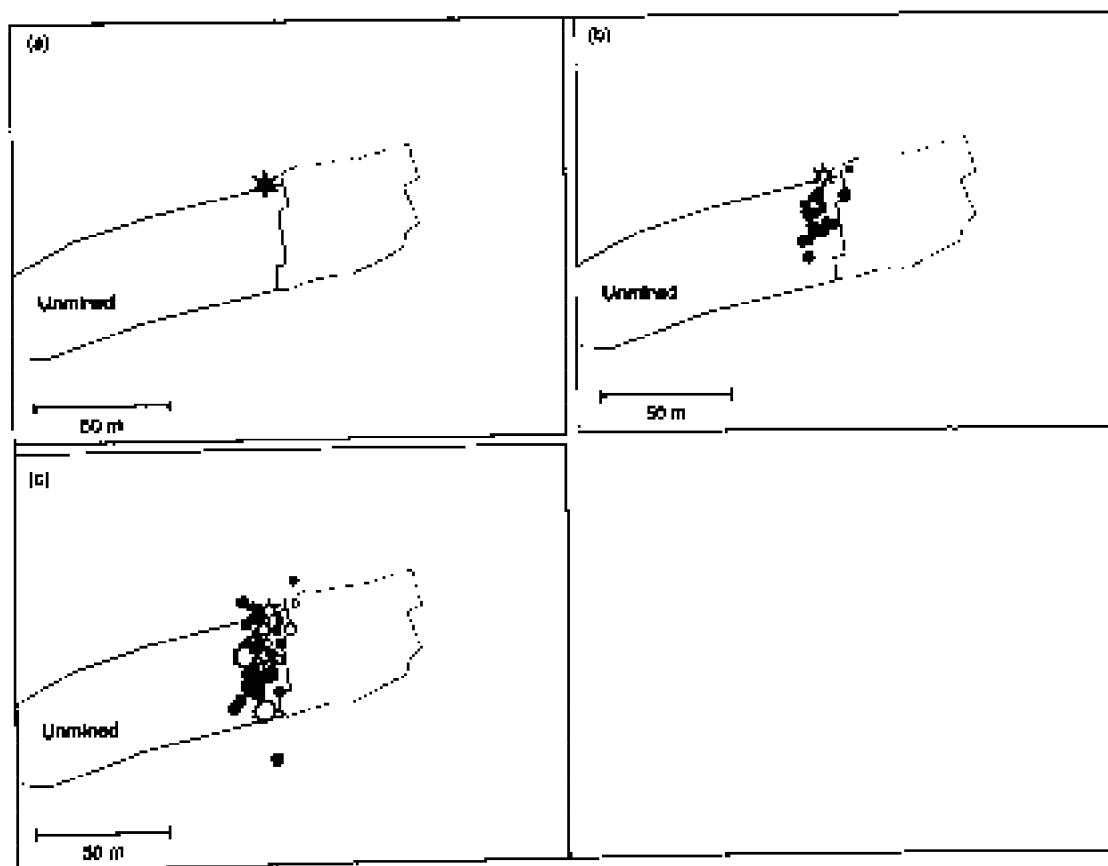
**Figure 4.2.9 Seismic data recorded during and following a preconditioning blast at the test site on 10 January 1995**

**Case 5:** The preconditioning blast in the top panel took place on 10 January 1995. The star in Figure 4.2.9 (a) shows the location of the blast event ( $M = 0.7$ ) as recorded by the PSS. The circles in Figure 4.2.9 (b) show the microseismicity recorded following the blast and indicate the stress transfer away from that panel towards the panel below. A production blast in the middle panel face on the following day then triggered the instability that had developed in the rockmass ahead of the panel, releasing the stored strain energy by way of two large ( $M = 1.7$ ) seismic events. The darker circles in Figure 4.2.9 (c) show the microseismicity recorded following the production blast and two white stars in Figure 4.2.9 (c) show the location of the triggered seismic events.

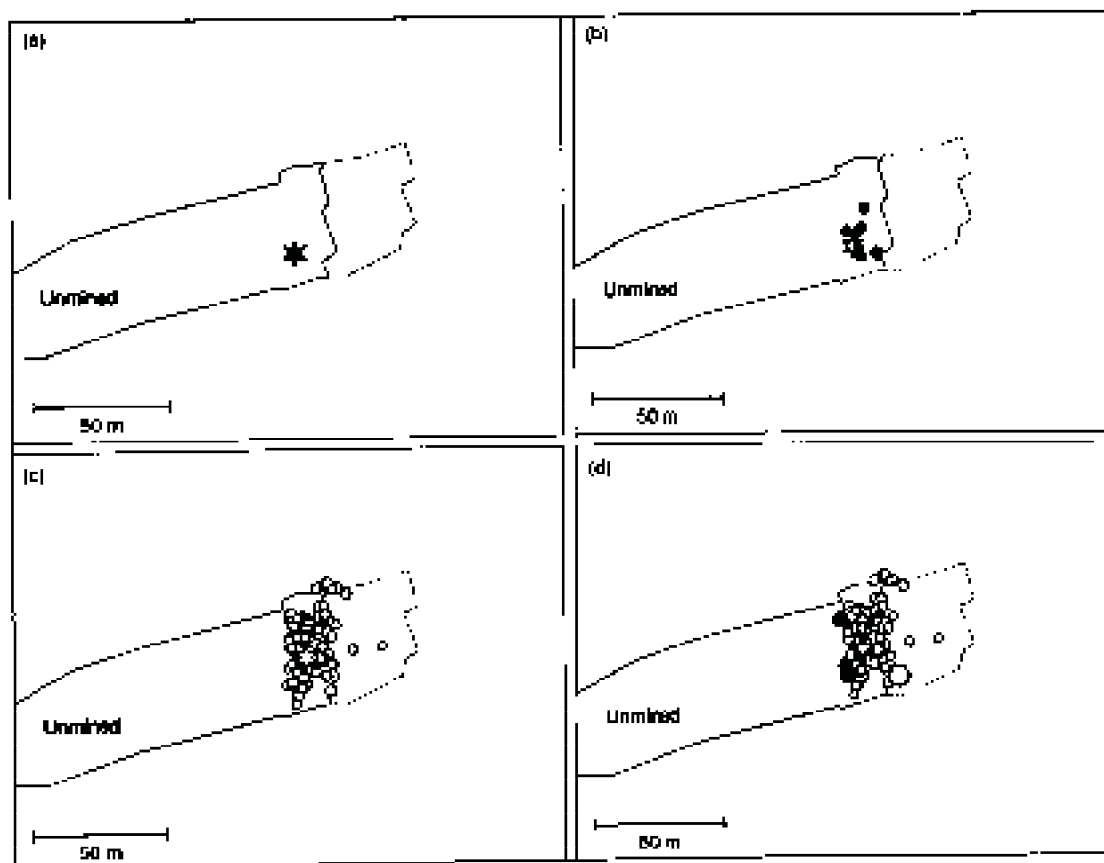
**Figure 4.2.10 Seismic data recorded during and following the preconditioning blasts at the test site on 11 April and 15 April 1994**

**Case 6:** An example that serves to illustrate the importance of correct sequencing is the pair of preconditioning blasts that were set off in April 1994. The preconditioning blast of 11 April 1994 was set off in the stub without the panel above having been preconditioned beforehand. The star in Figure 4.2.10 (a) shows the location of the blast event ( $M = 0.4$ ) as recorded by the PSS.

The stub preconditioning hole was oriented effectively perpendicular to the stope face, with the intention of remobilising the pillar-edge parallel fractures that were prominent ahead of the stub face. The result was that the preconditioning blast was effective further ahead of the face than it would have been had the hole been oriented parallel to the face. The net effect was to drive the stresses back towards the face, mostly in the area between the stub and the middle panel. The circles in Figure 4.2.10 (b) show the microseismicity recorded following the blast. This area is generally not effectively preconditioned, due to the geometric effect of the stemming near the collars of the stub and middle-panel preconditioning holes.

The three production blasts which took place over the following days do not appear to have altered the stress state between the middle panel and the stub significantly. The circles in Figure 4.2.10 (c) show the microseismic events associated with these production blasts.

On 15 April 1994, a preconditioning blast was set off in the panel above the stub. The star in Figure 4.2.10 (c) shows the location of the blast event ( $M = 1.4$ ) as recorded by the PSS. This seems to have had the effect of adding further to the stress which had concentrated in the area and a large ( $M = 2.3$ ) damaging seismic event resulted, located on the face between the middle panel and the stub. The white star in Figure 4.2.10 (d) shows the location of this triggered seismic event.

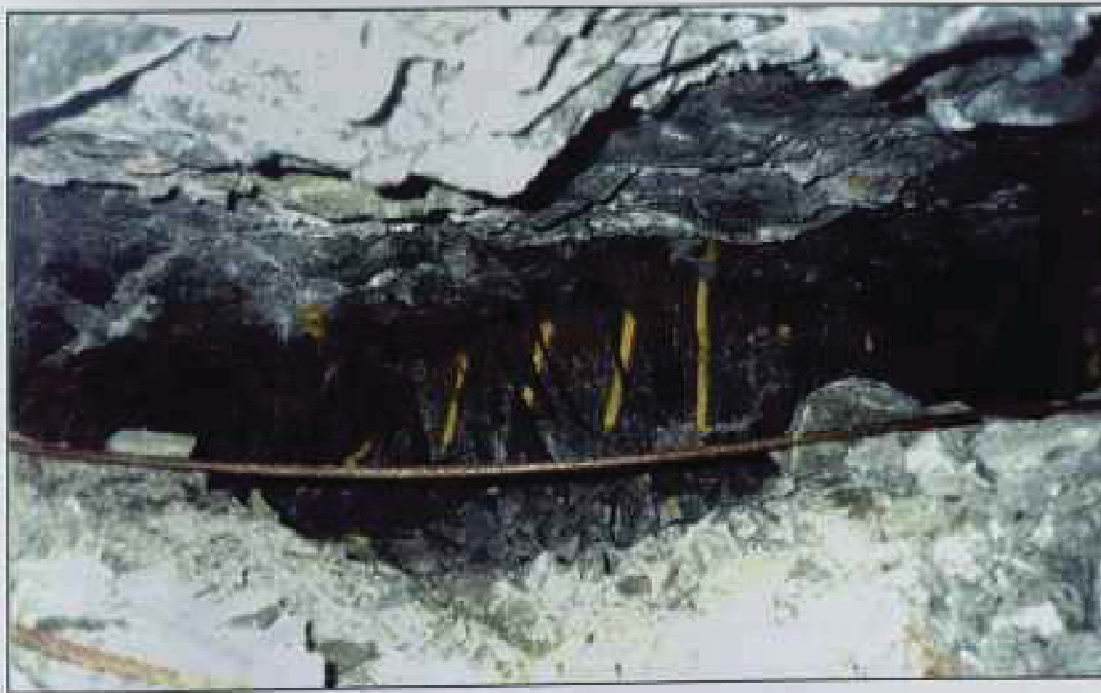
**Figure 4.2.11**      **The stope face appearance after a preconditioning blast**

An effective preconditioning blast resulted in scaling of rock off the face and shake-out of loose rock from the hangingwall. The extent of this depends largely on the fractured nature of the rock and the extent of baring undertaken by the slope crew. On several occasions, however, a considerable amount of dilation was noted on the face (Figure 4.2.11), providing more evidence to support the model of preconditioning (Lightfoot, 1993; Lightfoot, *et al.*, 1994; and Kullmann, *et al.*, 1994) and its interaction with the rockmass. Dilation of the face is clearly indicated by the open fractures enhanced by paint lines initially applied for a Ground Penetrating Radar (GPR) scan before the blast. Scaling of rock from the face resulted in the removal of paint lines on both sides of this area as shown in Figure 4.2.11. The amount of dilation, however, is extremely difficult to quantify, with any degree of accuracy, using conventional measuring techniques.

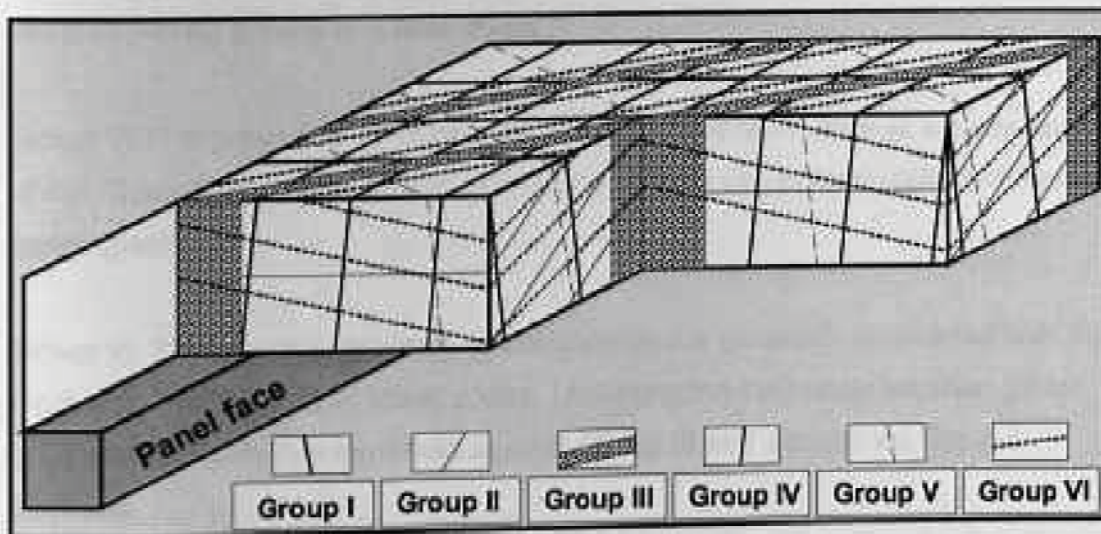
**Figure 4.2.14** Schematic view of fracture groups (not to scale)

*Group II:* As the second major cluster, this group also lies more or less perpendicular to the face, but has a shallower dip of between  $50^\circ$  and  $60^\circ$ . These are sinuous joints, often vein-quartz filled and are faults that appear to interconnect the fractures of Group III.

*Group III:* This group of fractures lies at an angle of  $35^\circ$  to  $45^\circ$  to the panel face. The fractures in this group are clustered into distinctive steeply dipping highly sheared zones containing both calcite and vein quartz. These shear zones are between 50 cm and 80 cm wide and occur at intervals of about 3 m. White crushed quartzitic gouge is also common in these fractures, which show several phases of movement. Fractures in this group have an orientation that is consistent with the regional trend of the dykes and faults across the mine. This suggests that the initial alignment of these fractures was strongly influenced by regional-scale tectonics. At a very late stage, probably due to current stoping and preconditioning, these fractures were abraded to form a fine white quartzitic gouge.

*Group IV:* This group consists of steeply dipping joints that are orientated approximately parallel to the panel face. These joints have a fairly low

persistence and usually do not contain any secondary minerals. Some of the Group IV fractures contain a whitish gouge similar to that of the Group III fractures. This leads to the interpretation that these joints were sheared as a result of mining activity at a later stage.

*Group V:* This group lies at roughly 130° to the strike of the face at a steep angle of dip. These joints interconnect with Group VI fractures to form distinctive hackly hangingwall.

*Group VI:* This group is relatively uncommon and is generally associated with the more prominent Group III shear zones. Underground they occur as short (often gouge-filled) faults that terminate against Group III and sometimes Group I fractures.

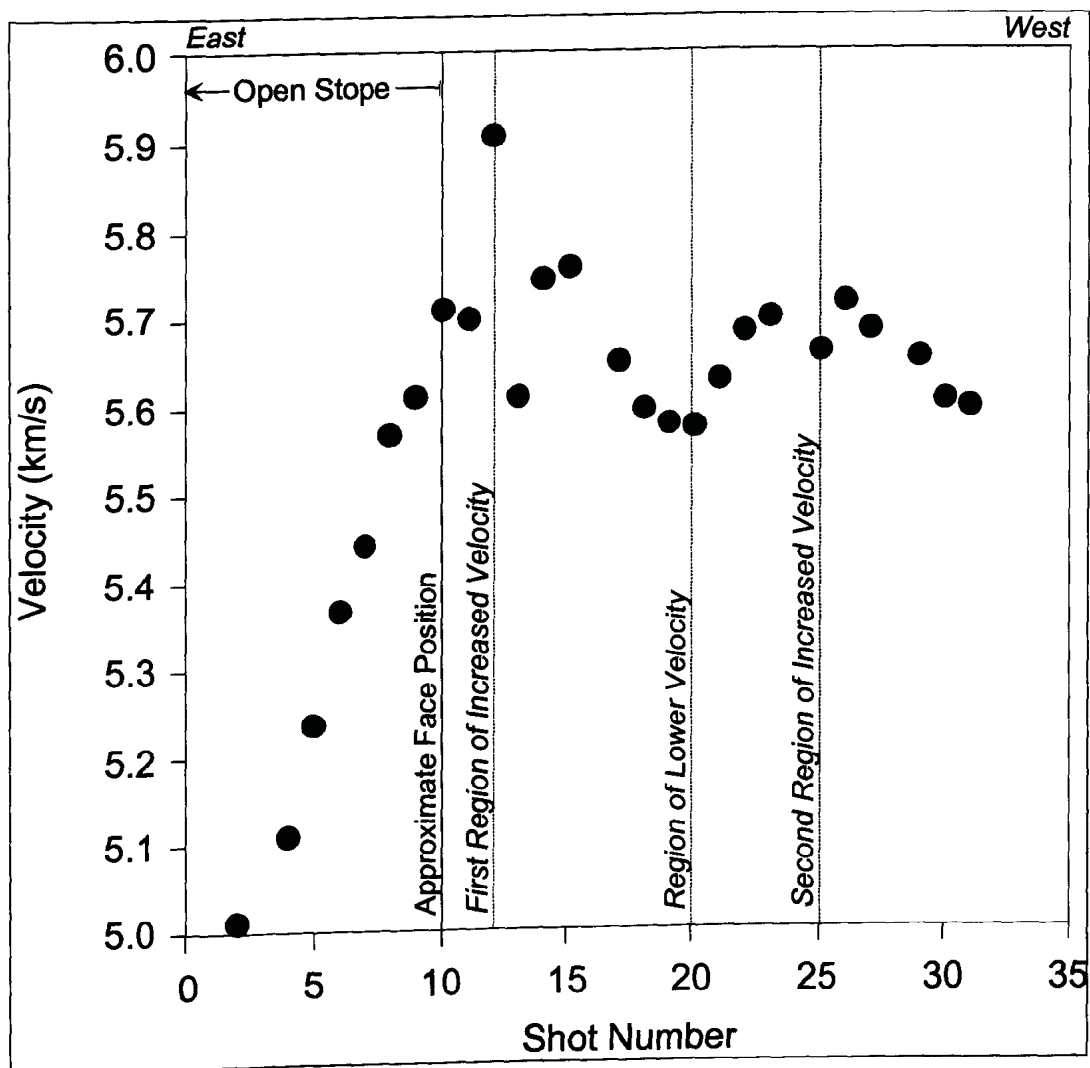
**Figure 4.2.16** Plot of the straight ray apparent velocity measured between common shot and receiver hole numbers, showing the velocity variation from east to west (after Maxwell and Young, 1995)

Significant velocity variations were detected in the pillar, with velocities of between 4.96 and 6.00 km/s being measured, the average value being 5.67 km/s (standard deviation 0.16 km/s). Figure 4.2.16 shows the variation in velocity from east to west, measured directly across the pillar between common source and receiver holes. A low-velocity zone in the east, corresponding to the open stope, is evident in the figure; ahead of the face, there is a region of increased velocity, corresponding to the expected high-stress anomaly in the pillar. Beyond this, there is a region of lower velocity, followed by a second region of moderately high velocity.

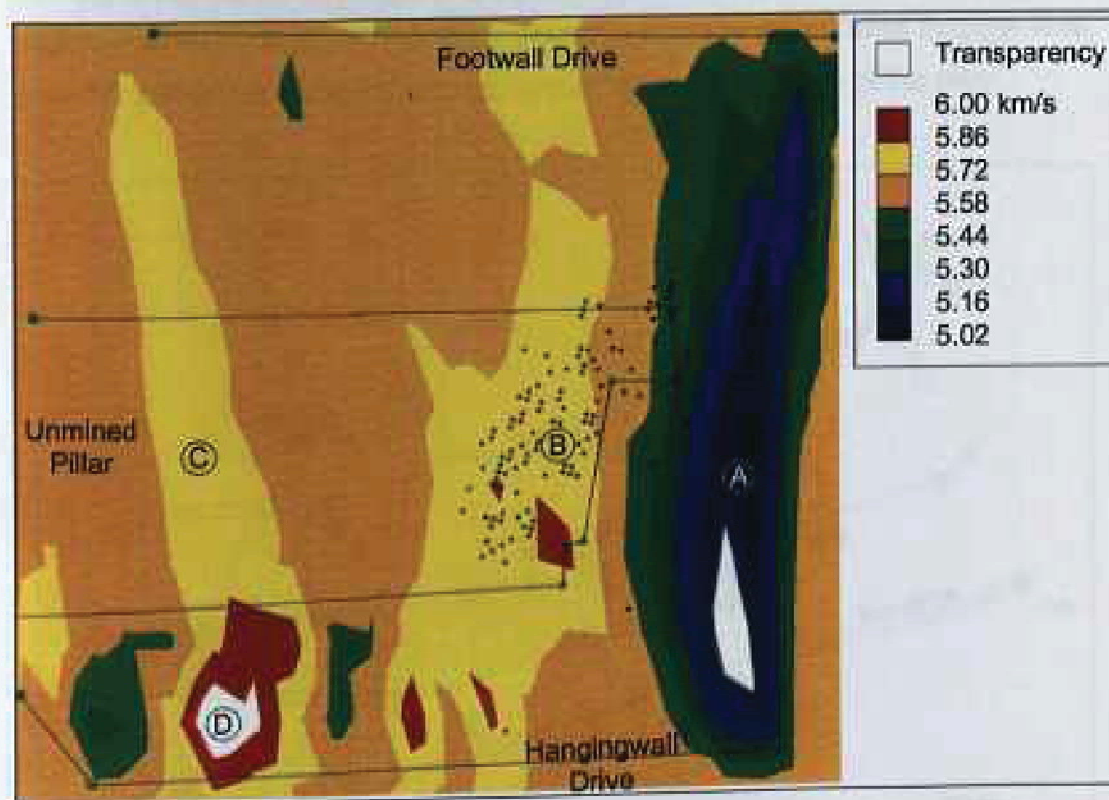
**Figure 4.2.17** Straight ray velocity image produced from the seismic tomography survey (after Maxwell and Young, 1995)

A high-velocity region extends from north to south across the pillar ahead of the stope face in the image ('B' in Figure 4.2.17). This increased velocity can be attributed to the expected stress increase ahead of the advancing face. The mining-induced seismicity recorded by the monitoring PSS during the period of the surveys tended to concentrate in this high-velocity region, as can be seen in Figure 4.2.17. The highest velocities were found in the southern portion of this region, ahead of the face between panel 2 and the advance heading (stub). This was an area of the pillar that was believed to be ineffectively preconditioned because of the geometries of the panel 2 and the stub preconditioning holes, as well as the influence of the stemming at the collars of the holes. It was the site of a large ( $M=2.3$ ) damaging seismic event in April 1994, after the stub was preconditioned out of sequence before the preconditioning of panel 2. This

appeared to add to the stress concentrated in the area and trigger the failure of the instability.

Within the pillar, the image shows a second moderately high velocity anomaly, roughly 50 metres ahead of the stope face ('C' in Figure 4.2.17), which appears to correspond to a secondary stress anomaly. Both of the high-velocity regions extend from the footwall drive to the hangingwall drive in the image: according to Maxwell and Young (1995), ray path smearing was to be expected in the north-south direction from the acquisition geometry. A secondary cluster of seismic activity was observed within the core of the pillar. Figure 4.2.18 shows the locations of the larger ( $M > 1.0$ ) seismic events, which were recorded by the PSS prior to this seismic tomography experiment. Figure 4.2.18 shows the locations in plan, while Figure 4.2.19 shows a time section in which the locations of the events through time are projected onto the line A-B in Figure 4.2.18. As can be seen in Figure 4.2.18, most of the events were located in the pillar ahead of and relatively close to the advancing stope faces, while the three events highlighted

The series of alternating high- and low-velocity regions along the southern boundary of the image ('D' in Figure 4.2.17) appeared to be localised, near-shot velocity variations; the average velocities showed a similar, consistent trend over a number of shot holes (Maxwell and Young, 1995). The velocity anomalies were thought to coincide with regions of relatively more and less fractured rock between the hangingwall drive and the pillar.

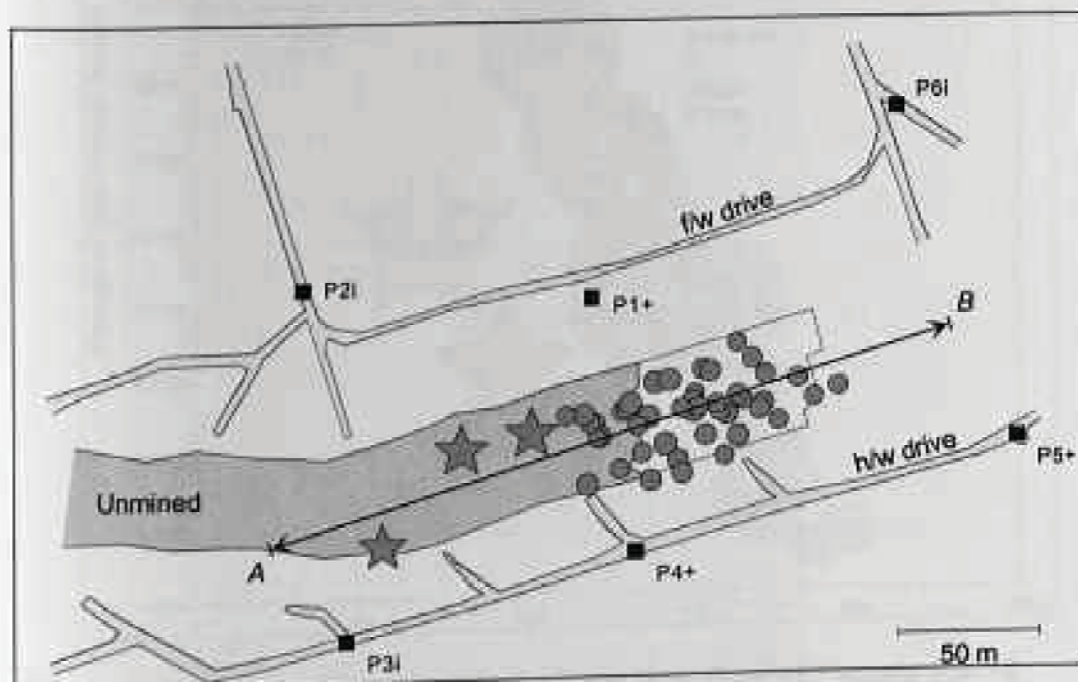
**Figure 4.2.18** Plan of the locations of the larger seismic events recorded prior to seismic tomography experiment

by stars in the figure were located between 50 and 100 metres ahead of the faces. This observation tended to confirm the presence of the secondary high-velocity anomaly in the image (Figure 4.2.17), and suggested that this secondary region of stress concentration was advancing with the stope faces through time, possibly indicating a degree of progressive failure of the core of the pillar.

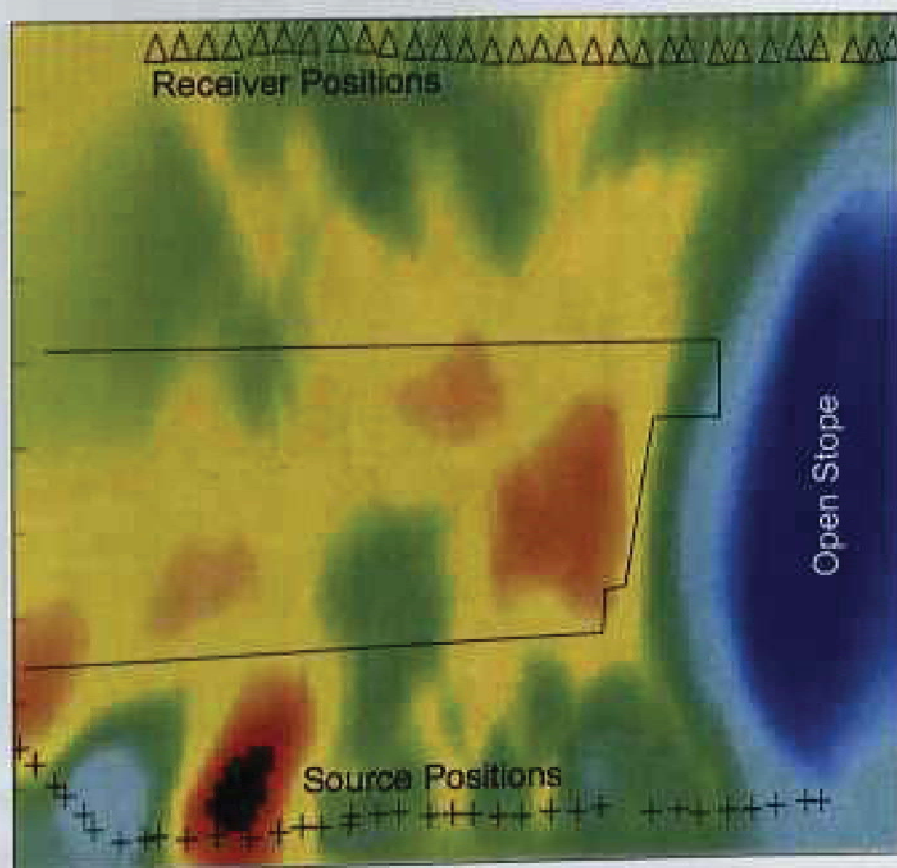
**Figure 4.2.20** Velocity image of Figure 4.2.17 reconstructed through curved ray tracing (after Carneiro, 1995)

Carneiro (1995) reprocessed the travel-time data, using a curved ray tracing algorithm, which caters for the effects of refraction of the seismic waves as they pass through the rockmass between source and receiver. The 5-by-10 metre pixels used by Maxwell and Young (1995) were thought to introduce interpolation-related numerical artifacts into the resulting image. The resolution of the image was improved by subdividing the surveyed area into 1-by-1 metre

pixels, ensuring that almost every pixel was crossed by at least one ray path. The resultant image (Figure 4.2.20) was similar to that produced by Maxwell and Young, but without the interpolation artifacts and with a clearer definition of the high-velocity regions.
