# **Power line-related mortalities of the Cape Vulture (*Gyps coprotheres*) within the Eastern Cape, South Africa;**

***Modelling terrain characteristics in hotspot areas using GIS***

***'A Research Report submitted to the Faculty of Science, University of the  
Witwatersrand,***

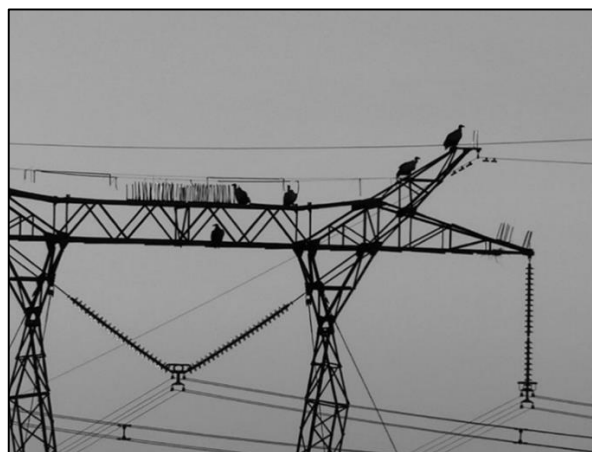
Figure 2-4: Cape Vultures roosting on an Eskom Transmission Power line, Eastern Cape by Kate Webster of CVC (2016).

Power line infrastructure is used more often for nesting, roosting or hunting in areas largely devoid of large natural trees, such as the spatially dominant Grassland and Karoo Biomes in the Eastern Cape (Bevanger, 1994, Boshoff *et al.*, 2007, 2011). Power line infrastructure in forested areas is rarely used for nesting (Bevanger, 1994). The Cape Vulture, in particular, is vulnerable to this risk, as it is known to readily use the various power line pylons as roosts (Figure 2-4) and perches in mostly flat areas as noted in a study by Ledger (1984).
