# **Assessing the effectiveness of projects aimed at reducing water loss in Ekurhuleni Metropolitan Municipality.**

A research report submitted to the Faculty of Engineering and the Built Environment, University of the Witwatersrand, Johannesburg, in partial fulfilment of the requirements for the degree of Master of Science in Engineering

Johannesburg 2017

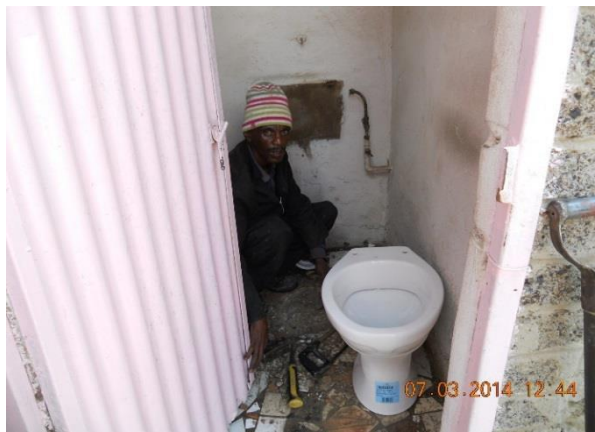
**Figure 4.1:** Retrofitting of an outside toilet on adjacent properties (pictures taken from: EMM, 2015).

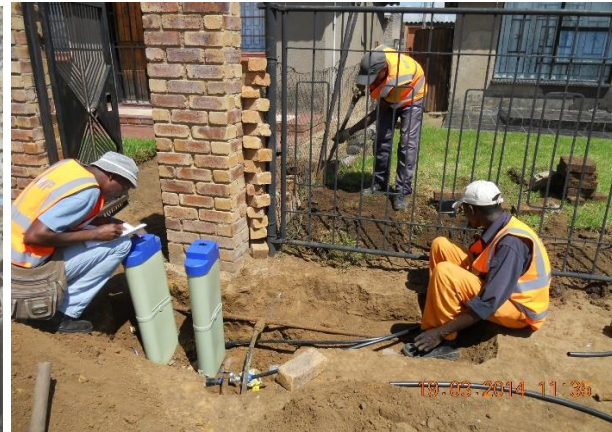
**Figure 4.2:** The labour team in the process of installing two meters

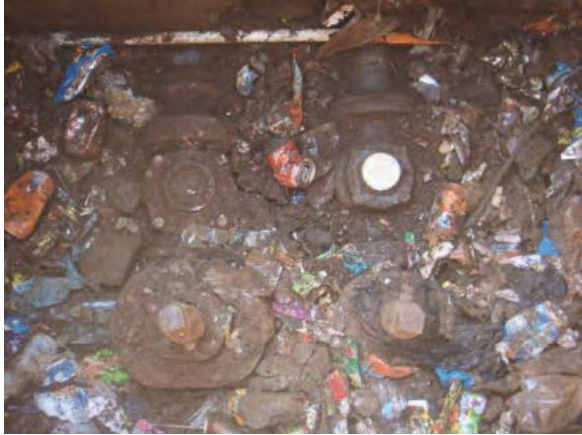
**Figure 4.3:** Buried and broken meters

The key objective of the project was to reduce non-revenue water and specifically the commercial losses, by addressing metering problems at the top 500 consumers within EMM. Most of these water connections for bulk consumers had been constructed many years ago, and in some cases decades ago, and had never been replaced or upgraded since they were installed. As a result, numerous of the existing below ground meters were no longer operational and some had been buried for years with the result that the meter chambers have become full of debris which must be removed before the meters can again be included in the billing process. Some of the typical problems encountered during the investigations are shown in Figure 4.3 to Figure 4.6.

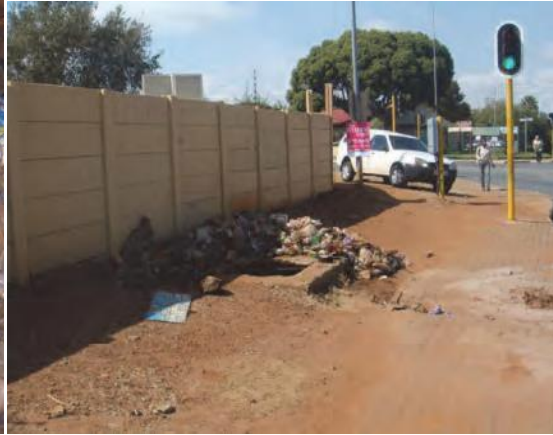
**Figure 4.4:** Cleaning rubbish from chamber

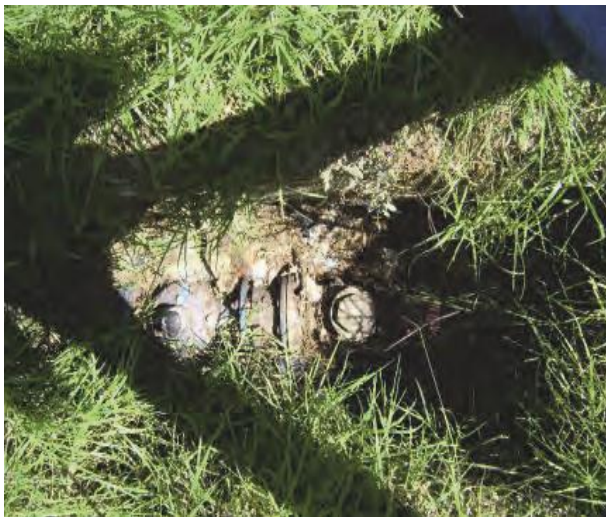
**Figure 4.5:** Meter buried in ground

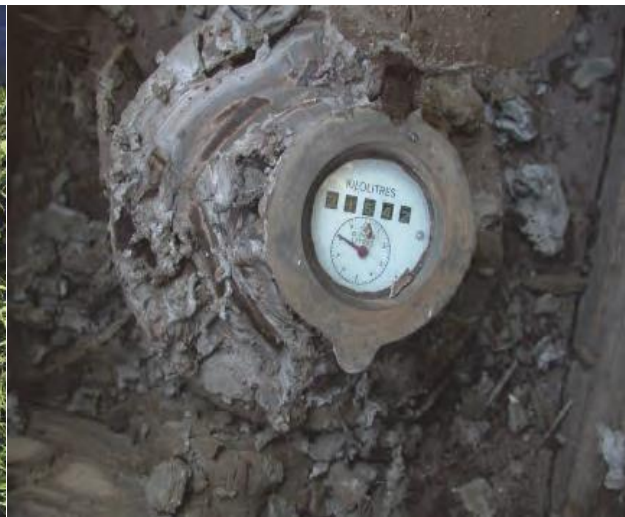
**Figure 4.6:** Non-functional and old meter
