**IDENTIFYING THE CAUSES OF FLOODING ON A NATIONAL ROUTE IN  
EKURHULENI, SOUTH AFRICA**

A research report submitted to the Faculty of Engineering, University of the Witwatersrand, Johannesburg, in partial fulfilment of the requirements for the degree of Master of Science.

The purpose of the study was to investigate the causes of flooding at the South African National Route-12 (N12), section-19, between the N12/R24 and Gillooly's Interchanges located in Johannesburg. This followed repeated flooding at the study area most notably on the 2<sup>nd</sup> of March 2017, 21<sup>st</sup> of January 2016 and 9<sup>th</sup> November 2016. The study determined the return period of the rainfall which led to these flood events using a previously developed regional approach of design rainfall estimation. The analysis revealed that only the rainfall event of the 9<sup>th</sup> of November 2016 exceeded the prescribed design return period of 1:80 years for the drainage structure. Further, hydraulic modelling using the HEC-RAS software package found that the current and older configurations of the drainage structure are inadequate for the recommended 80-year flood, but the upgrades improve capac

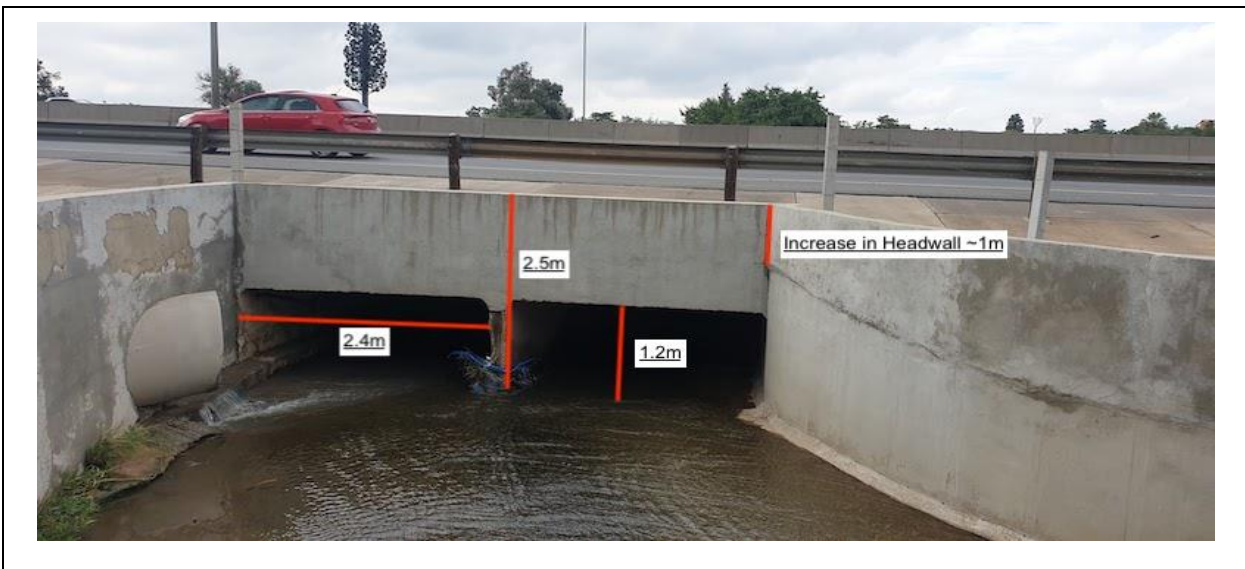
**Figure 3.2:** Showing the inlet at the drainage structure with a clear construction line on the wingwall indicating when increased height (See B in Figure 3.4)

The drainage structures at the study area are outlined in Figure 3.4 below. Figure 3.2, Figure 3.5 and Figure 3.6 highlight changes made by SANRAL (National Assembly (2020) at the inlet of the drainage structure. In chapter 5 of this study, a hydraulic simulation is conducted to assess the effectiveness of these changes, as stated in section 2.5.1 of this study.

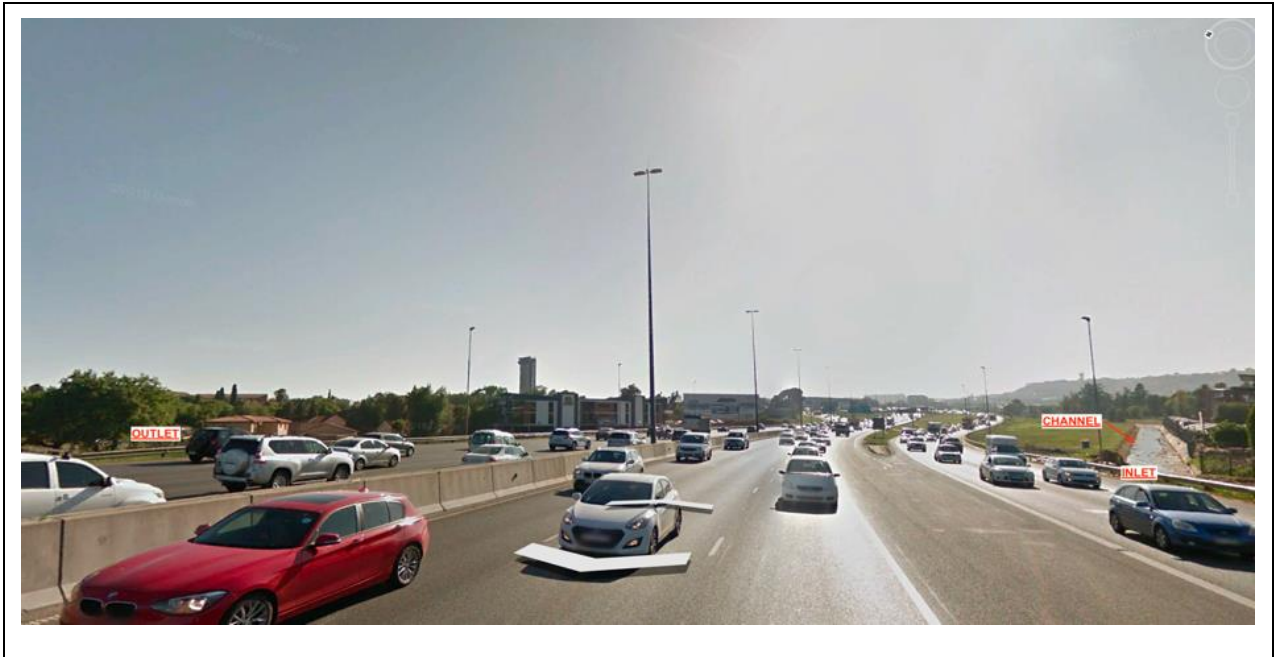
**Figure 3.3:** Section Showing Study Area (Google, 2017)

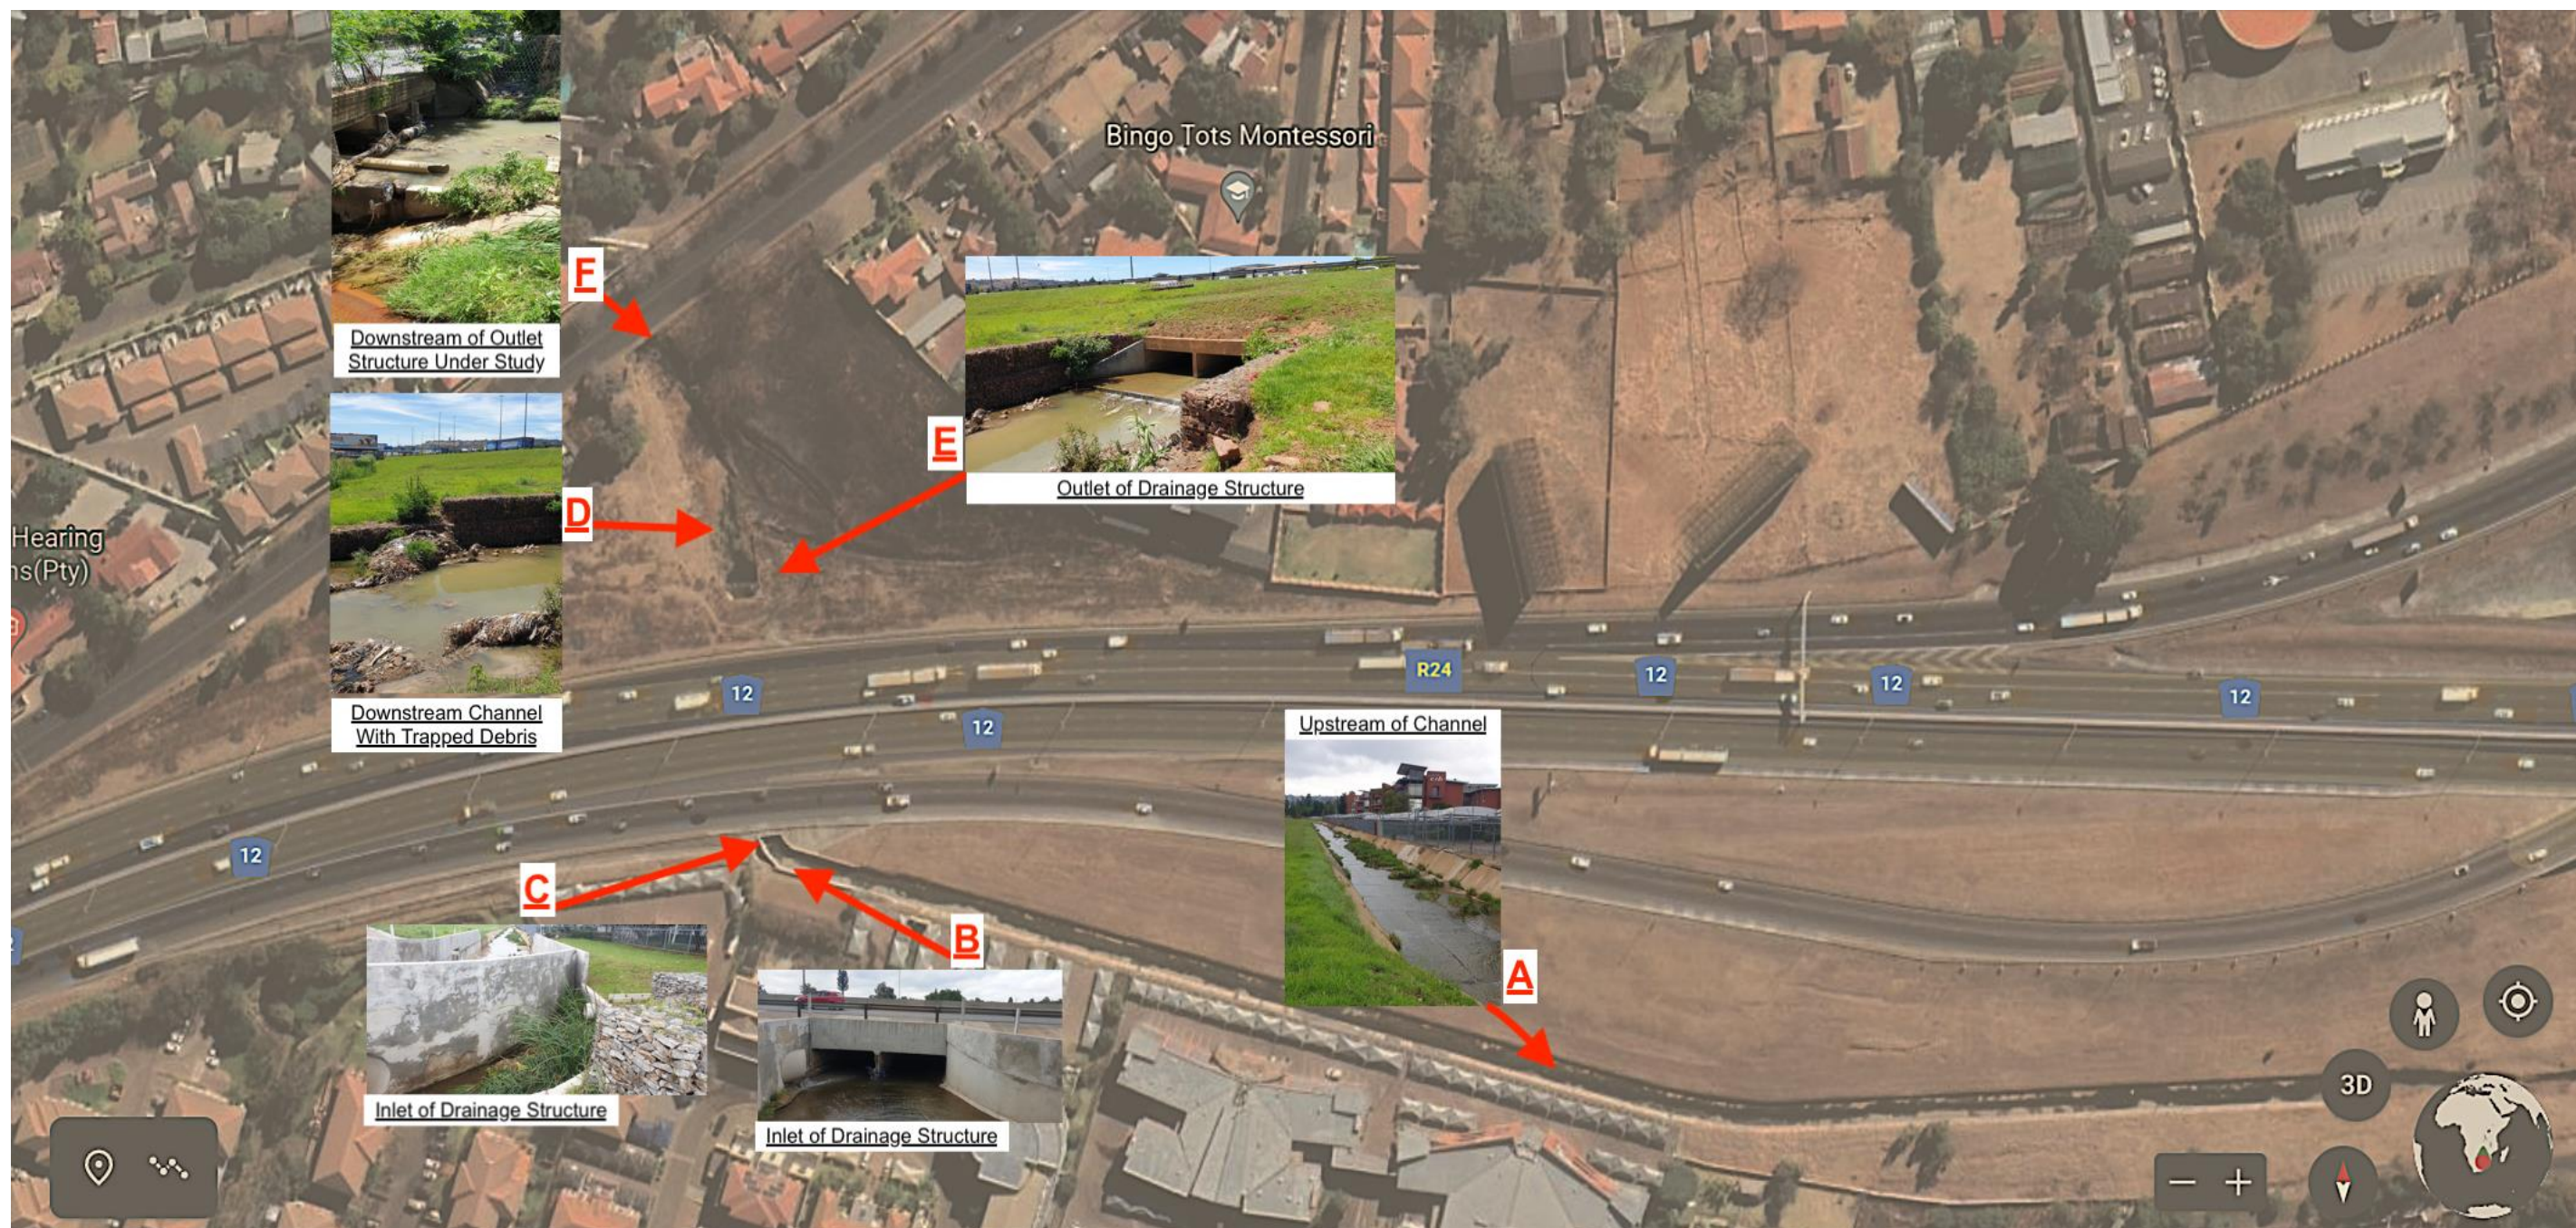
**Figure 3.4:** Photographic Summary of the Study Area

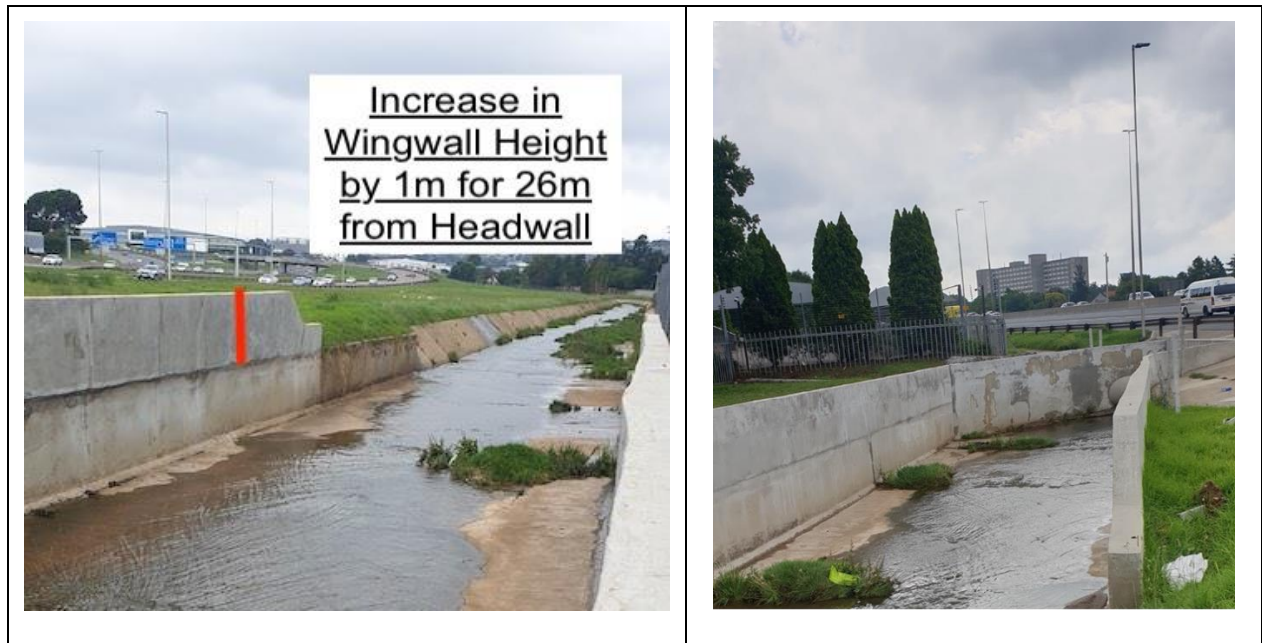
**Figure 3.5:** Upstream of the channel also showing the extent of the increased wingwalls (see A and B in Figure 3.4).

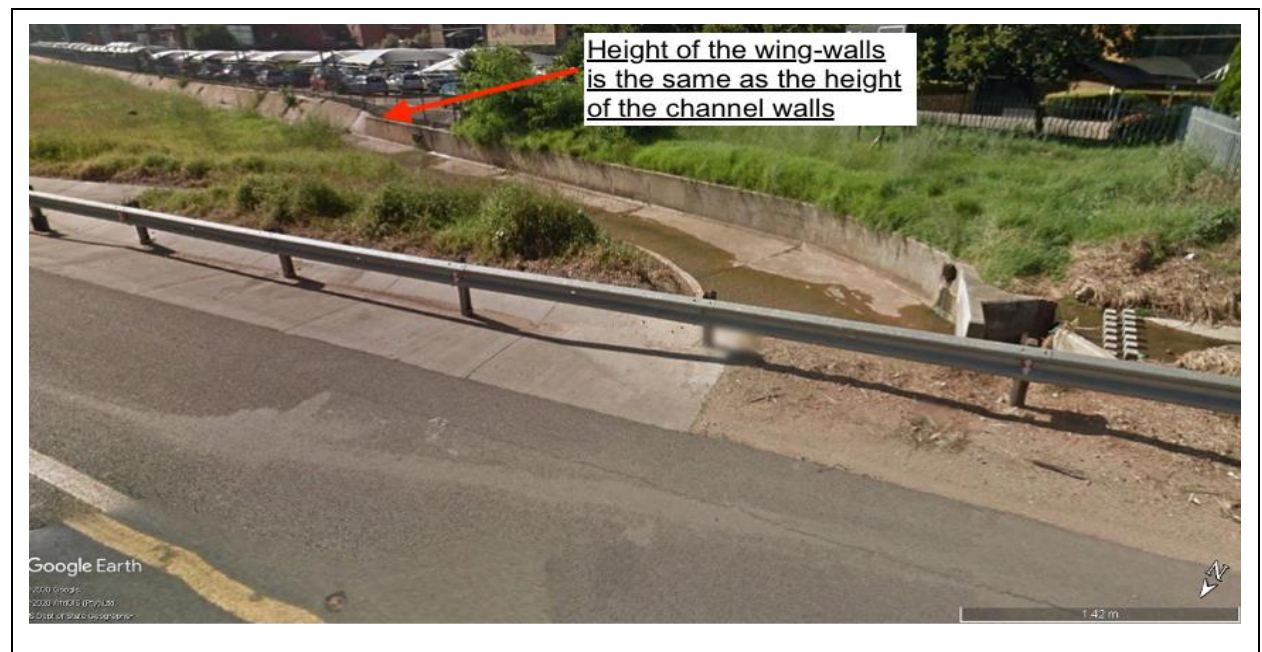
Figure 3.6 below shows that the elevation of the wing-walls of the drainage structure on the upstream-end used to be flush with the elevation of the channel. When compared to Figure 3.5 above, the extent of the upgrade work carried out by SANRAL is clear.

**Figure 3.6:** Upstream of the Drainage Structure Before Upgrades (Google Earth 2018)

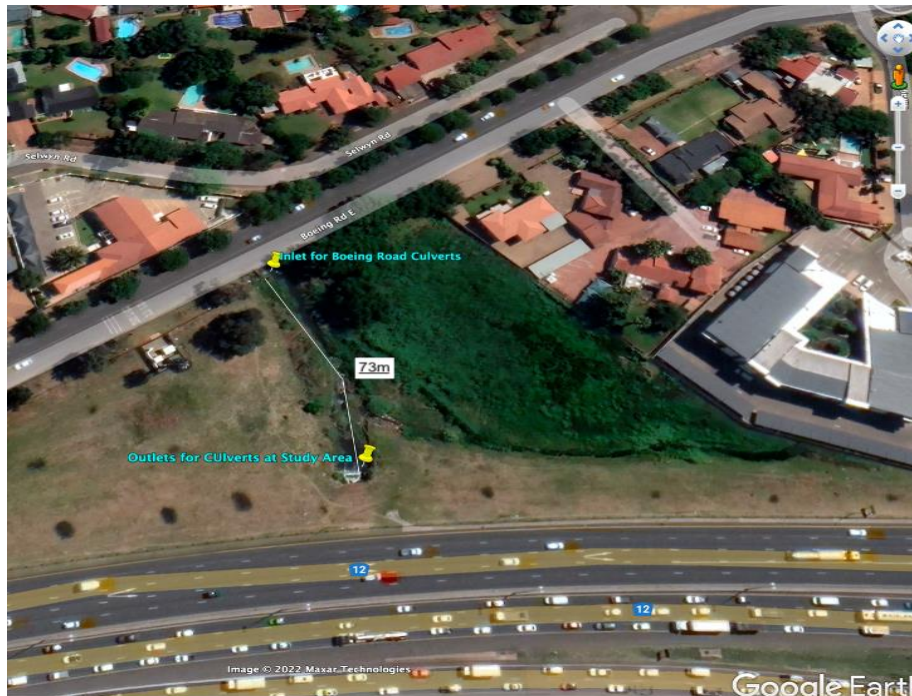
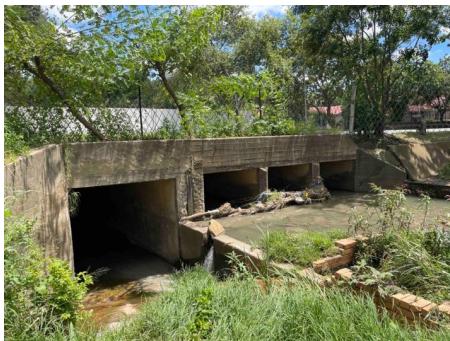
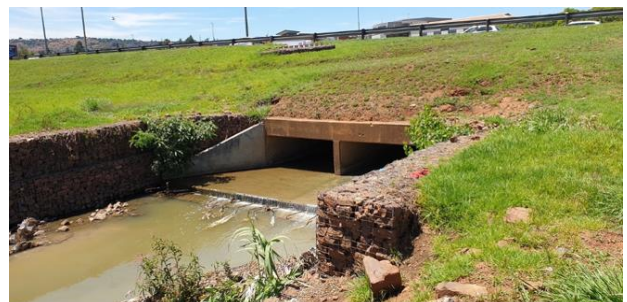
(a) Locality Map of the two drainage structures Being Compared

(b) Inlet of Parallel Road to the N12, Boeing Road

(c) Outlet of Study Area

**Figure 3.7:** High Level Comparison of the Drainage Structures Near the Study Area

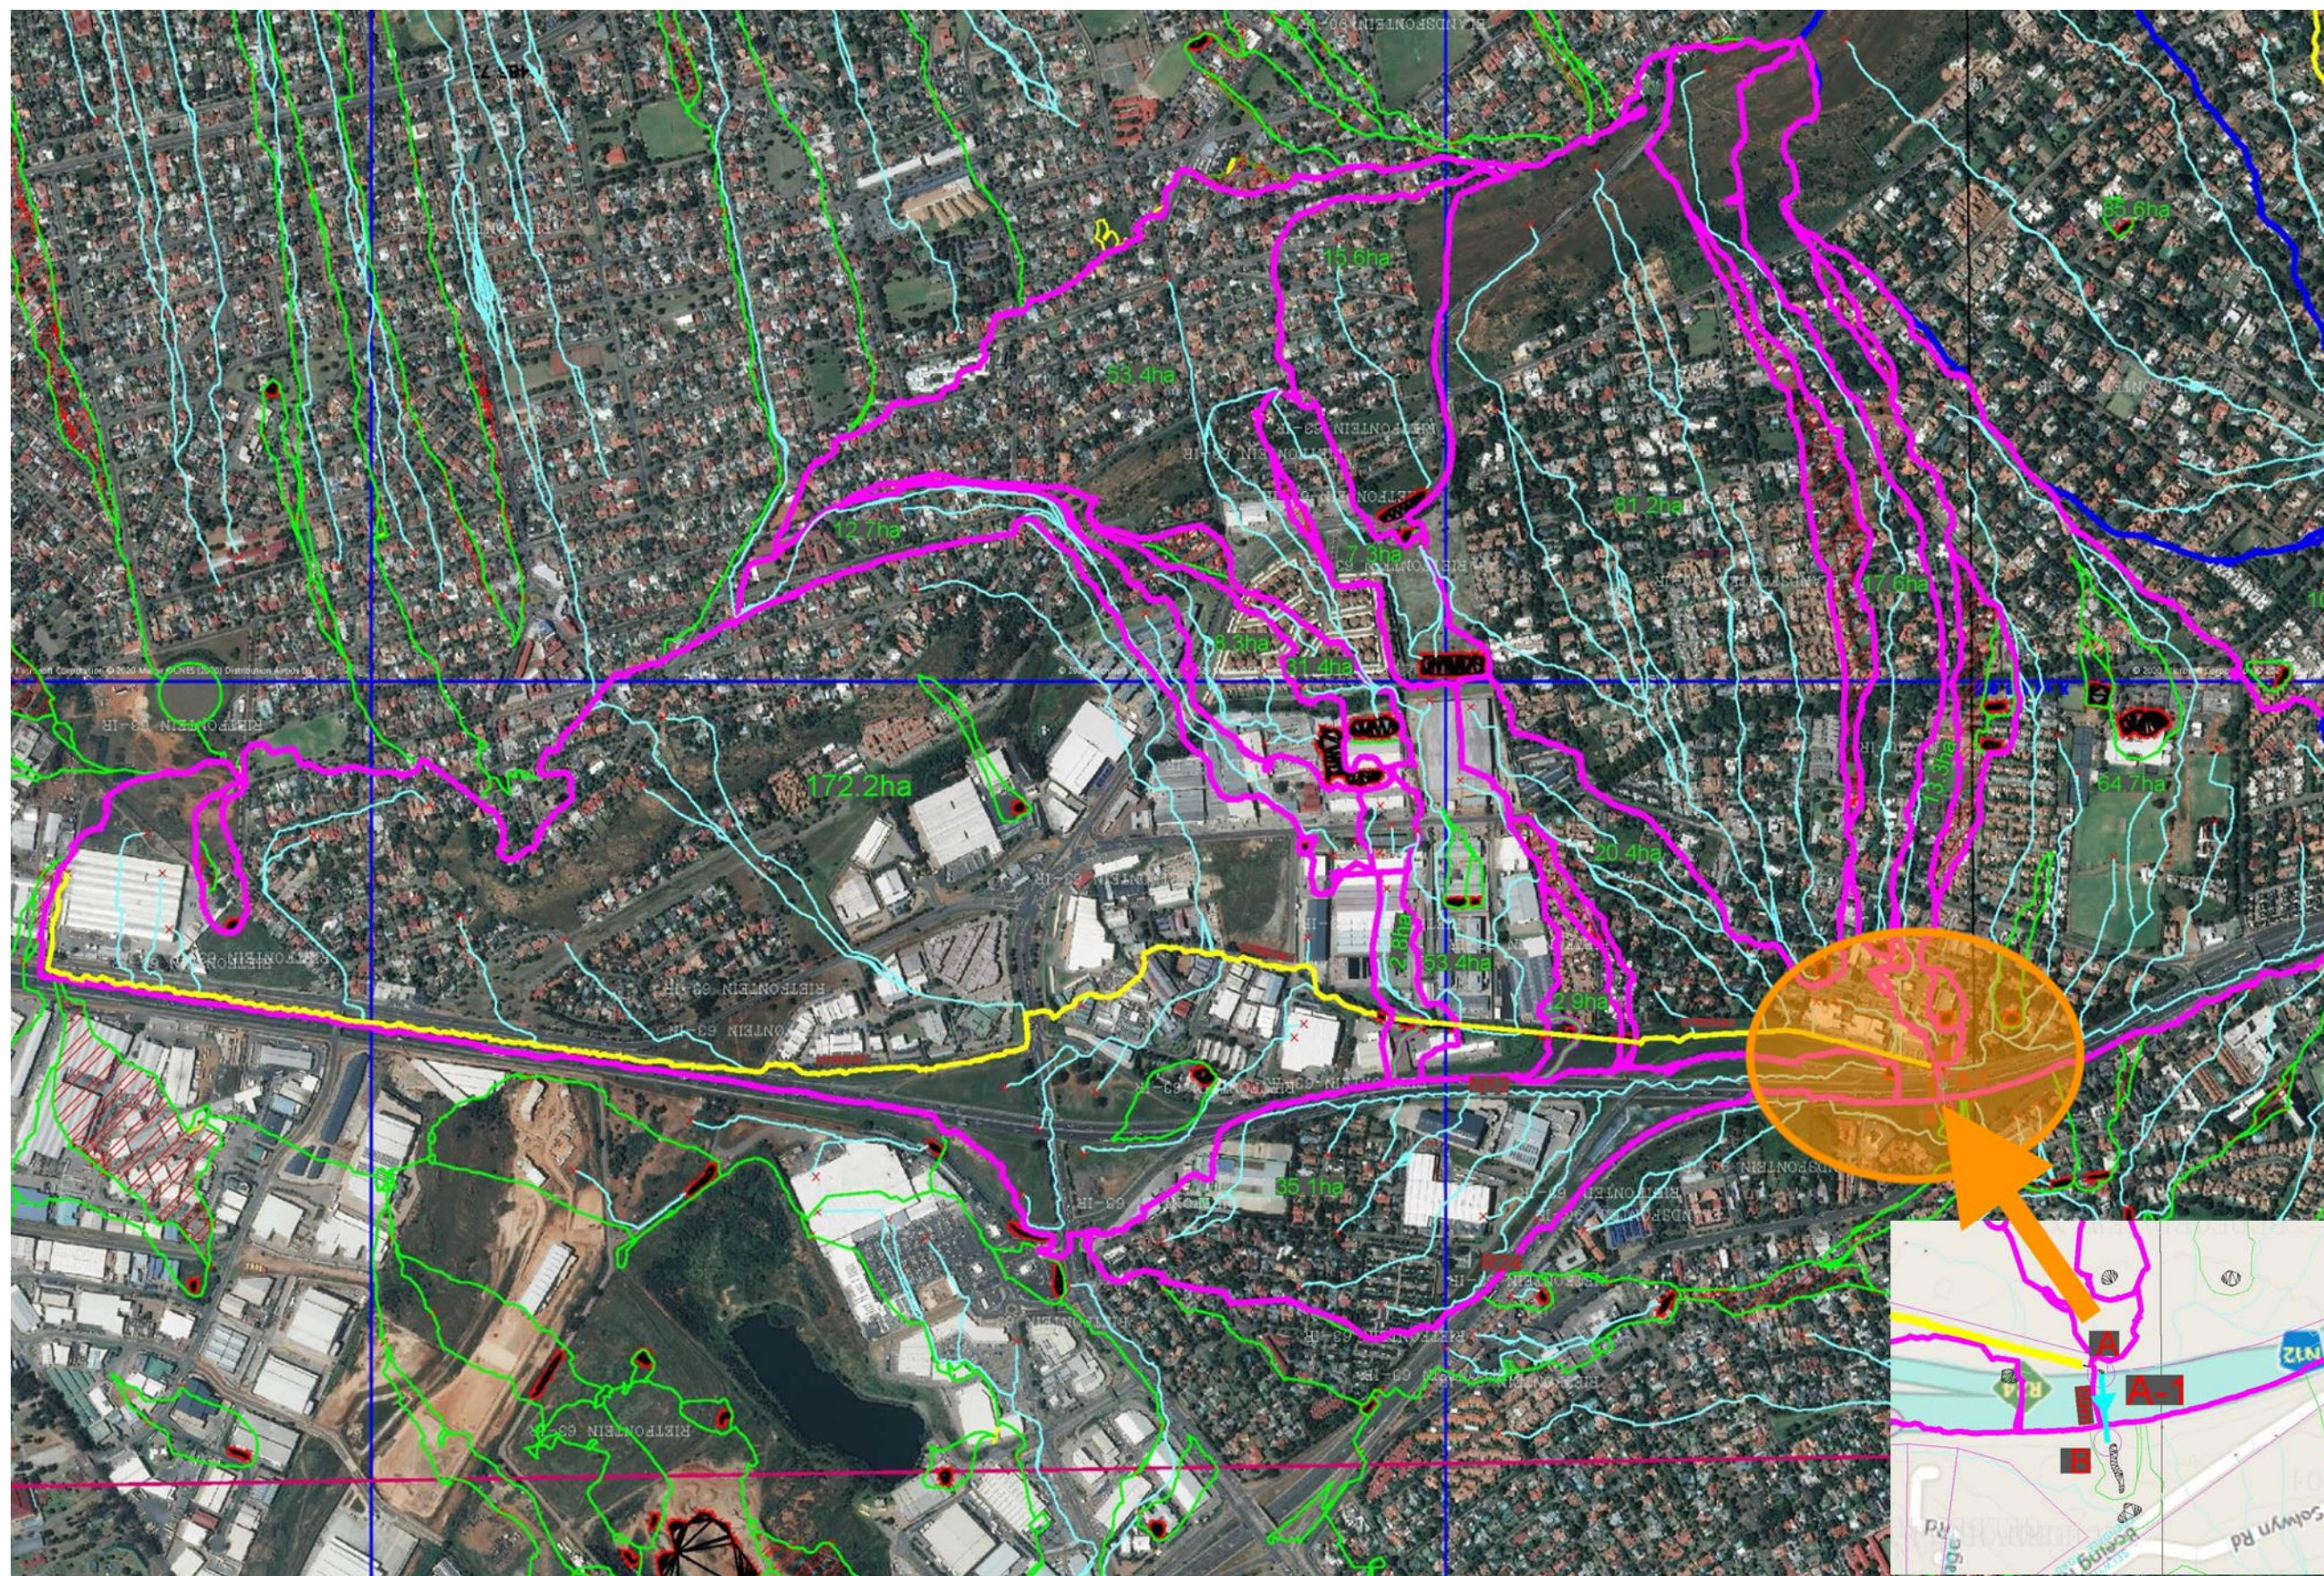
**Figure 3.8:** Catchment Delineation (catchment extent is shown in magenta/pink)

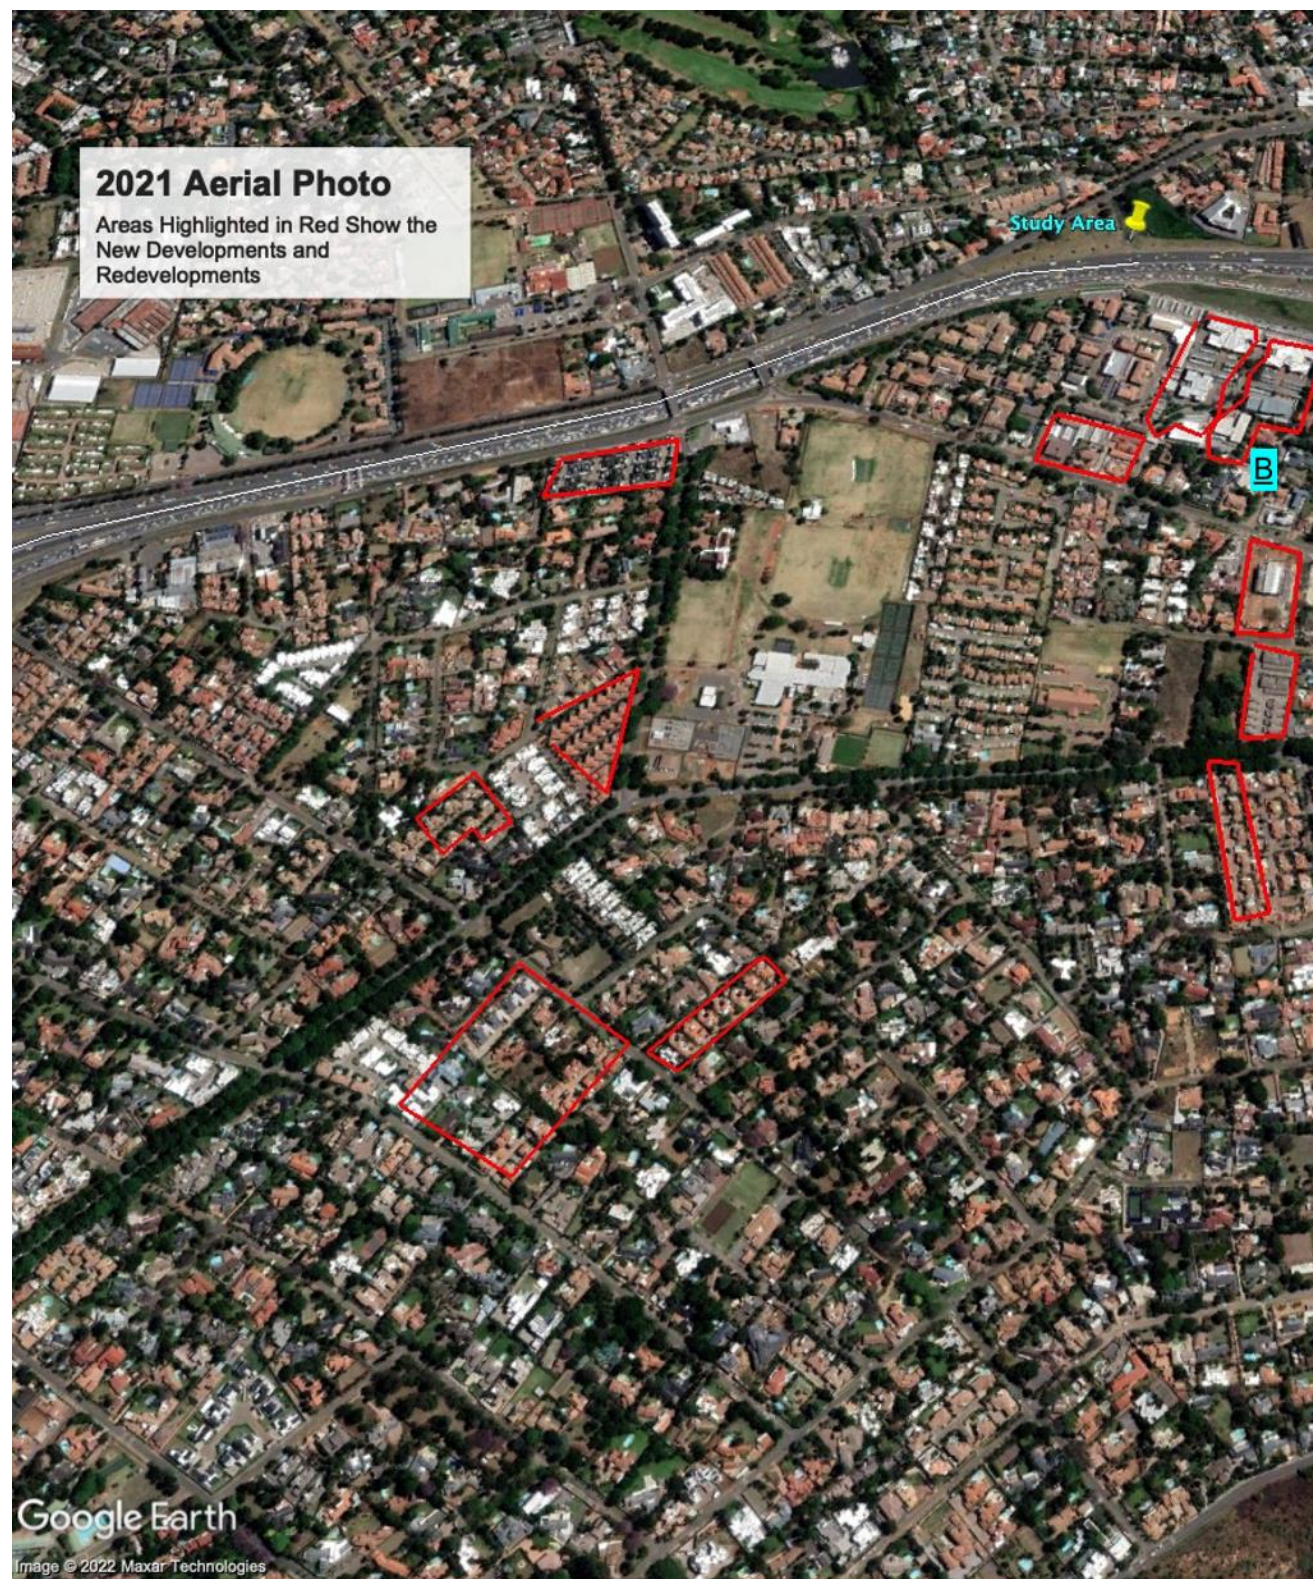
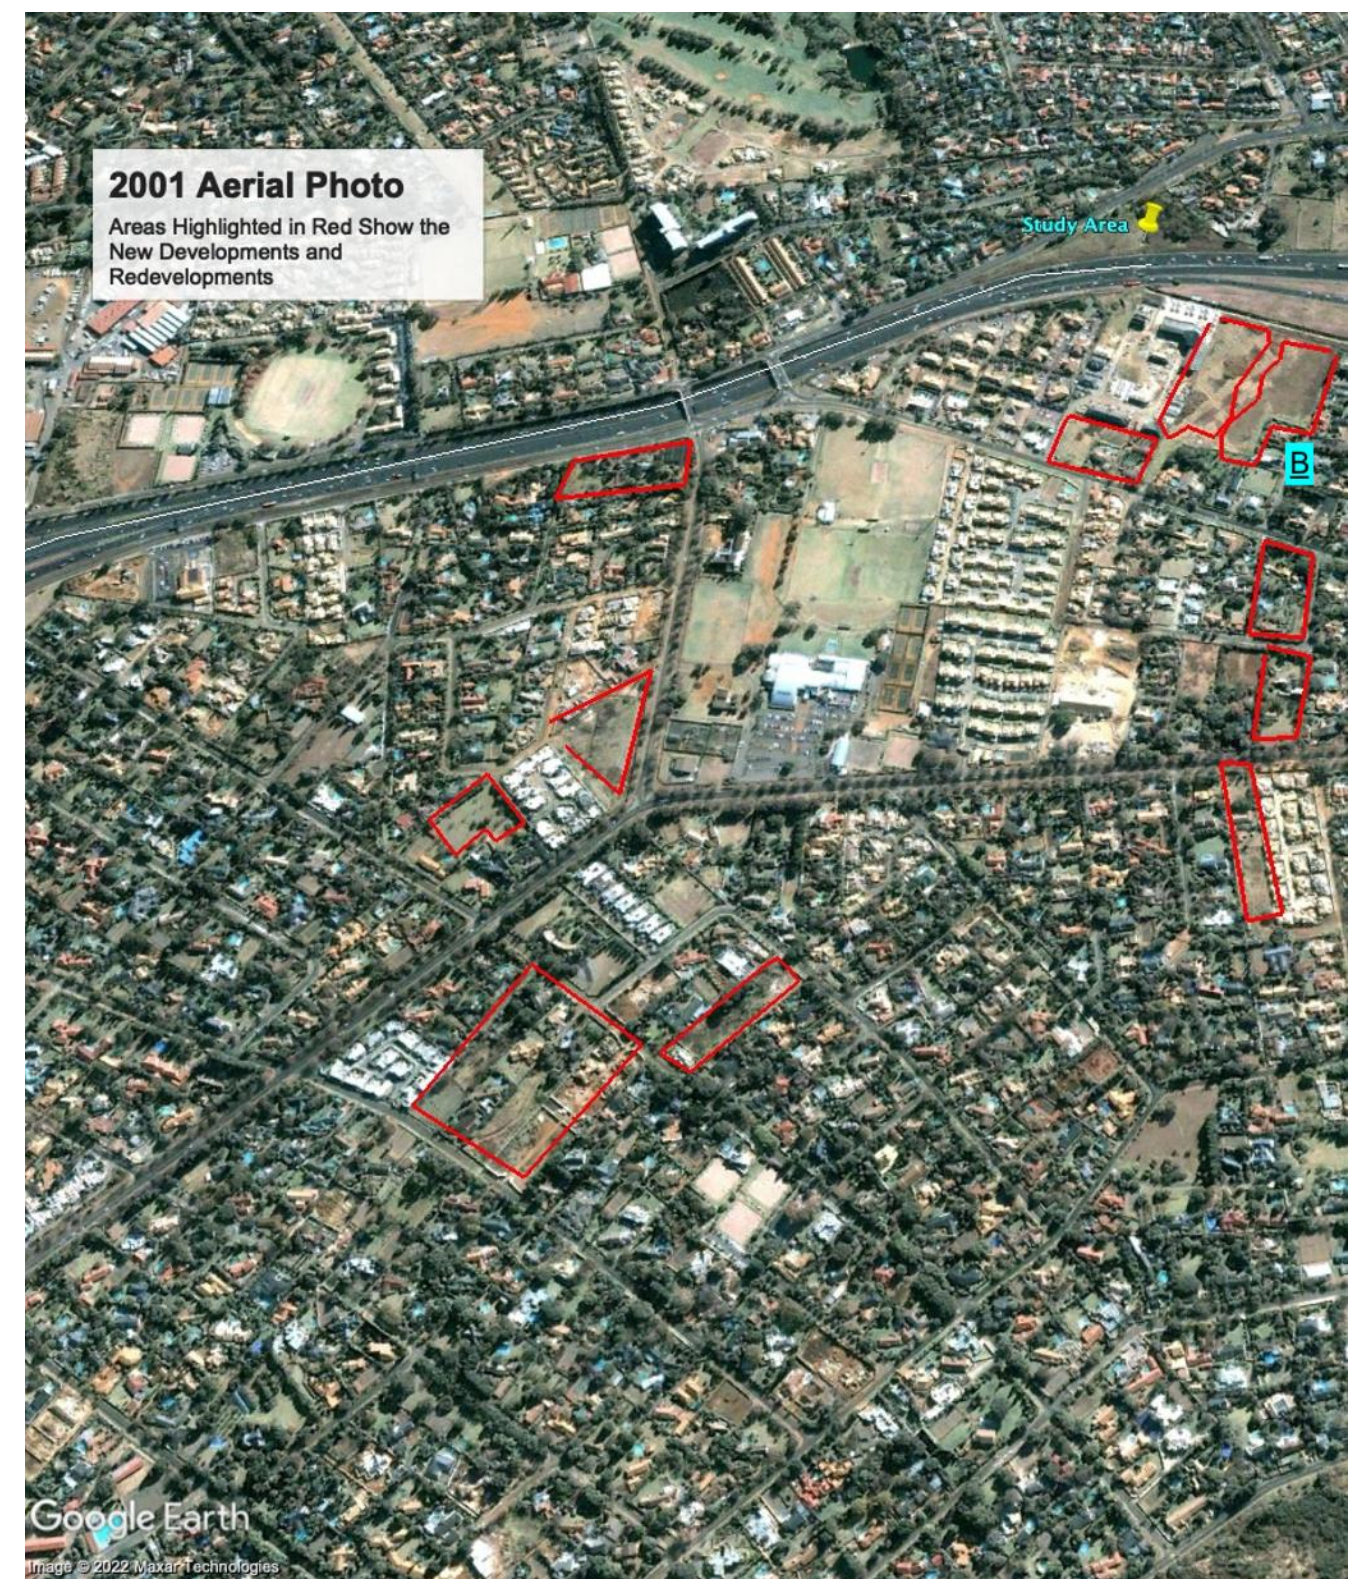
The assumption that the change in land use is predominantly the conversion of the given catchment surface area into an impervious surface is supported by the observations presented in Figure 3.11 below since most of the changes in land use are from the construction of buildings on greenfield sites.

**Figure 3.11:** Summary of Land Use Changes Within the Catchment Westbound of the Study Area.

The factor of 1.24 to account for the influence of changing land use will be applied to the theoretical peak flood to be calculated in the next chapter to determine the influence of the change in land use on the peak flood.

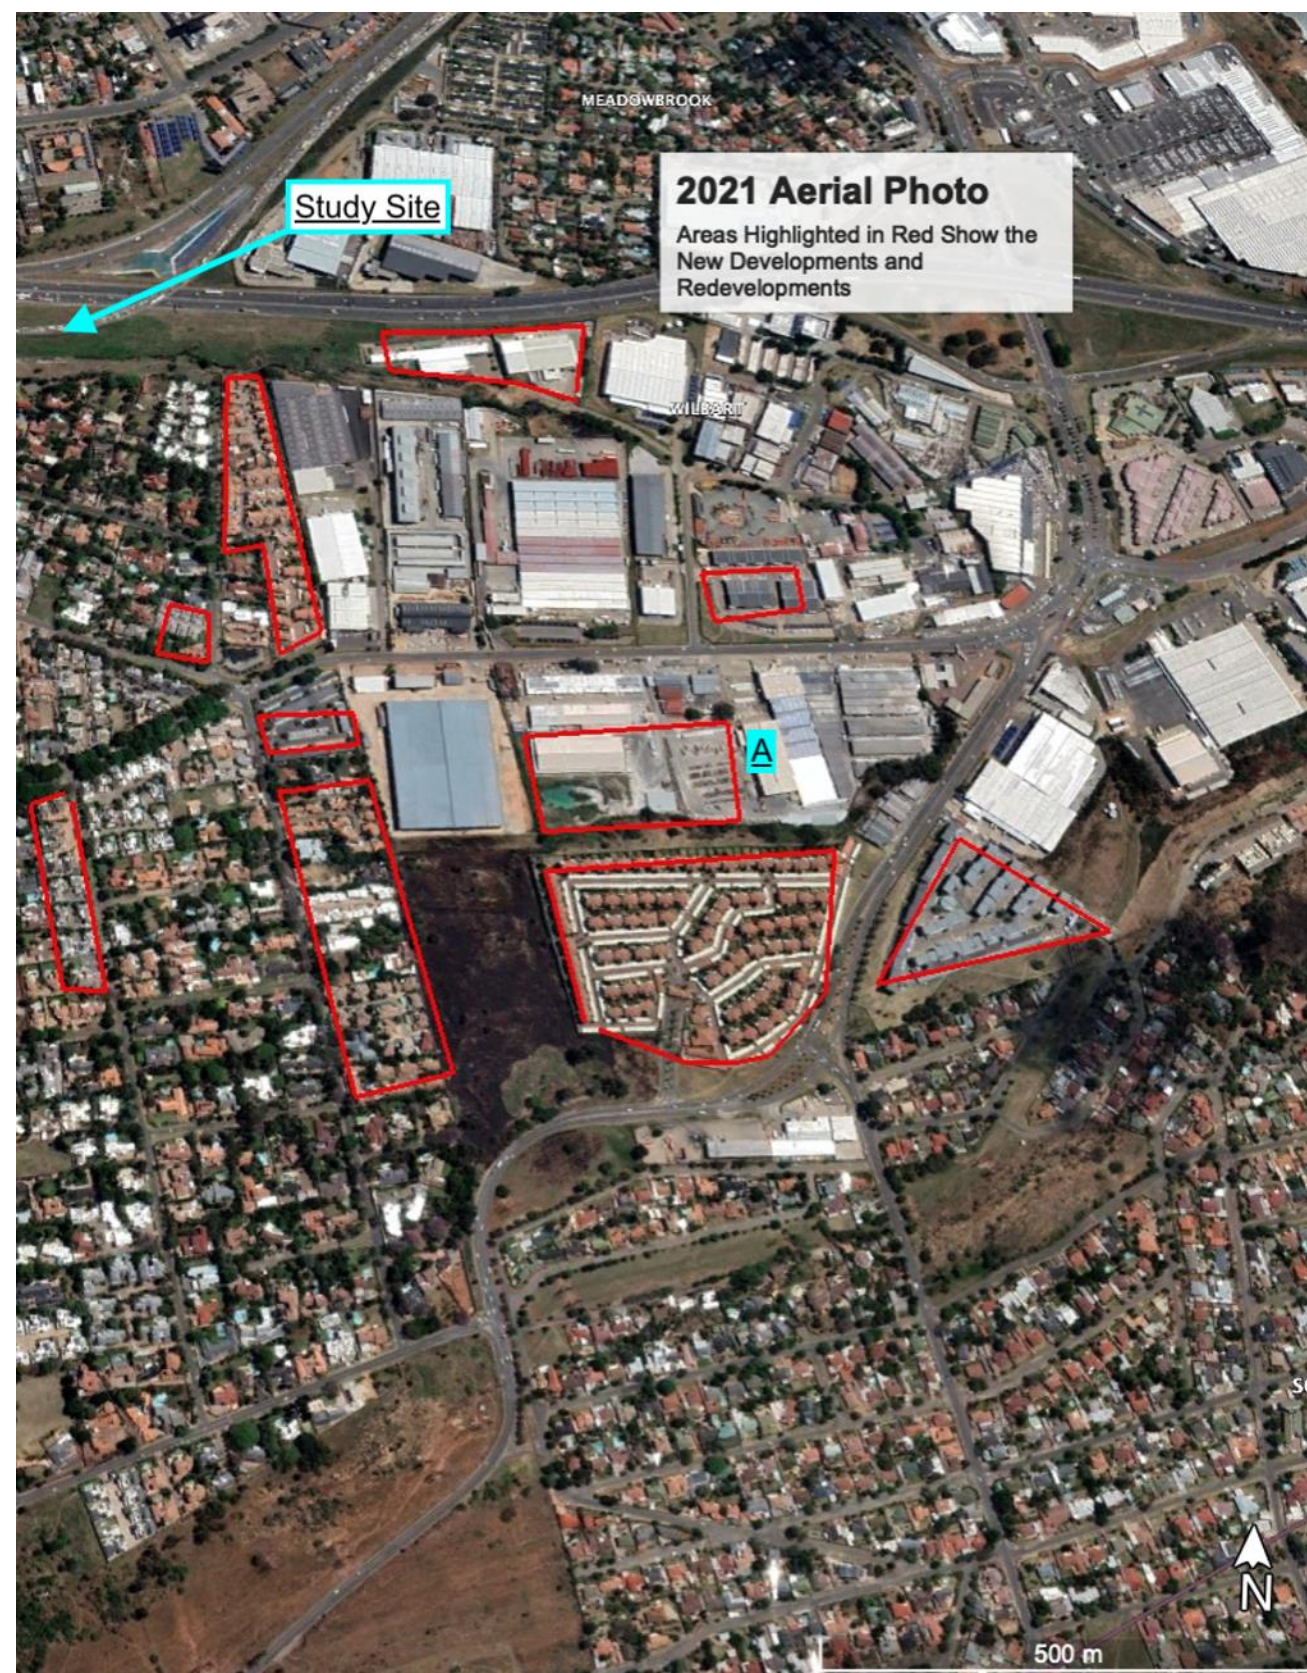
**Figure 3.12:** Summary of Land Use Changes Within the Catchment Eastbound of the Study Area.

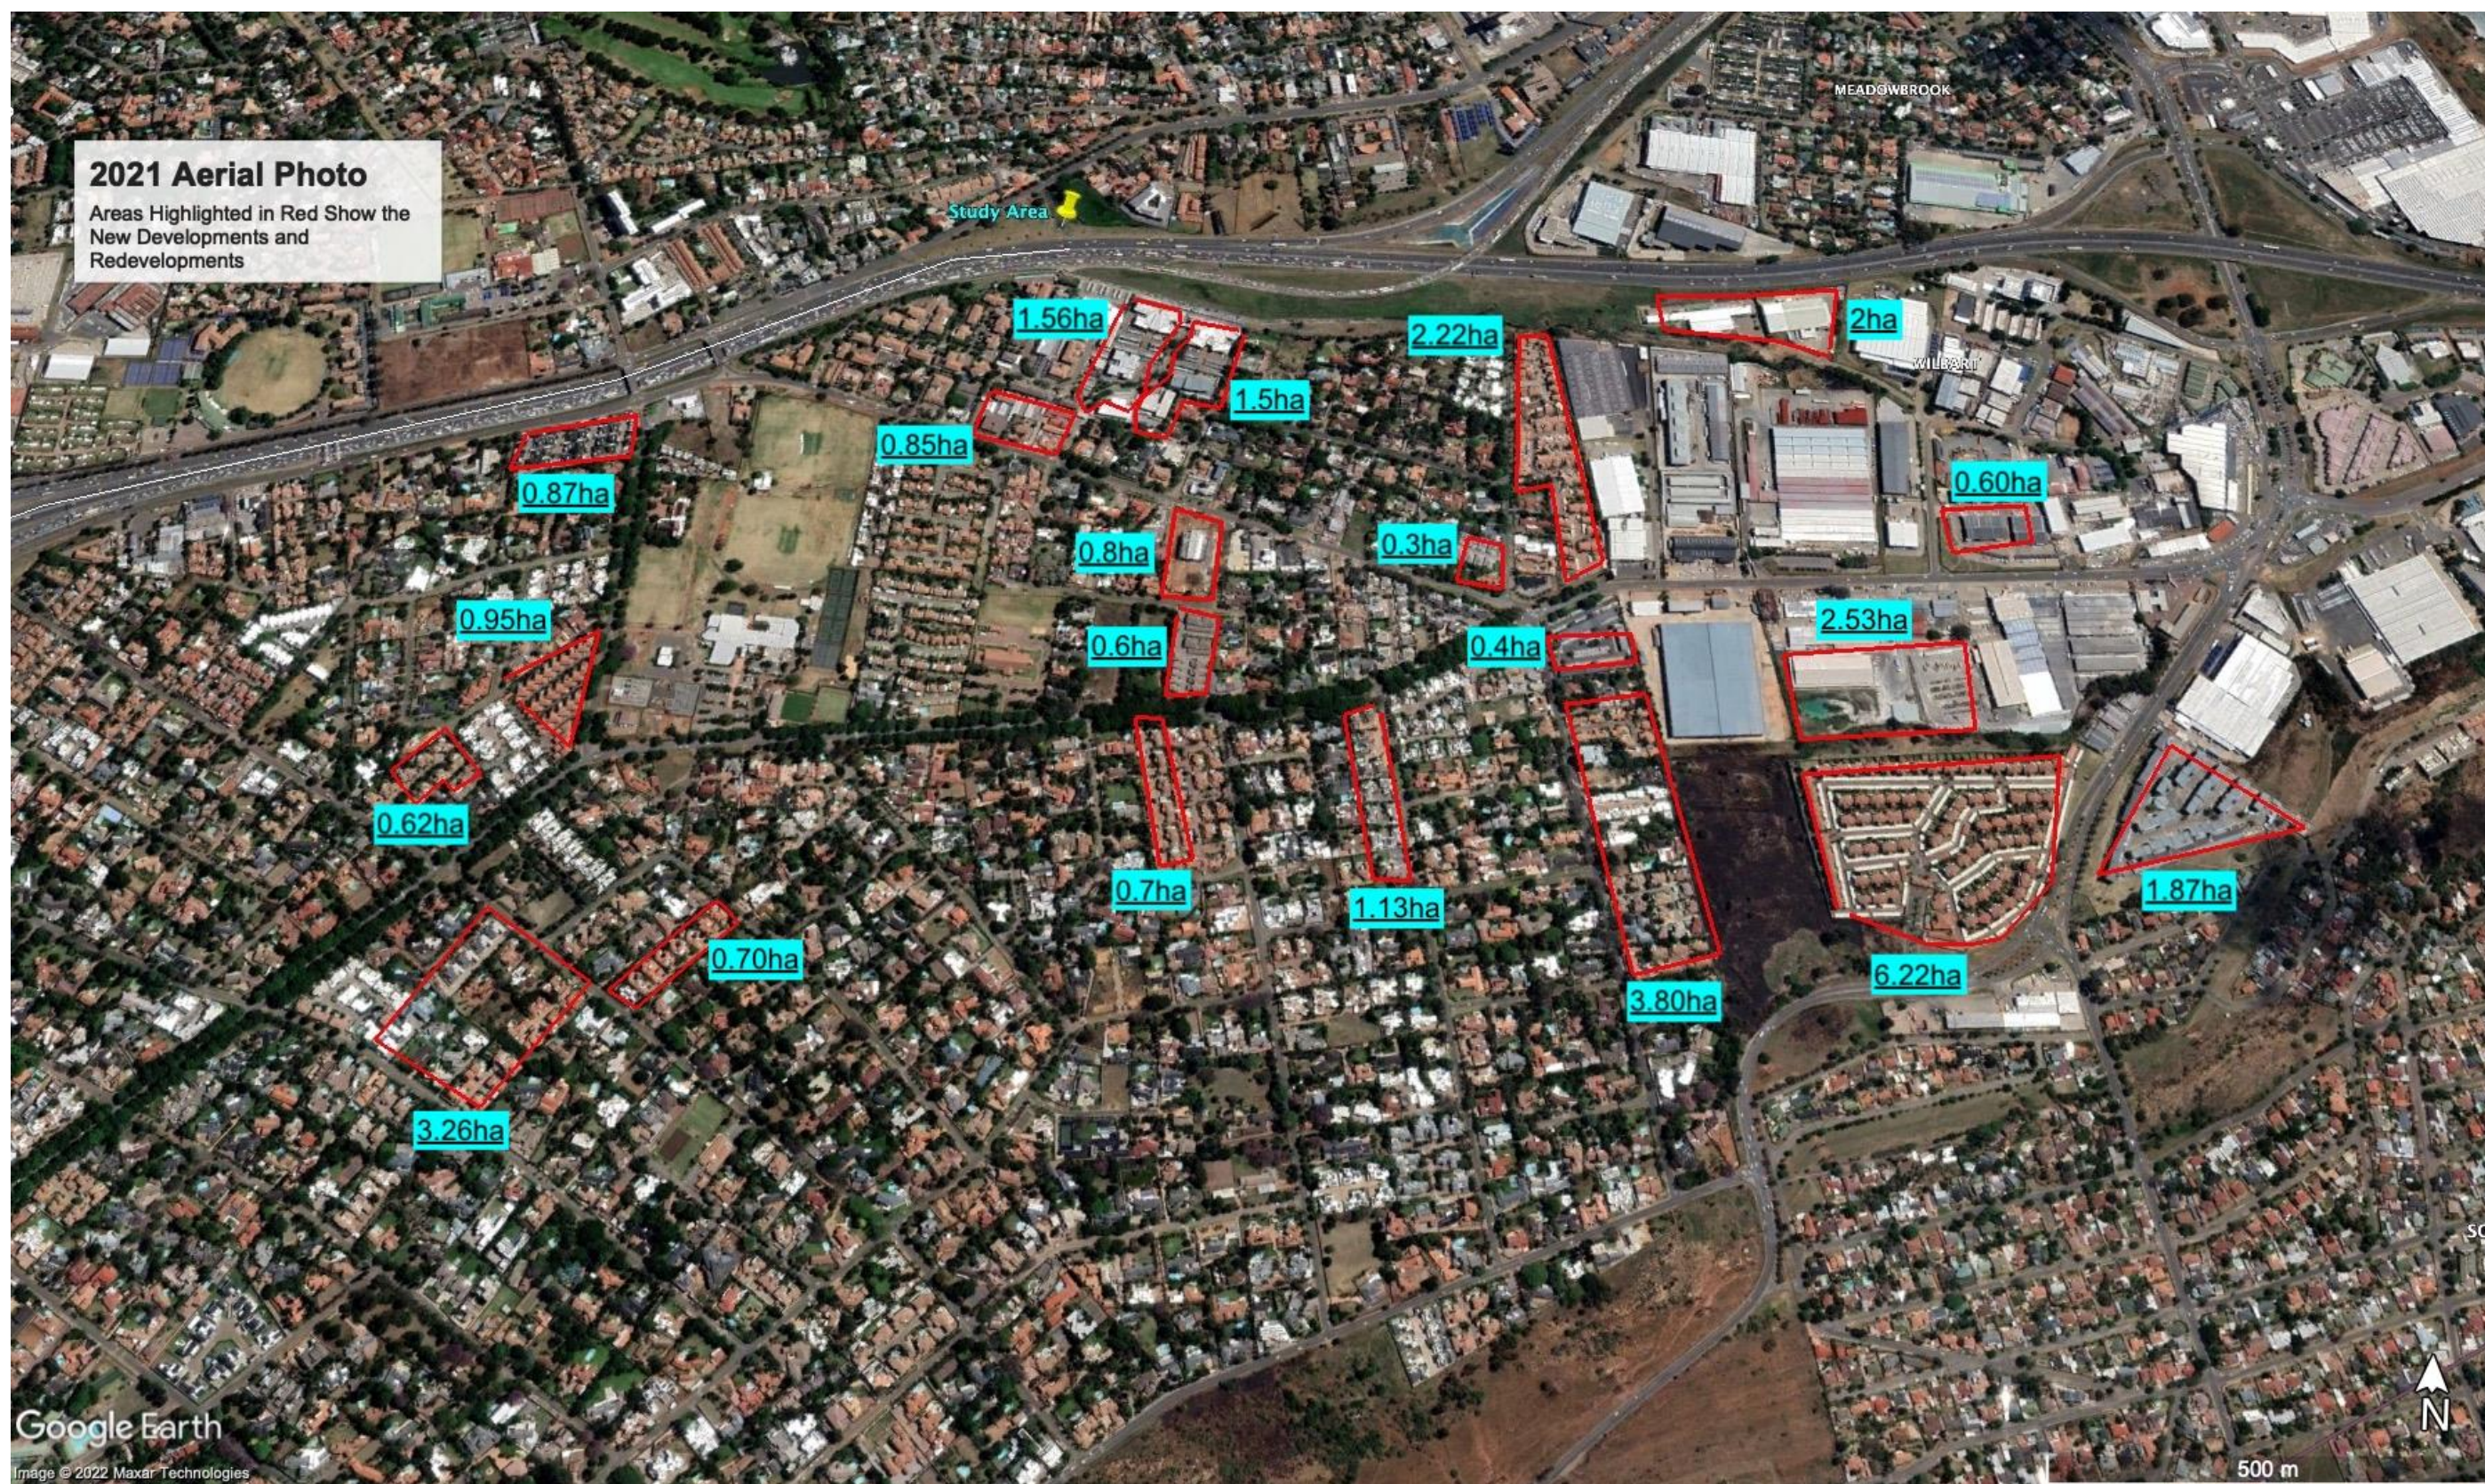
**Figure 3.13:** Summary of Areas of Land Parcels with Recorded Changes Within the Catchment Westbound of the Study Area.
