**IDENTIFYING THE CAUSES OF FLOODING ON A NATIONAL ROUTE IN  
EKURHULENI, SOUTH AFRICA**

A research report submitted to the Faculty of Engineering, University of the Witwatersrand, Johannesburg, in partial fulfilment of the requirements for the degree of Master of Science.

The purpose of the study was to investigate the causes of flooding at the South African National Route-12 (N12), section-19, between the N12/R24 and Gillooly's Interchanges located in Johannesburg. This followed repeated flooding at the study area most notably on the 2<sup>nd</sup> of March 2017, 21<sup>st</sup> of January 2016 and 9<sup>th</sup> November 2016. The study determined the return period of the rainfall which led to these flood events using a previously developed regional approach of design rainfall estimation. The analysis revealed that only the rainfall event of the 9<sup>th</sup> of November 2016 exceeded the prescribed design return period of 1:80 years for the drainage structure. Further, hydraulic modelling using the HEC-RAS software package found that the current and older configurations of the drainage structure are inadequate for the recommended 80-year flood, but the upgrades improve capac

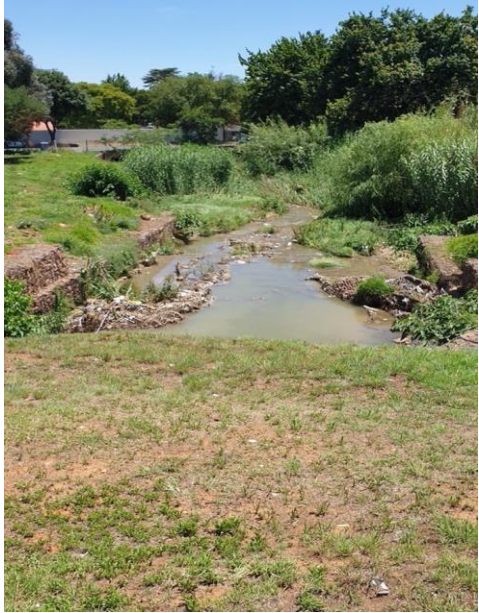
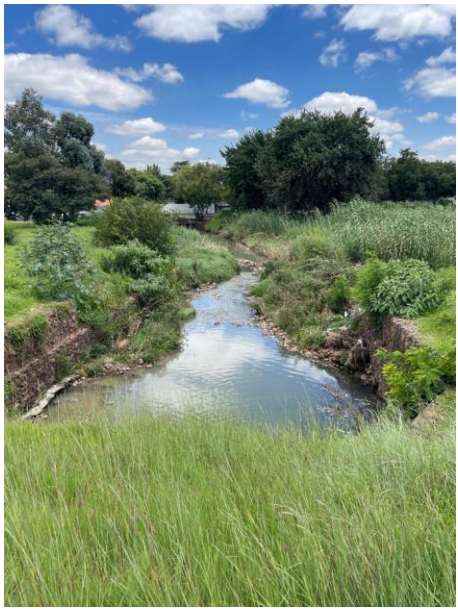
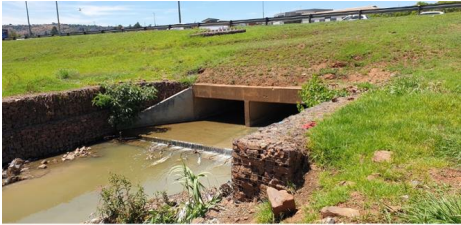
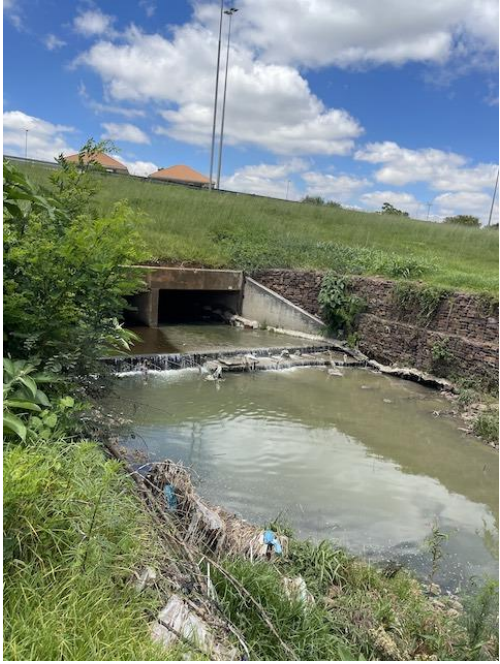
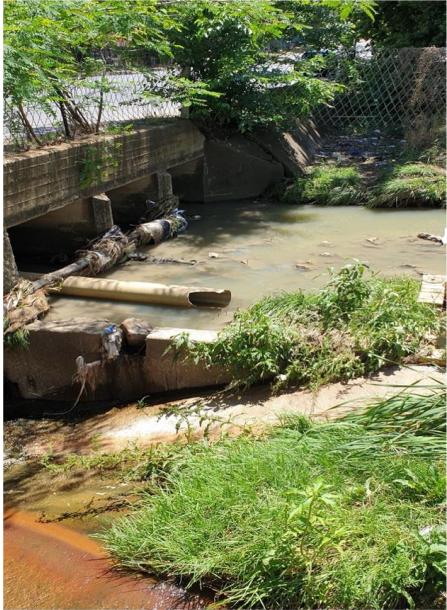
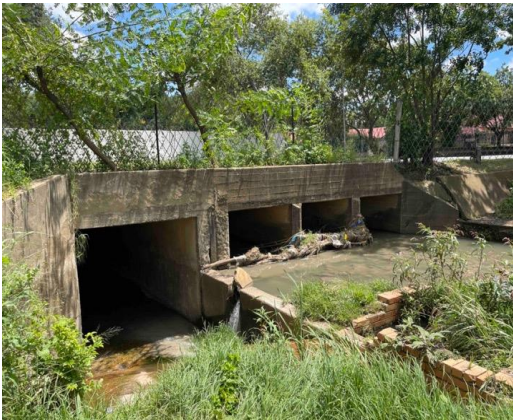
**Figure 3.14:** Re-photographs Illustrating a Deteriorating State of Maintenance.

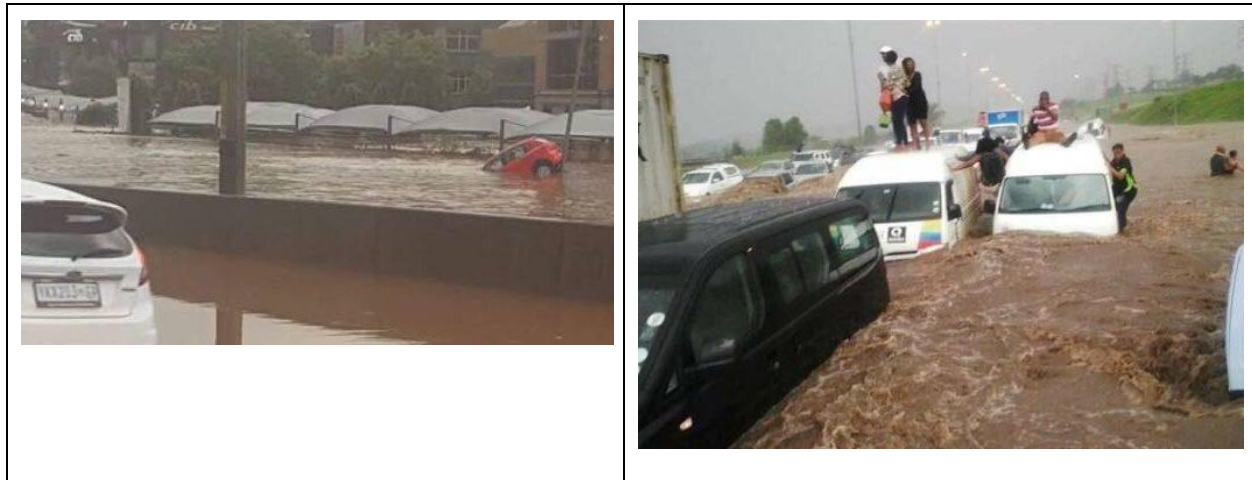
this contributed to the excessive rainfall depths. Figure 4.12 shows photographs of the flooding at the N12 section directly passing the study area on the 9<sup>th</sup> of November 2016.

**Figure 4.12:** Flooding on the N12 near the CIB Insurance on Riley Road (Comaro Chronicle, 2017)

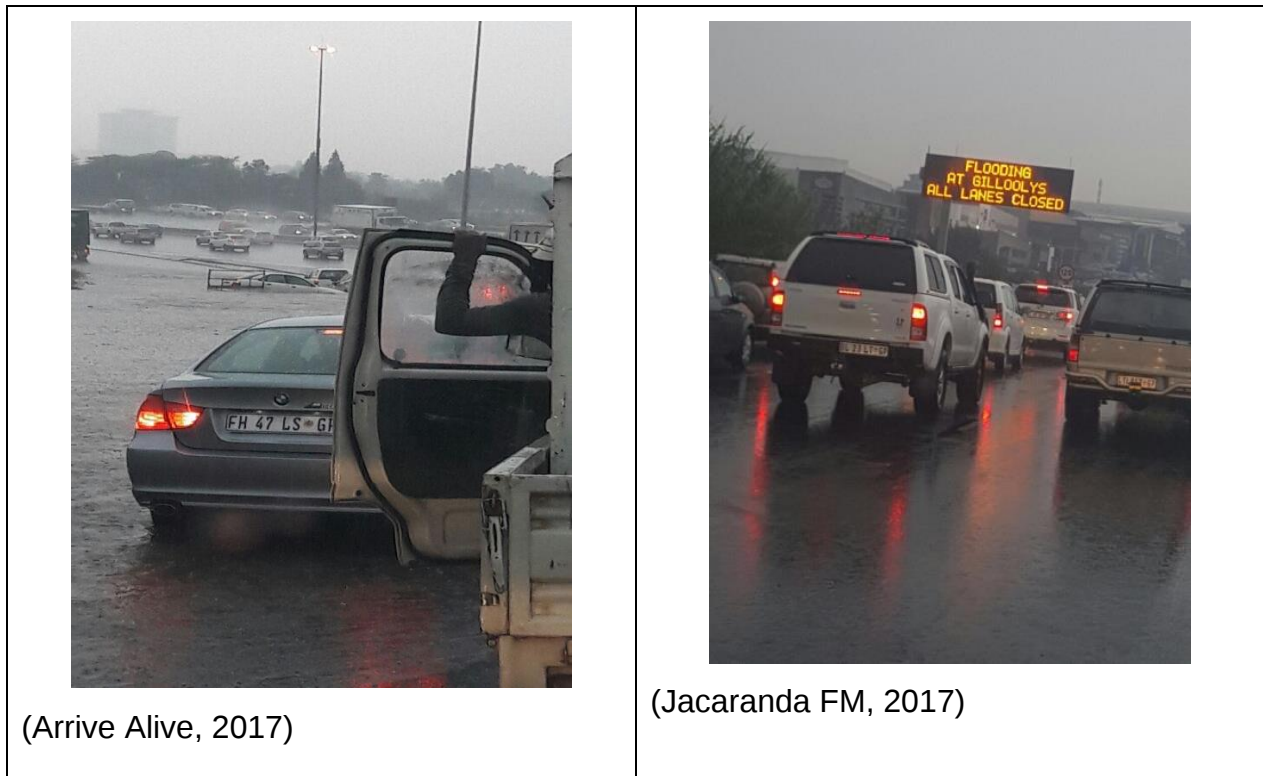
**Figure 4.14:** Flooding at the Gillooly's Interchange on 2 March 2017

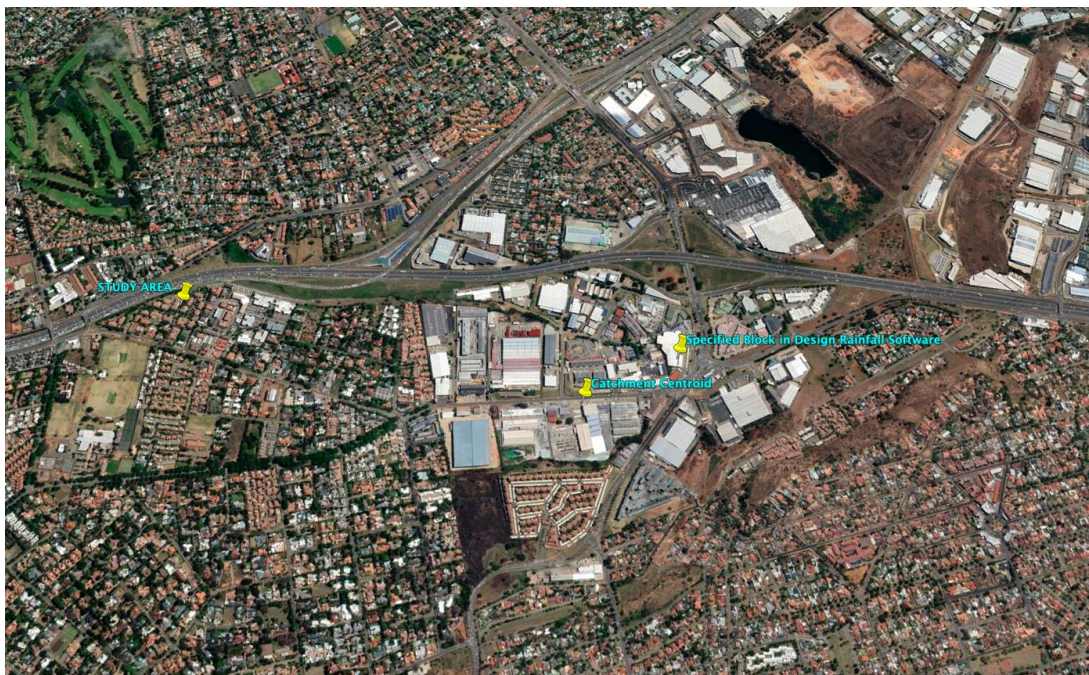
The data request in the design rainfall model was for a block with the coordinates; Latitude 26°10'S and Longitude 28°10'. This location is 370 m from the catchment centroid and is shown in Figure 4.15 below.

**Figure 4.15:** Location of Specified Grid in Design Rainfall Model in Reference to the Catchment Centroid and Study Area

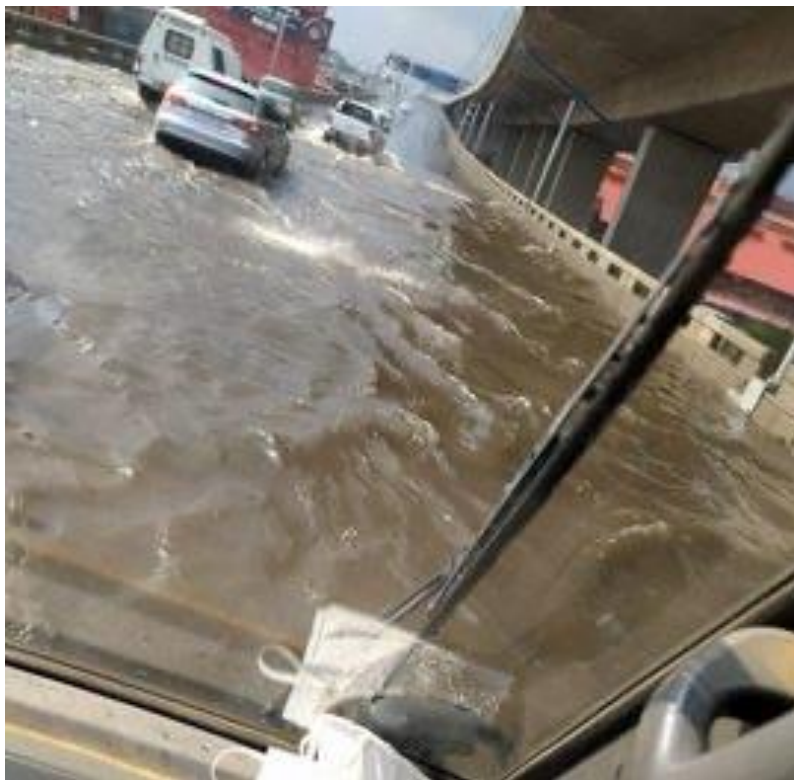
**Figure 5.1:** Flooding of the M1 Double Decker Bridge Lower Deck (Southbound-05 October 2020) (Rosebank Killarney Gazette, 2020)

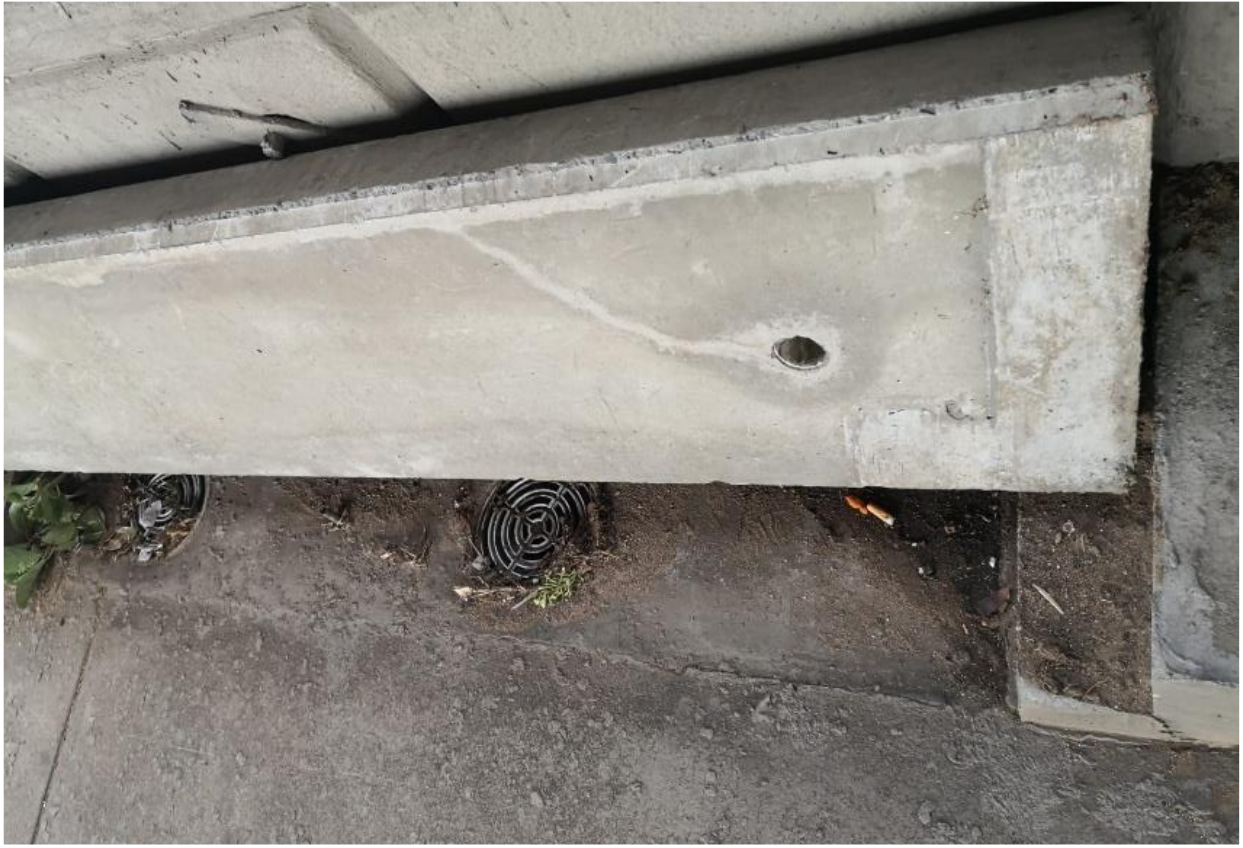
**Figure 5.2:** M1 Double Decker Bridge Kerb Inlet (Calliper Consulting Engineers, 2020)

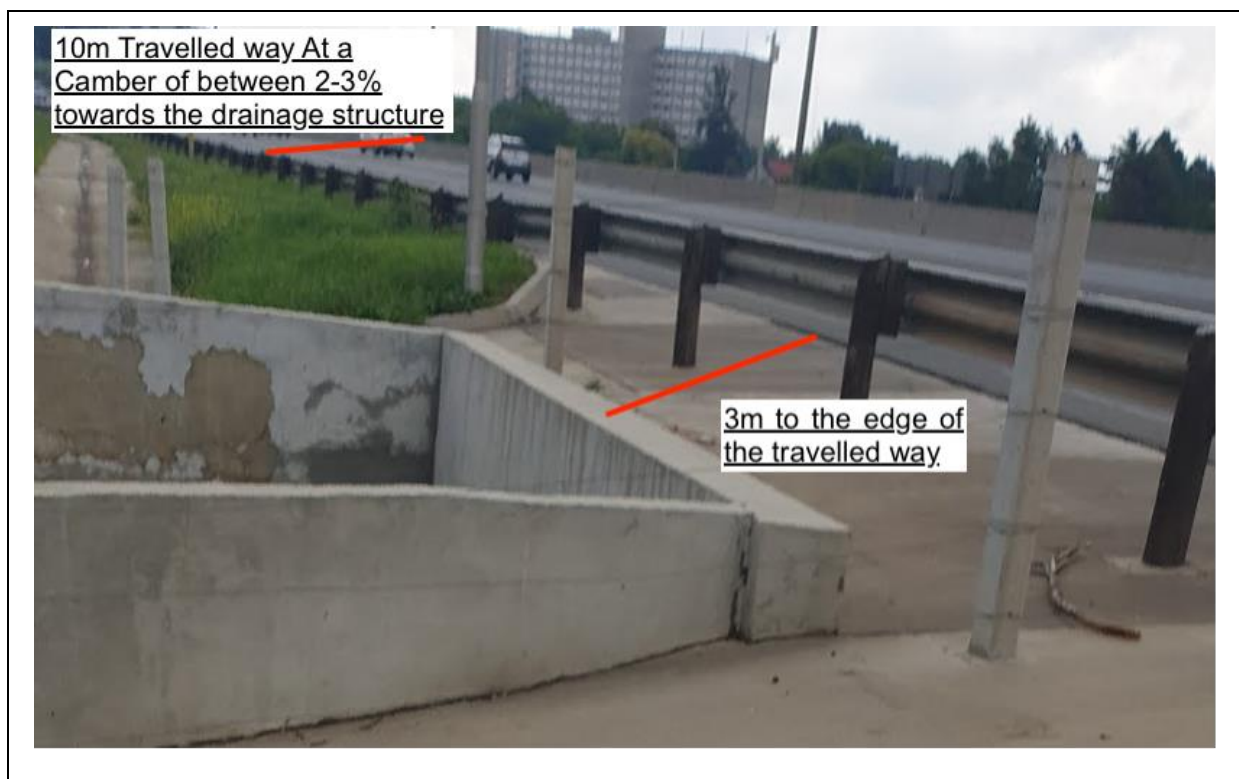
**Figure 5.9:** Inlet of the Drainage Structure at the Study Area.

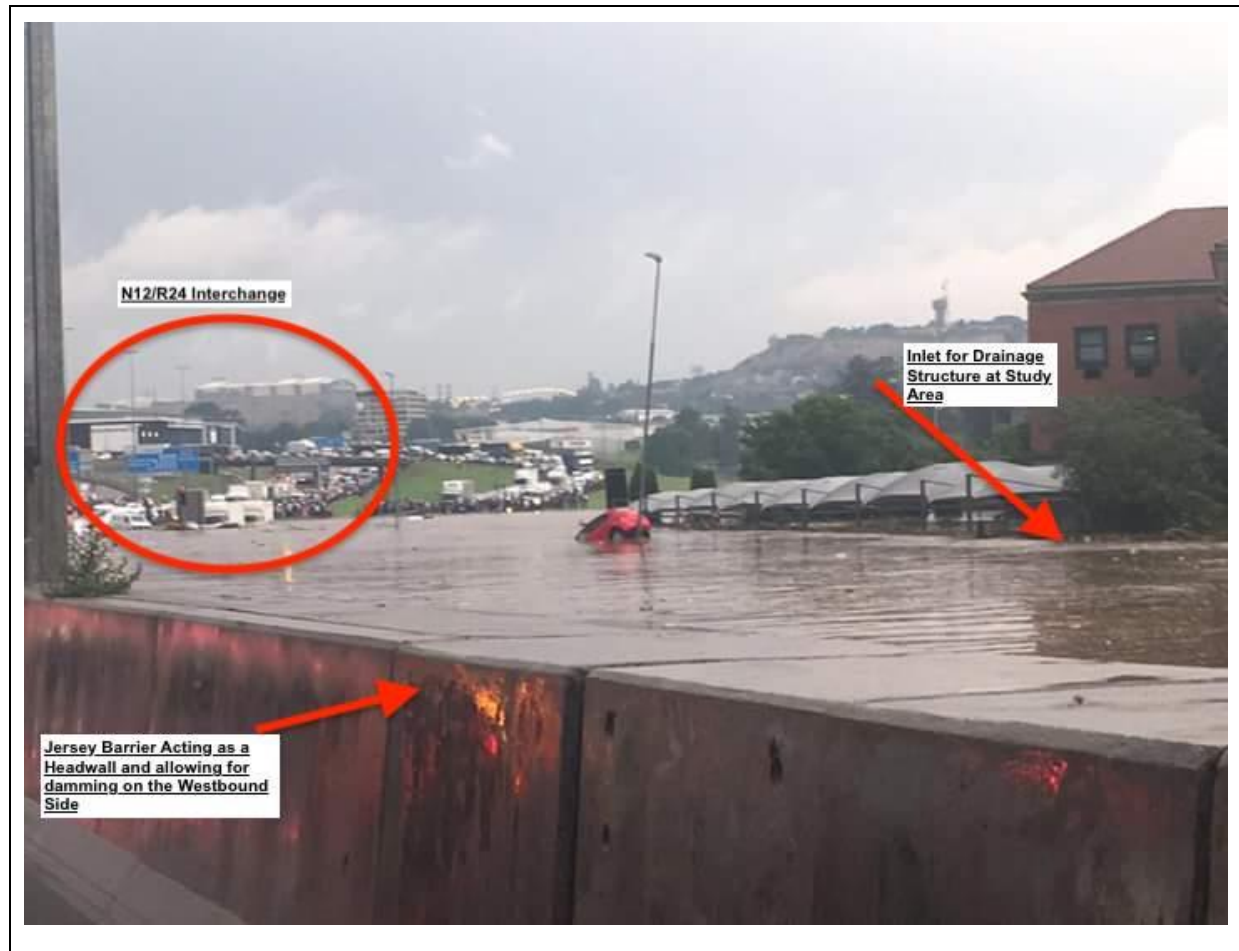
**Figure 5.10:** Flooding at the Study Area (Bedfordview and Edenvale News, 2016)

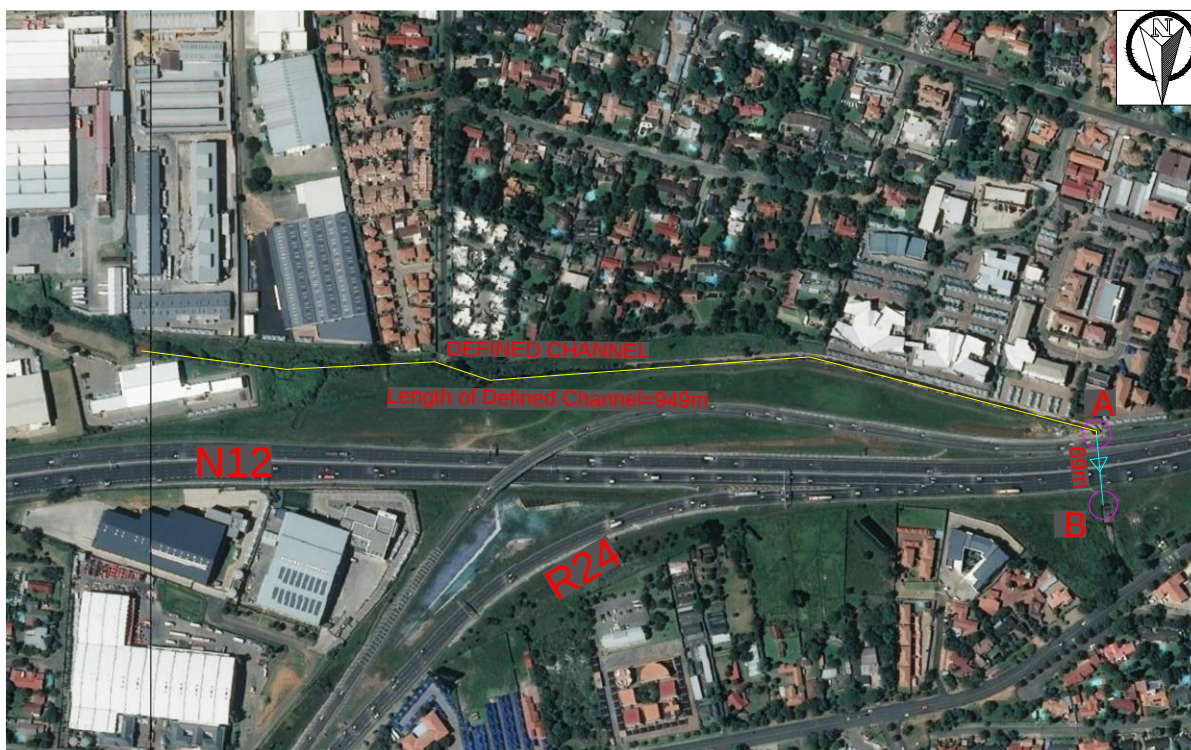
Figure A2.1: Defined Watercourse for Catchment A not to be Confused with Stream 1 which is the Hydraulic Length of the Catchment

| Steps | Calculation/Parameters |
|---|---|
| <b>Step 4:</b> Calculate Time of concentration $T_c$<br>The channel leading to the culvert under review does not span the entire channel. Its length was calculated at 949m. As such the time of concentration for overland flow and that of the defined watercourse will be summed.<br>Overland Flow:<br>$T_c = 0.604 \left( \frac{rL}{S^{0.5}} \right)^{0.467} = 0.228$ plus Channel Flow Components<br>$T_c = \left( \frac{0.87L^2}{1000S_{av}} \right)^{0.385} = 0.7015$ | $T_c = 0.2289 + 0.7015 =$<br><b>0.9304 Hours</b><br>Check average flow velocity ( $v = L/T_c$ ) =<br><b>1.94m/s</b> |
