# **THE FEASIBILITY OF USING RUBBLE MASONRY CONCRETE ON DAM STRUCTURES DURING DAM REHABILITATION IN SOUTH AFRICA TO INCREASE PRODUCTIVE LABOUR OPPORTUNITIES**

A research report submitted to  
the Faculty of Engineering and the Built Environment  
University of the Witwatersrand  
in partial fulfilment of the requirements for  
the degree of  
Master of Science in Engineering

Johannesburg  
February 2013

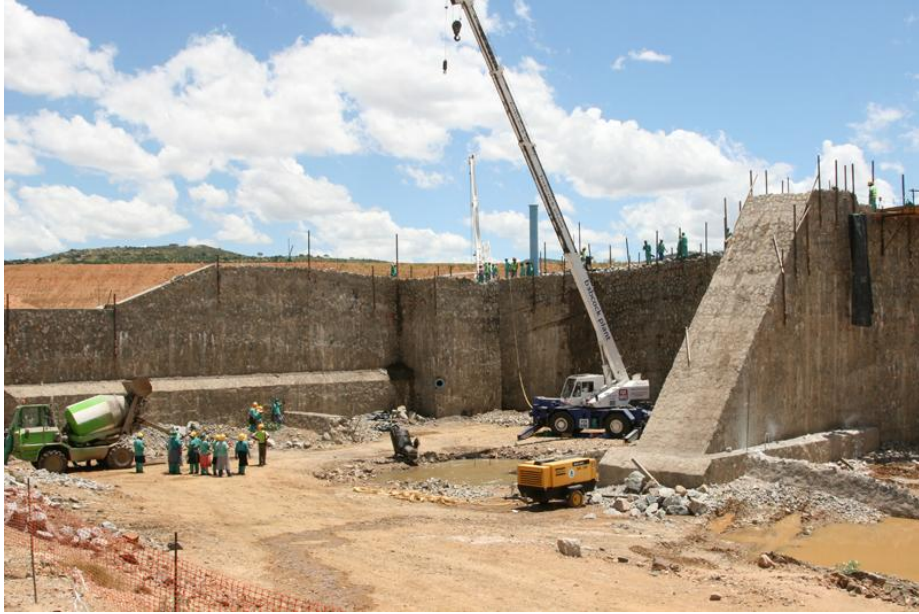
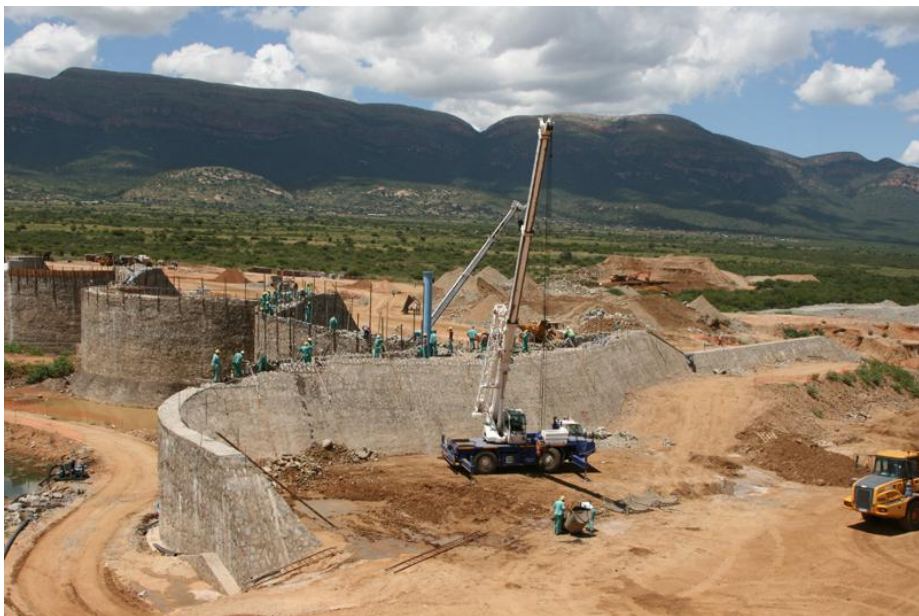
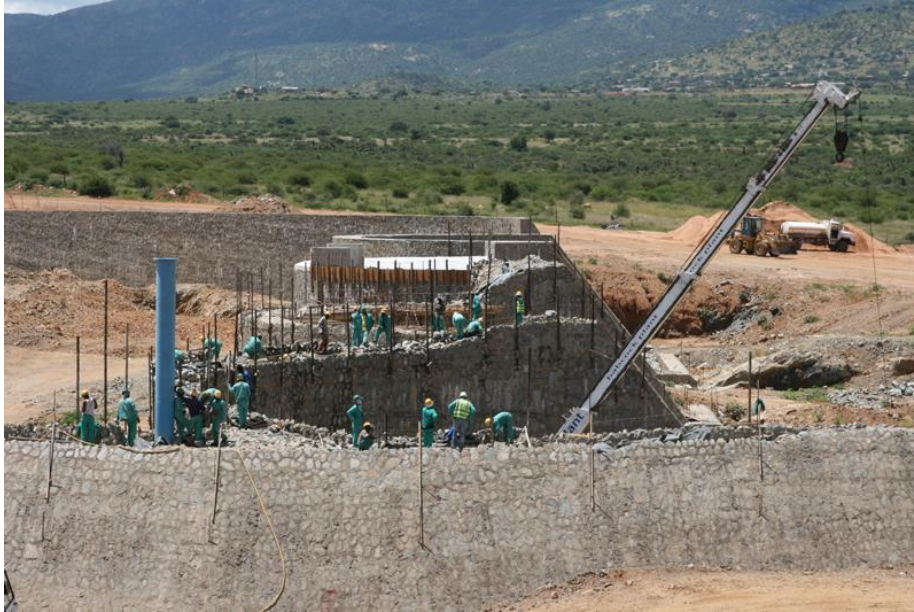
**Figure 3.1: Molepo Dam spillway during construction (1)**

**Figure 3.2: Molepo Dam spillway during construction (2)**

**Figure 3.3: Molepo Dam spillway during construction (3)**

Figures 3.1 to 3.6 show Molepo Dam spillway in various stages of construction and at completion.

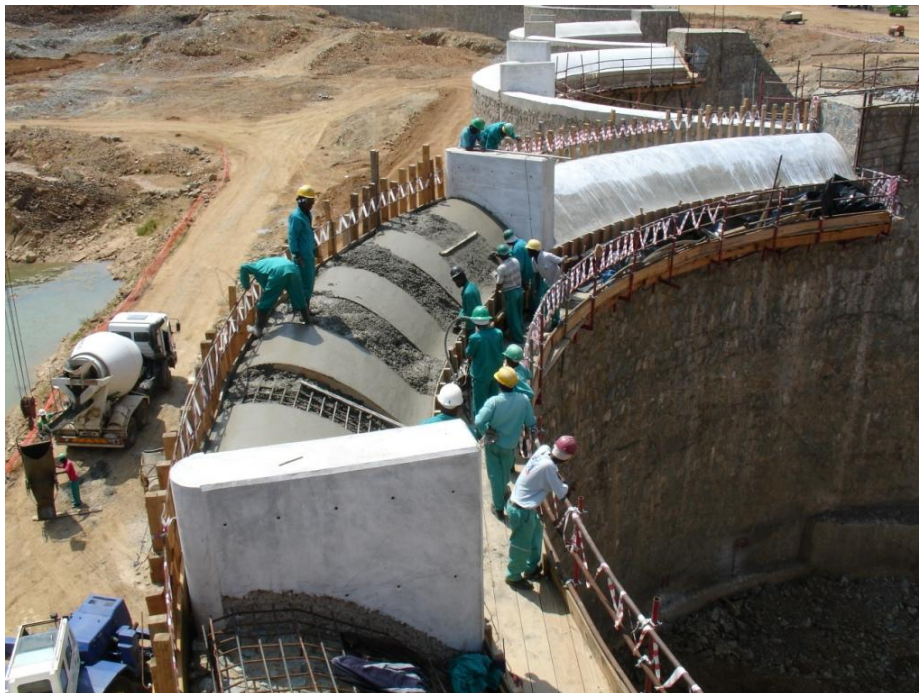
**Figure 3.4: Molepo Dam spillway ogee profile during construction**

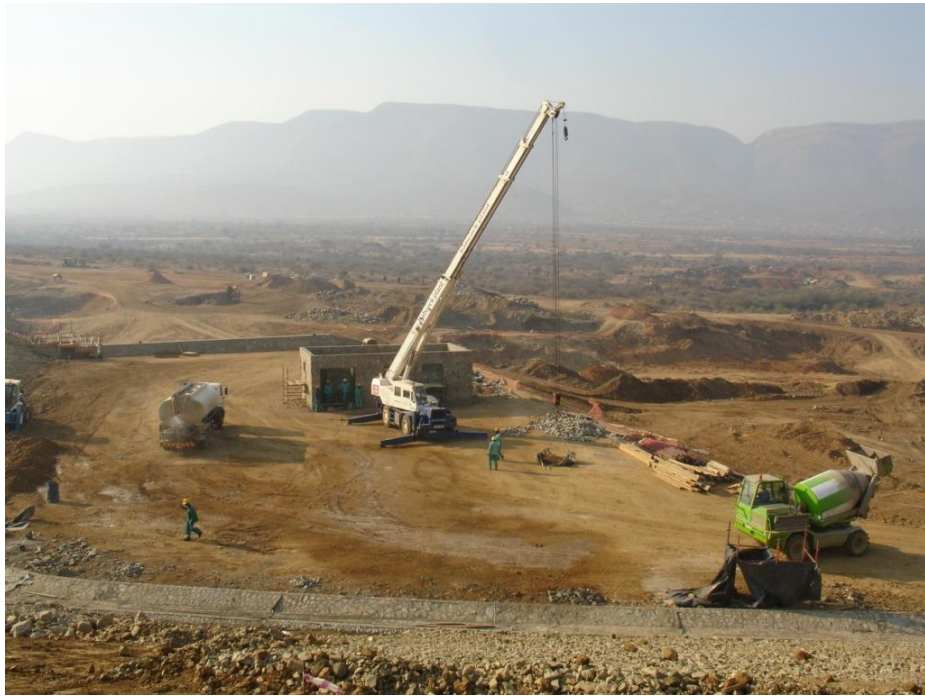
**Figure 3.5: Molepo rubble masonry concrete pump house during construction**

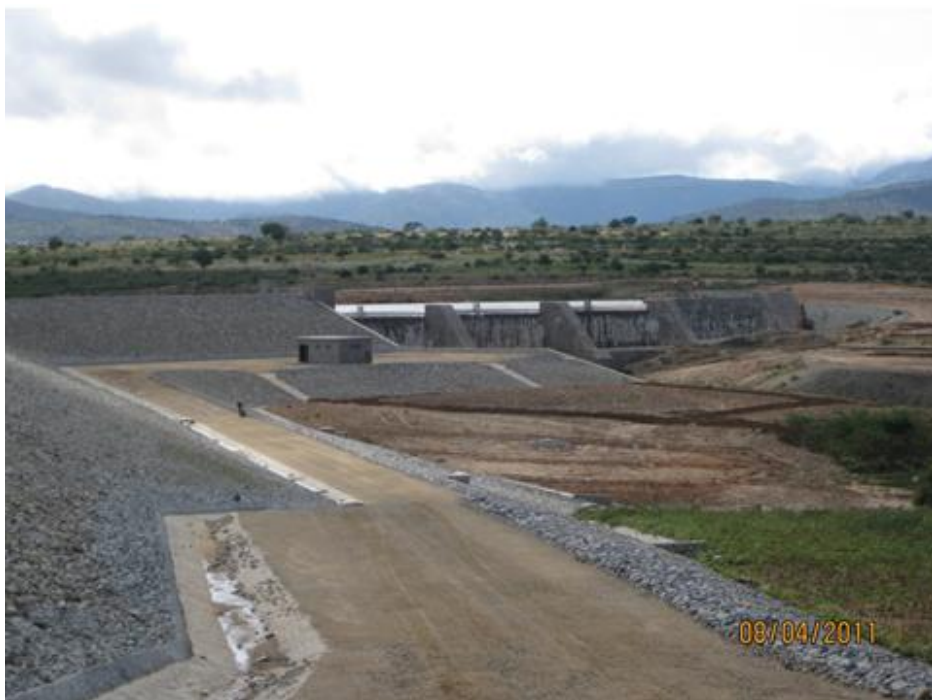
**Figure 3.6: Molepo Dam completed**

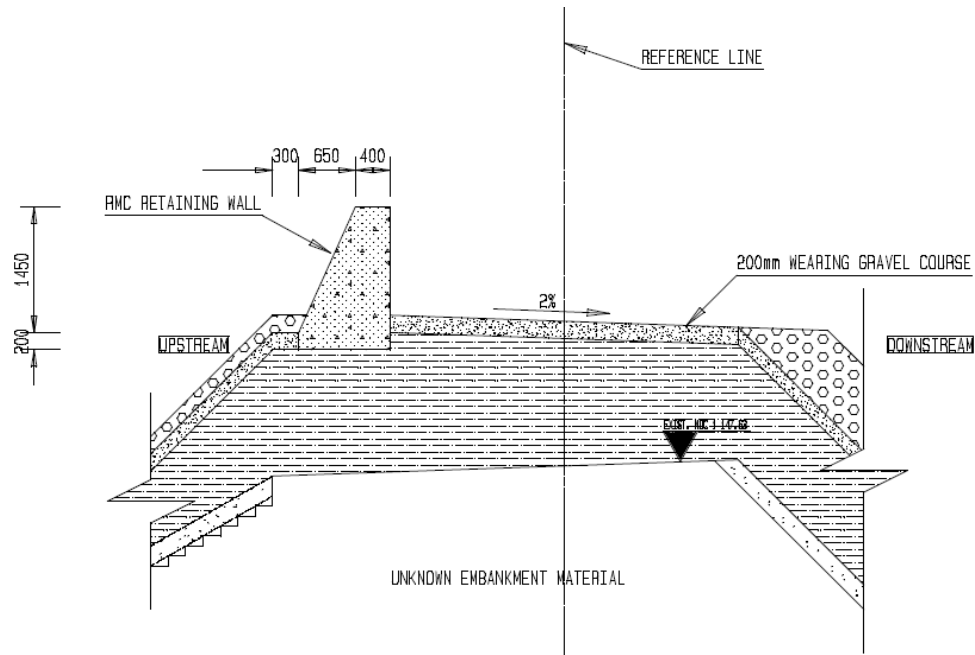
Figure 3.7: Chuniespoort Dam – sketch of parapet wall

The Chuniespoort Dam RMC parapet wall is discussed in two sub-sections – the labour opportunities and the productivity. A sketch of the dimensions of the Chuniespoort Dam RMC parapet wall is presented in Figure 3.7.

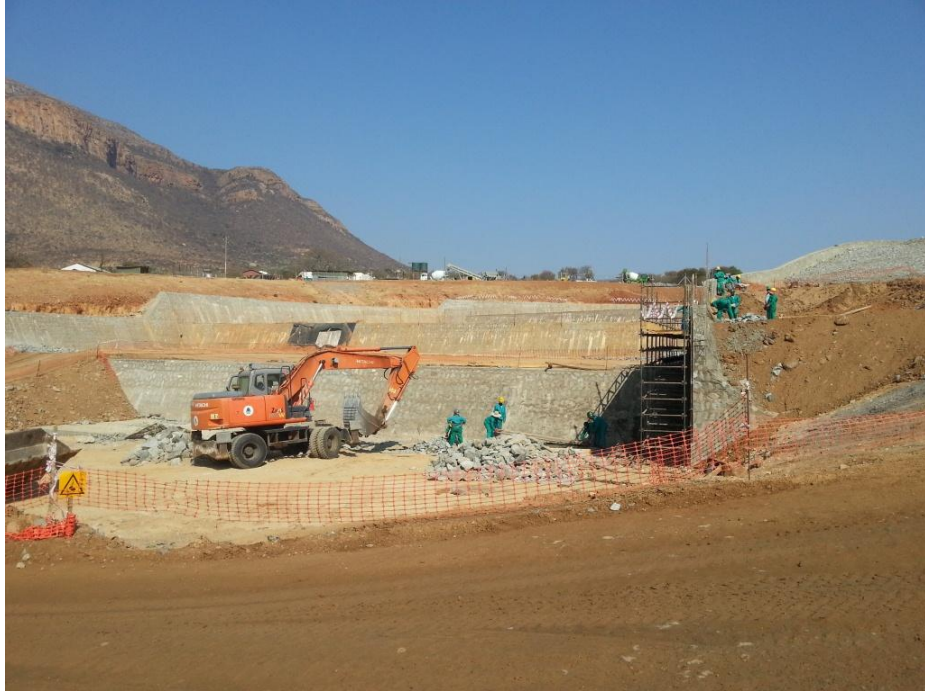
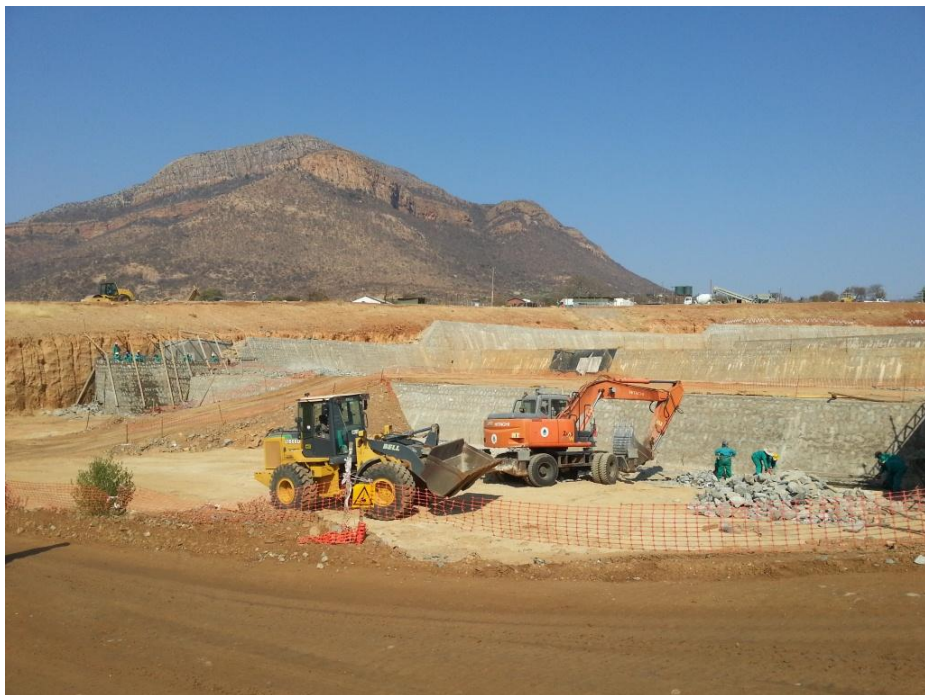
**Figure 3.8: Chuniespoort Dam spillway construction (1)**

**Figure 3.9: Chuniespoort Dam spillway construction (2)**

Figures 3.8 and 3.9 show the Chuniespoort Dam spillway construction. Figure 3.10 shows the Chuniespoort Dam parapet wall, Figure 3.11 shows the Chuniespoort Dam appurtenant structures and Figure 3.12 shows a Chuniespoort Dam stormwater canal. The completed Chuniespoort Dam RMC spillway is shown in Figure 3.13.

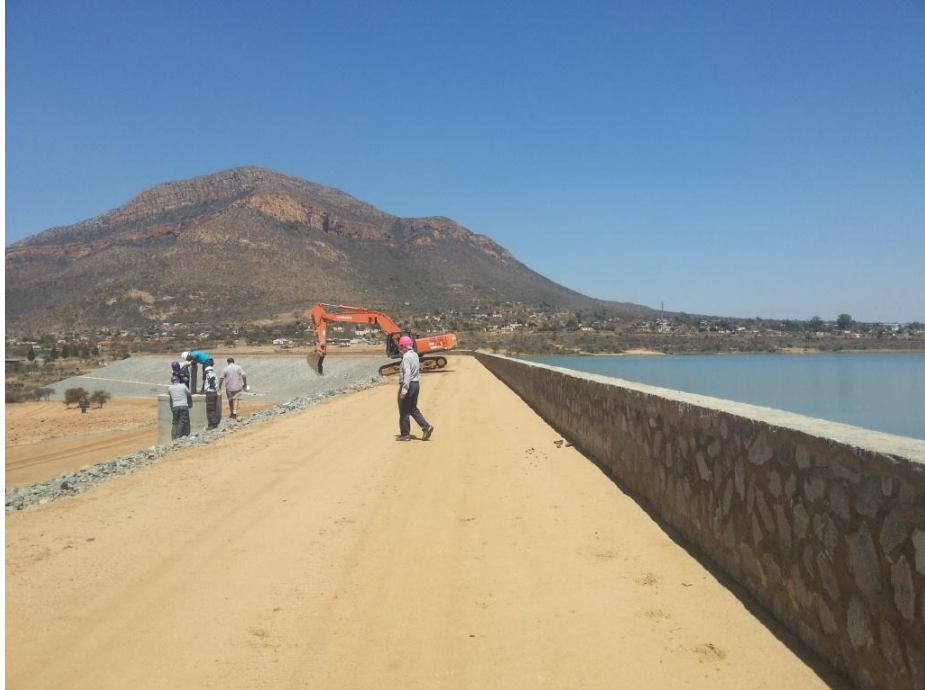
**Figure 3.10: Chuniespoort Dam parapet wall**

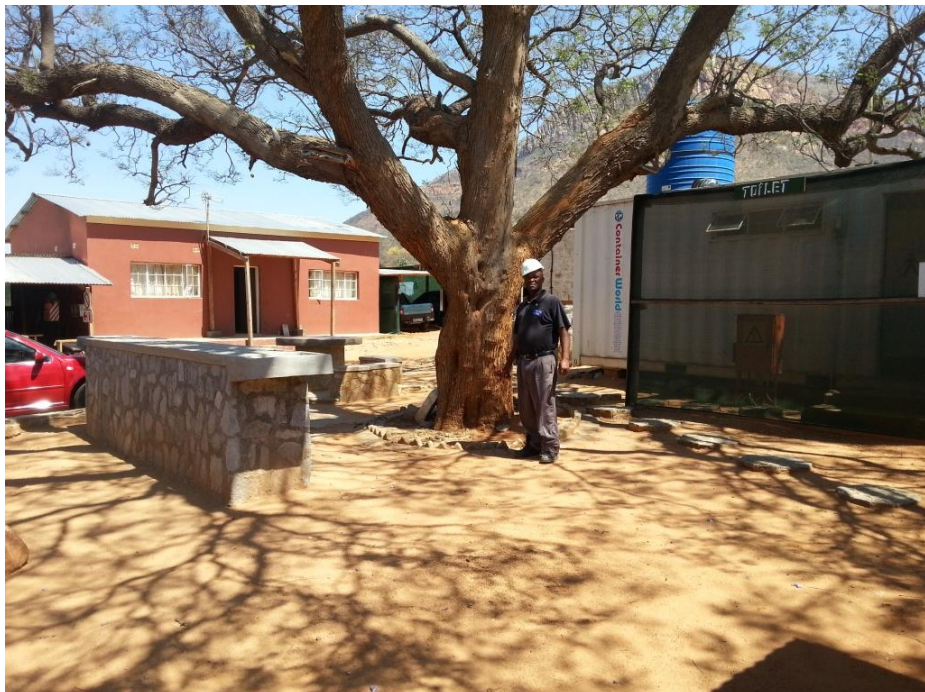
**Figure 3.11: Chuniespoort Dam appurtenant structures**

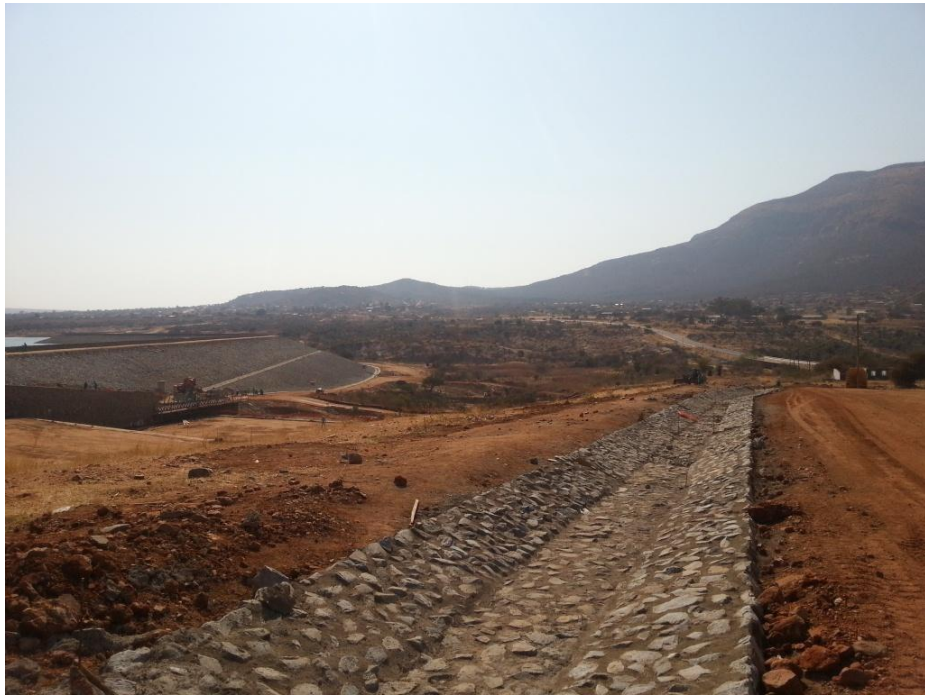
**Figure 3.12:** Chuniespoort Dam stormwater canal

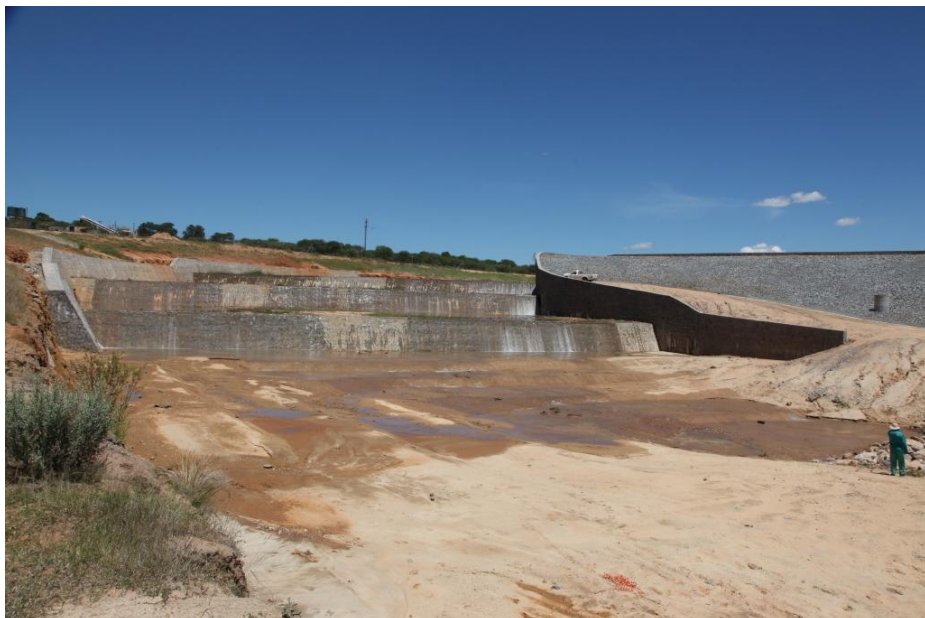
**Figure 3.13:** Chuniespoort Dam completed rubble masonry concrete spillway

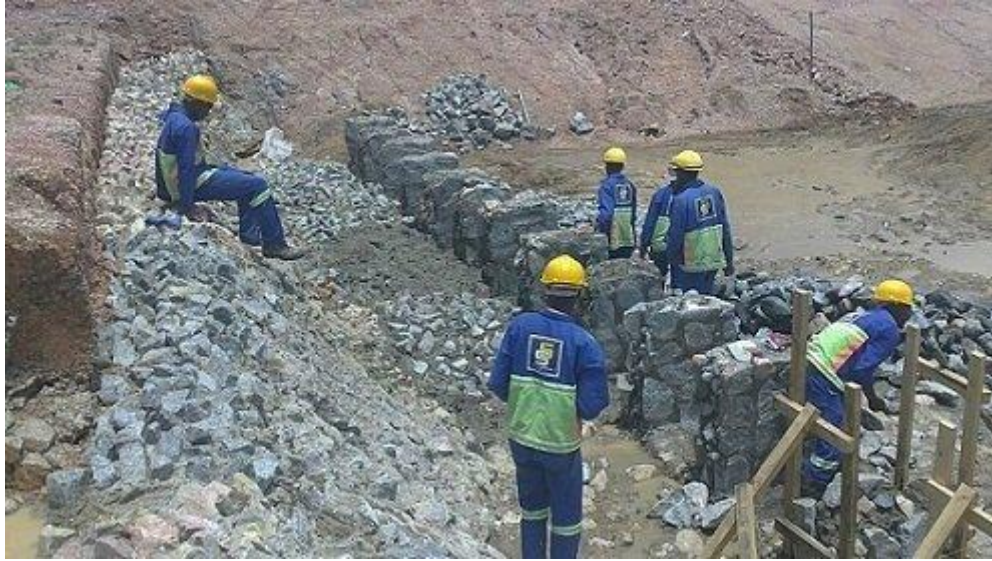
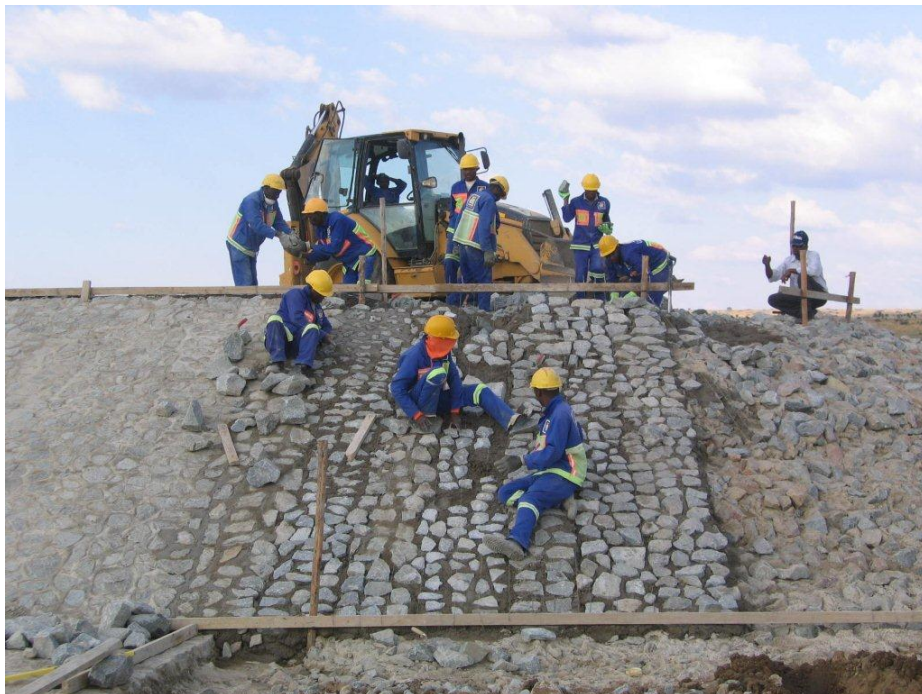
**Figure 3.14: Mashashane Dam spillway during construction (1)**

**Figure 3.15: Mashashane Dam spillway during construction (2)**

Figures 3.14 to 3.17 show the Mashashane Dam spillway during construction and after completion.

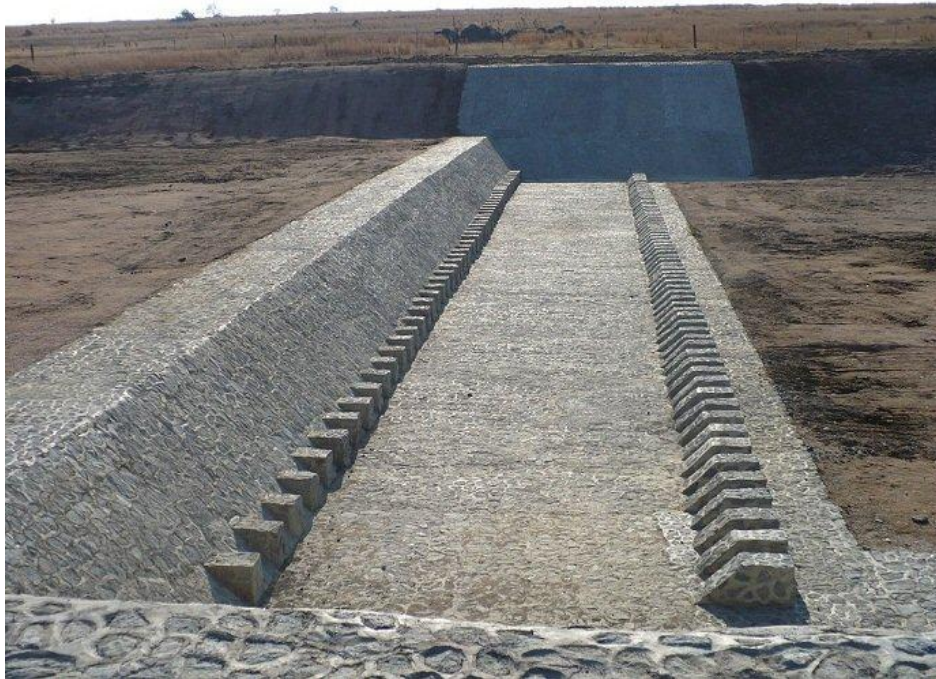
**Figure 3.16: Mashashane Dam completed spillway**

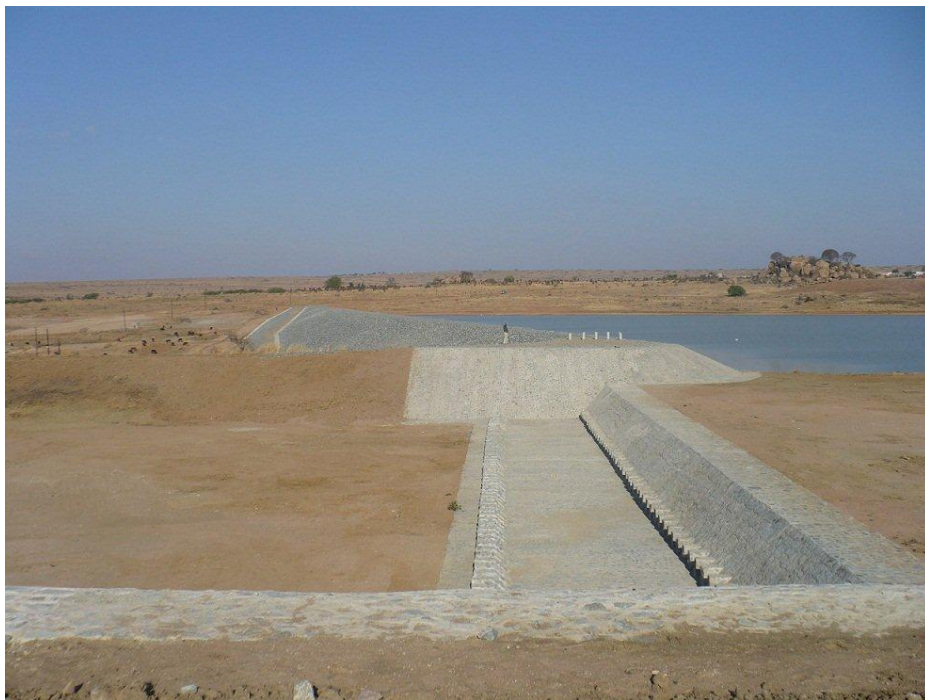
**Figure 3.17: Mashashane Dam completed**

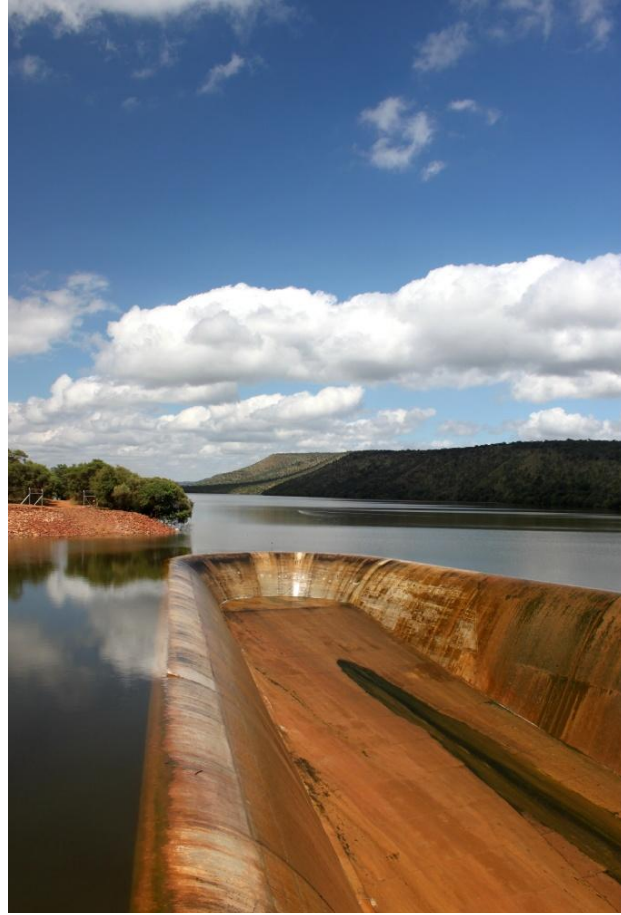
**Figure 3.18: Klein Maricopoort Dam new concrete spillway**

Figure 3.18 shows the Klein Maricopoort Dam new concrete spillway.

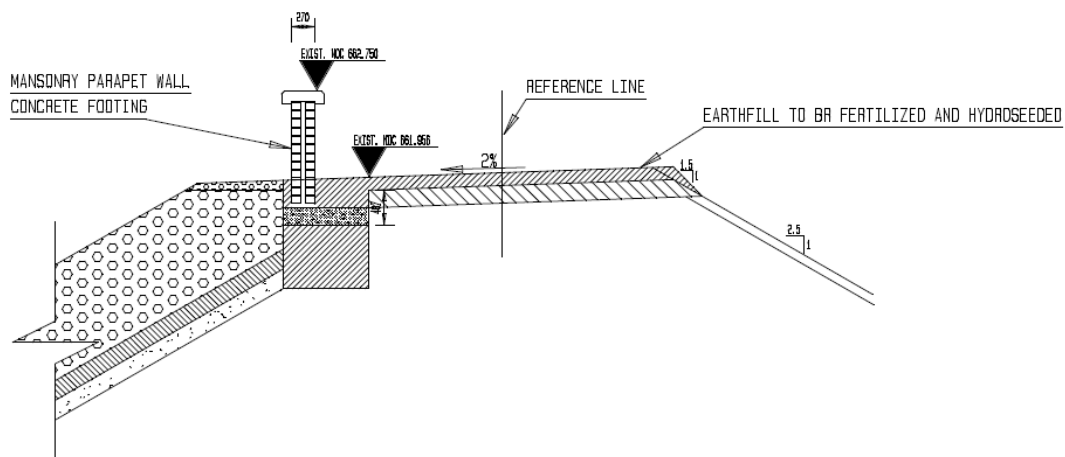
**Figure 3.19:** Albert Falls Dam – sketch of parapet wall

Albert Falls Dam is a composite earthfill/concrete structure in KwaZulu-Natal and is situated roughly 20 km north of Pietermaritzburg on the Umgeni River (Badenhorst and van Wyk, 2008). The dam had an insufficient spillway capacity prior to the raising that took place in 2010. The insufficient spillway capacity was overcome by constructing a parapet wall on the upstream side of the non-overspill crest. Three options were investigated to construct the parapet wall and the brick wall was not only the least expensive option, but was also chosen to promote labour-intensive construction. Figure 3.19 illustrates the dimensions of the Albert Falls Dam parapet wall.

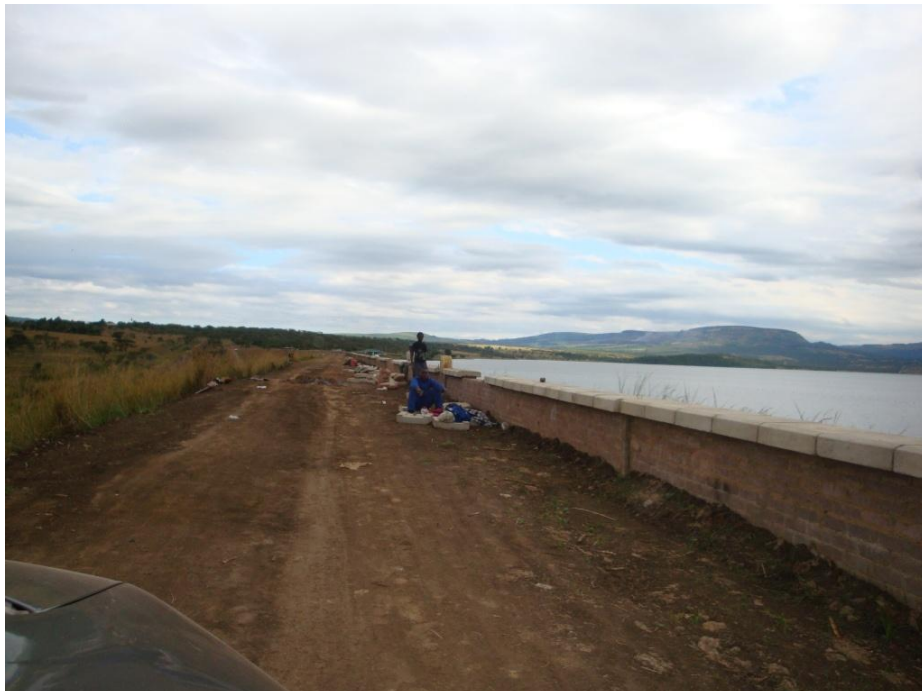
**Figure 3.20: Albert Falls Dam during construction of the parapet wall**

Photographs of the Albert Falls Dam parapet wall during and after construction are shown in Figures 3.20 and 3.21.

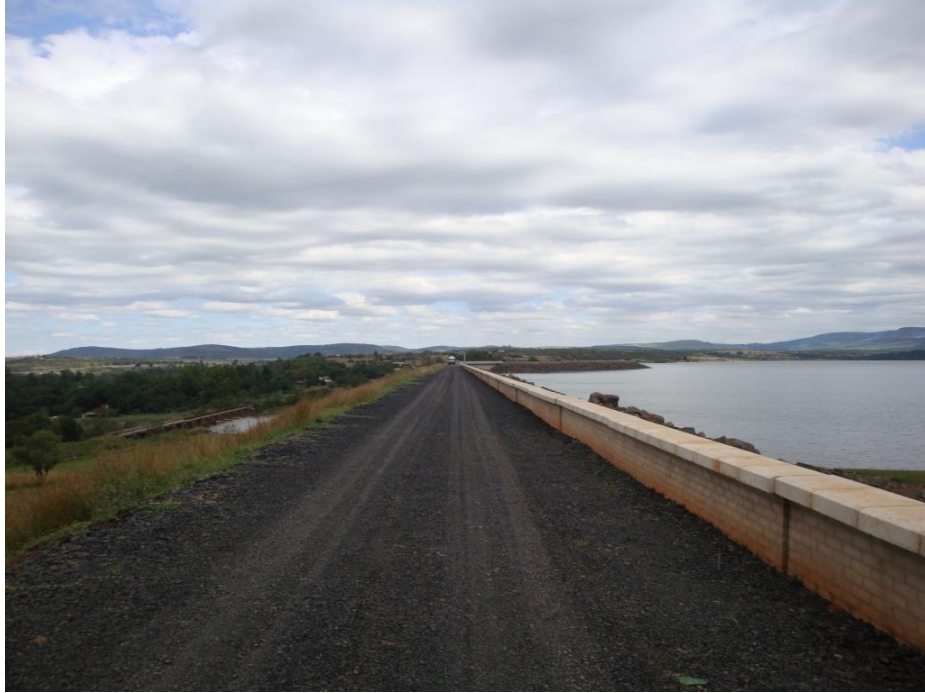
**Figure 3.21:     Albert Falls Dam completed parapet wall**

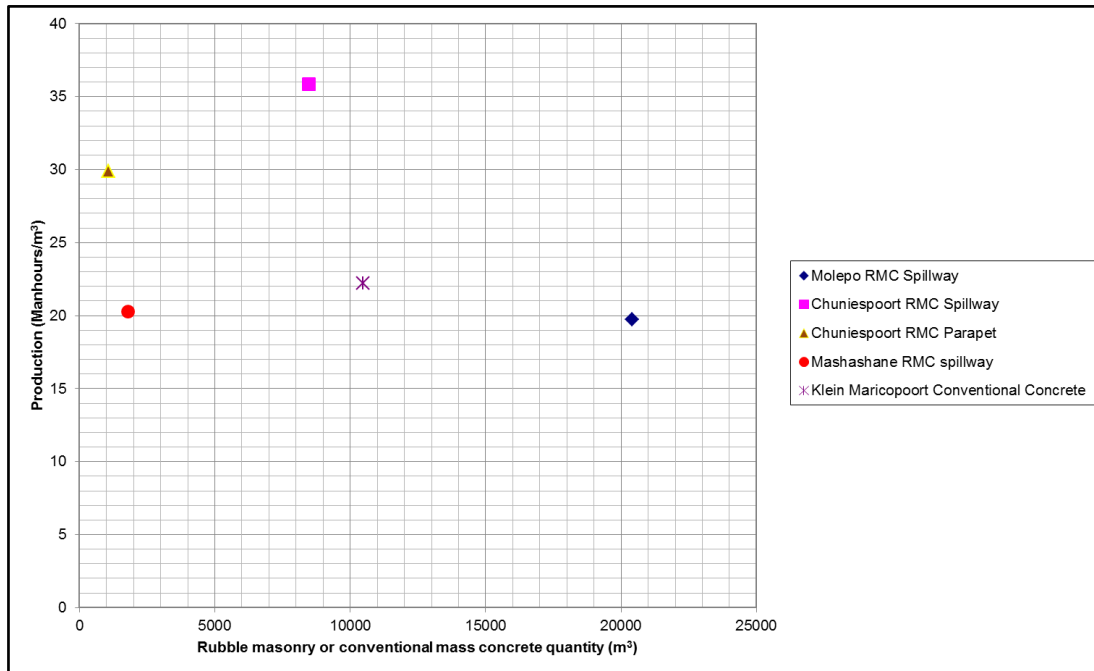
**Figure 4.1: Man-hours/m<sup>3</sup> for rubble masonry concrete and conventional concrete**

Figure 4.1 illustrates that for RMC structures between 20 man-hours/m<sup>3</sup> and 36 man-hours/m<sup>3</sup> were created for dam rehabilitation projects. No significant trend can be seen from this figure as there are too many variables that can influence the rate of production (for example, the quantity of RMC placed, the design and the contractor).

A plot of the number of man-hours per m<sup>3</sup> for RMC structures is shown in Figure 4.1.

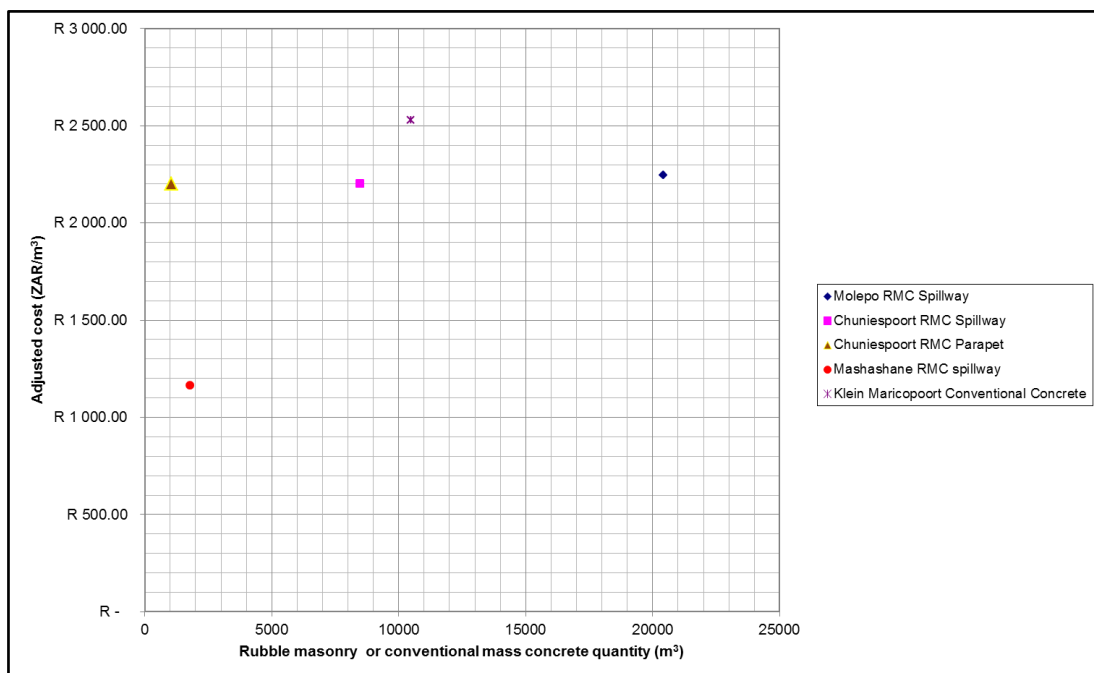
**Figure 4.2:** Cost comparison for rubble masonry concrete projects and conventional concrete projects (adjusted to 2012 cost)

From Figure 4.2 it can be seen that for DWA: Construction the adjusted cost of RMC varies between R2 203 and R2 246/ $\text{m}^3$ . This compares favourably with the DWA: Construction cost of R2 527/ $\text{m}^3$  for conventional concrete at Klein Maricopoort Dam. It should, however, be noted that at Chuniespoort Dam the rock was obtained free of charge from the mine and only hauling cost was necessary. At Molepo Dam, the rock was obtained from the area, but with costs for blasting and transporting the material.

A cost comparison for RMC projects and conventional concrete projects (adjusted to the 2012 cost) is shown in Figure 4.2.

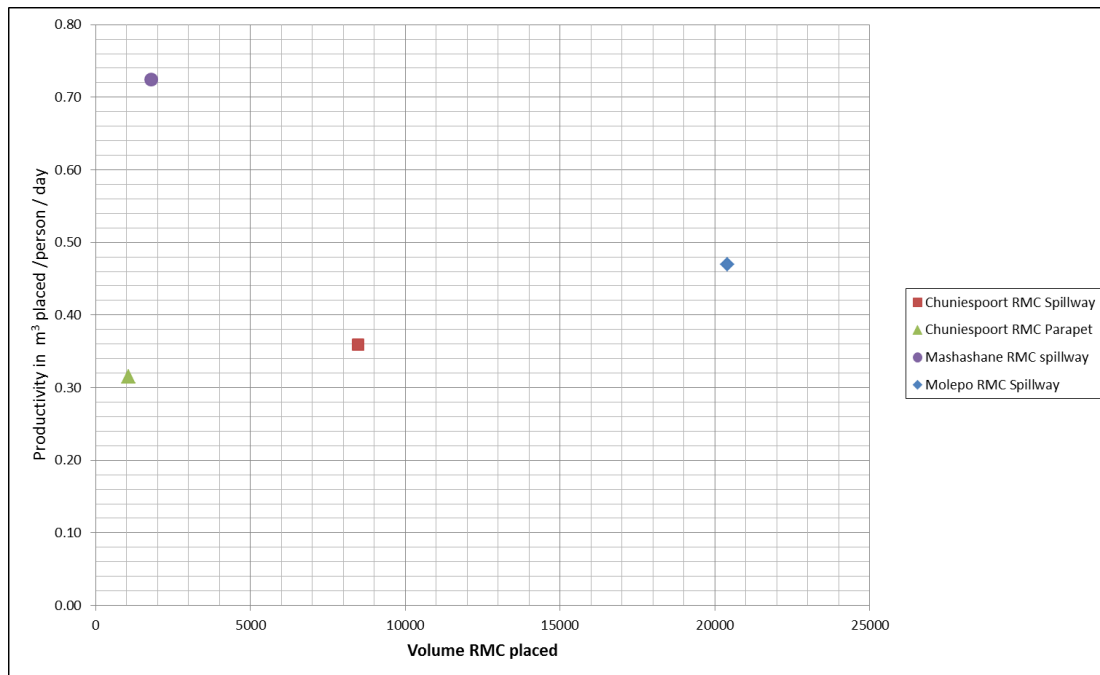
**Figure 4.3: Productivity rates of rubble masonry concrete projects**

When calculating the productivity, only the contributions of the labourers who placed the RMC were taken into account.

The productivity rates of RMC projects are shown in Figure 4.3.

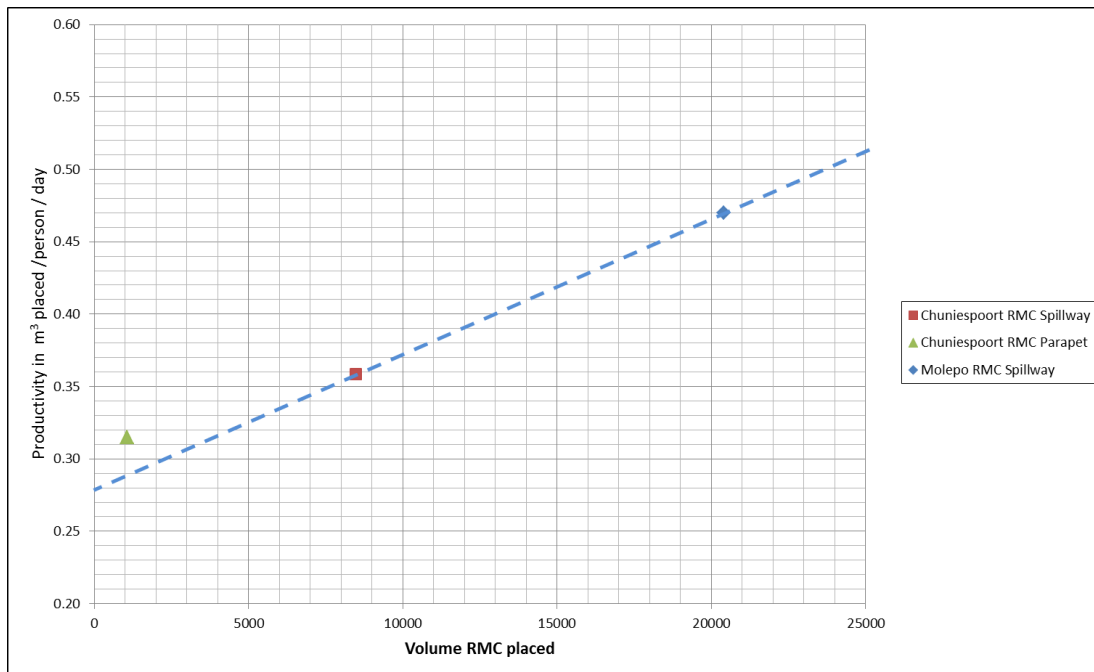
Figure 4.4 shows the productivity chart for DWA: Construction RMC sites. The trend line has been added to indicate a linear productivity rate based on the volume of RMC placed and figures obtained from Molepo Dam and Chuniespoort Dam's spillways without incentive schemes. This positive line is

to be expected as projects are normally more productive with increased quantities.

**Figure 4.4: Productivity rates and trend line for rubble masonry concrete structures constructed by DWA: Construction**

From Figure 4.4 it can be observed that the productivity rate for Chuniespoort Dam's RMC parapet wall lies above the trend line. The staff had an incentive scheme on the parapet wall project which led to significantly faster placement rates in order to be awarded greater remuneration or free time. The faster placement rate had no impact on the quality of the product. The nature of constructing a parapet wall requires more effort and workmanship than construction of a spillway (with its concomitant large volumes) as no dumping of mass rock is possible as would be the case on a larger RMC structure. Despite the more difficult construction methods for a parapet wall, the productivity decreased from 0.36 m³/person/day for the RMC spillway to only 0.32 m³/person/day for the RMC parapet wall.
