**CORROSION CHARACTERISTICS OF STEELS AND METALLIC ALLOYS USED AS  
CONSTRUCTION MATERIALS IN PLANTS EXPOSED TO FLUORINE CONTAINING  
ACIDS**

A dissertation submitted to the Faculty of Engineering and the Built Environment, University of the  
Witwatersrand, Johannesburg, in fulfilment of the requirement for the degree of Master of Science  
in Engineering

Johannesburg, August 2018

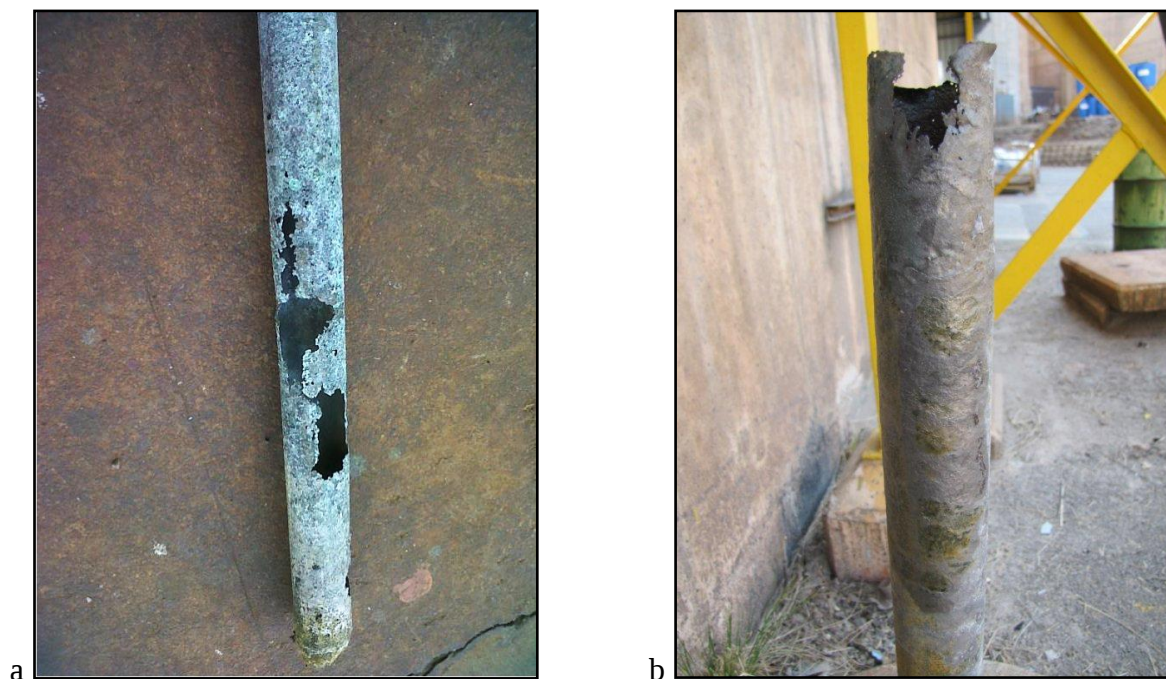
Figure 2.4: (a) Corrosion in the liquid phase, and (b) in the vapour phase above HF liquid level of Monel dip tubes installed on March 2012 into Storage tanks V1460 and removed 2 weeks later due to excessive corrosion (Valkenburgh, 2012e).

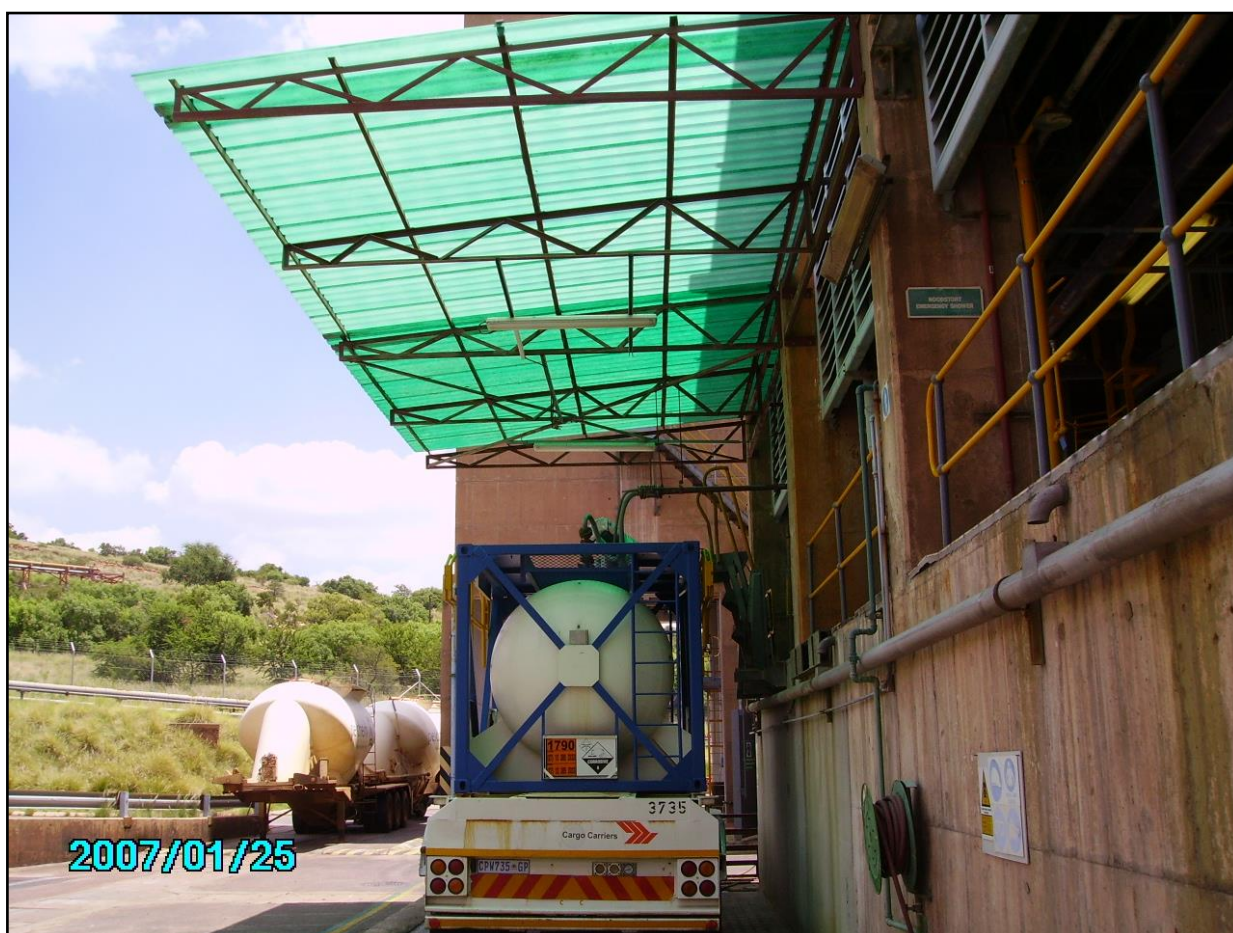
Figure 2.5: HF storage tank loading and transportation facility located on site at Necsa.

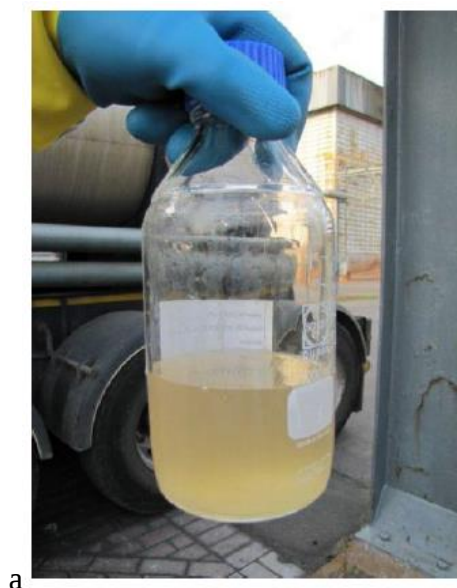
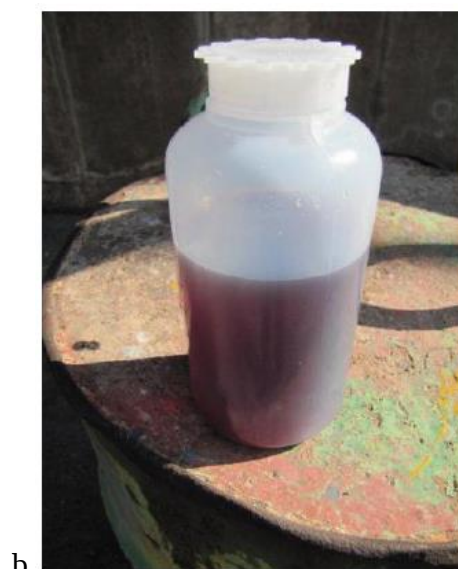
Figure 2.6: (a)  $\text{H}_2\text{SO}_4$  as-received from the supplier's tanker, and (b)  $\text{H}_2\text{SO}_4$  from the bottom of the plant storage tanks where the impurity which settled out was predominantly  $\text{FeSO}_4$  (Valkenburgh, 2012c).

It was first suspected that an oxidizing substance was introduced to the plant via the  $\text{H}_2\text{SO}_4$  feedstock when in July 2012 it was reported that “red fumes” were observed in the industrial grade HF circuit (Valkenburgh, 2012d). This initial observation was suggested by the internal plant advisor to be presence of nitrous compounds ( $\text{HNO}_2$  and  $\text{HNO}_3$ ). Subsequently, corrosion pits became visible in the HF storage tank walls. The inspection personnel reported this as pitting corrosion (Valkenburgh, 2012d). The corrosion could not be measured or quantified accurately because pitting can occur at any point and is difficult to detect with wall thickness measurements (Valkenburgh, 2012d).

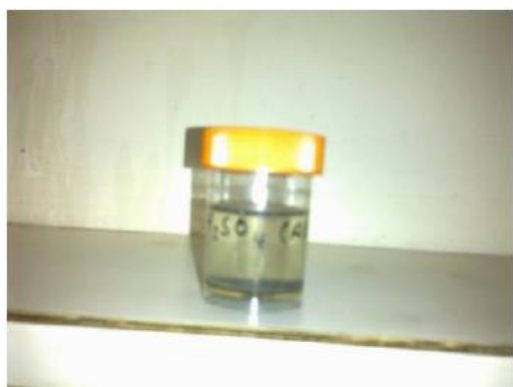
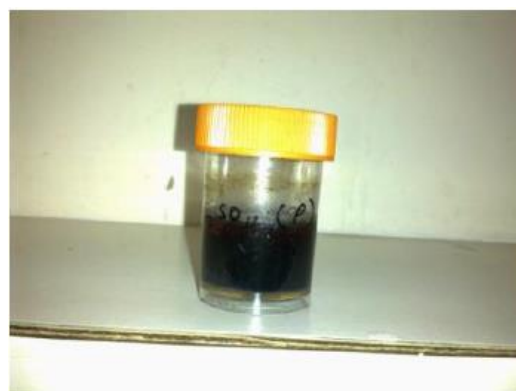
Figure 2.7: (a) 98% Laboratory grade  $\text{H}_2\text{SO}_4$  indicating no reaction with iron powder, and (b)  $\text{H}_2\text{SO}_4$  from the supplier which had reacted to form a thick brown residue with the iron powder (Valkenburgh, 2012c).

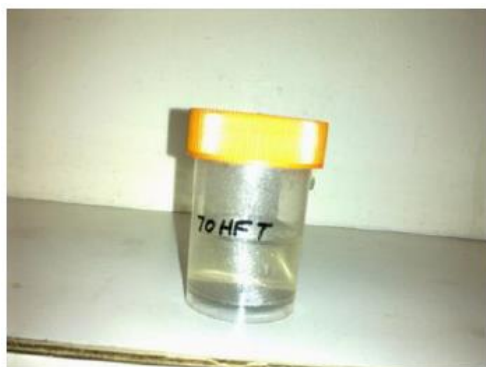
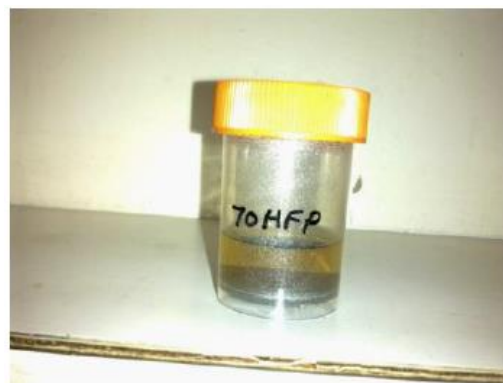
Figure 2.8: (a) 70% technical grade HF indicating no visual reaction with iron powder, and (b) 70% industrial HF showing some visible reaction had occurred with the iron powder (Valkenburgh, 2012c).

From the on-site examinations the need to do extensive laboratory corrosion tests to understand the impact  $\text{HNO}_3$  contamination on the corrosion of steels and nickel alloys used at the HF plant, became apparent. Using visual characterizations techniques were fast, inexpensive and safe and gave a good indication where the focus needed to be to solve the corrosion problem. However, quantitative data was also needed to predict the corrosion trends and provide definite evidence to the corrosion mechanism. However, conducting laboratory corrosion experiments using 70% HF and successfully analysing the corrosion products had high safety risk implications. Hydrofluoric acid at any concentration is extremely dangerous, and its vapours are extremely hazardous and even fatal to workers. Moreover, HF dissolves silica and silicon in glassware, and typical corrosion set-ups (ASTM, 2009a) are not suitable, because the acid can attack and dissolve the glassware and ceramic probes needed to conduct the corrosion experiments. Furthermore, a high concentration of HF has large quantities of  $\text{H}^+$  and  $\text{F}^-$  ions, which make it extremely difficult to analyse any other ions in solution when using Ion Chromatography (IC). This is due to the high charges associated with the higher concentration acids, which directly influences the accuracy and reproducibility of analyses during nitrate ( $\text{NO}_3^-$ ) quantification in solution.

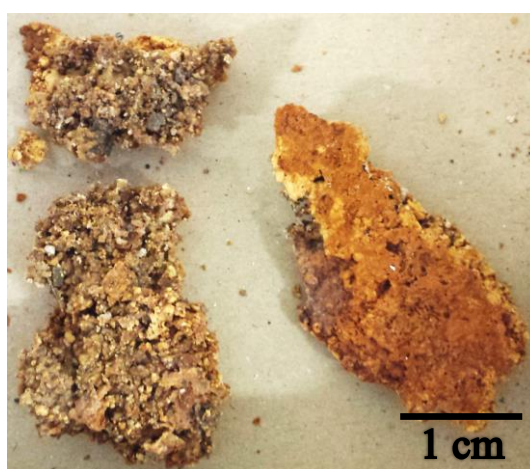
Figure 3.6: Removable scale, collected from below the liquid band (point 5 in Figure 3.4) on the inside of the HF storage vessel (Figure 3.2b), for XRD analysis.

Large agglomerates of scale (>4 cm in length) were removed from the inside of the storage tank (Figure 3.2b) in an area where corrosion occurred (e.g. point 5 in Figure 3.4), at points below the leaks (e.g. point 1 and 2 in Figure 3.4). This was slightly below the liquid band. Based on its colour and texture, this removable scale visually resembled iron fluorides which typically form when HF reacts with the exposed steel during corrosion. The scale was loose and relatively large compared to the protective scale that should have formed on the inside of the mild steel tanks. It was collected and examined, as the corrosion products were relevant to the catastrophic failure of the V1460 technical grade HF storage tank. Analysis of the composition of this scale was conducted by X-ray diffraction (XRD), after pulverising the scale to powder. Phase identification of the XRD pattern was done using the 2007 PDF-2database.

The  $\text{FeF}_3(\text{H}_2\text{O})_3$  identified by XRD indicated the  $\text{FeF}_2$  was oxidized by the  $\text{HNO}_3$  and became sufficiently porous to allow HF access to the steel substrate. The steel then reacted repeatedly with fresh HF and formed a succession of scale layers, similar to when a pre-passivation step was used in the commissioning of the storage vessels. This combined attack from  $\text{HNO}_3$  and HF continued and the porous scale layers increased to more than 220 µm (Figure 3.9), allowing corrosion of the steel underneath the scale. This continued until the scale formed large, unstable pieces (visible in Figure 3.6), which eventually peeled off exposing the steel to high corrosion rates.

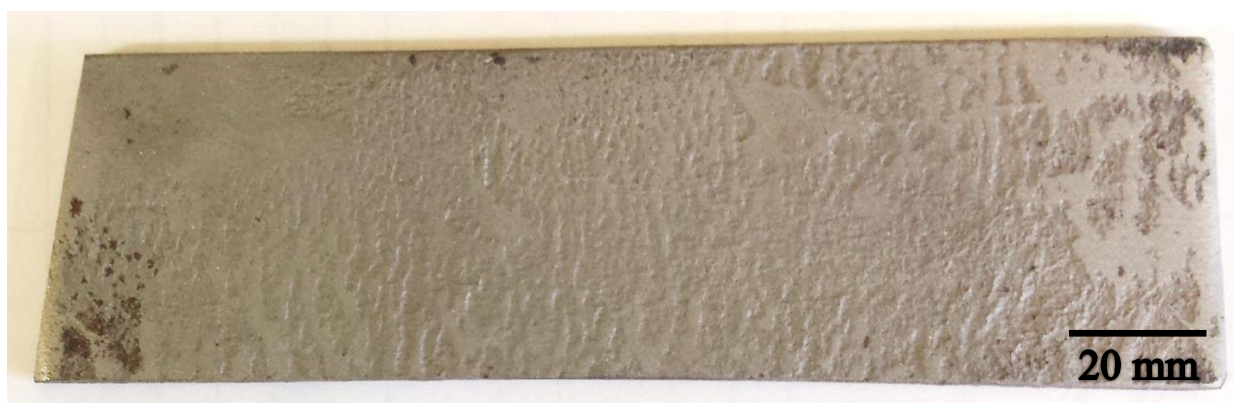
Figure 4.2: Example of the original steel received from hot rolling received after sand-blasting.

Coupons were cut from the centre of each rolled bulk sample (Figure 4.2) as the edges of the steels oxidized during hot rolling. This is visible from the white area in the etched microstructure of the mild steel (Figure 4.5). This practice ensured that representative and homogeneous samples were used during all corrosion tests and analyses.

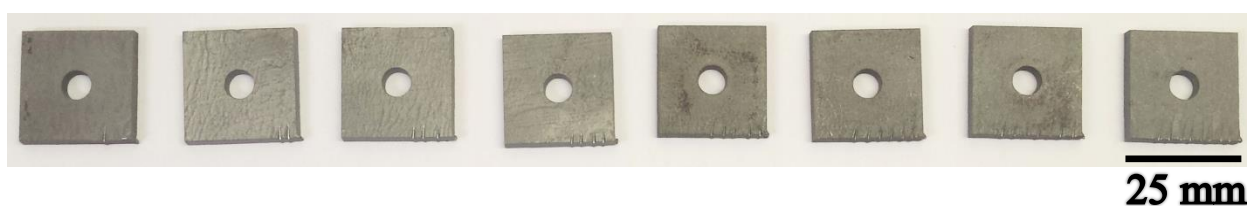
Figure 4.4: Examples of final coupons, after washing with acetone, prepared for corrosion immersion tests, with sequencing marks on the bottom edges.

A 1 mm part kept each coupon attached to the profile cut from the bulk metal sample and could easily be sheared off and collected for each corrosion experiment. However, this method did leave behind a slightly work-hardened 1 mm burr which needed to be cut and filed down before each experiment. The slightly deformed burr served as a reference mark during the orientation of the coupons into the corrosion reactor and was a valuable reference point during the macroscopic and microscopic examinations of the coupons before and after each test.

Before each corrosion test, coupons were removed from the water-jet cut template (Figure 4.3) marked (Figure 4.4) and ultrasonically cleaned with acetone for 30 minutes. The coupons were allowed to air dry and then weighed, after which “before” photos were taken under fluorescent light. Subsequently, the coupons were loaded into the corrosion rack and placed into a desiccator. Once the corrosion set-up was ready, the assembled corrosion rack was retrieved

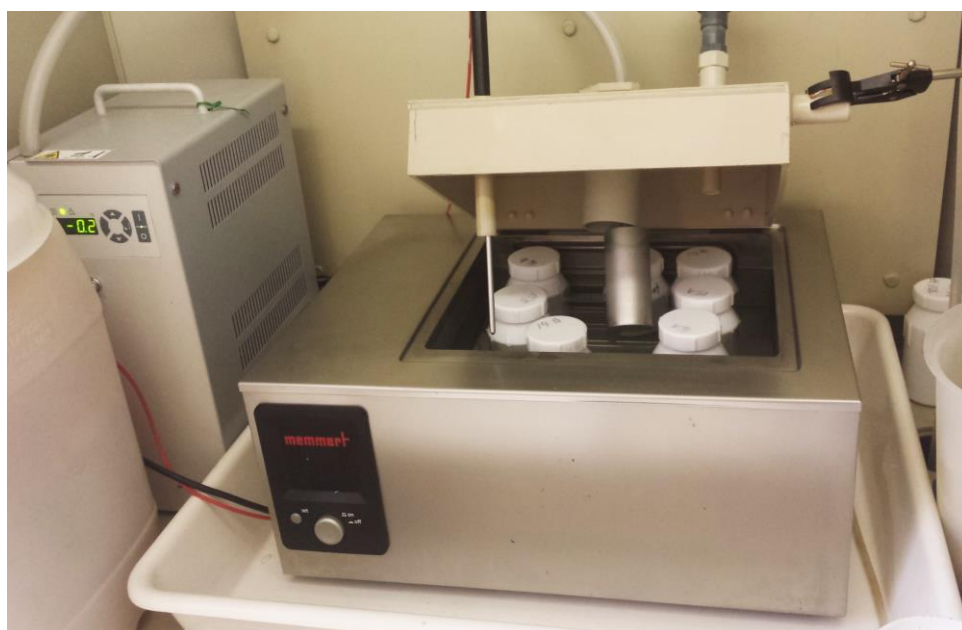
Figure 4.6: Water bath with immersion cooler set-up for corrosion tests.

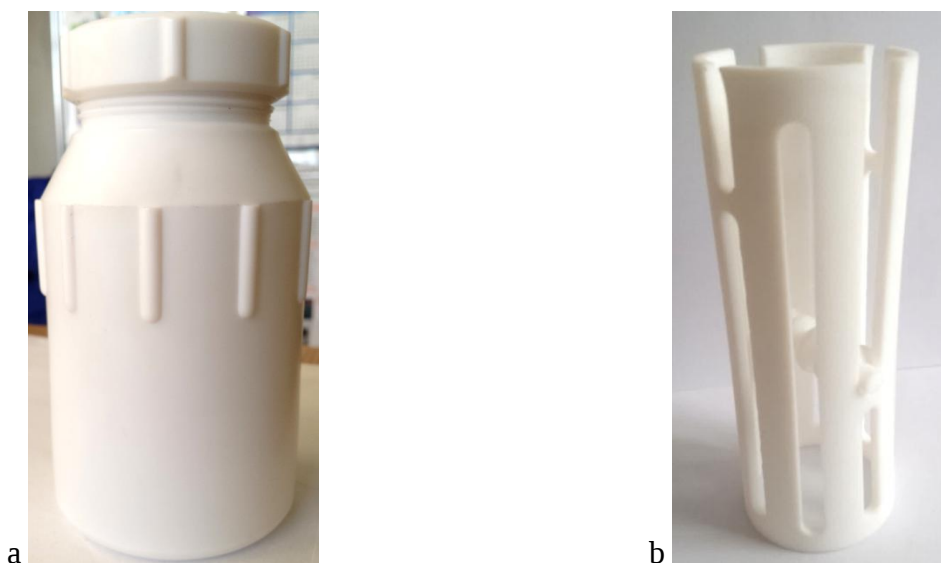
Figure 4.7: Corrosion reactor components: (a) Teflon bottle, and (b) cylindrical corrosion rack with Teflon rod to the suspend coupon.

PICTs were carried out in a 500 mL Teflon bottle (Figure 4.7a) placed in a 10 L 1800 Watt Memmet water bath which maintained the corrosion solution at a constant temperature. A photograph of the working immersion type corrosion set-up, as prescribed by ASTM standard practice G3 – 72 (ASTM, 2009a), is given in Figure 4.6. Since ambient temperature in the fume cupboard frequently was above 25°C, a Julabo FT402 immersion cooler was used to cool the water in the bath. The water bath could only regulate water by heating, hence external cooling needed to be implemented to maintain an opposing reduced temperature. The water bath was supplied standard with a steel lid, which was replaced with a polypropylene lid that was custom-made to cover the bath and allowed the immersion cooler to hang freely in the water (Figure 4.6). A Pt100 sensor was connected to the immersion cooler and was suspended from the water bath lid to measure temperature at the same point as the water bath's own thermometer. In this way, the sensors would match readings to facilitate the water bath heating and immersion cooling to reach a steady state at 25°C, after an hour.

For each test, coupons were assembled into a cylindrical rack which was machined out of a Teflon pipe (45 mm diameter x 130 mm height). A significant portion of the pipe was machined away to produce elongated gaps along the entire circumference of the rack (Figure 4.7b), to serve three purposes:

- 1) effectively reduce the volume of corrosion solution displaced by the rack in the Teflon bottles,
- 2) permit interaction between the HF and the coupons (i.e. not create a circulation barrier), and
- 3) hold the 46 mm Teflon rod (7 mm diameter) in place, from which the coupons were hung during the test (Figure 4.8).

For each PICT, the three coupons were assembled into the cylindrical rack (Figure 4.7b) and placed upright into the Teflon bottle (Figure 4.8). The HF corrosion solution was then poured into the bottle until the cylindrical rack was completely covered. The bottle lid was then screwed on to seal the corrosion reactor, and the bottle placed in the water bath (Figure 4.6). The lid of the water bath was closed, the immersion cooler submersed into the water in the bath, and the Pt100 sensor aligned with the water bath thermometer. The corrosion reaction was then allowed to take place, unhindered, for the allotted time.
