ANALYSIS OF PILLAR / ROCKMASS FAILURE AND PROPAGATION  
DYNAMICS DUE TO MINING IN HARD ROCK PLATINUM MINES

A research report submitted to the Faculty of Engineering and the Built Environment, University of the Witwatersrand, Johannesburg, in fulfillment of the requirements for the degree of Master of Science in Engineering

Johannesburg 2018

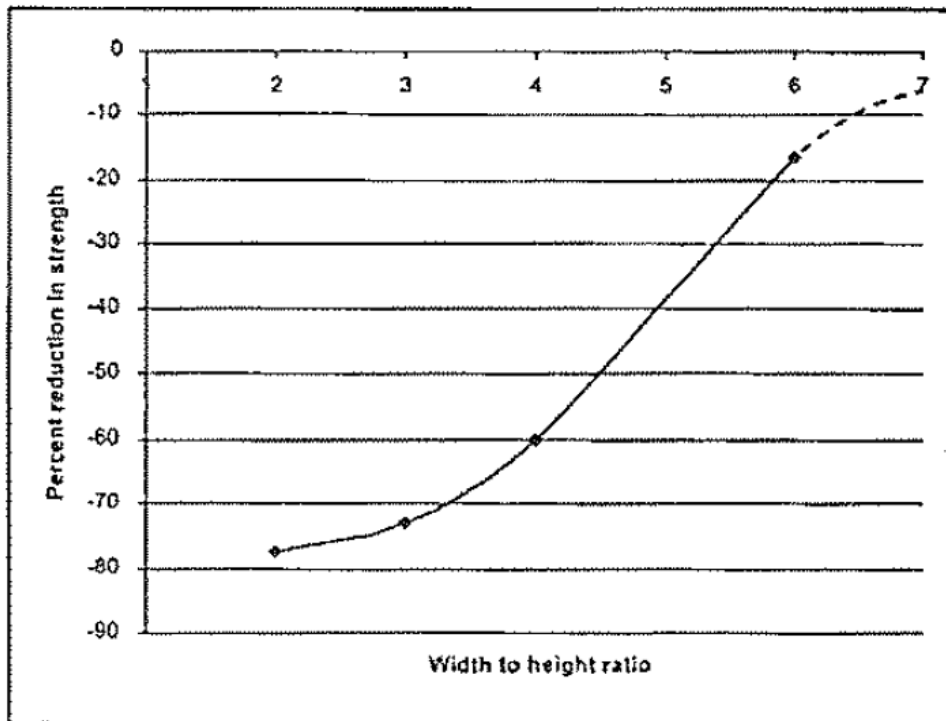
**Figure 2.1** Variation of effect of jointing with pillar width to height ratio (Esterhuizen, 2000)

From the above trend, the expectation is that pillars with a higher width to height ratio are less prone to failure when compared to pillars with a low width to height ratio.

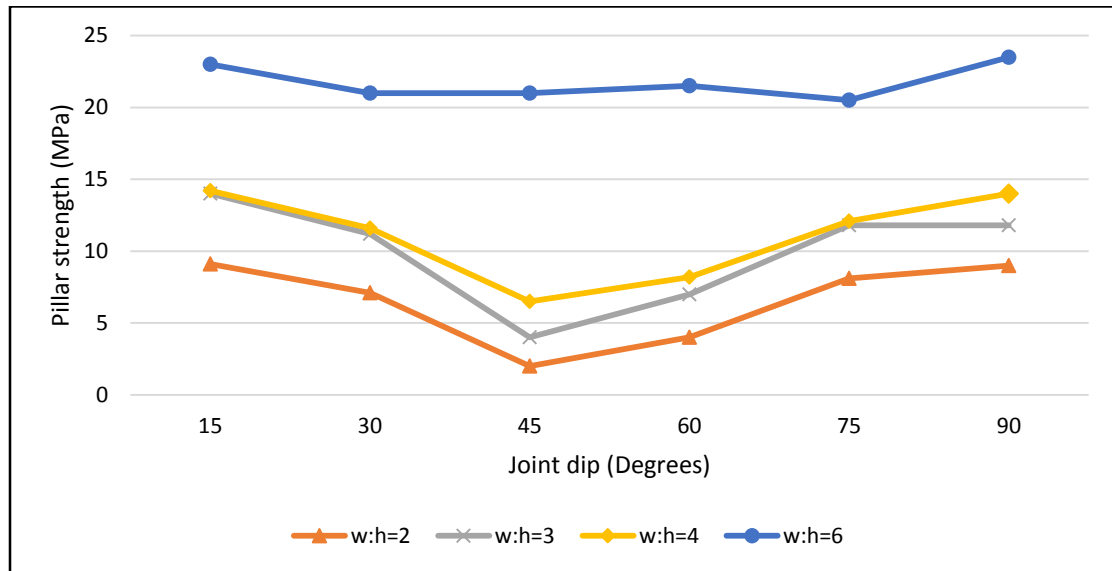
set is highly likely to daylight on opposite sides of the pillar forming a potential surfaces for deformation and eventual failure. The same analysis also showed that “pillars with a large width to height ratio are less affected by the presence of joints than narrow pillars” as shown in Figure 2.2 (Esterhuizen, 2000) (page 287).

**Figure 2.2** Effect of joint dip on pillar strength. (Esterhuizen, 2000)

Esterhuizen (2000)’s analysis has proven the impact of joint dip on pillar strength and this research on failure propagation dynamics will further test the impact of jointing and pillar strength on failure propagation.

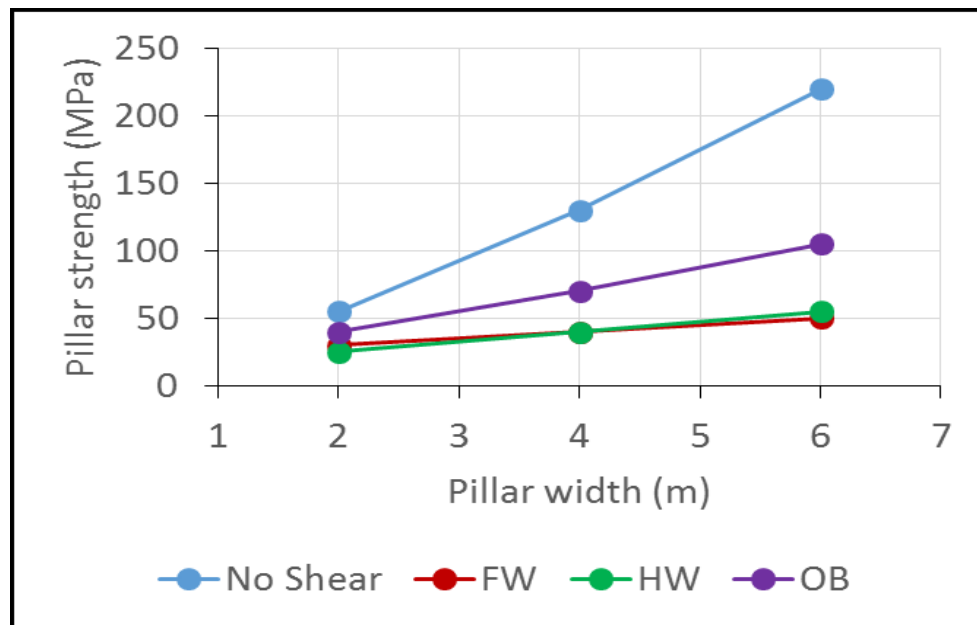
The propagation of failure within a pillar system is ultimately expected to trace the line of weakest strength pillars. The trends in Figure 2.3 show that the greatest impact on pillar strength is when the shear is in the footwall and hangingwall and least when it is on the reef horizon. This research examines and tests the correlation of these findings to the case study.

**Figure 2.3** Impact of shear on strength and pillar width (Muaka, et al., 2017)

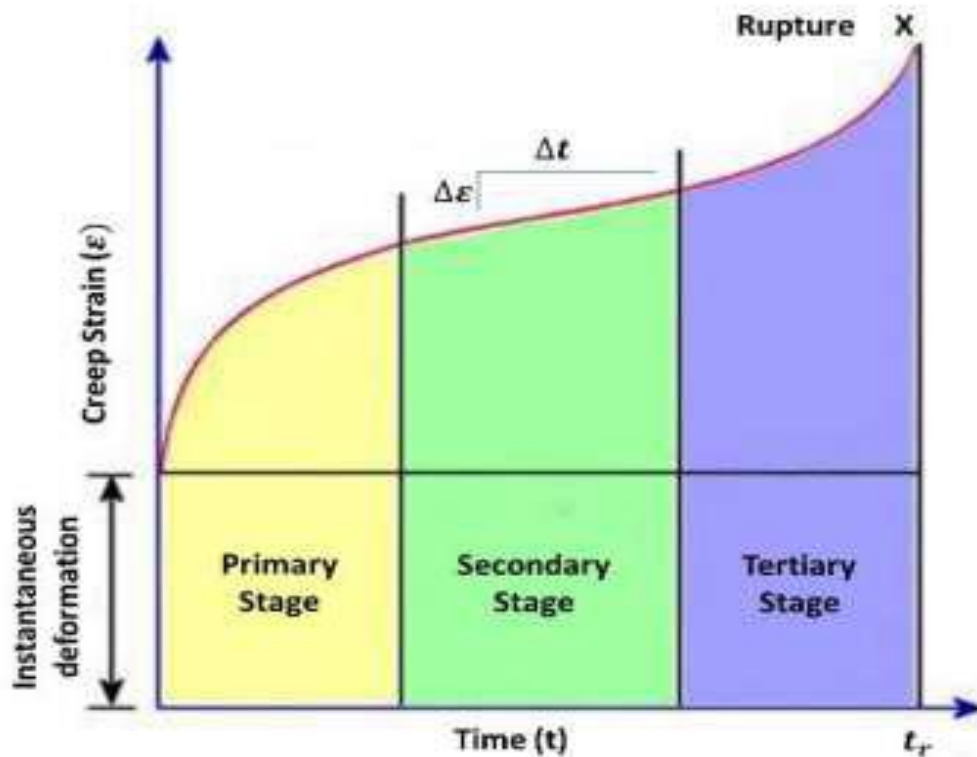
the strain rate will accelerate (tertiary creep) and eventual failure at the end of the tertiary creep stage. The tertiary stage is characterized by hyperbolic acceleration of the strain leading to failure.

**Figure 2.5** Idealised creep curve (Khoshboresh, 2013).

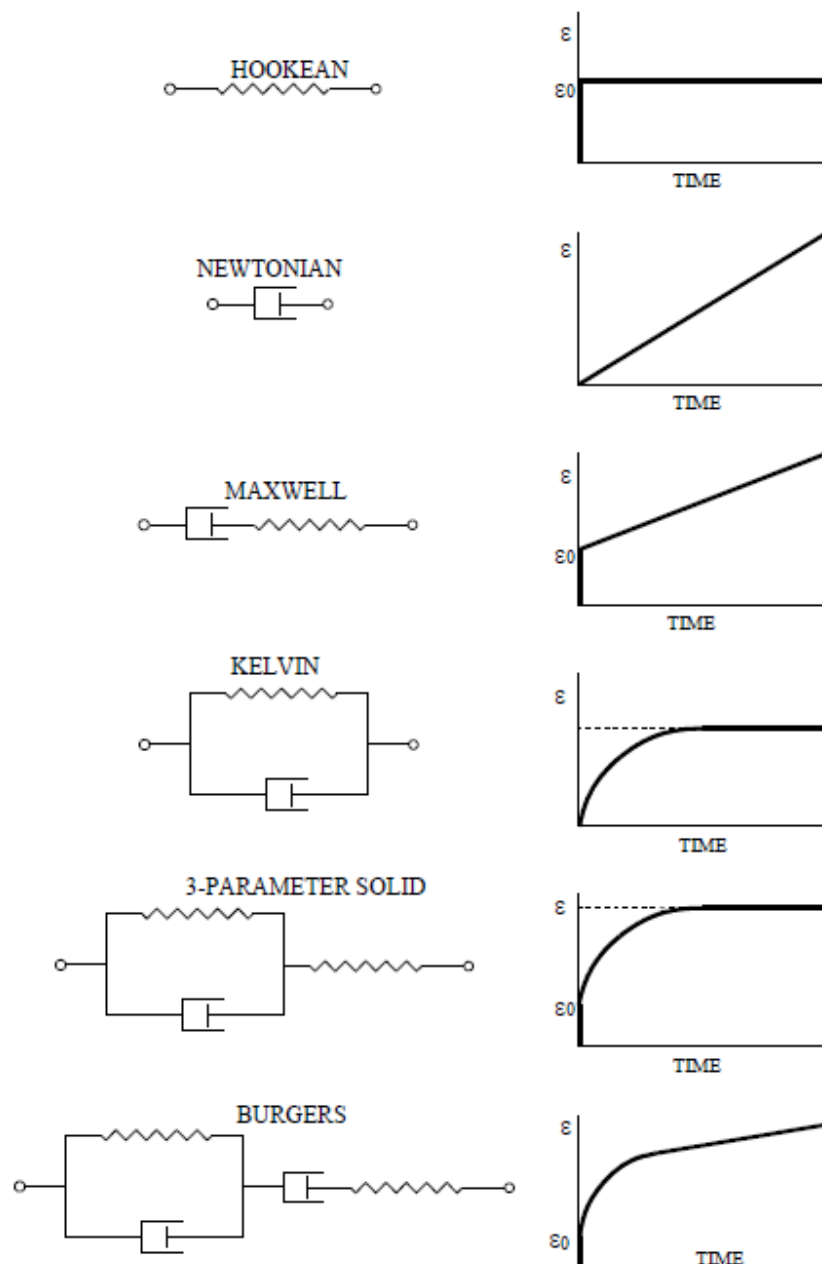
**Figure 2.6** Commonly used viscoelastic models and their respective strain-time behaviour for a stepwise application of constant stress adapted from (Ryder & Jager, 2002)

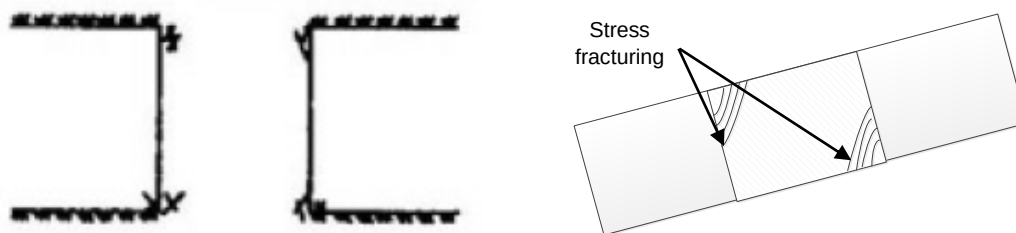
**Figure 2.7** Pillar failure modes (Brady & Brown, 2005)

Localized shear failure; cracking at excavation abutments and starting with the 2 diagonally opposite sides if the pillar is inclined.

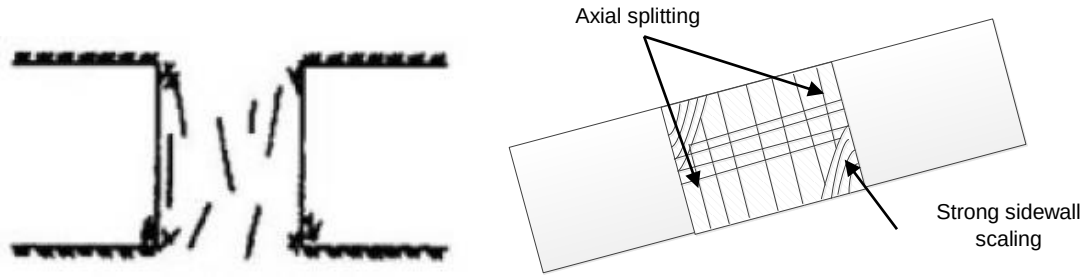
**Figure 2.8** Partially failed surface spalling with isolated internal fractures (Brady & Brown, 2005)

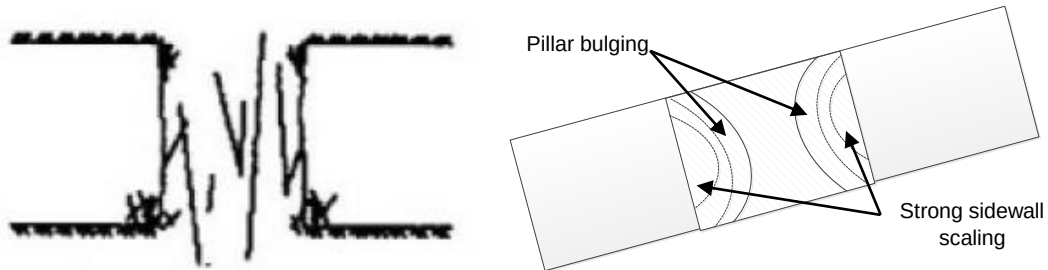
**Figure 2.9** Partially failed contacts with extensive internal fractures (Brady & Brown, 2005)

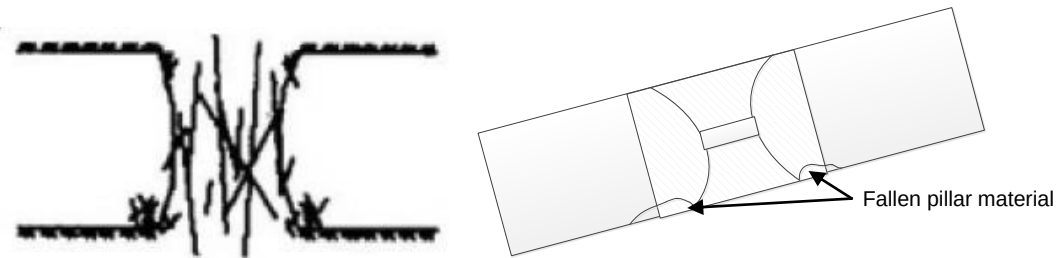
**Figure 2.10** Failed pillar with internal shear fractures (Brady & Brown, 2005)

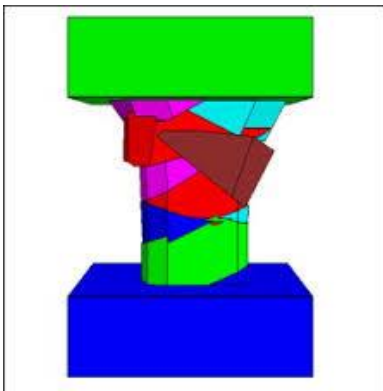
**Figure 2.11** Effects of scaling, buckling and spalling on pillars (Pritchard and Hedley, 1993)

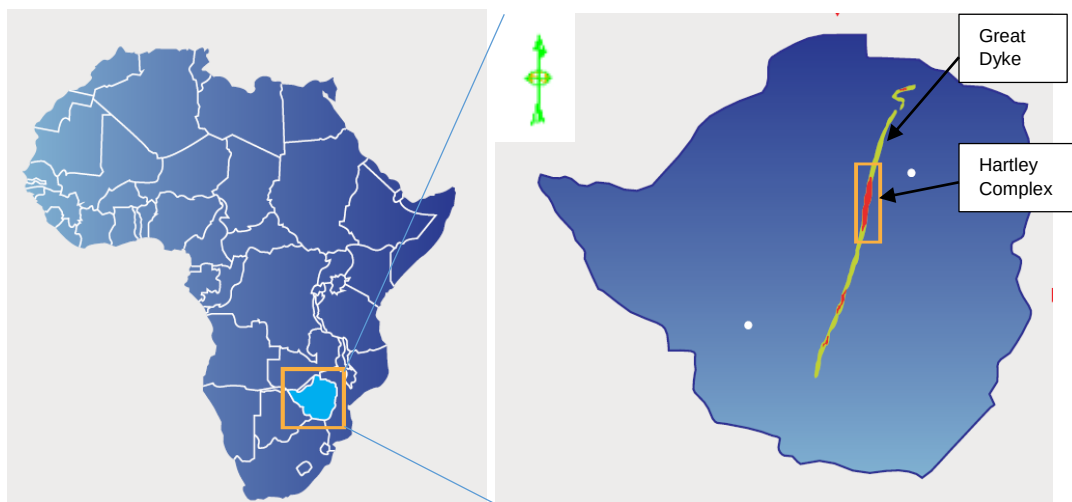
**Figure 3.1** Location of the Great Dyke on the Zimbabwean craton (Zimplats, 2017).

The Great Dyke is a layered mafic-ultramafic complex that transects the Zimbabwean Achaean Craton in a NNE-trending direction as shown in Figure 3.1. The Dyke is highly elongate, slightly sinuous, 550km long, with a maximum width of 12 km. It developed as a series of initially discrete magma chamber compartments, which joined up as the chambers filled (Wilson & Prendergast, 2001). The emplacement of the dyke is estimated at  $2575 \pm 0.7$  Ma (Wilson & Prendergast, 2001).

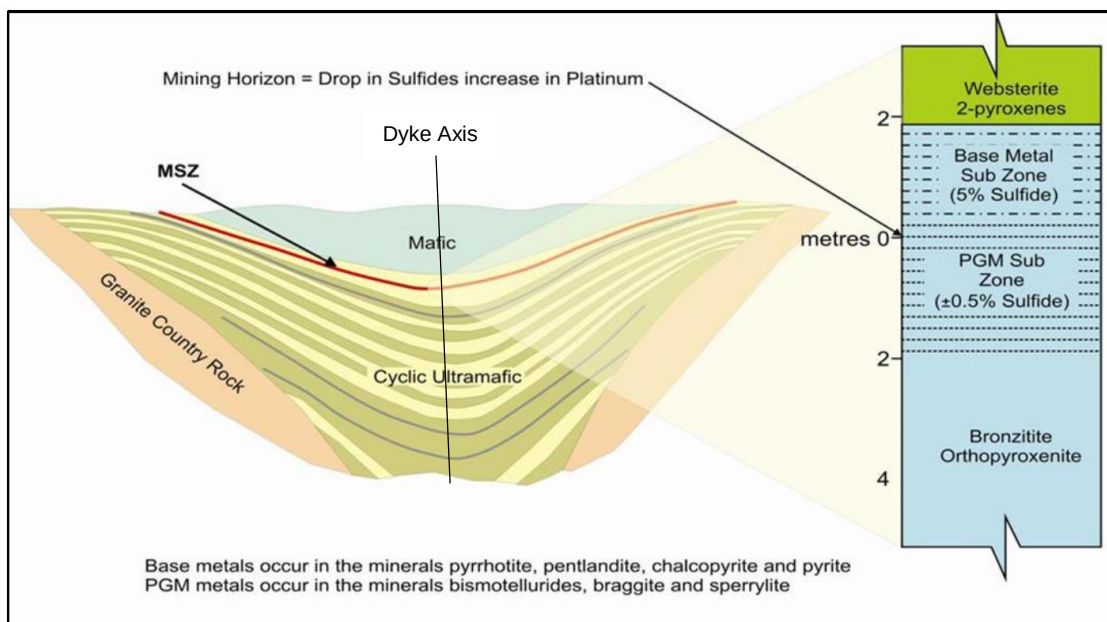
The Main Sulphide Zone (MSZ) covered in this case study is preserved in a continuous zone stretching 90km from Lake Manyame to Ngezi Dam, known as the Hartley Complex. Typically, the MSZ consists of 4-8m wide zone below the websterite and bronzitite contact with enrichment in base metal sulphides and platinum group metals. The plane immediately below the Peak platinum position is used as a reference plane, the Base of Main Sulphide Zone (BMSZ). The Hartley Complex straddles two sub-chambers, namely Darwendale and Sebakwe. Ngezi Mines lie towards the southern tip of the Sebakwe Sub-chamber (Zimplats, 2017). Figure 3.2 shows the generalized geological succession with the layering that forms the Great Dyke.

**Figure 3.2** Generalised geological succession (Walls & Mpunzi, 2017)

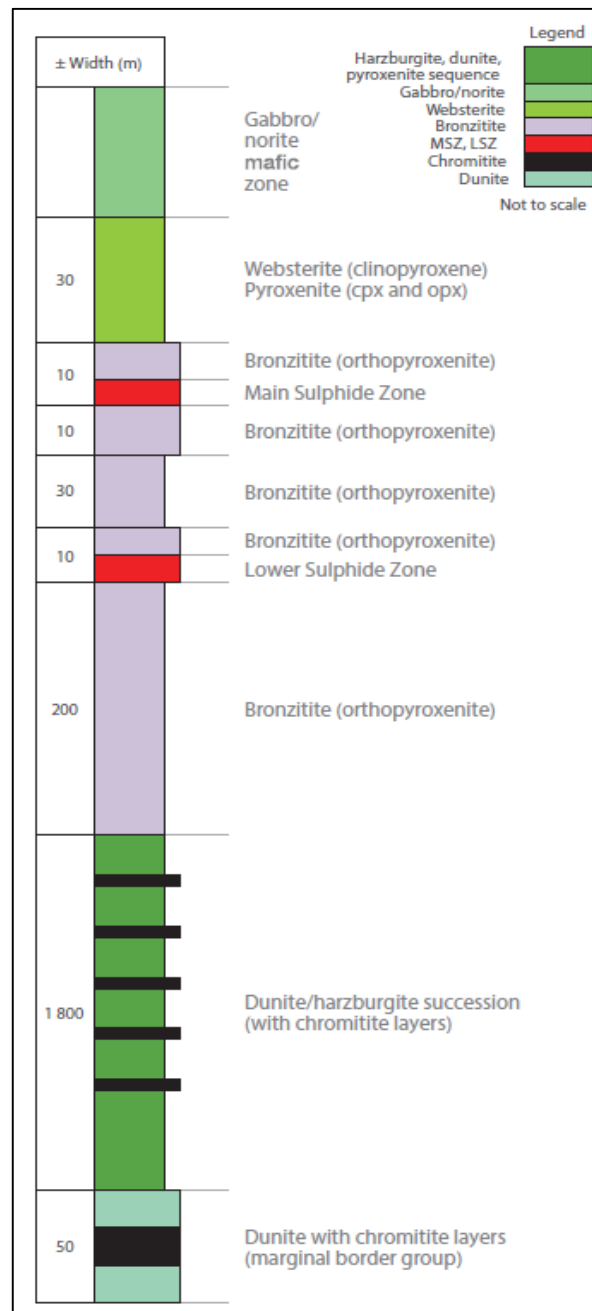
The MSZ which is the mineralised platinum rich horizon is hosted by the bronzitite. The reef dip is generally steep in the flanks flattening towards the dyke axis where it is flat as shown in Figure 3.2. The detailed geological succession showing the different rock types forming the Great Dyke are shown in Figure 3.3.

**Figure 3.3** Detailed geological succession of the Great Dyke (Zimplats, 2017)

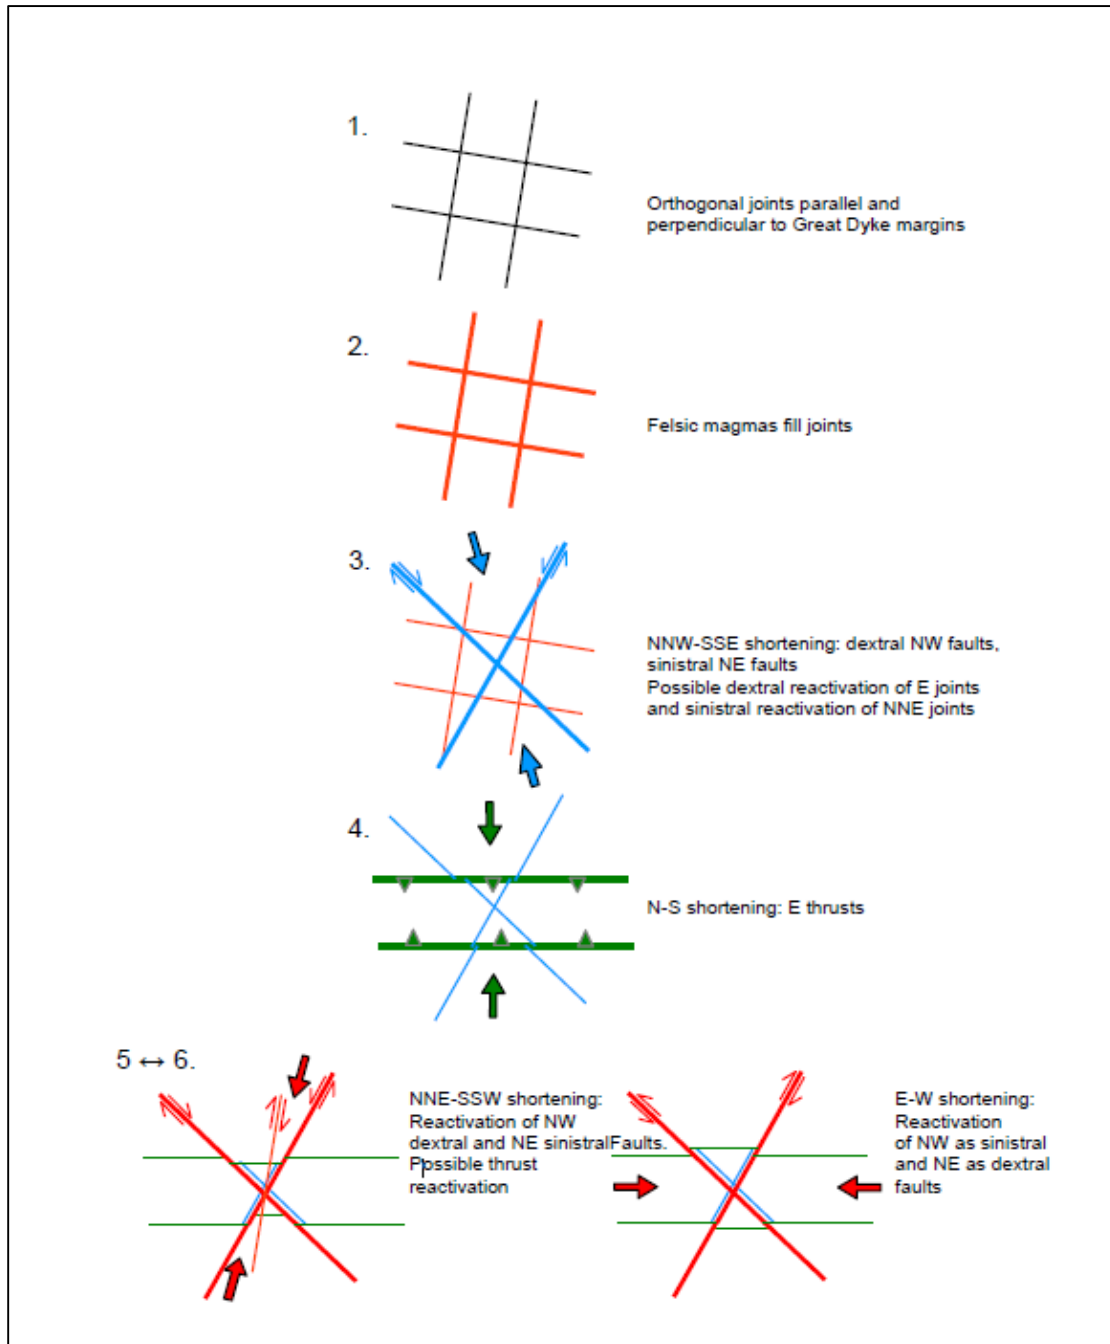
The post intrusion structural footprint of the Great dyke was analysed in relation to the overall history of the Zimbabwean craton as well as local structures. From analysis done by Blenkinsop (2014) six phases could be observed and interpreted from the structures present in the Ngezi area. These phases are shown in Figure 3.4. The first conjugate set is perpendicular and parallel to the Great Dyke margins and formed as cooling joints and dyke sagging during the placement of the dyke. These were then intruded by granitic magmas (stage 2) and has been confirmed by the orthogonal granitic dykes observed underground typically shown in Figure 3.5. Stage 3 was the formation of the NW and NE strike slip faults with dextral sinistral movement respectively. Most of the major fault systems in Ngezi area are NW trending though less frequent. The next phase was driven by the NS thrust with shortening of NW and NE faults in response to the Limpopo orogenic events. The EW shortening is associated with the Magondi orogeny and further reactivation in the opposite sense is associated with the Zambezi orogeny (Blenkinsop, 2014).

**Figure 3.4** Post Great Dyke tectonic history in Ngezi area. (Blenkinsop, 2014)

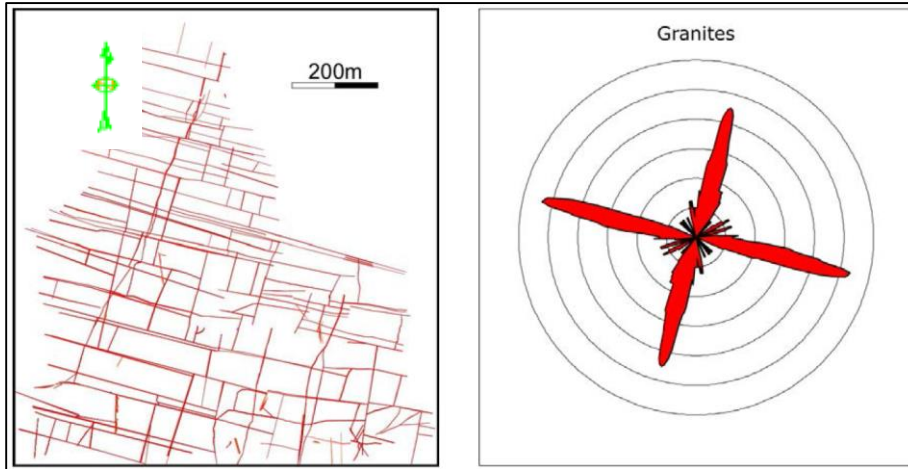
**Figure 3.5** Typical orthogonal network of granite dykes as mapped in Bimha north. With the equal area rose diagram of the strikes. (Blenkinsop, 2014)

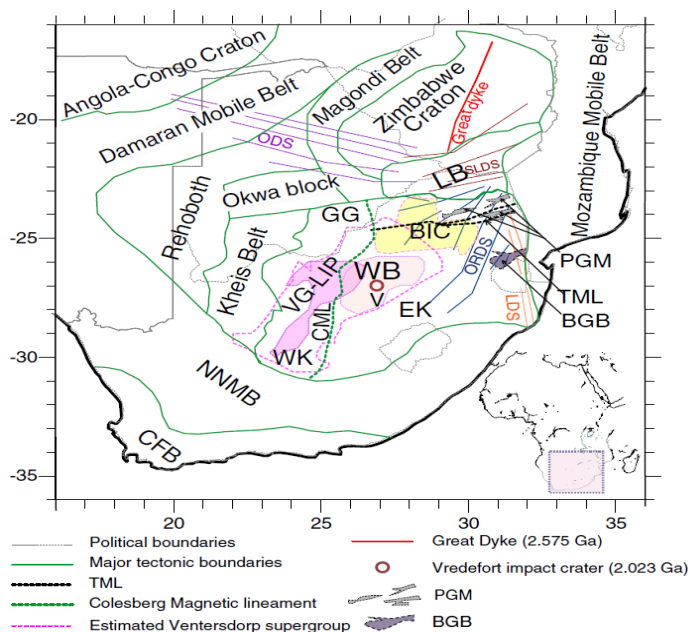
**Figure 3.6** General stratigraphy of Southern Africa (Youssof et al, 2013)

Figure 3.6 shows the different mobile belts on the generalised stratigraphy of Southern Africa as this is important in understanding the regional scale tectonic history and how it relates to the geological structure of the Great Dyke and in particular the case study area.

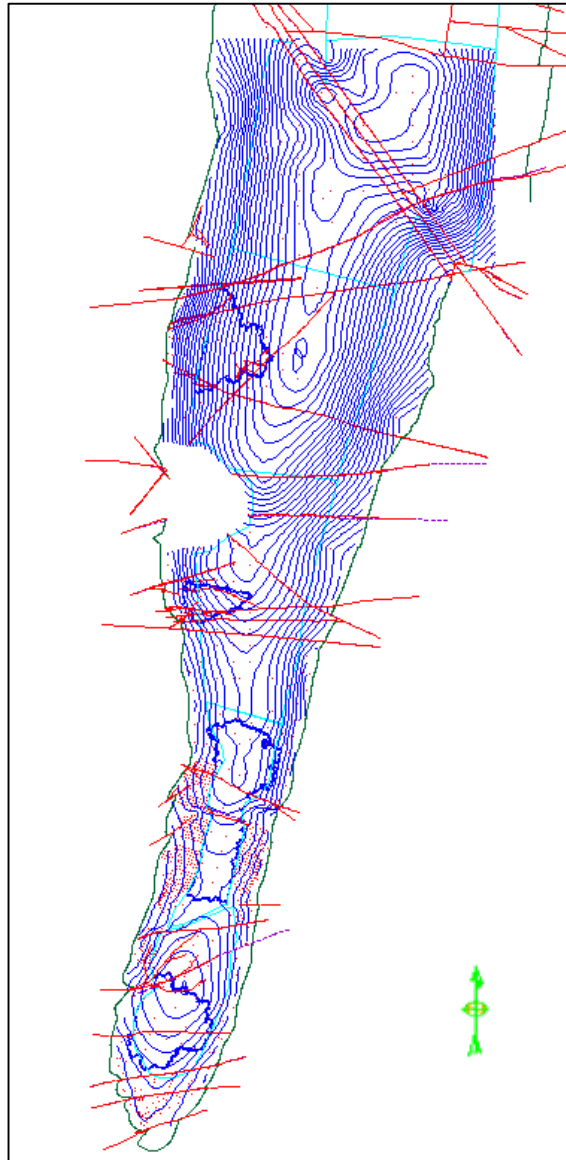
Figure 3.7 shows the structural model of the Ngezi area. The NE-SW and NW-SE conjugate set is the most common of the major fault systems in Ngezi (Zimplats Internal Report, (Kock S.), 2015). The orientation of these faults corroborate well with formation shown in the stage 3 explained by Blenkinsop (2015) in Figure 3.4.

**Figure 3.7** Ngezi structural model (Zimplats Internal Report (Kock S.), 2015)

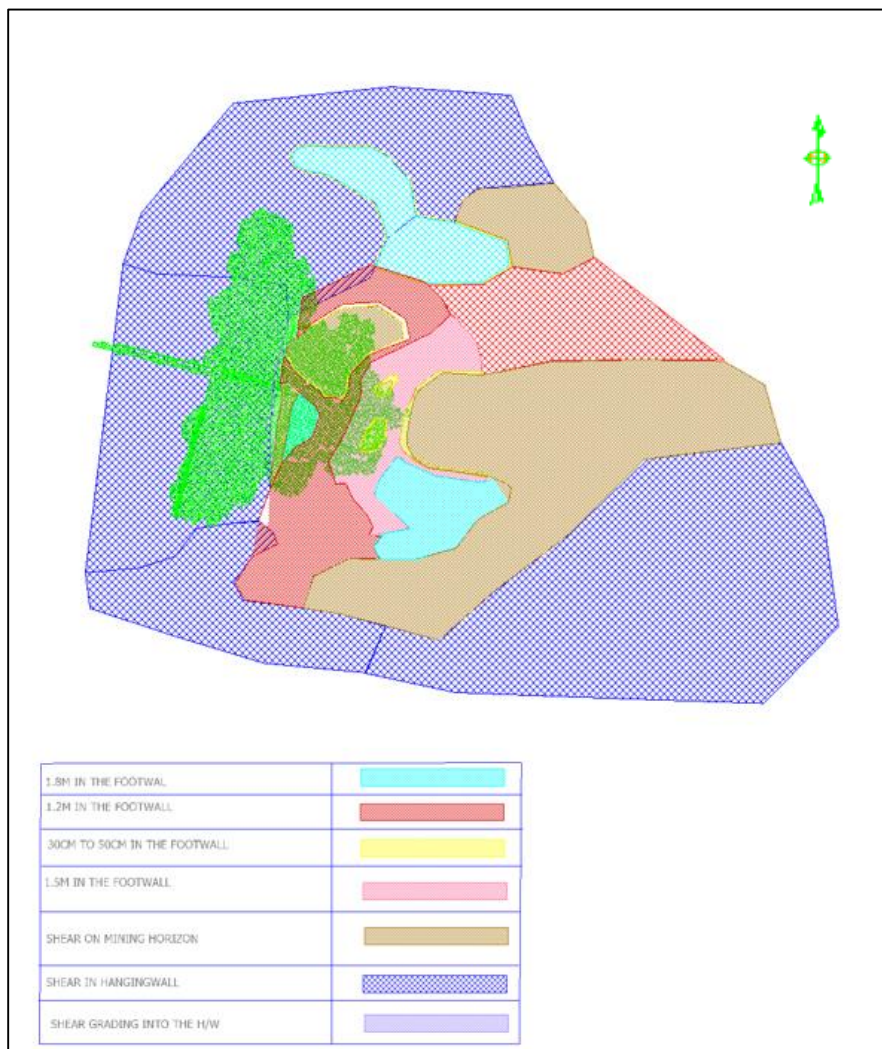
Figures 3.8 and 3.9 shows the nature, position and thickness (respectively) of the shear with respect to mining horizon. The variability as well as the randomness both in terms of position and thickness as shown in the Figures 3.8 and 3.9 make the projection of its behaviour very difficult and complex. In adjacent blocks, the shear can be mapped in the hangingwall in one block and in the footwall in the next block with no visible transition from hangingwall to the footwall making the interpretation complex.

**Figure 3.8** Position of the Mutambara shear with respect to the mining horizon (Zimplats Internal report, 2014)

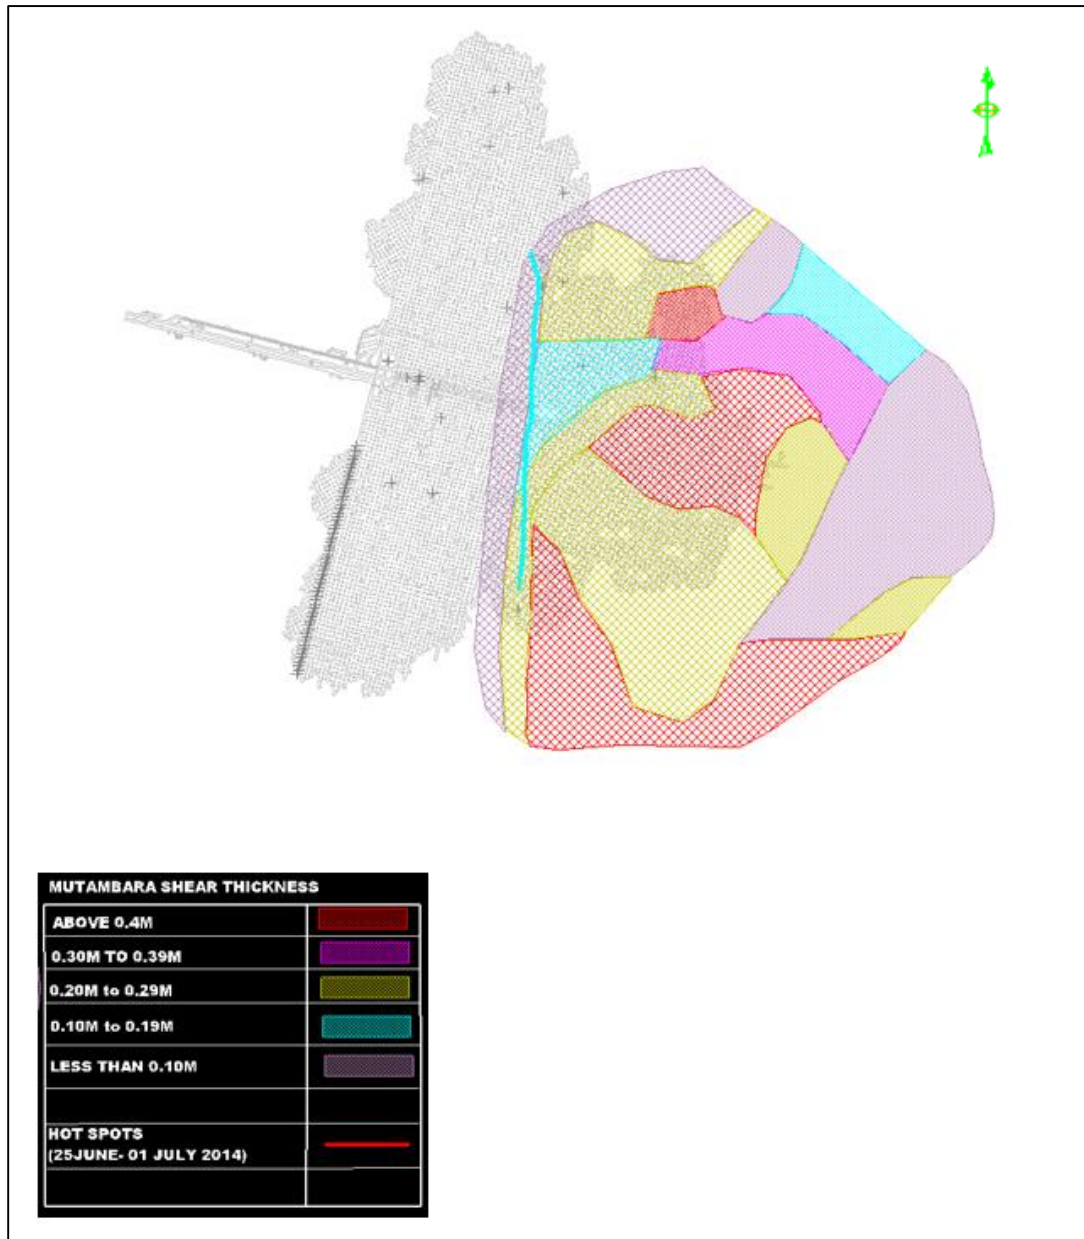
**Figure 3.9** Thickness of the Mutambara shear (Zimplats Internal report, 2014)

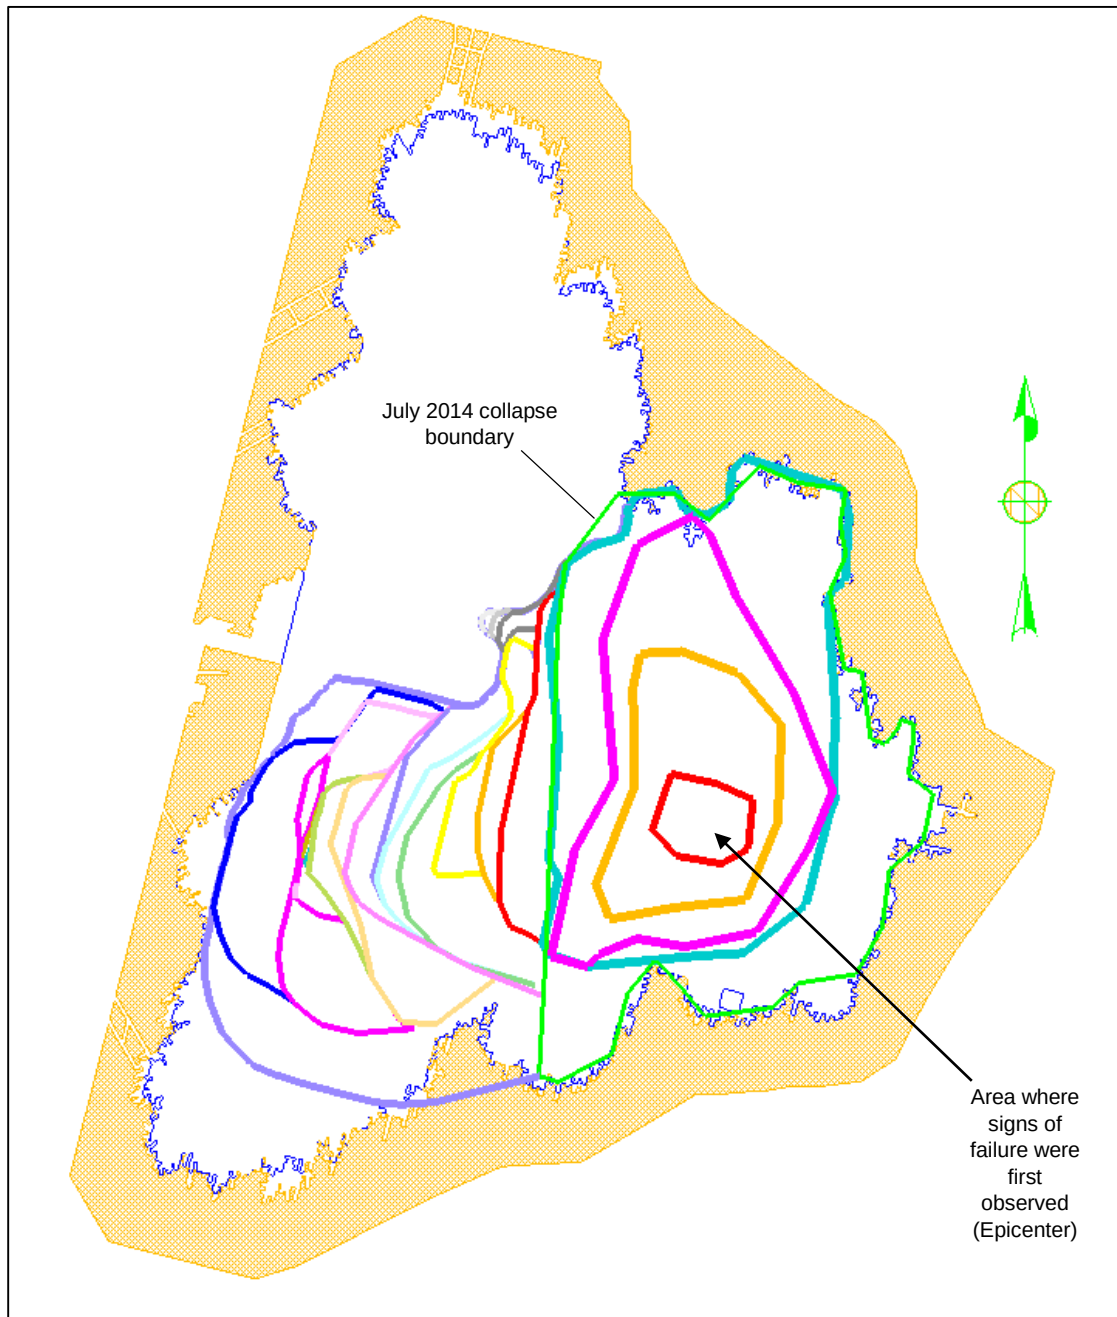
**Figure 3.10** Bimha Mine plan showing failure and progression

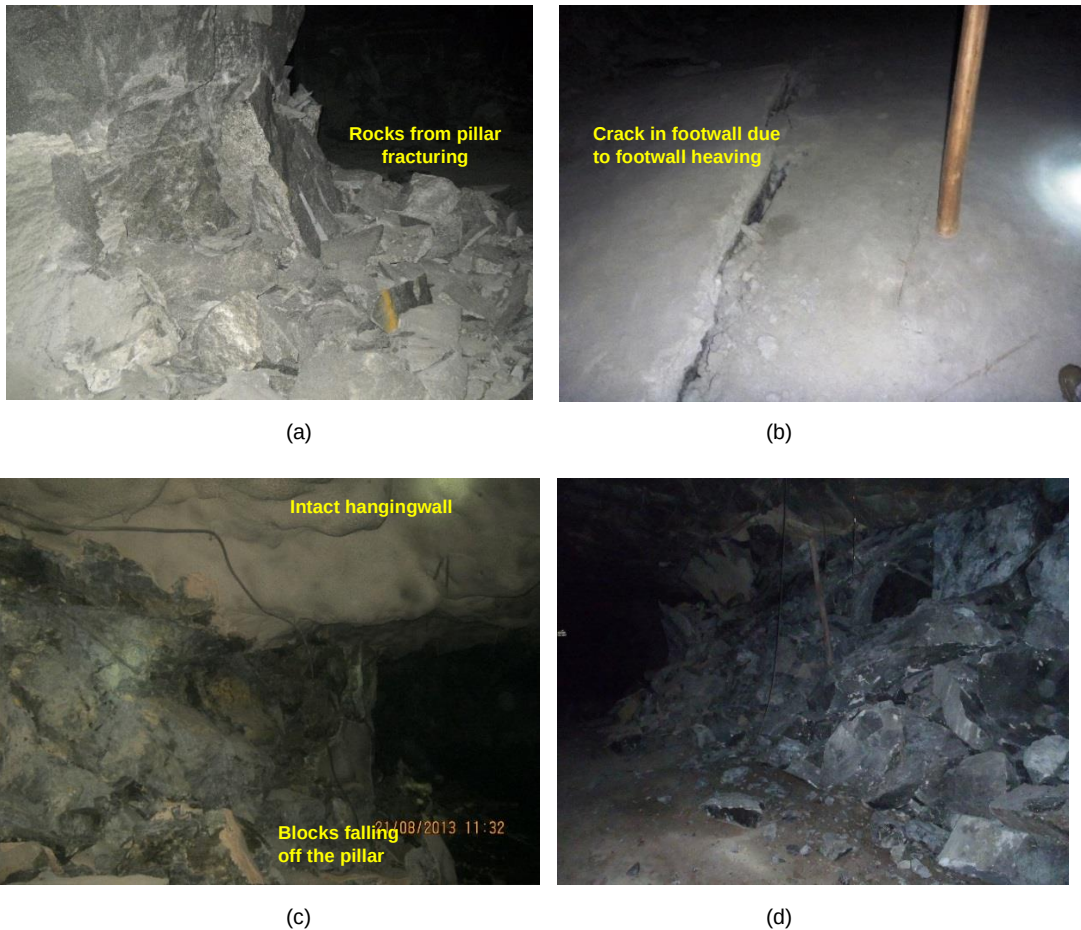
Stage 3 – Collapse – This is defined in areas where blocks have fallen from the hangingwall and pillars Figure 3.11d.

**Figure 3.11** Stages of rock mass failure (a) Stress fracturing, (b) Footwall heaving, (c) Intermediate stage, (d) Hangingwall collapse stage

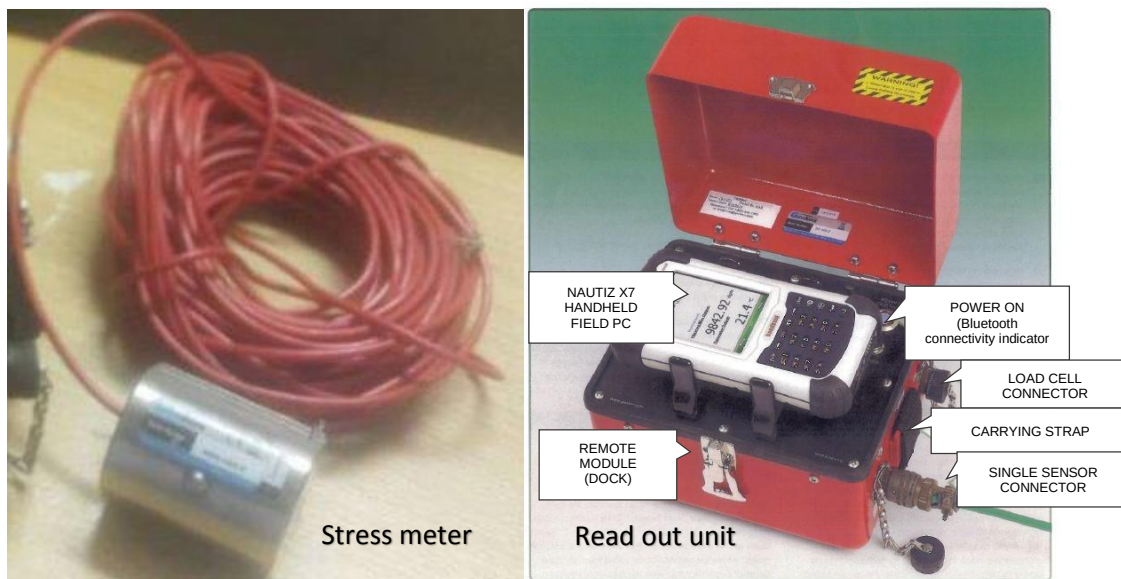
Stress meters were installed in August 2016 to monitor the stress change in the boundary pillar separating the old and the new footprint. A program has been put in place to install more stress meters in the boundary pillar in order to record the stress change around the old footprint as well as the stress gradient within the pillar. Figure 3.12 shows a picture of the typical stress meter and the readout device. While the measurements were not intended for quantifying the virgin in-situ stress levels, the stress meters provide a measure of the change in stress levels in the rockmass as the time progresses.

**Figure 3.12** Stress meter and read out unit

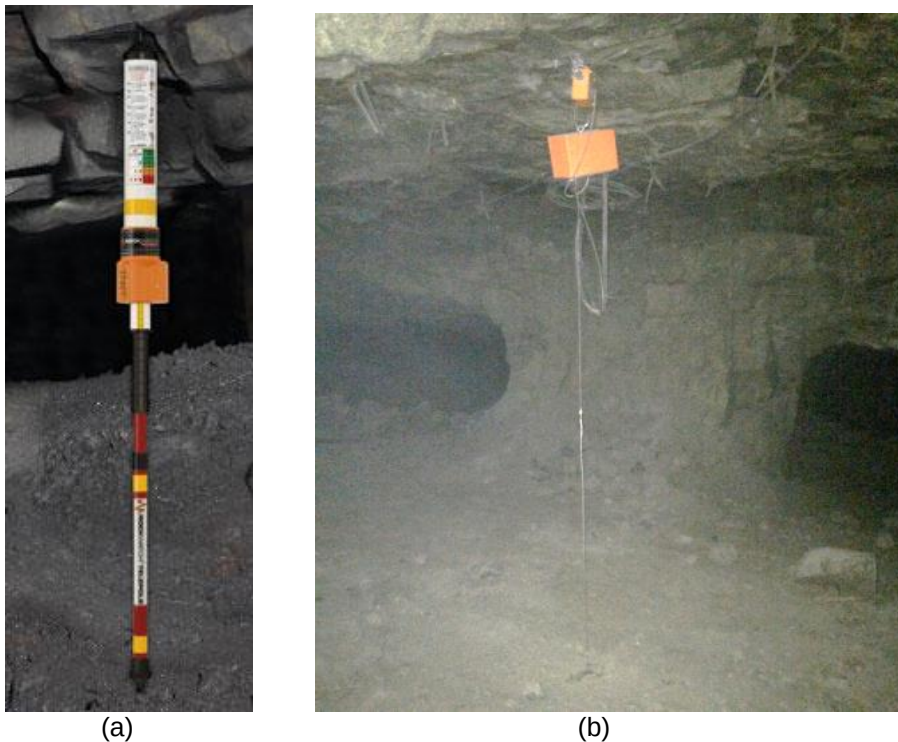
Closure can be defined as the amount by which the cross-sectional dimension of an excavation is reduced by the combined effect of convergence and additional in-elastic movements, such as bed separation (Implats Rock Engineering, 2003). The closure levels in Bimha Mine were initially measured by the use of standalone closure loggers, supplemented by the recent commissioning of a system of ultra-sensitive closure sensors with online reporting. Figure 3.13 shows the position of an installed closure logger and closure sensor. The positioning of the meters was based on a regular grid with increased density around the active stress boundary. The technicians were trained by the equipment manufacturer on installation, reading, maintenance and calibration of the closure meters in order to achieve accurate and consistent readings.

**Figure 3.13** Installed closure measuring devices (a) Closure logger, (b) Online closure sensor

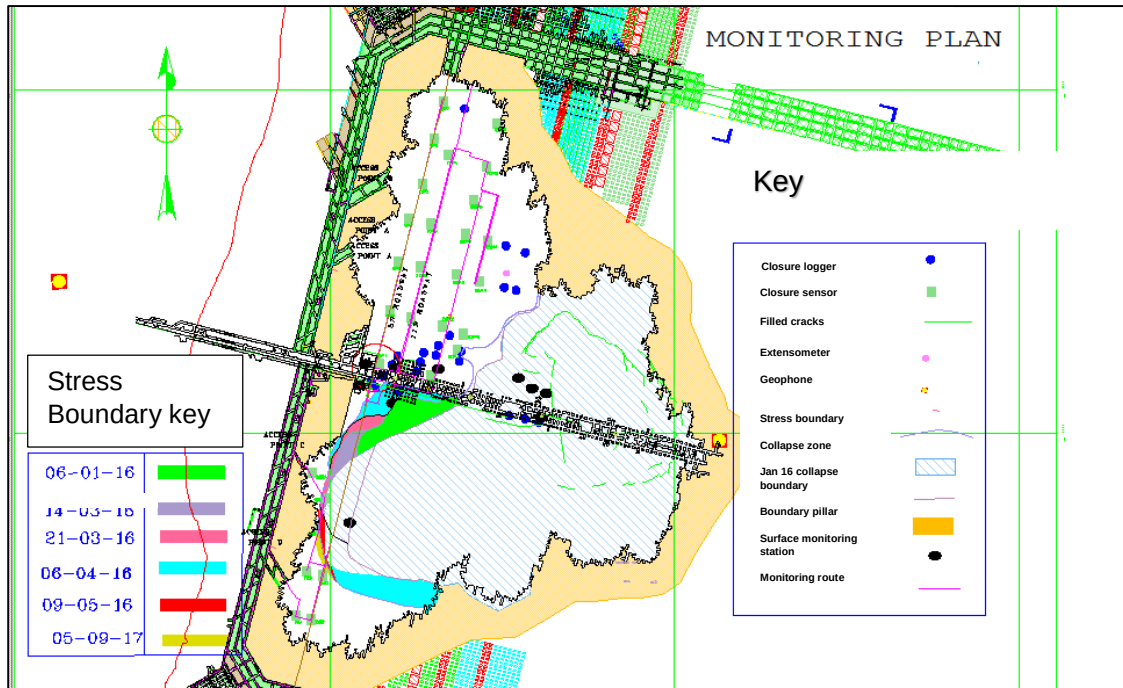
A number of variables were monitored on surface for correlation with underground rock mass behaviour. These included rainfall levels, development and extension of surface cracks and measurement of subsidence using survey beacons. The plan in Figure 3.14 shows the location of the different monitoring stations currently being used in this program.

**Figure 3.14** Bimha monitoring stations

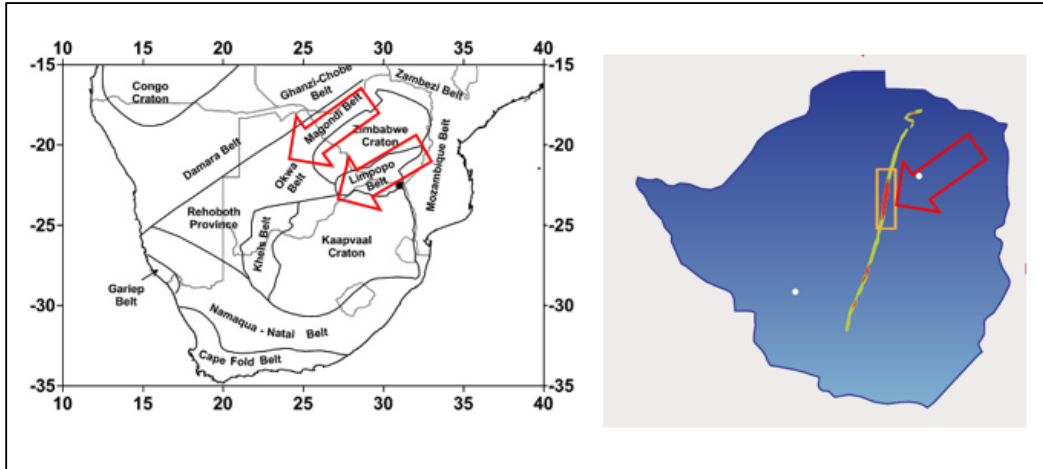
This section analyses the stress and collapse fronts (failure front) in relation to the tectonic history of the great dyke and the Zimbabwean craton. The analysis is meant to establish any correlations that can explain the preferred direction of migration as observed underground. The general trend of the migration after the July 2014 collapse was from northeast to southwest. The initial direction of migration in July 2014 from the epicenter of collapse was towards the northwest. Reading this in the context of the geotechnical conditions explained in chapter 3, in particular the formation of the major faults on the great dyke, is important. Blenkinsop (2014), explained the formation of NE and NW strike slip fault systems with the NW faults being more prevalent. Shortening of these faults was due to the orogenic activity in the Limpopo mobile belt. The formation of the NE and NW faults points to a creation of a lines of weakness in the NE and NW directions. Figure 4.1 shows the correlation of the dyke with respect to the orogenic events. The same direction is observed in the direction of migration of the stress front and could potentially be correlated.

**Figure 4.1** Direction of failure migration in relation to the regional tectonic events

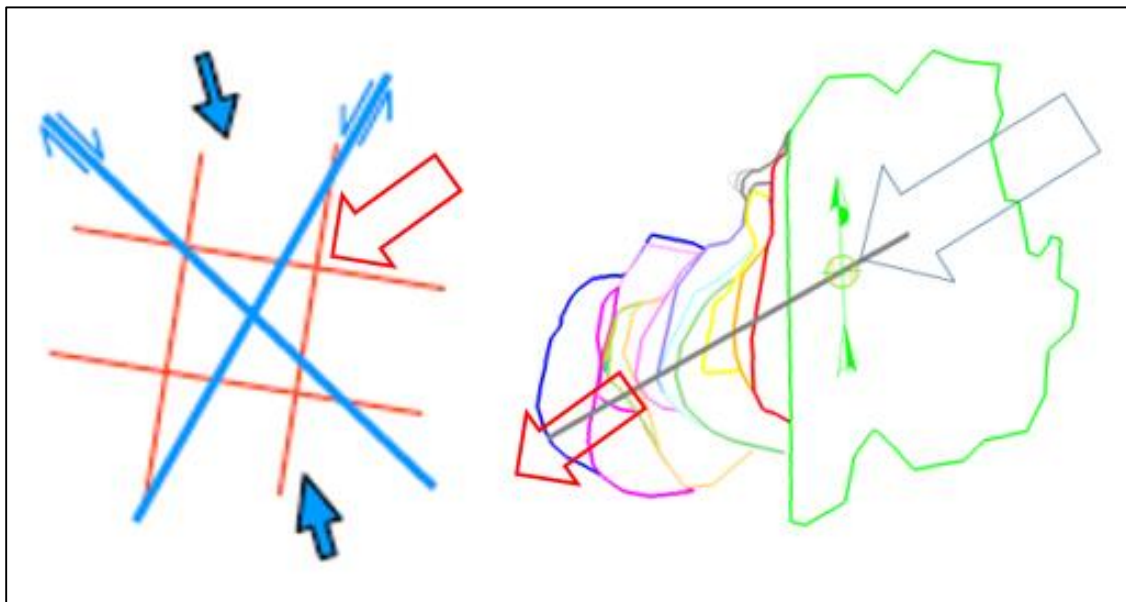
Blenkinsop (2014) also explained the formation of the conjugate set of joints that formed at the placement of the Great Dyke with the set being perpendicular and parallel to the Great Dyke strike as shown in Figure 4.2. This set was intruded by granitic material which exhibit underground as conjugate aplite dykes.

**Figure 4.2** Direction of failure migration in relation to the Great Dyke structures at Bimha Mine

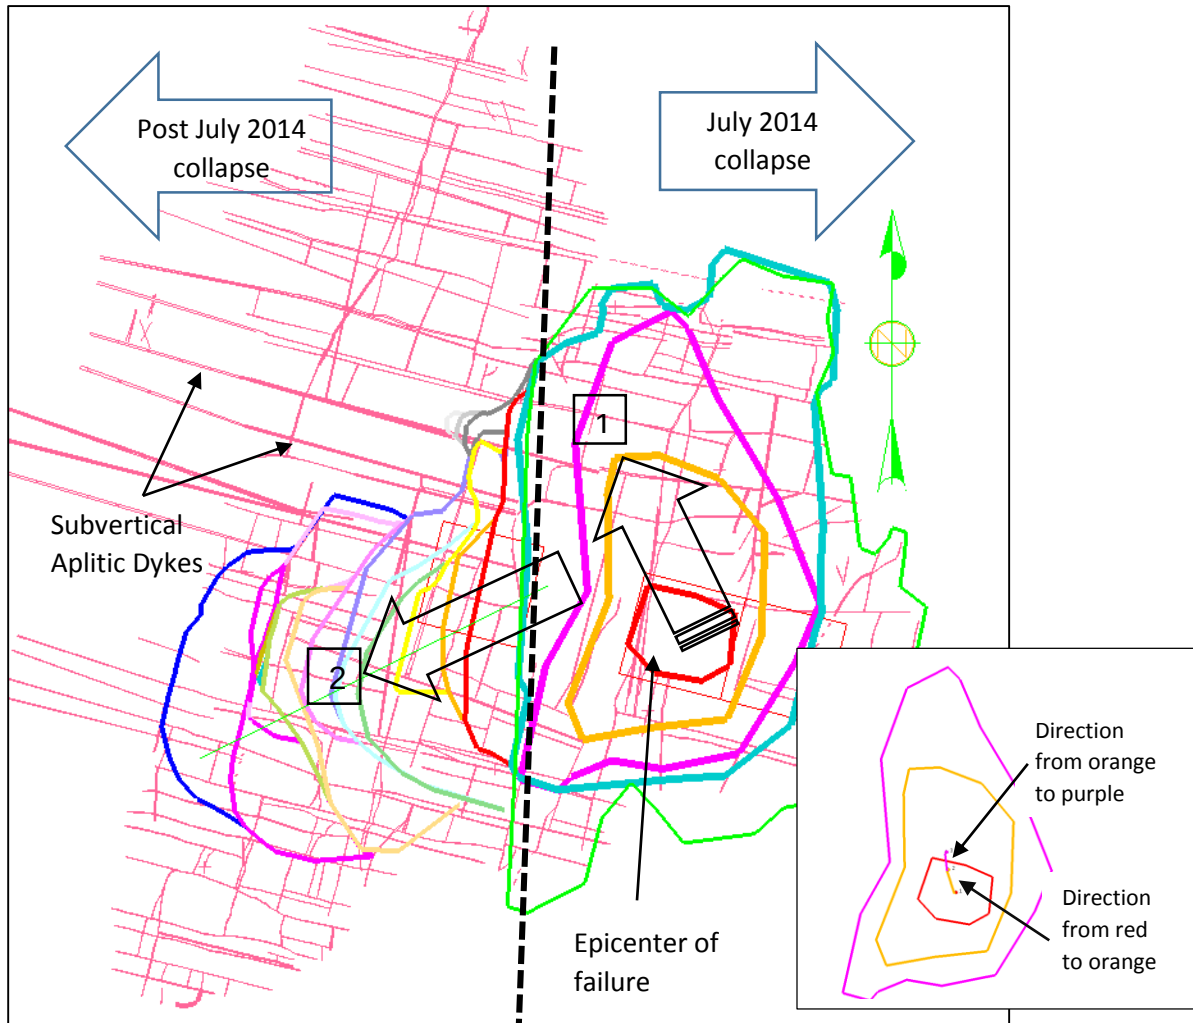
The direction of migration is closely related to the structures that formed at the time of placement of the dyke i.e.  $45^\circ$  to the structures. In comparison to the south, the north part of the mine has a lower density of the N-S aplitic dykes to form complete conjugates as shown in the dyke frequency Table 4.1. The frequency was calculated by taking a scan-line in the particular direction and counting the number of dykes that cross the scan-line. Frequency is the calculated by dividing total scan-line length by the number of dykes intersected.

**Figure 4.3** Direction of migration in relation to aplitic dyke structures showing pre and post July 2014 propagation and (insert) determination of direction of migration.
