ANALYSIS OF PILLAR / ROCKMASS FAILURE AND PROPAGATION  
DYNAMICS DUE TO MINING IN HARD ROCK PLATINUM MINES

A research report submitted to the Faculty of Engineering and the Built Environment, University of the Witwatersrand, Johannesburg, in fulfillment of the requirements for the degree of Master of Science in Engineering

Johannesburg 2018

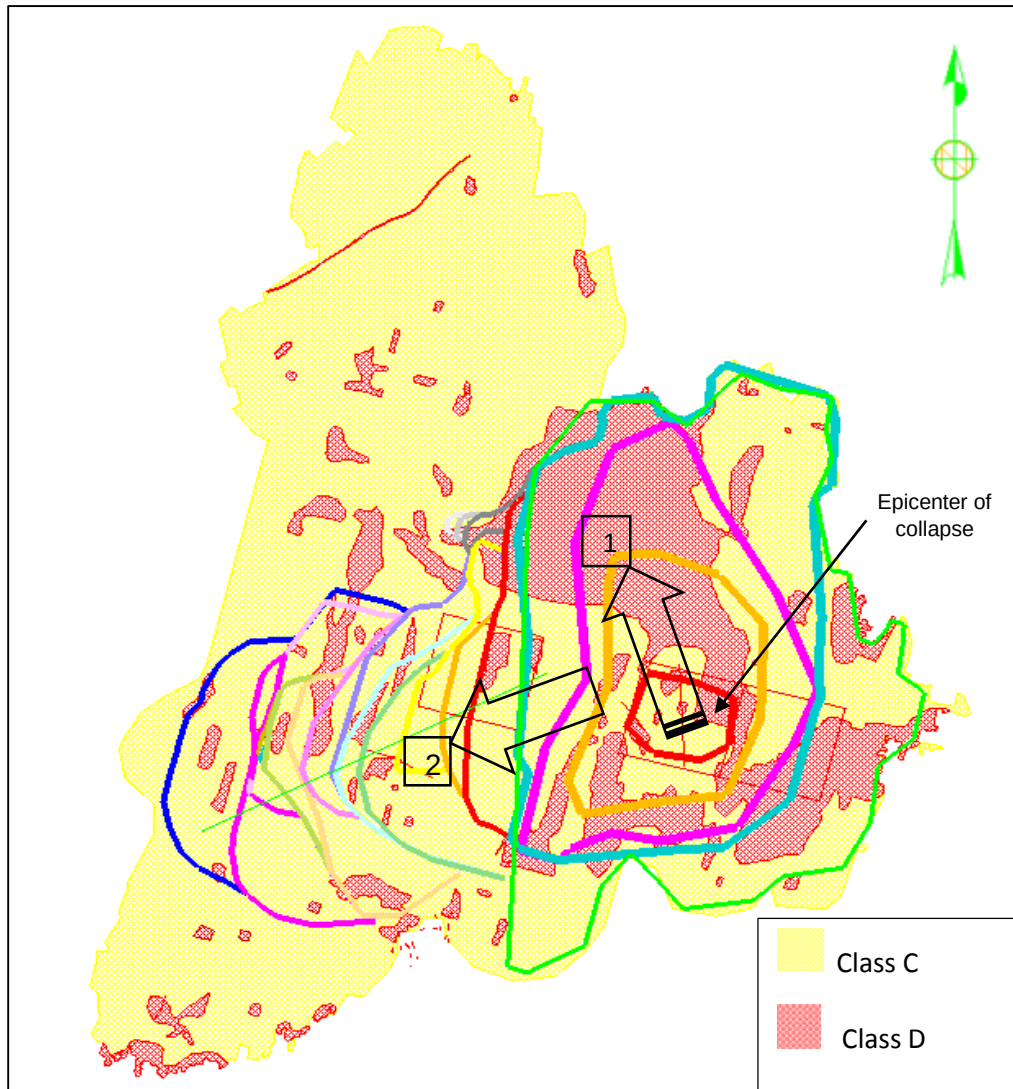
The influence of very poor ground conditions is therefore significant in the determination of the direction of migration of the failure front.

**Figure 4.4** Failure migration in relation to very poor ground conditions

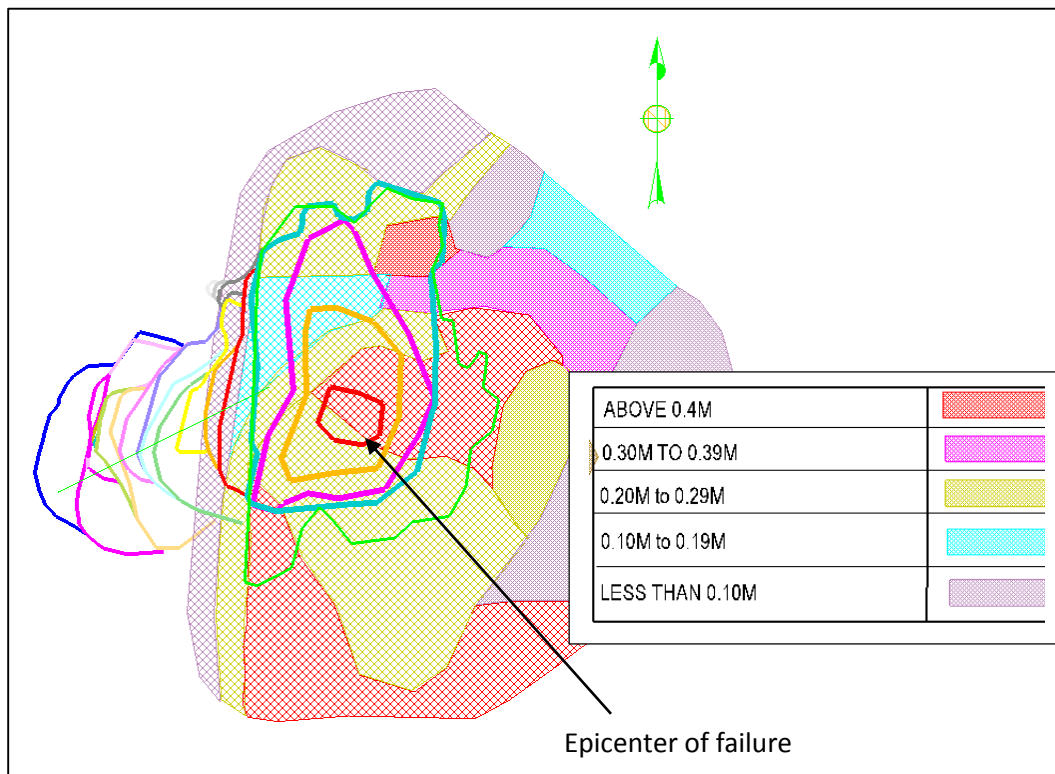
The relationship between the existence of the shear and the epicenter of failure as well as the propagation of the failure is shown in Figure 4.5. Figure 4.5 and 4.6 show the relation between the migration of failure to the thickness and position of the shear with respect to the mining horizon.

**Figure 4.5** Failure migration in relation to Mutambara Shear thickness

coincides with the plane where the shear is less than 0.10m thick as shown in Figure 4.5. The brief halt in propagation with the thin shear can be inferred to signify the influence that the thickness of the shear has on failure propagation.

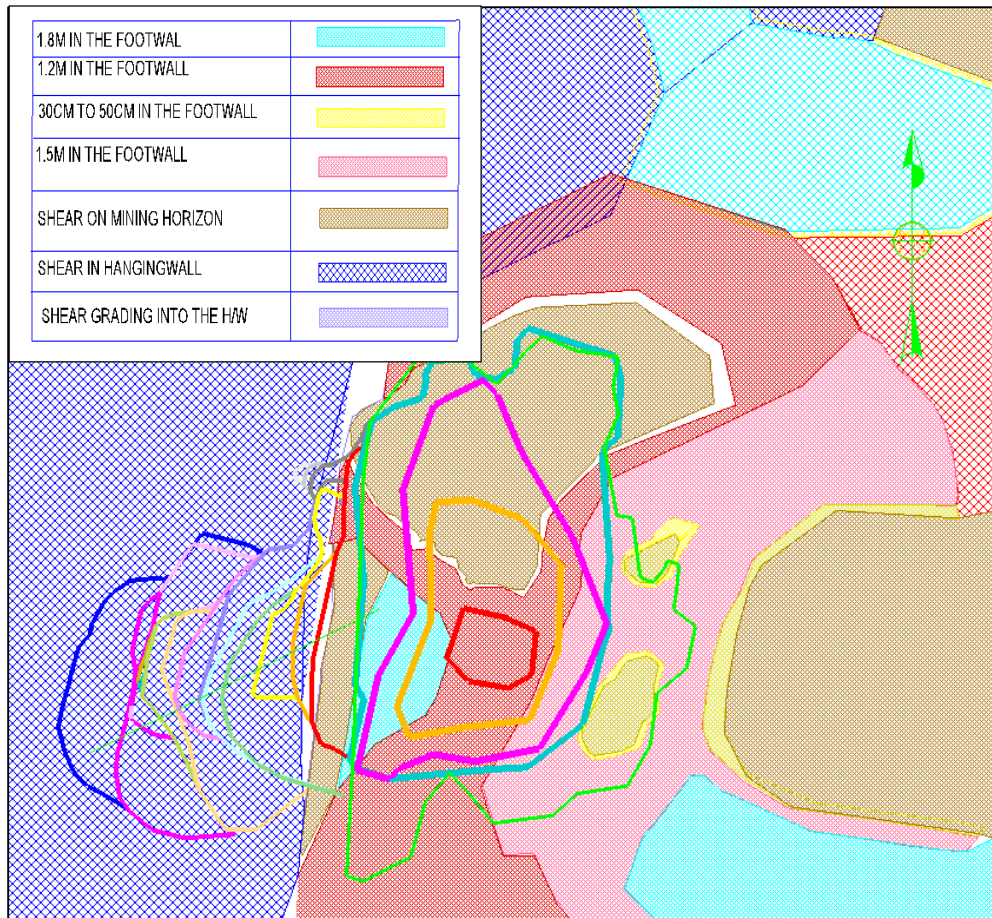
**Figure 4.6** Failure migration in relation to the position of the shear

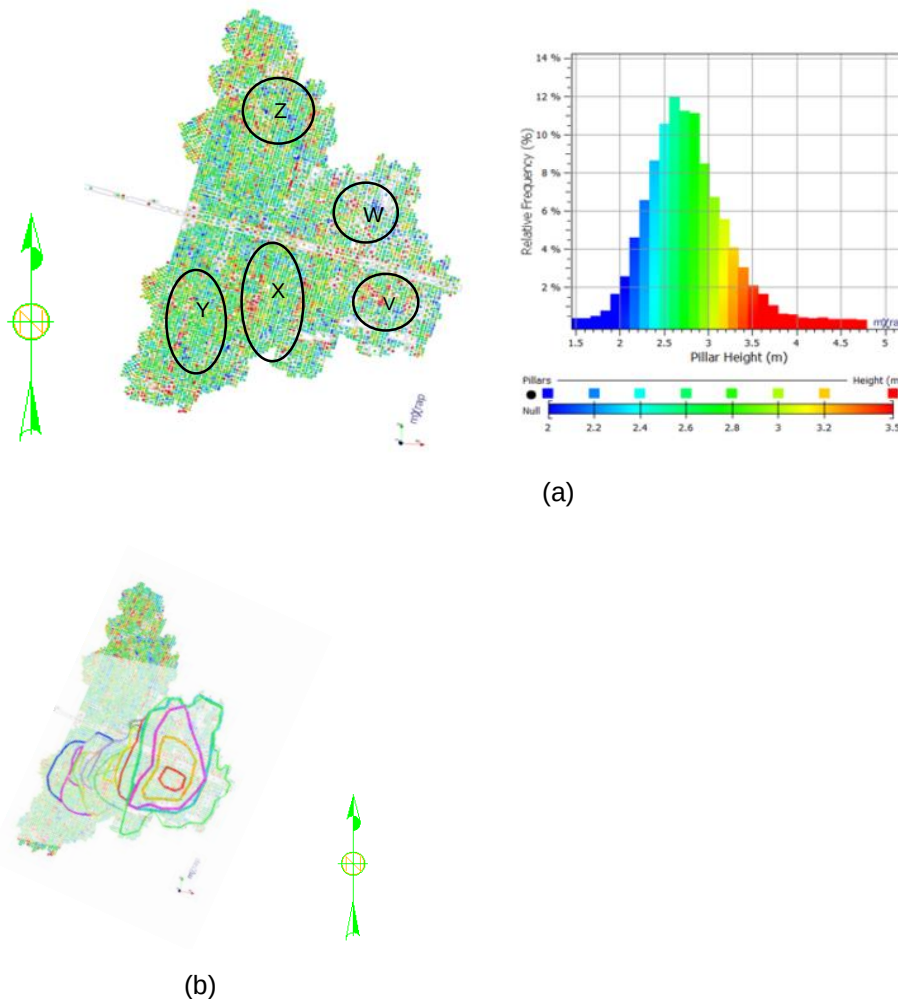
Design pillar size is governed by ground conditions, pillar height and pillar width. Figures 4.7 and 4.8 show the plot of the pillar height and width to height ratio together with the relative frequency distribution.

**Figure 4.7** Distribution of the pillar sizes a) Distribution of pillar height, b) Pillar height compared to failure direction (Zimplats Internal report (SRK ), 2016a), (Walls & Mpunzi, 2017)

The pictures in Figure 4.7 show a generally even distribution of all the pillar heights. Of note are some of the clusters with above normal heights circled out with “V” representing the epicenter of the collapse and the general trend of the failure migration towards areas “W” and “Y”.

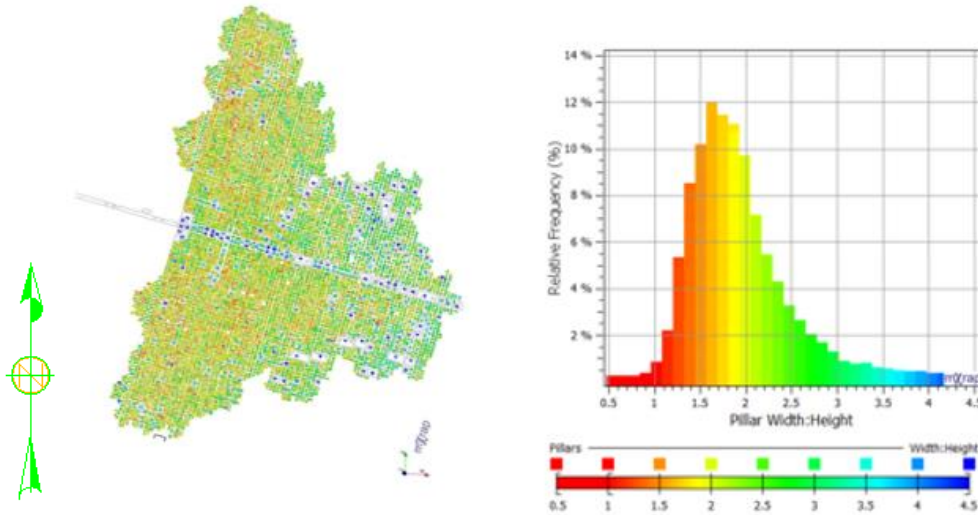
**Figure 4.8** Distribution of the w/h ratio (Zimplats Internal report (SRK), 2016a), (Walls & Mpunzi, 2017)

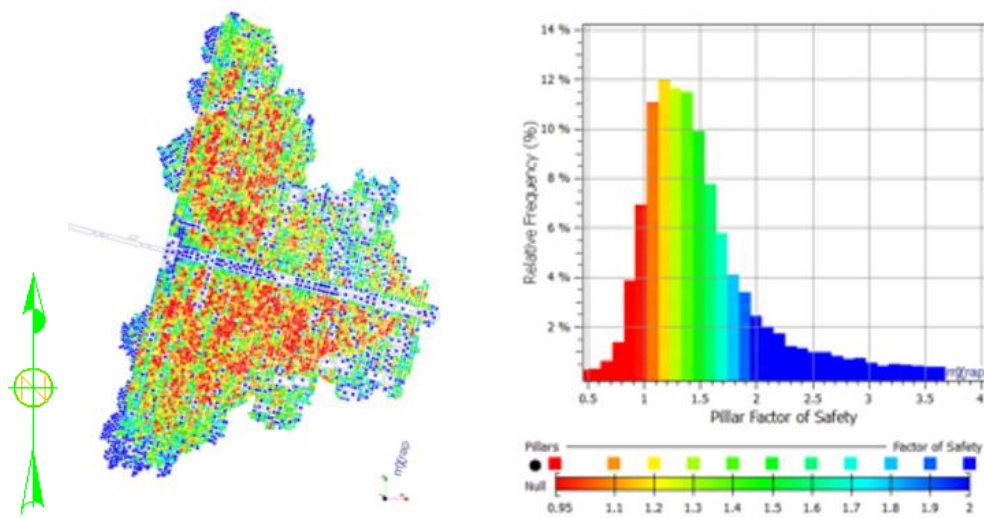
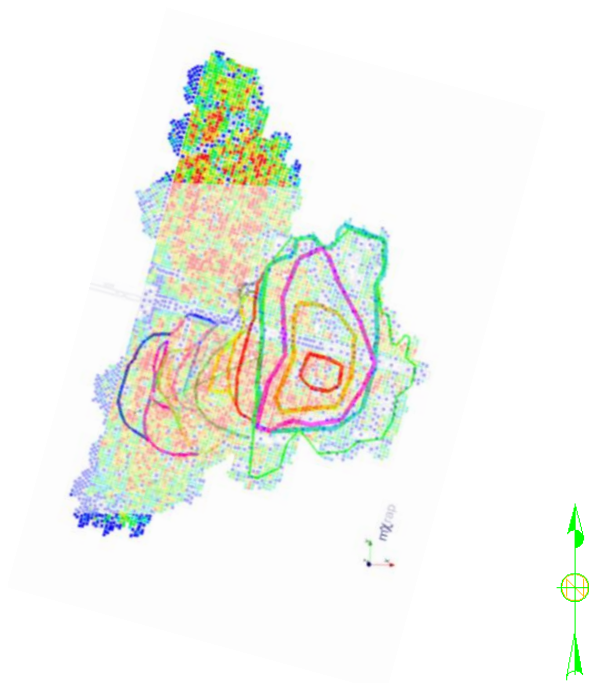
Figure 4.9 shows the distribution of the factor of safety and comparison with the failure migration. The distribution in Figure 4.9 shows higher concentration of the lower factor of safety on the southern side in comparison to the north. From this model used, it can be concluded that the estimation of the K-value in the bottom areas of the mine is more accurate to these conditions in comparison to the upper areas (Walls & Mpunzi, 2017). Therefore, the contribution of lower factor of safety to the failure migration trend is critical and cannot be overlooked as it should be taken into consideration in the determination of pillar strength and stress.

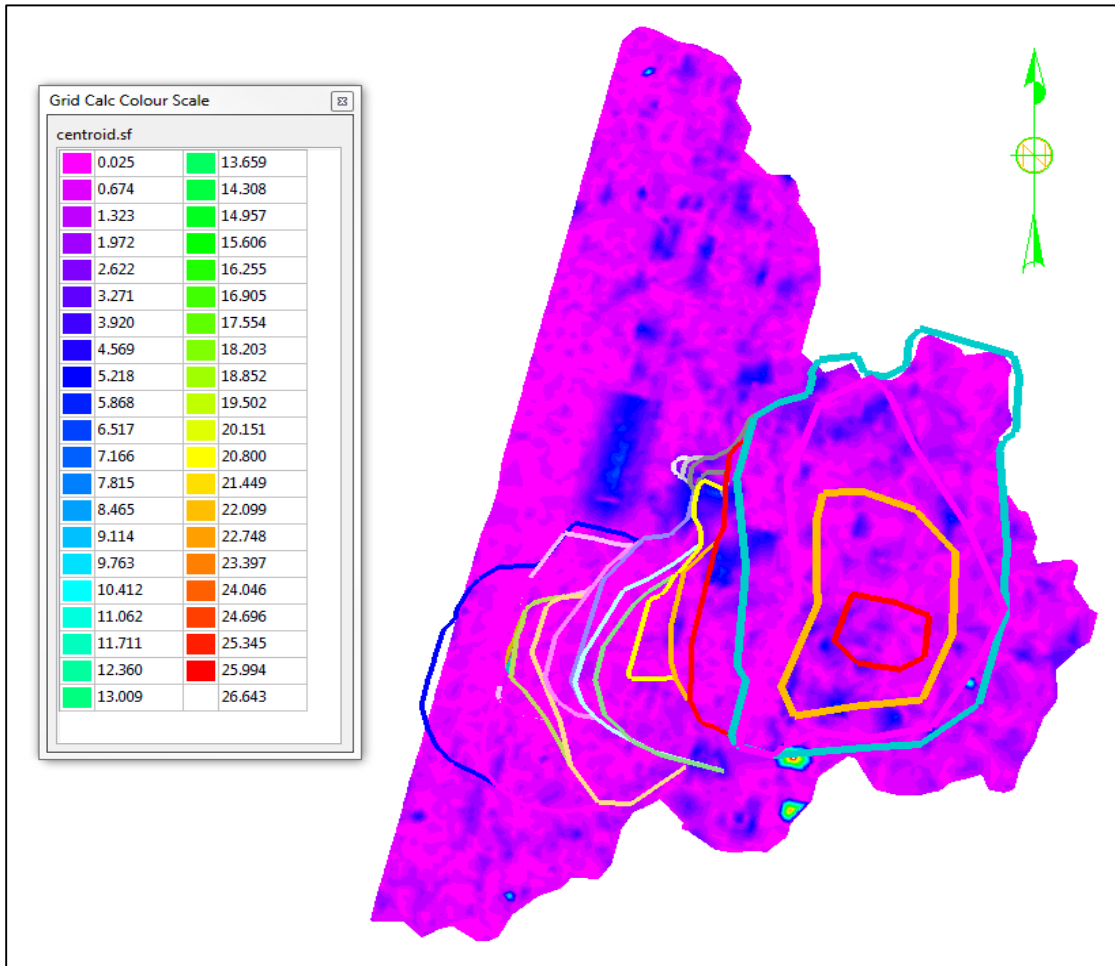
Figure 4.10 shows the distribution of the distance between the planned pillar centroid and the actual pillar centroid position. The analysis was done using Vulcan software from Maptek. The plot shows an even distribution of the distance between design and actual pillar centroid position with no clear and direct correlation to the failure migration front. To this end, it can be seen that the pillar position has low influence on the direction of failure migration.

**Figure 4.10** Pillar position with respect to design.

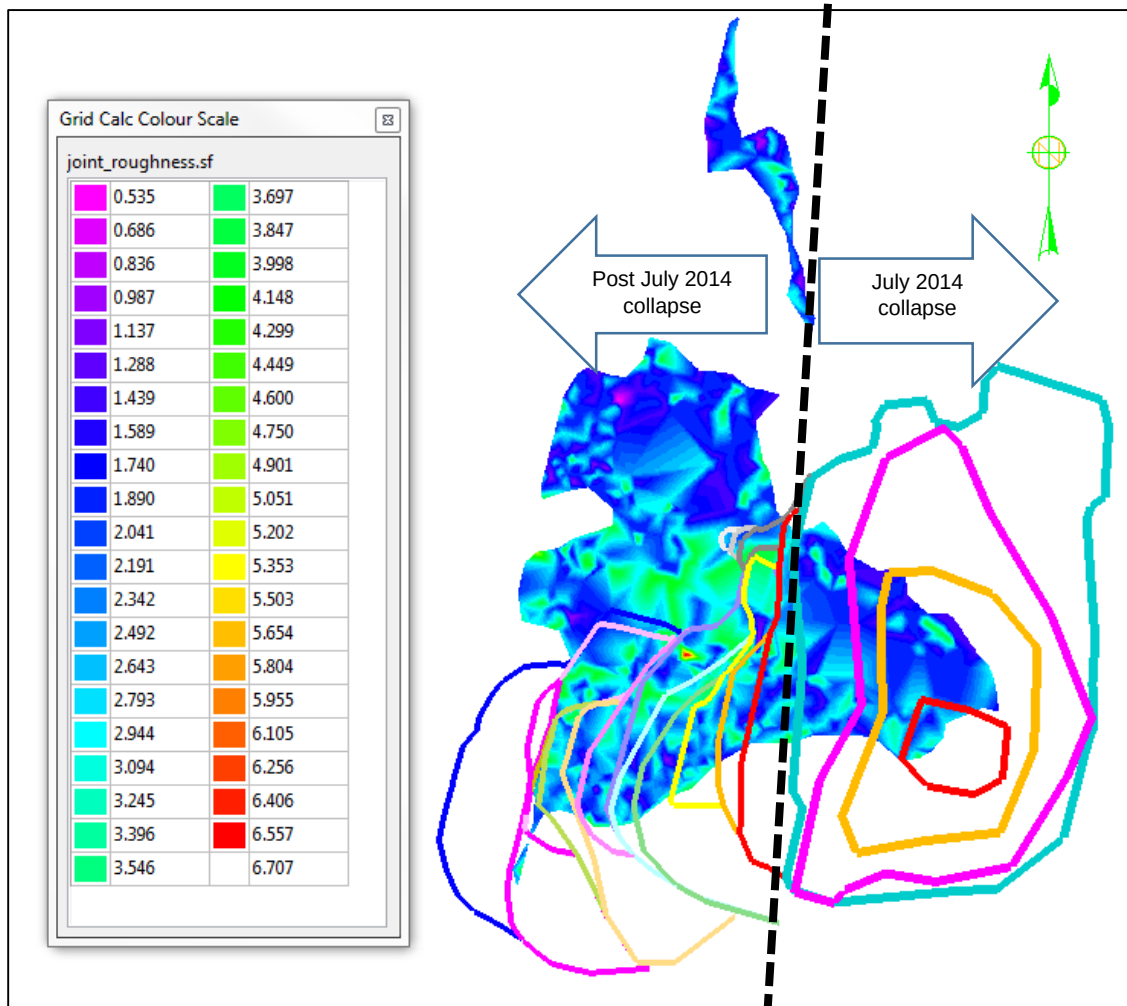
**Figure 4.11** Failure migration with respect to joint roughness

Joint roughness correlates well on the 2014 migration but has a low correlation post July 2014 collapse. In the 2014 migration area, the Mutambara shear is mostly more than 0.4m thick and close to the mining horizon and hence the influence of the shear to the joint properties could be significant. In subsequent migration events, the influence of the shear is reduced. Joint roughness therefore has limited independent influence on direction of failure front migration.

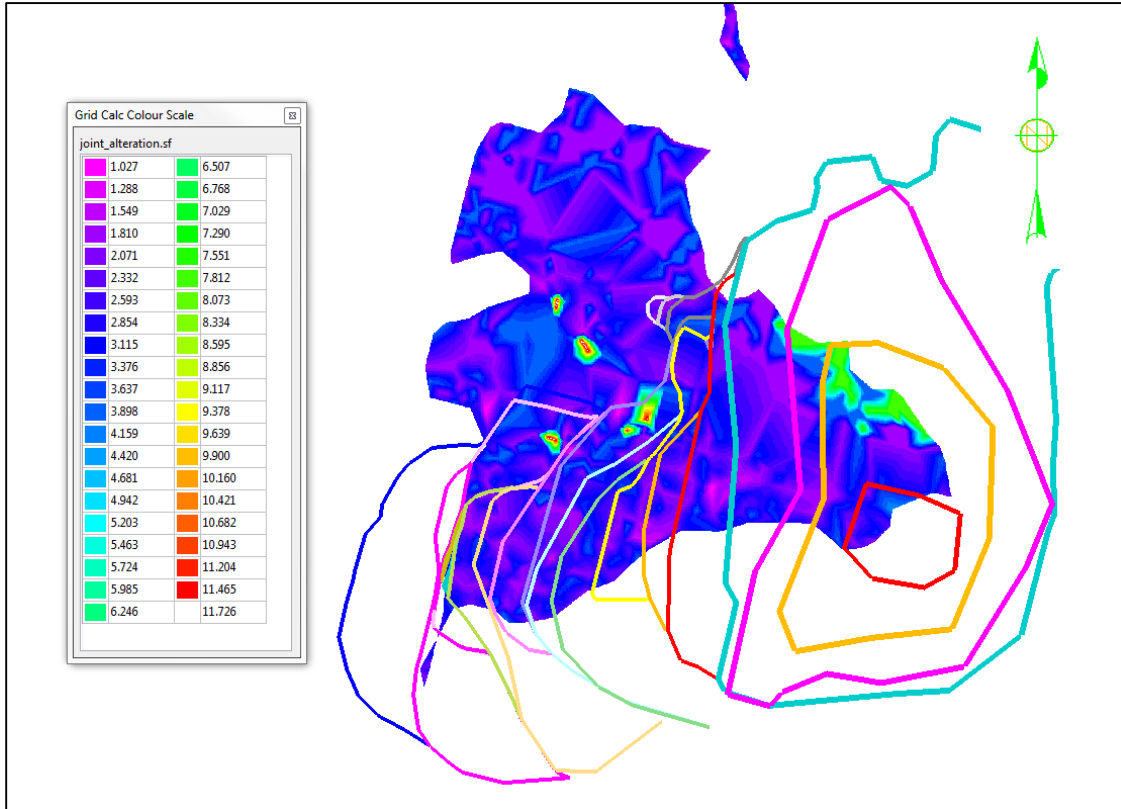
**Figure 4.12** Failure migration in relation to joint alteration.

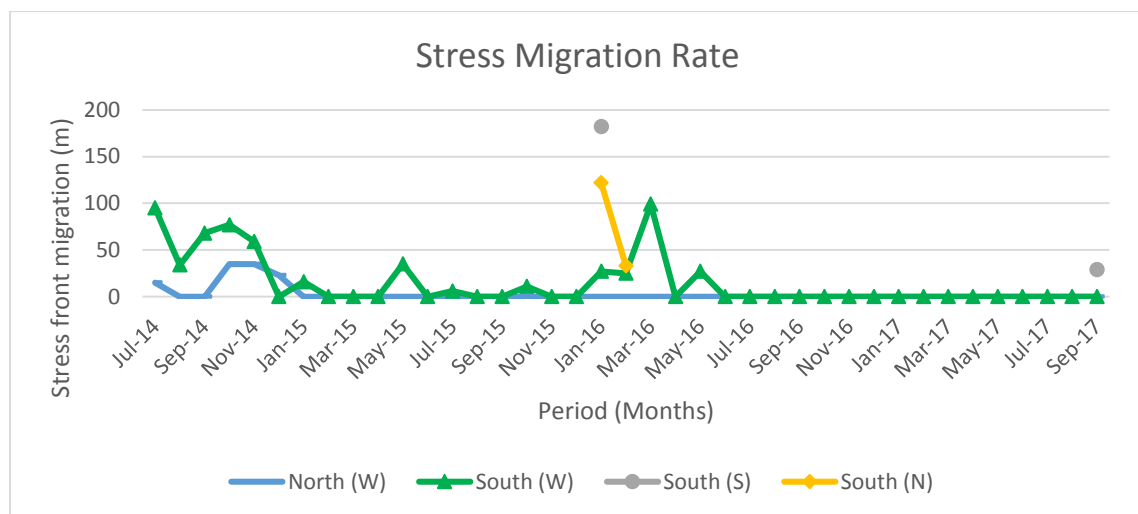
Figure 4.13 shows the historical monthly stress migration rates, and is used to trend the failure front migration rates since 2014. In the graph, North (W) means westward migration on the northern section of the mine, likewise South (N) means northward migration of the stress front in the south section of the mine. The last stress front migration event was recorded in August 2017. It is however important to note that some of the pillars within the stress zone have shown signs of increasing stress. The migration from the south towards the north appears to have been slowed down by the larger decline pillar separating the north and the south in the upper portion of the mine.

**Figure 4.13** Bimha monthly stress migration

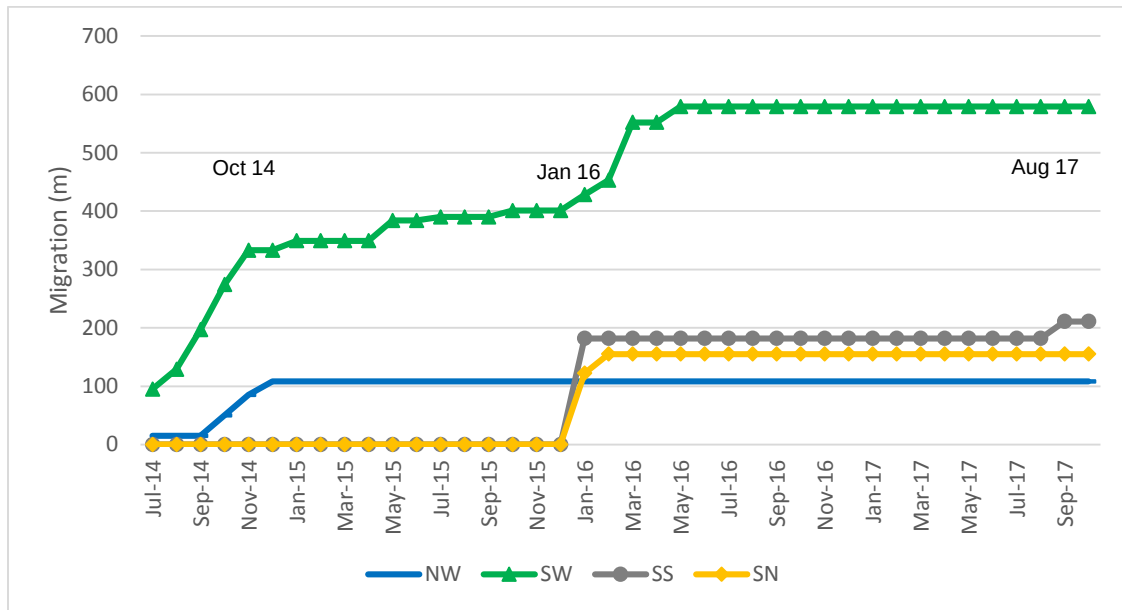
**Figure 4.14** Cumulative stress migration curve

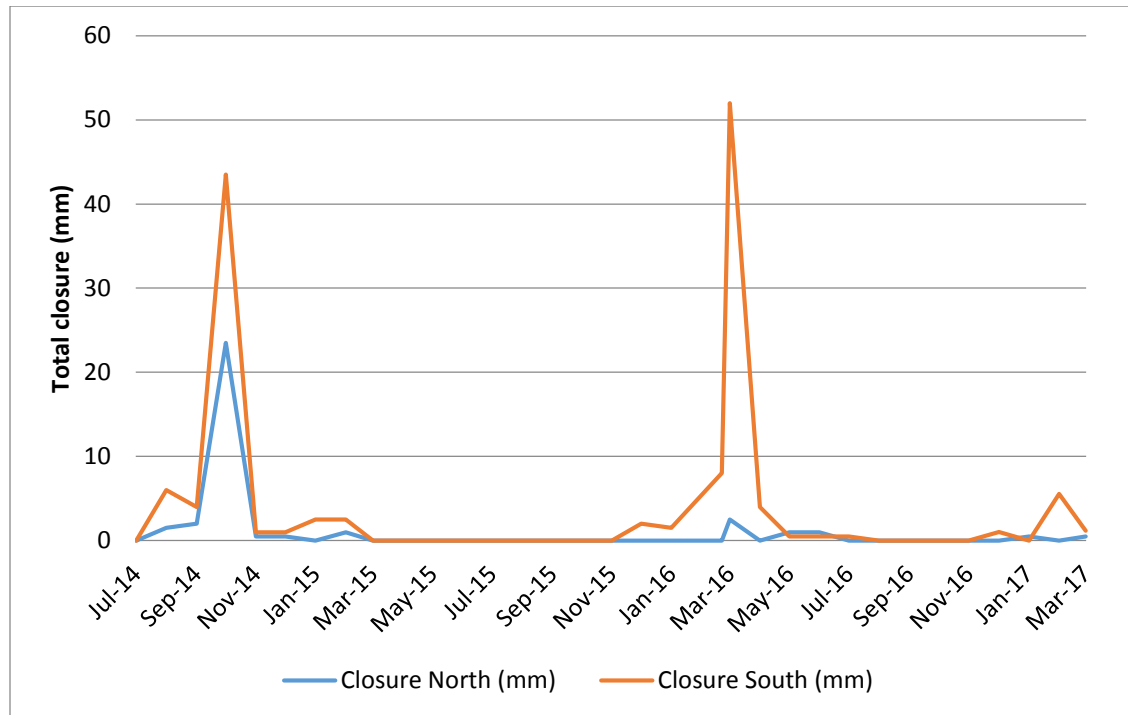
**Figure 4.15** Total closure trend.

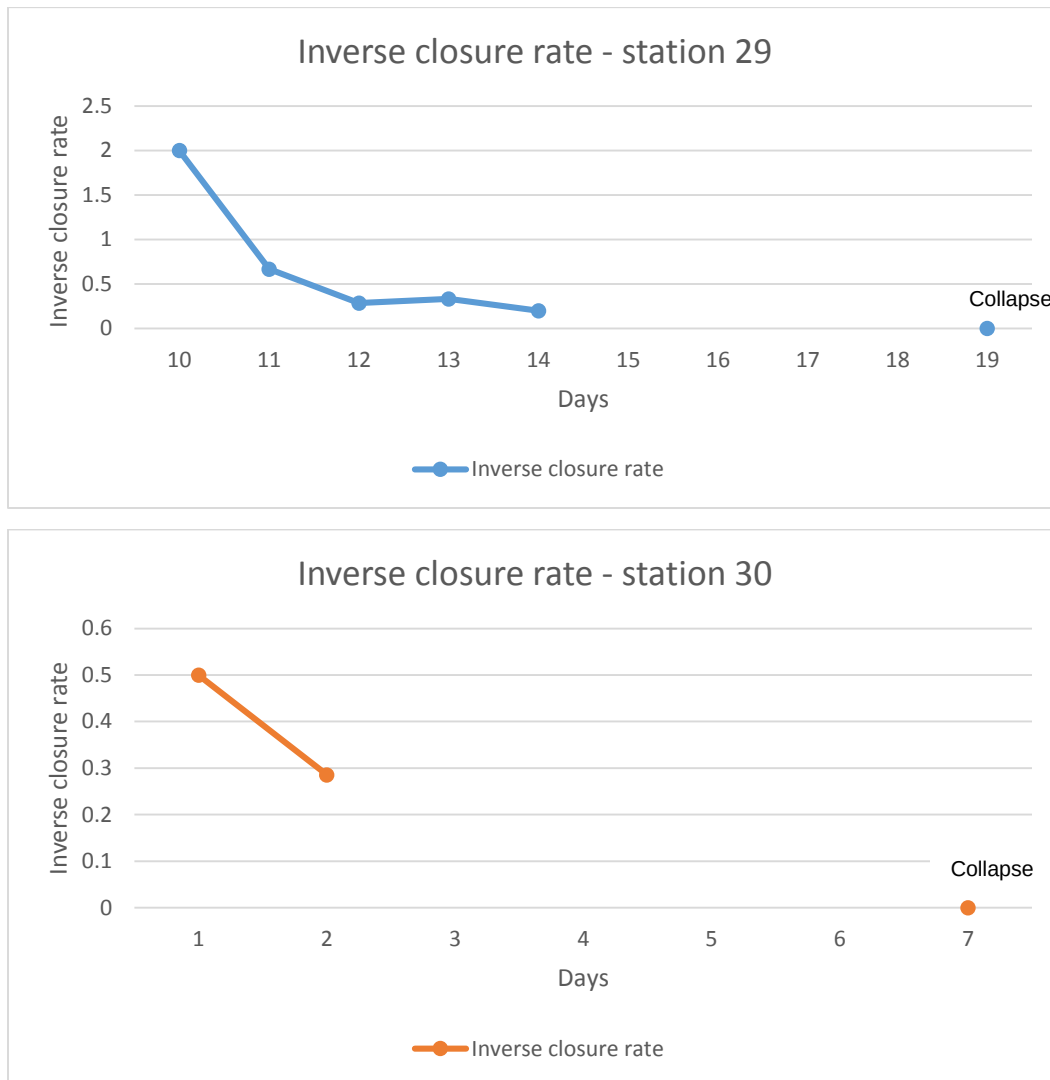
**Figure 4.16** Typical inverse closure rates for stations 29 and 30

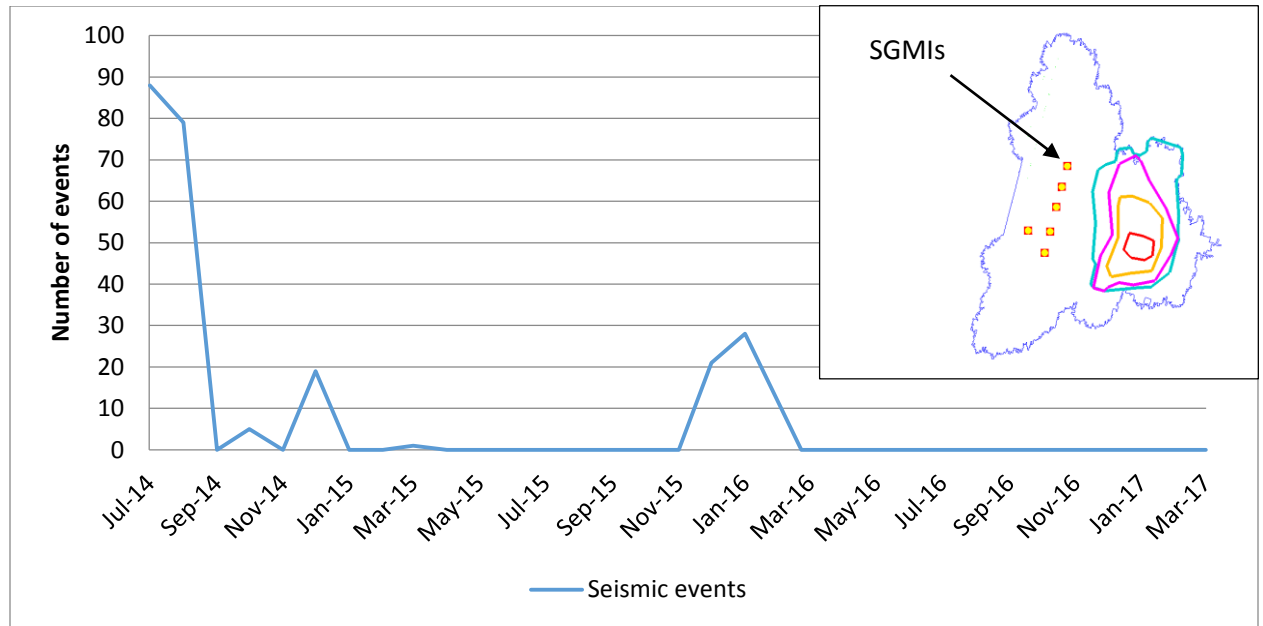
**Figure 4.17** Seismic events trend and location of the SGMIs (insert)

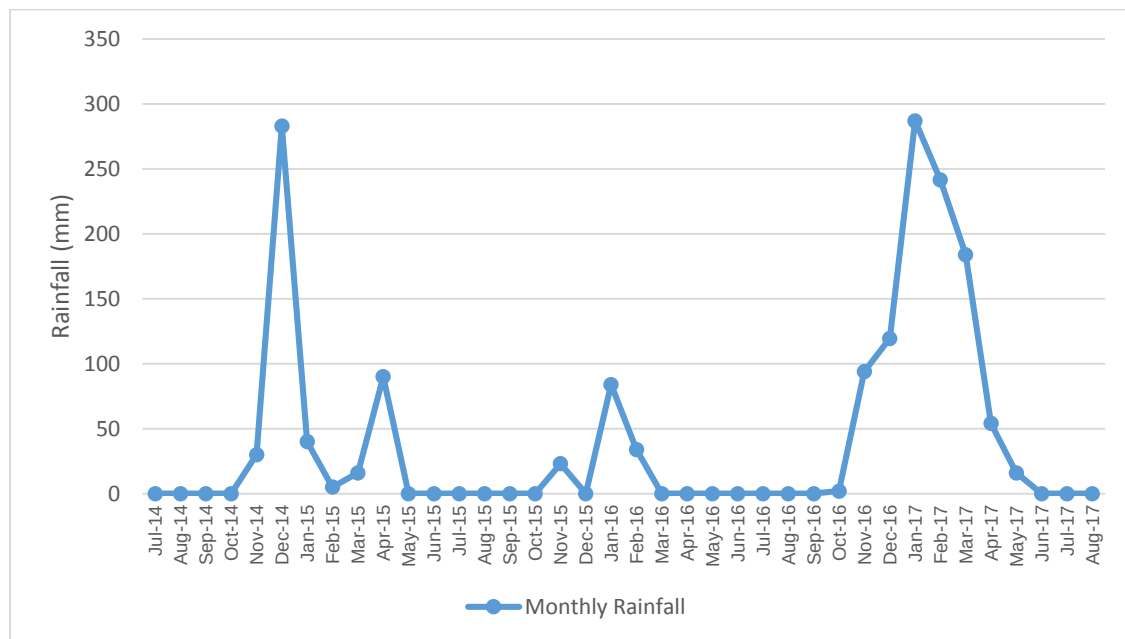
**Figure 4.18** Rainfall trend

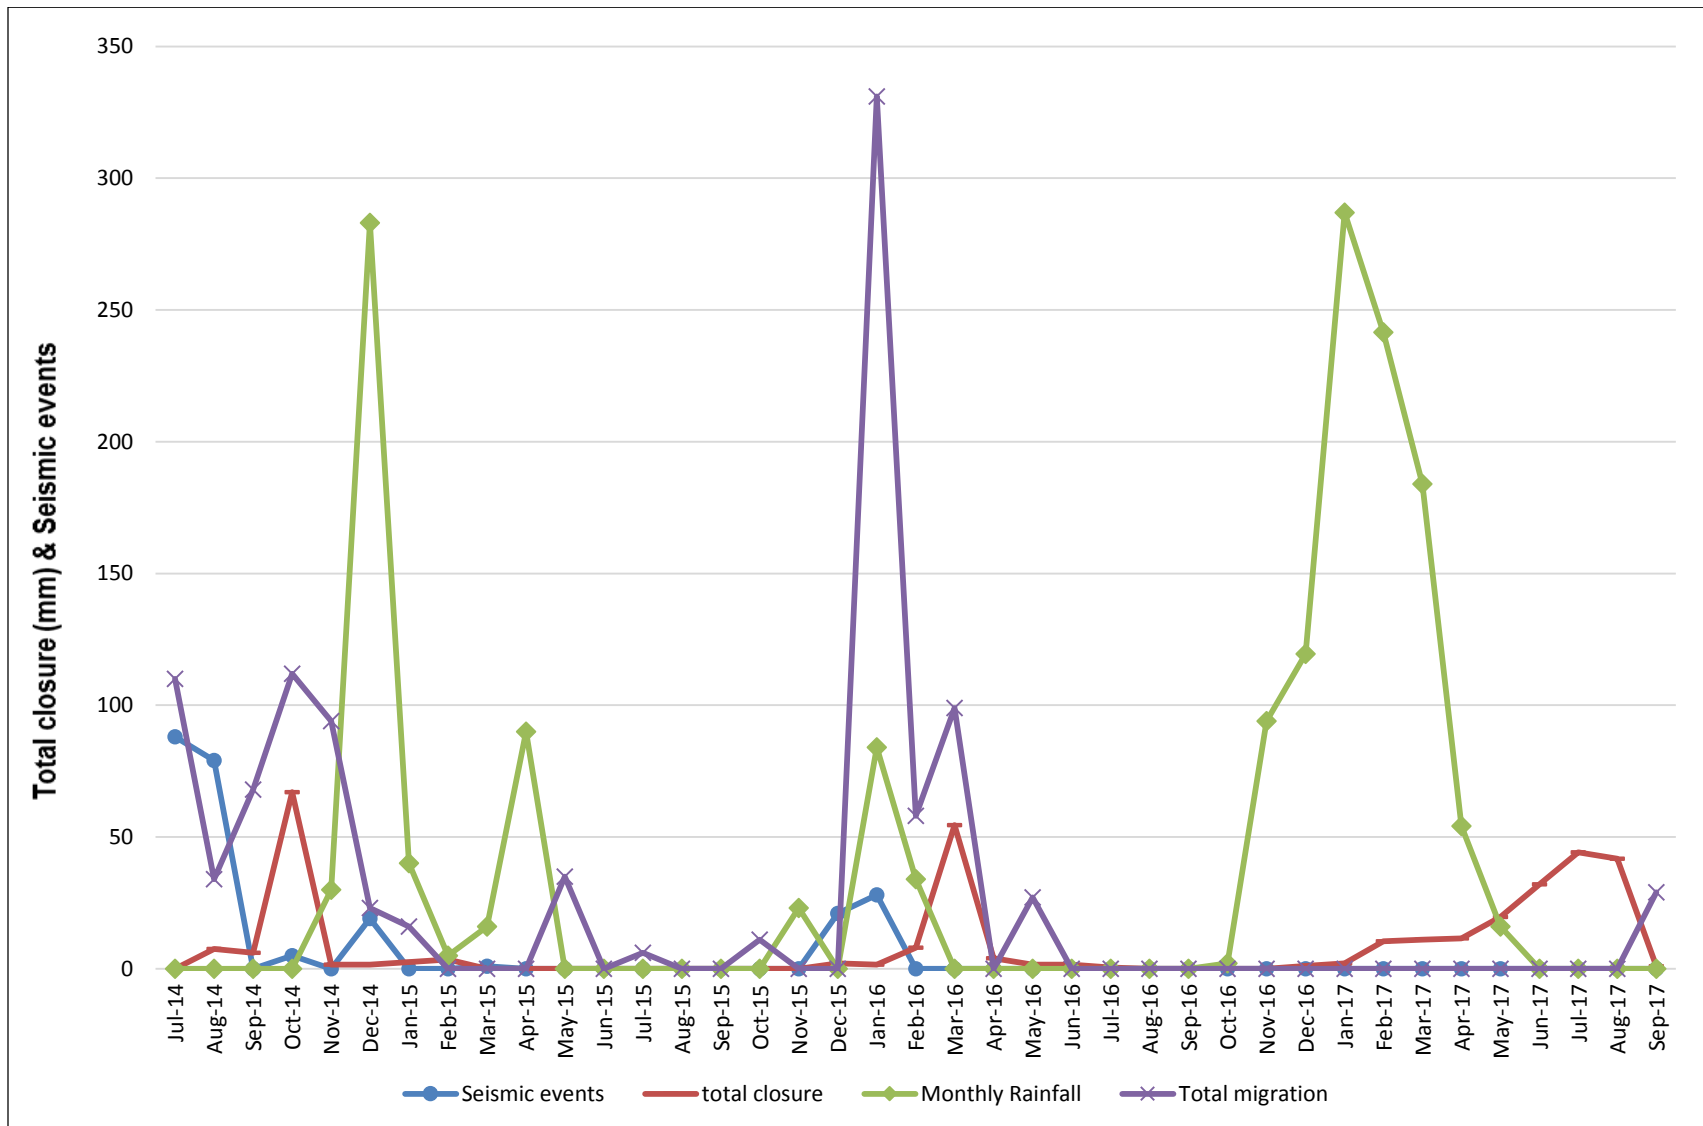
**Figure 4.19** Comparison of the Monitoring trends

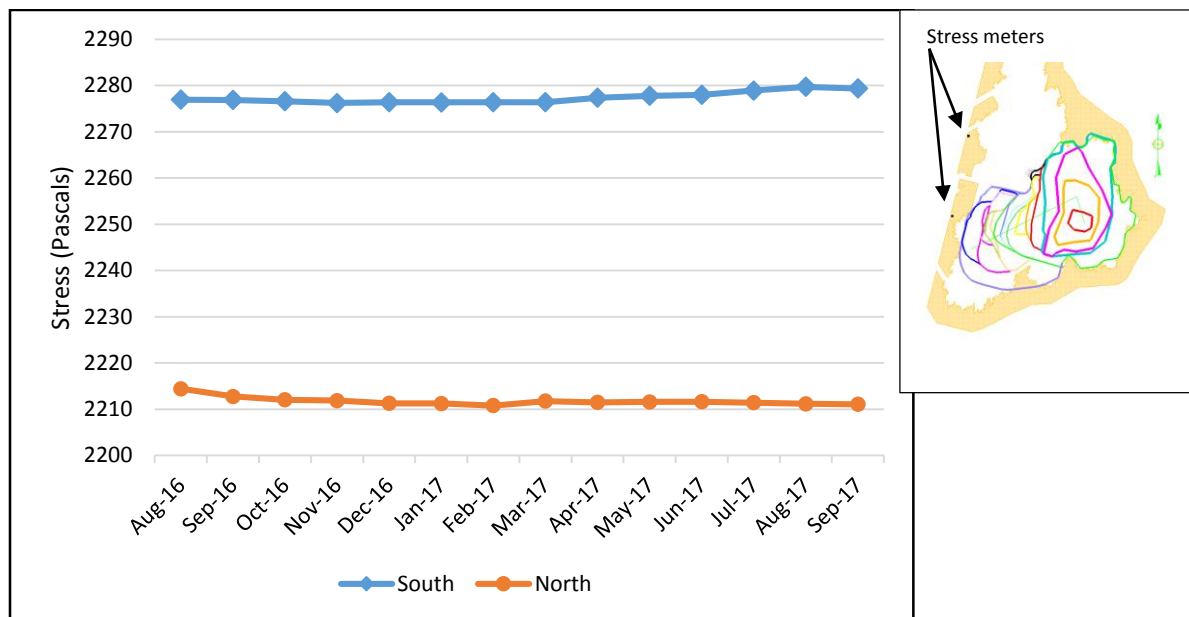
**Figure 4.20** Stress meter readings and position of stress meters (insert)

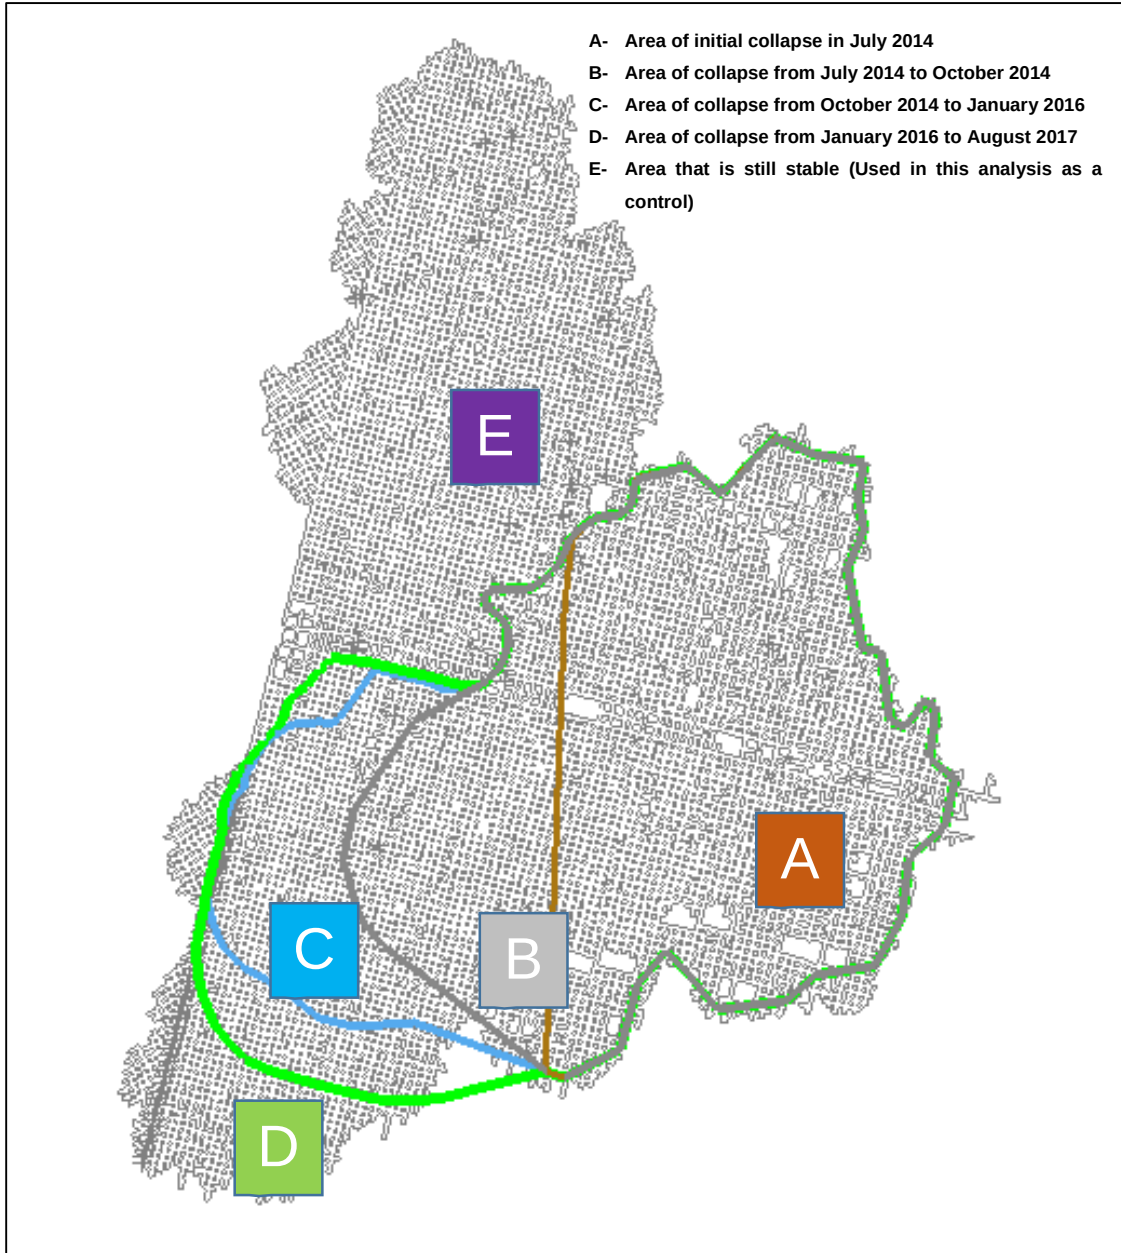
**Figure 4.21** Failure areas by period

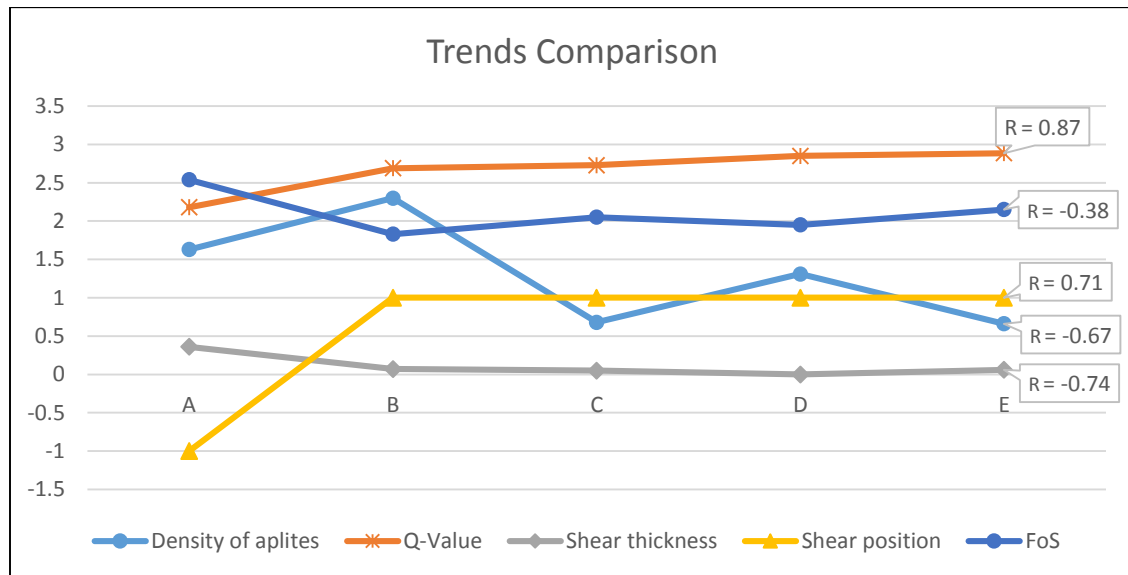
**Figure 4.22** Plot of the key variables analysed with respect to the different areas. The correlations are strong except for the Factor of Safety (FoS) which has a low negative correlation of 0.38. These correlations do confirm the key variables that govern the propagation of failure as described in this analysis. Ideally if all the variables are accurately enumerated and incorporated, the FoS should have a high correlation. A low correlation for FoS could be an indication that the design did not accurately consider all the variables.

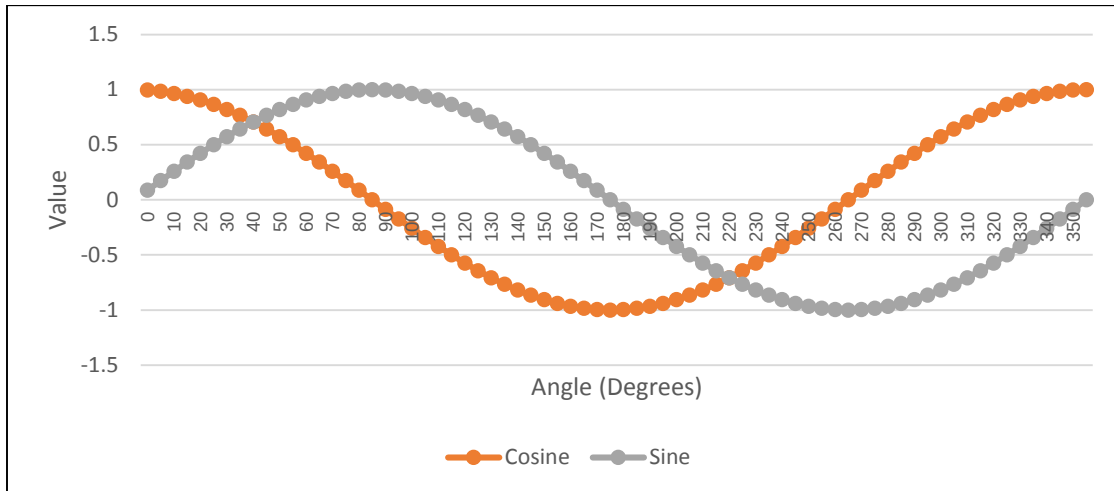
**Figure 4.23** Sine – Cosine curves

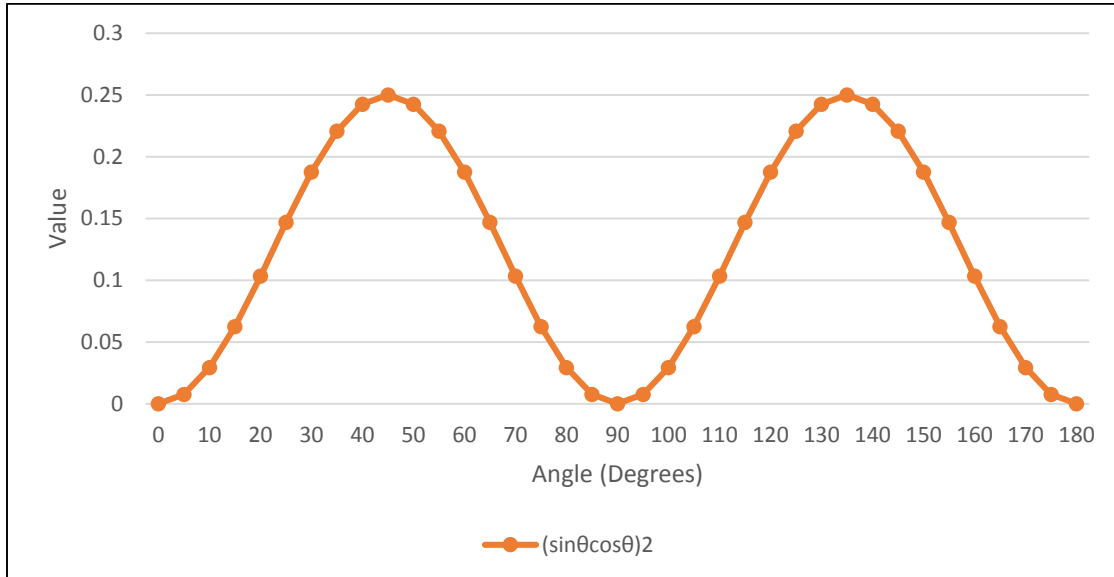
**Figure 4.24** Angle difference  $(\sin\theta\cos\theta)^2$  curve

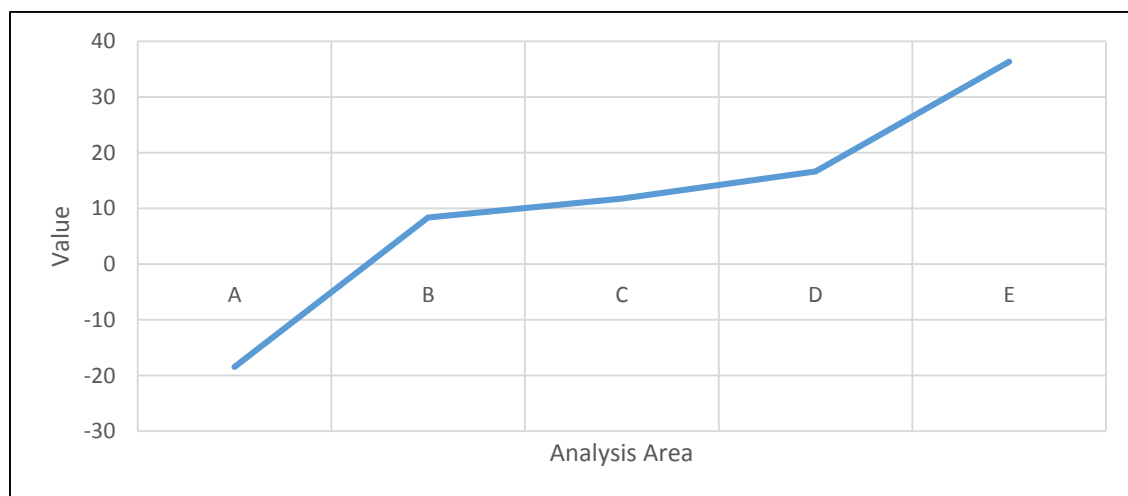
**Figure 4.25** Failure factor
