Investigation of the micro- and macroscopic wear properties
of cemented tungsten carbide for the wear lining material
selection of chutes

A dissertation submitted to the Faculty of Engineering and the Built Environment, University of the Witwatersrand, Johannesburg, in fulfilment of the requirements for the degree of Master of Science in Engineering.

Johannesburg, 2021

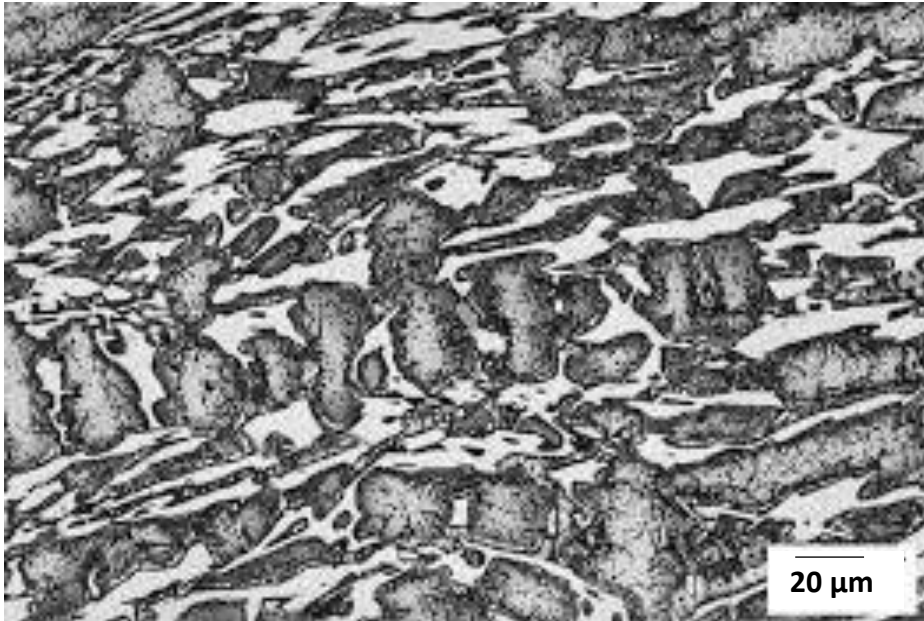
Figure 2.15: Optical micrograph showing microstructure of white cast iron (*Filipovic et al., 2012*).

The white cast iron gets its name from the silver-like white cracks throughout the metal (CorrosionPedia, 2016). Its white surface is as a result of the carbide impurities that allow light through its cracks when fractured. White cast irons have a light appearance as a result of the absence of graphite. It is unique in a sense that it is the only member in the cast iron family where all the carbon content (mainly greater than 2%) exists only as carbide. The absence of graphite occurs during the solidification process where the carbon in solution precipitates into a metastable phase cementite (Fe_3C) (CorrosionPedia, 2016; Domeij, 2019). Low silicon content and the rapid cooling rates also allows for the formation of Fe_3C instead of graphite. A typical microstructure of white cast irons consists of dendrites of pearlite (transformed austenite) in an interdendritic network of Fe_3C . The large white areas are the interdendritic networks of Fe_3C whereas the dark areas are pearlite (Figure 2.15) (Lavakumar, 2017).

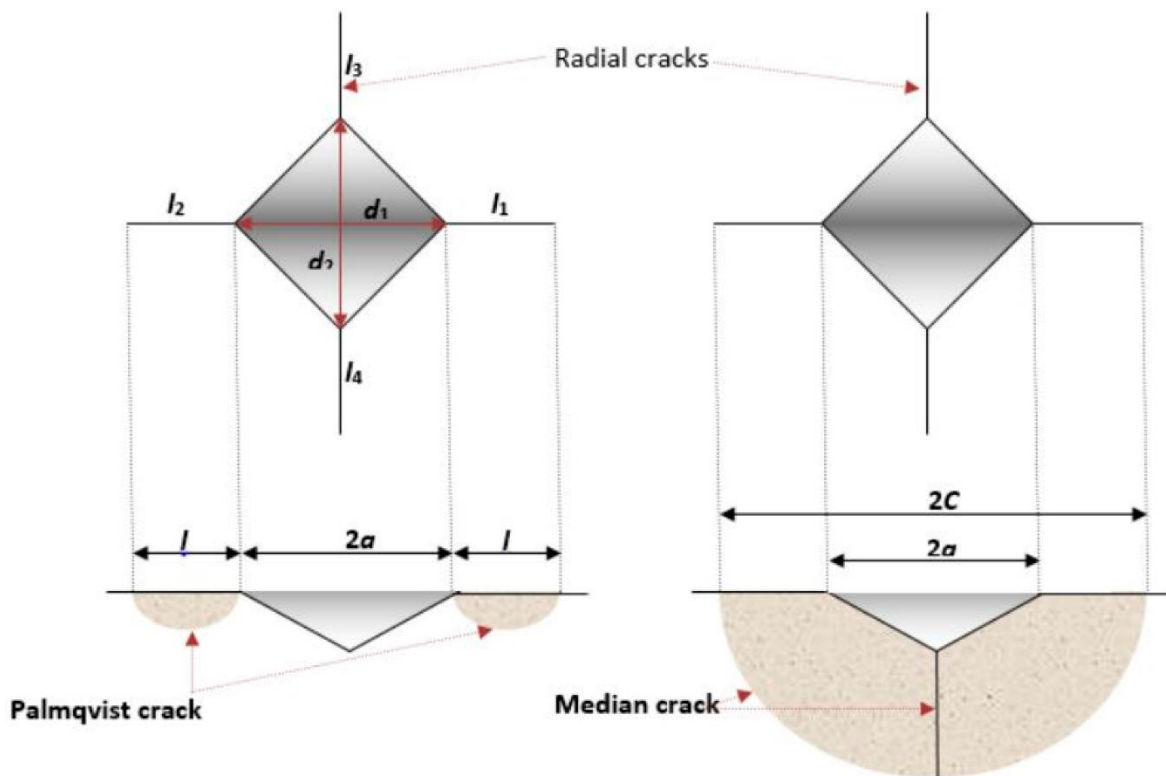
Figure 2.17: Schematic of the Vickers indentation and Palmqvist cracks (Fabijabić et al., 2017).

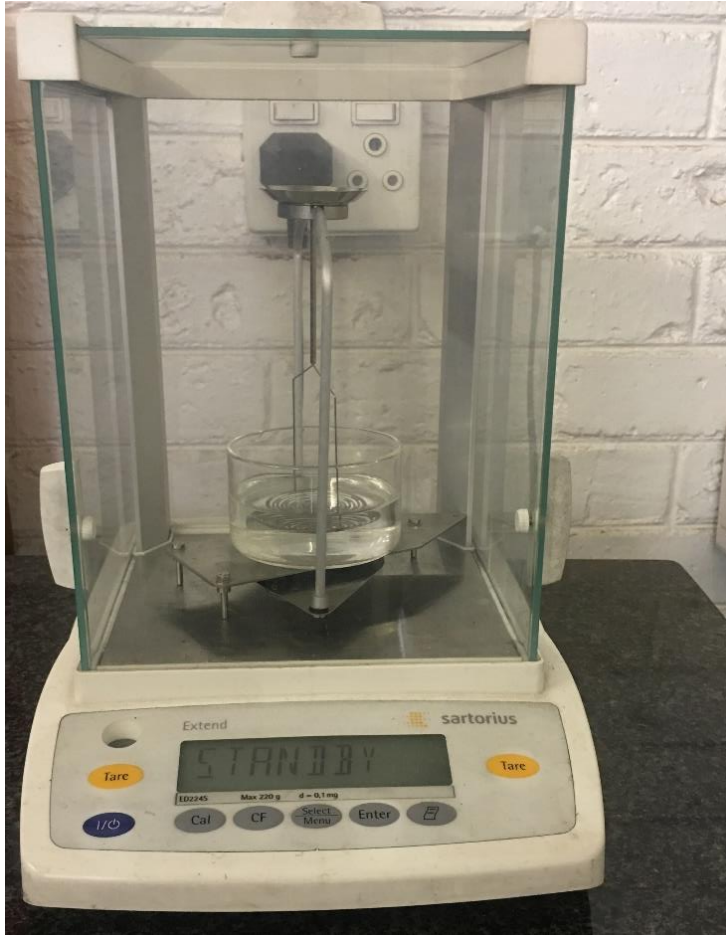
A Sartorius ED2245 densimeter was used to measure the density of the samples. The samples were first cleaned with 98% ethanol and then washed with distilled water. They were then air dried to remove any moisture.

The samples were first air-weighed to measure the dry mass and then weighed again in distilled water to measure the suspended weight. From there the density of the samples was calculated and displayed on the densimeter (Figure 3.1).

Figure 3.1: Macrograph of the densimeter used to measure the density of the investigated samples.

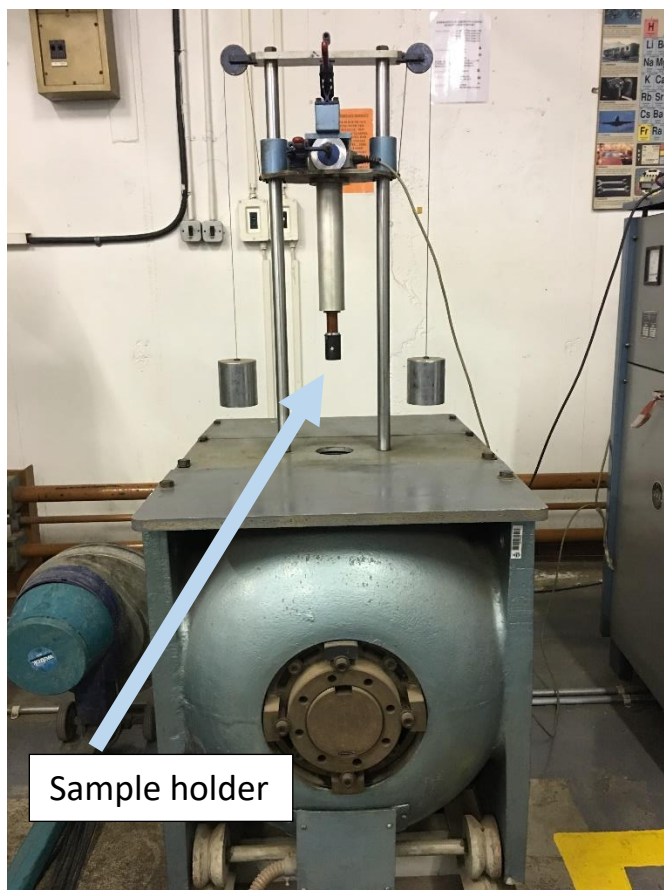
The actual binder magnetic saturation values were determined using the REEF-LEX magnetic analyser shown in Figure 3.2.

Figure 3.2: Macrograph of a magnetic saturation analyser.

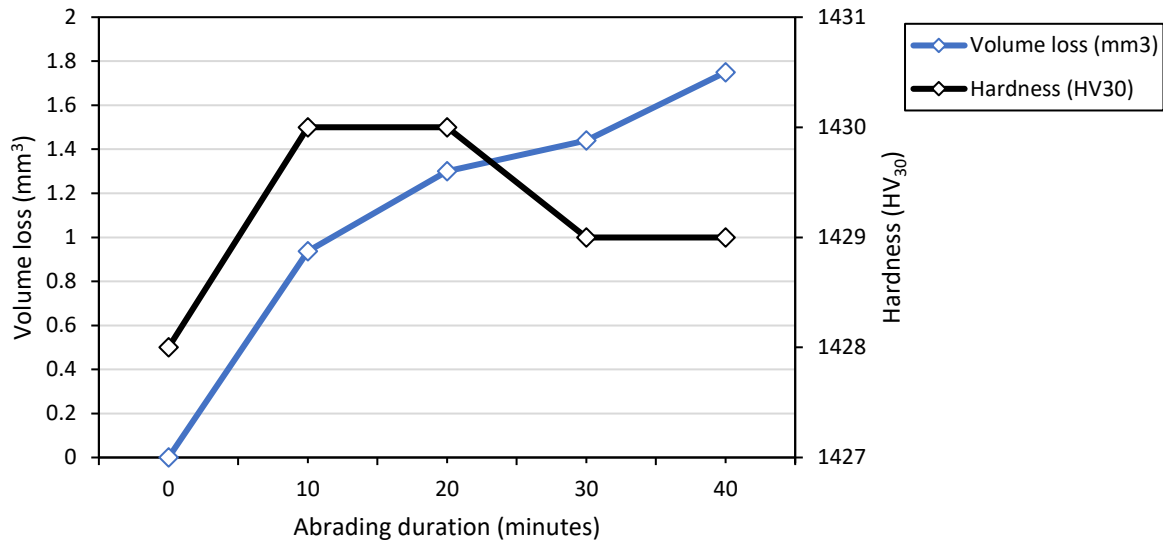
Figure 4.12: Volumetric wear losses and Vickers hardness values of the WC-6Co plotted as a function of the abrading duration.
