# **EARTH BRICK SHELL HOUSING IN SOUTH AFRICA: STRUCTURAL AND PERFORMANCE CONSIDERATIONS**

A thesis submitted to the Faculty of Engineering and the Built Environment, University of the Witwatersrand, Johannesburg, in fulfilment of the requirements for the degree of Doctor of Philosophy.

Johannesburg, 2021

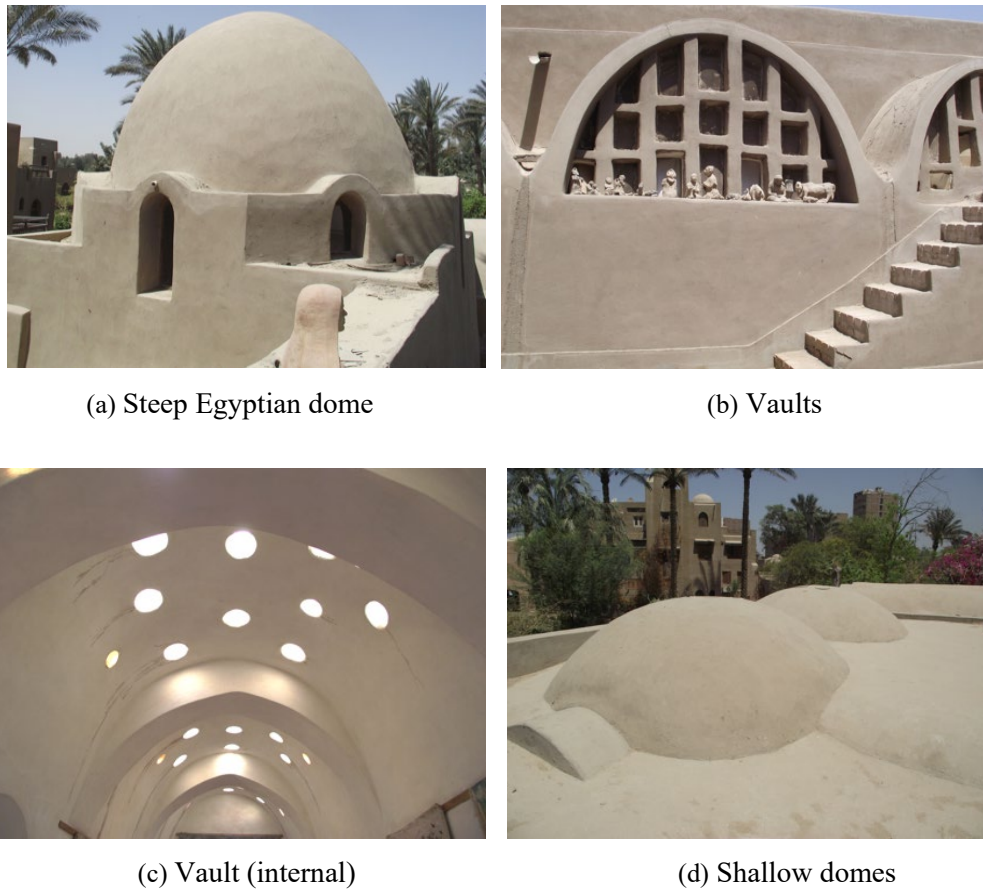
Figure 2.1 – Earth brick domes and vaults at the Ramses Wissa Wasef Arts Centre

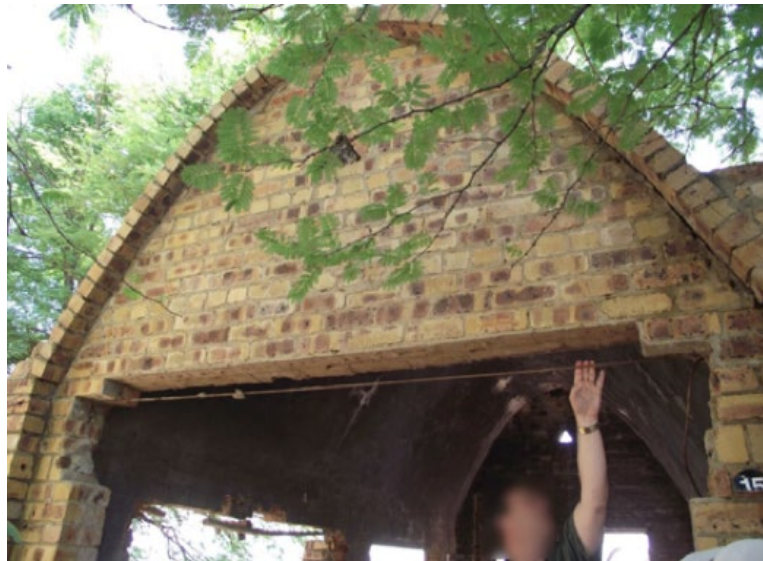
Figure 3.10 – Lintels removed from a vault in Bapong

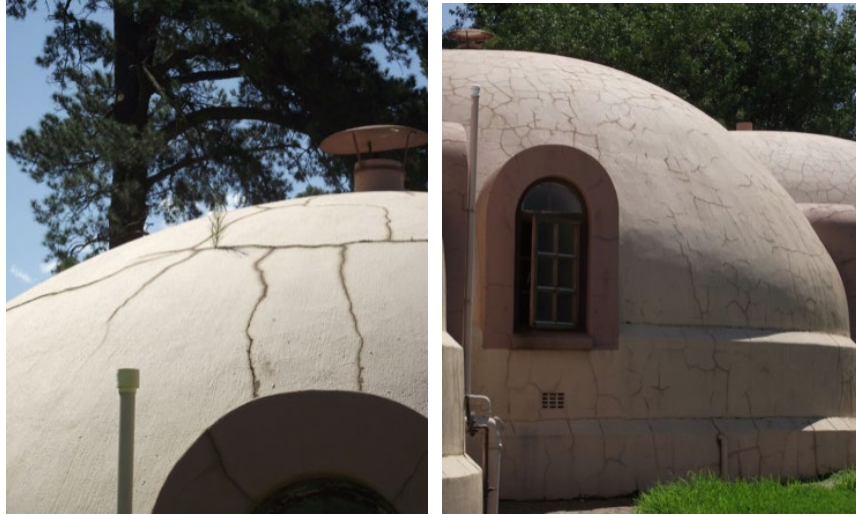
Figure 3.13 – External Surface cracking in two CMU domes

Vaults and domes are typically far more exposed to the elements (e.g., wind-driven rain, running water, and solar radiation) than walls. Furthermore, because the surfaces of shells are not vertical, cracks in the masonry are more accommodating to water penetration under the action of gravity. Water infiltration through surface cracks, created by thermally induced stresses, shrinkage, and repeated wetting and drying cycles, can become problematic if not repaired. Surface cracks within the external and internal render has been observed over numerous shells built in the inland provinces of South Africa, as shown in Figures 3.13 and 3.14.

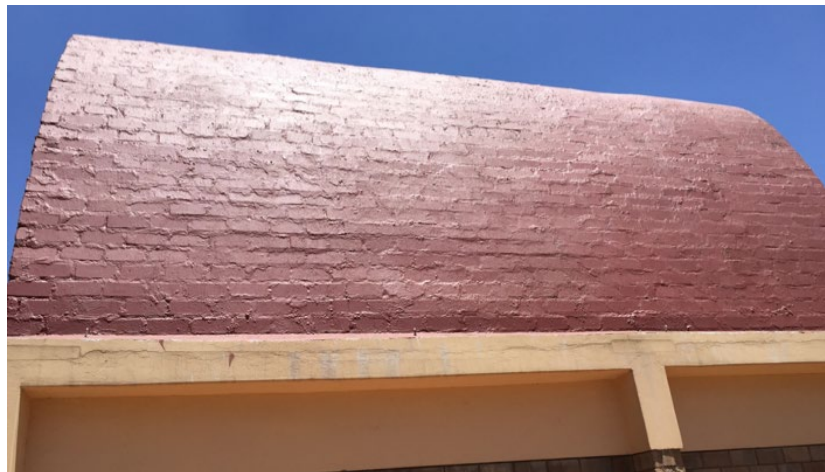
Figure 3.21 – Repaired steep catenary shells at Wits (June 2015)

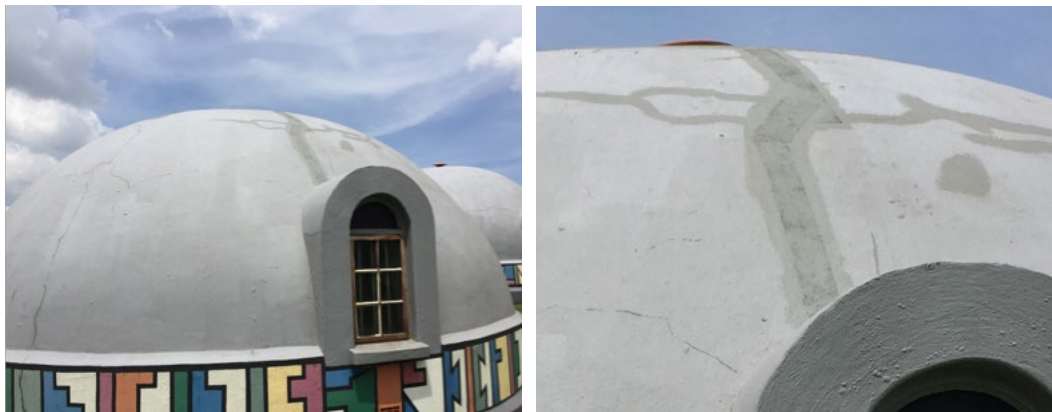
Figure 3.24 – Repairs to structural cracks in a CMU dome

An alternative repair technique is engineered composite materials, which incorporate high strength cementitious mortars and reinforcing (e.g., textiles and mesh) to bridge and waterproof cracks. However, such systems may be costly, and require specialized tools and training for proper application. Figure 3.24 shows a repaired structural crack in one of the domes at Sparrow Rainbow Village (These repairs were not implemented by the author of this thesis). These cracks were caused by an impact of a falling tree in November 2015. The cracks were repaired with strips of waterproofing membrane mesh. The membrane strip, although unsightly, was able to accommodate the inevitable stresses developed through the restraint of diurnal and seasonal thermal movements, which may be significant in Johannesburg (Gohnert, 2012). Furthermore, no evidence of water penetration was apparent approximately one year later. However, over time water may enter at the edges or seams of these elements, if not regularly maintained as shown in Figure 3.25.

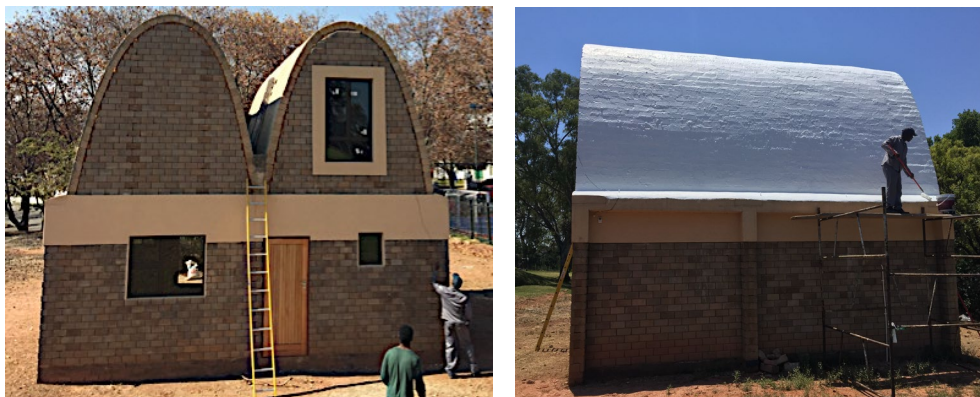
Figure 5.7 – Access onto steep catenary vaults at Wits

These analyses, in combination with the experiences gained during the construction and maintenance of two catenary vaults at Wits, indicate that even the relatively low surface load given in SANS 10160-2 is likely conservative for steeper profiles. The construction process of the steep Wits shells, with an average roof pitch of  $65^\circ$ , required the use of scaffolding and long ladders for workers to access all parts of the roof. Furthermore, during routine maintenance and repair work shown in Figure 5.7, workers were only able to stand, without the assistance of a ladder, over the apex of the shells. Consequently, one would reasonably expect that materials placed during maintenance work would most likely be positioned on scaffolding, at ground level, or over a limited area near the roof apex.

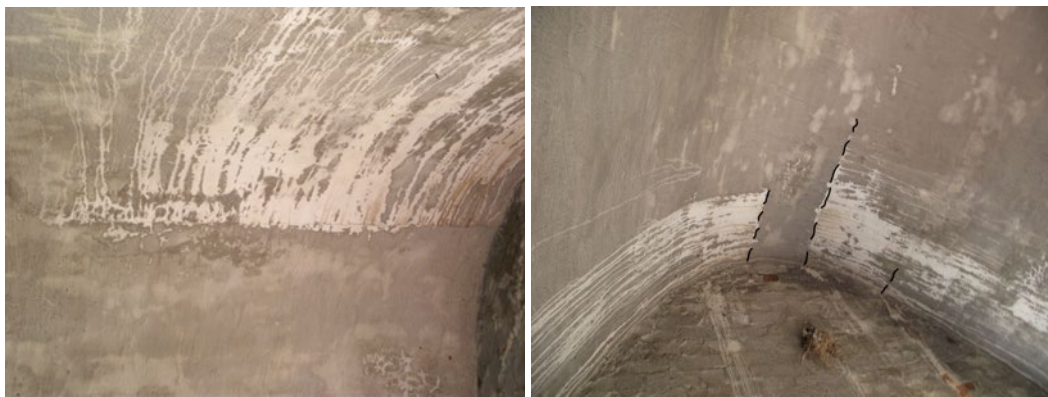
Figure 6.1 – Straight-line cracks in two of the Bapong shells (cracks traced for clarity)

mortar and brick. Stress concentrations may also align with the joints, resulting in large, relatively straight, cracks. This is illustrated in several fired clay brick catenary vaults in Bapong, as shown in Figure 6.1, where longitudinal cracks appear to coincide with the joints and/or along the unit-mortar interface. Although cracks are only visible in the overlying plaster, the location of cracking in the joints is supported by the appearance of lime run, as shown in Figure 6.1. Rain water entering the masonry through these cracks dissolves water-soluble calcium compounds (e.g., free lime) within the mortar, which subsequently runs down to the surface and reacts with carbon dioxide in the atmosphere to form white calcium carbonate deposit.

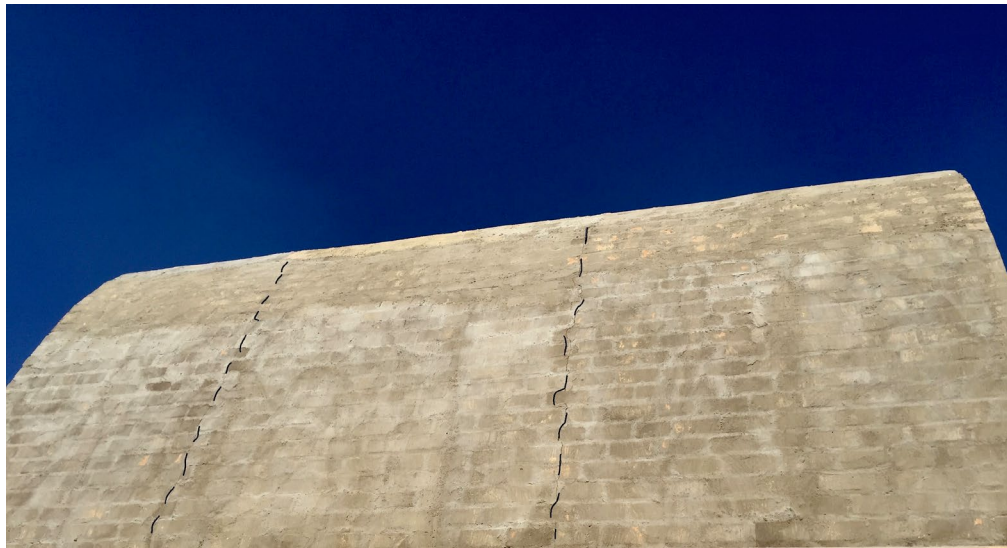
Figure 6.9 – Vertical shrinkage cracks in a CSEB vault (Bradley *et al.*, 2017a)

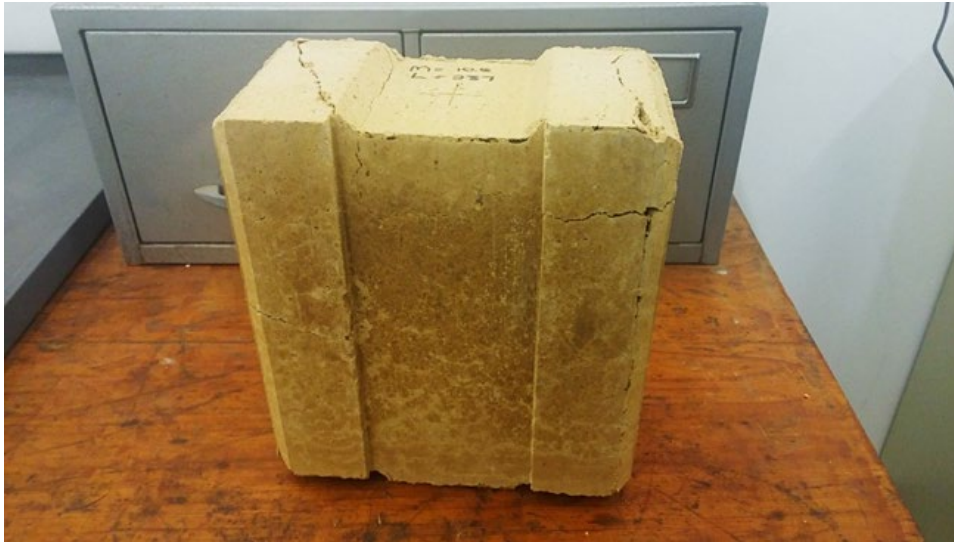
Figure 7.9 – Typical shrinkage cracking in a CSEB

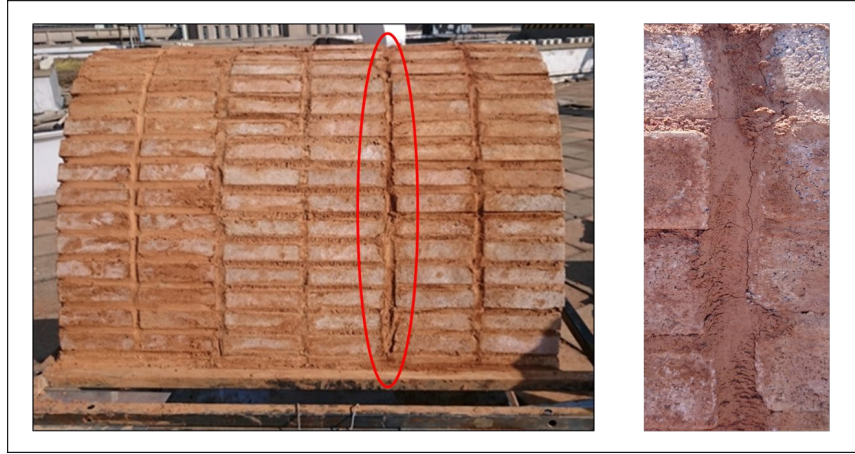
Figure 7.15 – Vertical crack in a catenary vault model

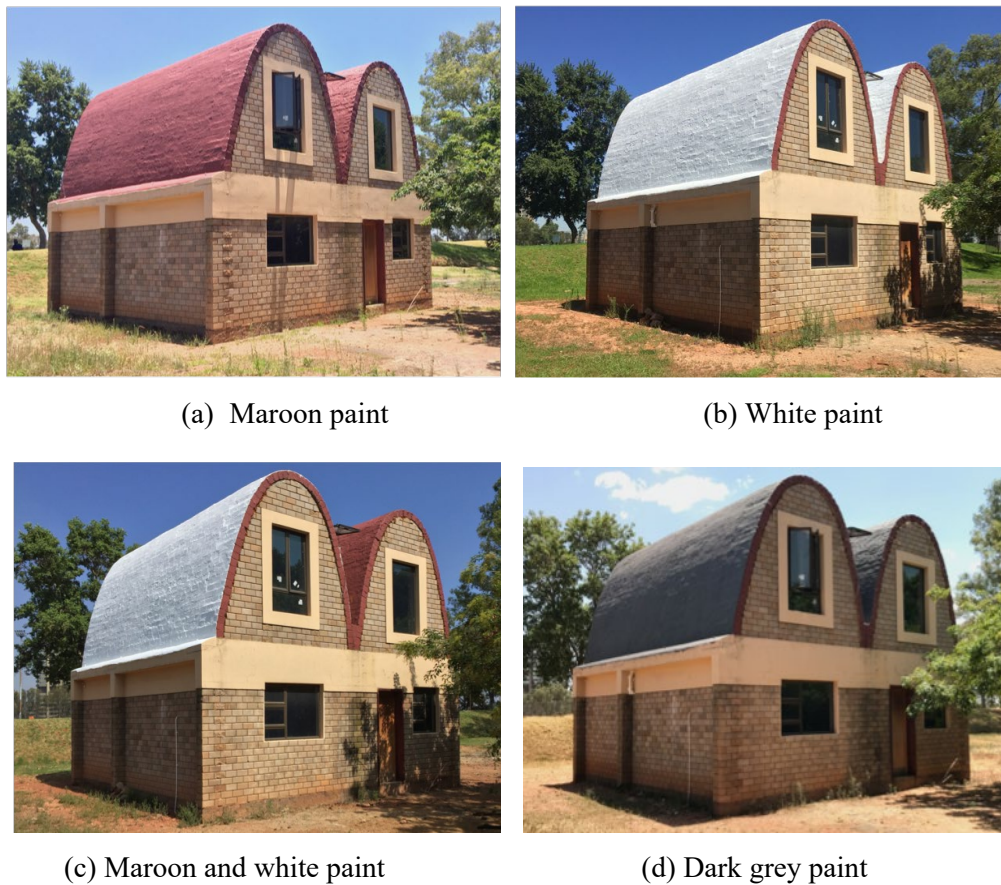
Figure 8.11 – Examined surface colour conditions
