## **MICROBIAL CORROSION OF ALUMINIUM ALLOYS IN MINE WATER**

**A dissertation submitted to the Faculty of Engineering, University of the Witwatersrand, Johannesburg, in fulfilment of the requirements for the degree of Master of Science in Engineering.**

**Johannesburg, 1990**

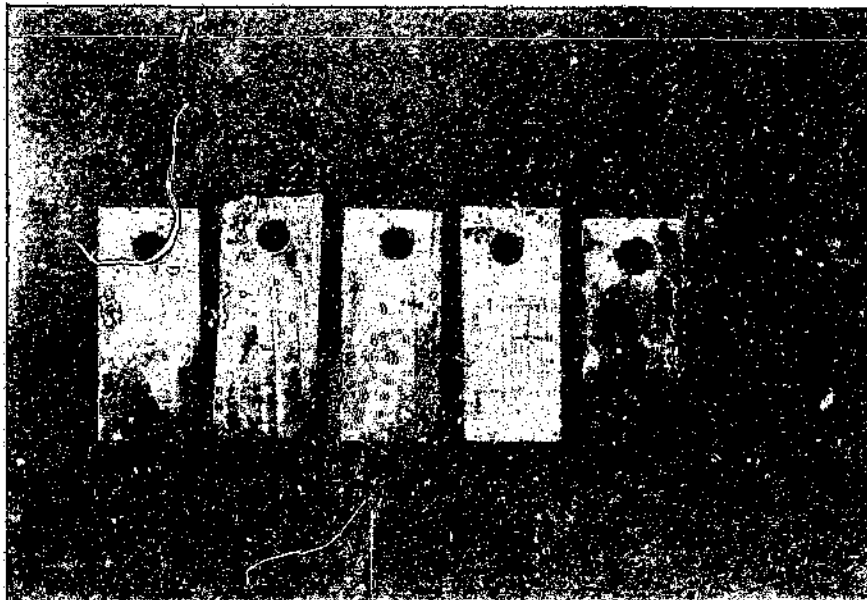
Figure 47. Condition of coupons on removal from the static immersion tests: in a mixed SRB culture in medium

- 1 - 1070
- 2 - 5182
- 3 - 6063
- 4 - 6261
- 5 - 3CR12
- 6 - mild steel

mine water and medium were covered by a thin white film and a yellow-brown film respectively. The films adhered loosely.

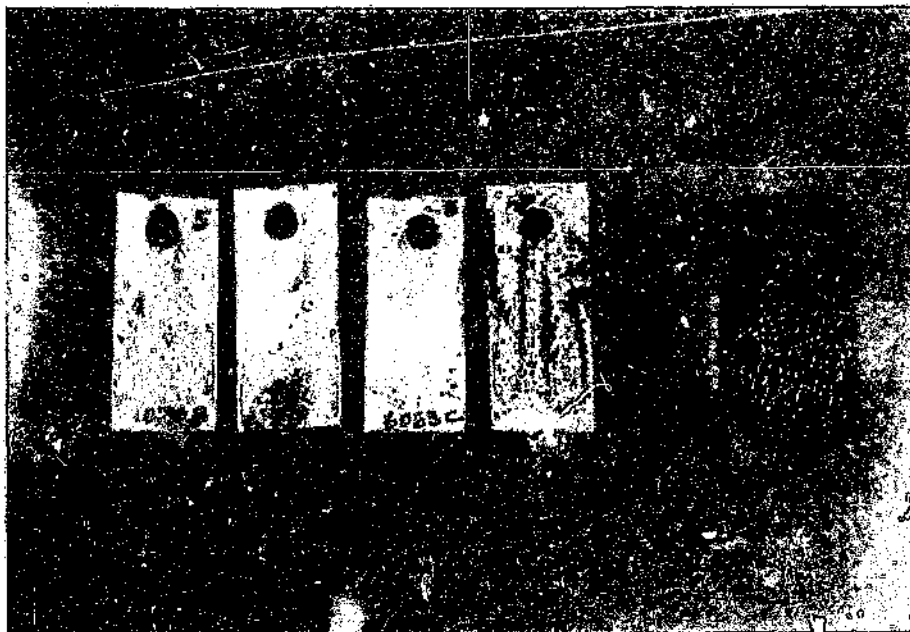
Figure 48. Condition of coupons on removal from the static immersion tests: in *D. desulfuricans* culture in medium.

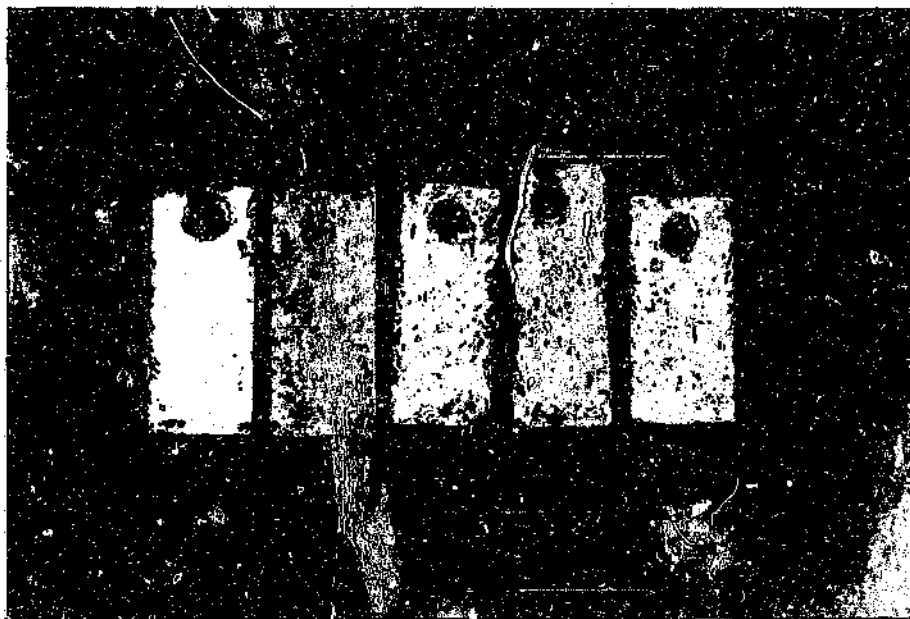
Figure 52. Condition of coupons on removal from *D.desulfuricans* culture in mine water.

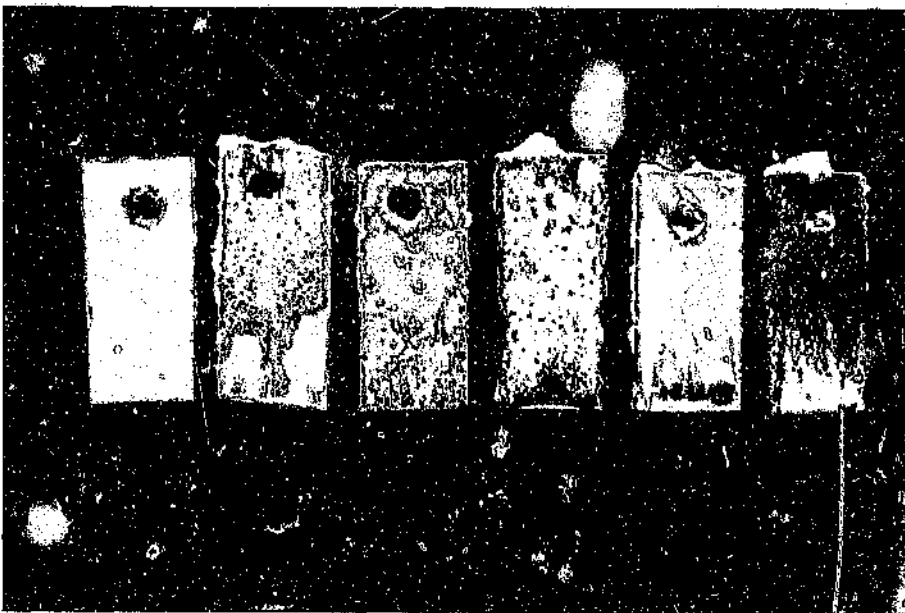
Figure 55. Condition of coupons on removal from sterile deaerated mine water

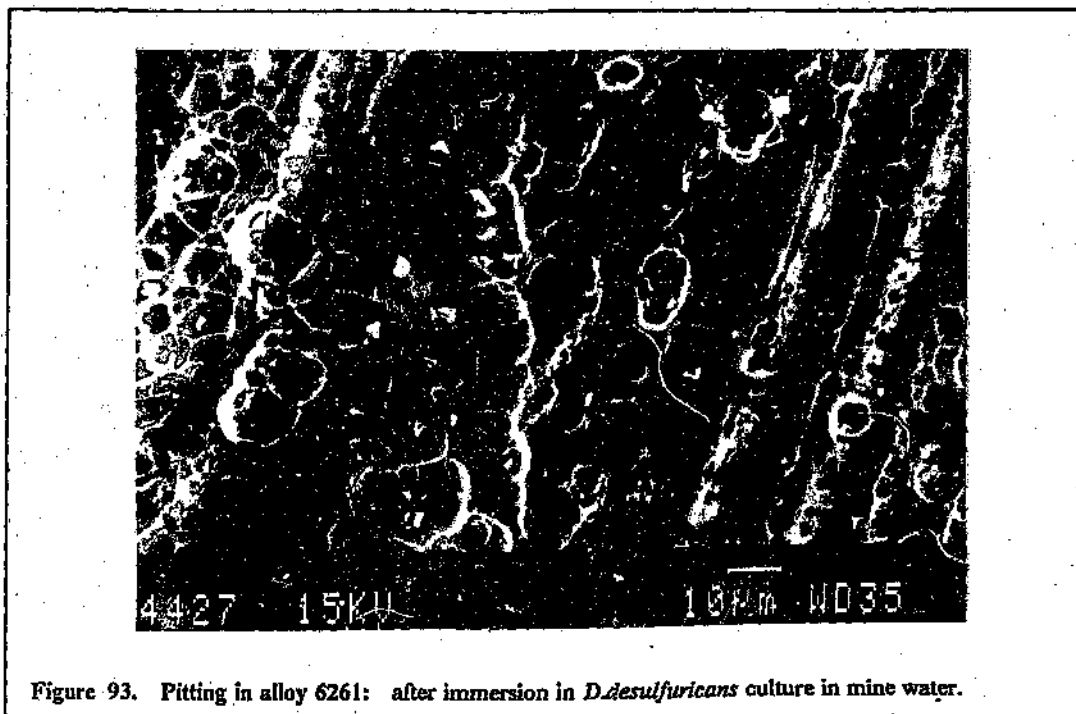
Figure 93. Pitting in alloy 6261: after immersion in *D. desulfuricans* culture in mine water.

Coupons exposed to *D. desulfuricans* cultures were damaged by pitting attack especially in the case of the 6-series alloys (Fig. 93). In some cases, this was seen to follow the grain boundaries (Fig. 94). The 1070 and 5182 alloys tended to show selective phase attack as in the controls (Fig. 95).

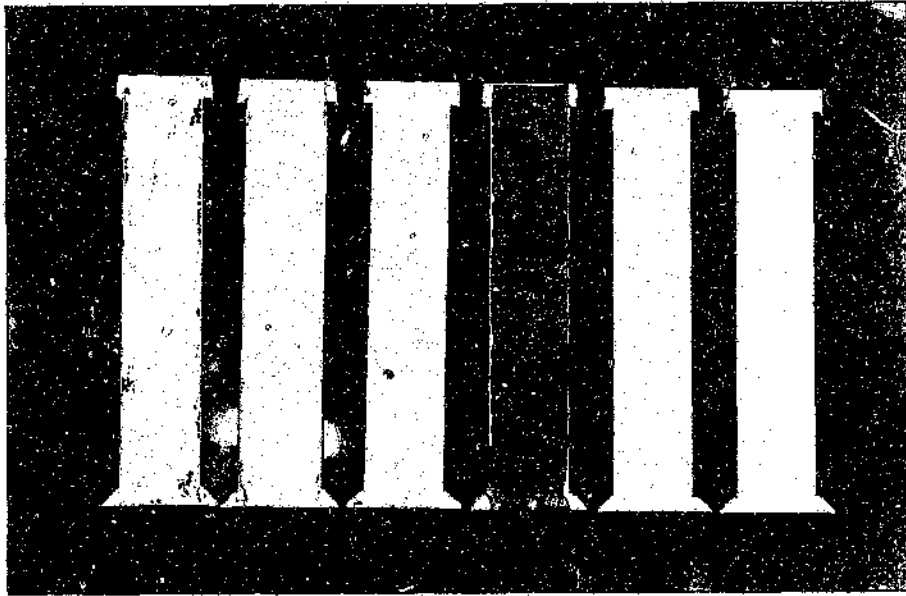
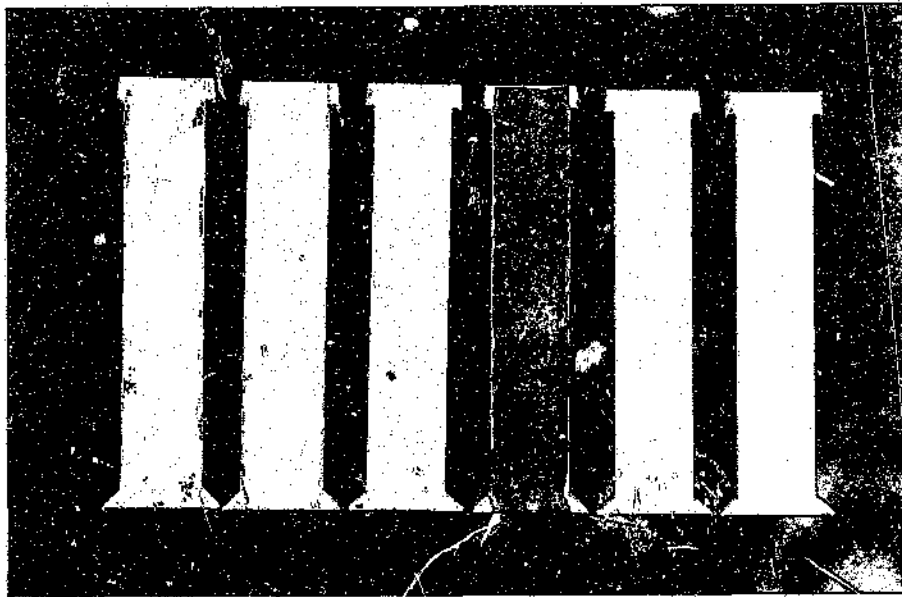
Figure 108. Condition of coupons on removal from sterile flow loop.

The condition of the samples on removal from the flow loop after exposure to both sterile mine water and mine water containing bacteria are shown in Figs. 108 and 109. Under both exposure conditions, the samples appeared to be visually largely undamaged. In both cases the 6261 alloy was covered with an adherent dark brown film, though in the mine water containing bacteria, this alloy was also encrusted with a scale-like deposit in places.

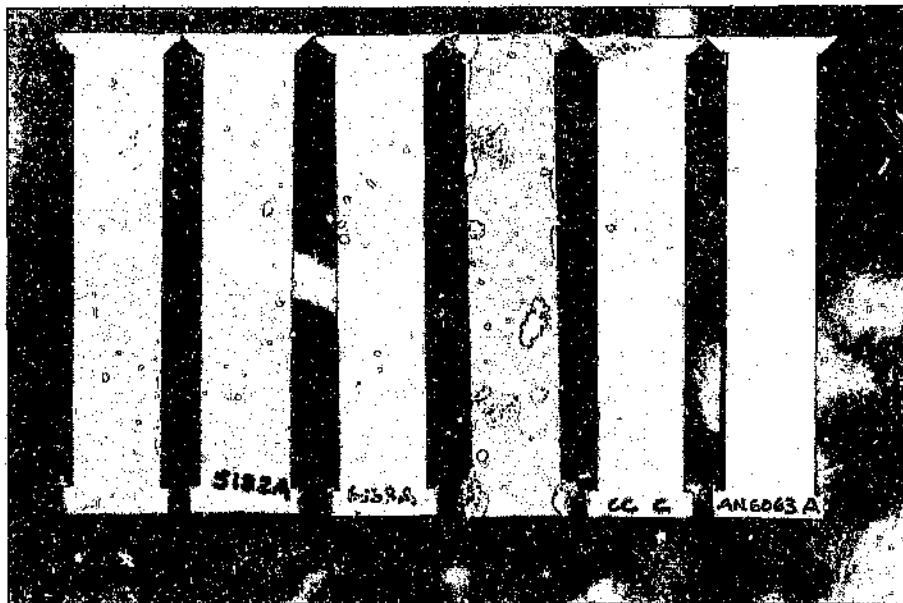
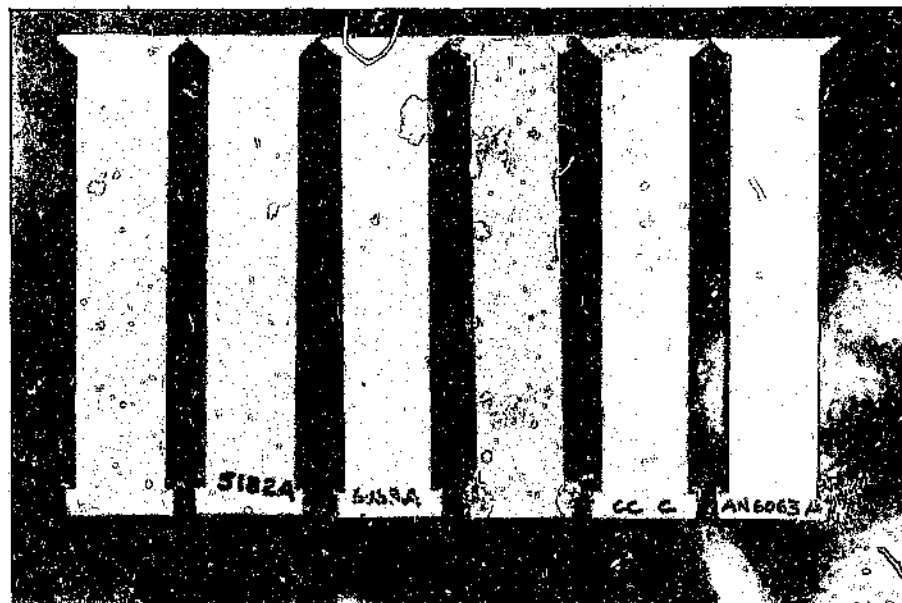
Figure 109. Condition of coupons on removal from flow loop with bacteria.

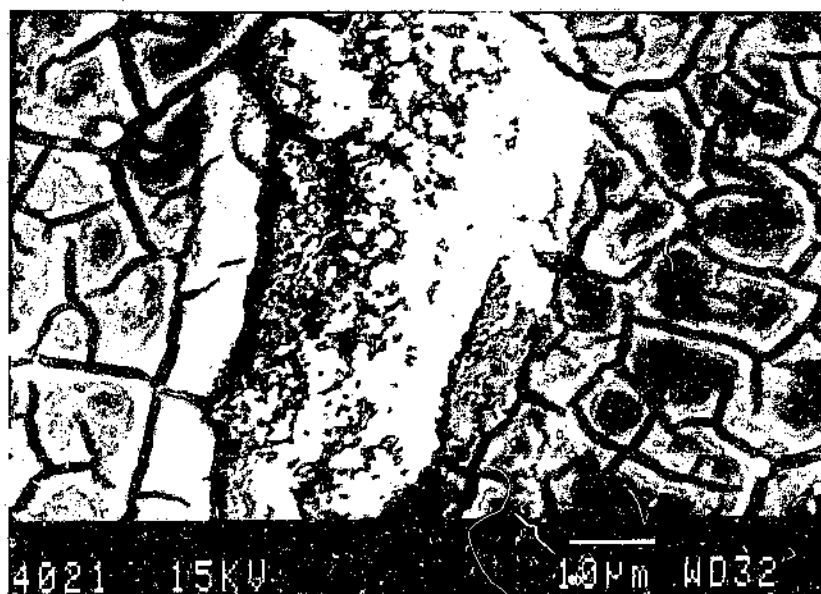
Figure 110. Alloy 1070 from flow loop with bacteria.

Using SEM, it was observed that the alloys were in fact sparsely populated by clumps of cells covered with corrosion product comprising mainly Al, S, P and Ca. (Figs. 110 and 111). Most of the surface was covered by a layer of 'mud-cracked' corrosion product (Fig. 112), which was also present on the control samples. The dark surface deposit on alloy 6261 was shown by the EDAX analysis to contain Al, Si, S, Ca and Cu (Fig. 113). This was for both the control and test samples. The scale deposit on 6261 was identified by EDAX as containing Al, Si, S and Ca. There was no colonization on either the anodized or conversion coated specimens.
