**UNIVERSITY OF THE WITWATERSRAND  
JOHANNESBURG**

**A thesis submitted to the Faculty of the  
Built and Environment, University of the  
Witwatersrand, Johannesburg, in  
fulfilment of the requirements for the  
degree of Doctor of Philosophy**

# **Discrimination between Nearby and Direct Lightning Strikes to a Long Operational Medium Voltage line to Assist in the Determination of the Basic Insulation Level (BIL)**

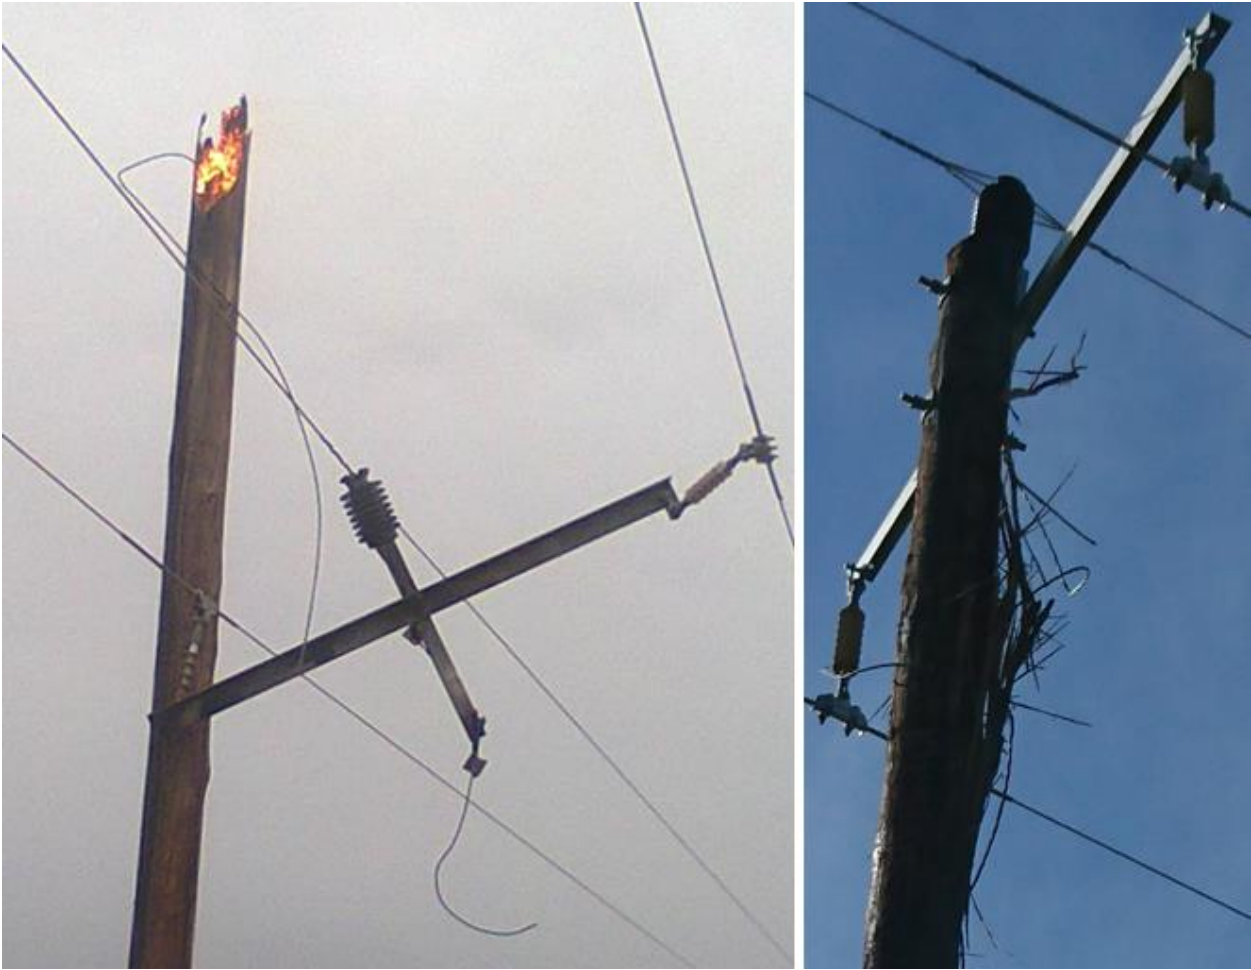
*Figure 1.2 Lightning either ignites or splinters (if the lightning strike exceeds 7 kA [10]) the wood. The insulators of the charcoaled pole were tested to be in perfect order.*

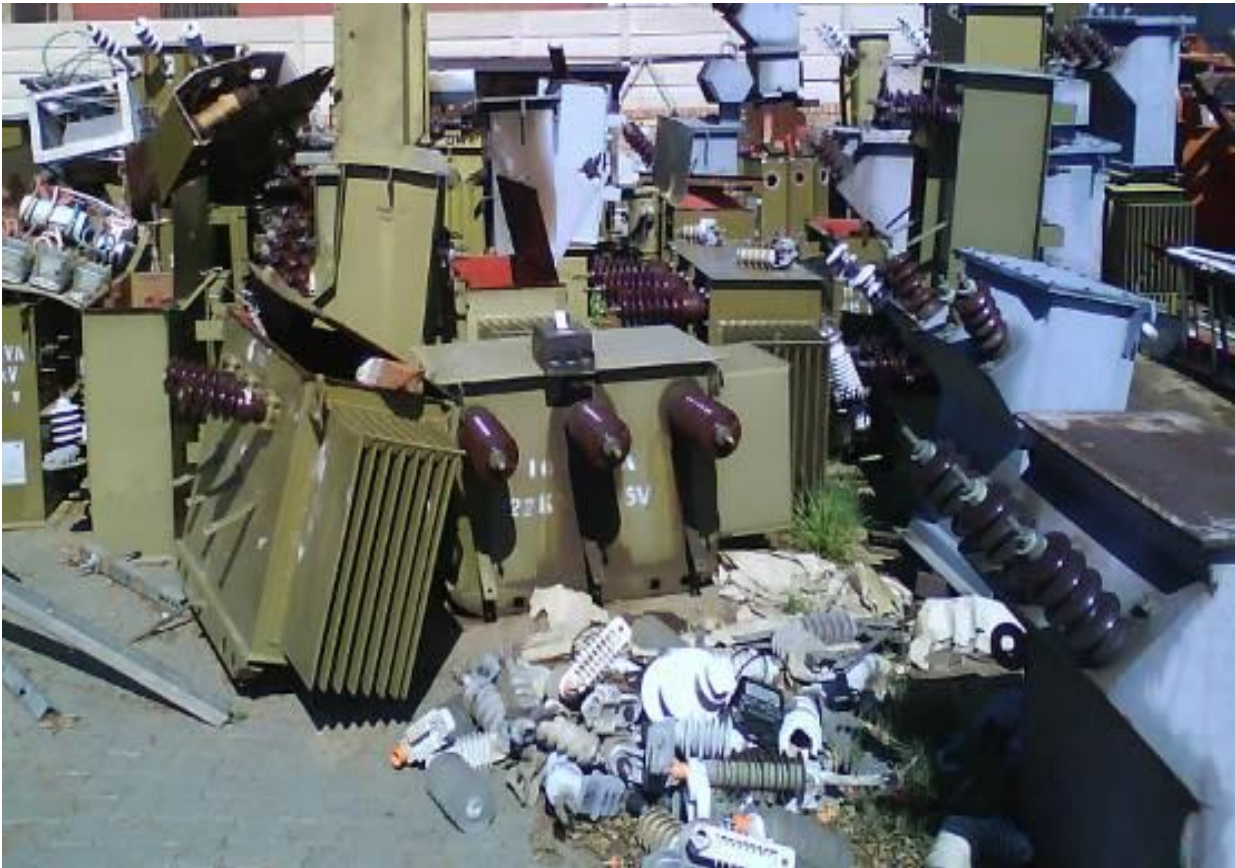
*Figure 1.3 Surge arrester failures resulted in transformer failures at one of the customer Network Centres.*

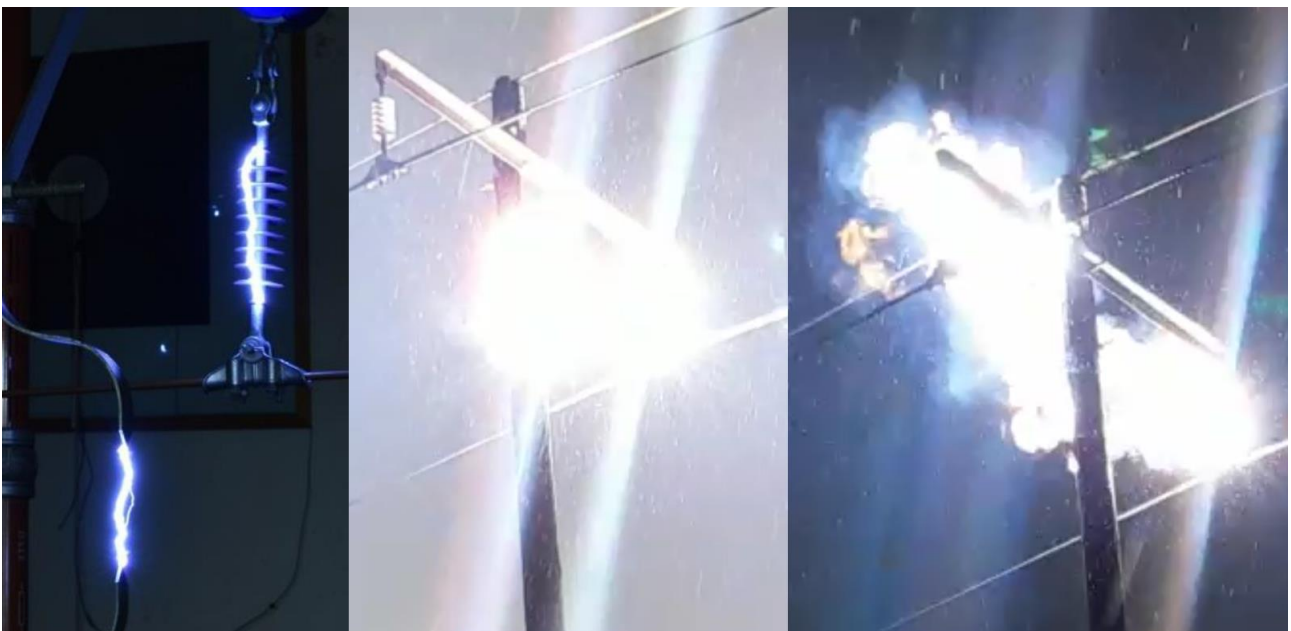
*Figure 1.4 A LIOV that exceeds the BIL will flash over to earth (left). A power frequency fault will then follow (middle) along the spark caused by lightning and if not isolated in time can be developed into a three-phase fault (right).*

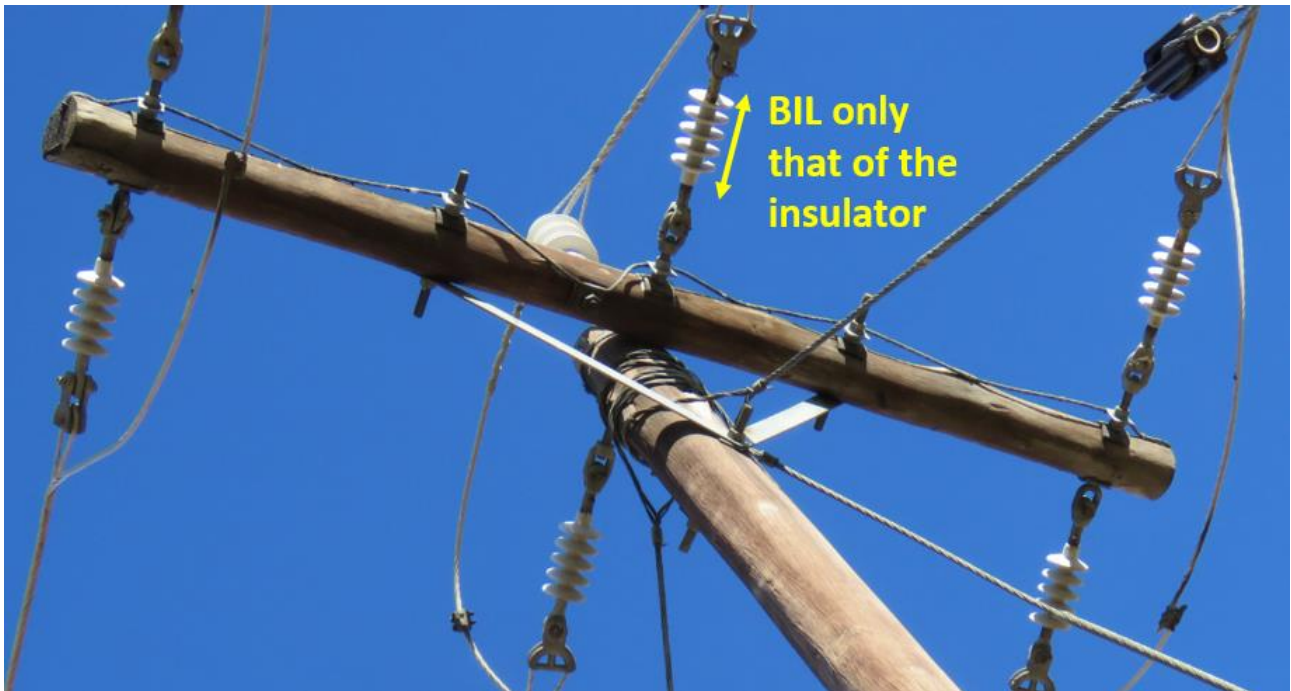
Figure 2.36 A pole-top configuration of a strain pole with stays. The BIL was limited to the insulator BIL of 150 kV. The contribution of the stay insulator to the BIL was negligible.

The intention was to design the RVZ line according to a 300 kV philosophy which was implemented on most of the line suspension poles as shown in Figure 2.35. The reason for using wood as part of the insulation was to increase the line BIL at a low cost to improve the nearby lightning performance of the line during lightning storms [150]. A flashover (due to high LIOV) along a wood path is characterized by a relatively high residual arc voltage which gives the wood some arc-quenching properties [150]. Strain poles with stays had a BIL of 150 kV (only the insulator BIL) as shown in Figure 2.36. The strain poles also effectively lower the suspension poles' BIL.

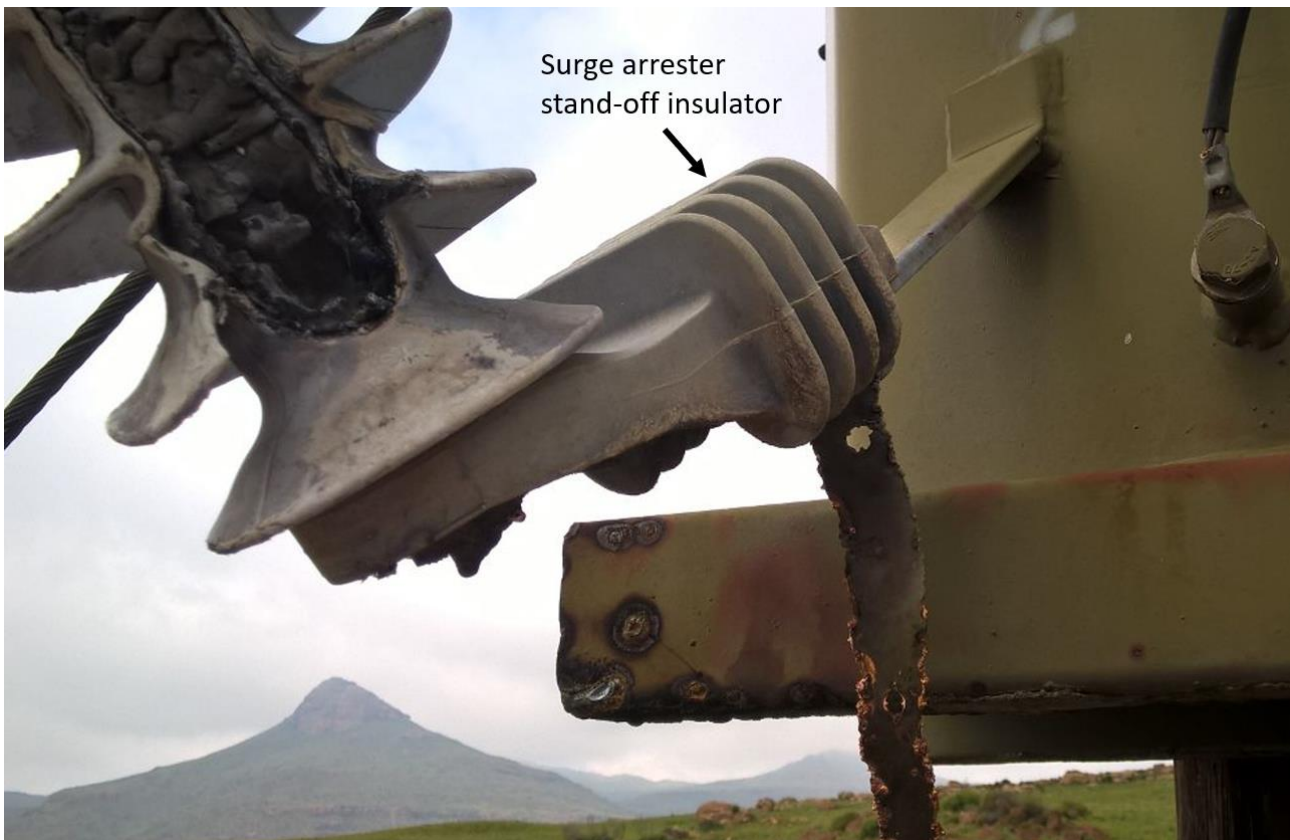
*Figure 4.5 A surge arrester with a failed ground lead disconnecter. The surge arrester stand-off insulator had a very short creepage distance and the power frequency insulation was further compromised by moisture during thunderstorms.*
