**UTILISING INTERFEROMETRIC SYNTHETIC  
APERTURE RADAR AND GROUND-BASED  
RADAR DATA TO PREDICT TIME TO FAILURE  
AND TO CALIBRATE NUMERICAL MODELS  
ON AN OPENCAST COAL MINE**

A research thesis submitted to the Faculty of Engineering and the Built Environment, University of the Witwatersrand, Johannesburg, in partial fulfilment of the requirements for the degree of Master of Science in Engineering.

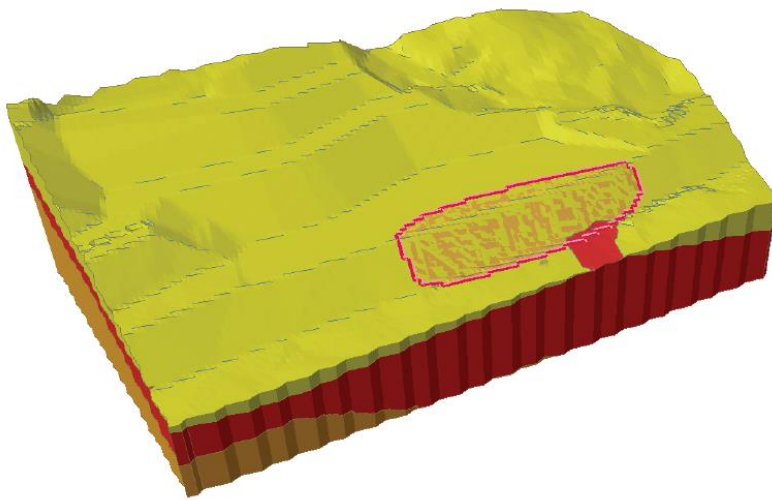
Slope instability was detected with a ground-based radar in a 250 m deep gold mine in Papua New Guinea. The initial 3D limit equilibrium stability analysis indicated that the slope had an SF of 1.49 (refer to *Figure 5*).

*Figure 5: Initial 3D limit equilibrium stability analysis indicating an SF of 1.49 (McQuillan et al., 2020).*

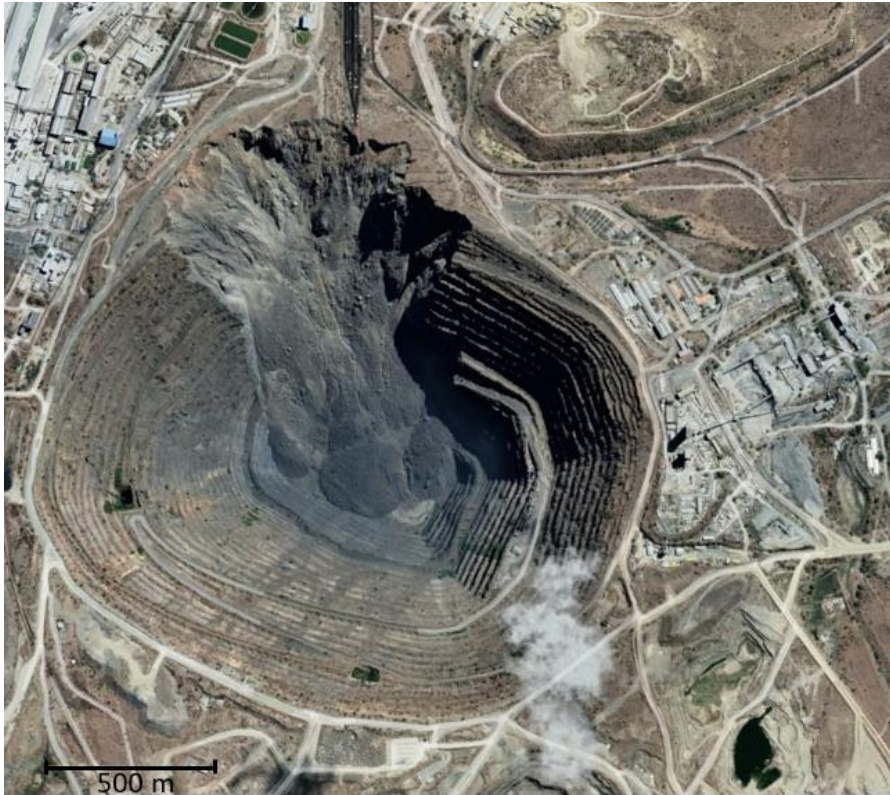
The Palabora copper mine is situated in the Limpopo province of South Africa. The opencast operation is approximately 800 m deep and 1900 m wide. The mine transitioned from an opencast operation to an underground block-caving operation in April 2001. Three years after the underground block caving had commenced, cracks were observed on the northwest wall of the pit. The cracks propagated over several months until the pit wall failed (Woo et al., 2012). The extent of the failure can be seen in Figure 9.

*Figure 9: Slope failure at Palabora copper mine (Woo et al., 2012).*

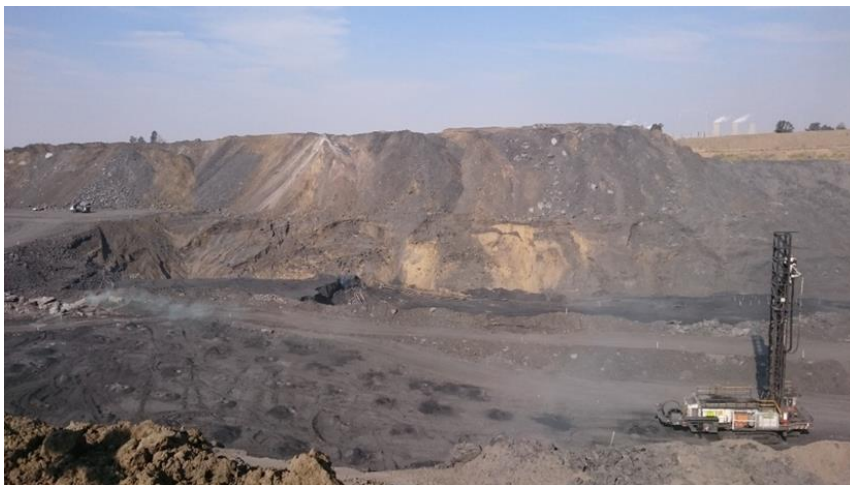
A low wall circular failure occurred on 18 August 2016. The low wall, which was placed by a dragline, consisted of a mixture of sand and blasted siltstone and shale; refer to Figure 11.

*Figure 11: Ramp 19 low wall failure that occurred on 18 August 2016.*

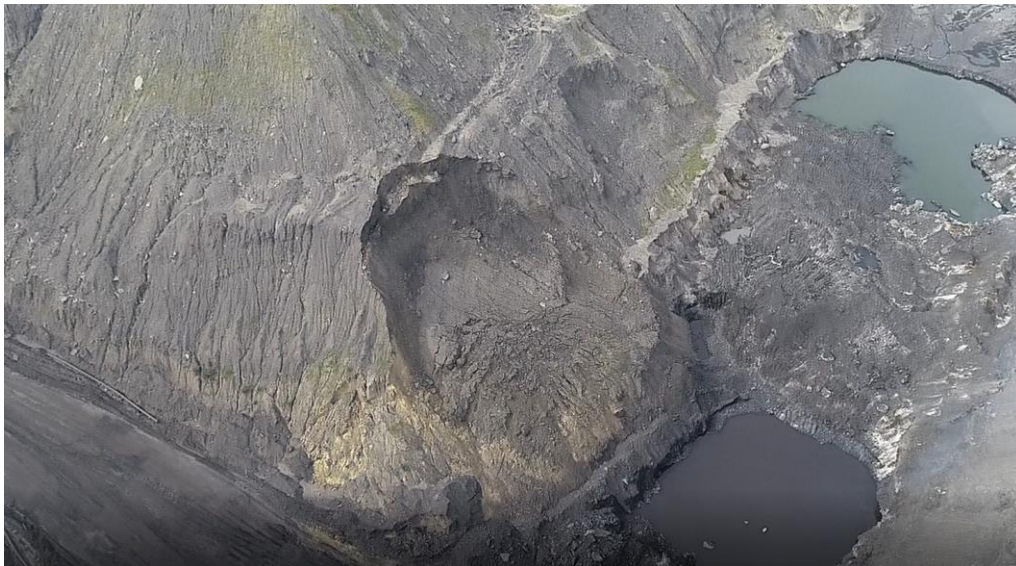
A low wall circular failure occurred in Ramp 20 on 30 March 2019. The low wall, which was placed by a dragline, consisted of a mixture of sand and blasted siltstone and shale; refer to Figure 13.

*Figure 13: Ramp 20 low wall failure that occurred on 30 March 2019.*

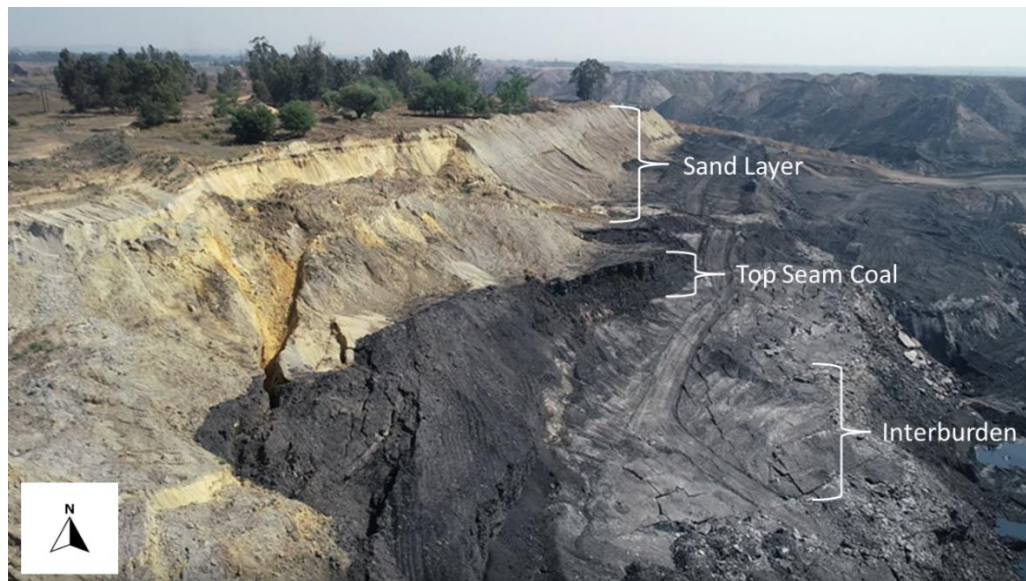
A multi-bench highwall failure occurred in Ramp 2-4 on 22 October 2020. The slope height was 62 m and consisted of sand, siltstone and shale; refer to Figure 15.

*Figure 15: Ramp 2-4 highwall failure on 22 October 2020.*

A pinnacle and fault plane were visible on the highwall. Take note of the relatively intact interburden. The sand layer is approximately 20 m thick. The measured LOS displacement can be seen in Figure 16.

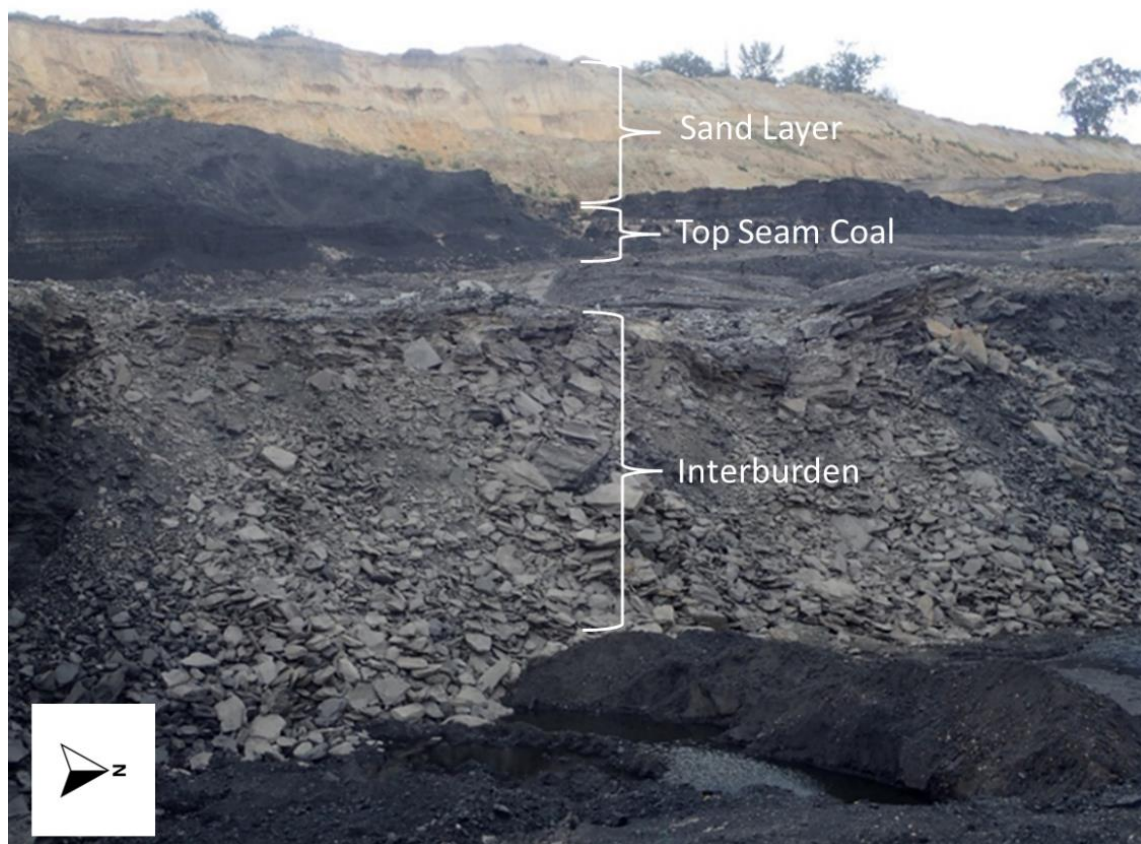
On 8 December 2020, a second failure occurred on the interburden of the highwall failure discussed in section 3.4.3; refer to Figure 17. The area was monitored with a ground-based radar at the time of the failure and discussed in section 3.4.3 of this report. The interburden is approximately 12 m thick. Take note that the interburden bench did not fail completely.

*Figure 17: A second interburden failure that took place on the highwall of Ramp 2-4.*

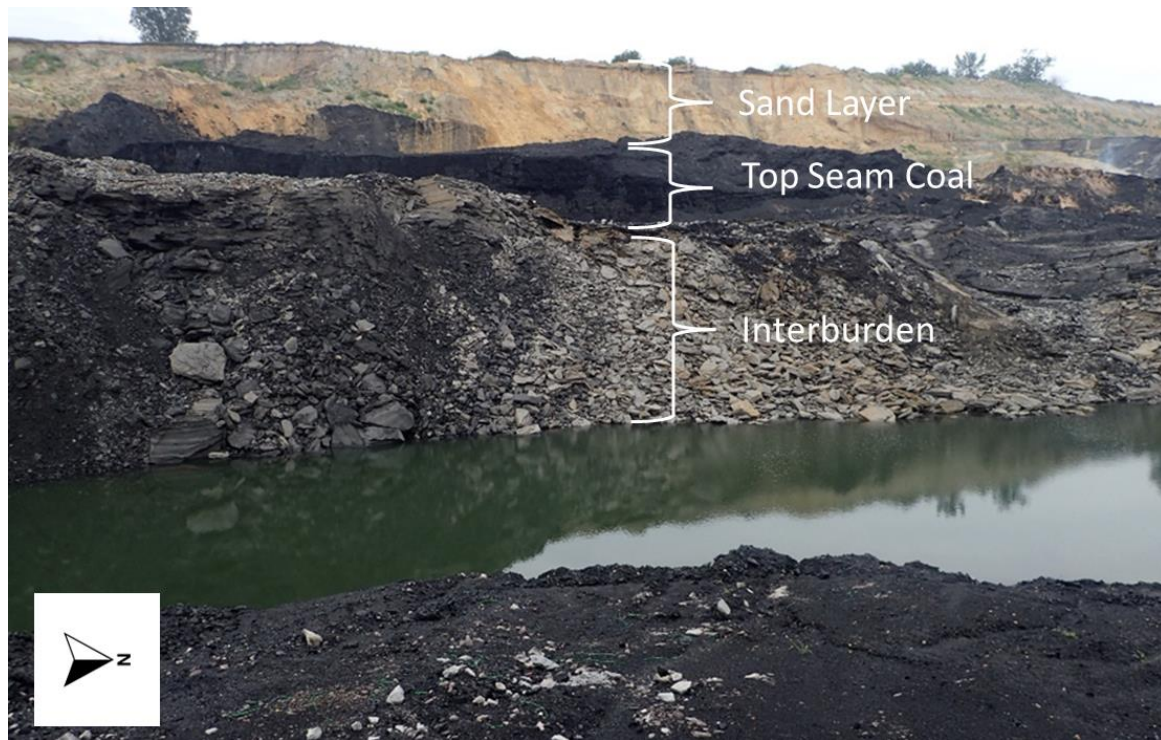
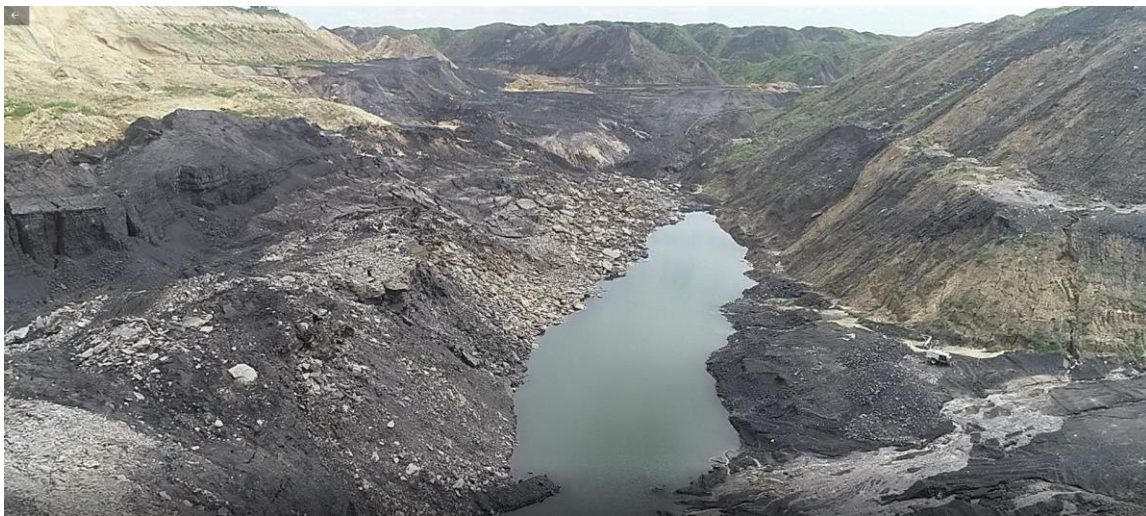
On 1 January 2021, a third failure occurred on the interburden of the highwall failure discussed in section 3.4.3 of this report (refer to Figure 19). The interburden was approximately 12 m thick in this area. The area was monitored with a ground-based radar at the time of the failure. Refer to section 3.4.3 of this report.

*Figure 19: Complete interburden failure of the highwall in Ramp 2-4.*

*Figure 20: Drone image of the complete interburden failure of the highwall in Ramp 2-4.*
