**UNIVERSITY OF THE  
WITWATERSRAND,  
JOHANNESBURG**

**ASSESSMENT OF IN-SERVICE DURABILITY  
PERFORMANCE OF NATURAL DRAFT COOLING TOWERS  
IN A PETROCHEMICAL ENVIRONMENT**

A Dissertation submitted to the Faculty of Engineering and the Built Environment, University of the Witwatersrand, Johannesburg, in partial fulfilment of the requirements for the degree of Master of Science in Engineering.

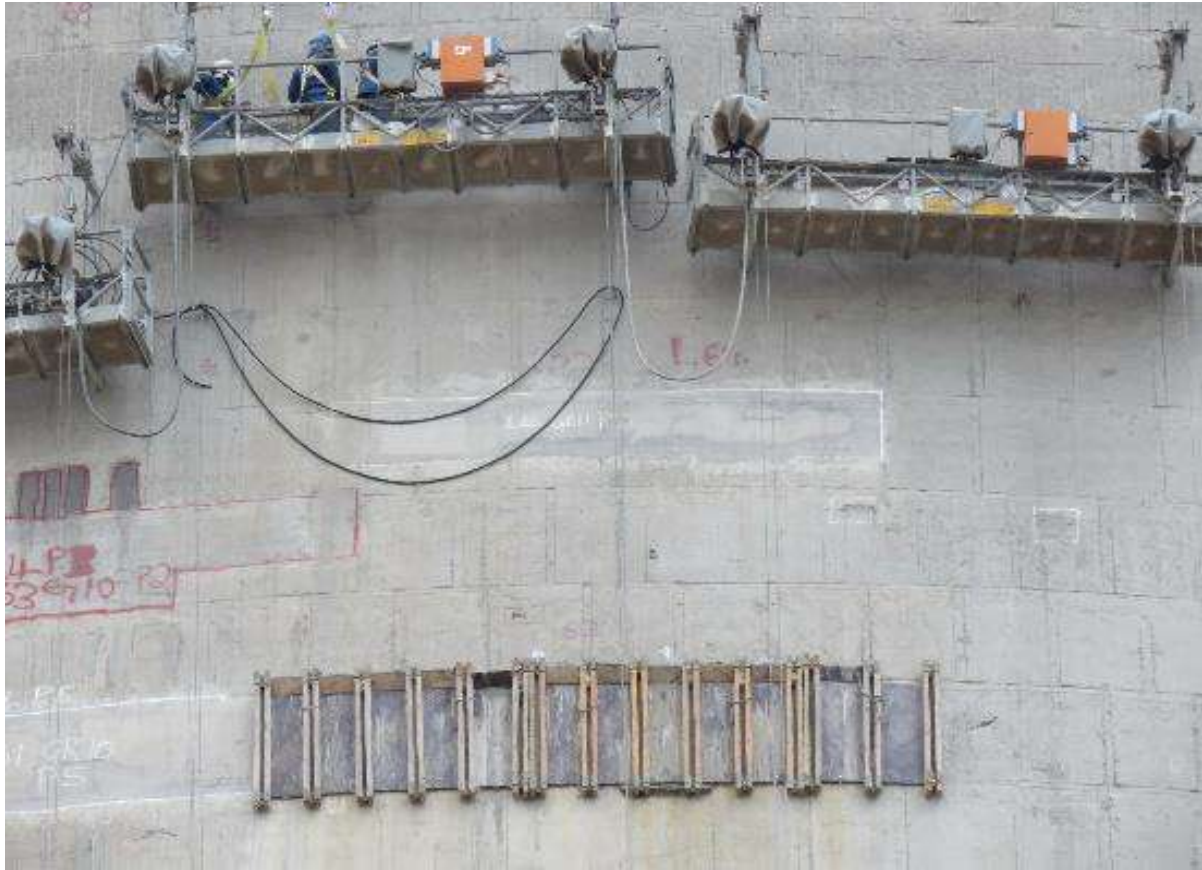
Figure 3-7: TSPs being supported by their associated guy ropes.

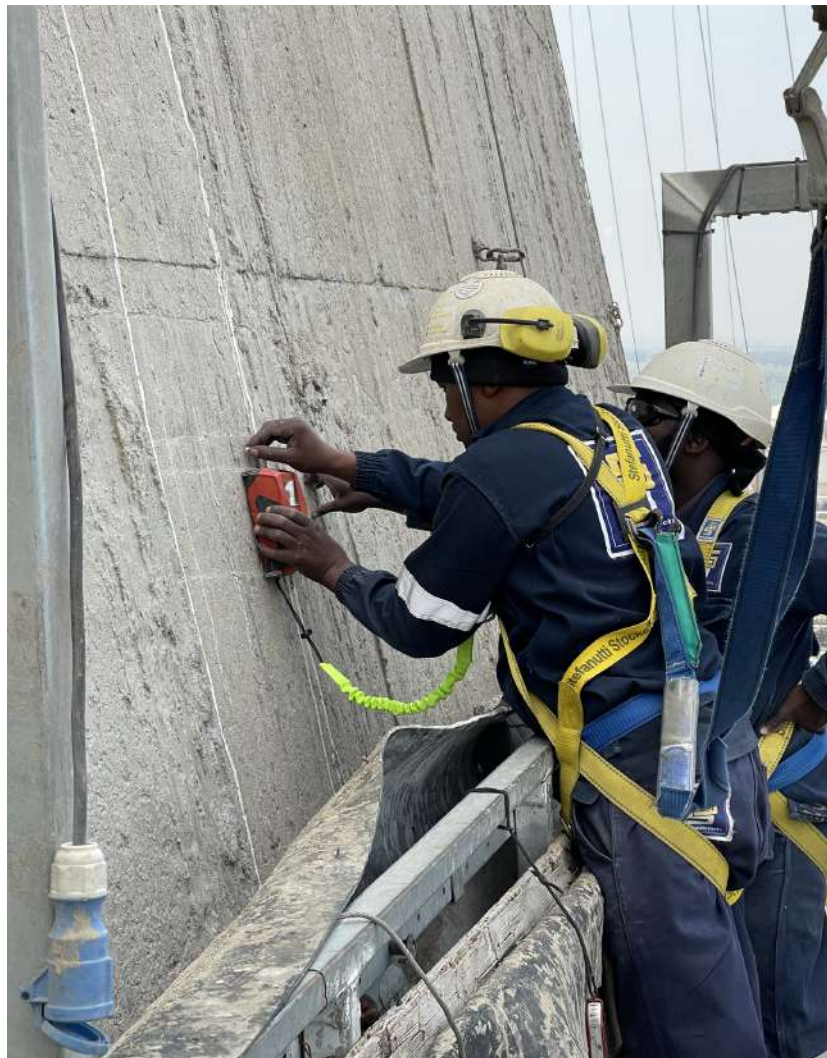
- Care was taken to minimize damage to reinforcing bars (rebar) during the core extraction process as shown in Figure 3.8. This was done through the use of Ground Penetrating Radar (GPR) scanning technology to detect the presence and approximate location of reinforcing steel within the concrete. Core extractions were strategically positioned to minimize interference with the reinforcing as far as possible.

*Figure 3-8: Contractor using GPR Technology to identify the location of Reinforcing bars.*

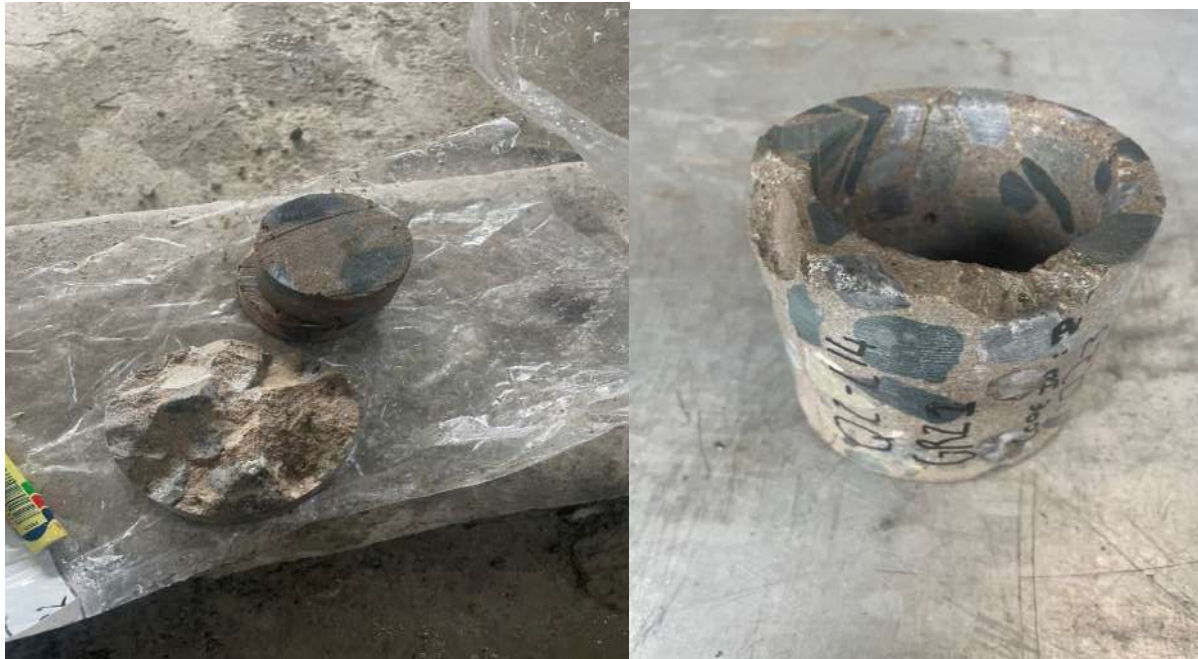
In order to conduct these tests,  $70 \pm 2$  mm diameter cores are extracted from the designated locations within the test structures. In the case of the Sasol Secunda cooling towers 100 mm cores were extracted from the test structures. Subsequently, the  $70 \pm 2$  mm cores were extracted from the 100 mm core as shown in Figure 3.9 below.

Figure 3-9: 70mm durability specimen extracted from a 100mm core.

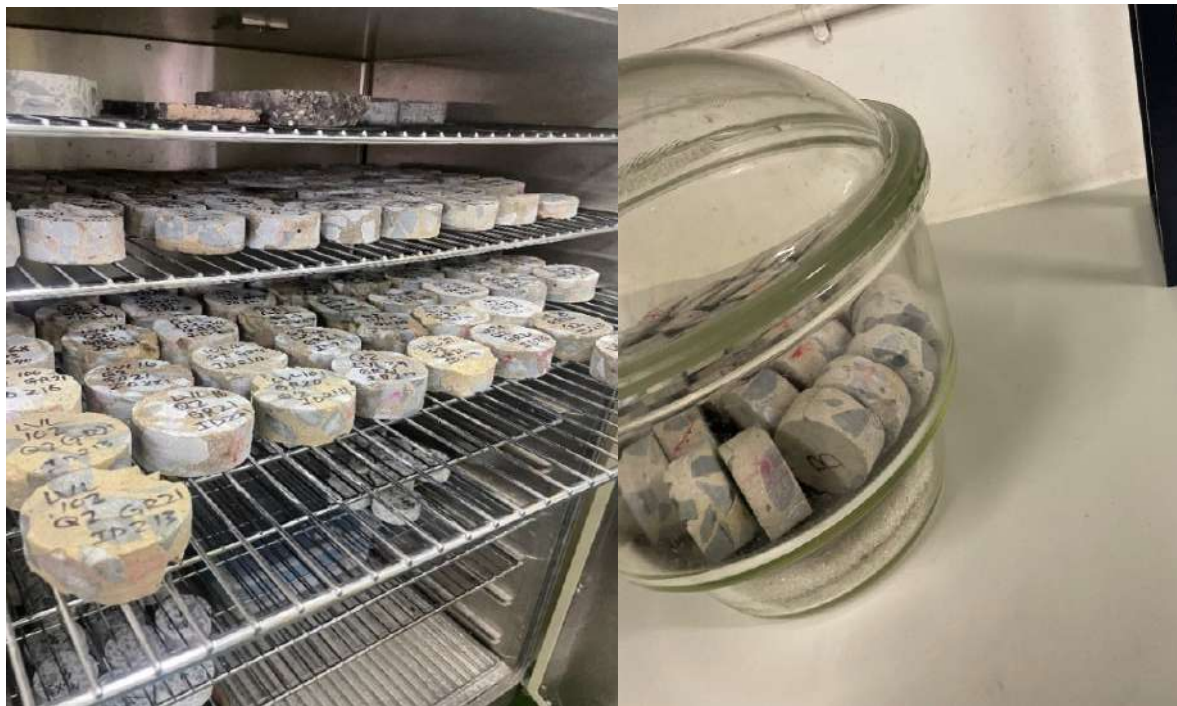
The specimens were placed in the oven as shown and maintained at  $50 \pm 2^\circ\text{C}$ , for a period of 7 days. Sufficient space was allowed between and around specimens to ensure uniform drying. The specimens were removed from the oven and immediately placed in the desiccator as shown.

Figure 3-10: Durability specimens discs being dried in the oven and dessicator.

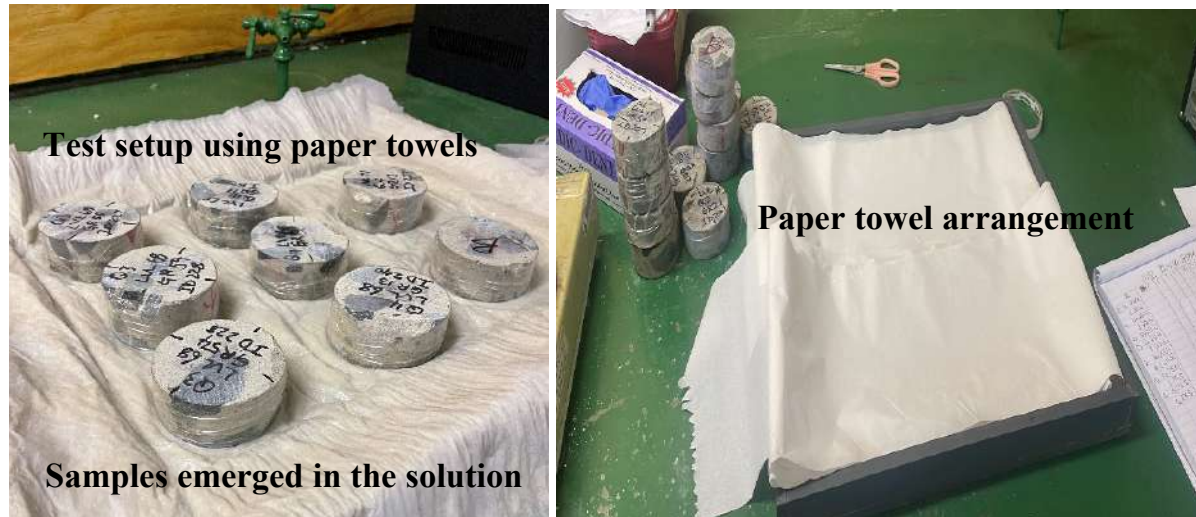
The weight of the partially immersed concrete discs ( $M_{sat}$ ) was accurately measured at intervals of 3, 5, 7, 9, 12, 16, 20, and 25 minutes. The samples underwent vacuum saturation at pressures ranging from  $-75\text{kPa}$  to  $-80\text{ kPa}$  for a duration of three hours. The chamber was then filled with the  $\text{Ca}(\text{OH})_2$  solution to a level of 40 mm above the top of the specimens. The vacuum saturation process was repeated at the same pressures for an additional one hour, plus or minus 15 minutes. The specimens were allowed to soak for an additional 18 hours before being subjected to another round of weighing to achieve the vacuum saturated mass ( $M_{sv}$ ) of the samples. An image of the experimental procedure is depicted below in Figure 3.12 and 3.13.

Figure 3-12: Water Sorptivity Test being carried out in the laboratory.

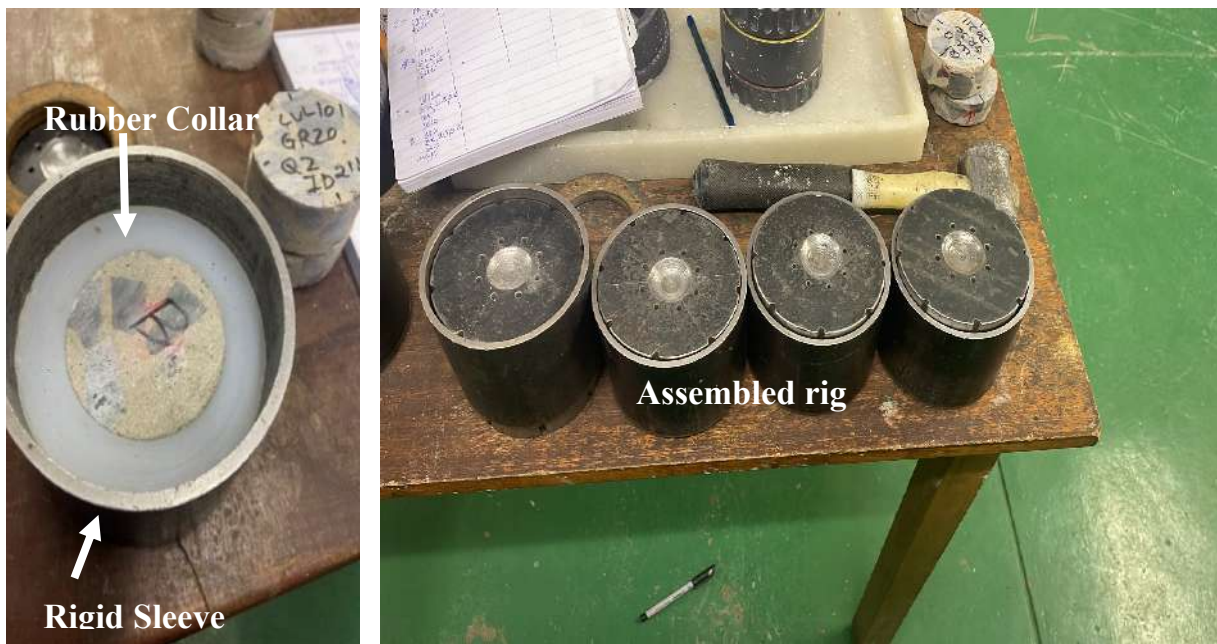
Figure 3-17 – Samples being inserted into the collar.

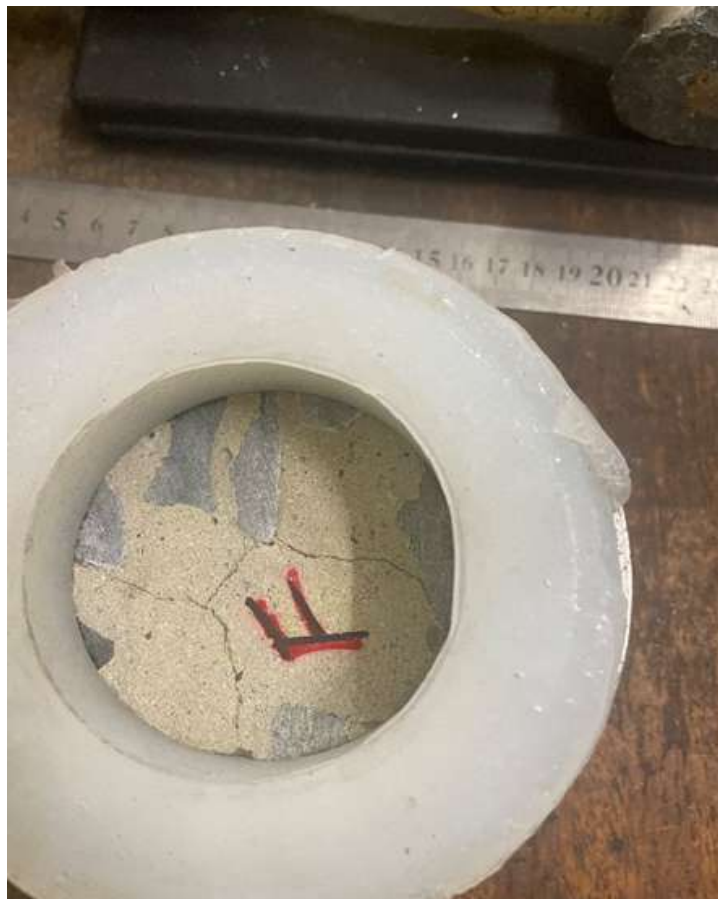
The limitation with this testing method is that it only focuses on sound concrete for testing (Kanjee, 2015). Regardless of whether the structure exhibits signs of cracking on the surface, this area of concrete cannot be used for testing Figure 3.19 below indicates a cracked sample being inserted to the collar that was rejected for testing.

*Figure 3-19: Cracked specimen inside the collar rig.*

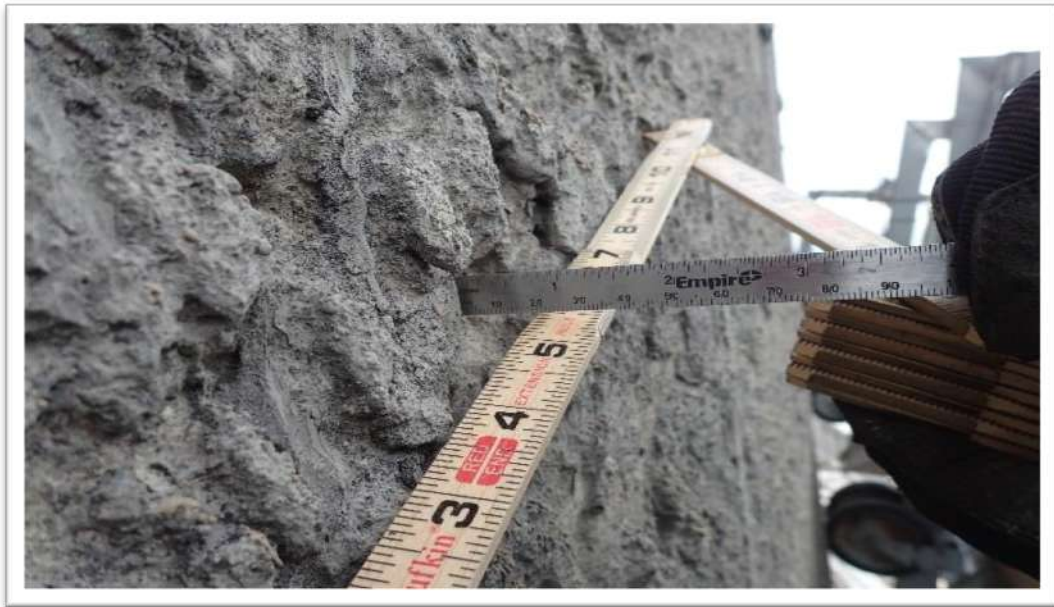
Beyond cracking and spalling, visual assessment revealed areas of softened concrete, surface erosion, and exposed aggregate (Figure 4.1). This erosion of the cement paste matrix is indicative of advanced deterioration and exposes the concrete to further degradation. The variability in concrete condition, even within the same lift level, suggests potential inconsistencies in material properties, construction practices, or localized exposure to aggressive environmental factors.

*Figure 4-1: Exposed aggregate due to erosion of cement paste (Gries et al, 2022)*

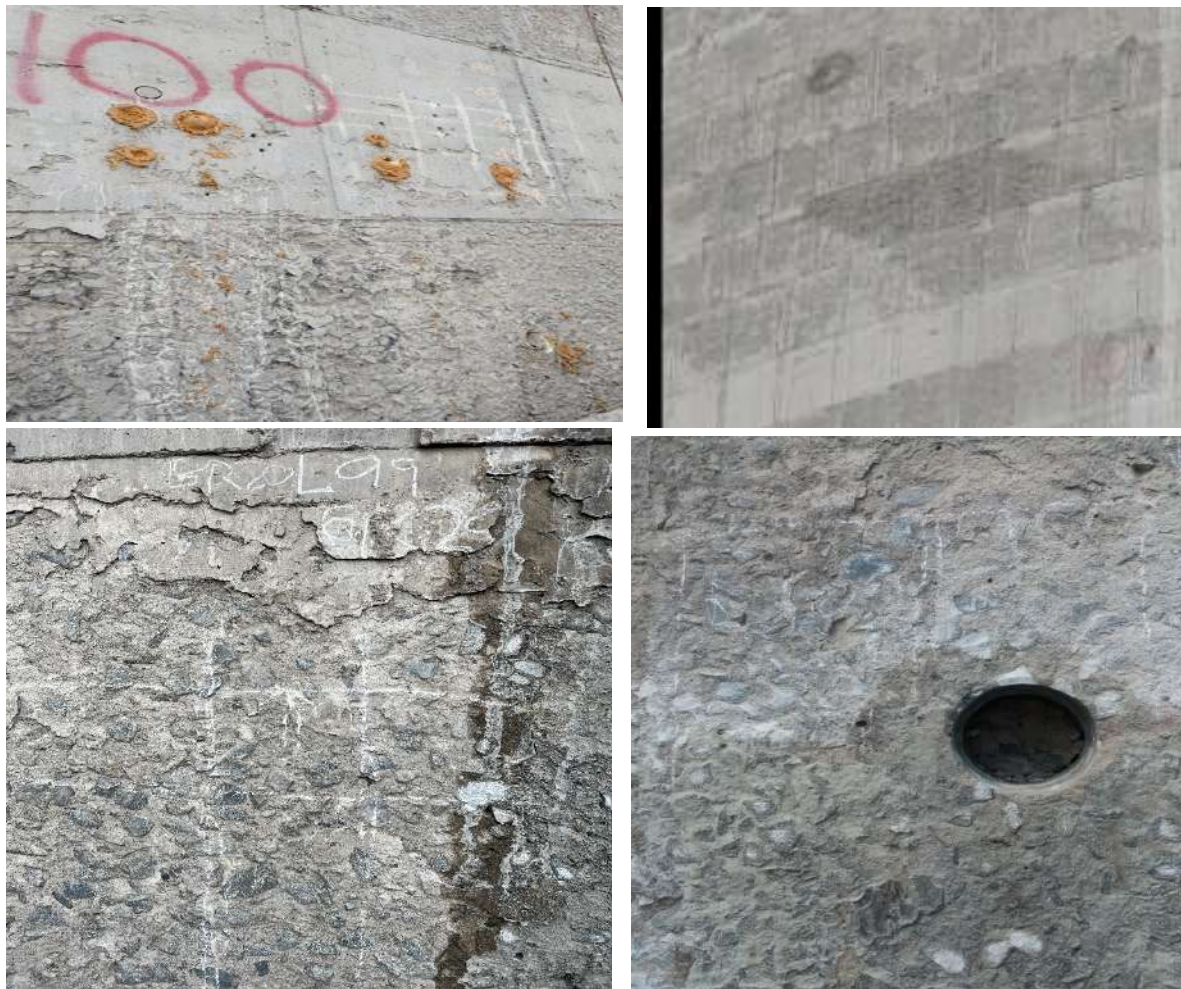
These observations suggest a potential combination of factors contributing to the observed deterioration. The localization of severe erosion at the upper level aligns with the view of increased exposure to aggressive chemicals such as chlorides and sulfates, temperature fluctuations, and moisture accumulation discussed previously. The significant variation in concrete quality, even within close proximity, could be attributed to inconsistencies in material properties, construction practices, or the presence of localized aggressive agents within the process water in the cooling tower. The water chemistry is discussed later in this chapter.

*Figure 4-2: Varying concrete conditions at different locations of the tower*

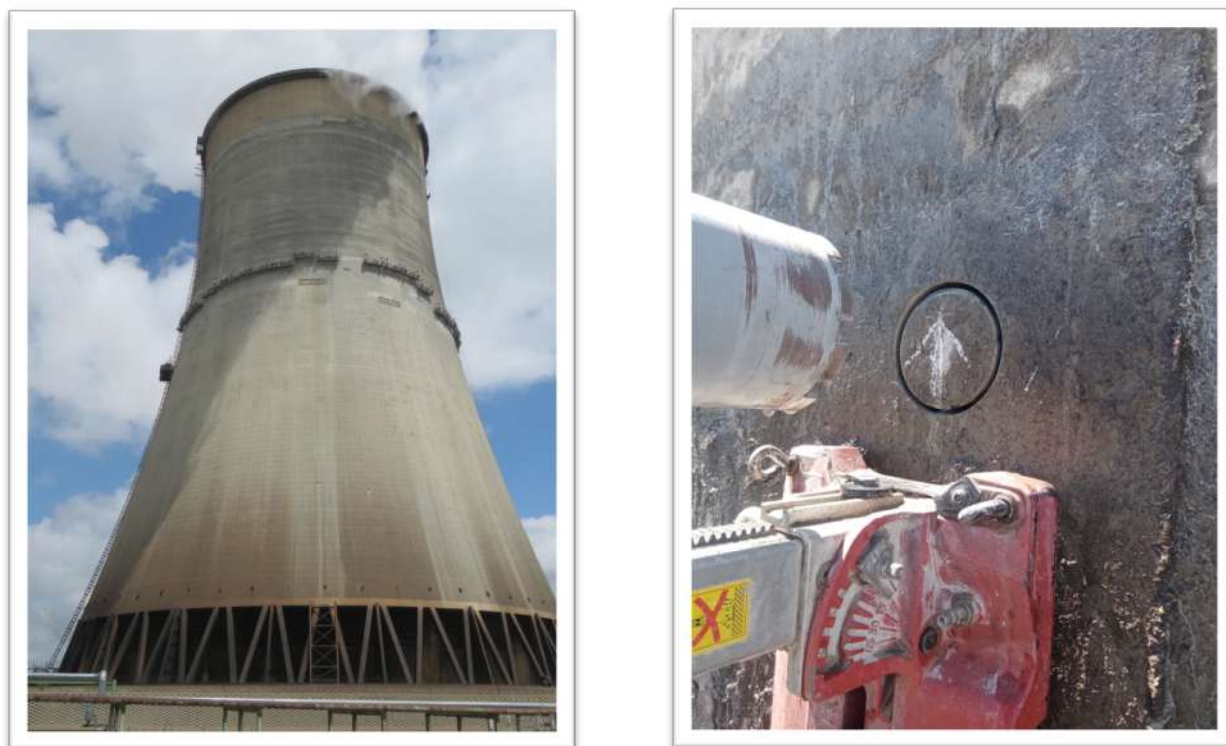
Figure 0-1 - Overall image of CT 245B and the core drilling rig being aligned into place

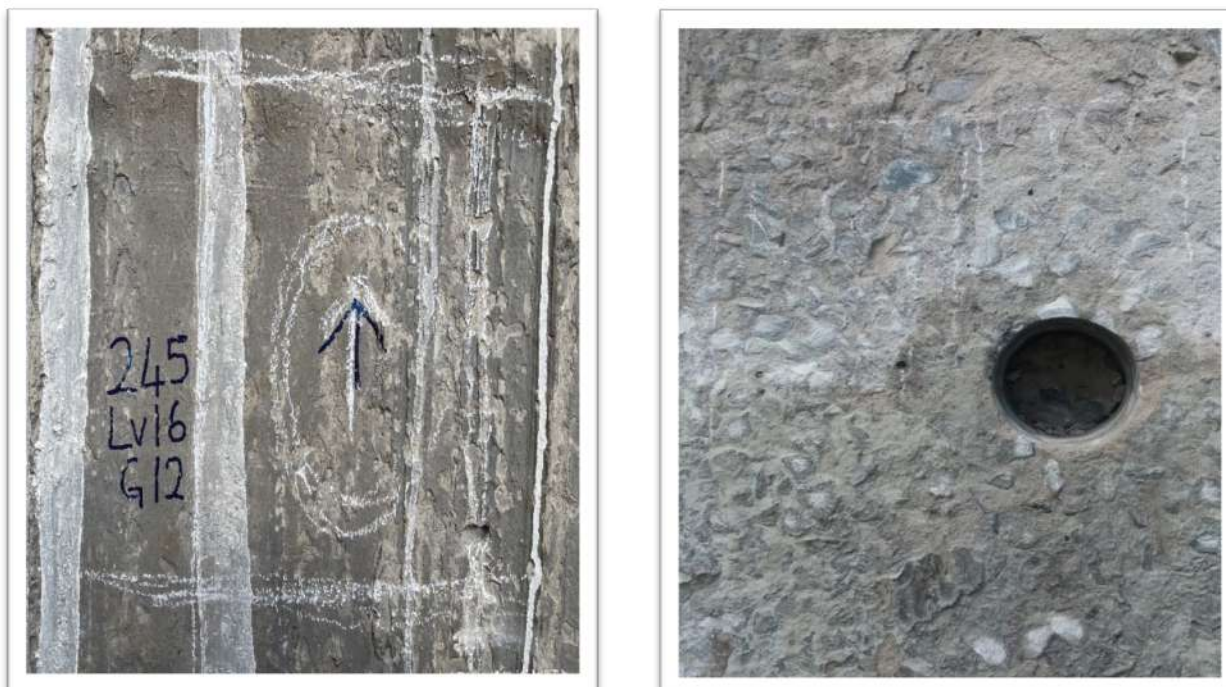
Figure 0-2 Marking out of core location and after core was extracted

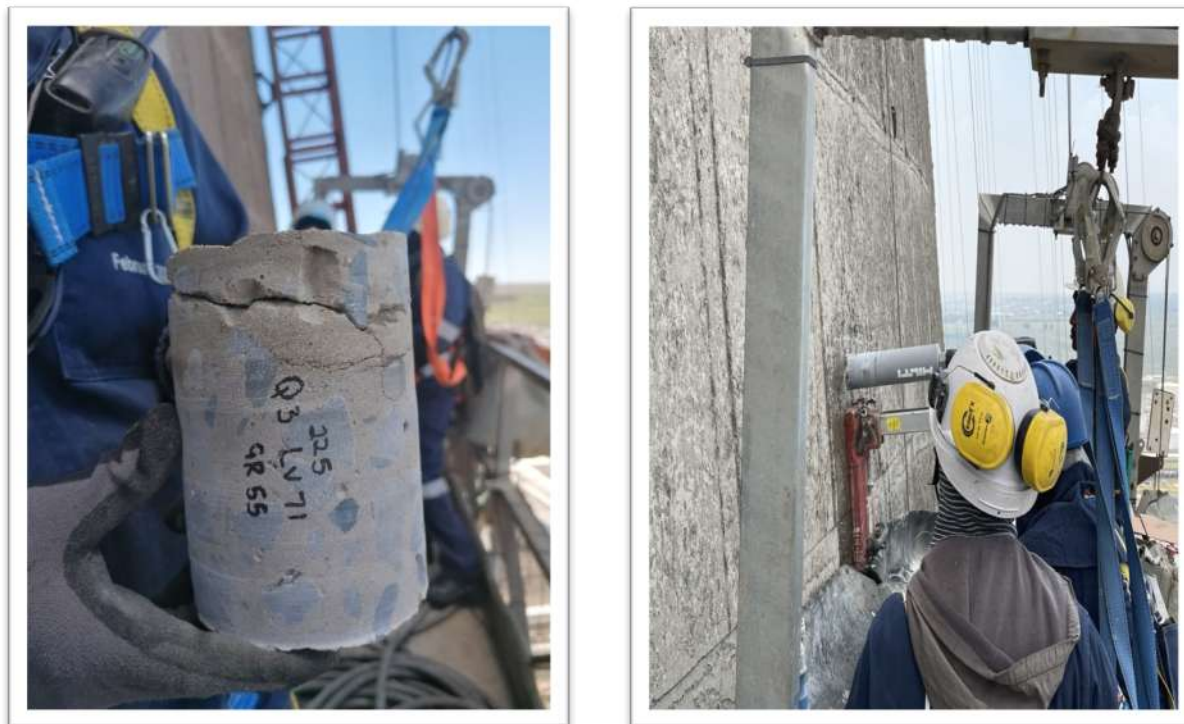
Figure 0-3 General photographs of the extraction process

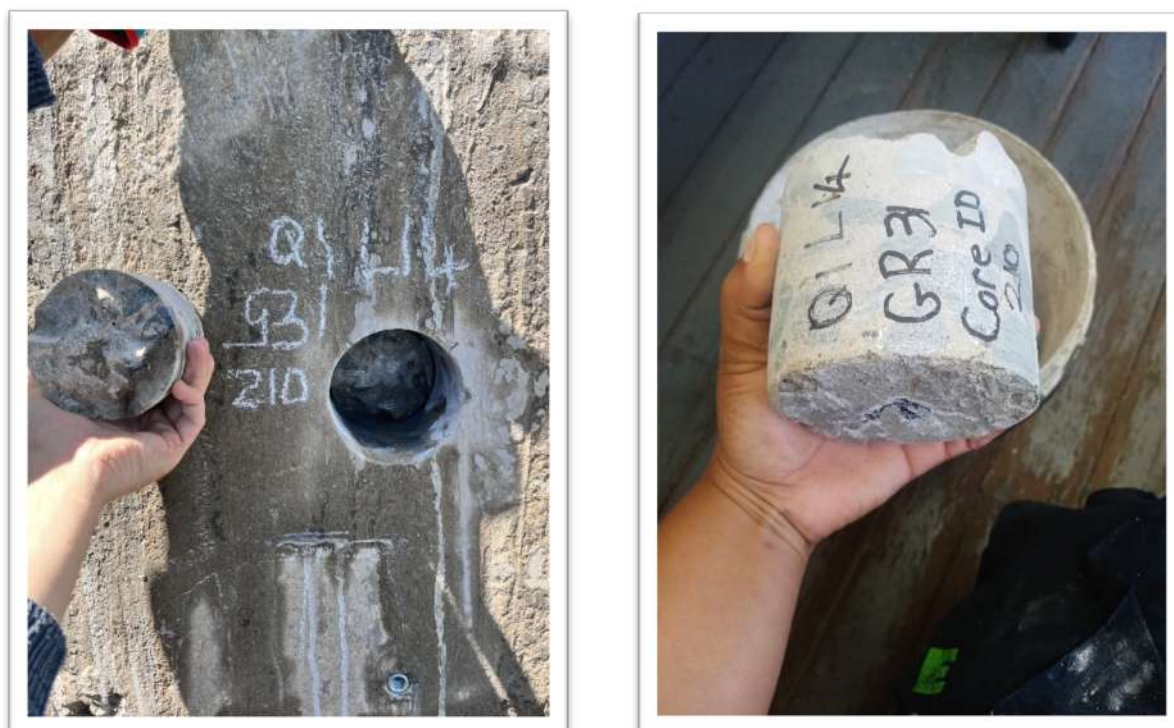
Figure 0-4 Core extracted from Quarter 1 level 14

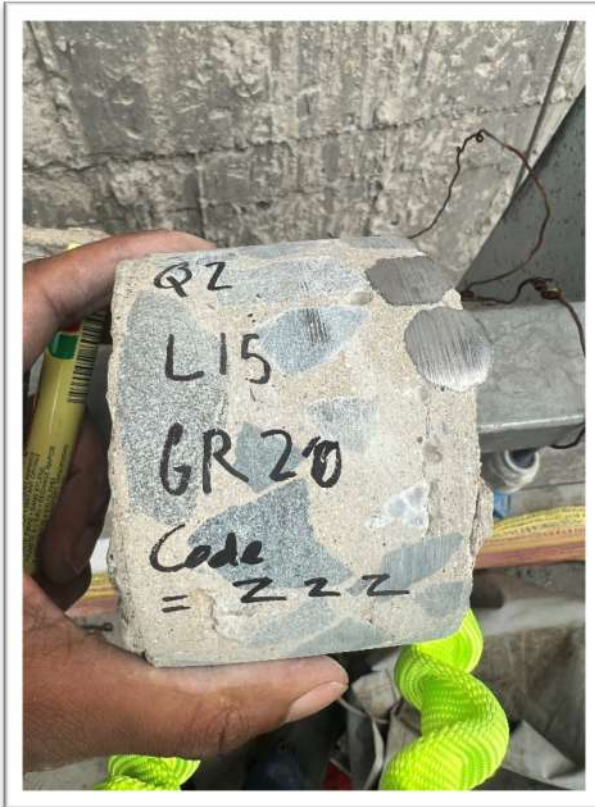
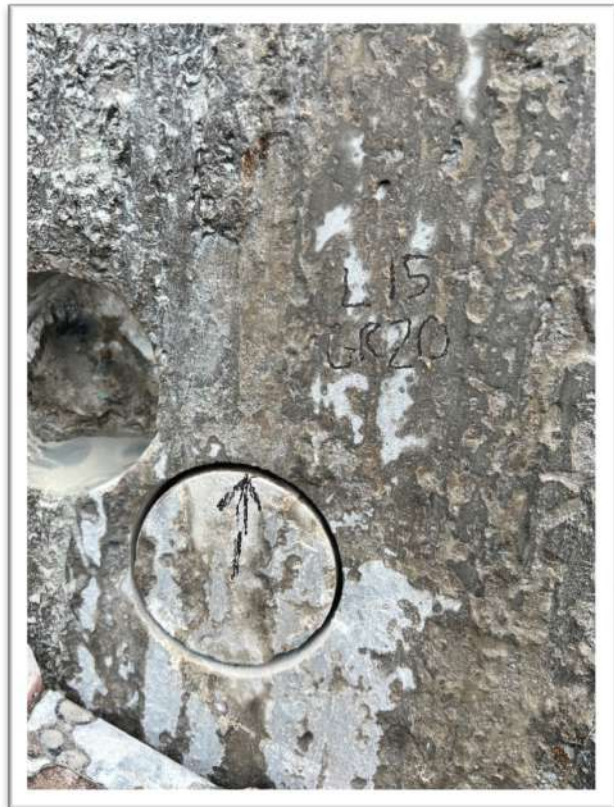
Figure 0-5 Cores extracted from Quarter 2 level 15

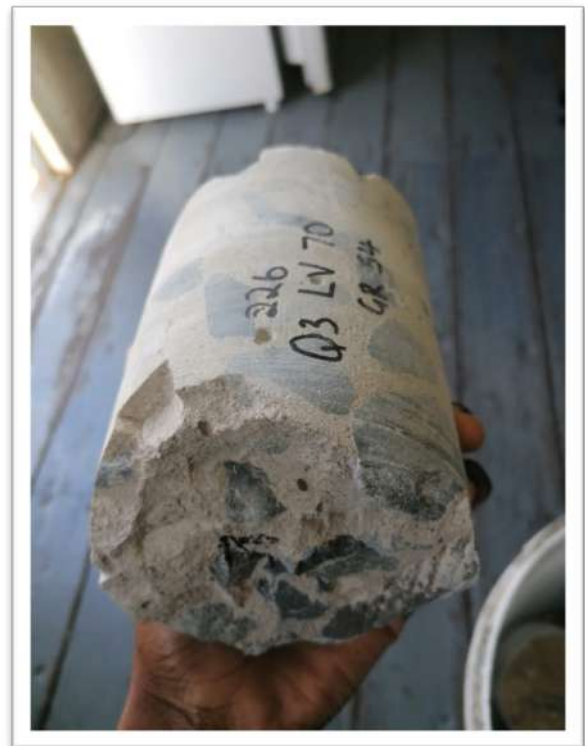
Figure 0-6 Core extracted from Quarter 3 level 70

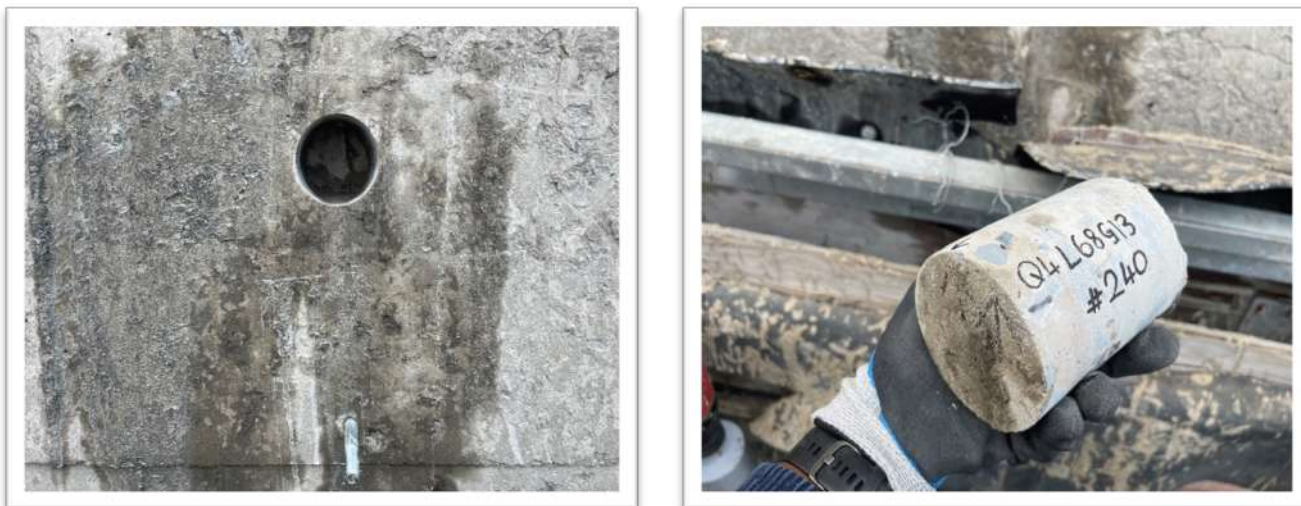
*Figure 0-7 Core extracted from Quarter 4 level 68*
