# **Assessment of the impacts of agricultural activities on surface water and groundwater quality: a case study in the Brits area, North-West Province, South Africa**

Research Report submitted for the partial *Fulfilment* of the degree *Master of Science in Hydrogeology* at the University of the Witwatersrand, Johannesburg.

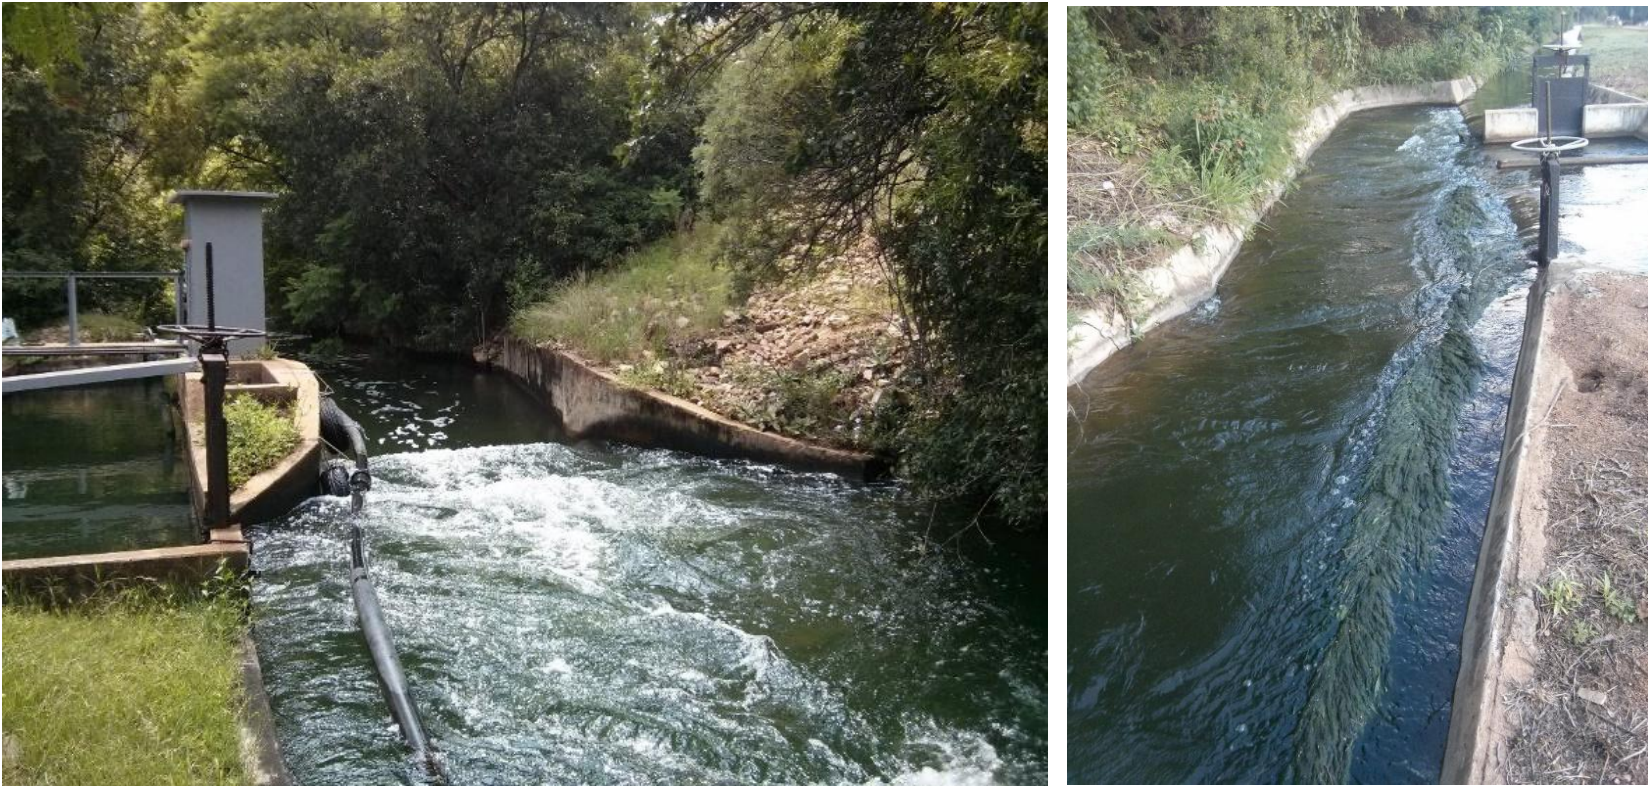
*Figure 4: Distribution of water from the Hartbeespoort Dam through canals. (Source: [www.wateradmin.co.za](http://www.wateradmin.co.za)).*

According to the Water Administration System (WAS) which is an integrated management tool for irrigation schemes that distributes water through a network of canals, pipelines and rivers, the total volume of water allocated for all uses annually from the Hartbeespoort Dam is 99 280 117  $\text{m}^3$ , with 86 249 627  $\text{m}^3$  allocated for irrigation purposes. Each hectare of scheduled irrigation land is allocated 6 200  $\text{m}^3$  of water per year, and the total irrigated area spans 13 911.23 hectares. Most farmers in this area rely on surface water for irrigation; however, some depend on groundwater extractions (Leketa, 2019). Water from the Hartbeespoort Dam is distributed through canals as shown in Figure 4 below.

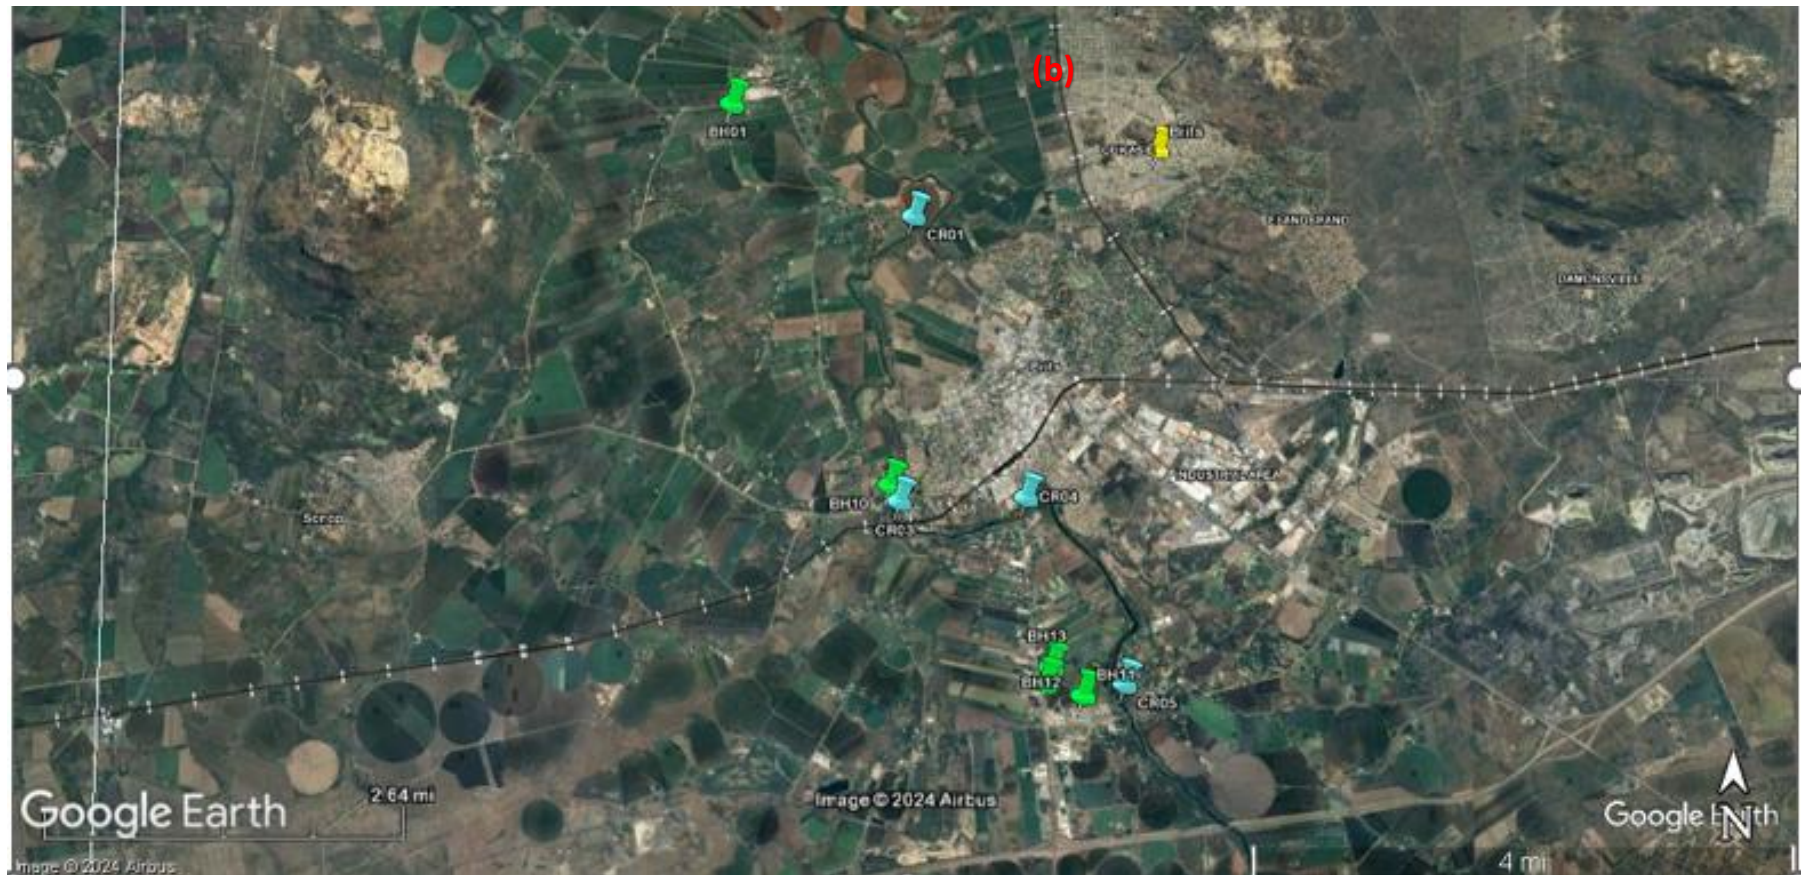
Figure 8: Google Earth image showing sampling locations in the Brits study area. (a) All sampling locations; (b) zoomed-in image of sampling locations showing the dense agricultural landuse around the area.

GPS coordinates for each sampling location were recorded and subsequently plotted using Google Earth (Figure 8a and Figure 8b). A temporal assessment of land use changes, based on satellite imagery on Google Earth, was used in selecting the most appropriate sites to collect samples from (Figure 8b). The green areas visible in both Figure 8a and Figure 8b correspond to agricultural fields that are irrigated by the Hartbeespoort irrigation system, indicating zones of intense agricultural activity. The fields are also located near the Crocodile River, highlighting their potential influence on both surface and groundwater quality.

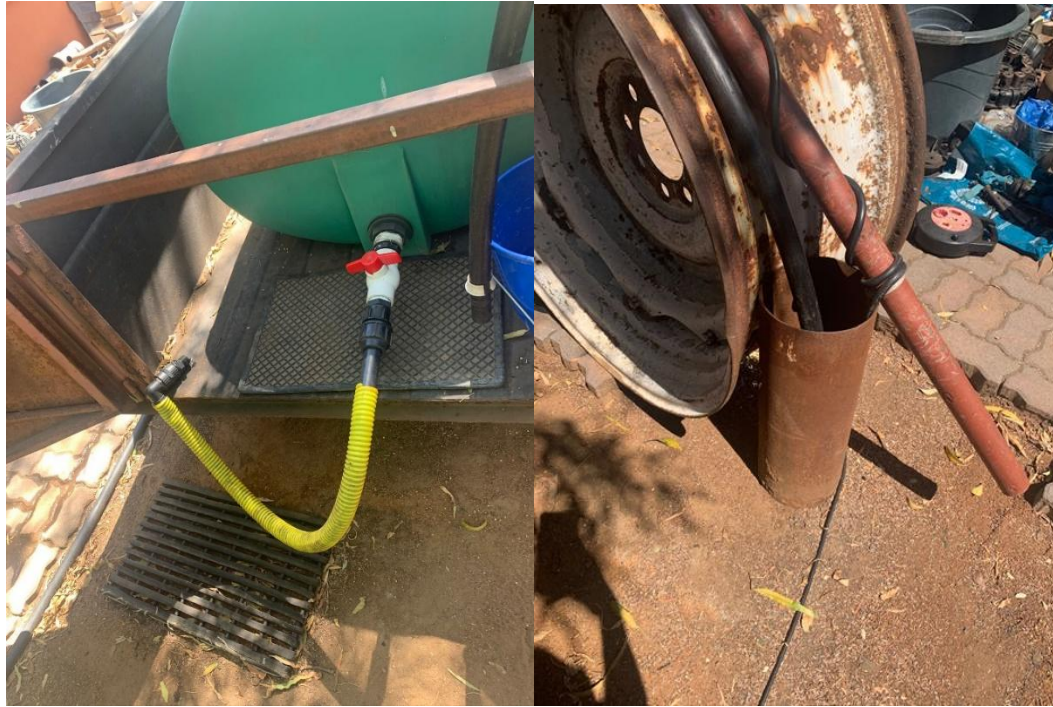
*Figure 9: A picture shown depicts a borehole used for domestic supply with a storage tank.*

Boreholes are drilled into aquifers to access groundwater for household consumption, and storage tanks enable regulated water distribution and ensure availability during periods of high usage (Figure 9).

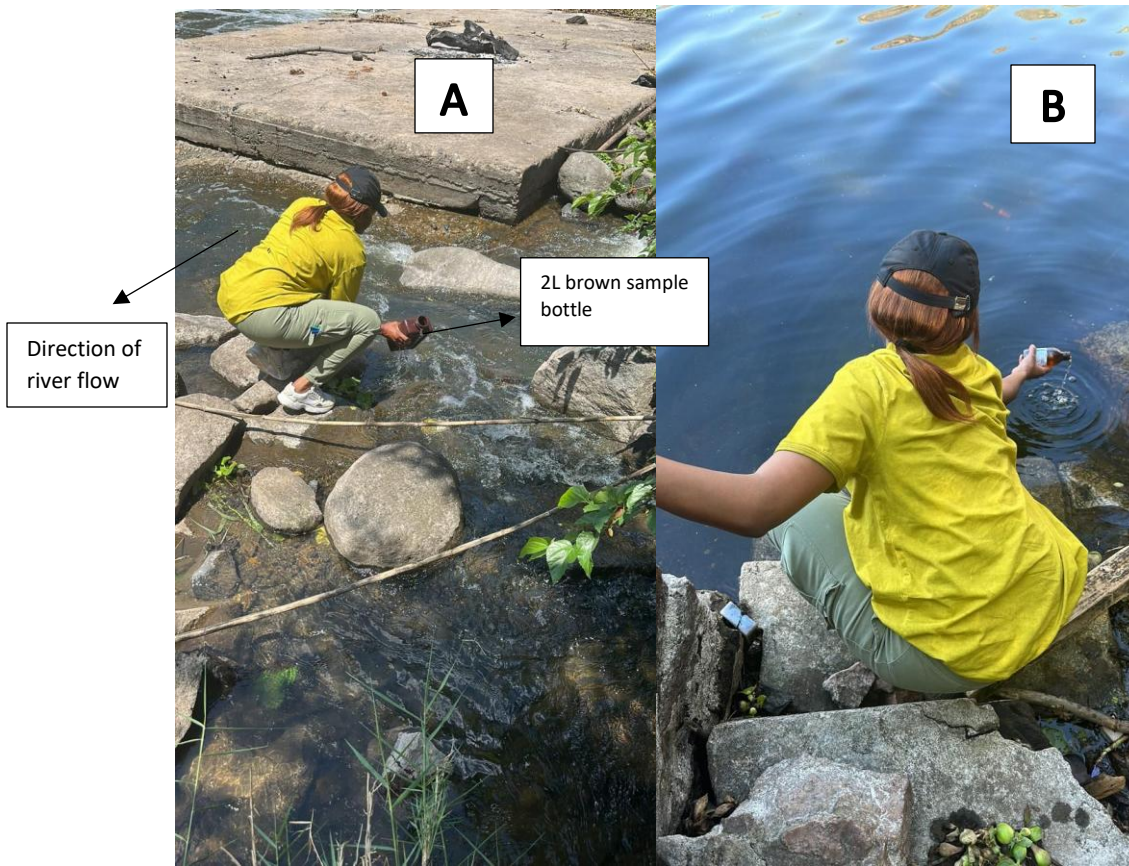
*Figure 10: A picture showing bottle washing of the sample bottles from the Crocodile River (A) and water from the Hartbeespoort dam (B).*

At each sampling site, standard field procedures were followed, including the identification of potential pollution sources, taking a photograph of the site, and a brief written description of the site. Boreholes were pumped for 30 minutes or more before obtaining a sample to eliminate stagnant water from within the casing and to obtain a representative groundwater sample. Sampling bottles were rinsed five times with the sample water before collecting samples to minimise the risk of cross-contamination (Figure 10). For surface water samples, such as rivers and dams, sampling bottles were submerged below the water surface, facing the direction of the flow of water.

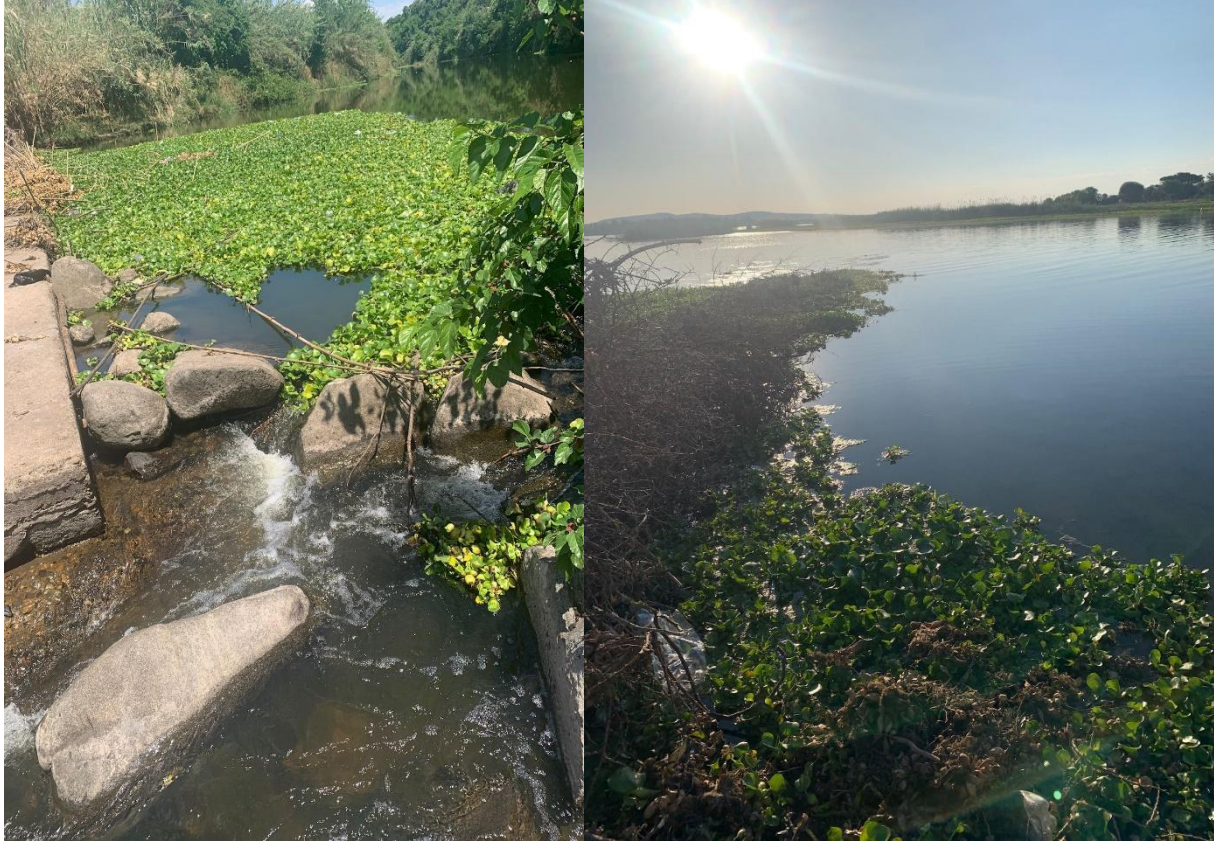
*Figure 11: Pictures showing sampling points from the Crocodile River (A) and Roodekoptjes Dam (B), showing the extent of algal bloom.*

Observations of algal bloom were also recorded where applicable (Figure 11). At each sampling site, two sample bottles were taken, one 2L dark-colored plastic sampling bottle and a 200ml brown, amber sampling bottle to accommodate different analytical requirements.

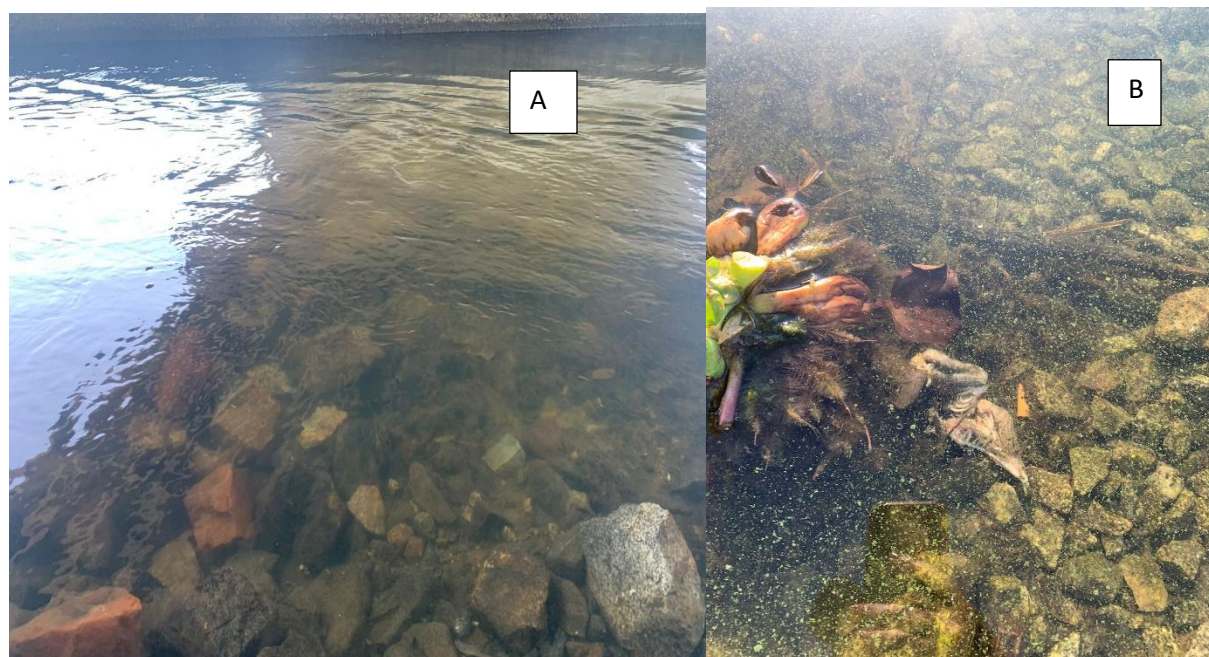
Figure 12: Pictures showing variations in the water quality with (A) clear water in one of the sampling points from the Crocodile River and (B) showing algae residuals in the Roodekoptjes Dam.

The physical condition of the water, including its colour and odour, was recorded during sampling as illustrated in Figure 12. Figure 12A depicts clear water with no visible impurities, whereas Figure 12B shows algal residues exhibiting a greenish colour indicative of algal presence.

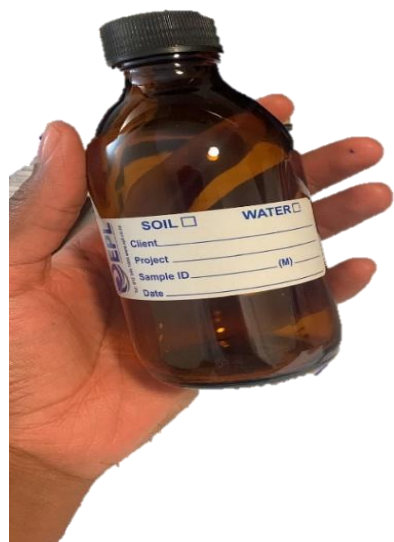
Figure 13: Picture showing the 200ml amber sample bottle with sampling labels

At all sampling sites, sampling bottles were clearly labelled with site name, date, and sample ID as illustrated in Figure 13.

These sampling bottles were filled and tightly capped, and placed in a cooler box full of ice to preserve the samples from degradation. Physical parameters such as pH, temperature and electrical

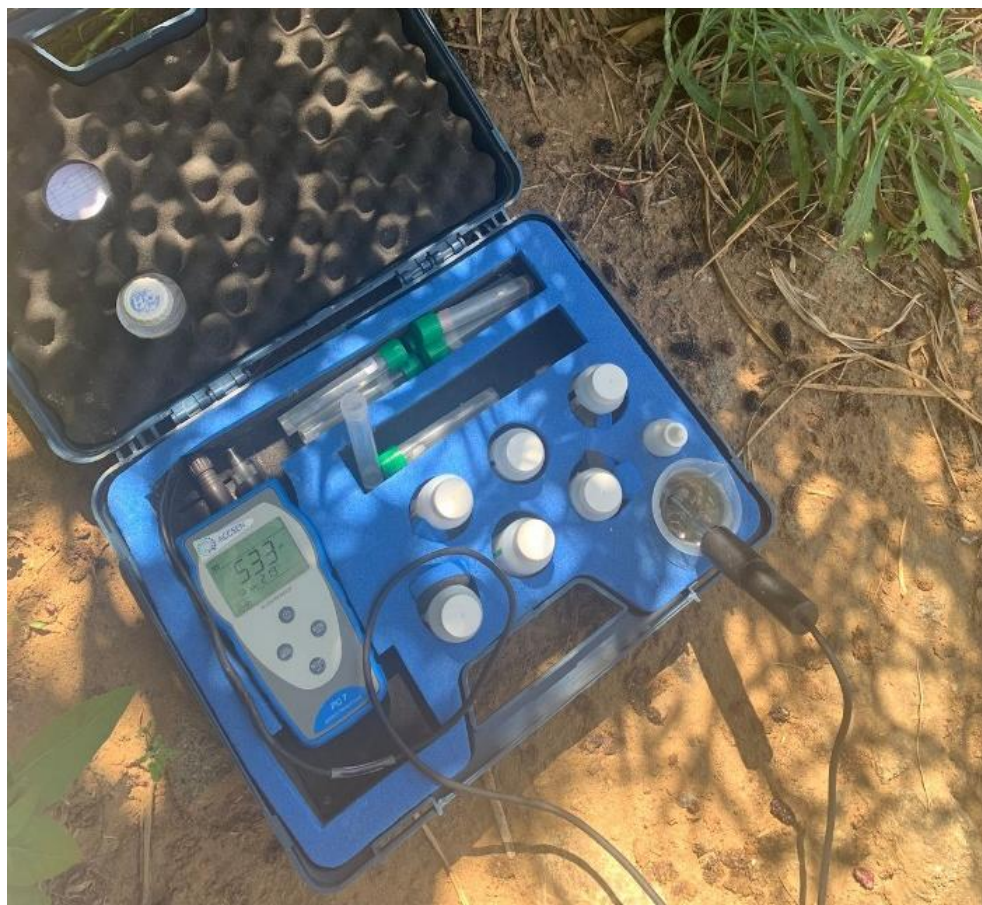
*Figure 14: A photo showing pH, temperature, and electrical conductivity testing on one of the sampling sites.*

conductivity (EC) of the water samples were measured in the field at the time of sample collection by a multiparameter probe (Figure 14). For the reliability of the values read from the multiparameter probe, calibration was also performed on sampling sites.

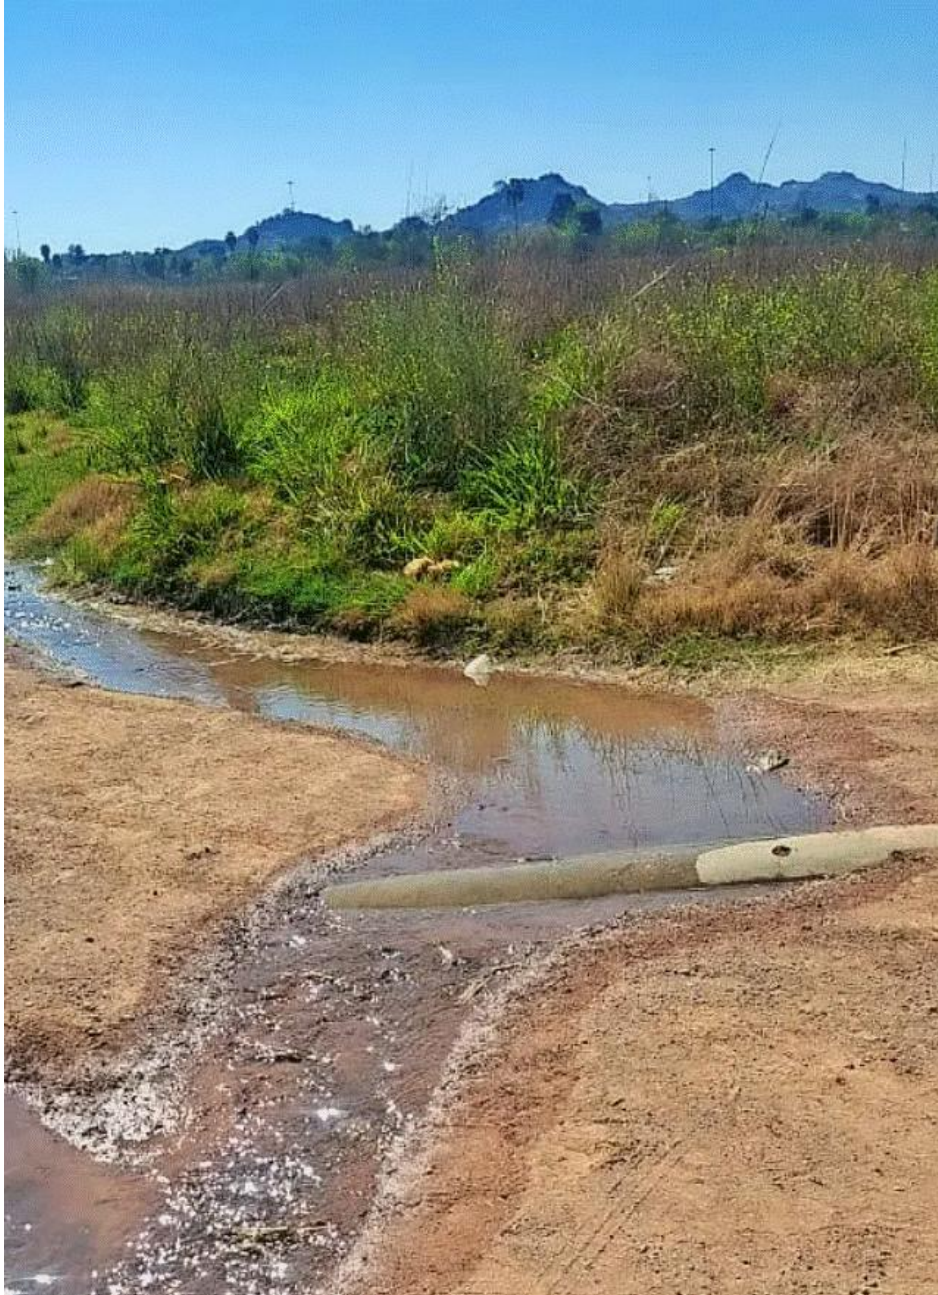
*Figure 20: A picture showing sewage on a farmer's residence (Source: Kormorant, 2024)*
