PERFORMANCE COMPARISON OF EXISTING AC AND DC TRANSMISSION LINES  
WITHIN SOUTHERN AFRICA WITH PREDICTIONS FOR LINES ABOVE 765 KV

A dissertation submitted to the Faculty of Engineering and the Built Environment, University of Witwatersrand, Johannesburg, in partial fulfilment of the requirements for the degree of Master of Science in Engineering.

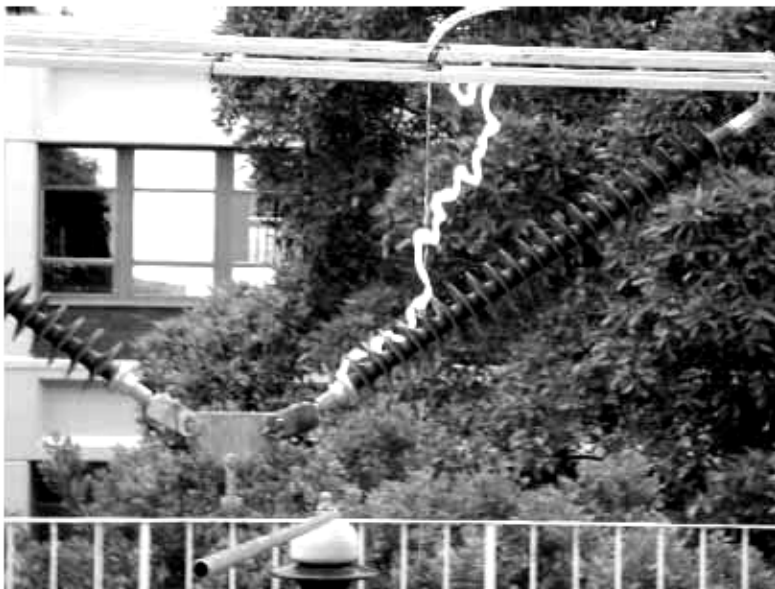
*Figure 3 Bird streamer simulations performed on outdoor insulation system (Vosloo H. F., 2004).*

Faults from bird streamers are generally only found to be caused by larger birds such as vultures and Blue Herons. Occurrence of these faults has been found to peak around 06H00 and 22H00 when there is high level of bird activity and also an increase towards the late summer months when the bird populations reach a maximum (Vosloo H. F., 2004). In order for a fault of this type to occur, it is not necessary that the streamer bridges the entire gap but rather creates a bridge sufficiently long enough for the breakdown strength of the air gap to be exceeded. The state owned utility, Eskom, has performed many insulator tests simulating bird streamer scenarios in order to understand the effect that bird streamers have on the line and also the possible mitigation methods as will be discussed later on (Naidoo, et al, 2006). Figure 3 below shows a laboratory setup used to simulate bird streamer faults on outdoor insulation using an egg yolk and soap solution (Vosloo H. F., 2004).
